# Wood Cove Park HOA

## Level 2 Reserve Study

Type of Study	Update w/Site Visit
Date of Property Inspection	10/30/2017
Prepared By	Dale Gifford
Analysis Method	Cash Flow
Funding Goal	Full Funding

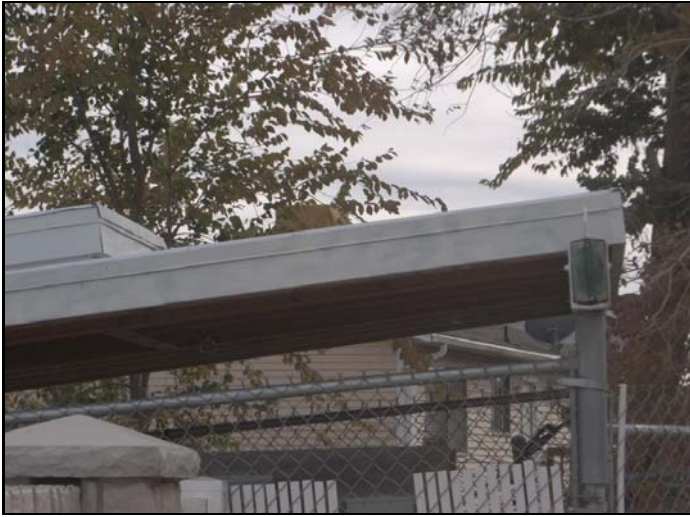
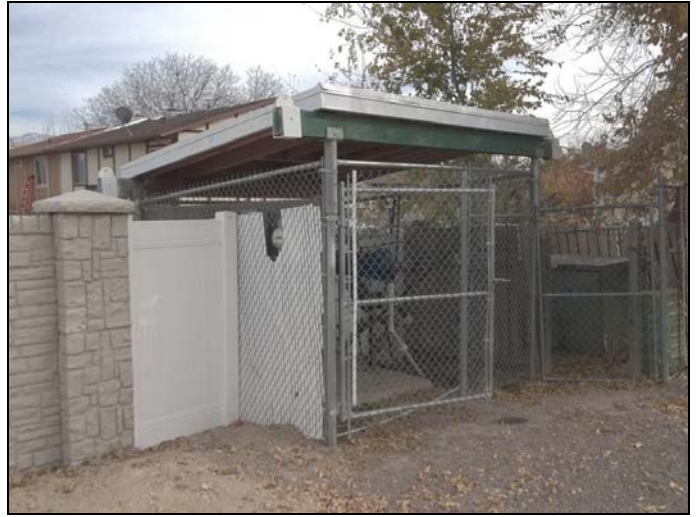
Comp #: 104 Pump Enclosure Roof - Replace

The roof are in good condition. We recommend funding to replace this component approximately every 15 - 20 years. Remaining life based on current age.

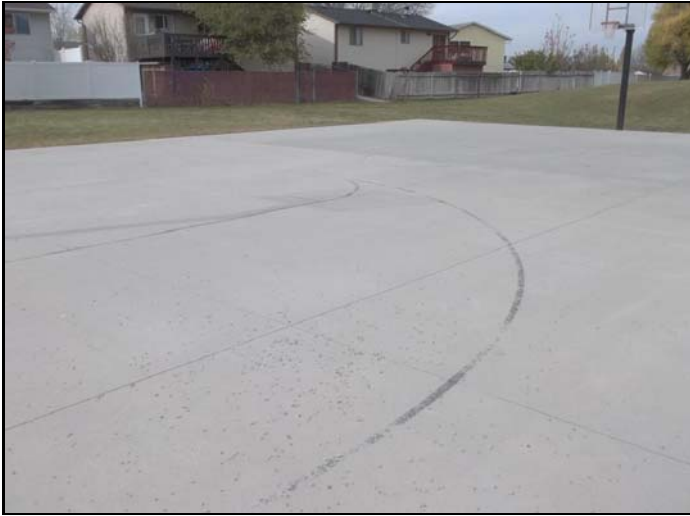
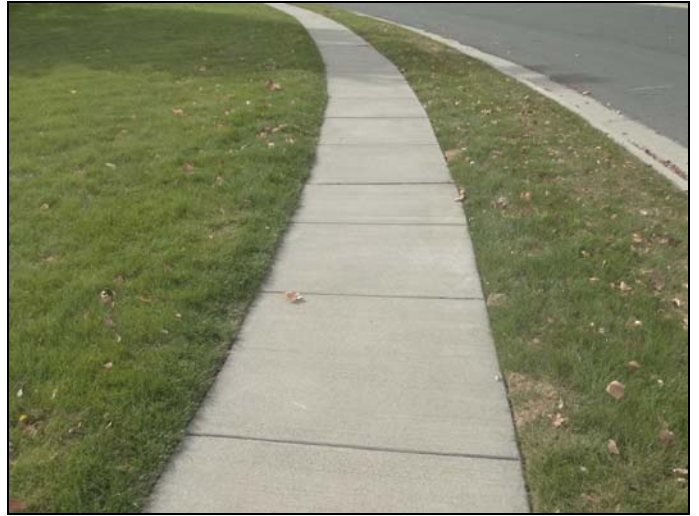
Comp #: 403 Concrete - Repair/Replace

The concrete is generally in good condition. We recommend funding to make repairs and partially replace this component approximately every 10 years. Remaining life based on current age.

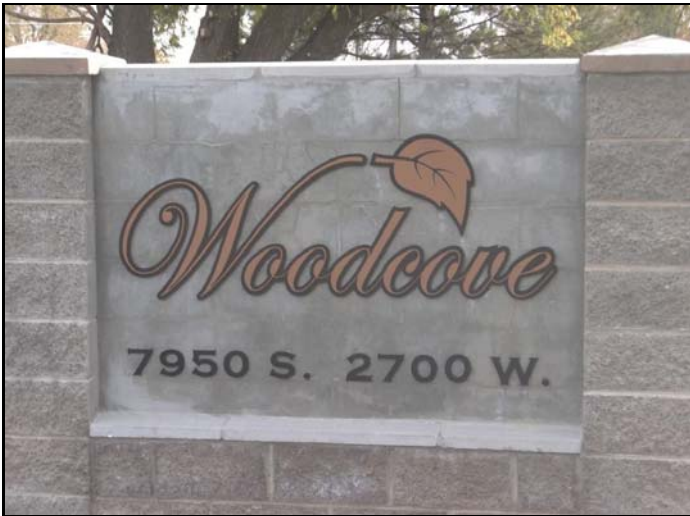
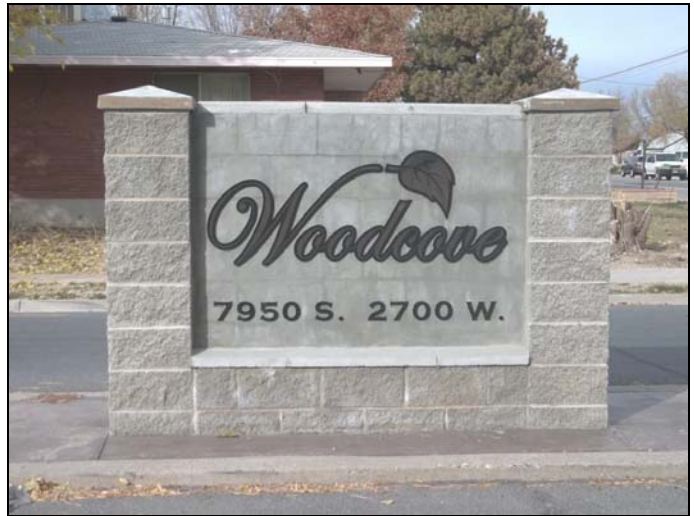
Comp #: 801 Monument Sign - Refurbish

The monument sign is in good condition. We recommend refurbishing the sign approximately every 18 years to ensure appearance and to keep up with current decorative tastes. Remaining life is based on current age.

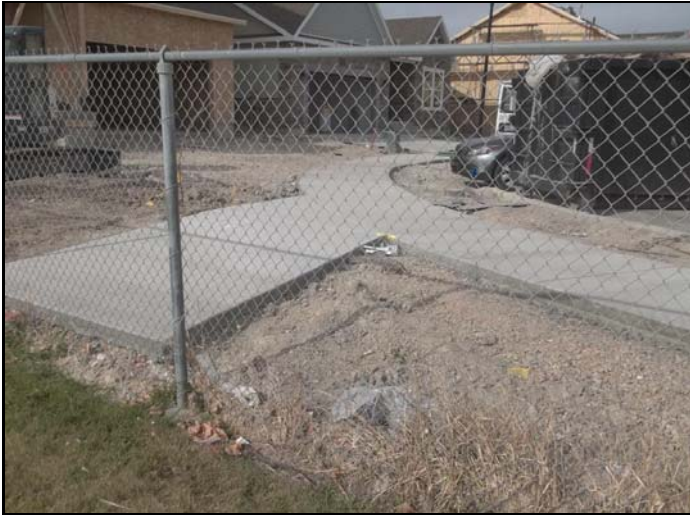
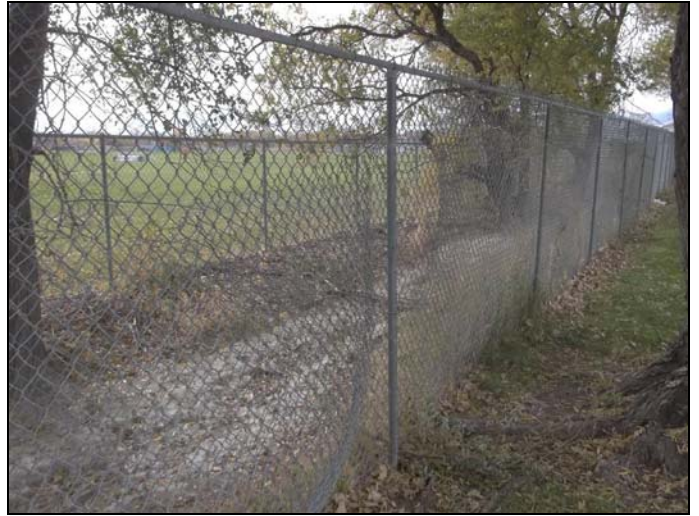
Comp #: 1003 Chain Link Fencing - Replace

The chain link fencing is in generally in good to fair condition. We recommend funding to replace this component approximately every 30 - 40 years. Remaining life based on current age.

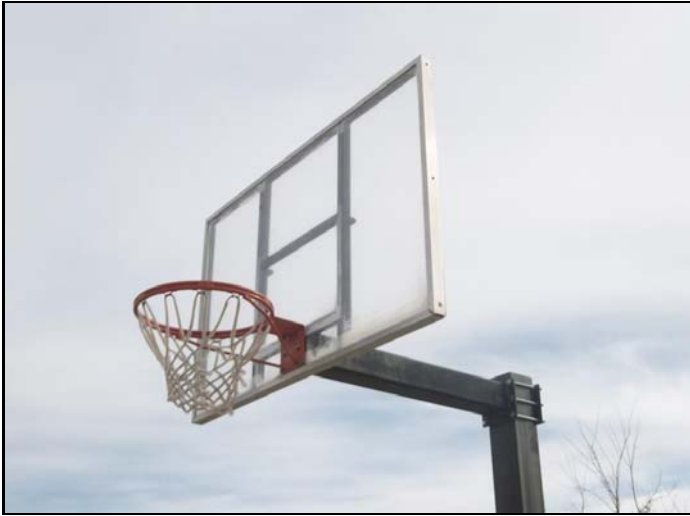
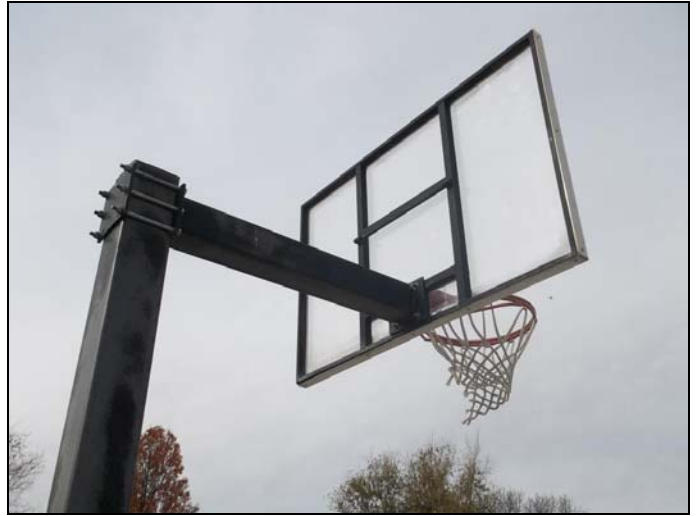
Comp #: 1207 Basketball Equipment - Replace

The basketball equipment is in fair condition. We recommend funding to replace this component approximately every 10 - 12 years. Remaining life is based on current age.

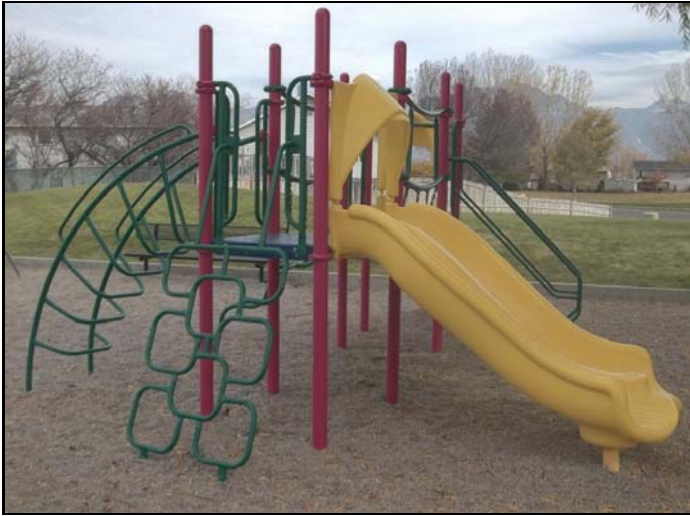
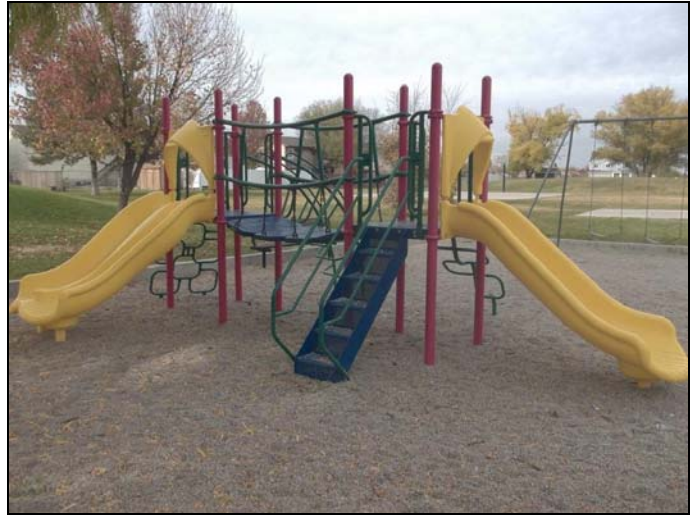
Comp #: 1301 Play Structure - NW Park - Replace

The play structure is in good condition. We recommend funding to replace this component approximately every 20 - 25 years. Remaining life based on current age.

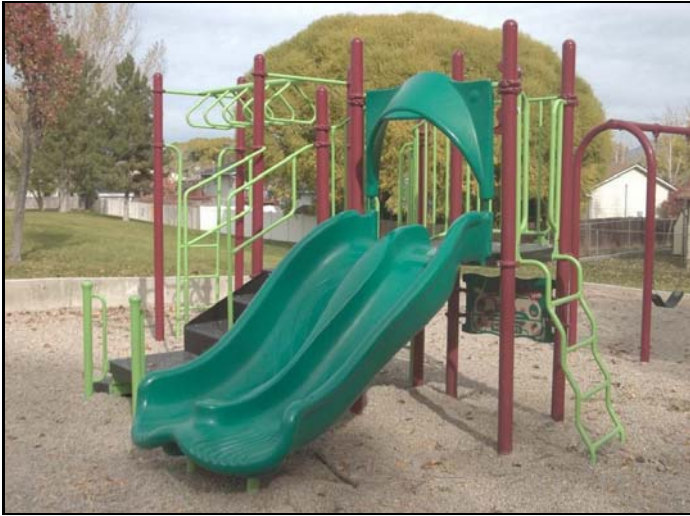
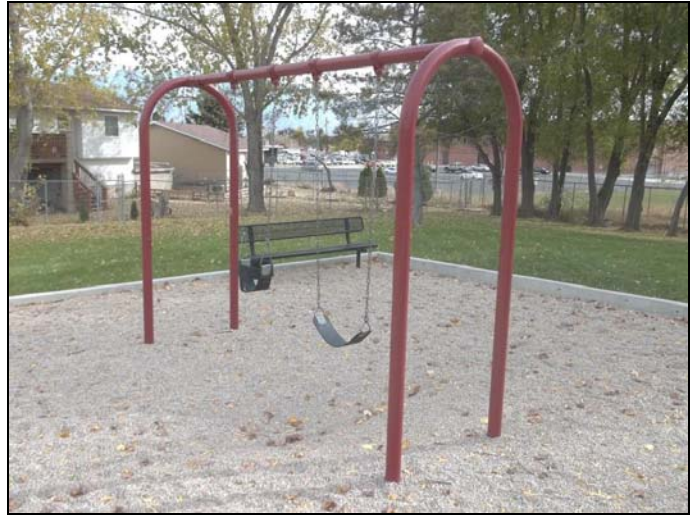
Comp #: 1301 Play Structures - NE & SW Parks - Replace

The play structures are in good condition. We recommend funding to replace this component approximately every 20 - 25 years. Remaining life based on current age.

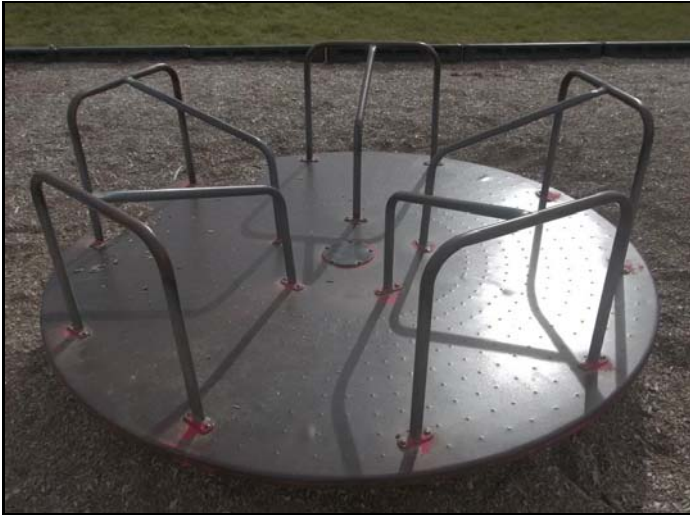
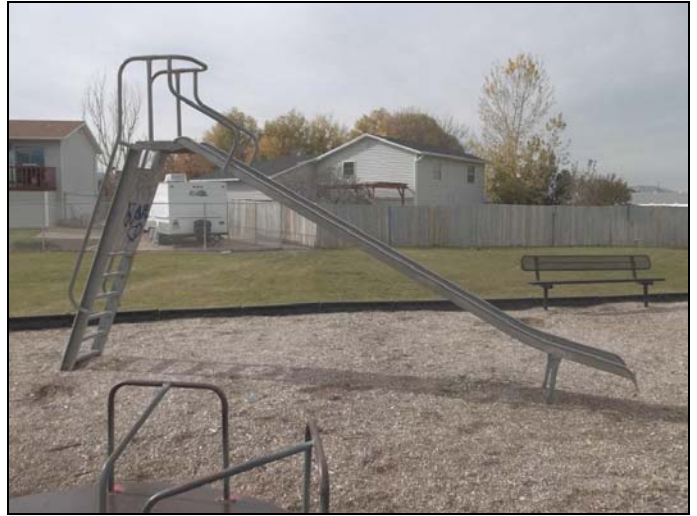
Comp #: 1301 Play Structures - Replace

The play structures are older and in poor shape. Safety issues found and against CPSC code. We recommend funding to replace this component approximately every 20 - 25 years. Remaining life based on current condition.

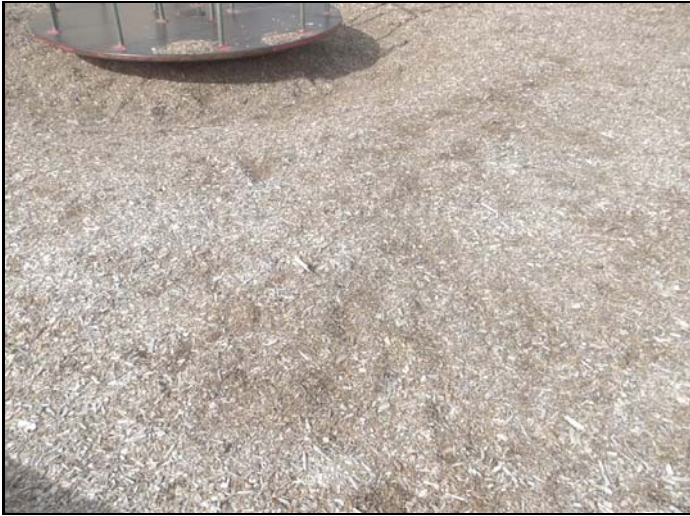
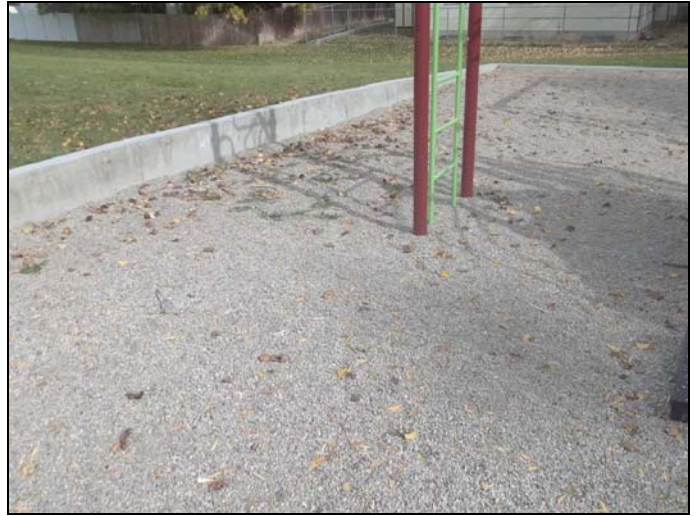
Comp #: 1303 Play Area Groundcover - Refill

The play area groundcover is in fair condition. We recommend funding to refill this component approximately every 3 - 5 years to maintain appearance and ensure proper function as a safety component. Recommend 10-14 inches for fall safety cushion. Remaining life is based on current age.

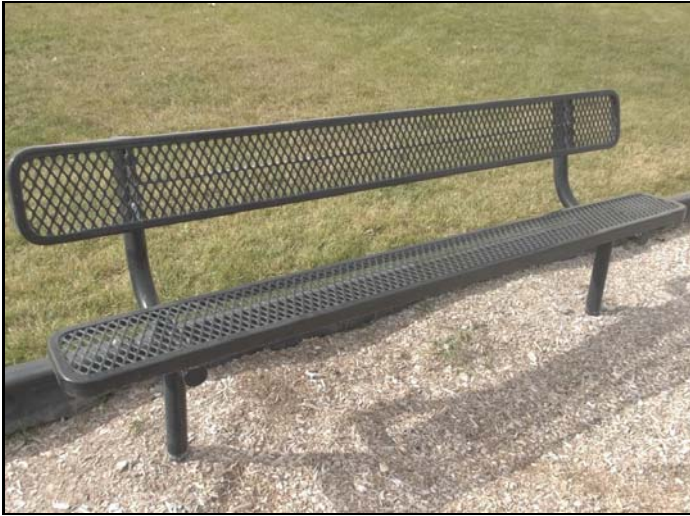
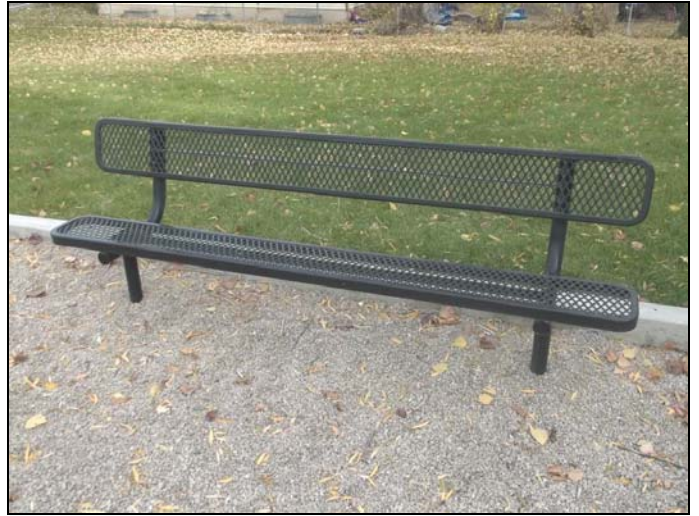
Comp #: 1307 Benches - Replace

The benches are in good condition. We recommend funding to replace this component approximately every 10 - 15 years. Remaining life based on current age.

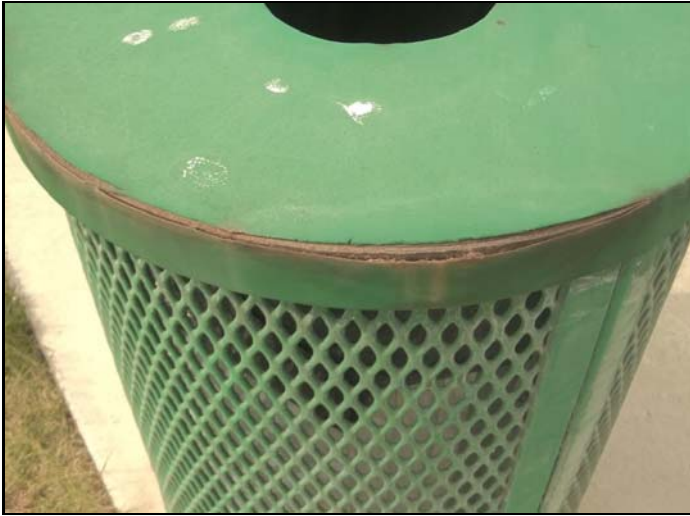
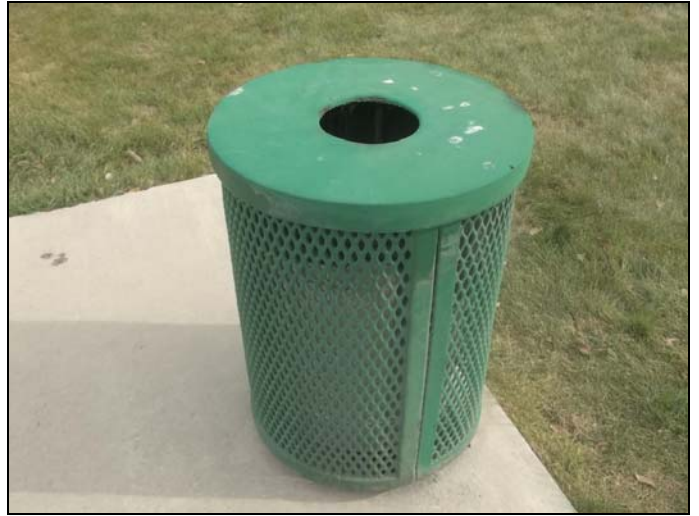
Comp #: 1308 Trash Receptacle - Replace

The trash receptacles are in poor condition. We recommend funding to replace this component approximately every 10 - 12 years. Bare metal and rust showing. Sharp edges also visible in lower parts. Remaining life based on current condition.

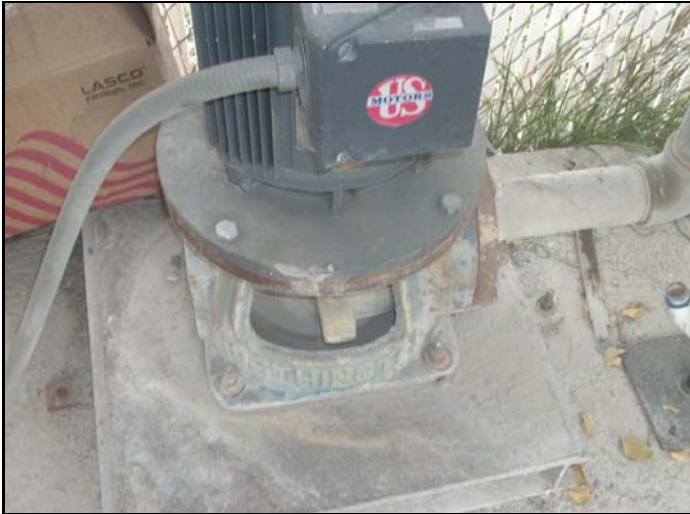
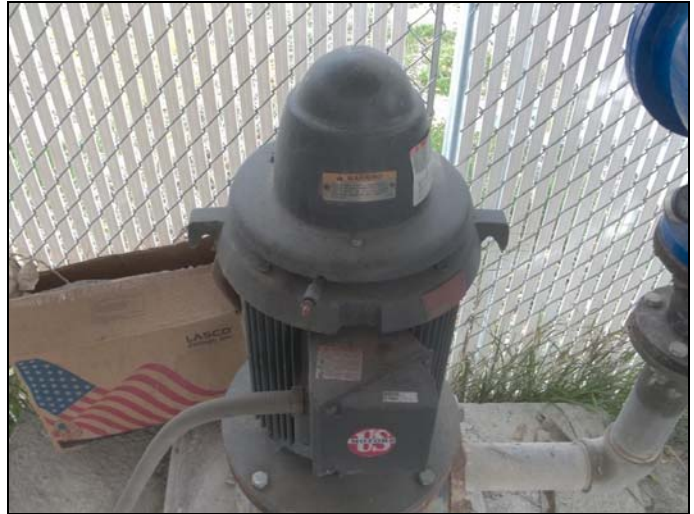
Comp #: 1705 Irrigation Pump - Replace

The pump is in working condition. We recommend funding to replace this component approximately every 10 - 15 years. Remaining life based on current age.

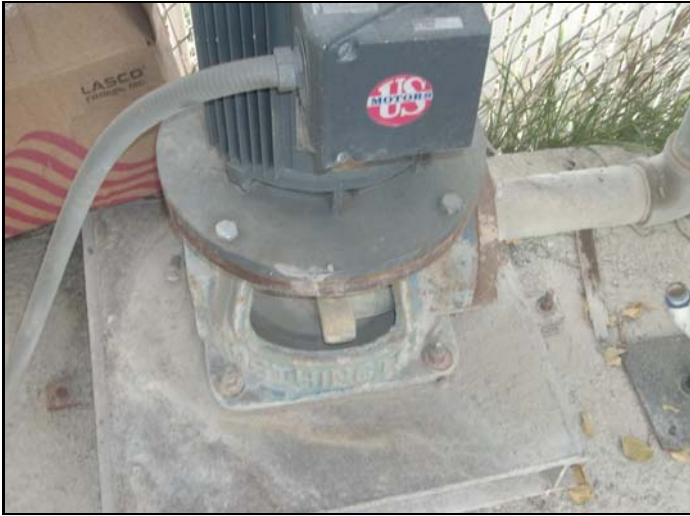
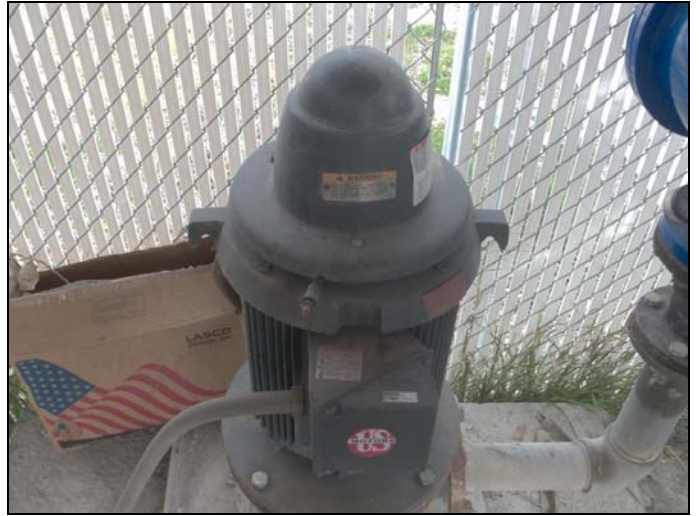
Comp #: 1706 Pump Shaft Propeller - Replace

The pump is in working condition. We recommend funding to replace this component approximately every 20 years. Remaining life based on current age. Client states DTM Services recommends replacement/rebuild of shaft immediately.

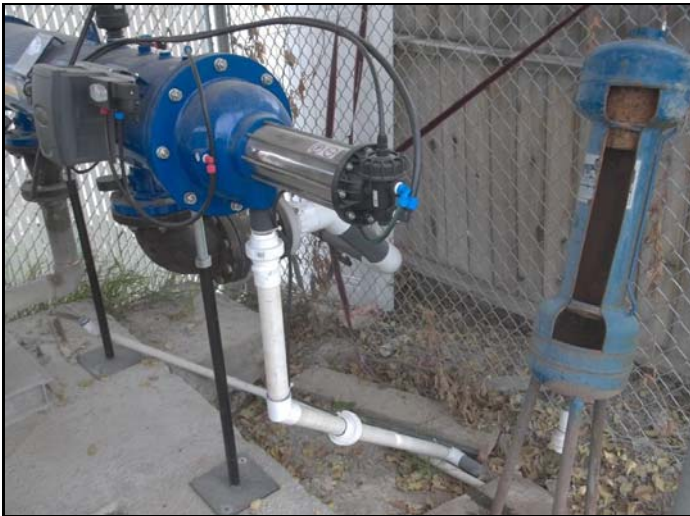
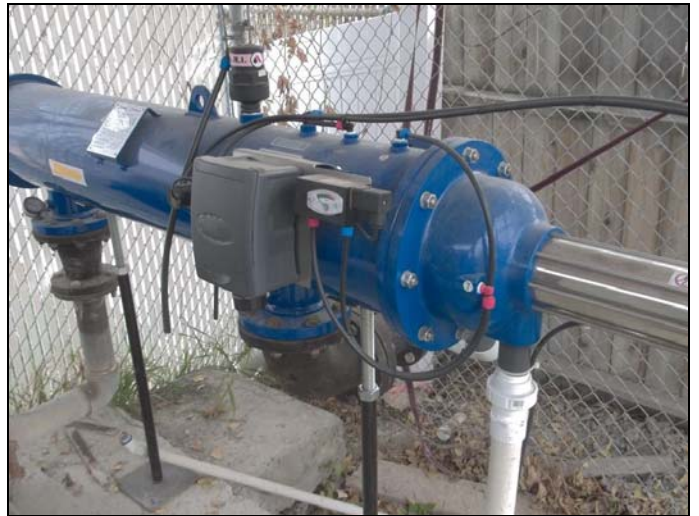
Comp #: 1790 Irrigation Filter System - Replace

The irrigation filter system is in working condition. We recommend funding to replace this component approximately every 15 - 20 years. Remaining life based on current age.

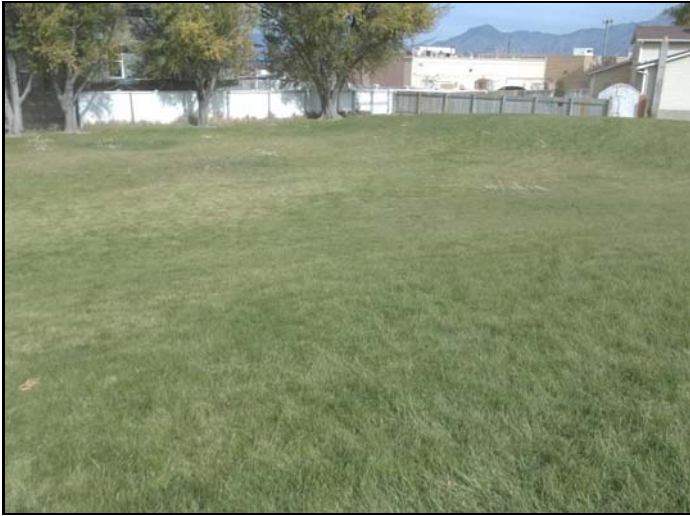
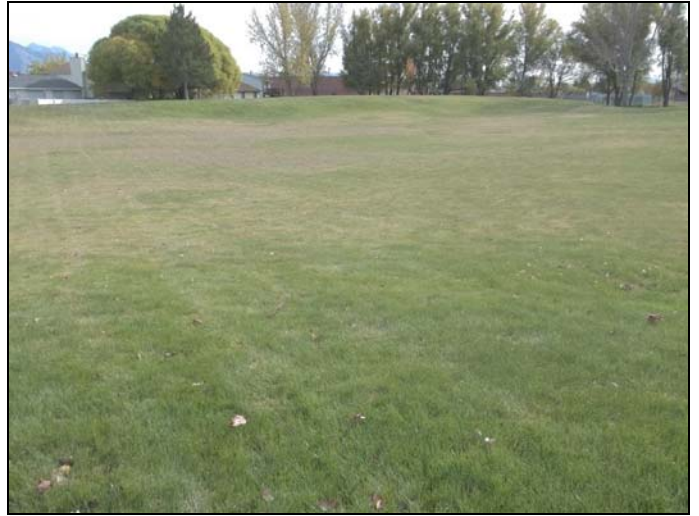
Comp #: 1812 Landscaping - Renovate

The landscaping and irrigation system are in good condition. We recommend funding for an allowance to renovate the landscaping and irrigation system approximately every 20 years. Remaining life based on current age.

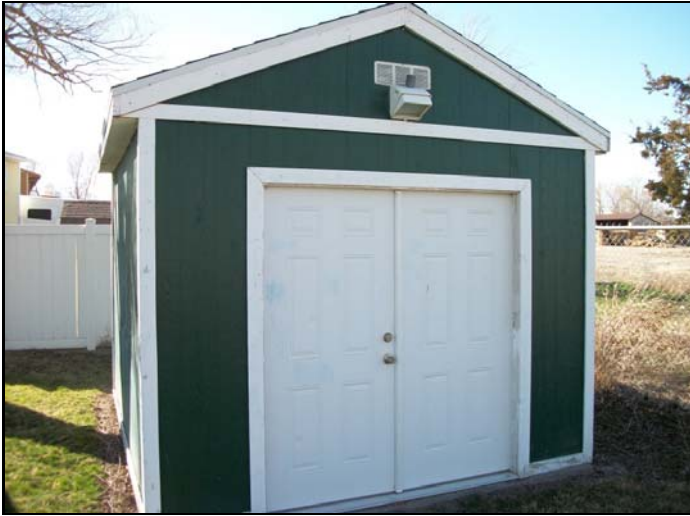
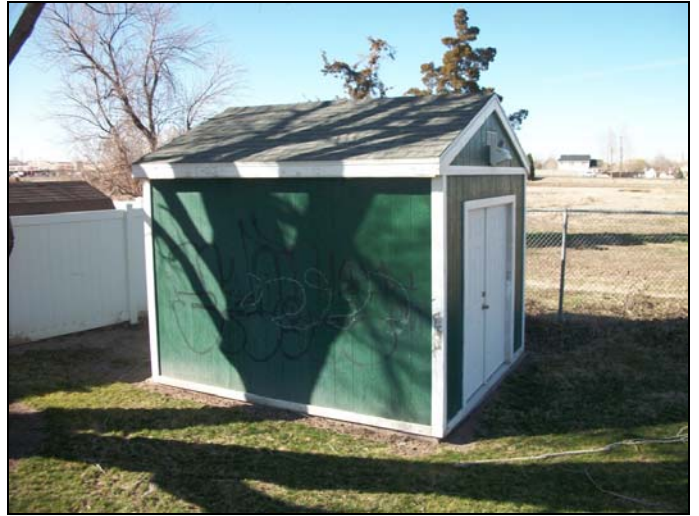
Comp #: 2301 Storage Shed - Replace

The shed is in fair condition. Repaint this component as necessary as an operating expense. We recommend funding to replace this component approximately every 15 - 20 years. Remaining life is based on current age.
