# Wood Cove Park HOA

## Level 2 Reserve Study

**Report Period – 10/01/2023 – 9/30/2024**

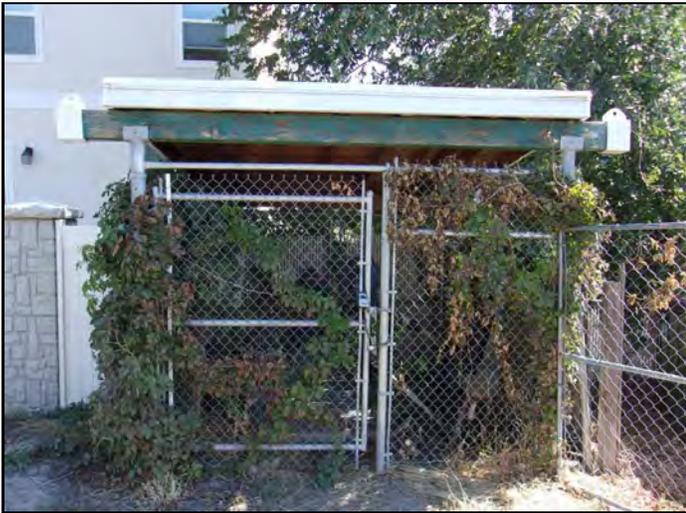
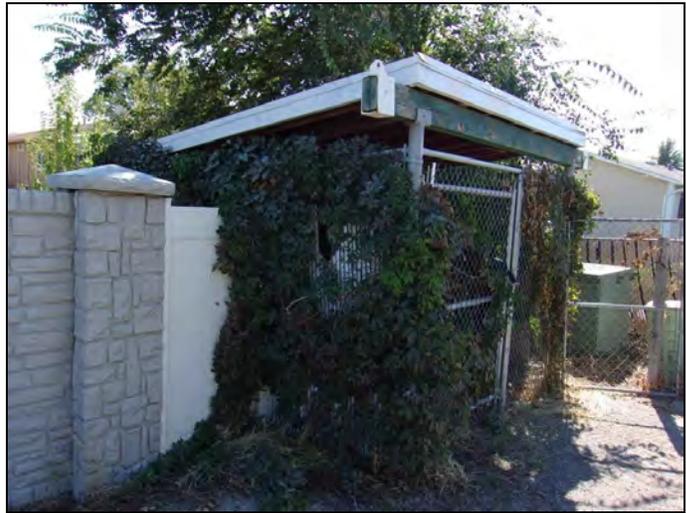
Comp #: 104 Pump Enclosure Roof - Replace

*Location:* Pump Enclosure Roof NW Corner

Due to the minimal cost to replace this component, reserve funding is not appropriate. Replace as necessary as an operating expense. No reserve funding necessary.

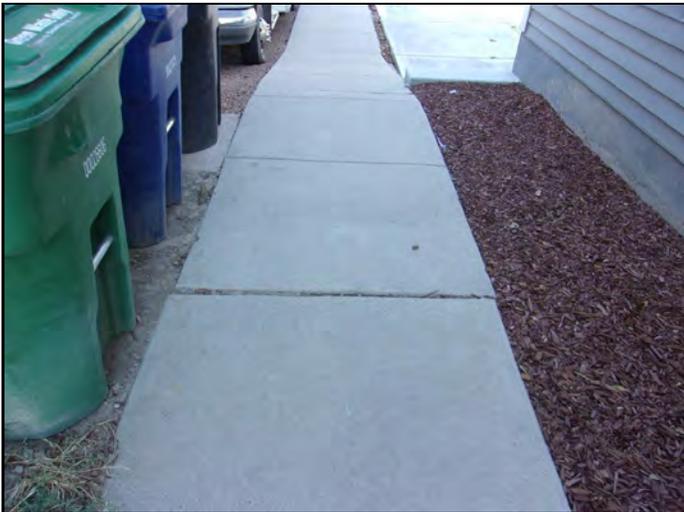
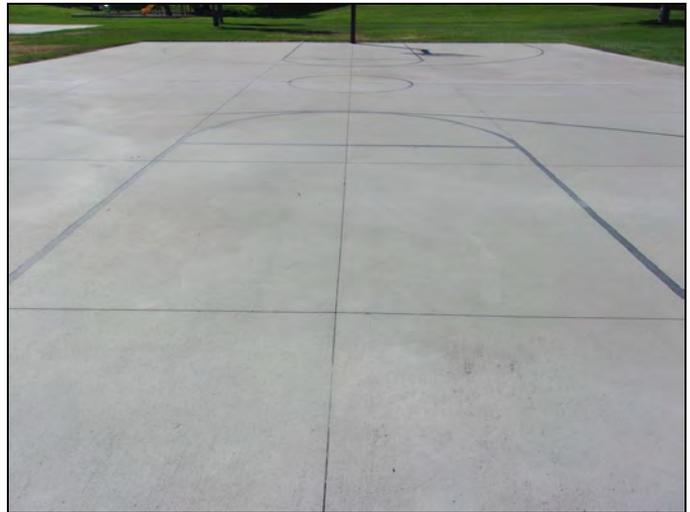
Comp #: 403 Concrete - Repair/Replace

*Location:* **Common Areas**

The concrete is in good condition. This component has an extended useful life under normal conditions. We recommend funding to make repairs and partially replace this component approximately every 10 years. Remaining life based on current age.

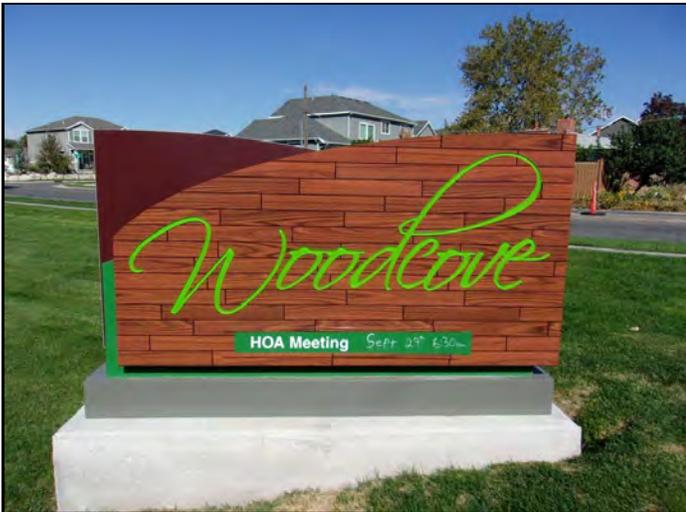
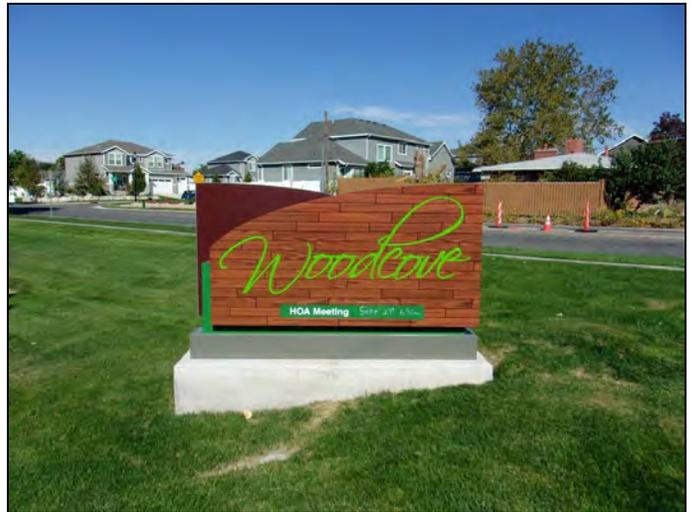
Comp #: 801 Monument Sign - Replace

*Location:* **Community Entrance**

The monument sign is in good condition. We recommend funding to replace this component approximately every 20 - 30 years. Remaining life is based on current age.

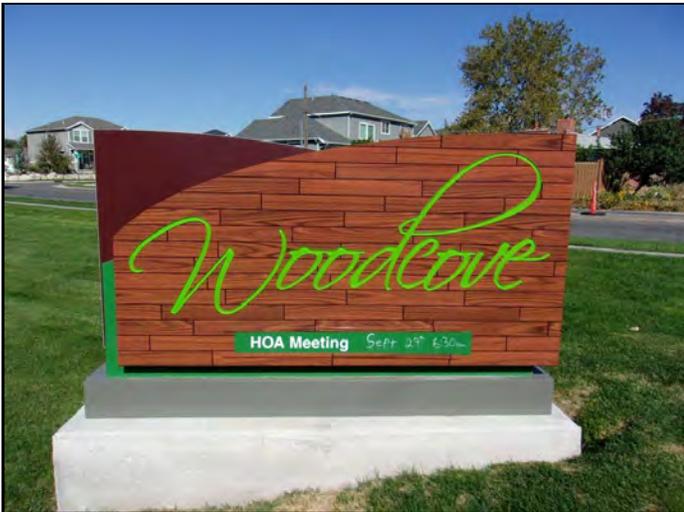
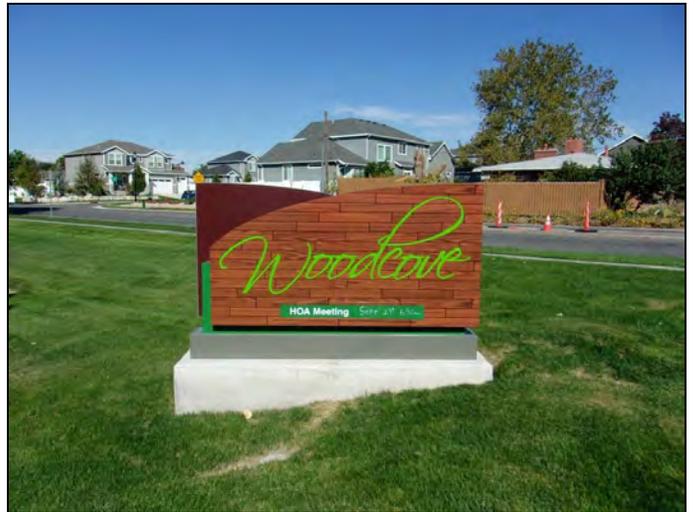
Comp #: 802 Monument Sign - Refurbish

*Location:* **Community Entrance**

The monument sign is in good condition. We recommend funding to refurbish this component approximately every 8 - 10 years. Remaining life is based on current age.

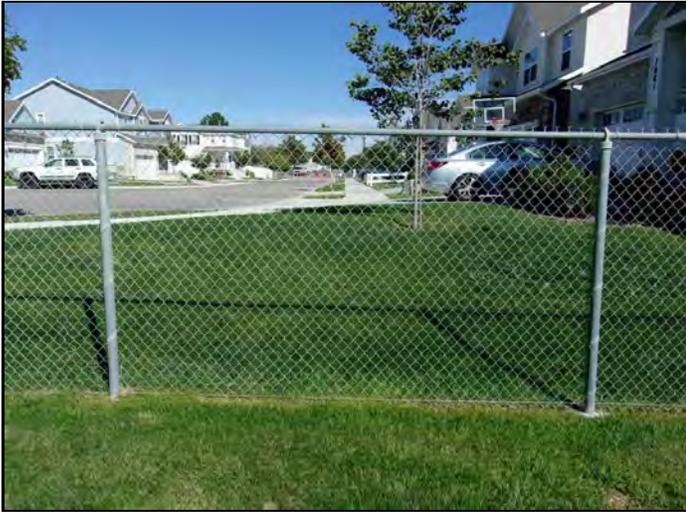
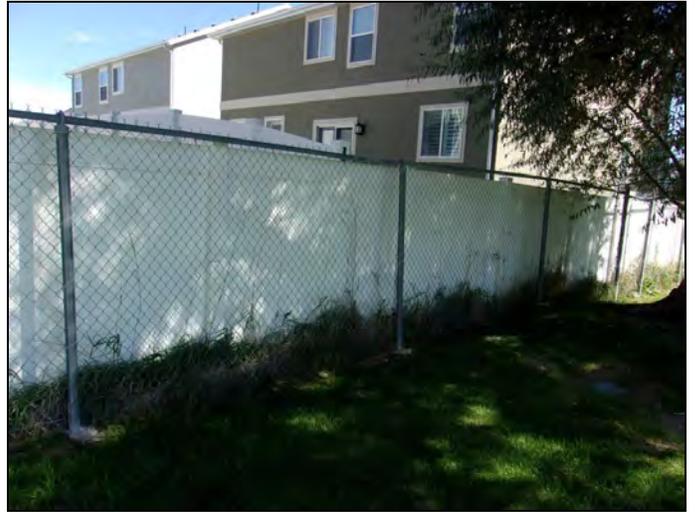
Comp #: 1003 Chain Link Fencing - Replace

*Location:* **Community Perimeter**

The chain link fencing is generally in good to fair condition. We recommend funding to replace this component approximately every 30 - 40 years. Remaining life based on current age and condition.

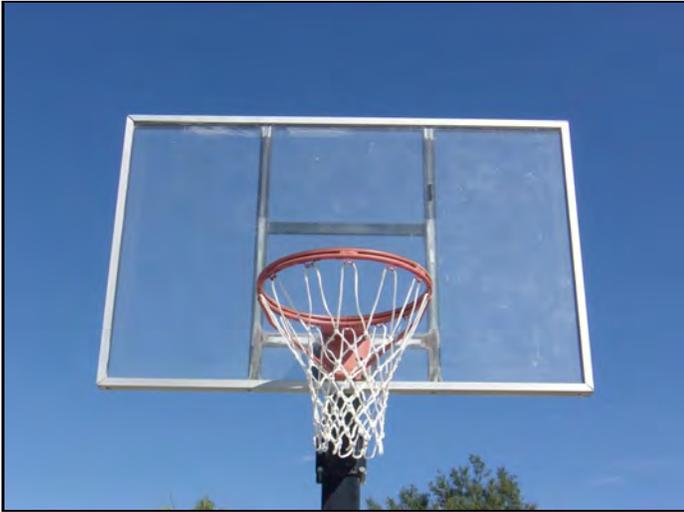
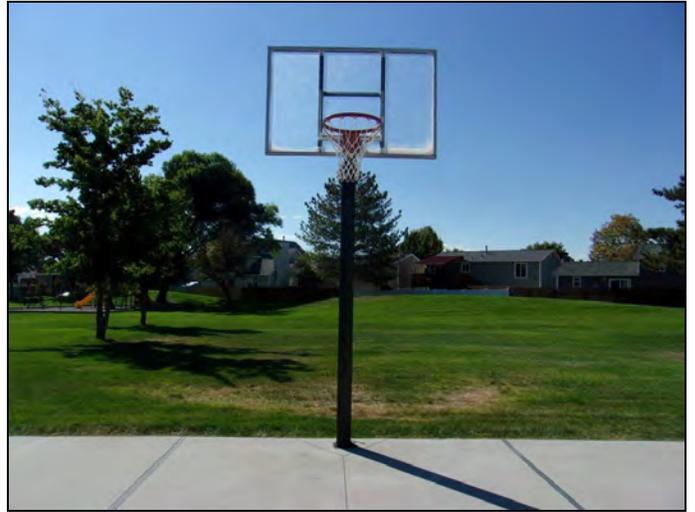
Comp #: 1207 Basketball Equipment - Replace

*Location:* **NW Community Park**

The basketball equipment is in fair condition. We recommend funding to replace this component approximately every 10 - 15 years. Remaining life is based on current age and condition.

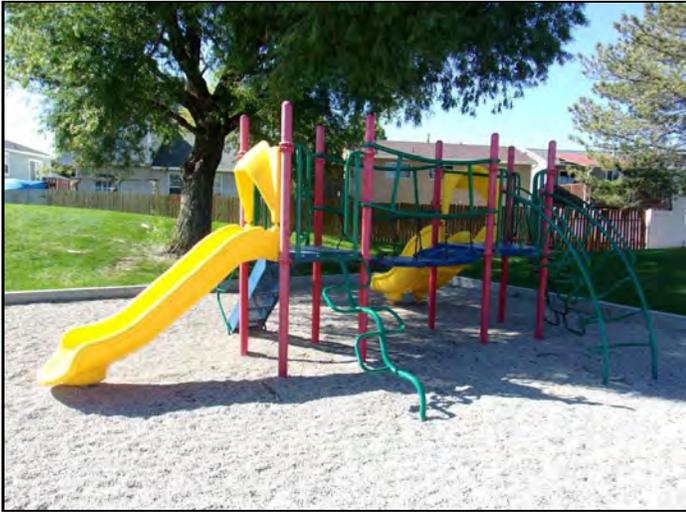
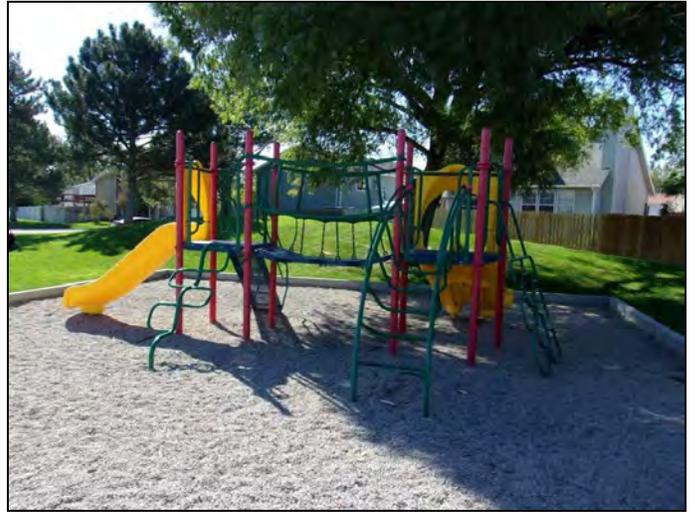
Comp #: 1301 Play Structure - NW Park - Replace

*Location:* **NW Community Park**

The play structure is in fair condition. We recommend funding to replace this component approximately every 20 - 25 years. Remaining life based on current age.

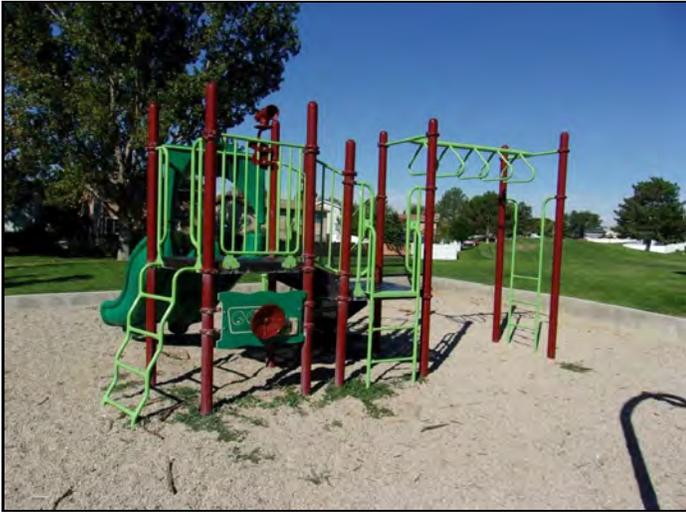
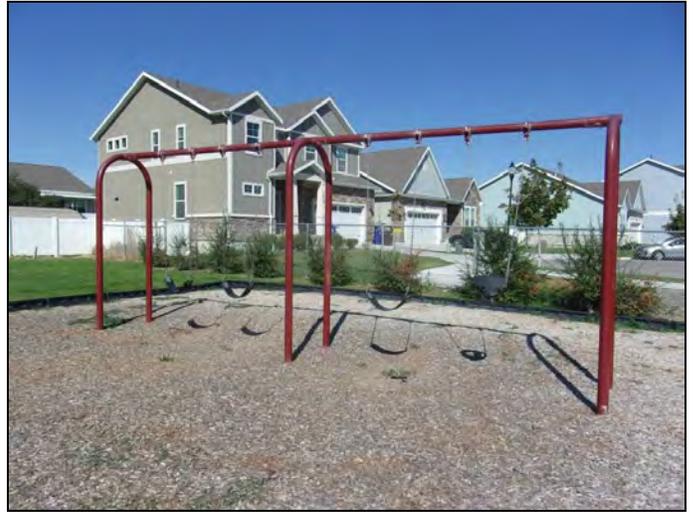
Comp #: 1301 Play Structures - NE & SW Parks - Replace

*Location:* **Community Parks**

The play structure is in good to fair condition. We recommend funding to replace this component approximately every 20 - 25 years. Remaining life based on current age.

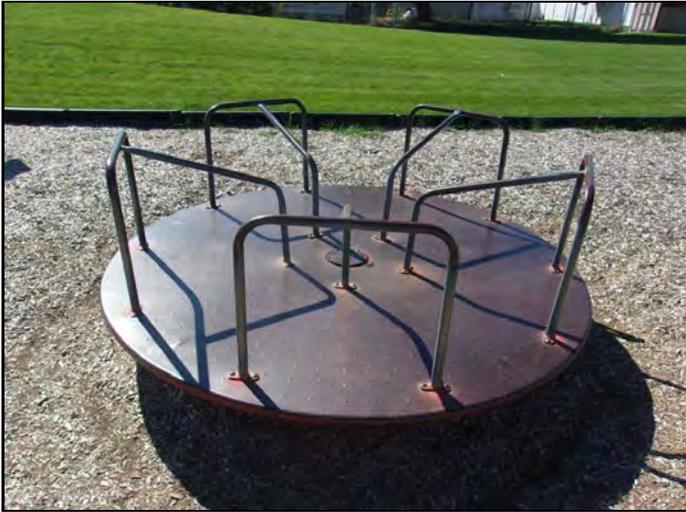
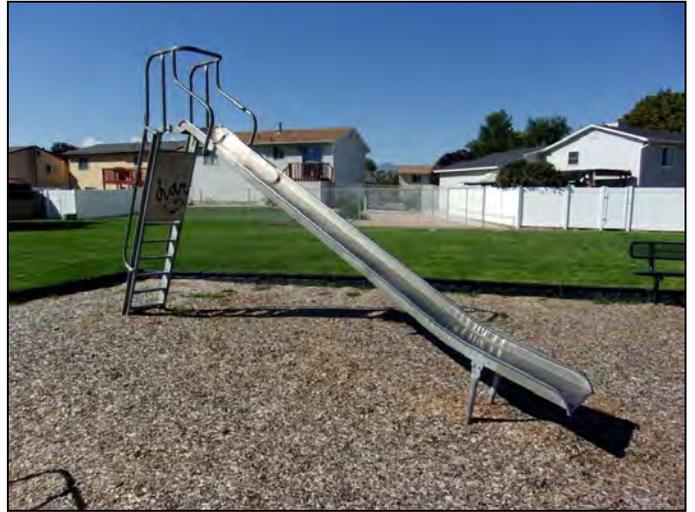
Comp #: 1301 Play Structures - Replace

*Location:* **Community Parks**

The play structures are older but still in functional condition. We recommend funding to replace this component approximately every 20 - 25 years. Remaining life based on current age and condition.

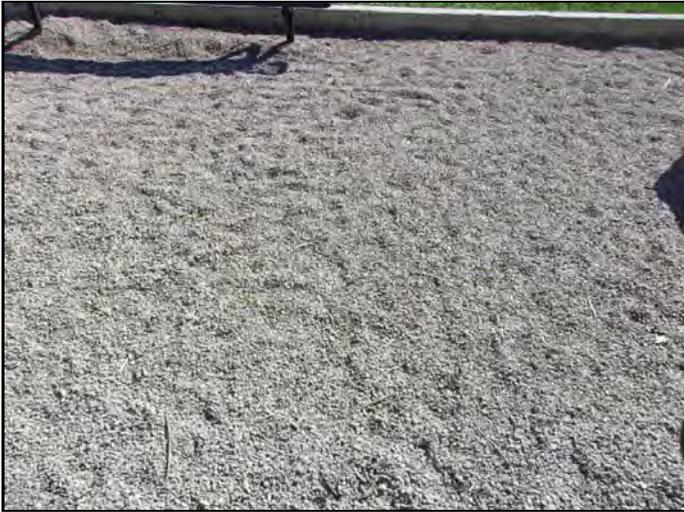
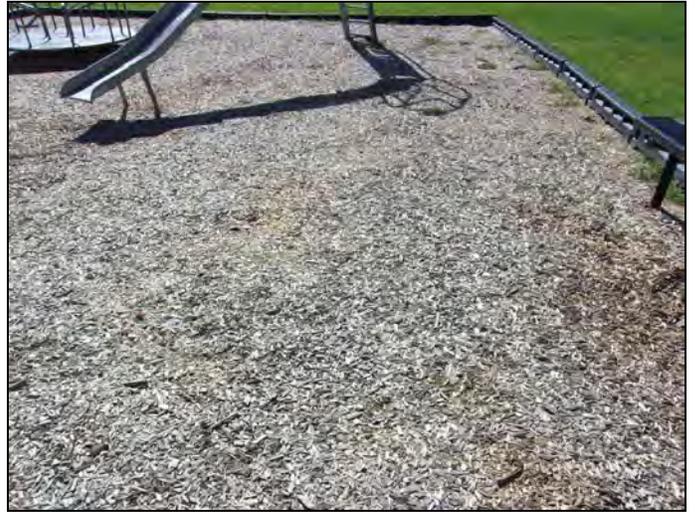
Comp #: 1303 Play Area Groundcover - Refill

*Location:* **Community Play Areas**

The play area groundcover is in fair condition. We recommend funding to refill this component approximately every 3 - 5 years. Remaining life is based on current age.

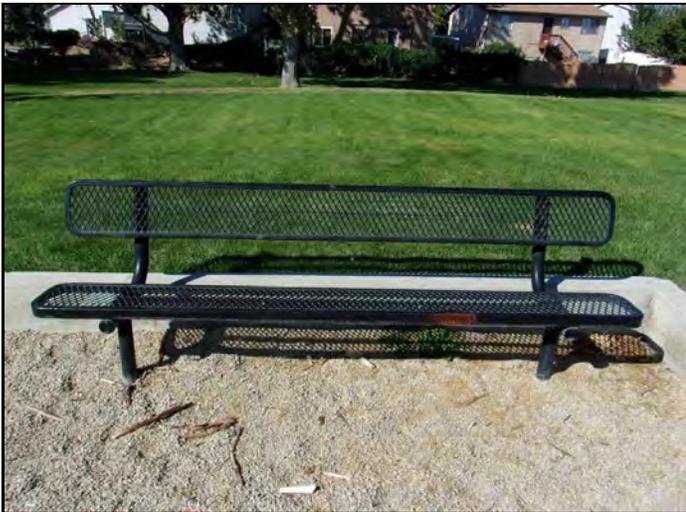
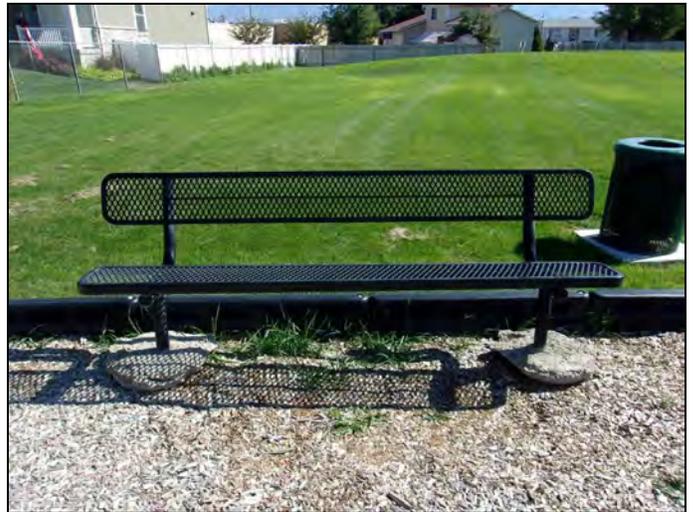
Comp #: 1307 Benches - Replace

*Location:* **Community Playgrounds**

The benches are in fair condition. We recommend funding to replace this component approximately every 10 - 15 years. Remaining life based on current age.

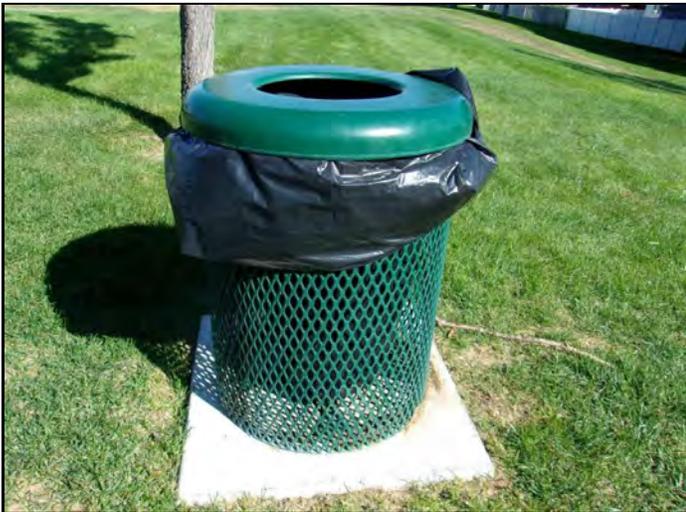
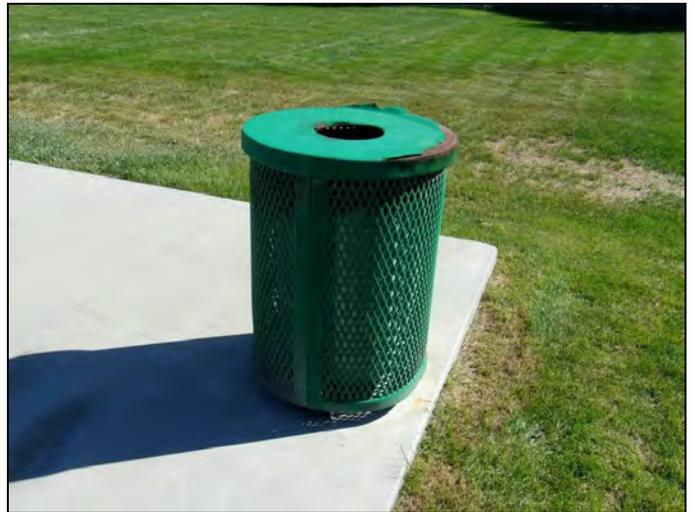
Comp #: 1308 Trash Receptacles - Replace

*Location:* **NW Community Park**

Due to the minimal cost to replace this component, reserve funding is not appropriate. Replace as necessary as an operating expense. No reserve funding necessary.

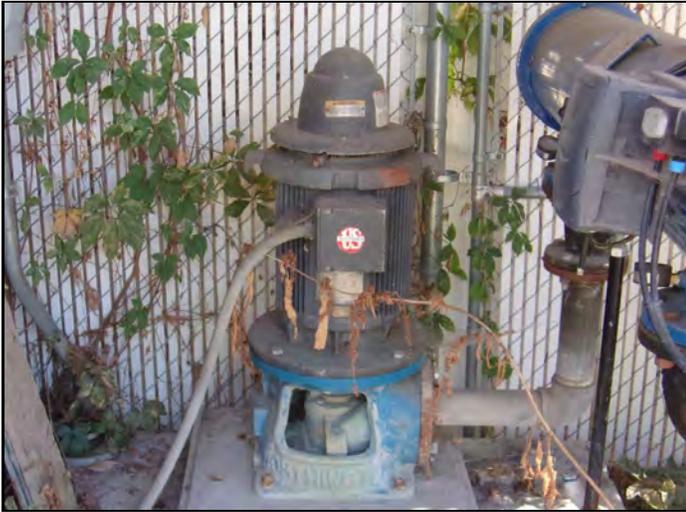
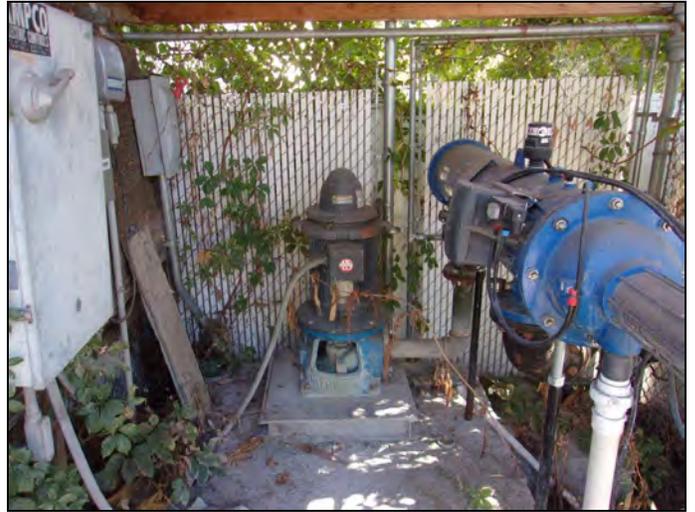
Comp #: 1705 Irrigation Pump - Replace

*Location:* **NW Corner of Community**

The pump is in working condition. We recommend funding to replace this component approximately every 10 - 15 years. Remaining life based on current age and condition.

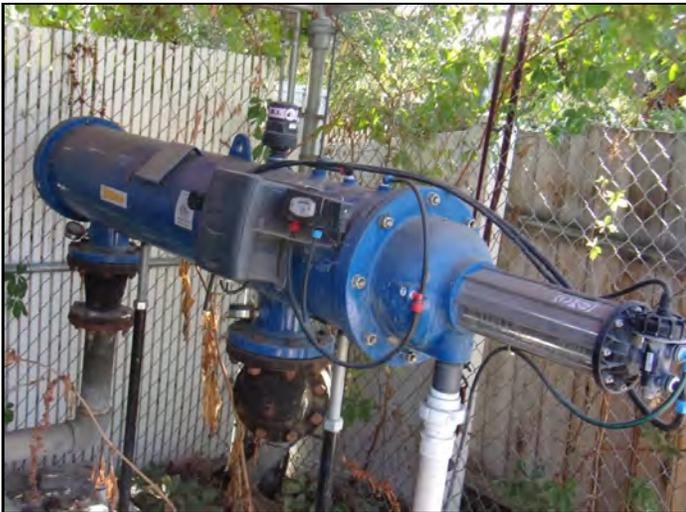
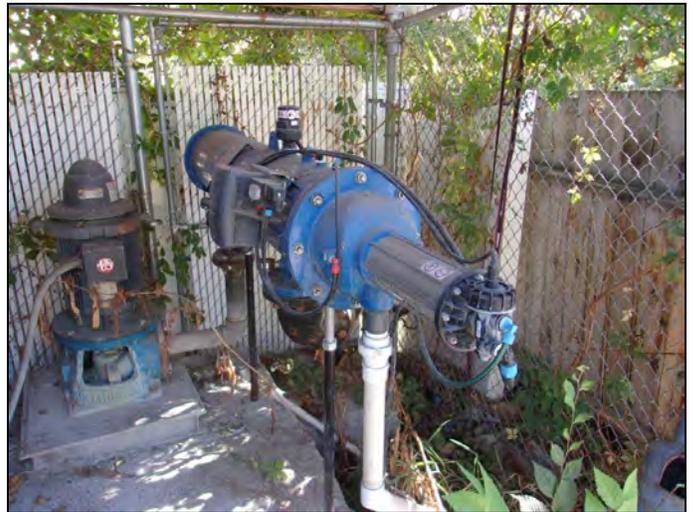
Comp #: 1790 Irrigation Filter System - Replace

*Location:* **NW Corner of Community**

The irrigation filter system is in working condition. We recommend funding to replace this component approximately every 15 - 20 years. Remaining life based on current age.

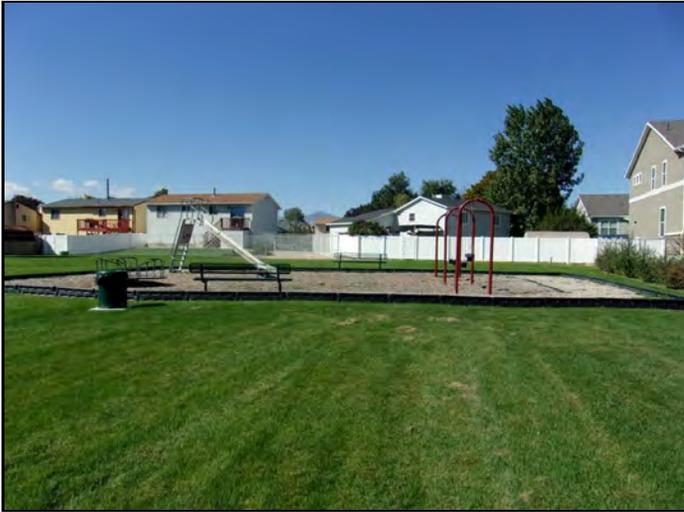
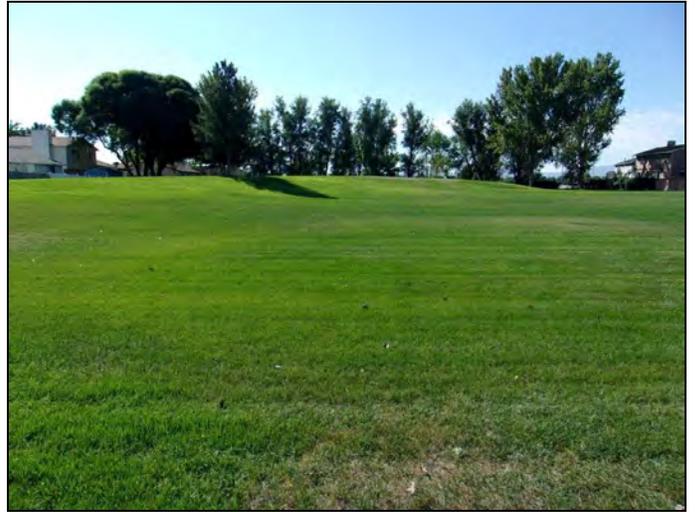
Comp #: 1812 Landscaping & Irrigation System - Renovate

*Location:* **Community Park**

The landscaping and irrigation system are in good to fair condition. We recommend funding for an allowance to renovate this component approximately every 20 years. Remaining life based on current age.

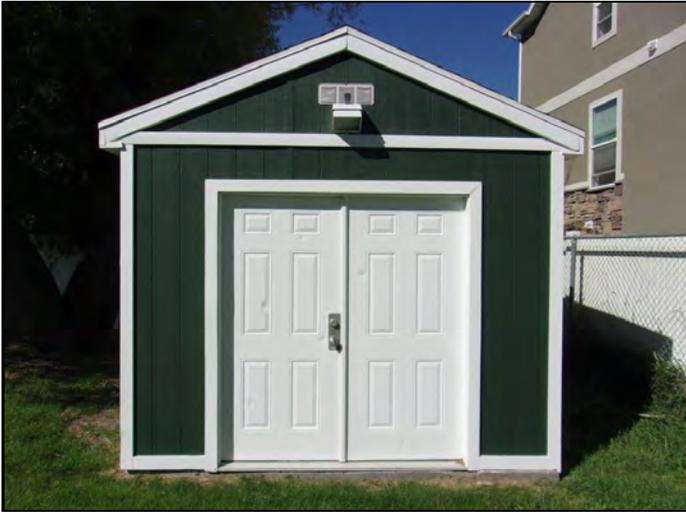
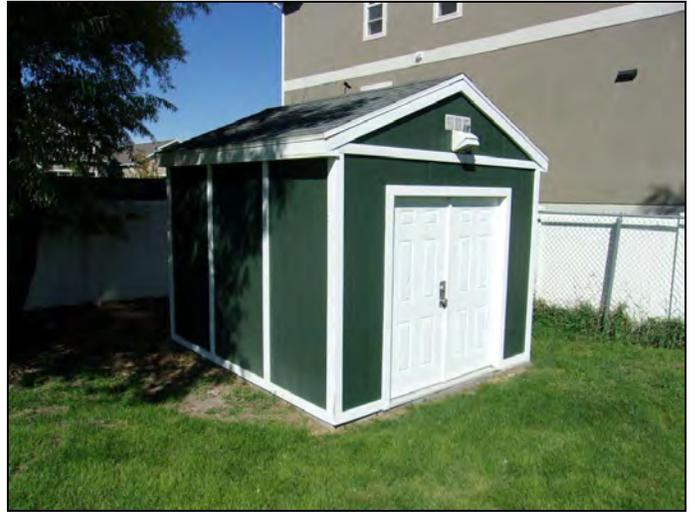
Comp #: 2301 Storage Shed - Replace

*Location:* **NW Community Park**

The shed is in fair condition. We recommend funding to replace this component approximately every 25 - 30 years. Remaining life is based on current age.
