# Inspection Report

**Property Address:**  
3156 Lakefield Rd.  
Lakefield

**Paul Galvin Residential Home Inspections**

<b>Date:</b> 2021-09-22	<b>Time:</b>	<b>Report ID:</b>
<b>Property:</b> 3156 Lakefield Rd. Lakefield	<b>Customer:</b> Dominic Cole	<b>Real Estate Professional:</b> Dominic Cole Ball Real Estate

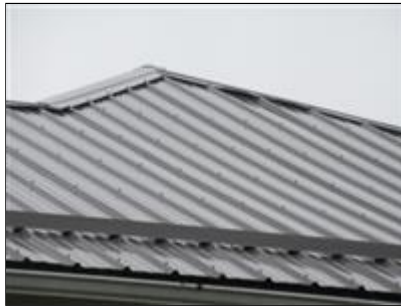
1.0 Picture 1

The entire roof surface is metal. This roof surface appears to be in good overall condition and installed well. All of the necessary caps and flashings were present.

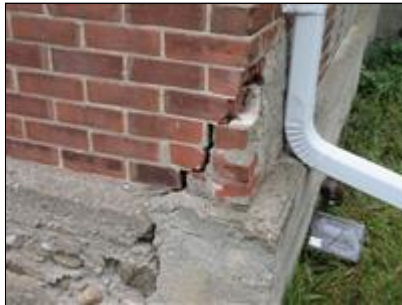
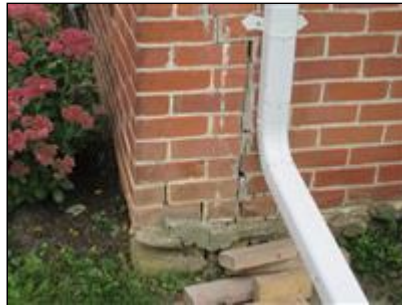
2.0 Picture 1

(1) The entire wall surfaces are brick. For the most part the brick is in good overall condition for the age and installed well. There are a couple areas (outside corners) where the brick is loose. The foundation corners here are slightly deteriorated which has caused the brick to crack and loosen. Although not an immediate concern, these corners should be repaired.

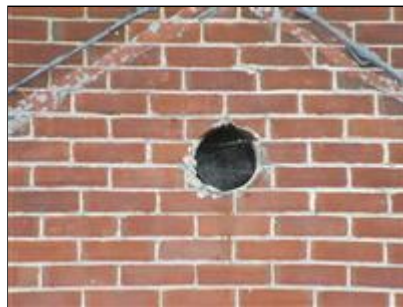
2.0 Picture 3

(2) There is an old chimney hole in the brick. It would be a good idea to fill this.

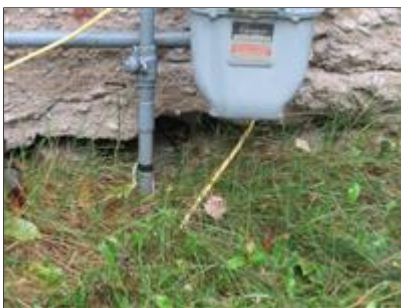
2.1 Picture 1

Although not an immediate concern, the exterior foundation could use some minor repair / reparging.

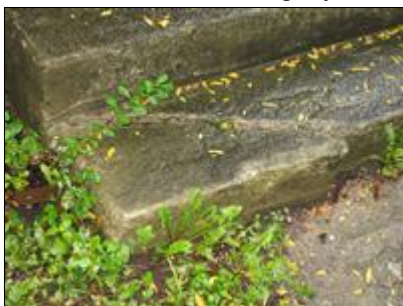
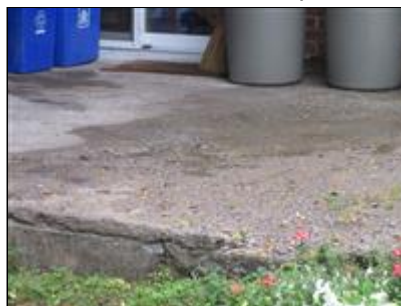
2.4 Picture 1

The concrete porches / stairs are cracked and slightly deteriorated. Some concrete repairs will eventually be needed.

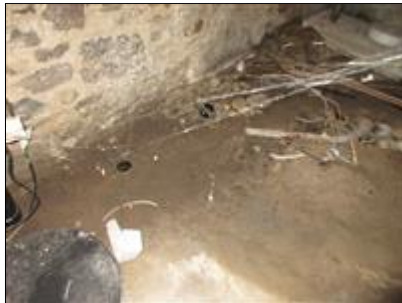
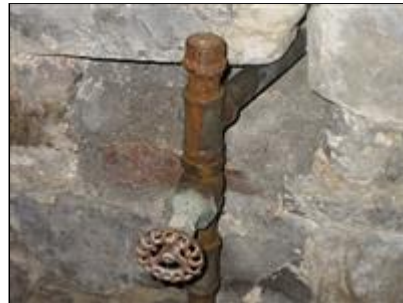
3.0 Picture 1

- (1) Structurally the house appears to be in good overall condition for the age. All visible framing members appear to be adequately sized and free from damage or wear. There were no signs of any unusual settlement or shifting.
- (2) There is evidence of water / moisture seepage into the basement. Some may be quite typical with an old stone foundation. Although I cannot offer any guarantee of a dry basement, new eavestroughs / downspouts where missing may help this. There also appeared to be a leak in a plumbing line at the foundation wall appeared to be leaking slightly. Repair will be needed.

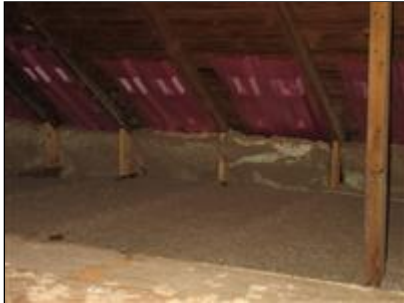
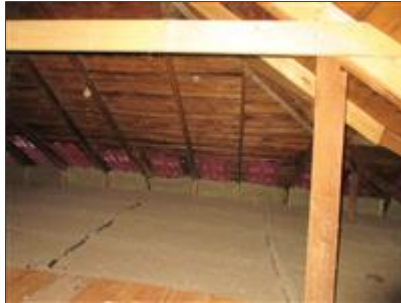
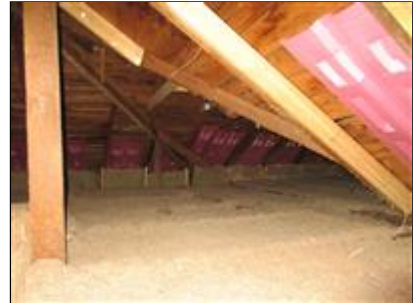
4.0 Picture 1

The attic contains blown in cellulose insulation installed in the floor of the attic. This insulation appears to be well placed and installed in more than adequate amounts.

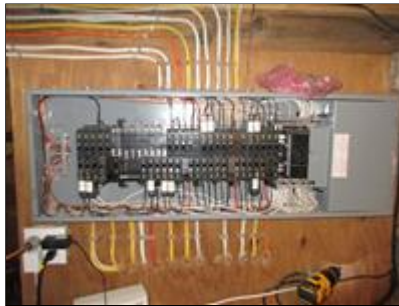
5.2 Picture 1

The main electrical panel was inspected and found to be installed properly and wired correctly. All of the proper sized breakers were present.

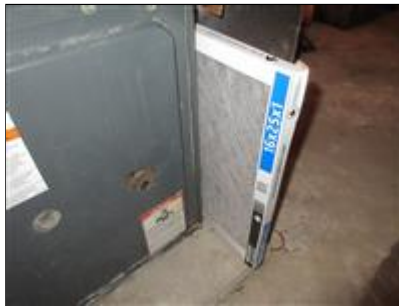
6.0 Picture 1

- (1) The furnace was tested and inspected and found to be installed properly and working well. All the necessary safety features were present.
- (2) The furnace filter should be changed on a regular basis.

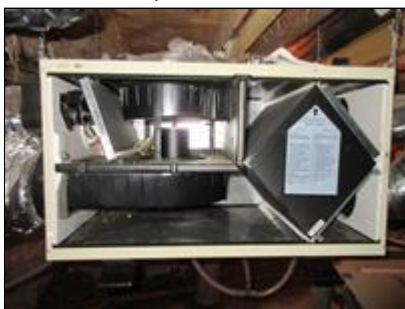
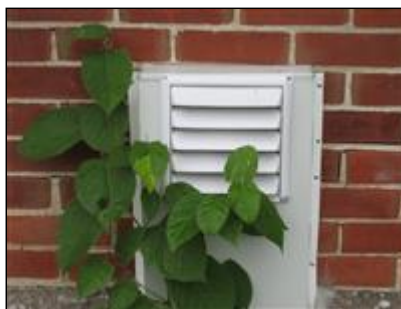
6.9 Picture 1

The heat recovery ventilator filters including the outside fresh air intake screen will require cleaning on a regular basis (see manufacturers recommendations).

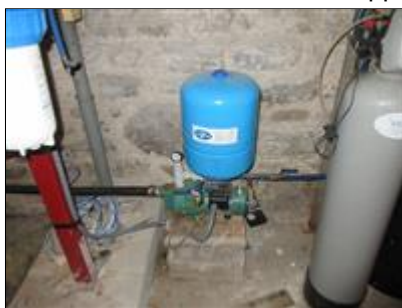
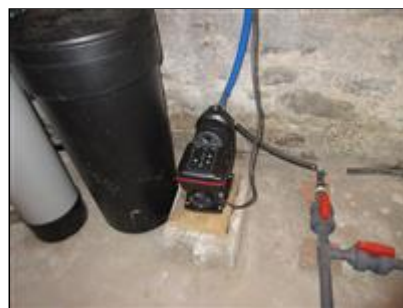
7.2 Picture 1

(1) There is a pump/ pressure tank which draws water from the well and keeps the cisterns filled with water. (trickle system) Another pump then draws from the cistern to supply water to the house fixtures.

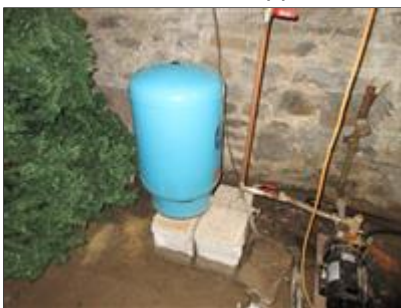
7.2 Picture 3

(2) There is another pump/ pressure tank in the basement that supplies water to the storage building.

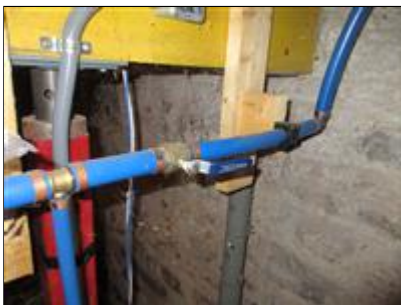
7.4 Picture 1

At pressure tank.

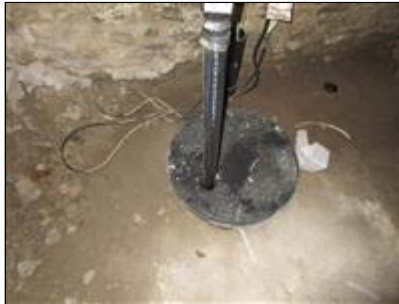
7.12 Picture 1

The sump pump should be tested on a regular basis to ensure its proper operation. The sump pump currently pumps out to the septic. If the sump pump is cycling on quite often, it would be a good idea to pump this outside onto the lawn well away from the house.
