Holden Beach

Annual Beach Monitoring Report 2025

Prepared For:
Town of Holden Beach, North Carolina

February 2026

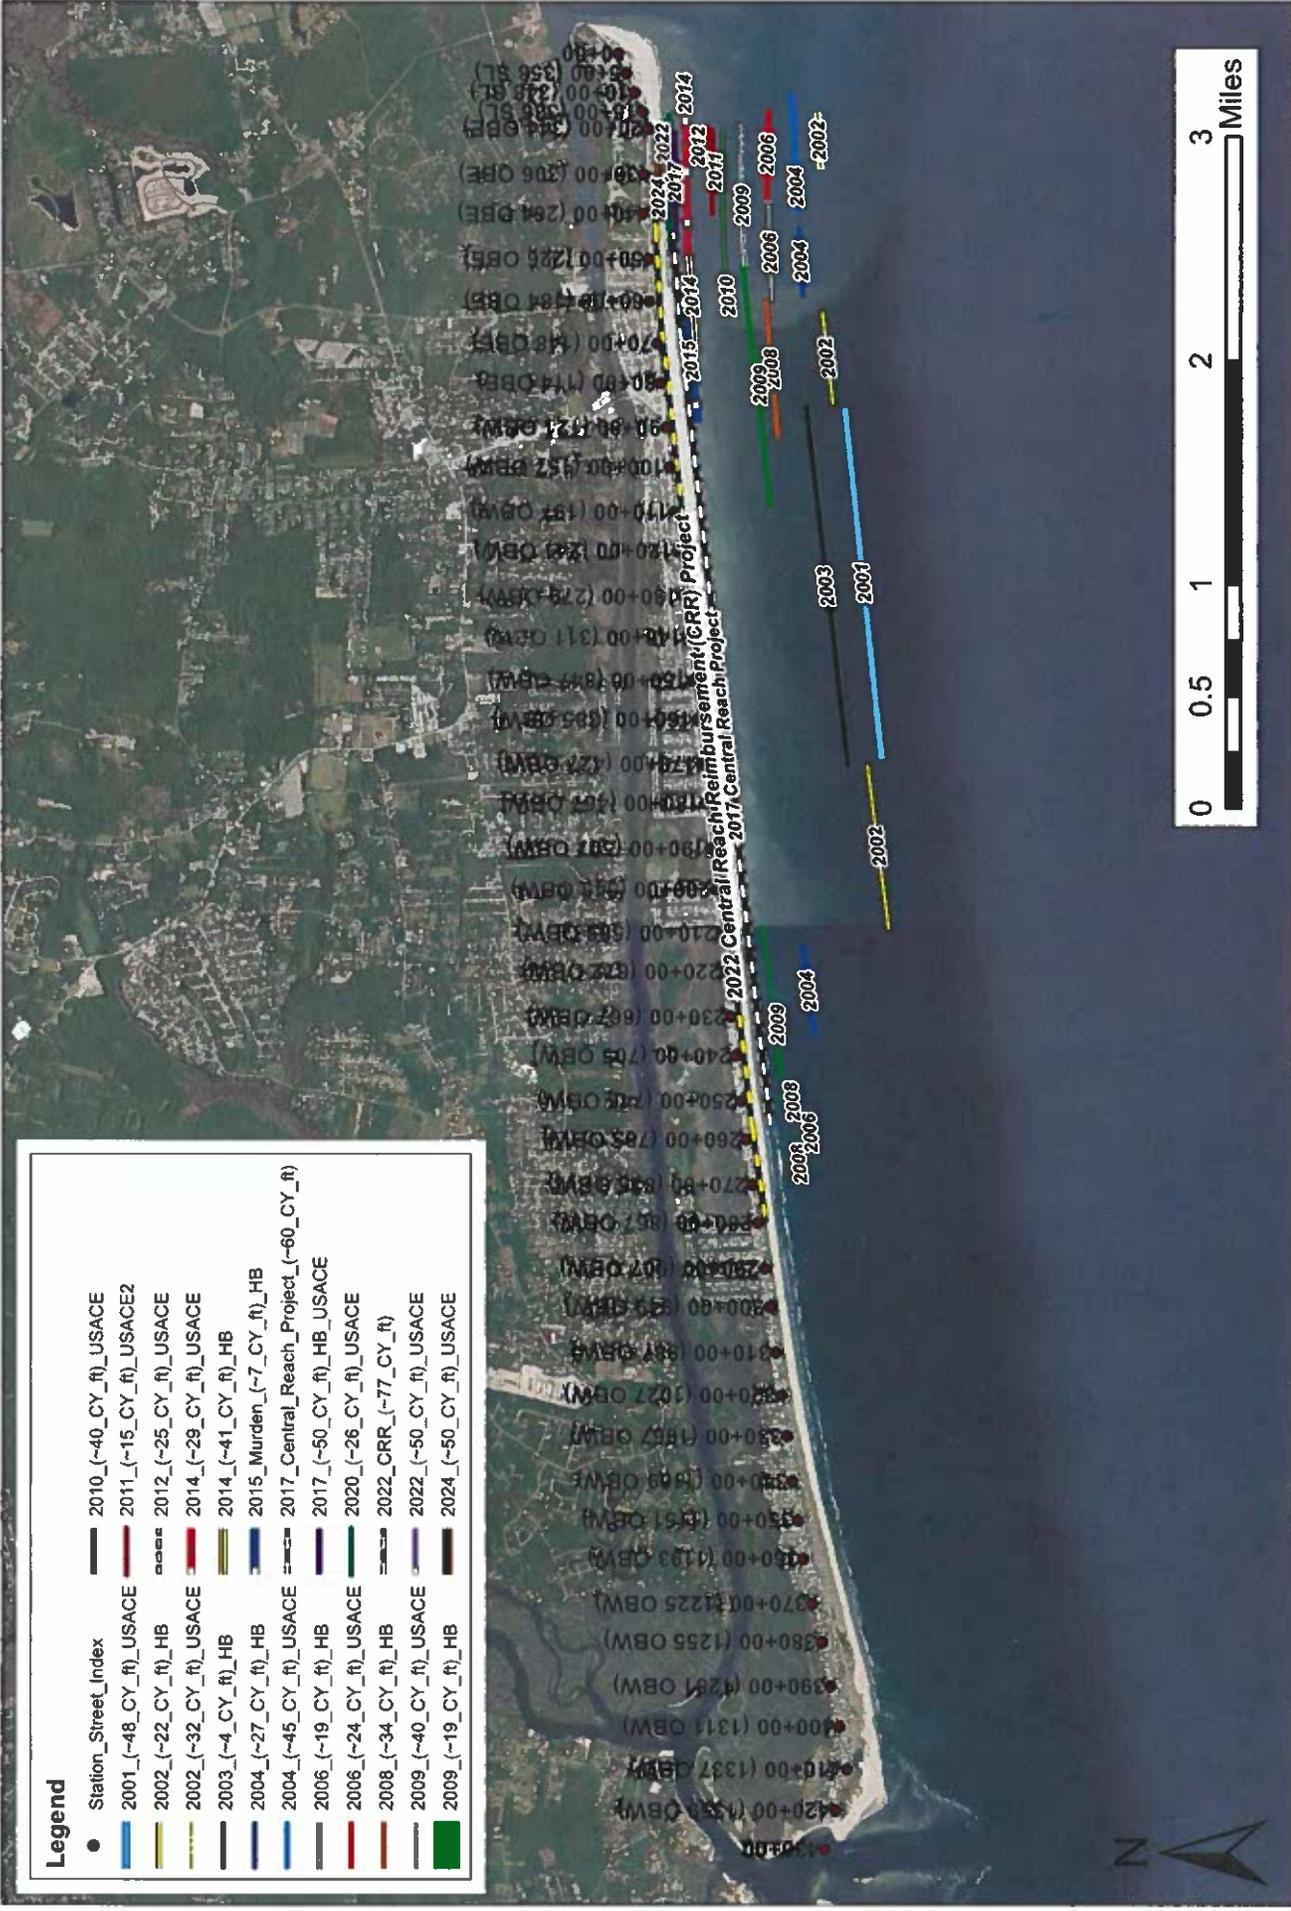
Holden Beach nourishments since 2001 and beach stationing for surveying. Survey stations begin at LWF Inlet (0+00) and are generally at 1,000 foot intervals, ending at Shalotte Inlet (430+00).

This section provides a brief project site history, beginning with the 2001/2002 U.S. Army Corps of Engineers (USACE) Wilmington Harbor Deepening nourishment project. Prior to this event, Town and USACE beach management efforts were sporadic and on smaller scales, with the first documented nourishment occurring in 1971. Beach scraping and dune repairs have been documented as far back as 1954, mitigating Hurricane Hazel impacts. Significant erosion and the loss of more than 30 houses on the eastern end of Holden Beach in the 1990s were major factors in establishing current beach management activities. Table 2-1 and Figure 2-1 summarize nourishment activities and locations since 2001.

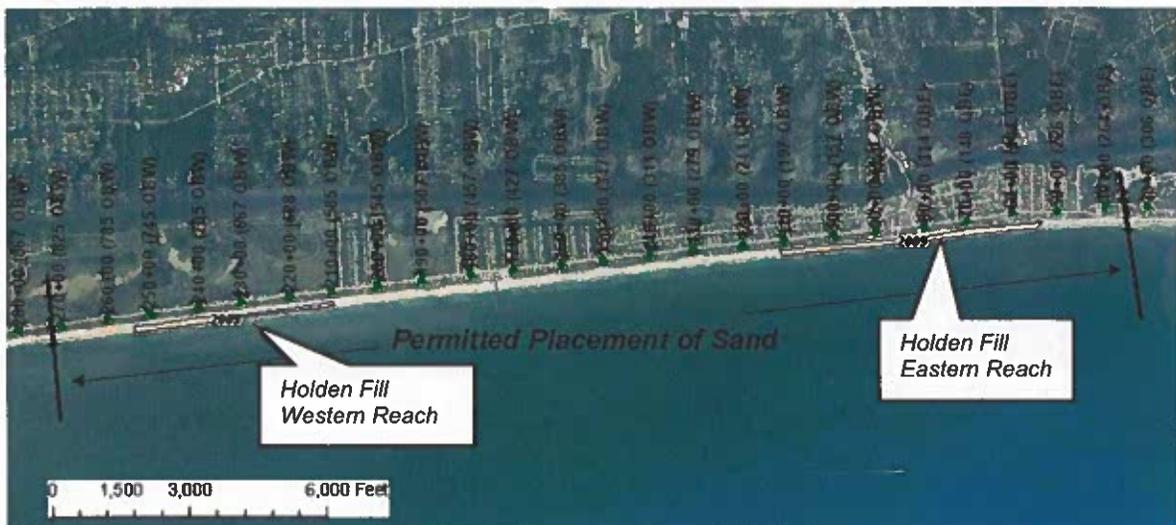
Figure 2-2. 2009 Constructed Project Reaches and 2009 Permitted Sand Placement (the Permitted Placement Has Been Modified over the Years).

The Town has a history of successful upland fill projects, with the most recent occurring in 2009, primarily as Hurricane Hanna mitigation. Approximately 115,000 cy was placed between Stations 55+00 and 110+00 [21 cubic yard per linear foot (cy/lf) average] along the Eastern Reach and 75,000 cy between Stations 210+00 and 255+00 (16.5 cy/lf average) along the Western Reach. Figure 2-2 illustrates the placed-fill footprint and the permitted footprint. Sand was obtained from the Smith upland borrow site.

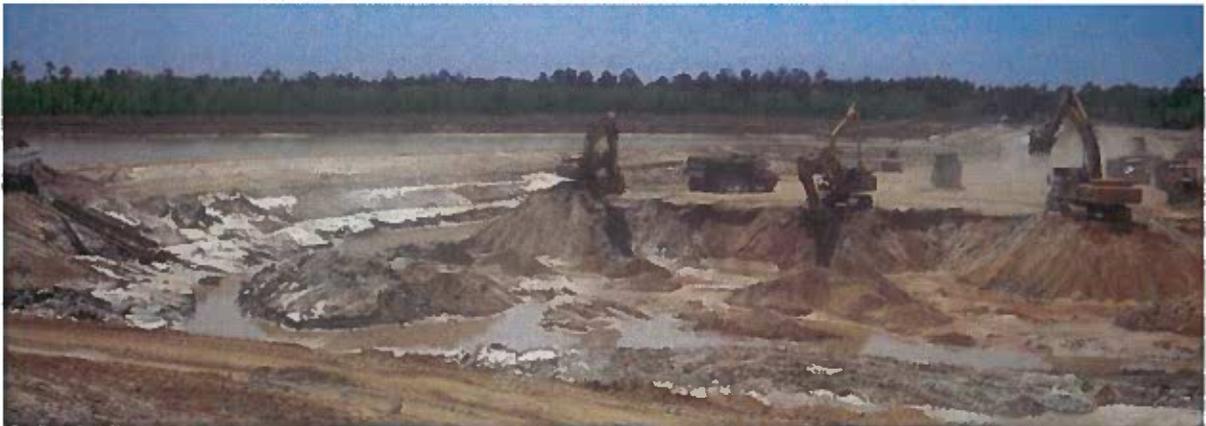
Figure 2-3. Smith Upland Borrow Area During 2009 Holden Beach Nourishment Project.

The Town owns the Turkey Trap Road upland borrow site whereas other potential borrow area sites have been used in the past and may be available in the future. The Turkey Trap Road site has been successfully permitted, which significantly enhances post-storm mitigation response time. While the Smith site in Figure 2-3 is now under development and development pressure on other large tracts of land is currently strong, other upland sources of sand are potentially available

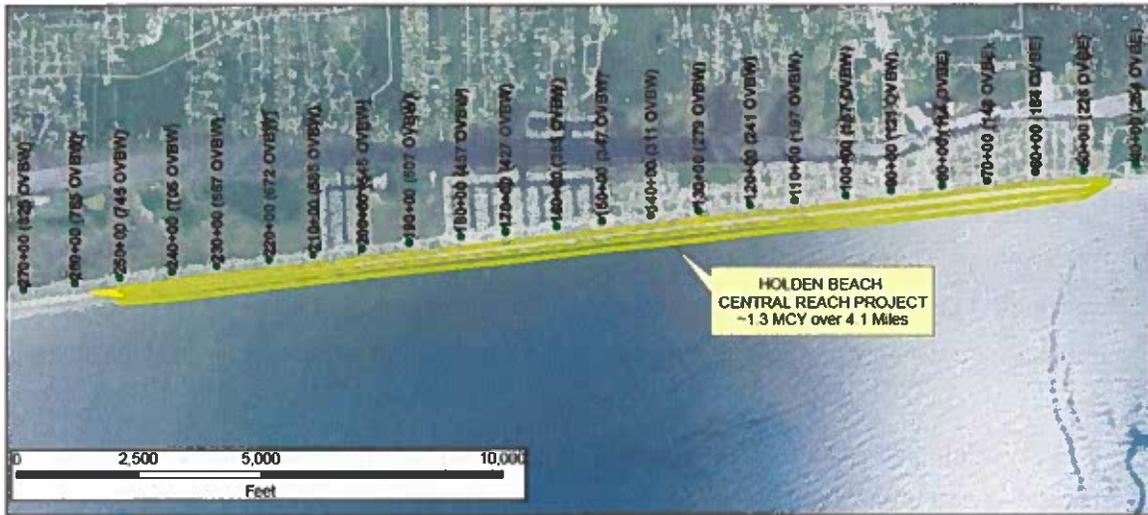
Figure 2-4. Central Reach Beach Fill Placement Footprint (Construction From 1/3/17 to 3/17/17 From Approximately Station 45+00 to Station 257+00).

Figure 2-4 presents the beach fill project footprint. On average, constructed berm widths were about 150 ft wide and fill placements were about 60 cy/lf (with a range typically varying between 50 and 70 cy/lf).

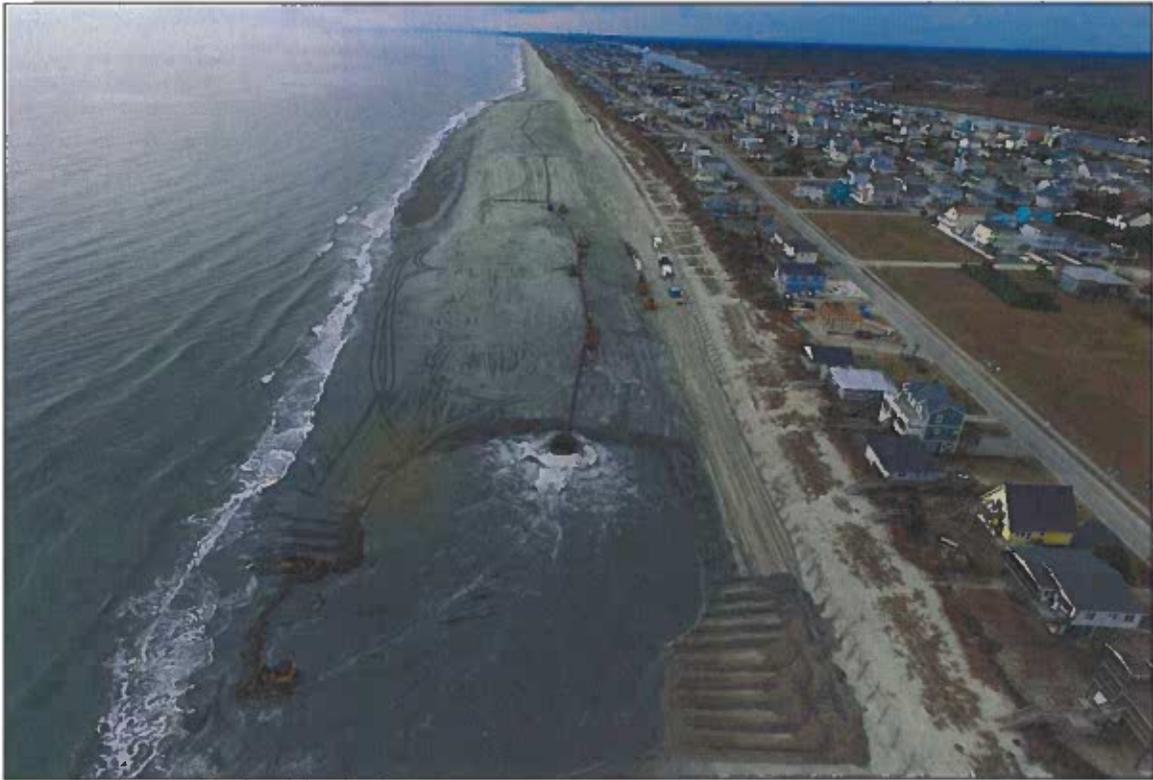
Figure 2-7 (A). Aerial Photograph During CRR Construction, Photo Taken Near East Taper, ~Station 40+00, Looking West (ATM Drone Photo 01/20/22).

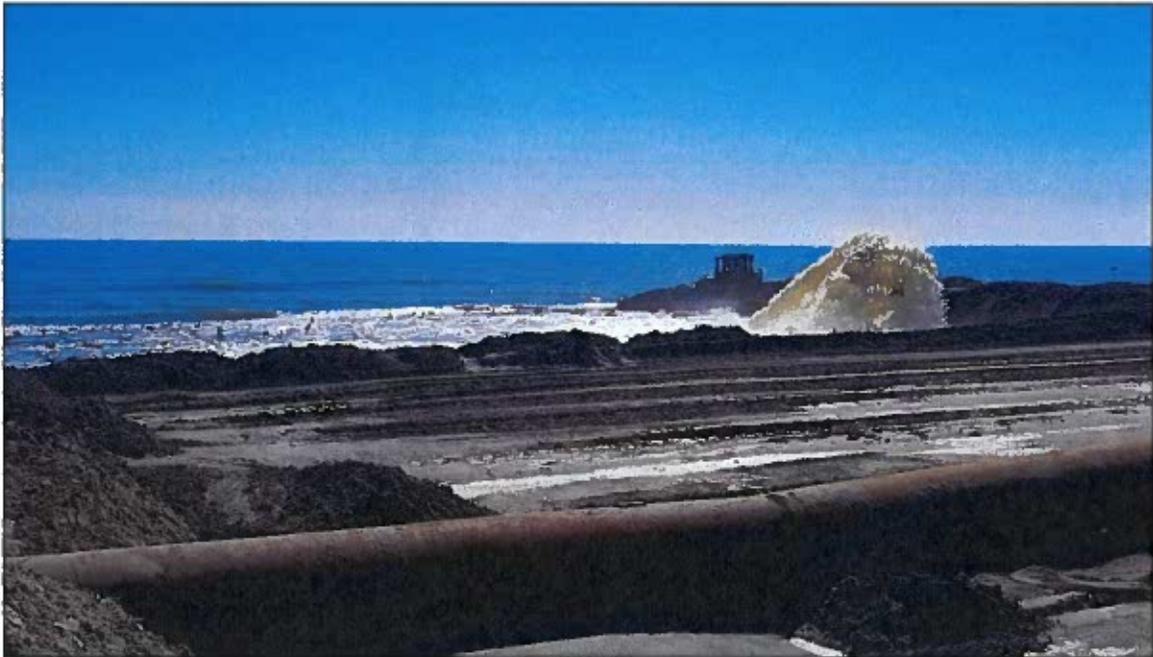
Figure 2-7 (C). CRR Construction Ground Photo (ATM Photo Taken 03/03/2022).

With the help of the two hopper dredges, the Weeks Marine crew worked quickly, pumping sand on the beach and progressing at an average rate of about 300 feet of shoreline per day. Aerial and ground photographs taken during construction can be seen in Figures 2-7 (A-D).

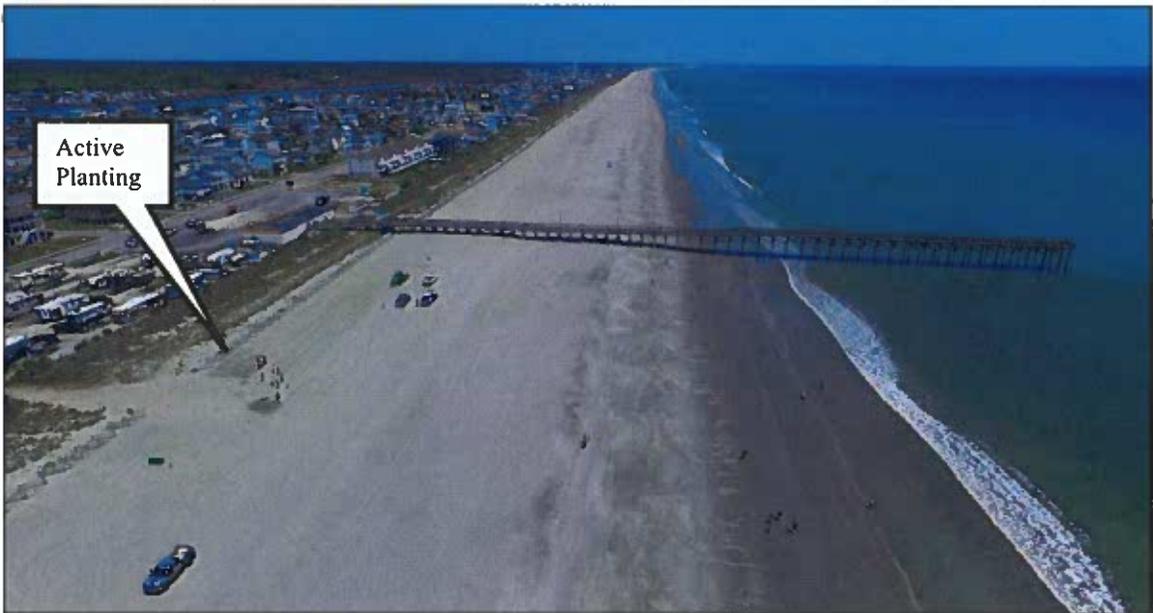
Figure 2-7 (D). Aerial Photograph Take From ~Station 180+00 Following CRR Construction During Active Planting Efforts Near Pier (ATM Photo Taken 04/28/2022).

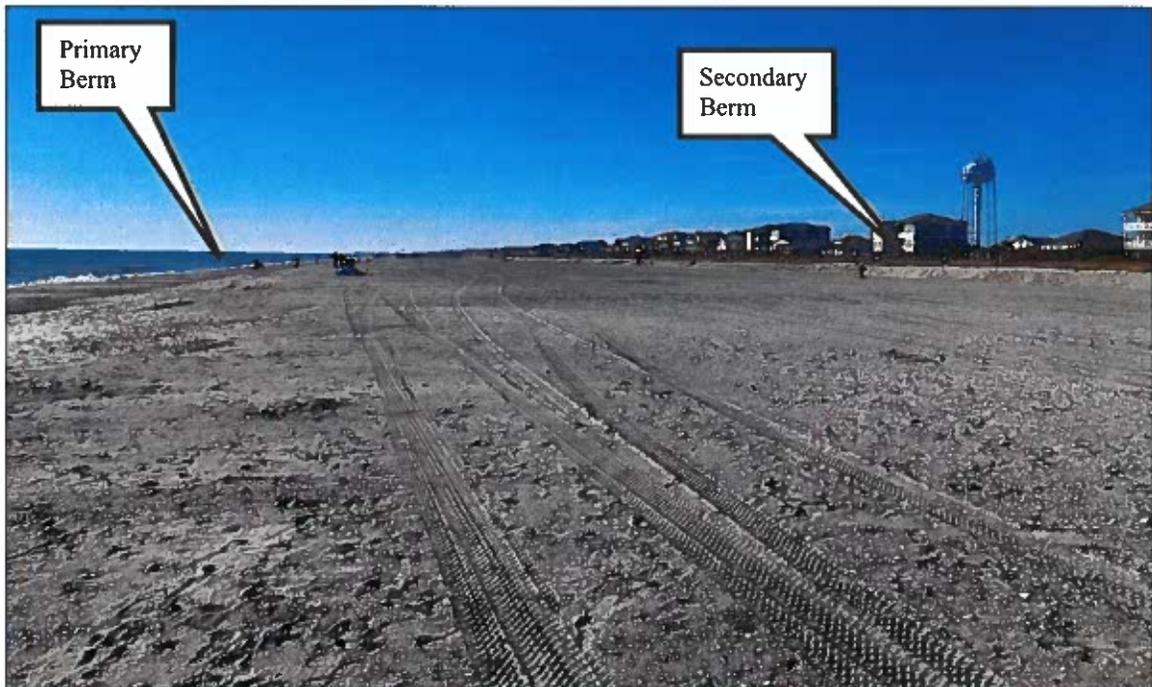
Figure 2-9 (A). CRR Post-Construction Near Station 80+00 (ATM Photo Taken 02/10/2022).

Sediment monitoring of the placed sand occurred daily throughout the project and immediately following completion. The nourishment sand was found to be a very good match to the existing beach with slightly coarser sand than the native sand (but well within

tolerance standards), which is fortunate as slightly coarser sand erodes less quickly than finer material. Figure 2-9 (A-C) show photographs of the good color and consistency of the nourishment sand placed as well as the significantly widened beach conditions immediately following construction.

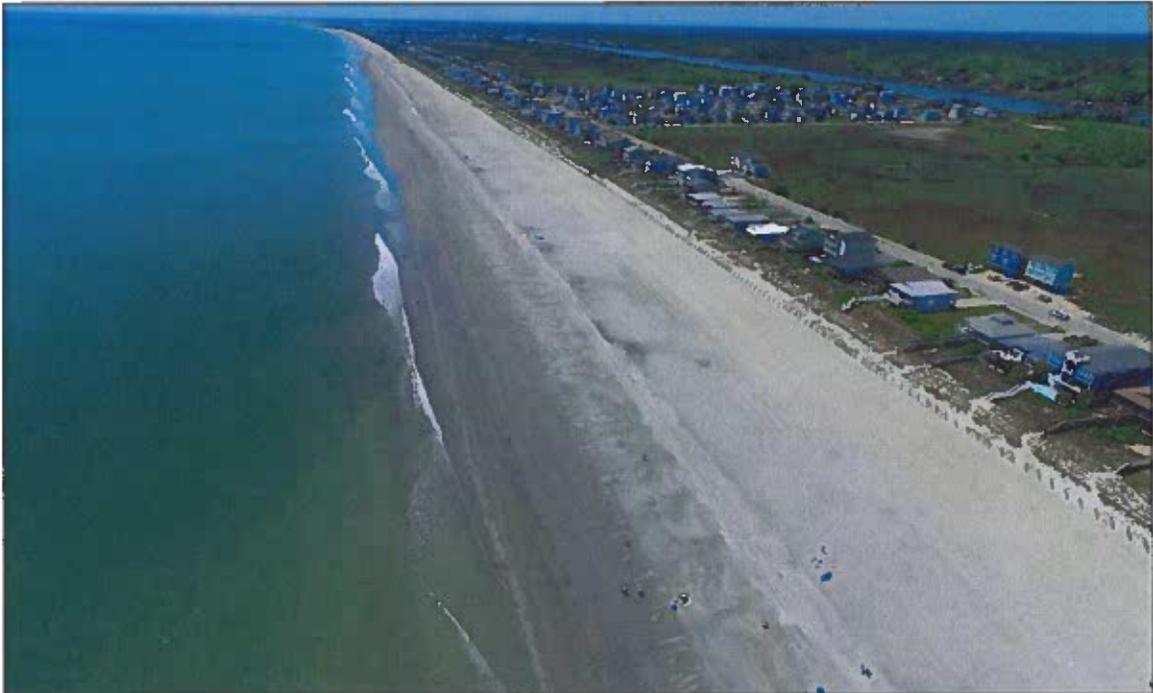
Figure 2-9 (B). CRR Post-Construction Aerial Photograph Taken Near Pier Looking West (ATM Photo Taken 04/28/2022).

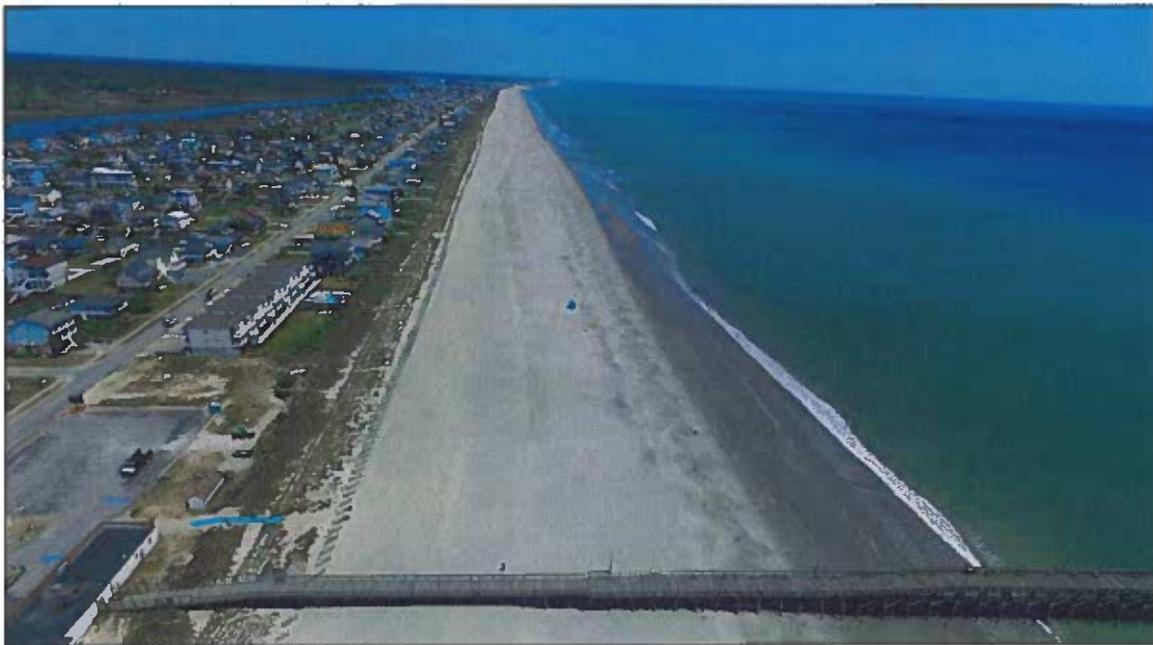
Figure 2-9 (C). CRR Post-Construction Aerial Photograph Taken Near Pier Looking East (ATM Photo Taken 04/28/2022).

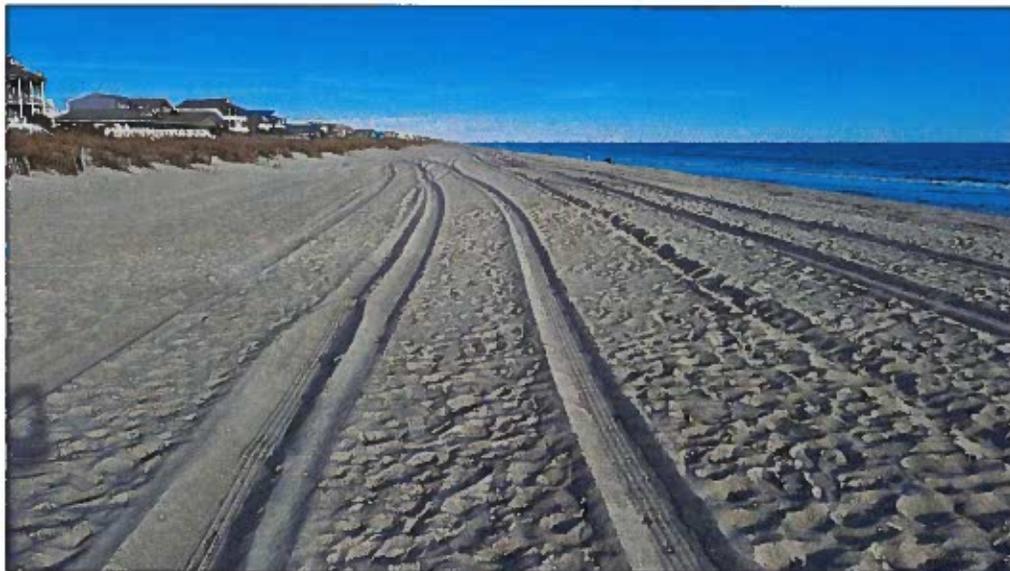
Figure 2-10 (A). CRR ~3.5 Year Post-Construction Photo of Wide Beach Near Station 280+00 Facing East (Photo Taken November 2025).

Recent photographs taken approximately 3.5 years following construction are presented in 2-10 (A-D) and Figure 2-11 (A-D) and show a wide, healthy beach, dune and vegetation growth throughout the project area.

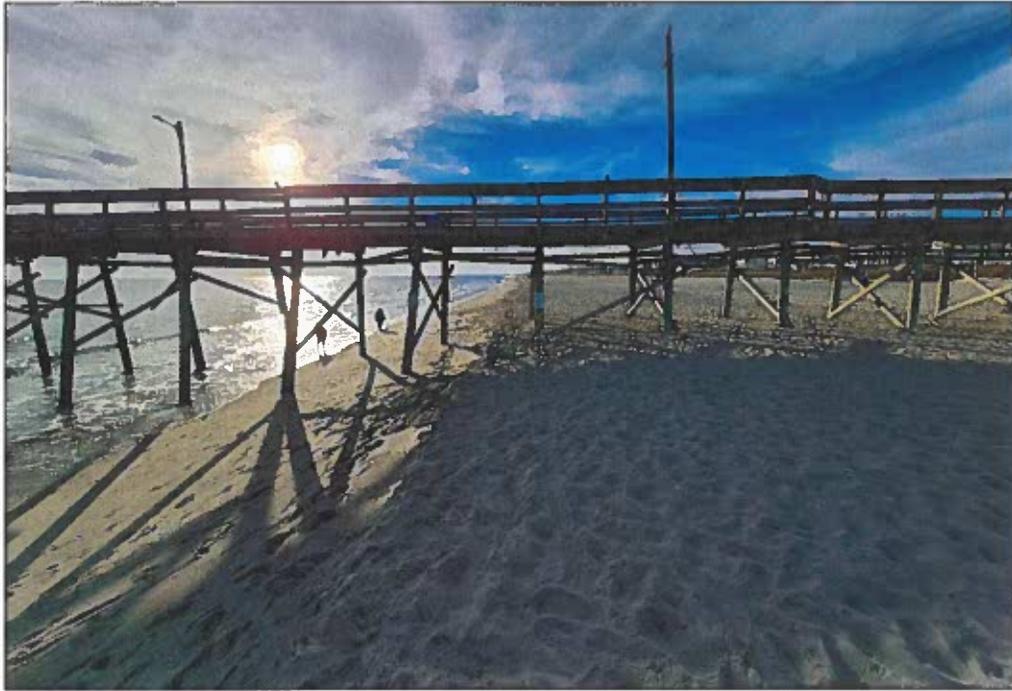
Figure 2-10 (B). CRR ~3.5 Year Post-Construction Photo of Wide Beach Just East of Pier Near Station 170+00 Facing West (Photo Taken November 2025).

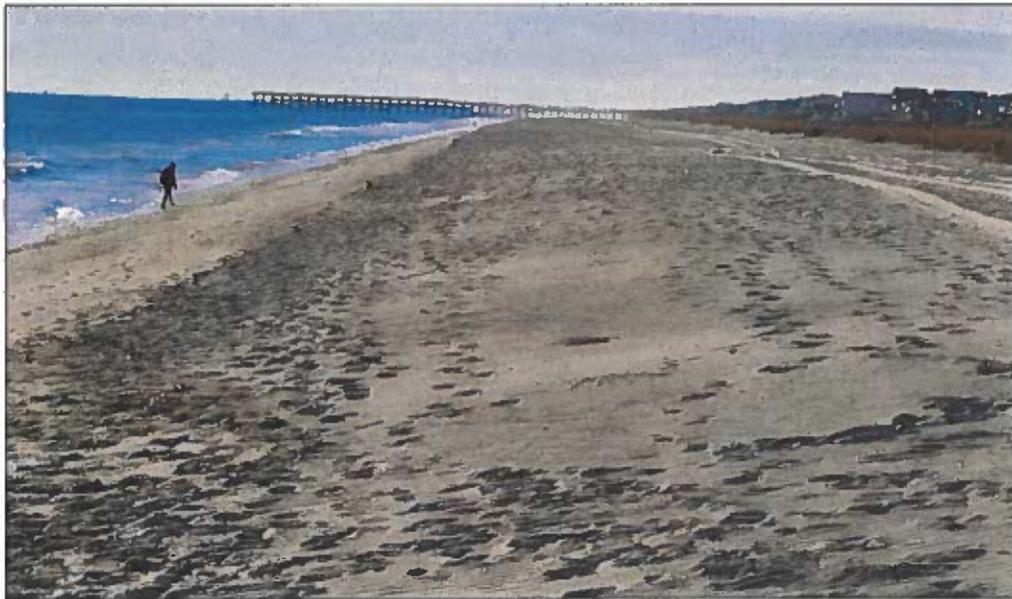
Figure 2-10 (C). CRR ~3.5 Year Post-Construction Photo of Wide Beach Near Station 130+00 Facing West (Photo Taken November 2025).

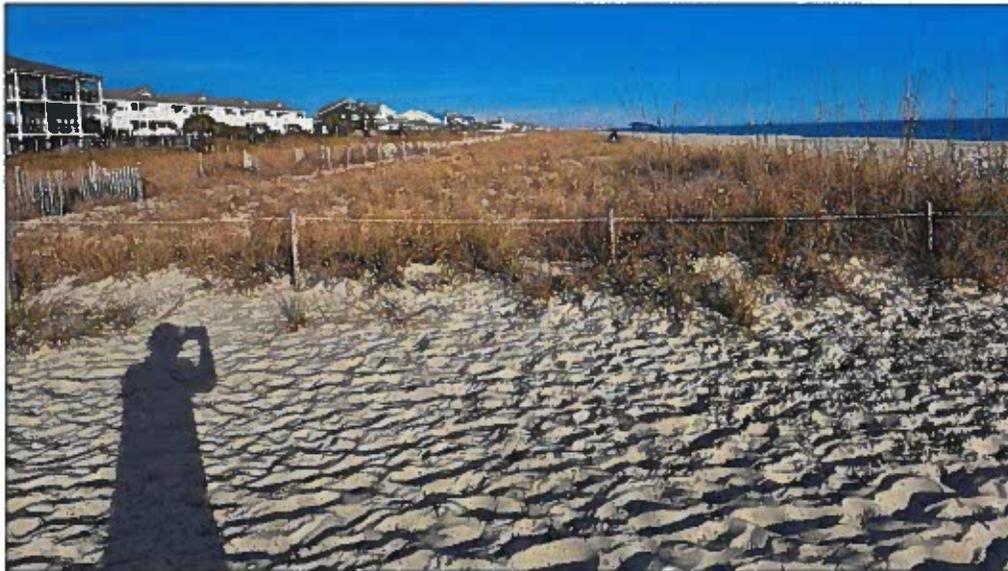
Figure 2-11 (A). CRR ~3.5 Year Post-Construction Photo of Vegetation Just East of Pier Near Station 170+00 Facing East (Photo Taken November 2025).

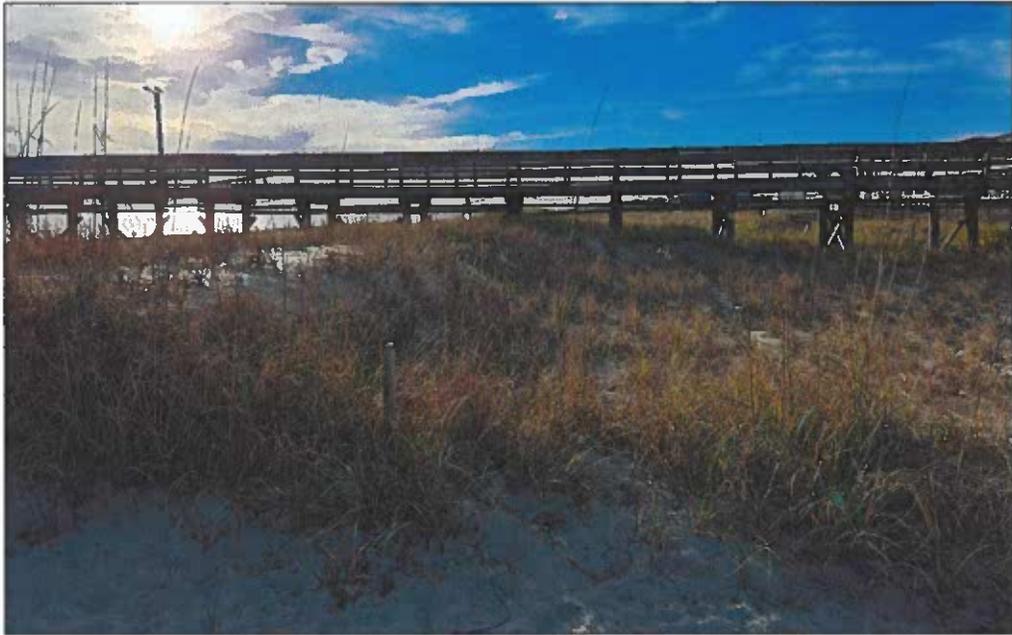
Figure 2-11 (B). CRR ~3.5 Year Post-Construction Photo of Vegetation Near Station 170+00 Facing West (Photo Taken November 2025).

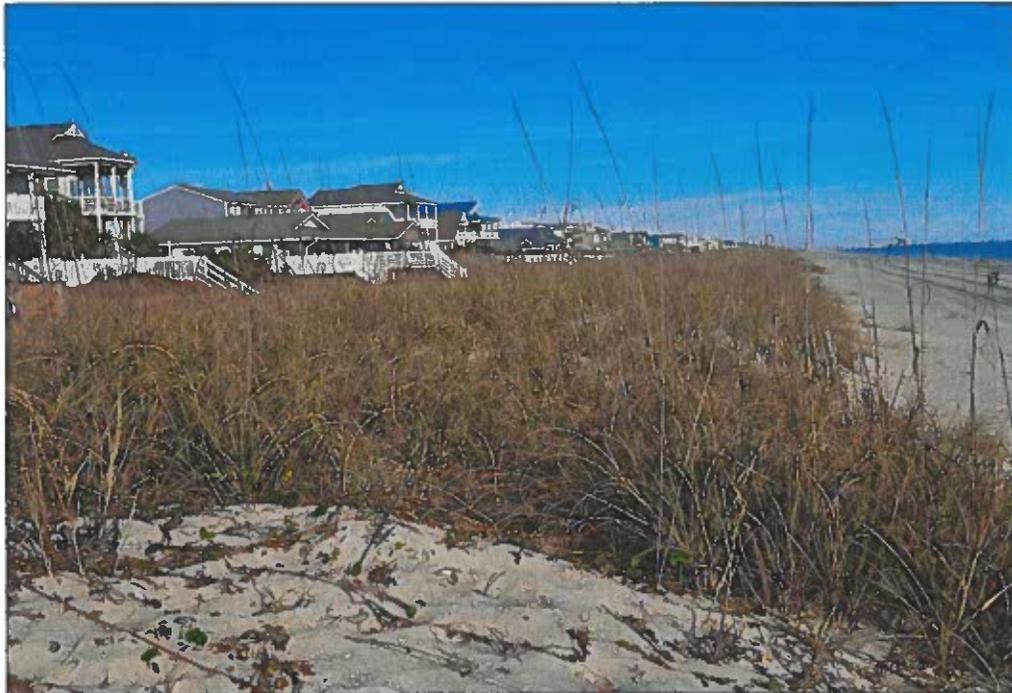
Figure 2-11 (C). CRR ~3.5 Year Post-Construction Photo of Vegetation Near Station 280+00 Facing East (Photo Taken November 2025).

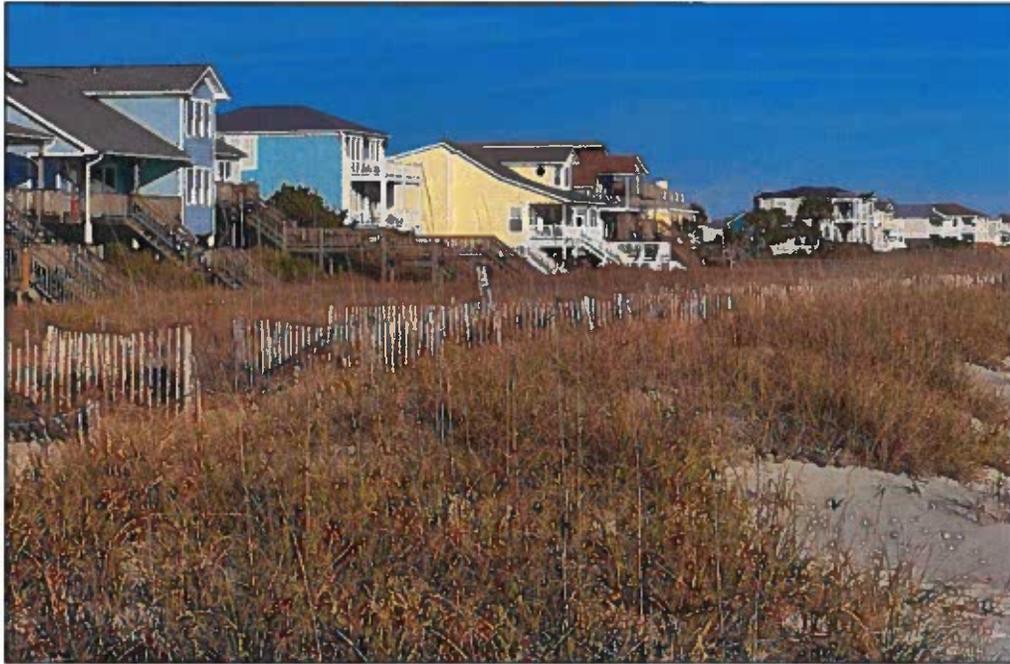
Figure 2-11 (D). CRR ~3.5 Year Post-Construction Photo of Vegetation Near Station 70+00 Facing East (Photo Taken November 2025).

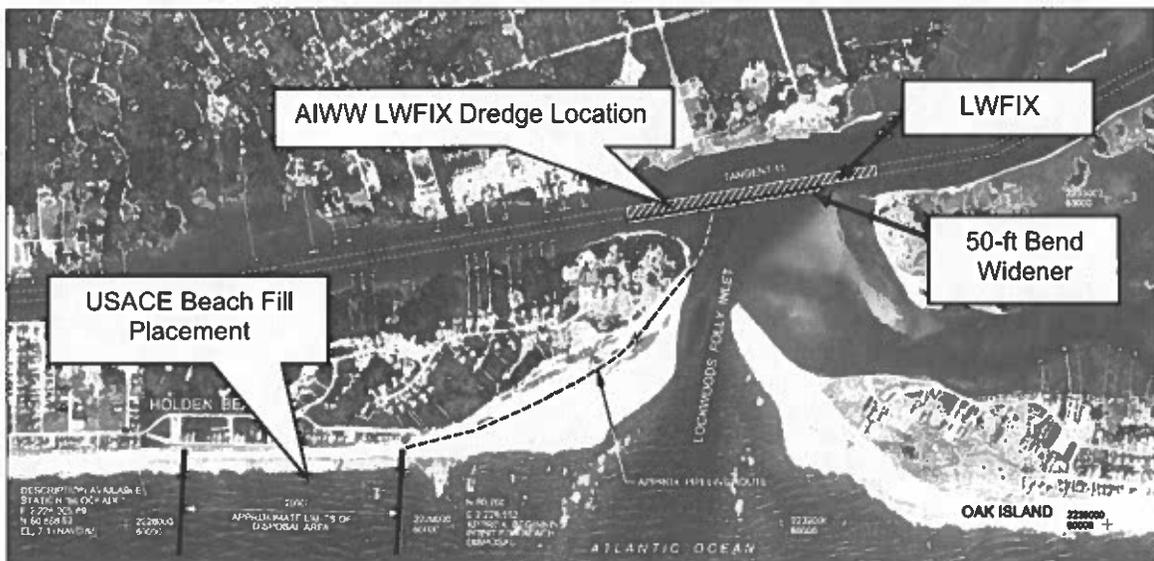
Figure 2-12 (A). USACE LWFIX Dredging and Beach Placement Schematic (Source: USACE Request for Proposal). Placement Typically Occurs Between Holden Beach Stations 20+00 and 40+00.

The LWFIX project typically includes the AIWW itself as well as a “bend widener.” The bend widener typically varies from 50 ft wide (Figure 2-12 [A]) to 400 ft wide (Figure 2-12 [B]). The 400-ft bend widener is the largest widener allowed by USACE permit conditions. The 400-ft bend widener was rarely dredged by the USACE due to limited Federal funding prior to 2010, however, the USACE did include it for the 140,000-cy project in 2010 due to economic stimulus funding (i.e., American Reinvestment and Recovery Act).

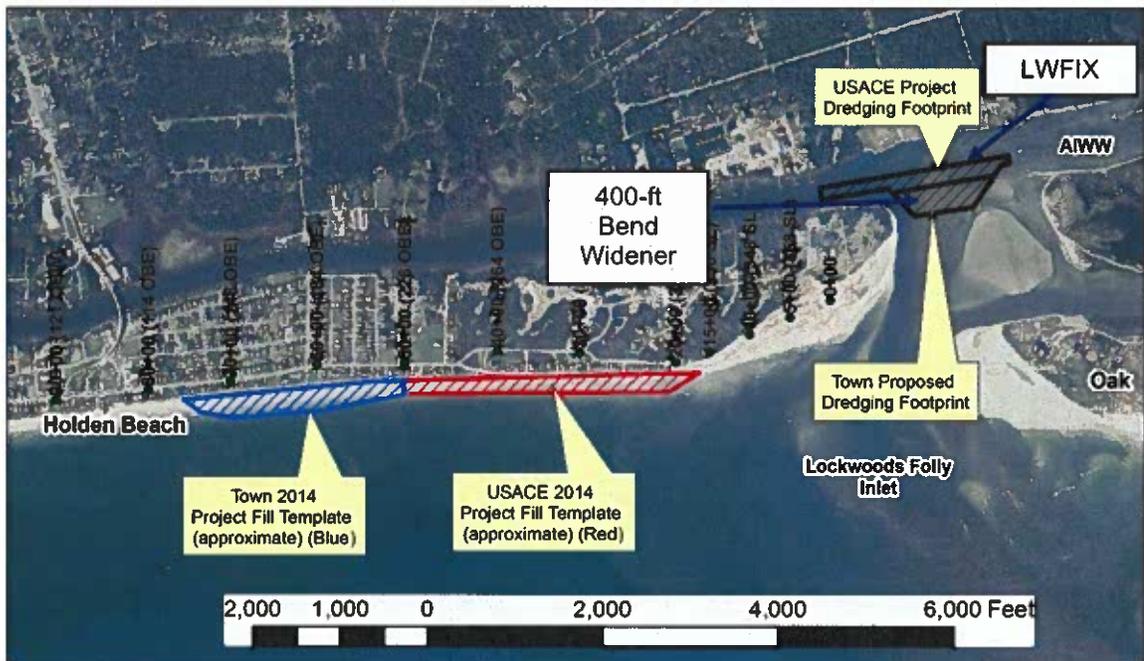
Figure 2-12 (B). USACE and Town LWFIX 2014 Project Dredging and Beach Placement Which Included the 400-ft Bend Widener.

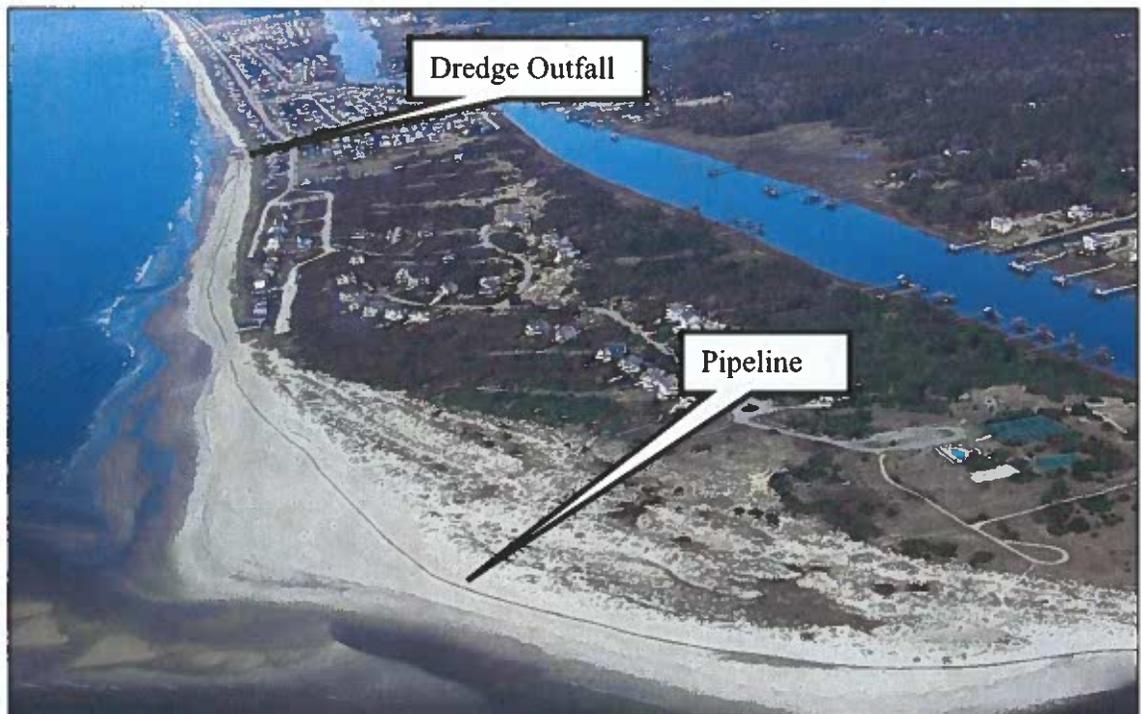
Figure 2-13. Aerial Photograph of 2014 LWFIX Nourishment [Source: NC Division of Coastal Management (DCM)].

The Town’s piggybacking of the USACE project maximized sand placement while minimizing costs by use of the dredge already onsite for the Federal project. The Town project placed approximately 95,000 cy of beach-compatible material along approximately 2,300 ft of Holden Beach shoreline, between baseline Stations 50+00 and 73+00 (41 cy/lf average). Figure 2-13 provides an aerial photograph taken during the 2014 LWFIX project.

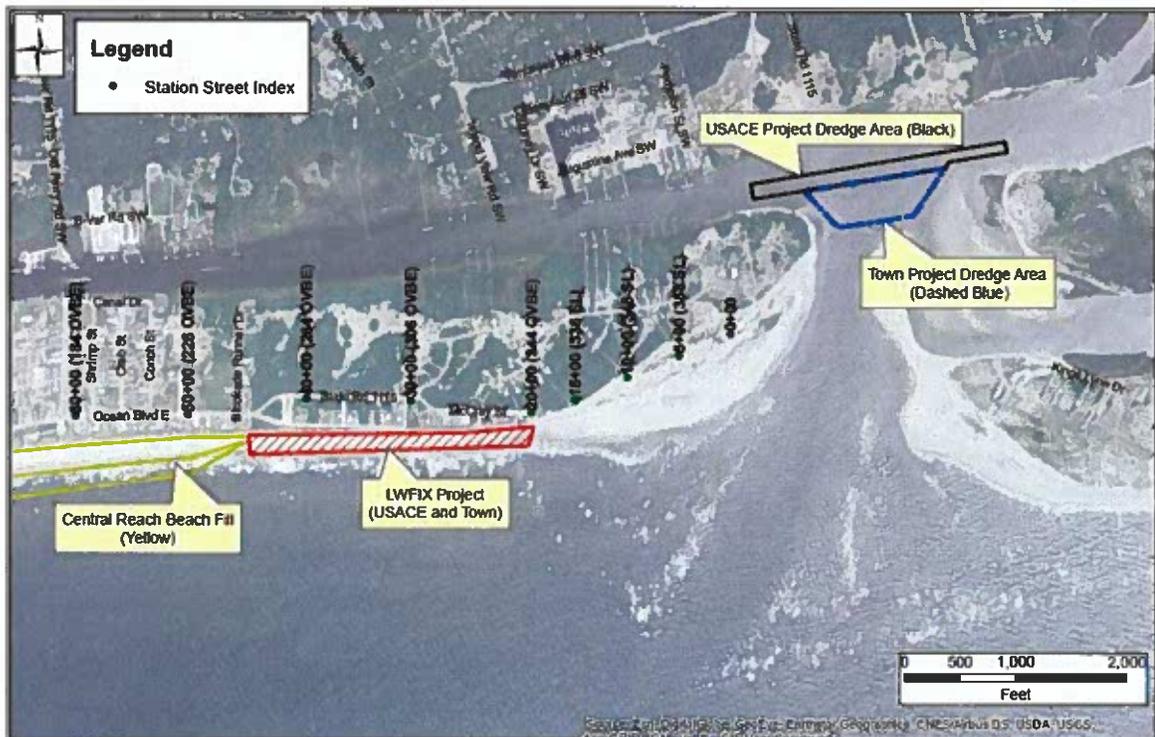
Figure 2-14. 2017 USACE LWFIX Dredging and Beach Placement Schematic (Source: USACE Request for Proposal). Placement of Approximately 120,000 cy Occurred in March 2017 Between Holden Beach Stations 20+00 and 45+00 to Tie in with the Central Reach Project.

Figure 2-14 presents a plan view schematic of the 2017 LWIFX dredging and Town nourishment project. Including the 400-ft widener resulted in a total of approximately 130,000 cy that was dredged and approximately 120,000 cy placed along the Eastern Reach Project area (a small percentage of material is always lost during the dredging and construction process). To ensure maximum benefits to the central and eastern reaches of Holden Beach, the dredged material was placed immediately adjacent to the Town's CRP's eastern taper, where CRP construction began in January 2017.

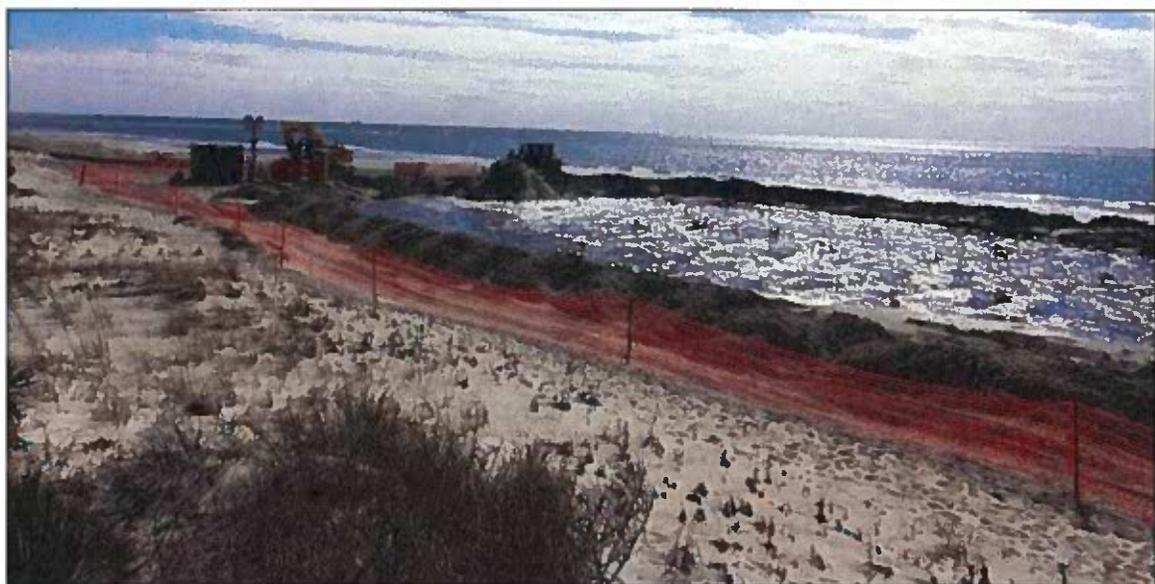
Figure 2-15. Holden Beach POA Photograph Taken Near 323 McCray Street (Approximately Station 26+00) During 2017 Eastern Reach Project Construction.

The Eastern Reach Project was very successful, and photographs taken during construction are presented in Figures 2-15 and 2-16. The Town's involvement allowed for the placement of an additional 60,000 cy at a very inexpensive rate. The cost for the project was \$465,000, and the Town's portion was only about \$76,000 (with the State providing 66.7 percent).

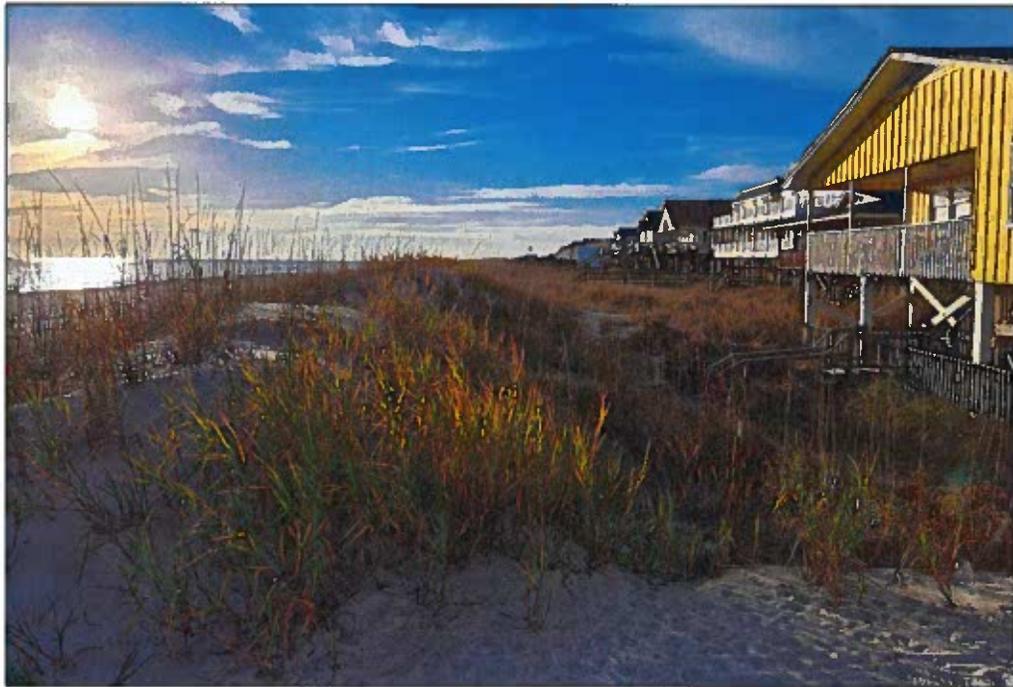
Figure 2-17. Recent East End Photo (November 2025). The Most Eastern Oceanfront House, Amazing Grace, is Shown. Significant Dune Growth Has Occurred Over the Last Few Nourishment Projects; However This is Still a Vulnerable Area.

Figure 2-17 presents a November 2025 photo of the east end. In general and based on site observations, the east end is continuing to benefit from this and the more recent 2022 LWFIX project (discussed in the following section). The east end does need nourishing every 2 years to avoid extreme erosional conditions that have occurred in past decades. More details on beach survey monitoring are provided in Section 3.

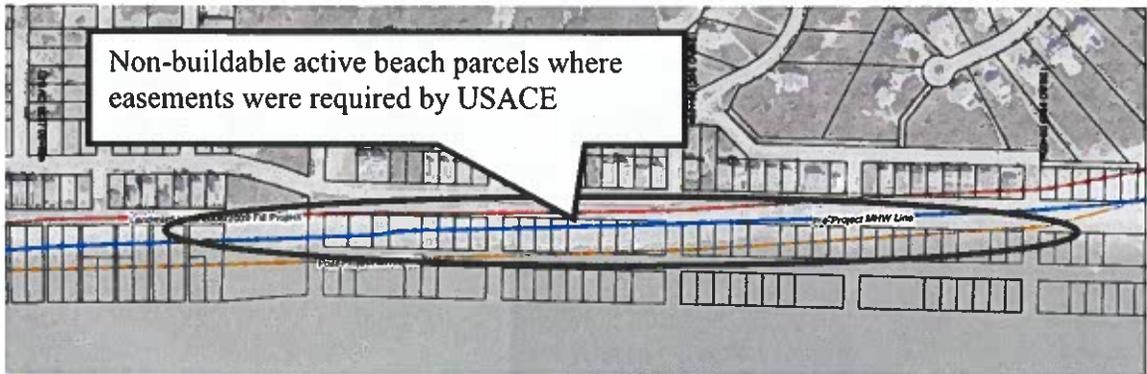
Figure 2-19. In 2018, the USACE Required Easements for Numerous Lots Before East End LWFIX Placement Can Resume. Easements Were Obtained in 2019.

According to the USACE, Oak Island fill placement only required easements from the Town of Oak Island (i.e., not from individual homeowners). For the east end of Holden Beach, the USACE identified more than 50 homeowner easements needed, with many of these on active beach (not buildable lots, see Figure 2-19). Updated easements were obtained in 2019 and placement on the east end can now again occur. Since this time, the USACE has been alternating placement between Oak Island and Holden Beach on an annual basis.

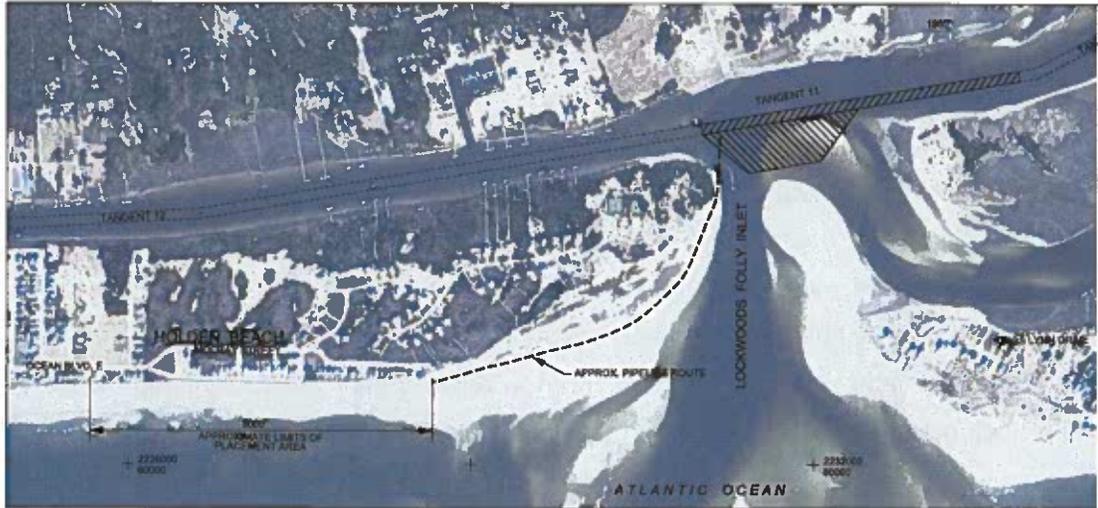
Figure 2-20. 2020 LWFIX Placement on Holden Beach. 400-ft Bend Widener Included as Bid Option Item (Alt) But Was Only Lightly Dredged During Actual Project.

The 2020 LWFIX dredging project was completed in early spring of 2020 with placement on the east end of Holden Beach (see Figure 2-20). Goodloe Marine was awarded the USACE contract. Approximately 60,000 cy of dredge material was estimated in the inlet crossing for the base-bid, and ~110,000 cy of material to be dredged was estimated within the 400 ft bend widener.

The bid included the 400 ft bend widener as an optional bid item, however, as mentioned previously the base-bid items get priority and dredger scheduling/mechanical issues or other delays can limit additional work like bend-widener dredging. Some dredging of the bend widener did occur as part of the 2020 LWFIX Project, but not near the full amount of the

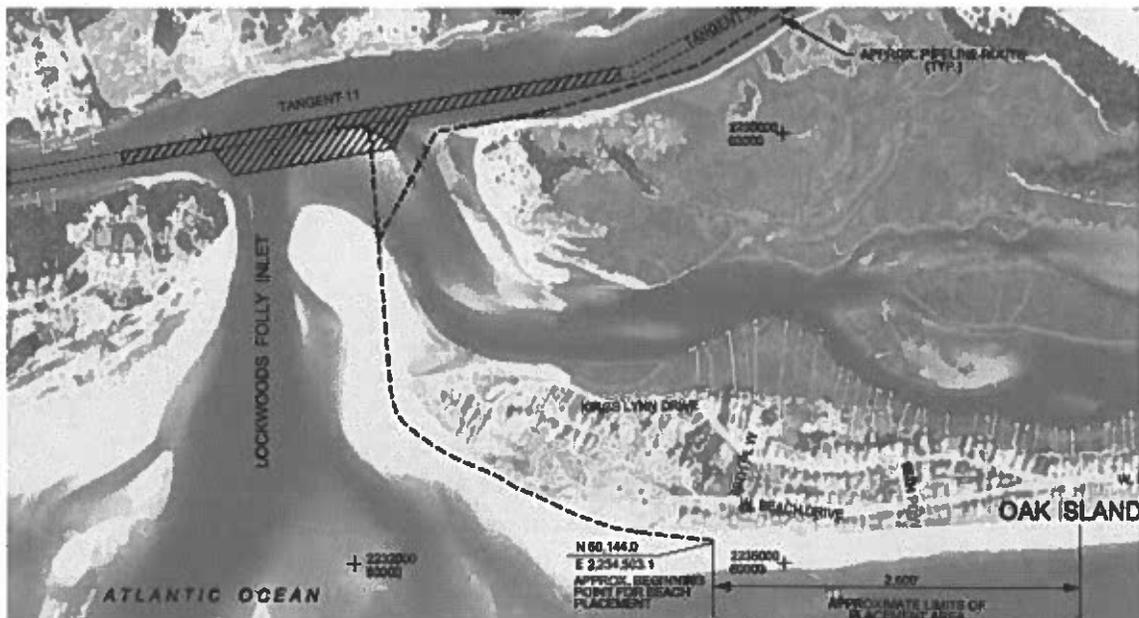
Figure 2-21. LWFIX 2020/2021 Bid Plans (November 3, 2020 Plans).

Similar to the 2019 LWIFX project, dredging placement for the 2021 LWFIX project was on Oak Island's west end. The project estimated 165,000 cy be dredged from the LWFIX and a 200-ft bend widener (note that volume placed on the beach will be ~20-30% less than volume dredged) (see Figure 2-21).
