Holden Beach

Annual Beach Monitoring Report 2025

Prepared For:
Town of Holden Beach, North Carolina

February 2026

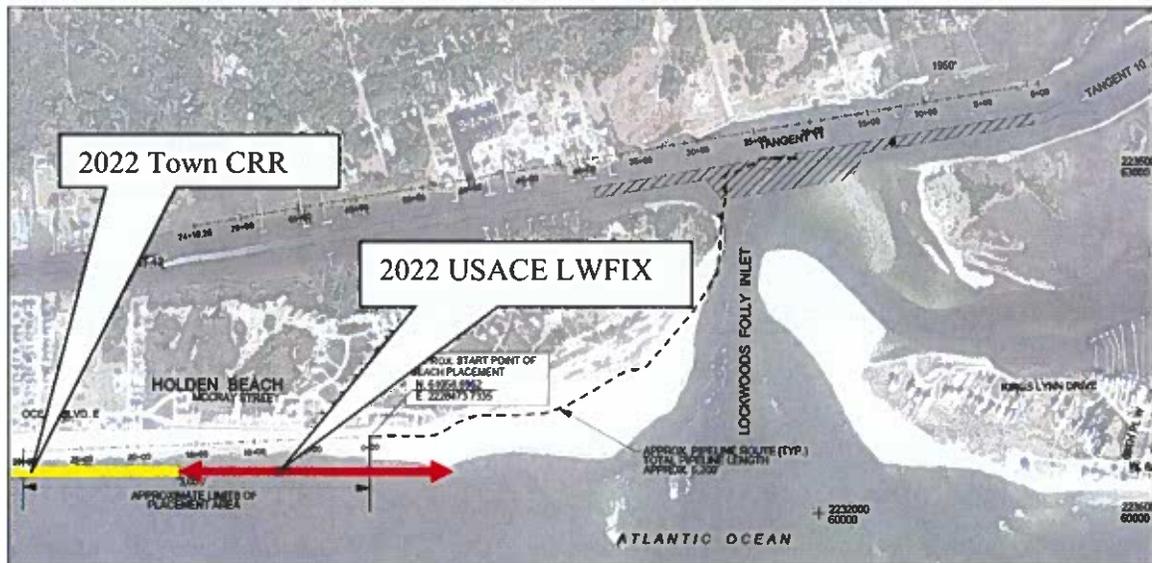
Figure 2-22. LWFIX 2021/2022 Bid Plans and Actual Placement Tying in with the CRR Project Highlighted. (July 2021 Plans).

Similar to the 2017 USACE and Town LWFIX Project and the 2017 CRP, the 2022 USACE LWFIX project occurred in conjunction with the Town's 2022 Central Reach Reimbursement Project in winter/spring 2022. The 2022 LWFIX project was completed in the early spring of 2022 with placement along ~2,000 linear feet of shoreline on the east end of Holden Beach (see Figure 2-22). The Town and ATM staff coordinated with USACE-Navigation personnel in order to maximize volume placed on Holden Beach. It was estimated the project added

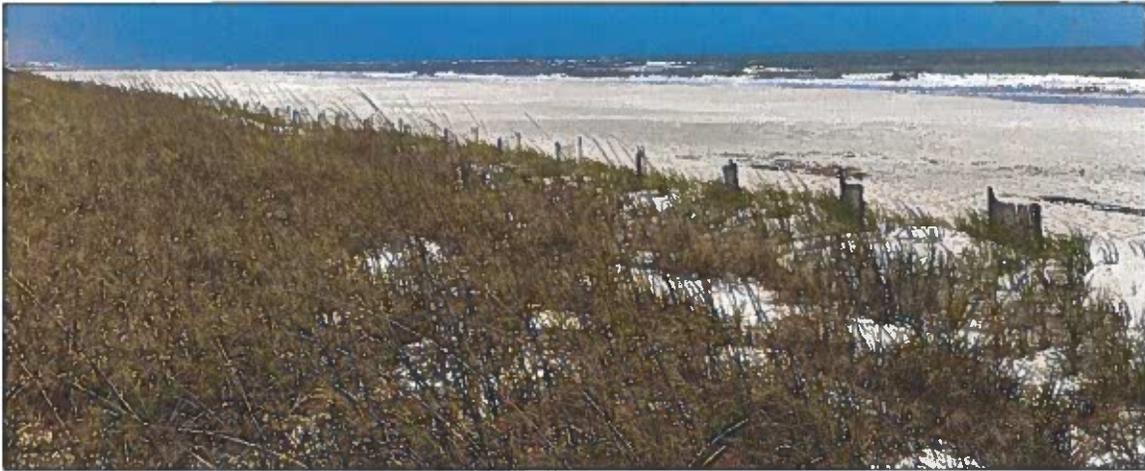
Figure 2-23 (A). April 2022 Upland Photograph Taken near Station 40+00 Showing Healthy Dune Vegetation and Wide Beach Following 2022 LWFIX Construction.

Immediate post-construction photos are shown on Figures 2-23 (A-C), showing the wide dry beach as a result of the project. The 2022 USACE LWFIX was very successful and the timing of this nourishment coincided well with the Central Reach Project and to help “fill out” much of the remaining shoreline of Holden Beach east of the larger CRR.

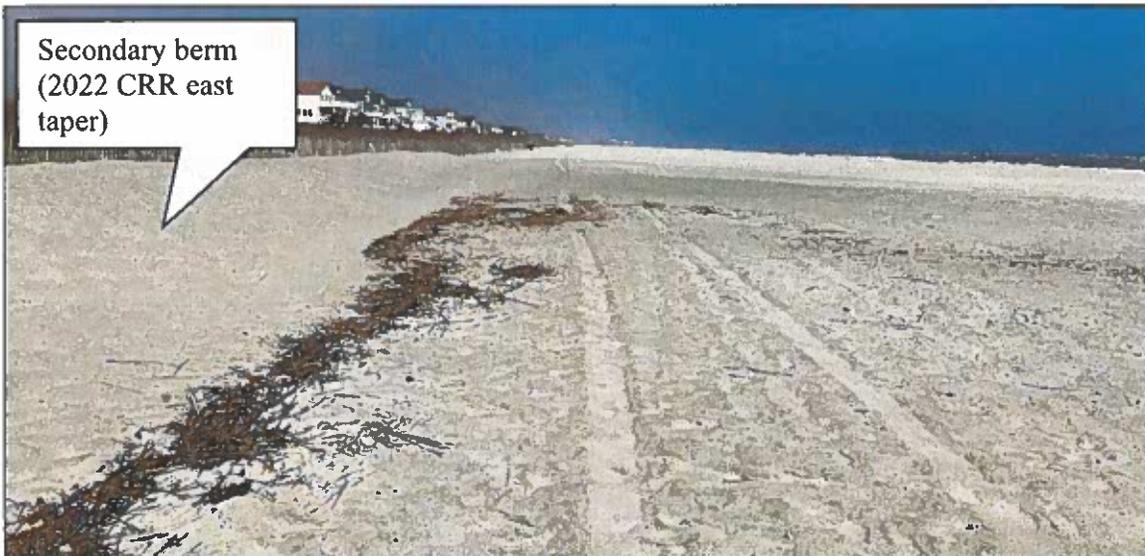
Figure 2-23 (B). April 2022 Photograph near Station 40+00 Looking East. Note Newly Constructed Secondary Berm along East Taper of CRR which Ties in with the 2022 LWFIX Project at this Location.

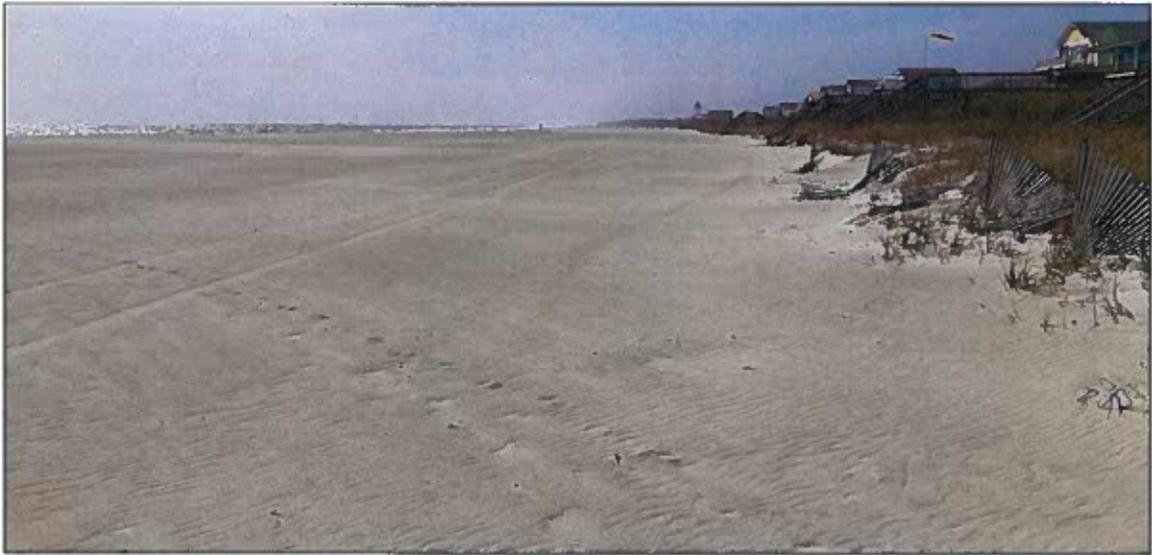
Figure 2-23 (C). April 2022 Photograph Taken between Station 20+00 and Station 30+00 Looking West Showing Newly Constructed 2022 LWFIX Beach Fill.

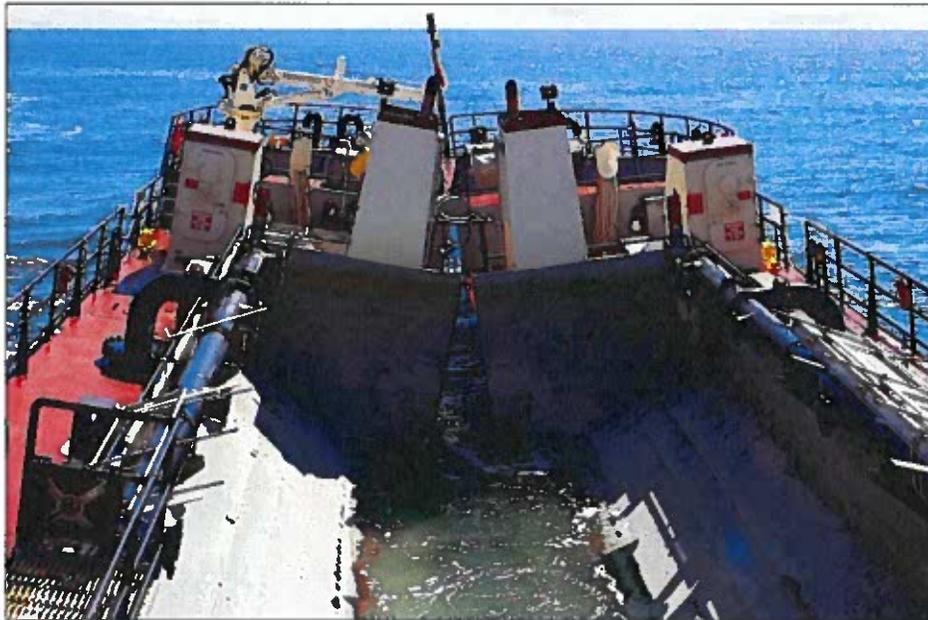
Figure 2-25. USACE Shallow Draft Split-Hull Hopper Dredge the Murden.

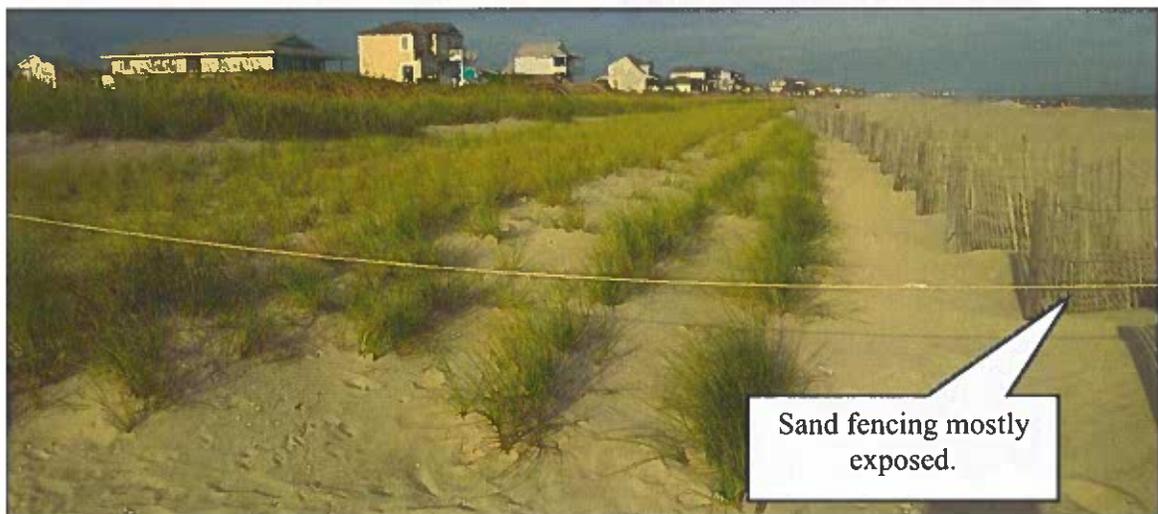
Figure 2-28 (A). Sand Fencing along the Seaward Edge of the Starter Dune for the Central Reach Project at Station ~60+00 Showing Planted Dune Vegetation. (ATM Photo, Taken August 2018).

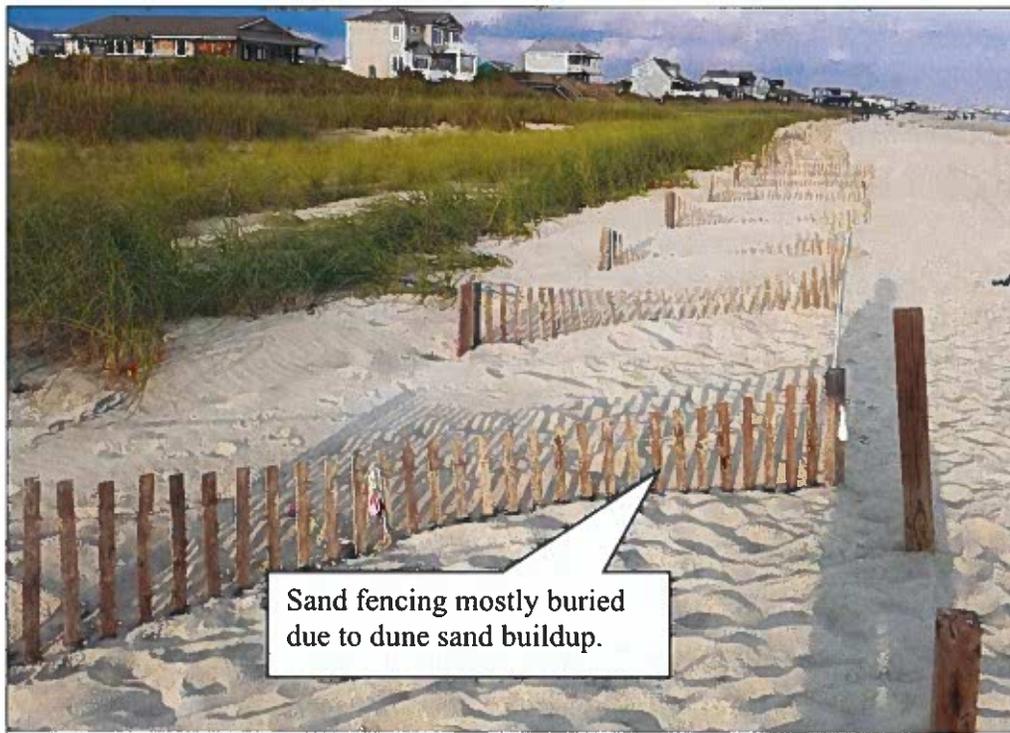
Figure 2-28 (B). Sand Fencing for the Central Reach Project at Station 60+00 Showing Dune Vegetation and Sand Growth About 2-years Post Project. (ATM Photo, Taken September 2019).

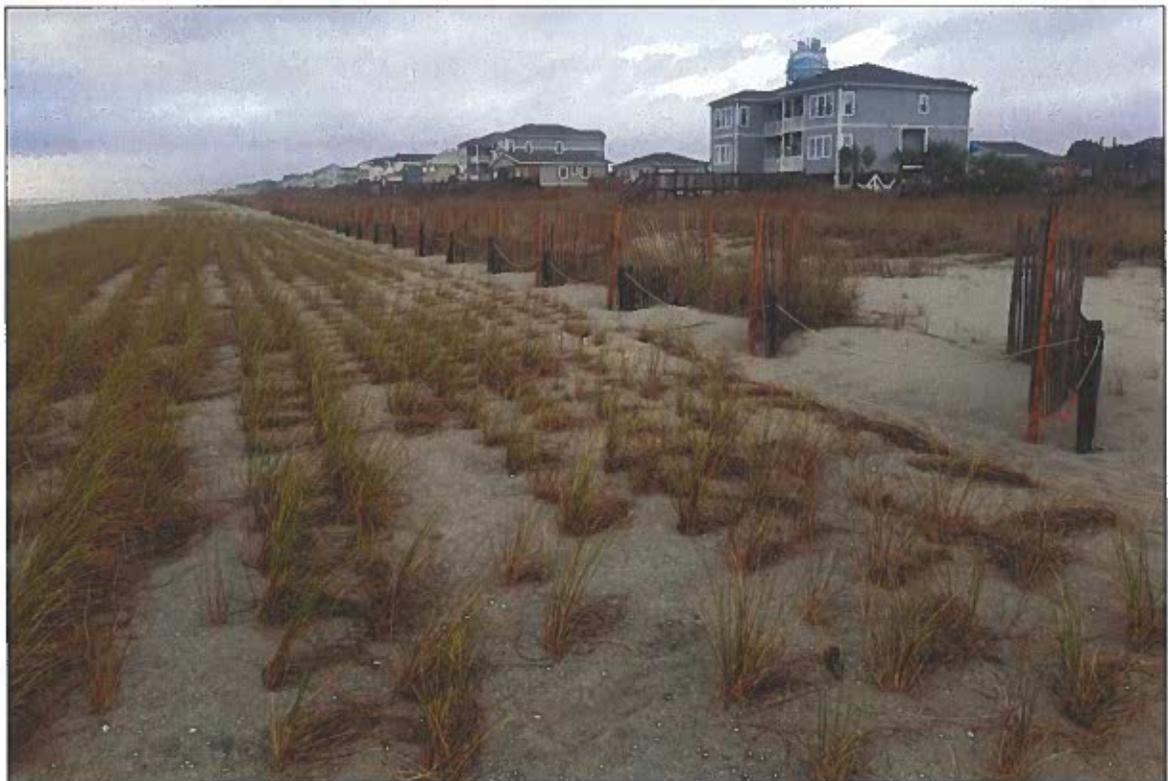
Figure 2-29 (A). November 2022 near Station 80+00 Showing New Plantings Following CRR along Newly Constructed Secondary Berm (and after Hurricane Ian).

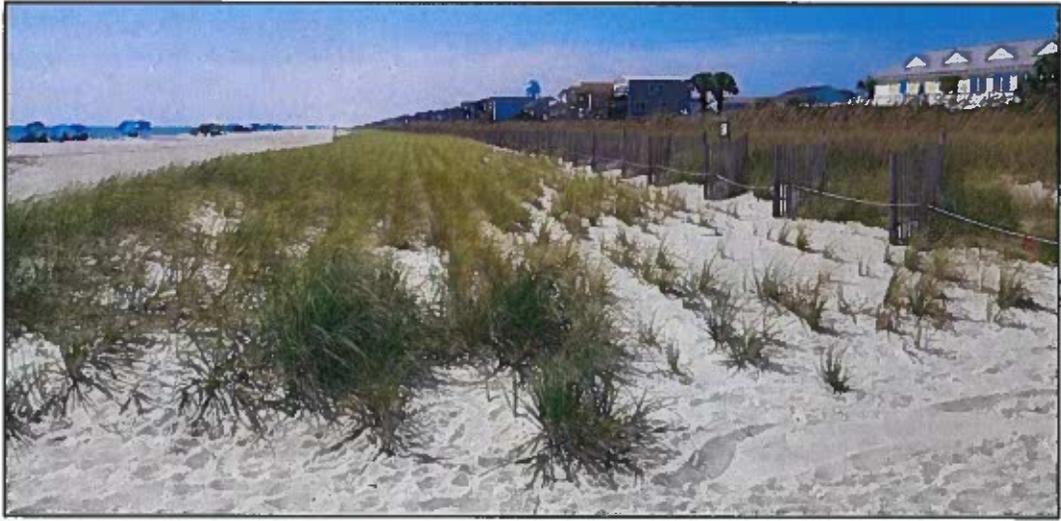
Figure 2-29 (B). September 2023 between Station 60+00 and Station 70+00 Showing Plant Growth ~1.5-year Post CRR along Constructed Secondary Berm.

occurred primarily along the newly constructed secondary berm extending seaward from the existing sand fencing. Dune growth suffered some substantial damage as a result of Hurricane Isaias in August of 2020 and Hurricane Ian in September 2022. Figure 2-29 (A) – (D) shows photos of the area from 2022 to 2025, revealing healthy growth of the new and previous plantings.

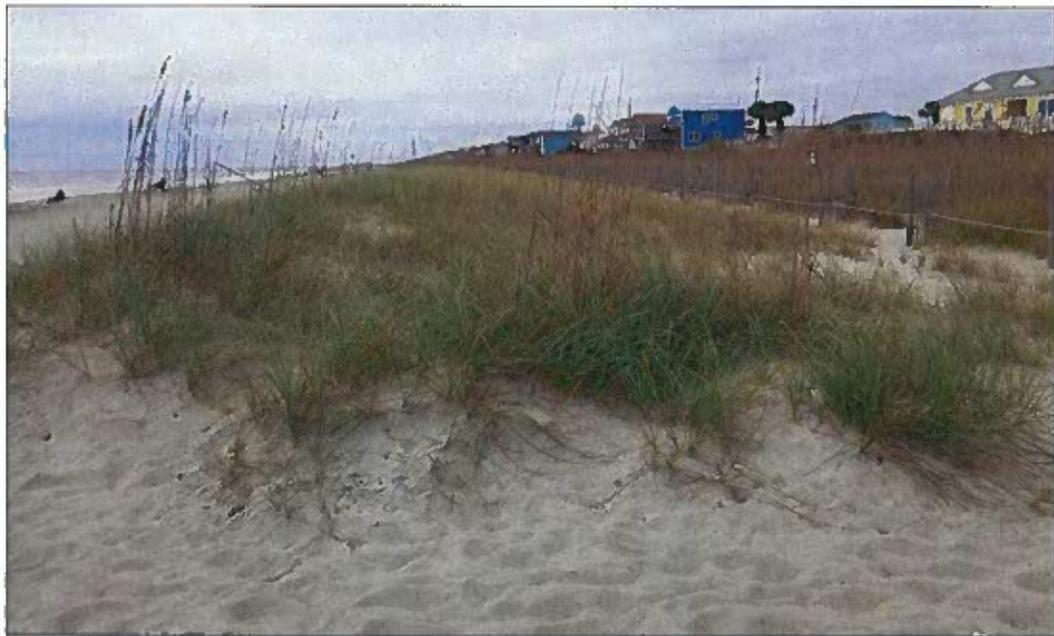
Figure 2-29 (C). October 2024 between Station 60+00 and Station 70+00 Showing Plant Growth ~2.5-year Post CRR along Constructed Secondary Berm.

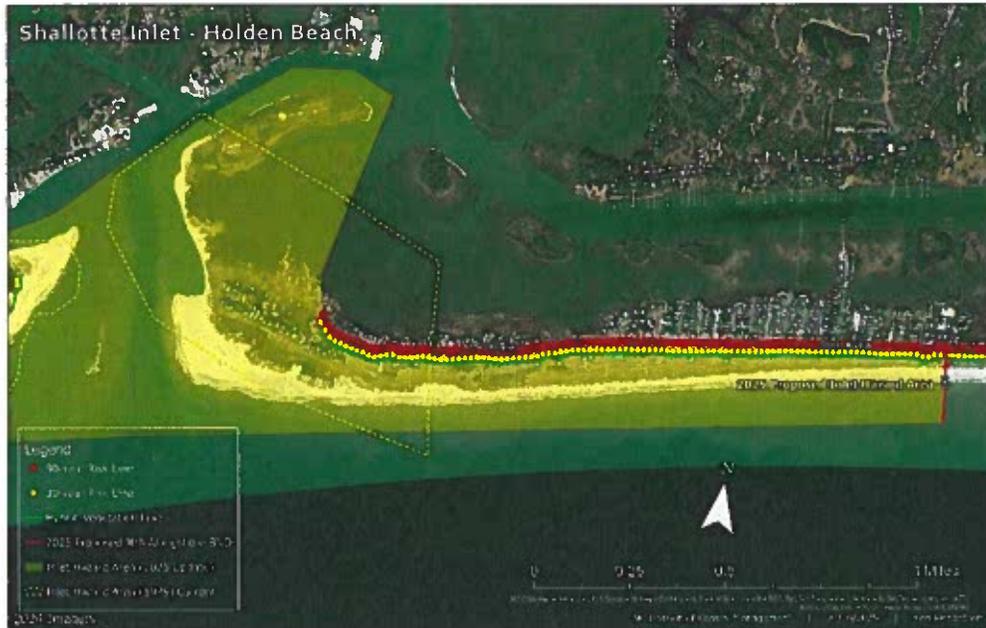
Figure 2-33. Proposed IHA for the West End of Holden Beach (Source: 2025 DCM IHA Report).

Revised IHAs were previously introduced around 2010 and again in 2019, however, these were never implemented. A recent report published in August 2025 presents the most recent proposed Inlet Hazard Areas expanded for Shallotte and LWF Inlets (as with most of the IHAs statewide). Figure 2-33 and 2-34 present the proposed IHAs affecting Holden Beach (more information available on this topic at <https://deq.nc.gov/about/divisions/coastal-management/>). The 2025 IHAs are still listed as “pending” on the DEQ website and it is not known when/if they become officially adopted.

In general, the new methodology for the IHA determination appears reasonable for the east end of Holden Beach bordering LWF Inlet, however, the west end (adjacent to Shallotte Inlet) is accretional and the IHA methodology is overly conservative. The “hybrid-vegetation” line along the west end is decades old (vegetation lines making up the HVL are from 1970-1993).

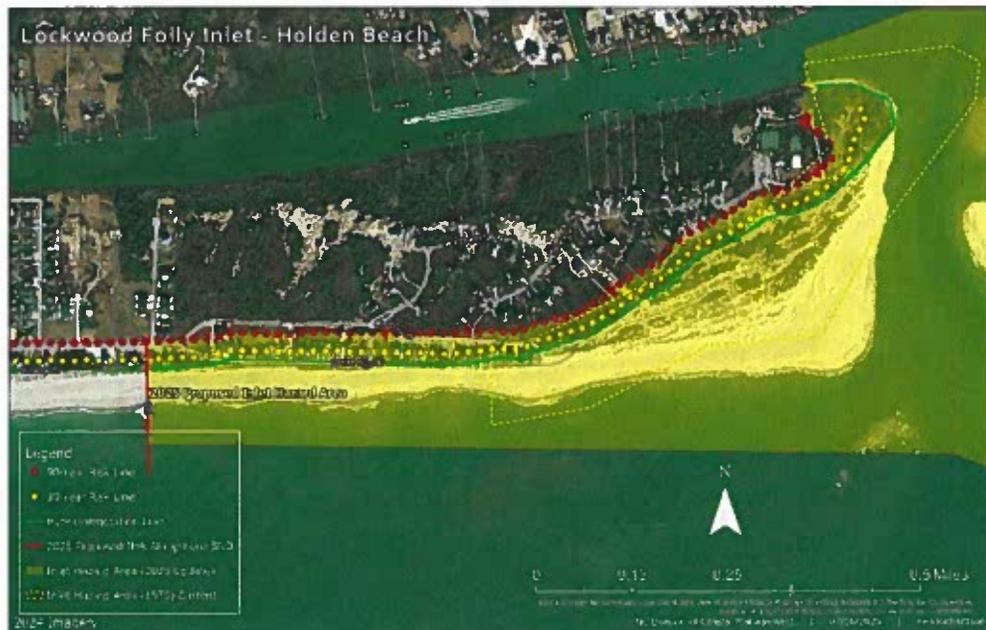
Figure 2-34. Proposed IHA for the East End of Holden Beach (Source: 2025 DCM IHA Report).

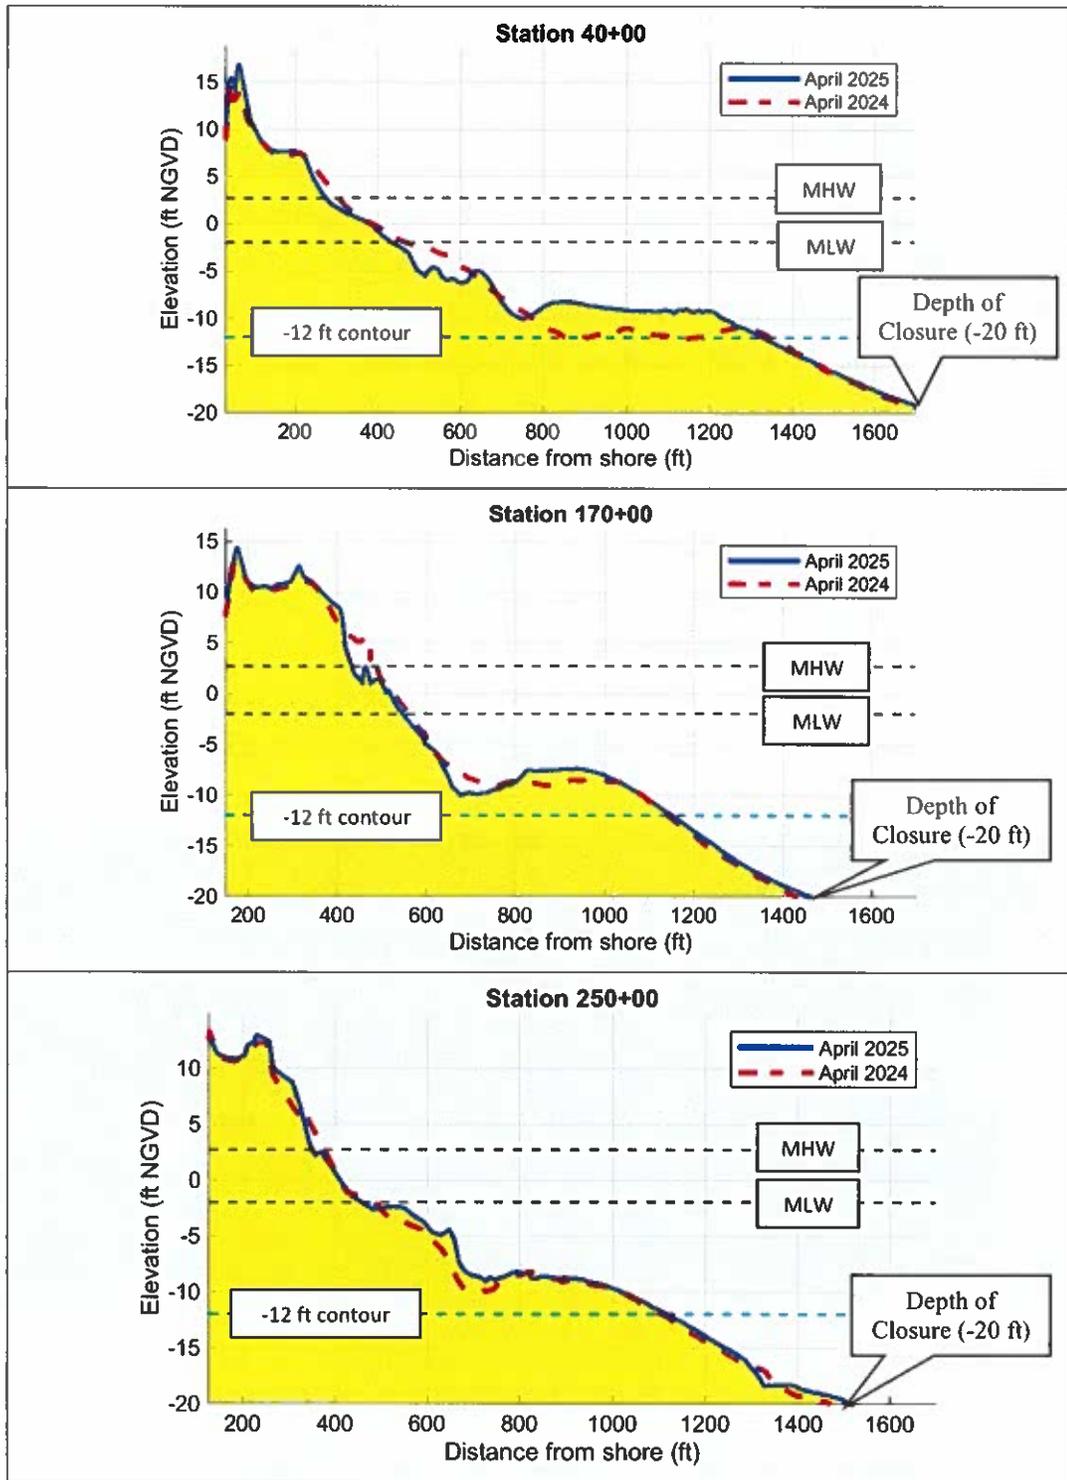
Figure 3-2. Upper Panel Shows Station 40+00 Profile Transect Comparison on the Town East Reach of Holden Beach. This Location is near the Eastern Taper of the CRR Template Where it Adjoined the USACE LWFIX Project. Middle Panel Shows Station 170+00 Profile Transect Comparison at the Pier. Bottom Panel Shows Transect 250+00 Profile within the Town of West Reach. The -12 ft Contour Line is Plotted to Show how Profile is Relatively Stable/Mildly Accretional from -12ft to -20ft NGVD.

Figure 3-2 presents three example transect surveys comparing April 2024 and April 2025 survey data. The April 2025 survey represents three-year post-construction conditions of the Town's recent 2022 Central Reach Reimbursement and the USACE 2022 LWFIX projects.

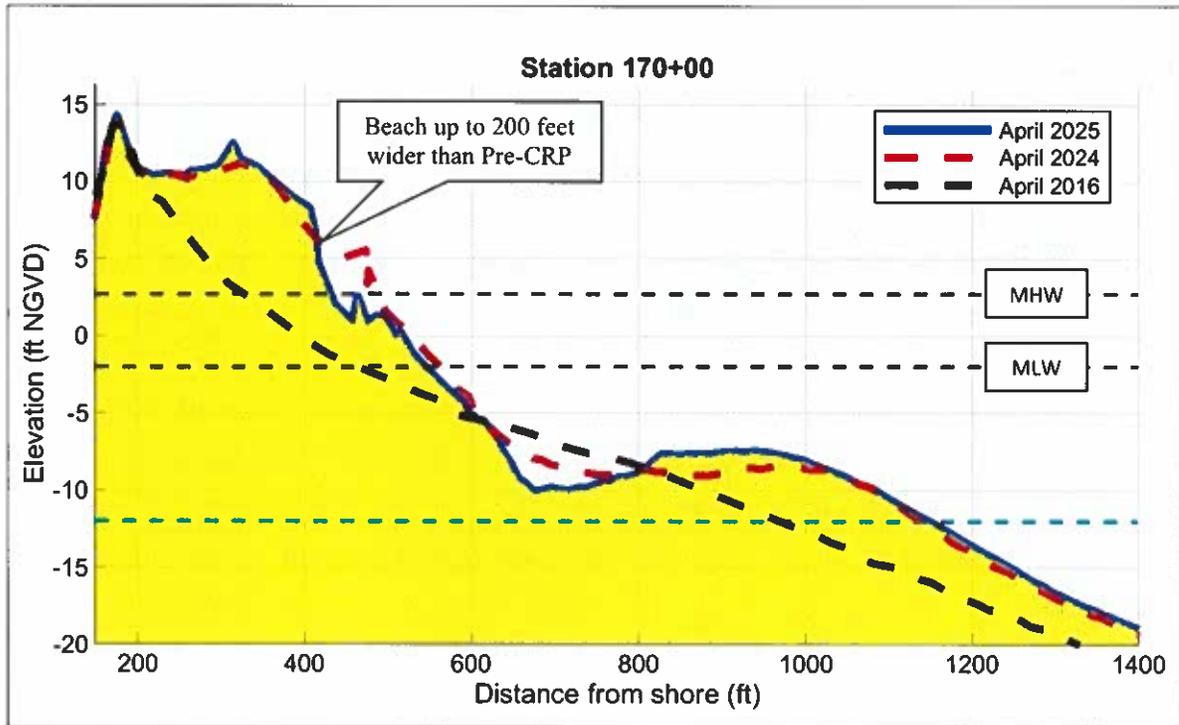
Figure 3-3. Panel Shows Station 170+00 Profile Transect Comparison at the Pier.

Of note is that current conditions in the upper beach and nearshore are better than Pre-CRP conditions (2016). Figure 3-3 shows the 2024 and 2025 profiles for Transect 170+00

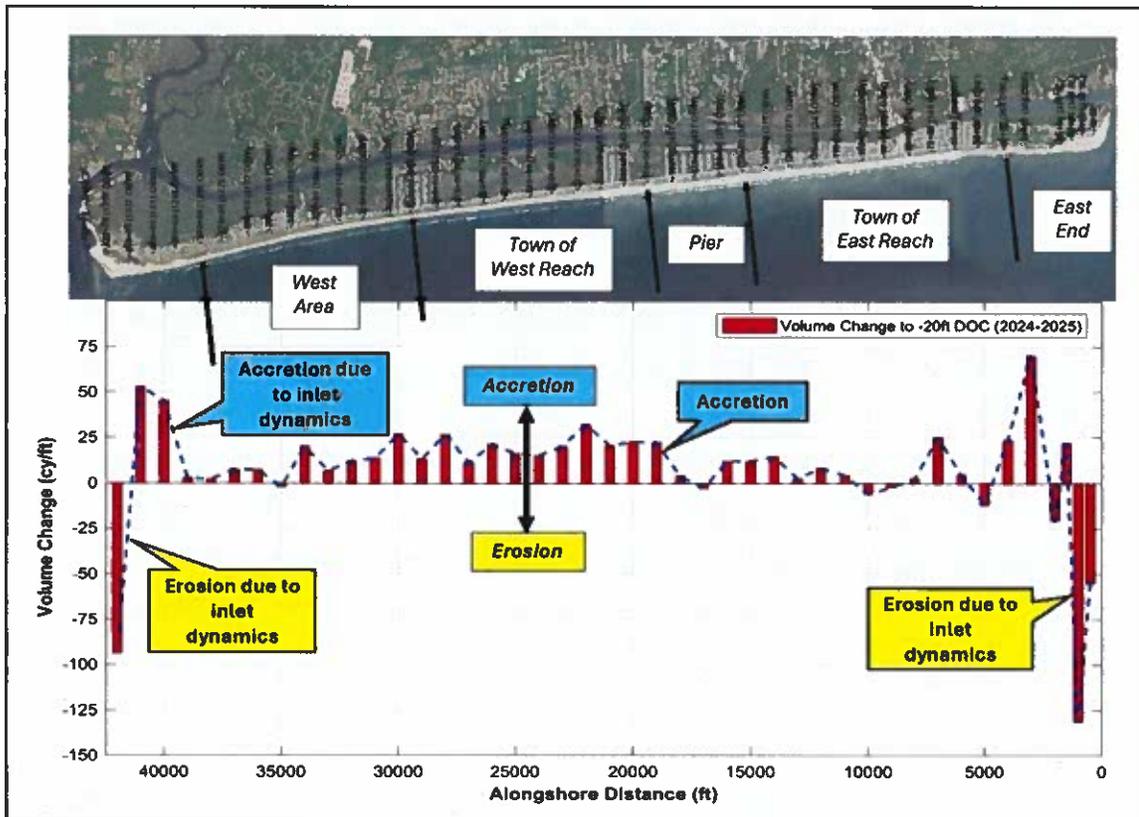
Figure 3-4. Volume Change from the Dune to -20 ft Depth Using April 2024 and April 2025 Surveys. Positive Values Indicate Accretion, Negative Values Indicate Erosion. The Most Significant Erosion over the Past Year is Seen near the Inlets, Which is not Uncommon due to Inlet Dynamics.

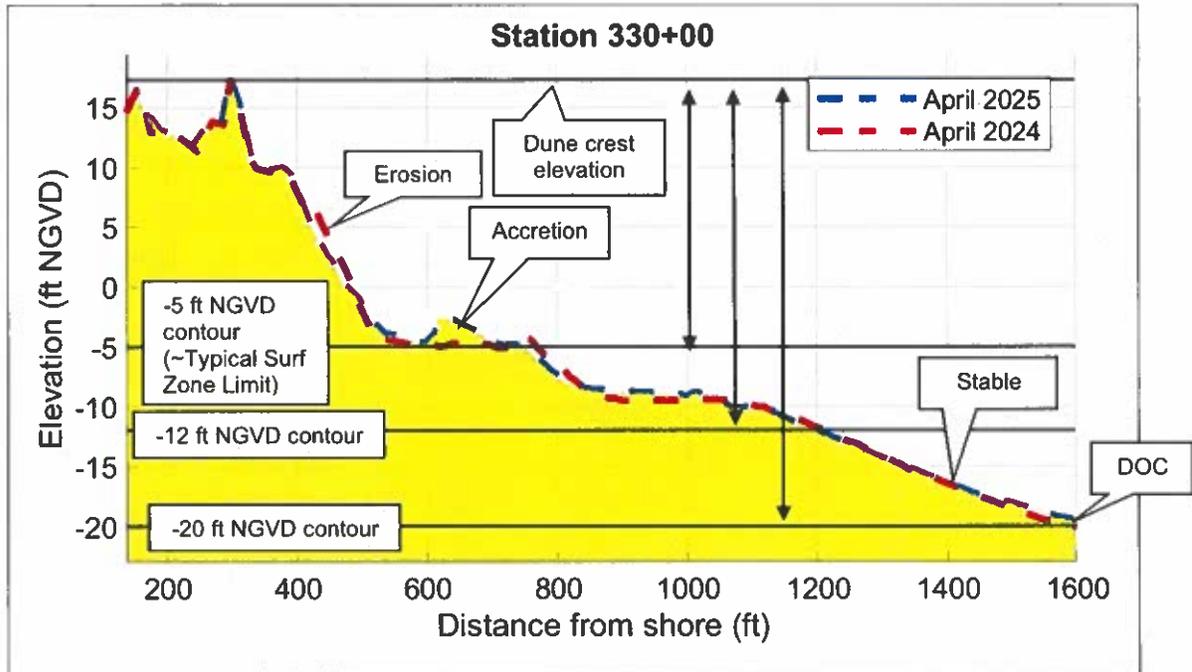
Figure 3-5. Three Different Volume Calculation Limits Used for this Analysis: Dune to -20 ft NGVD, Dune to -12 ft NGVD, and Dune to -5 ft NGVD.

Volume calculations were also performed from the dune to the -5 ft NGVD contour, which represents the approximate typical surf-zone limit. The -5-ft volume limit is more characteristic of visible/tangible beach conditions than the deeper -12-ft or -20-ft limits that can occur more than a quarter mile offshore.

Figure 3-5 presents the three different boundaries historically used for volume calculations and illustrates some of the surf zone accretion that was observed in the West Area at

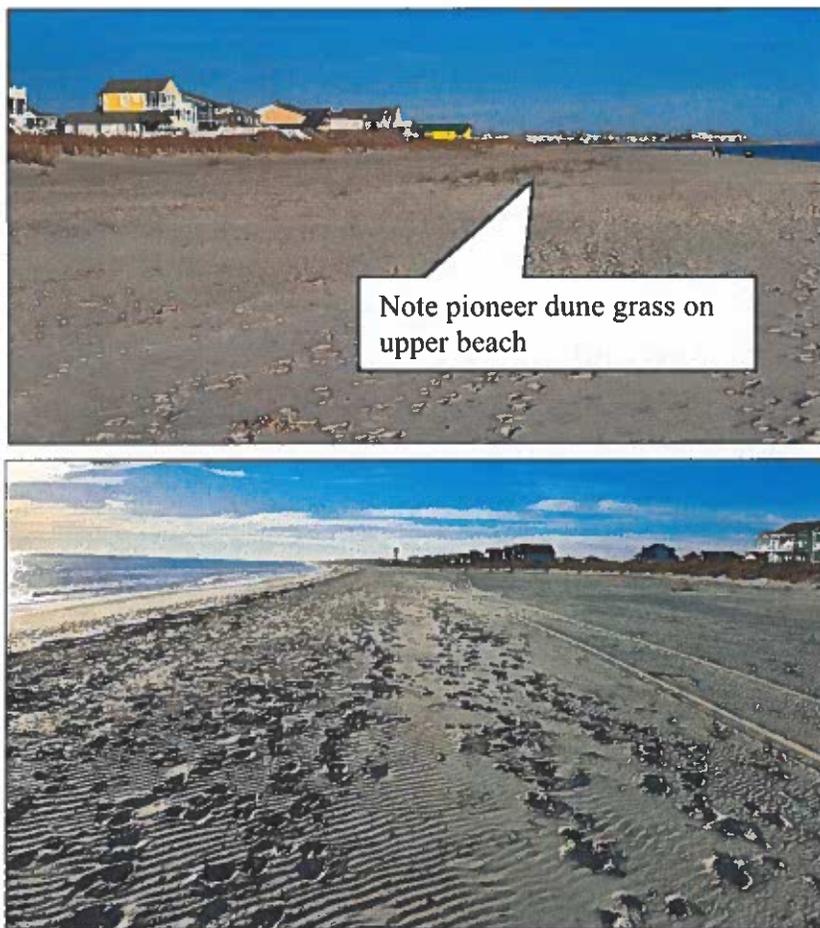
Figure 3-6. Recent Photographs of East End Beach Conditions Taken between Stations 30+00 and 40+00 Looking East (Upper Panel) and between Stations 40+00 and 50+00 Looking West (Lower Panel). ~3.5-year post 2022 LWIFX Placement Showing Wide Beach Present in What Is Typically an Erosional Hotspot Area (Photos Taken November 2025).

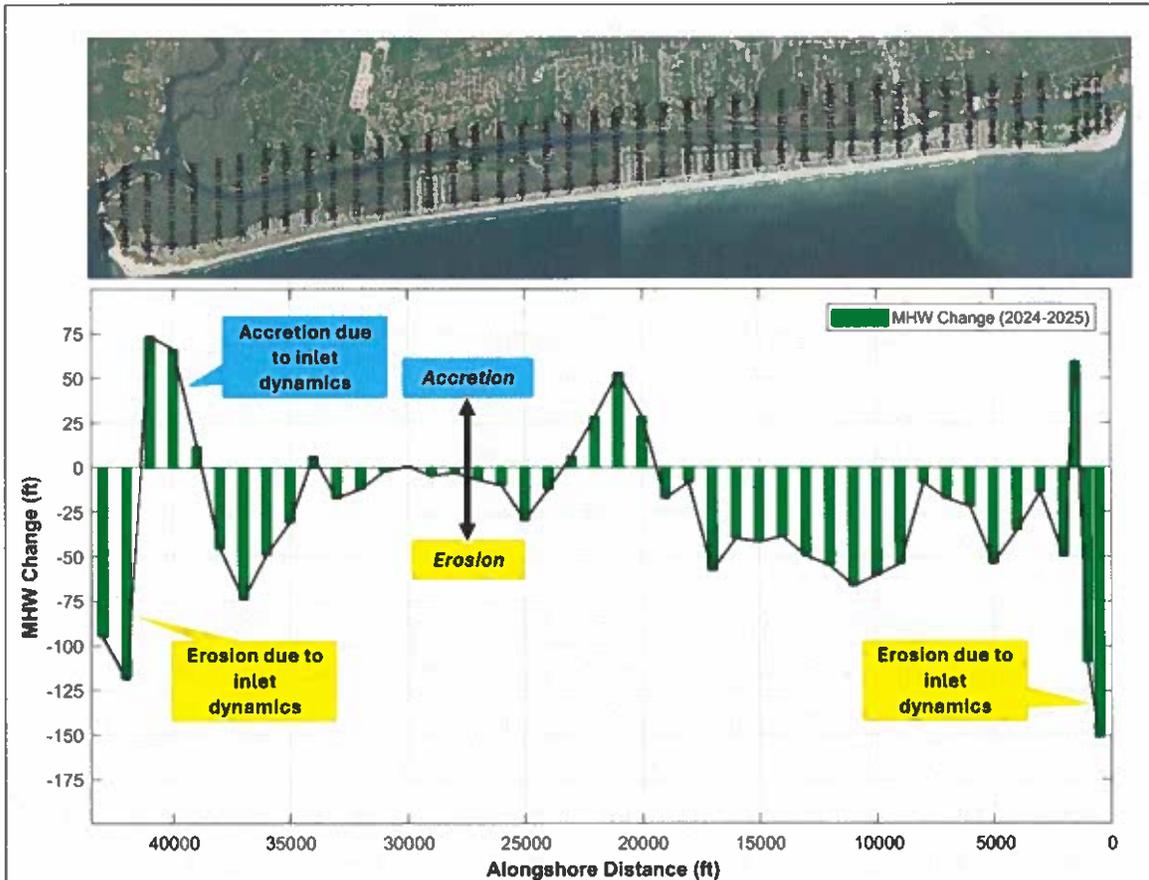
Figure 3-7. MHW Shoreline Change from 2024 to 2025. Erosion/Landward Movement of the MHW Shoreline along Most of Holden Beach. Fluctuations in Erosion at the Extreme East and West Ends are due to Inlet Dynamics.

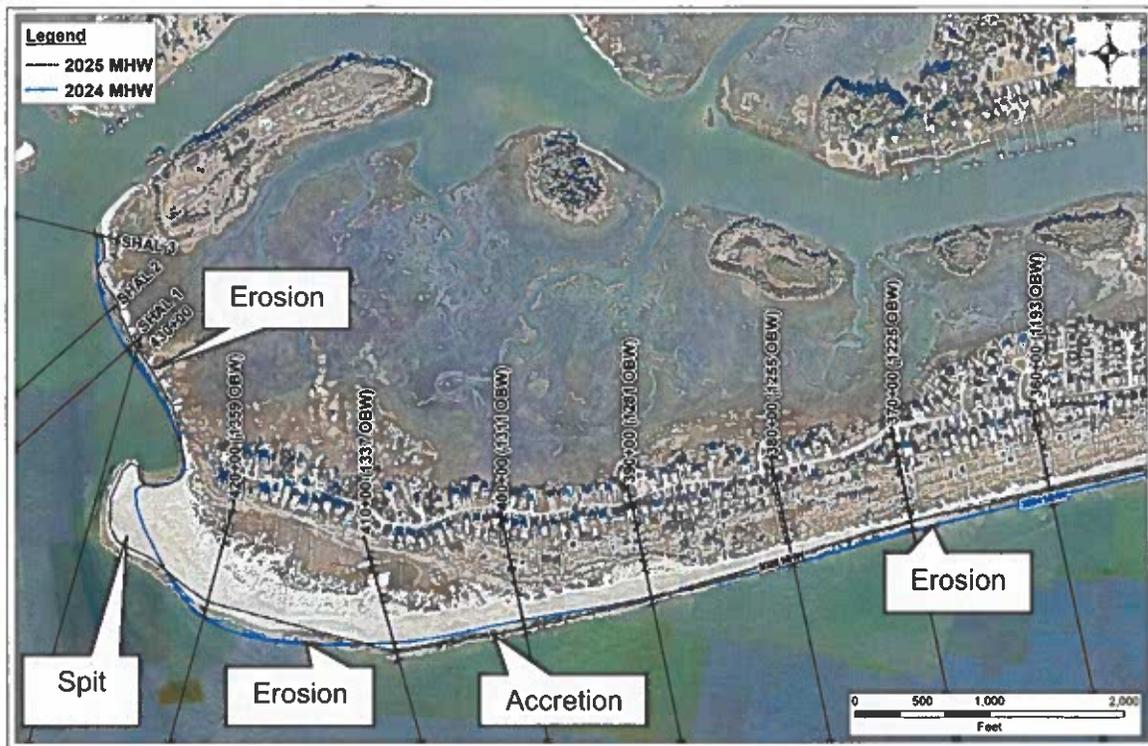
Figure 3-8 (A). 2025 (Black) and 2024 (Blue) MHW Shoreline Positions along the West End of Holden Beach near Shallotte Inlet. "SHAL 1" Begins at the Same Location as 430+00. (January 2025 Aerial Shown).

The MHW line and aerial analysis on the far west end shows that this section of shoreline experienced variability in MHW change, with a mildly erosional trend overall. As shown in Figure 3-8(A), there is variability in position of the MHW line by station as expected closer to the inlet. The localized erosion/accretion is likely due to sediment movement during energetic wave conditions and/or inlet related processes.

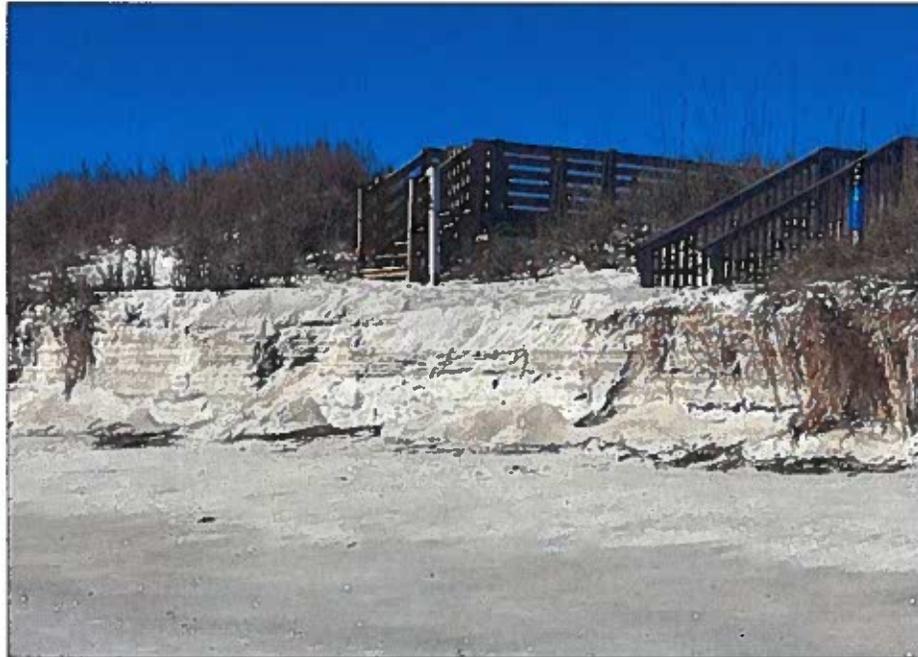
It is noted that some upper beach erosion has occurred in the vicinity of Stations 360+00 (~1193 OBW) and 380+00 (~1255 OBW) where scarping is occurring up to the dune vegetation line. Figure 3-8(B) presents a photo of the scarping. Figure 3-8(C) presents the 2025 MHW line on a 2008 aerial in this area. The island's morphology shows a classic "drumstick" feature on the west end where the shoreline (and dune) protrude. The island has grown over the years and this drumstick feature is moving west. The scarping is occurring where the drumstick had been 15-20 years ago. This reorientation is expected to continue. Dune system widths in the West Area can be ~400-500ft (discussed in the

Figure 3-8(B): Upper Beach Scarping on West End near Station 360+00 (~1193 OBW).

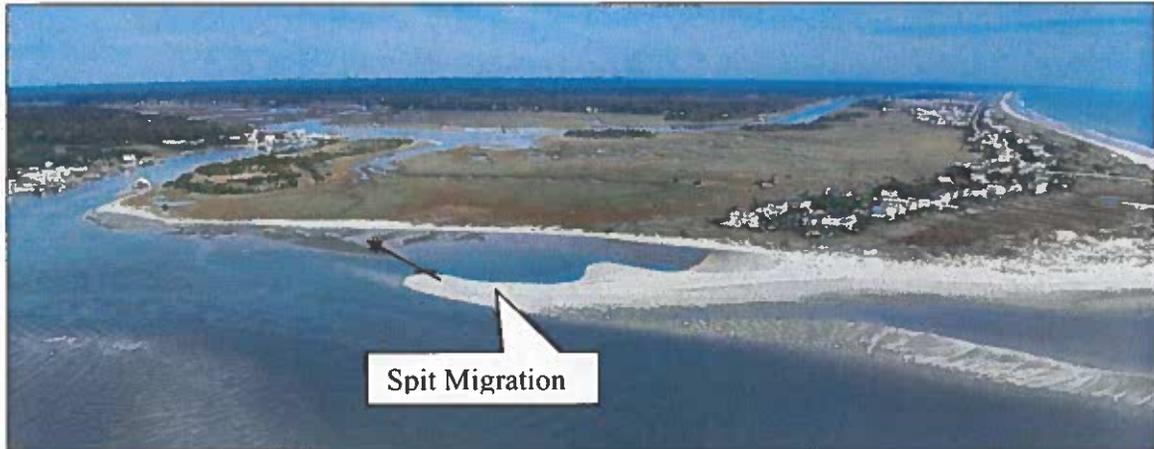
Figure 3-8(D). December 4, 2025 Oblique Aerial Where the Spit is Seen Arcing Towards the Inlet Shoreline along Holden Beach (Source: CPE).

Note that the elongated spit on the west end appears to be arcing back towards the Shal 1, Shal 2, and Shal 3 stations. Figure 3-8(D) presents an oblique aerial from December 4, 2025 where the spit is seen arcing towards the inlet shoreline along Holden Beach.

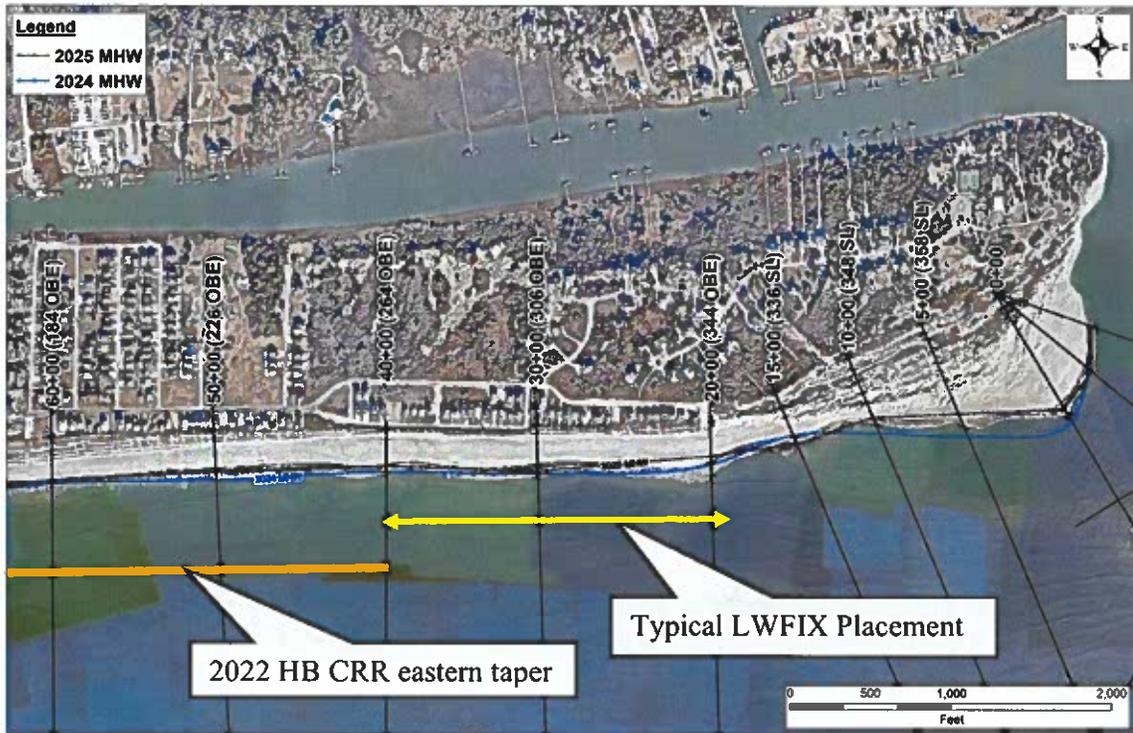
Figure 3-9. 2025 (Black) and 2024 (Blue) MHW Shoreline Positions along the East End of Holden Beach near Lockwood Folly Inlet (January 2025 Aerial Shown).

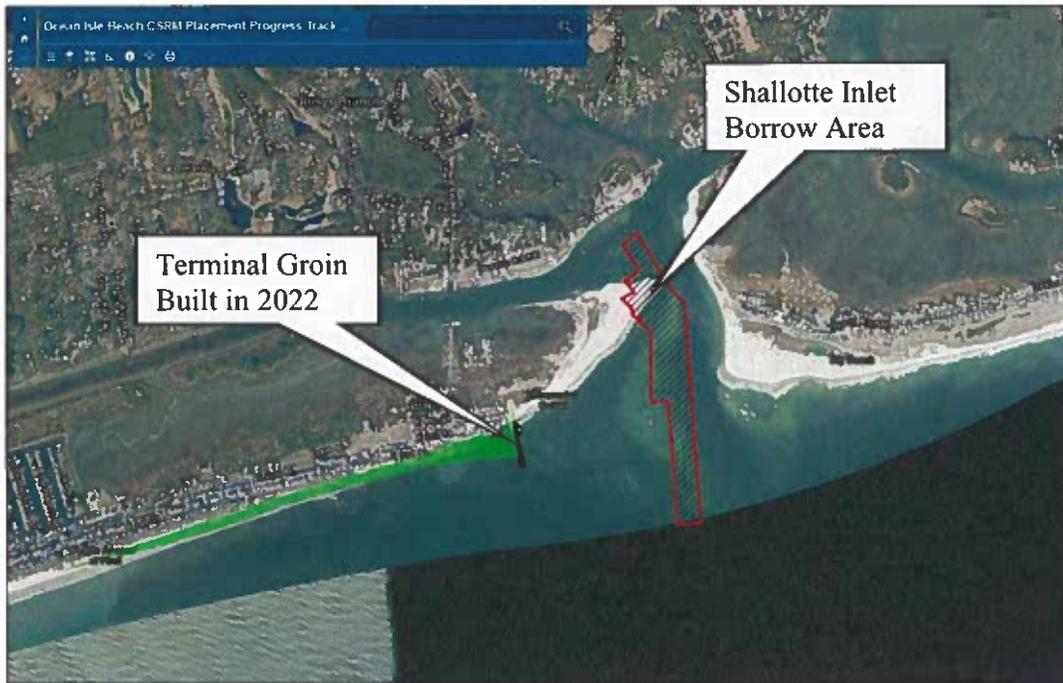
Figure 3-10. Ocean Isle Beach 2021/2022 Terminal Groin and Federal CSRM Beach Renourishment Projects. Shallotte Inlet Borrow Area and Placement Area Shown (USACE Ocean Isle Beach CSRM Placement Progress Tracker).

As previously discussed, the Ocean Isle nourishments typically use Shallotte Inlet as a borrow area. The most recent of these nourishment events occurred in the winter/spring of 2021/2022 as part of the USACE Federal Coastal Storm Risk Management (CSRМ) project, which coincided with construction of Ocean Isle Beach’s terminal groin project (see Figure 3-10). This project included dredging about 760,000 cy from Shallotte Inlet and placement onto the eastern shoreline of Ocean Isle, west of the newly built groin structure.

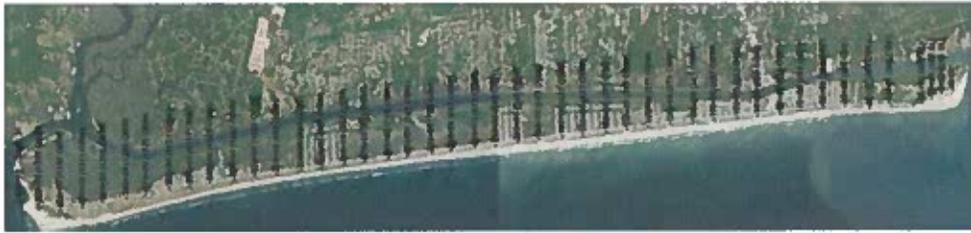
Figure 3-12. Dune Vegetation Buffer Width along Holden Beach.

Due to consistent dune vegetation efforts in conjunction with nourishment activity, the vegetated dune system is healthy and wide. Figure 3-12 shows the current width of the vegetated dune system alongshore from Stations 0+00 to 420+00. Figure 3-13 presents an example dune vegetation width transect at Station 370+00 (~1225 OBW). The seaward dune line was delineated using high-resolution (i.e. 3-in horizontal resolution) aerial imagery taken in early January 2025 from Nearmap.com. The current buffer width is over 100 ft wide across the majority of Holden Beach, with sections of the West Area, Shallotte Inlet, and Lockwood Folly Inlet showing widths in the range of ~200-700 ft.

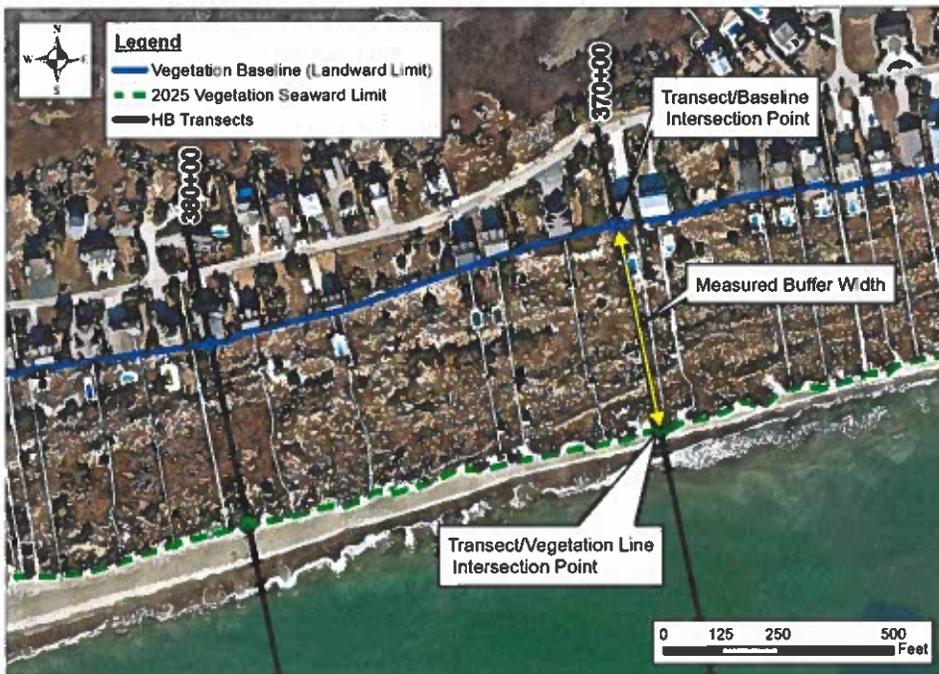
Figure 3-13. Planview Illustration of How Measurements Were Taken for Dune Vegetation Buffer Width.

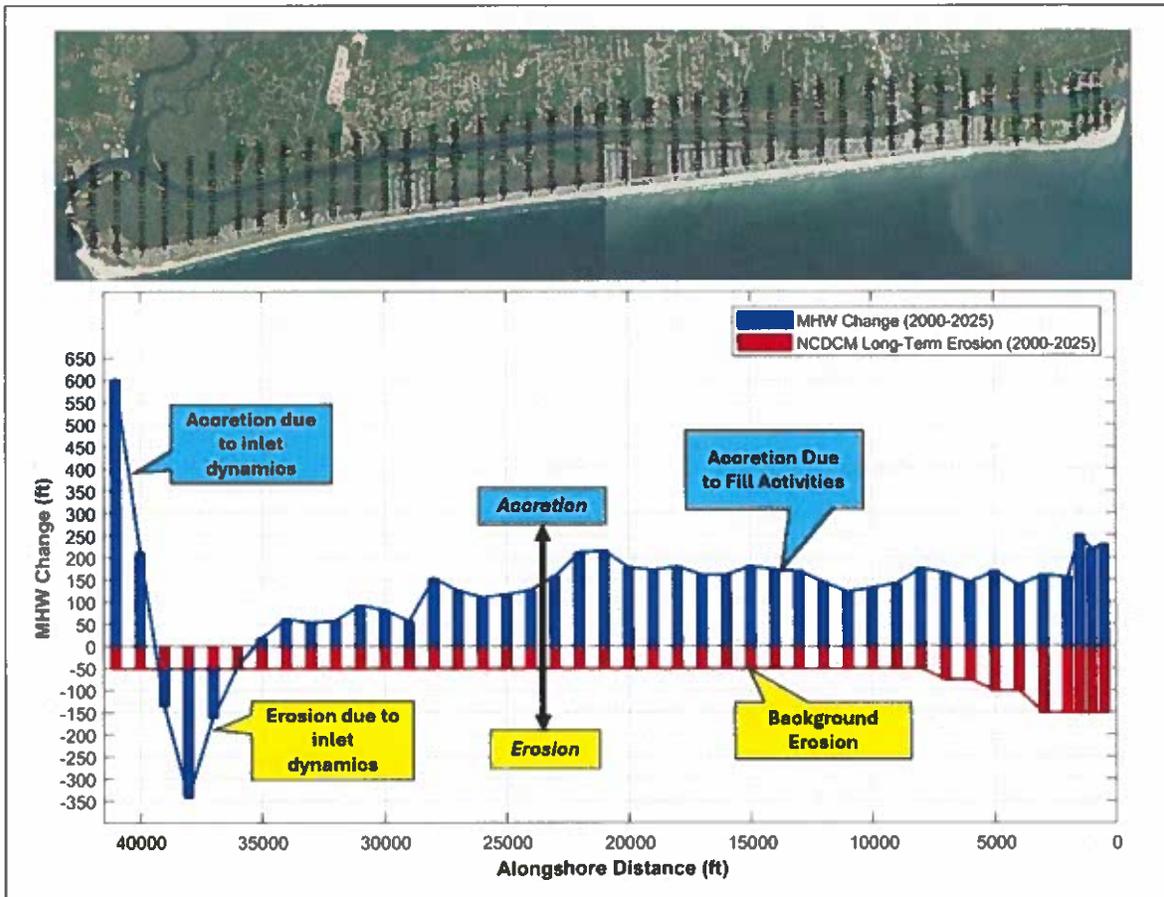
Figure 3-15 presents an approximate 25-year MHW shoreline comparison using 2000 and 2025 survey data. The 2000 survey represents a significantly erosional condition. A general accretional trend of 50 to 220 ft is exhibited for the MHW shoreline between 2000 and 2025, with an average change of +115 ft (not including the more variable inlet shorelines and east end nourishments). Of note is the western reach of the island where an erosional trend has occurred. This was discussed in Section 3.3 where island morphology is shifting the "drumstick" feature westward.

Figure 3-15. MHW Change from 2000 to 2025 Compared to DCM Background Erosion for the Same Period.

As a result of the Central Reach nourishments the Town East and Pier Reaches exhibit a large increase (~155-170 ft) in MHW change over the last 25 years, excluding inlet reaches. Similarly, the Town West and USACE East reaches show large increases (~148 to 176 ft). The decrease observed in the West Area is primarily driven by significant changes in beach morphology and the “drumstick” feature moving westward.
