Holden Beach

Annual Beach Monitoring Report 2025

Prepared For:
Town of Holden Beach, North Carolina

February 2026

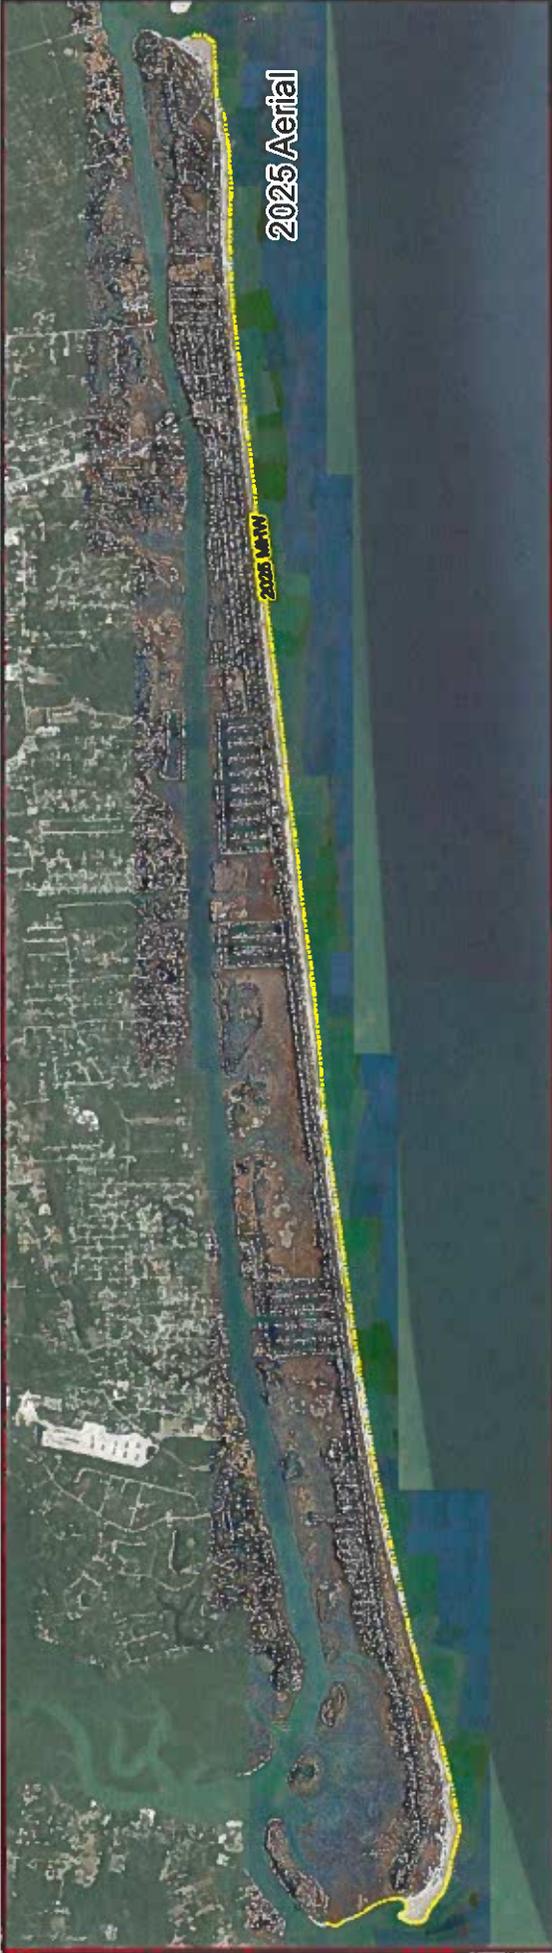
1993 Beach Conditions Significantly More Erosional Than Today

Figure 3-16
 1993 and 2025 Aerial Comparison with 2025 Mean High Water (MHW) line.
 2025 aerial and 2025 MHW Line shows overall accretion in comparison with 1993 conditions.

Figure 3-16 compares a 1993 aerial of Holden Beach with a 2025 aerial. The 2025 MHW line is shown on both aerials for comparison purposes. Figure 3-16 clearly shows that the overall health of the Holden Beach shoreline is significantly better than it was decades ago.

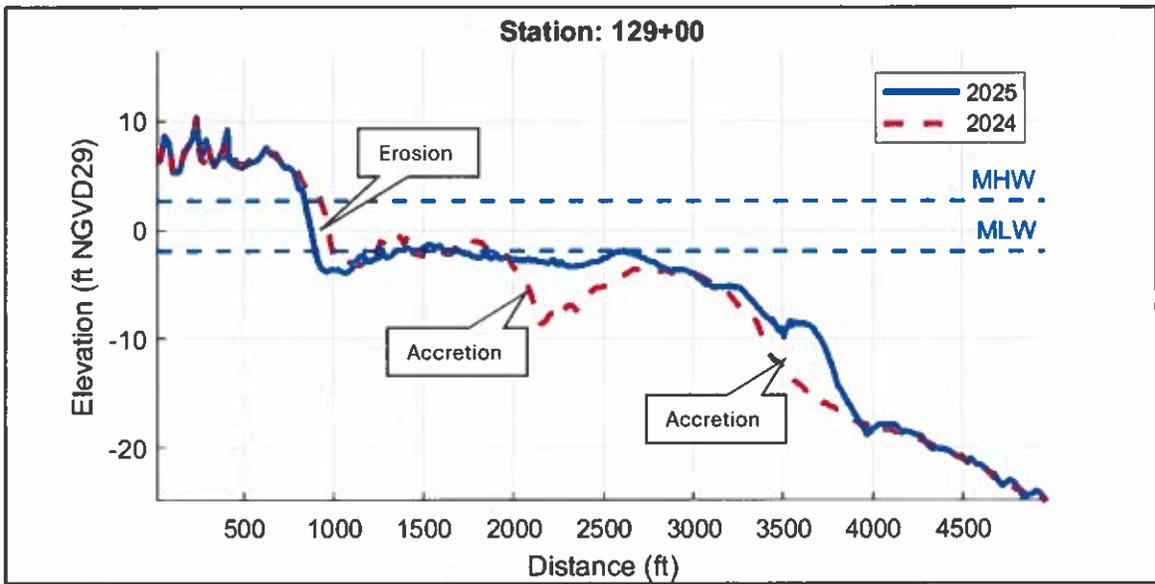
Station 129+00. LWF Inlet Channel. Intertidal erosion and accretion of the flood shoal offshore is observed since the 2024 survey. MHW=Mean high water, MLW=mean low water.

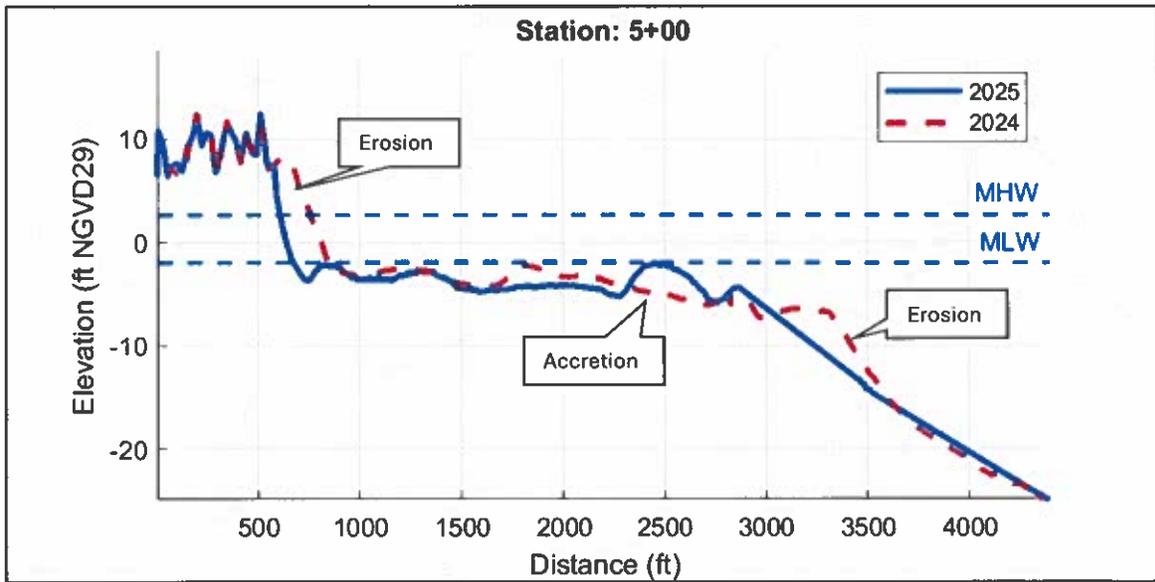
Station 5+00. Upper beach and Intertidal erosion observed since 2024 survey. MHW=Mean high water, MLW=mean low water.

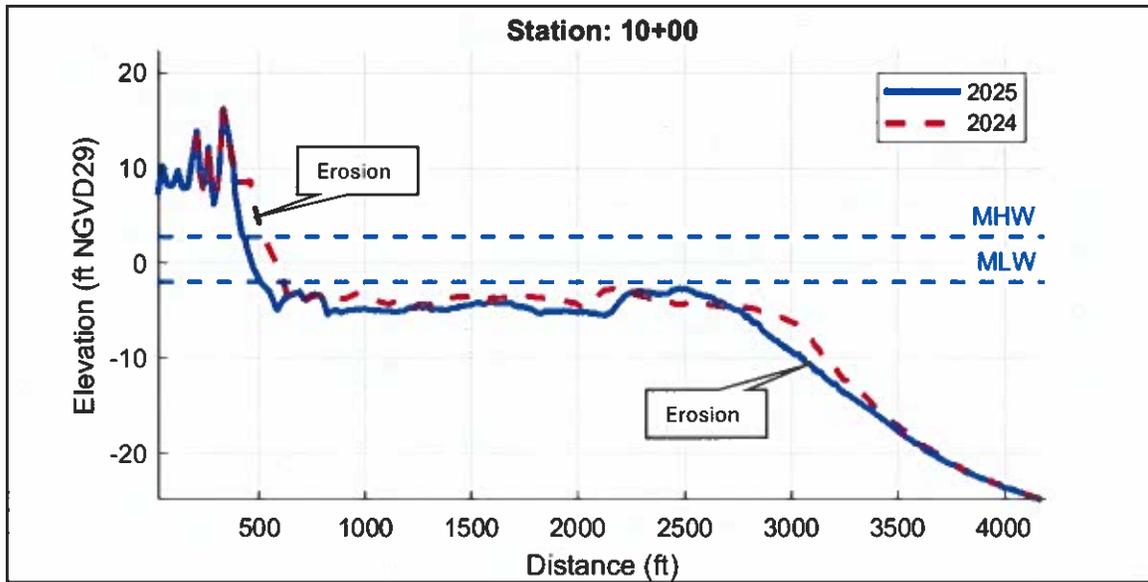
Station 10+00. Upper beach and Intertidal erosion observed since 2024 survey. MHW=Mean high water, MLW=mean low water.

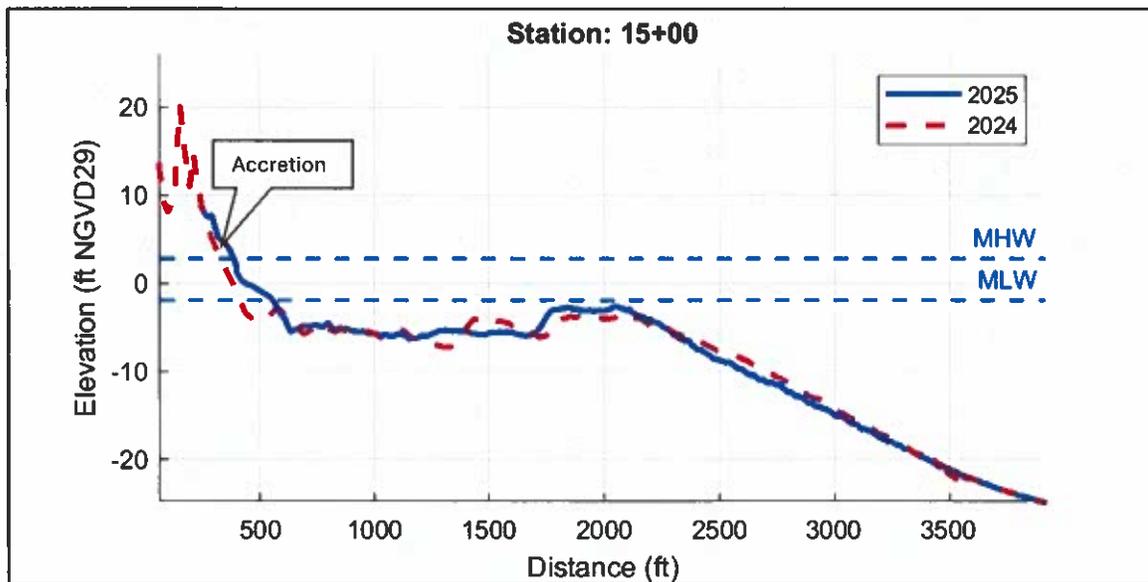
Station 15+00. Upper beach and Intertidal accretion observed since 2024 survey. MHW=Mean high water, MLW=mean low water.

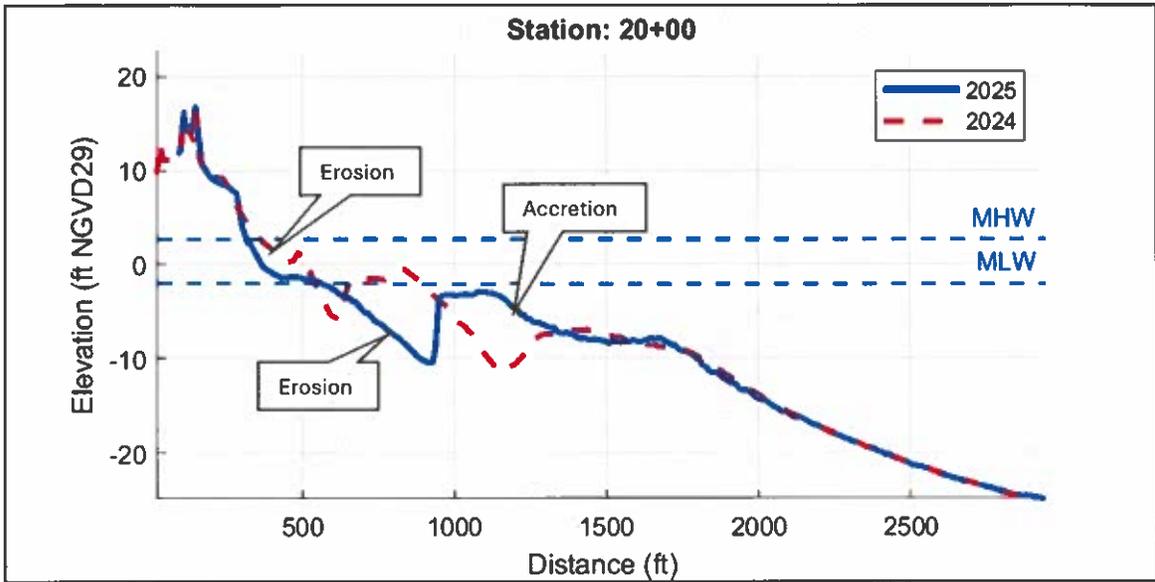
Station 20+00. Stability observed in upper beach, erosion in the surf zone and accretion observed further south/seaward in the surf zone, indicative of shoal movements since the 2024 survey. MHW=Mean high water, MLW=mean low water.

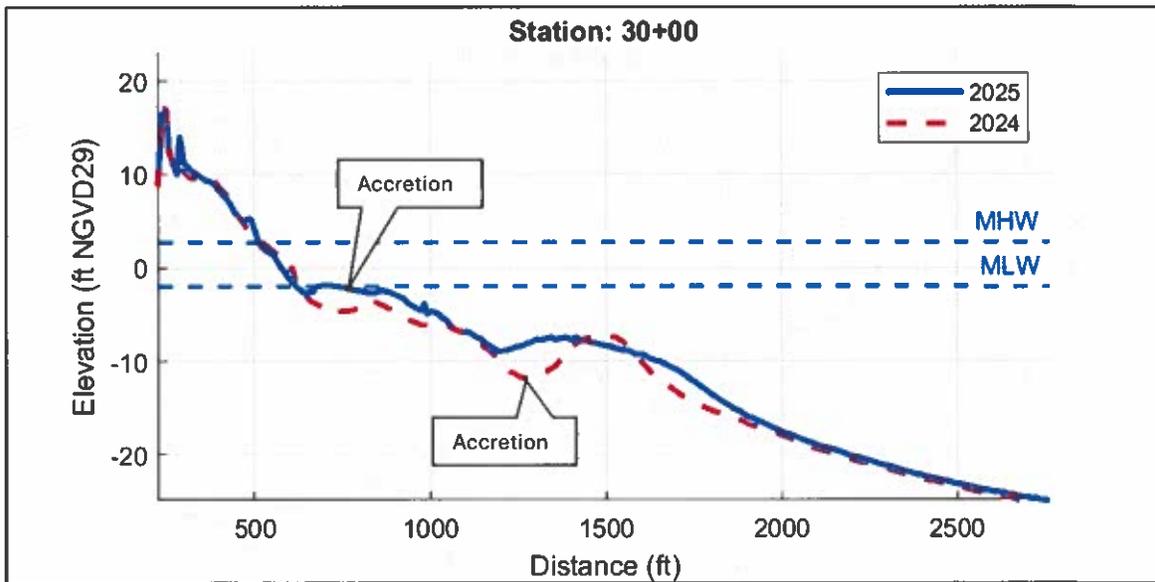
Station 30+00. Upper beach area is relatively stable with consistent accretion observed seaward of MLW. MHW=Mean high water, MLW=mean low water.

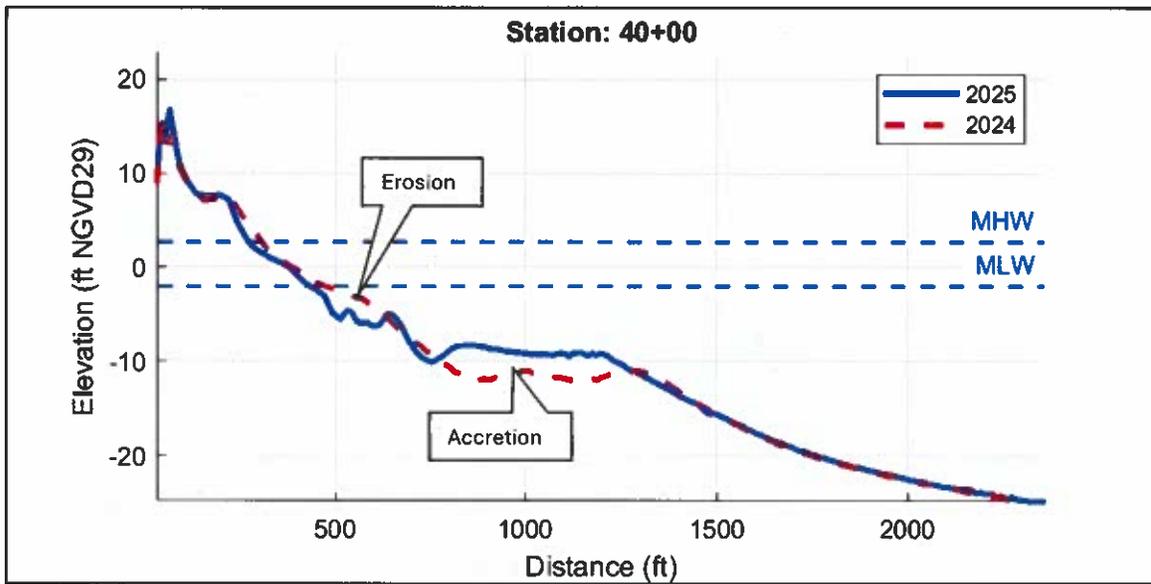
Station 40+00. Eastern extent of the Central Reach Reimbursement (CRR) Project in early 2022. Sand placement extended from Station 40+00 to Station 260+00 (ended just east of Station 270+00). Some erosion along the beach slope (upper, intertidal and nearshore region) and deposition/accretion farther offshore. MHW=Mean high water, MLW=mean low water.

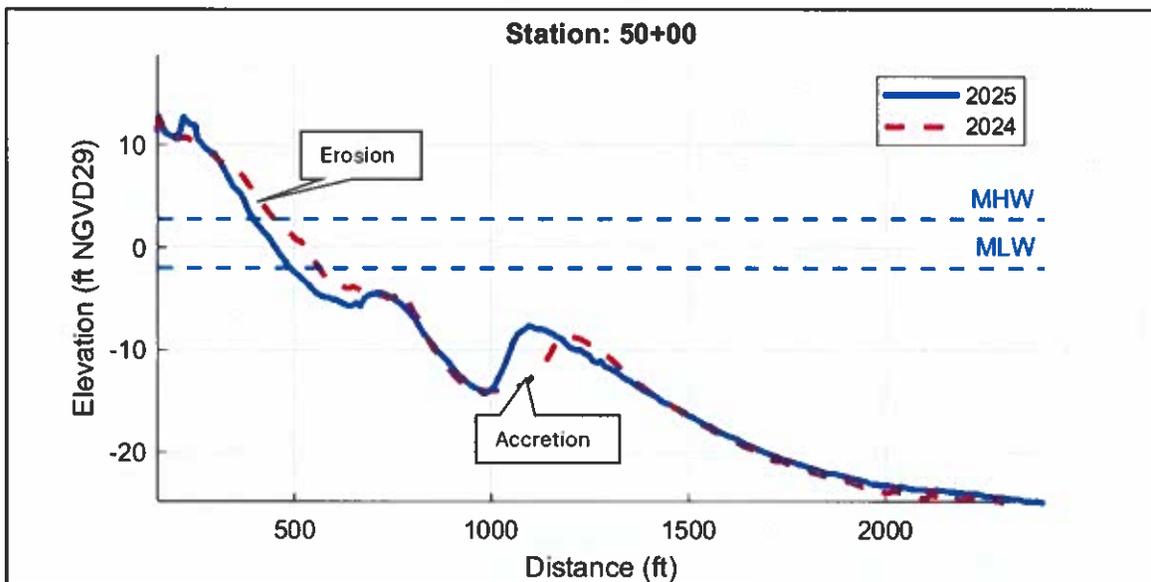
Station 50+00. MHW=Mean high water, MLW=mean low water. Intertidal beach erosion and nearshore accretion noted.

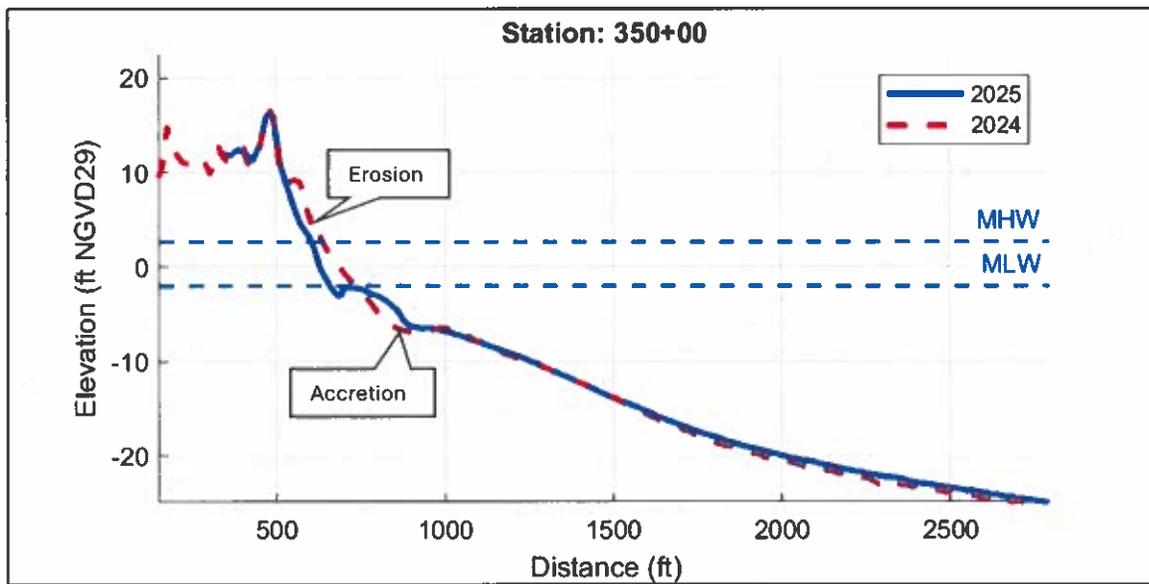
Station 350+00. Some upper beach erosion at dune face observed over the past year along the west end from 350+00 to 380+00. MHW=Mean high water, MLW=mean low water.

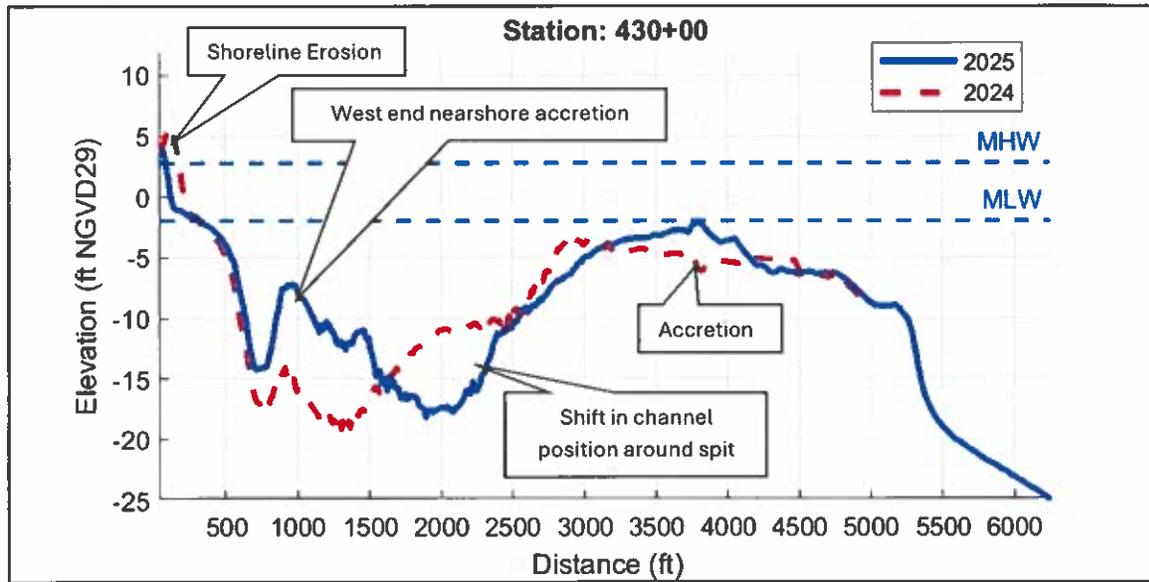
Station 430+00. 2025 survey shows an increase in volume over past year on west end of Holden Beach, and as a result a shift in the position of the channel to the southwest of the elongated spit. Some erosion of the upper beach observed on the Holden Beach side. MHW=Mean high water, MLW=mean low water.

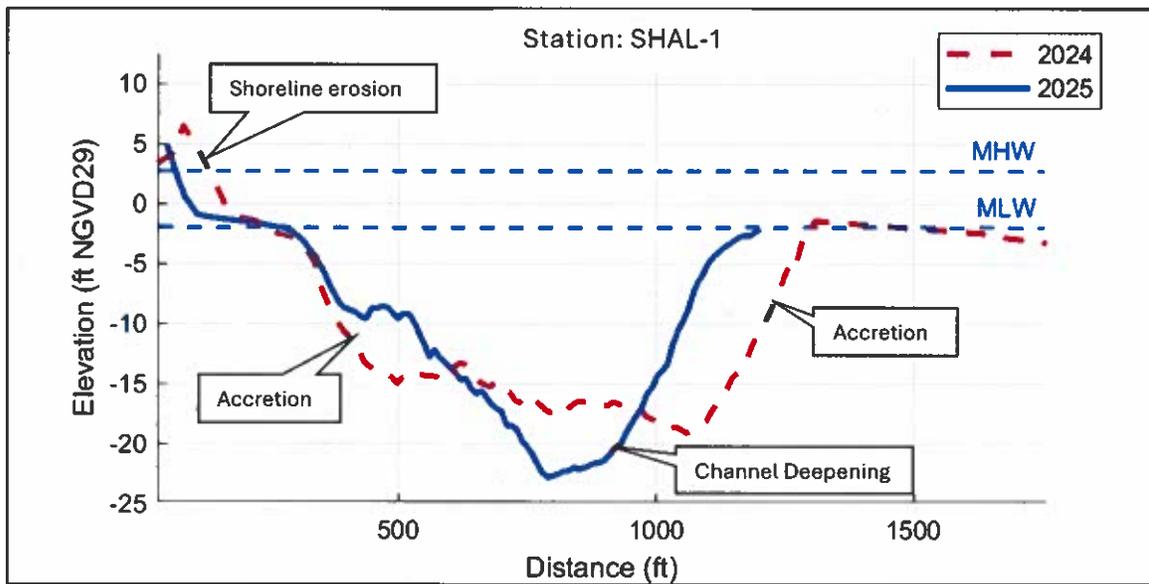
Station SHAL-1. Erosion of the upper beach observed on the Holden Beach side. 2025 survey shows the main channel has reduced in width below MLW since the 2024 survey as the Ocean Isle side has accreted sand. The maximum depth of the channel has also deepened ~4 feet since the 2024 survey. MHW=Mean high water, MLW=mean low water.

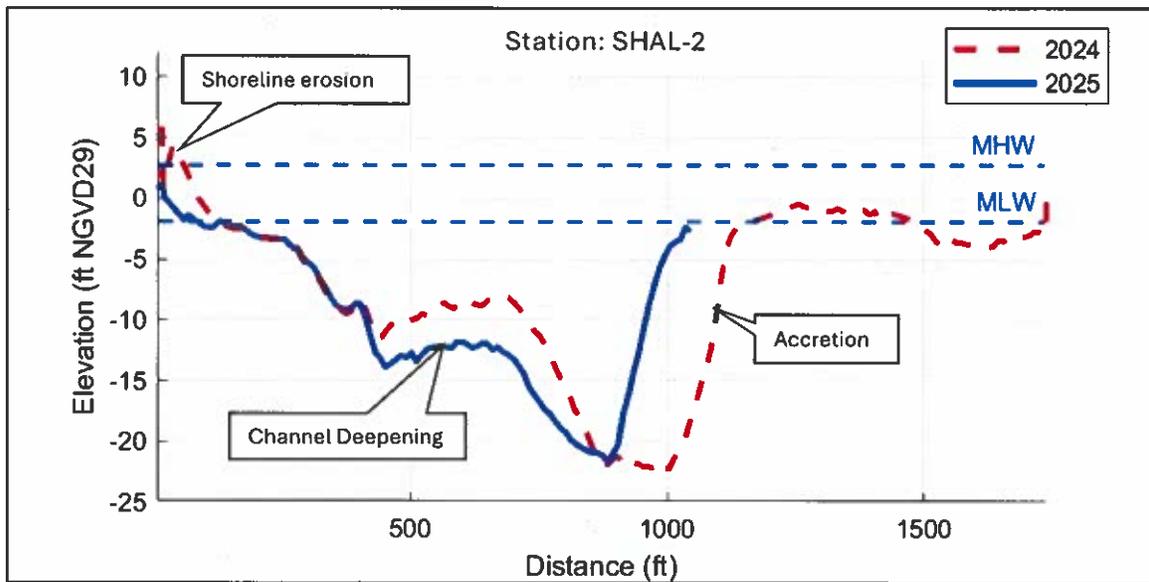
Station SHAL-2. Similar to SHAL-1, the 2025 survey shows erosion of the upper beach observed on the Holden Beach side. There is also a reduction in width of the main channel below MLW due to accretion on the Ocean Isle side and deepening of the main channel. MHW=Mean high water, MLW=mean low water.

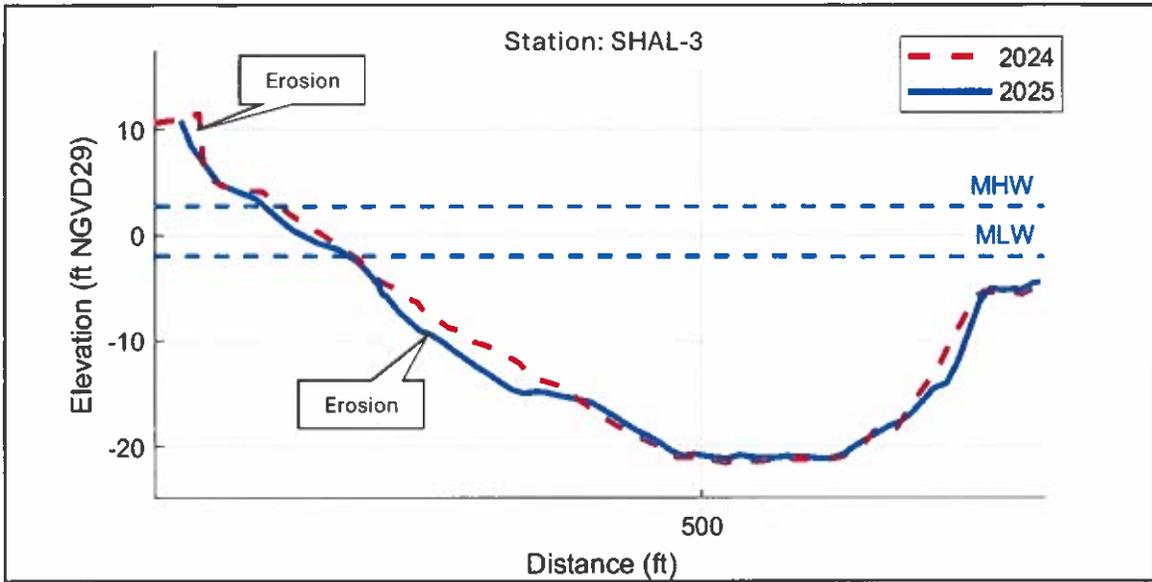
Station SHAL-3. Some erosion of the upper beach observed on the Holden Beach side. A generally stable channel observed over the past year here, with some erosion of the channel side slope on the Holden Beach side. MHW=Mean high water, MLW=mean low water.

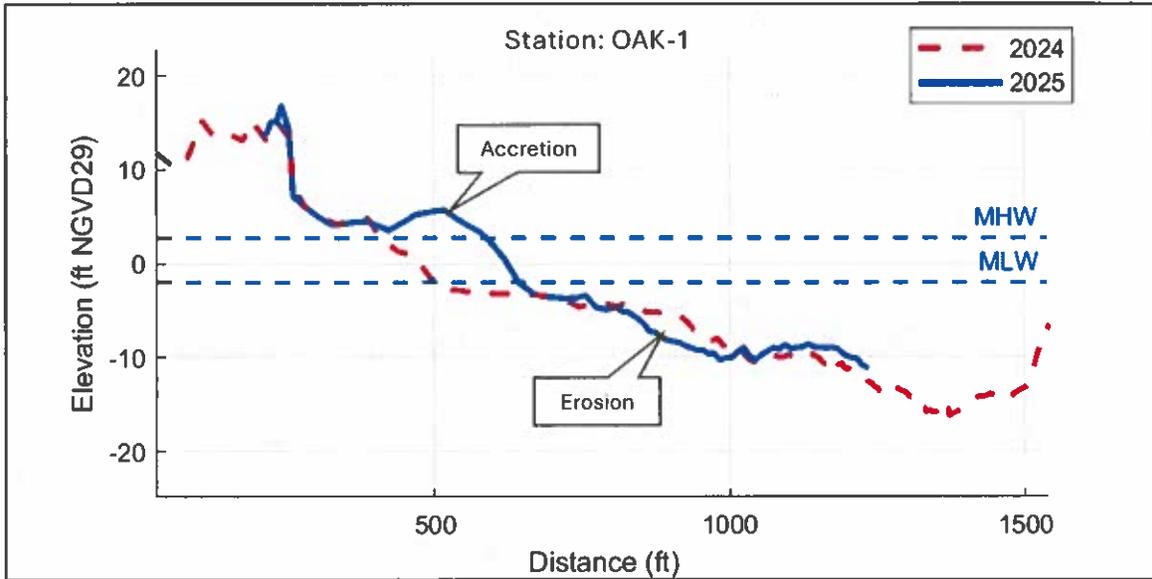
Station OAK-1. Significant intertidal accretion is seen along the Oak Island side likely due to a combination of inlet dynamics and the 2025 USACE LWFIX dredging and beach placement. MHW=Mean high water, MLW=mean low water.

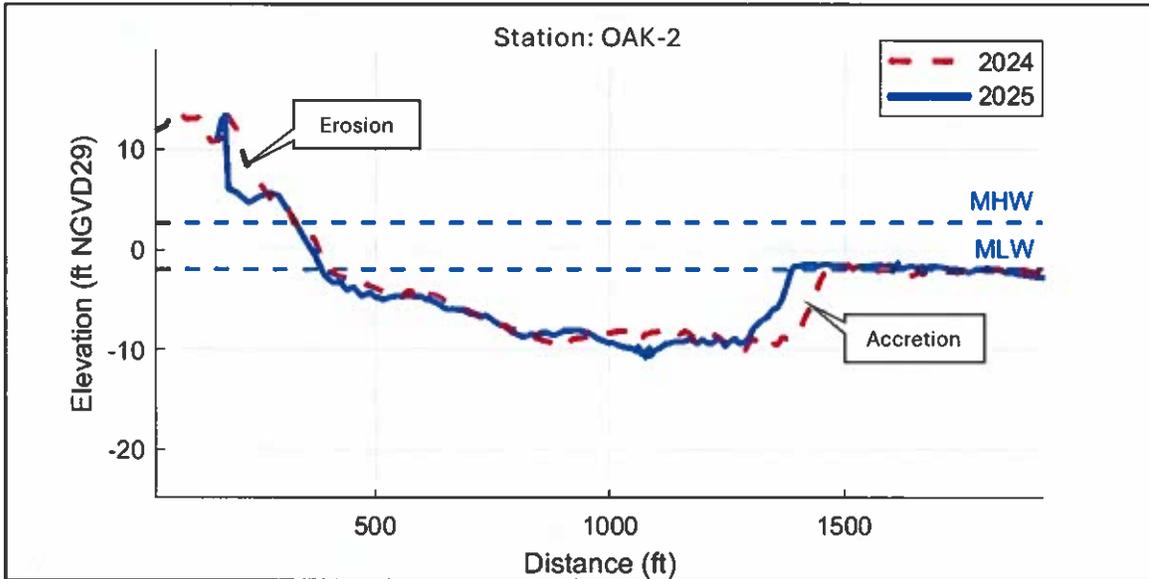
Station OAK-2. Upper beach erosion observed on Oak Island side. Intertidal accretion observed on Holden Beach side indicating bar movement due to inlet dynamics. Inlet channel relatively stable over past year. MHW=Mean high water, MLW=mean low water.

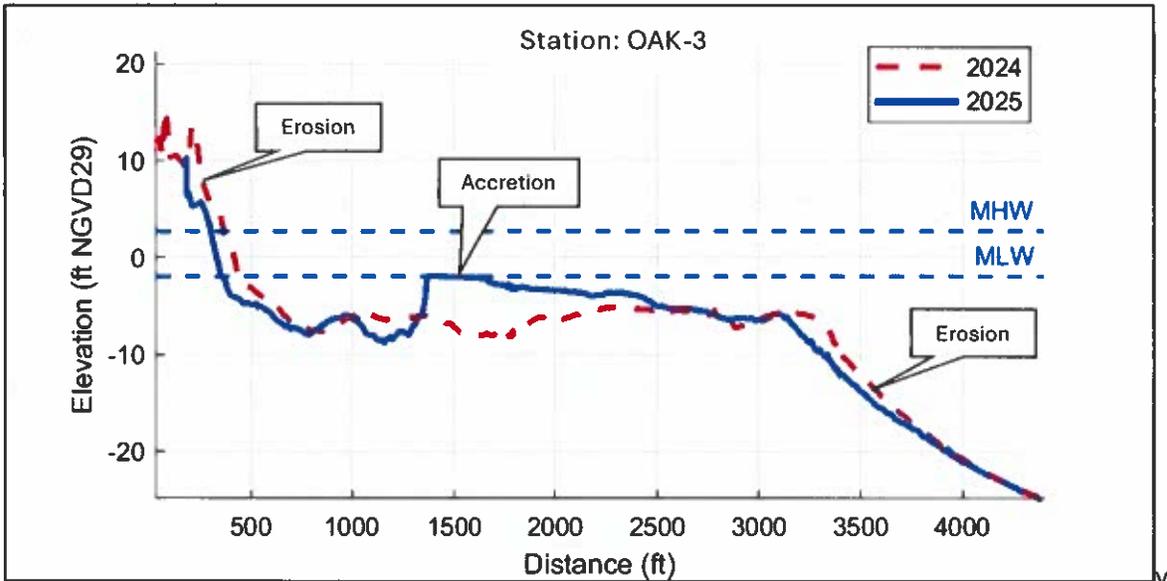
Station OAK-3. Similar to Oak 2, upper beach erosion and intertidal accretion are observed. Spatial variability between years is likely driven by inlet dynamics. MHW=Mean high water, MLW=mean low water.

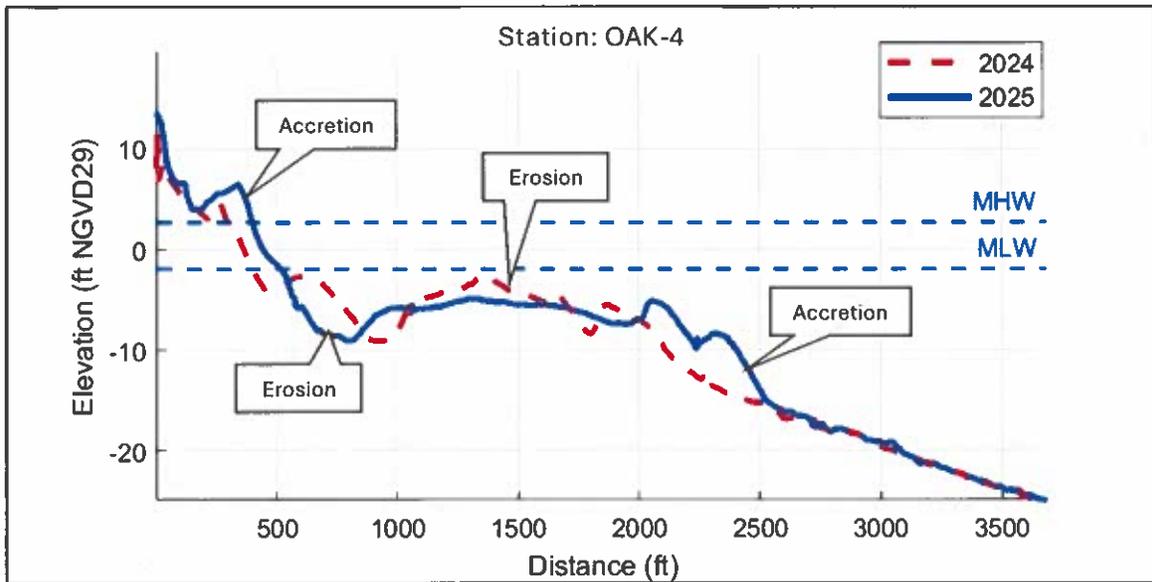
Station OAK-4. Significant upper beach and nearshore accretion observed here likely due to continued equilibration and spreading of the 2025 USACE LWFIX dredging and beach placement. Some areas of erosion observed in nearshore as well. Spatial variability between years is also likely driven by inlet dynamics. MHW=Mean high water, MLW=mean low water.

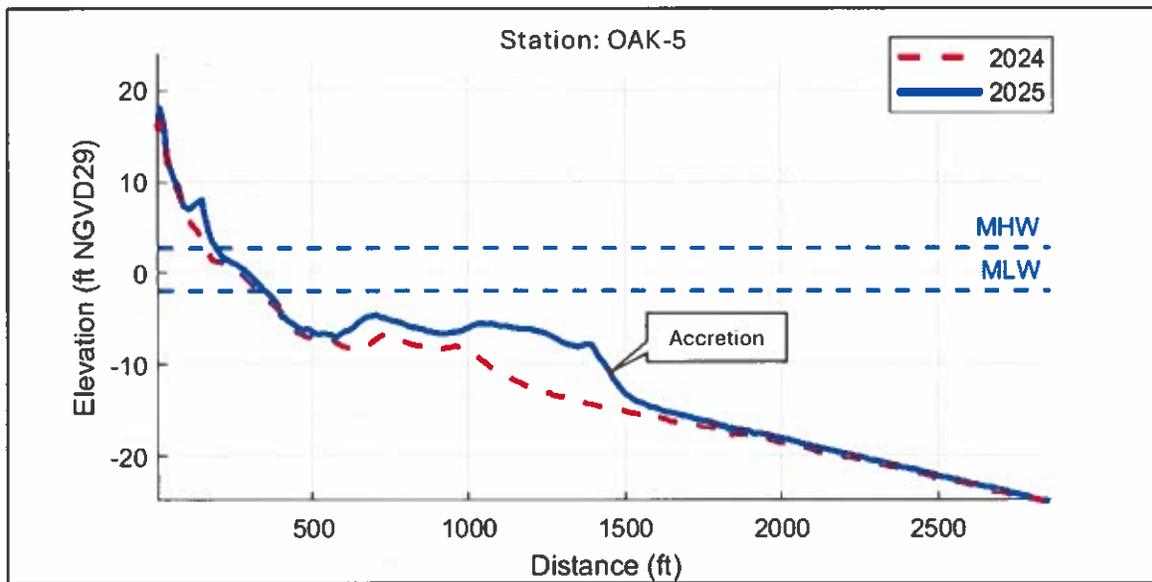
Station OAK-5. Significant nearshore accretion observed is likely due to the 2025 USACE LWFIX dredging and beach placement. MHW=Mean high water, MLW=mean low water.

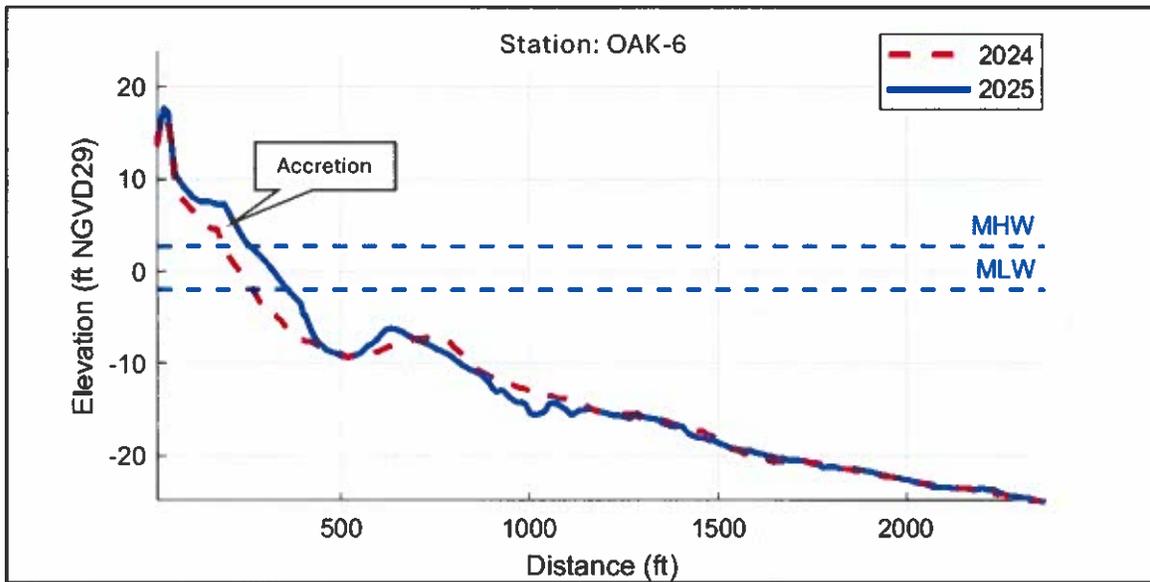
Station OAK-6. Significant upper beach and surf zone accretion is likely due to the 2025 USACE LWFIX dredging and beach placement. MHW=Mean high water, MLW=mean low water.

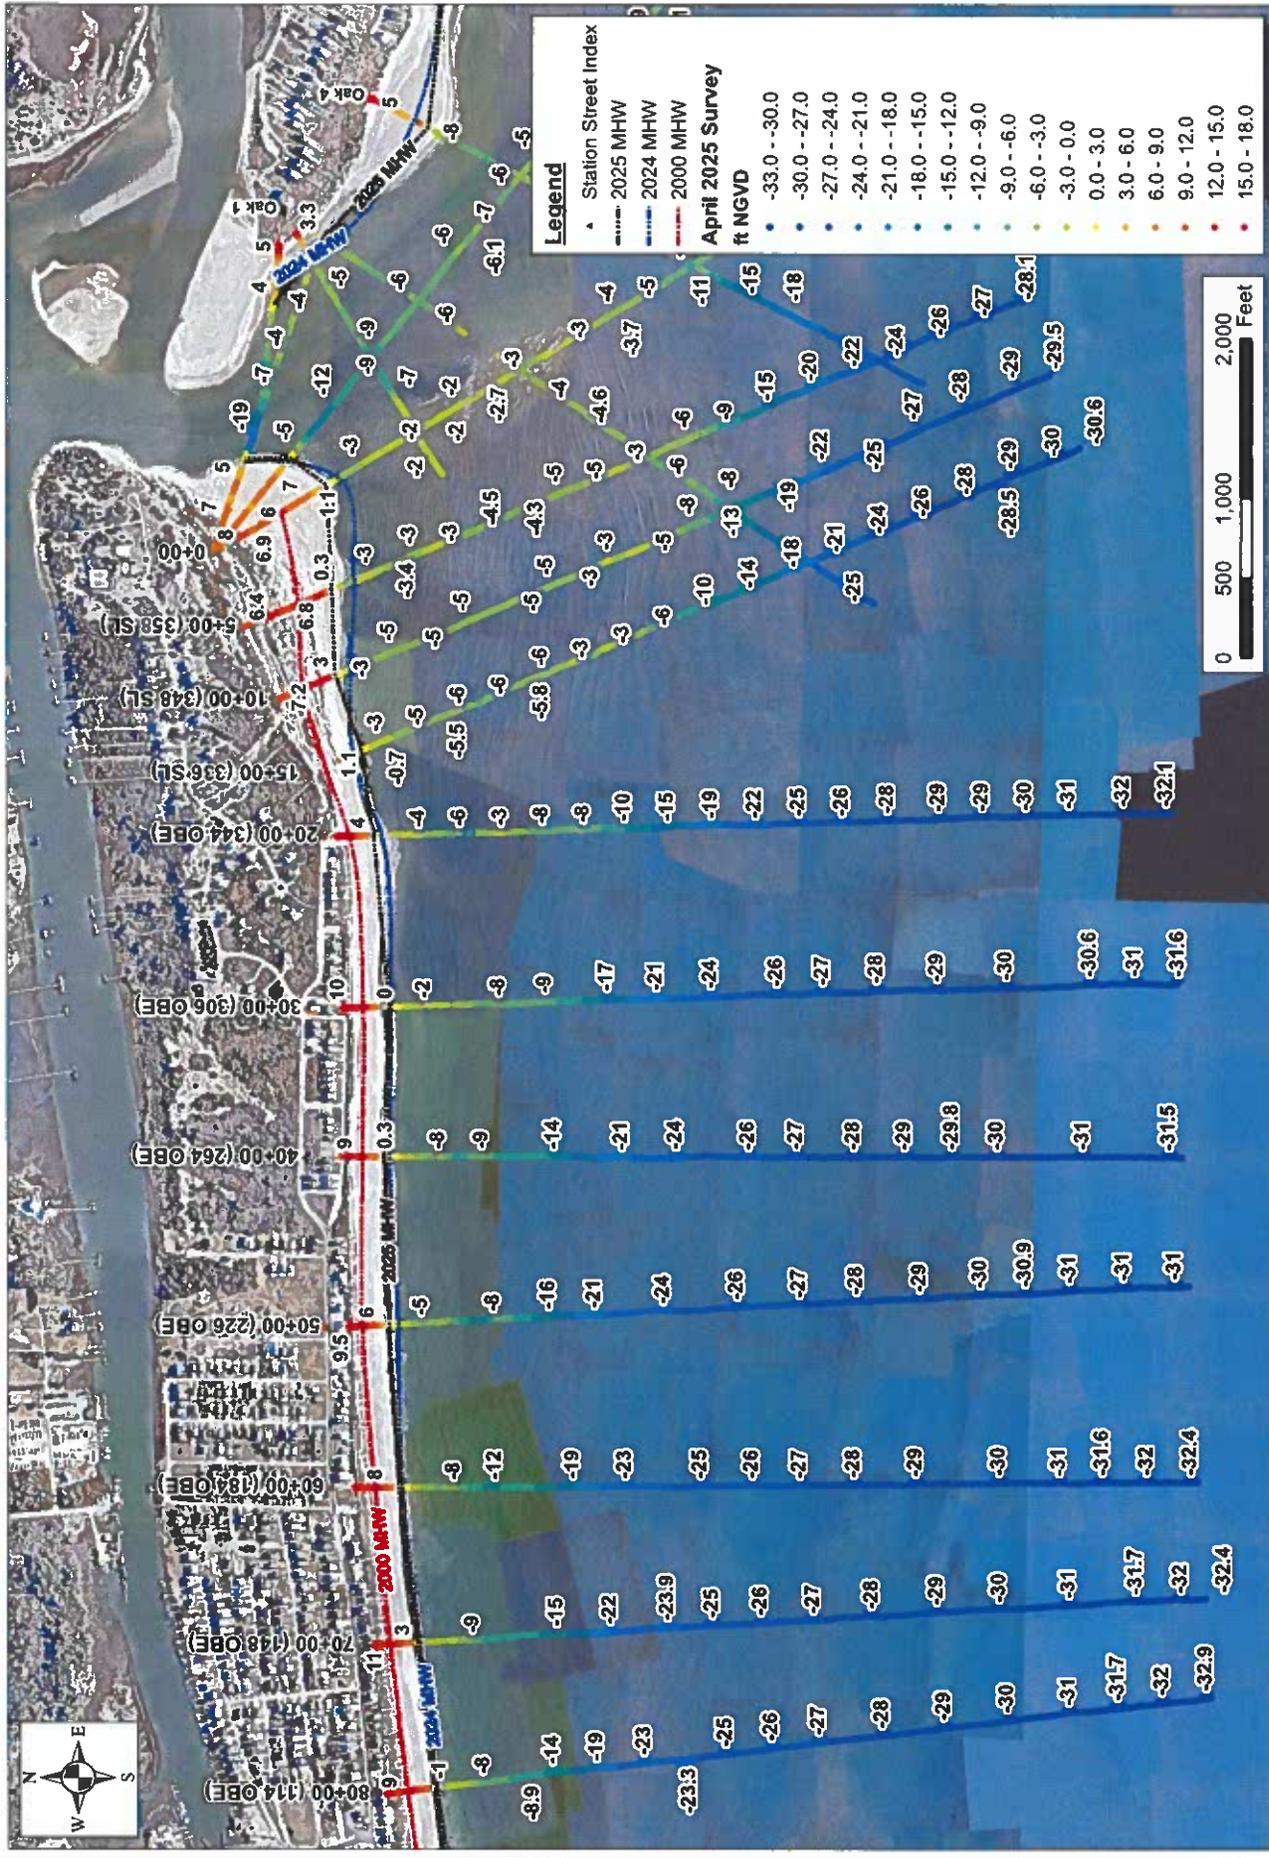
FIGURE B-2
2025 Survey Data and Established Monitoring Stations Shown. 2025 Mean High Water (MHW) Shoreline, 2024 MHW Shoreline, and 2000 MHW Shoreline Monitoring Stations Shown. 2025 Aerial Imagery (Source: Nearmap.com).

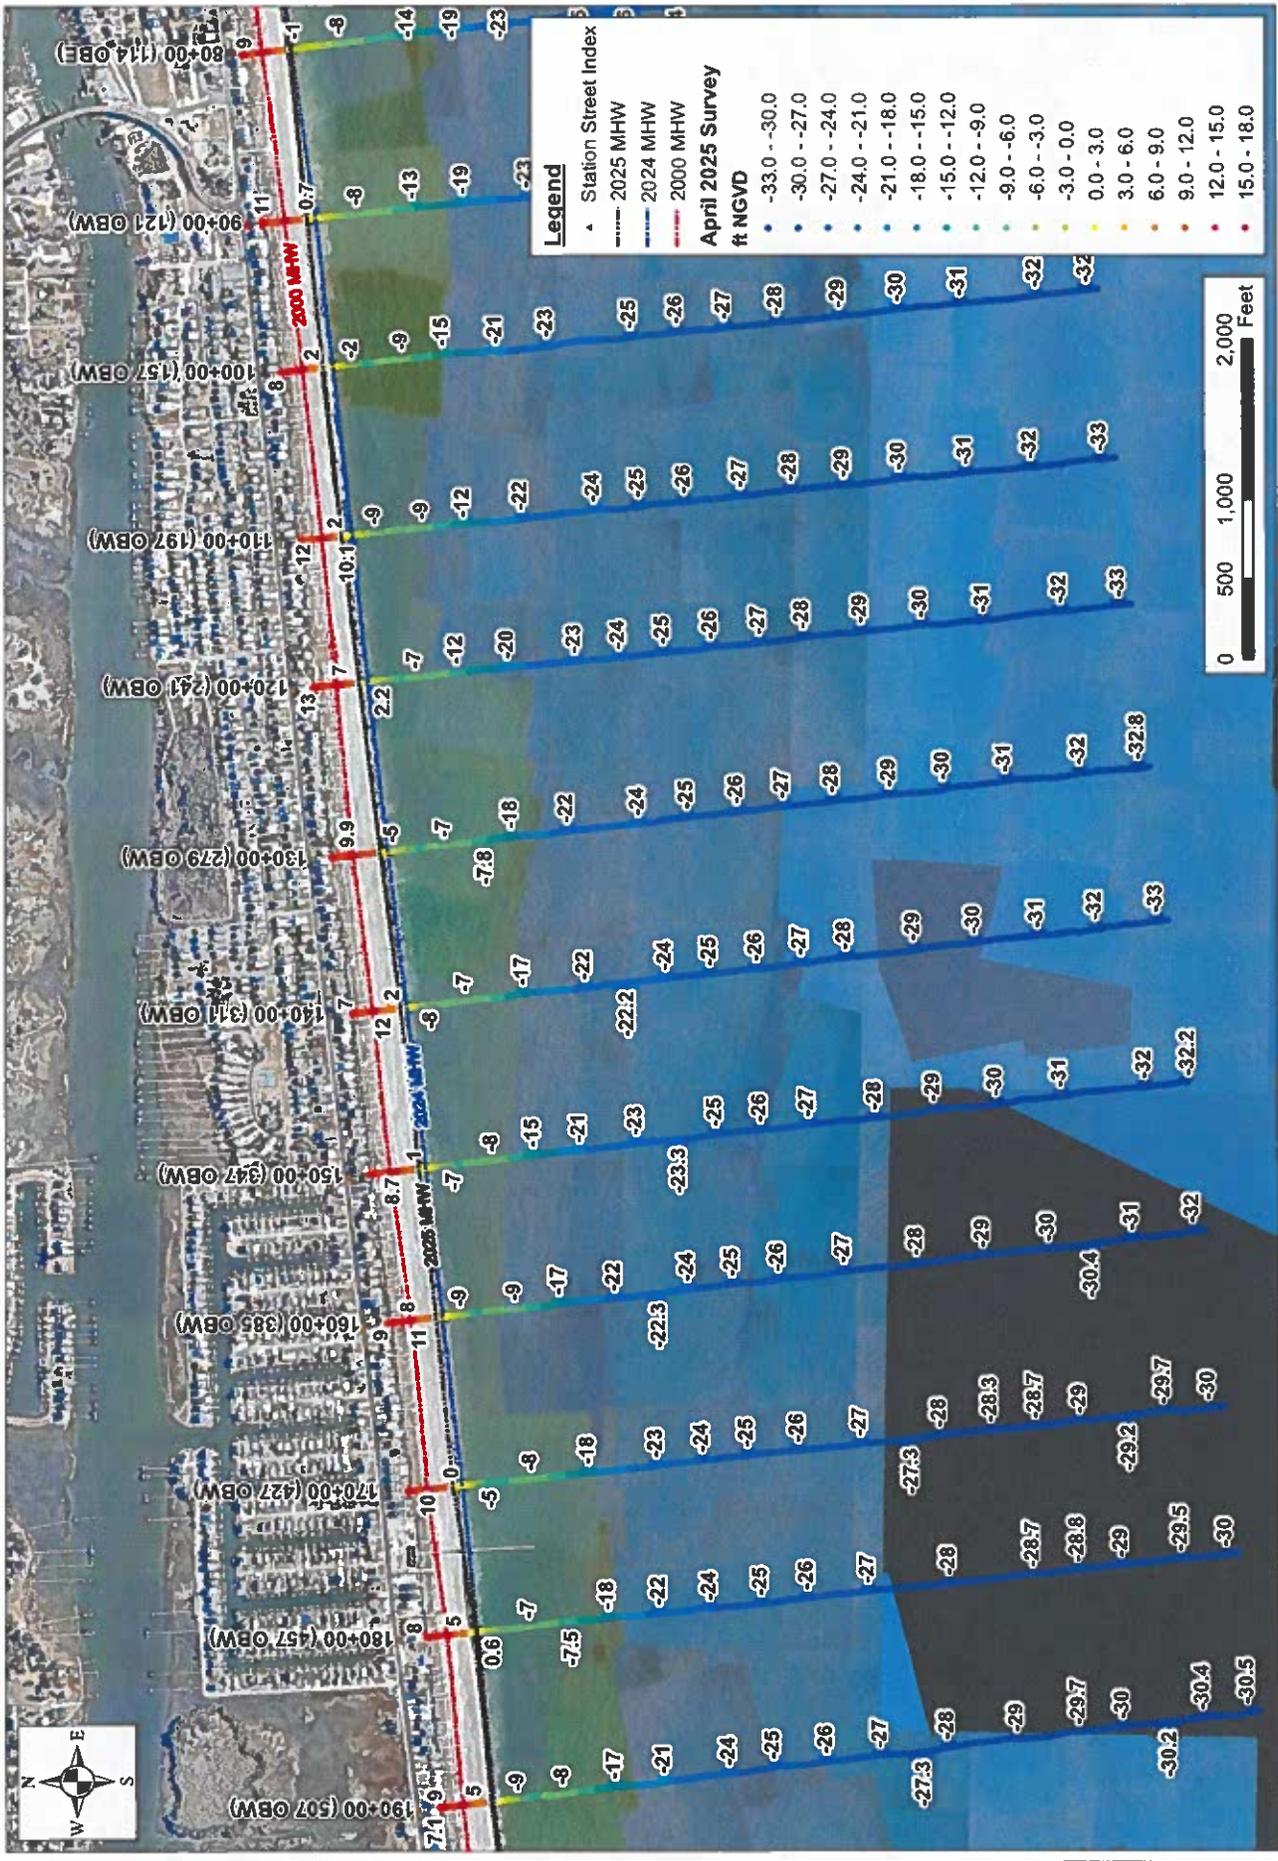
FIGURE B-3
2025 Survey Data and Established Monitoring Stations Shown. 2025 Mean High Water (MHW) Shoreline, 2024 MHW Shoreline, and 2000 MHW Shoreline Overlayed on 2025 Aerial Imagery (Source: Nearmap.com).

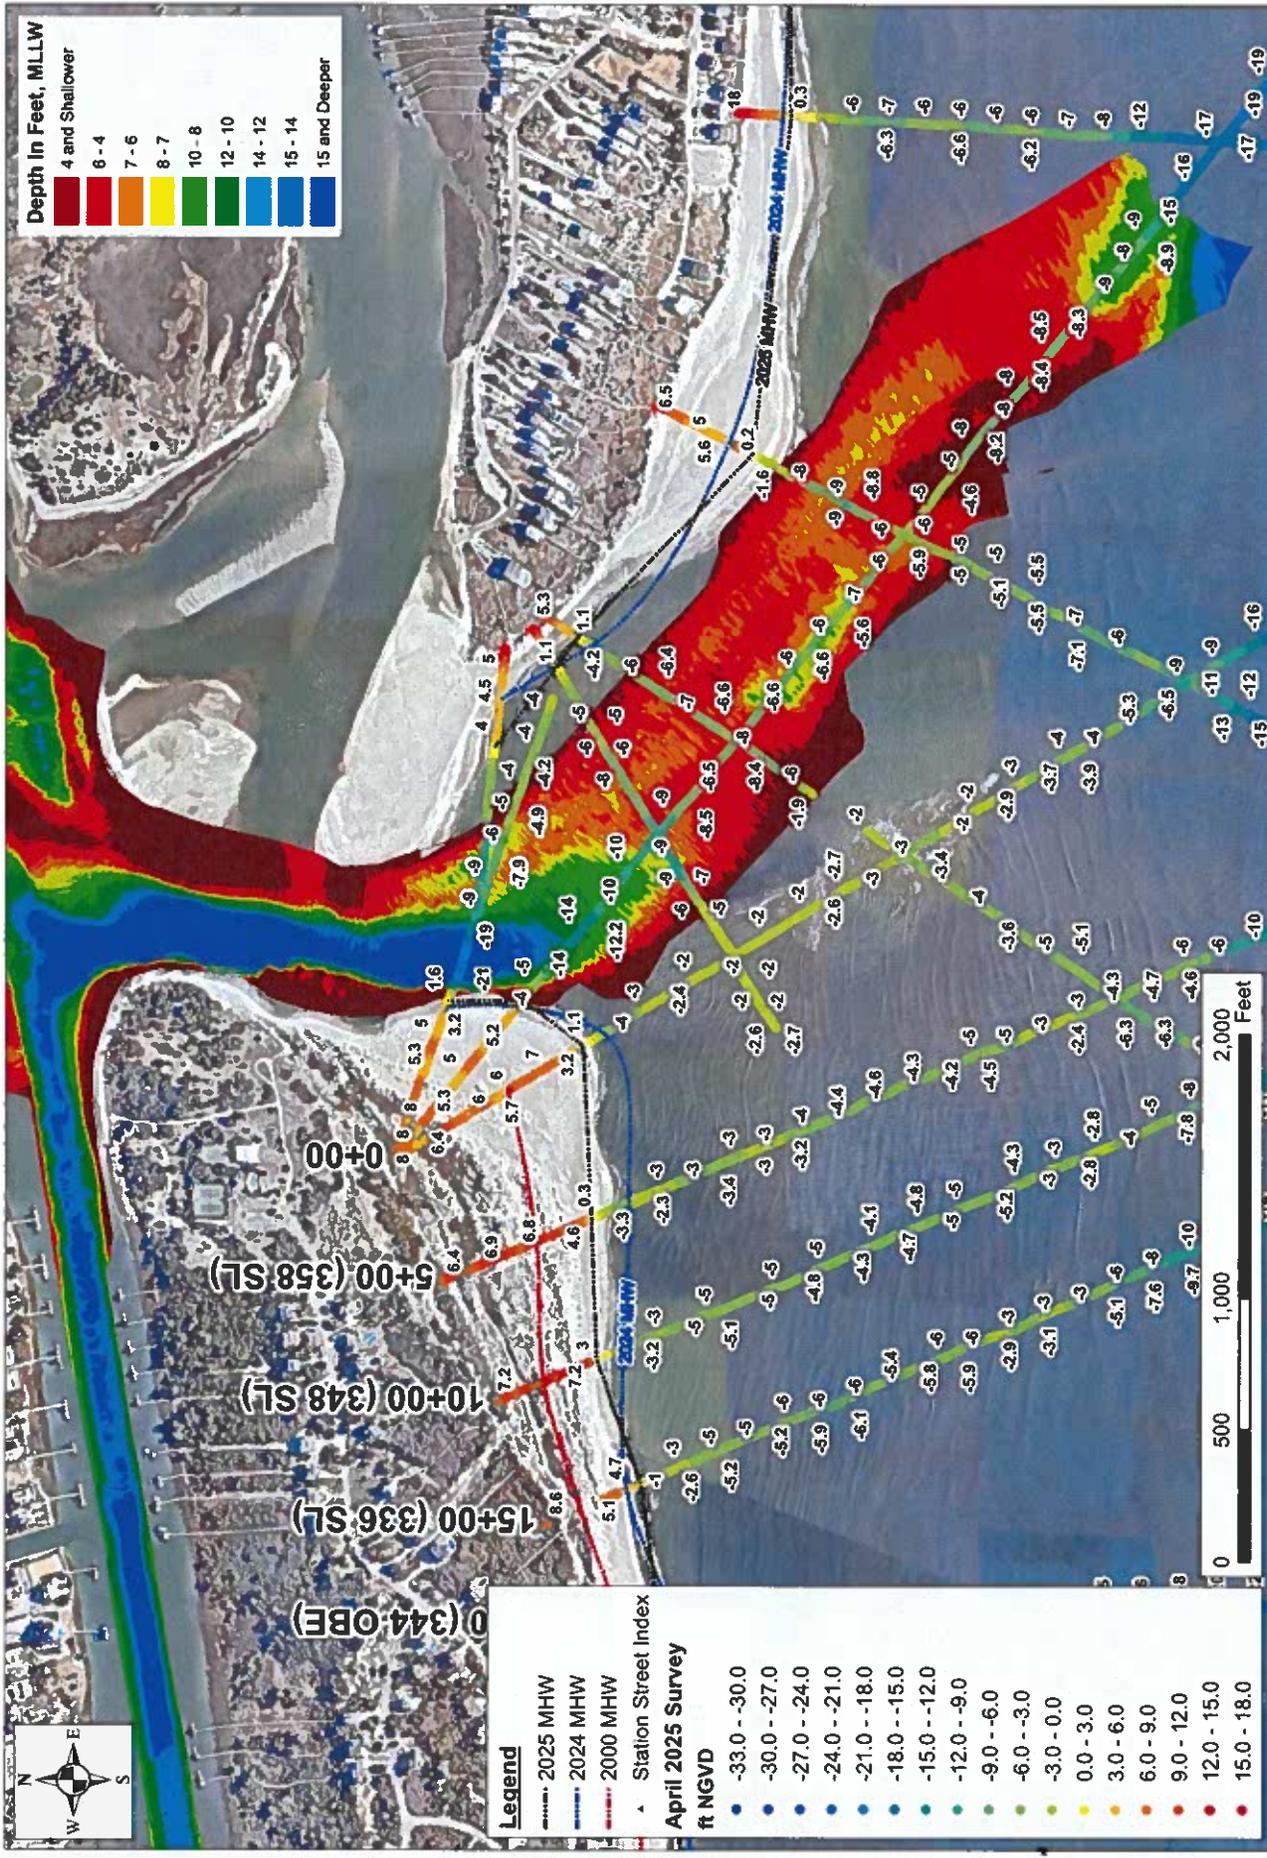
FIGURE B-7
 April 2025 Survey Data and recent Lockwood Folly Inlet Survey Data (Taken October 2025) Overlaid on 2025 Aerial
 Imagery (Source: Nearmap.com).
