HOLDEN BEACH ANNUAL MONITORING October 17, 2023

Marina, Coastal, Environmental & Water Resources Engineers

Annual Monitoring Analysis

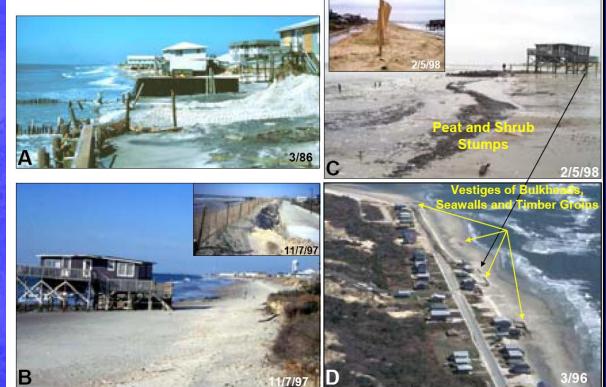
Figure 39. Photographs of the eastern portion of Holden Beach. A. West view (3/86) of eroding shoreline and houses stranded on recreational beach. Note bulkheads, timber groins and vestiges of seawalls that litter the beach. The eastern portion of Holden Beach shoreline near the inlet has been a chronic erosion zone since the late 1970s. B. West view (11/7/97) of same area in "A" retreat of the shoreline, removal of all but one home and a refurbished dune/dike composed of truck hauled sand. C. Aerial photograph of house on beach and peat exposure. Insert depict dike along road. D. Aerial photograph depicting shoreline and chronic erosion zone. Note the homes fronted by bulkheads and remnants of those destroyed.

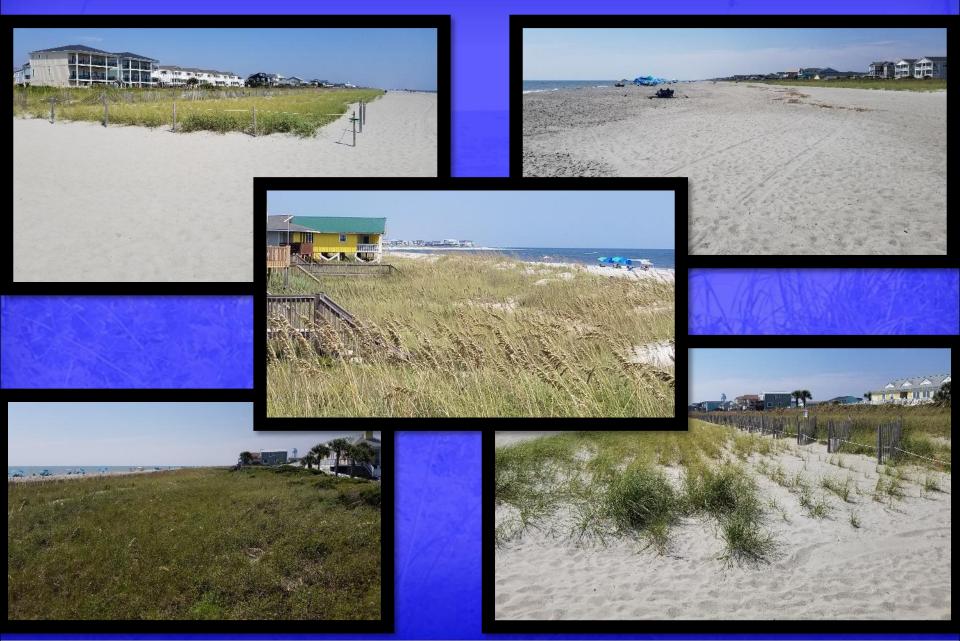
~1.5 Years Post-Project

September 2023 – Beach Looks Great

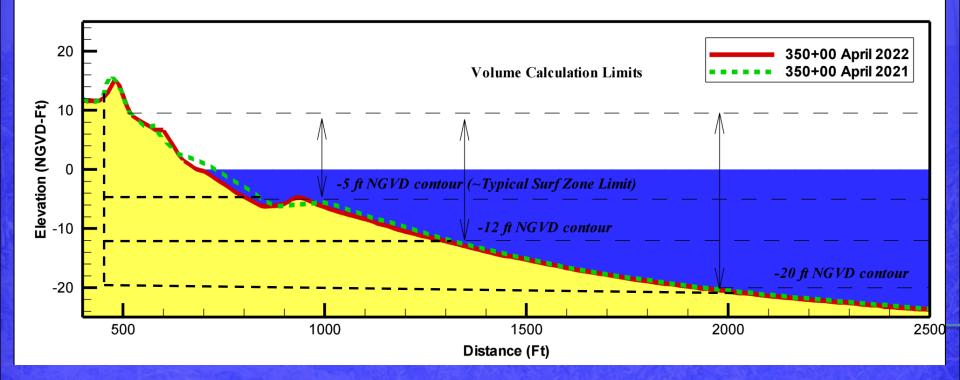
Volume Analysis

Three Volume Calcs. From Dune to -5 ft, -12 ft and -20 ft

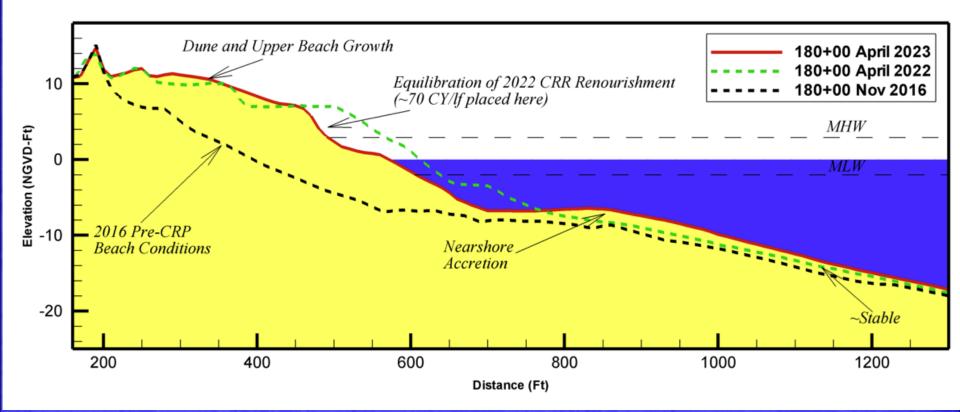
Cumulative Effect of 2017 and 2022 Nourishments

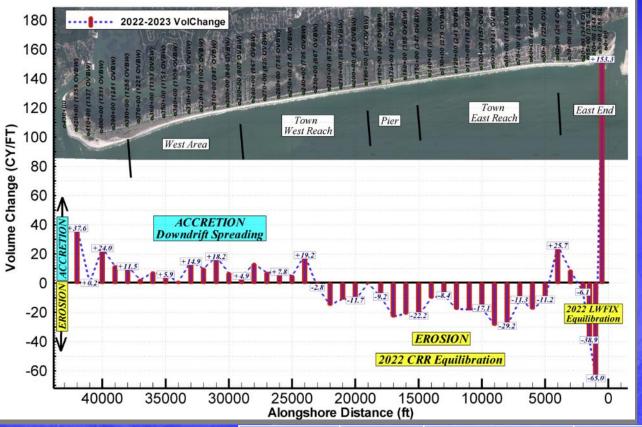
BEACH FILL EQUILIBRATION THIS YEAR

Volume Change (to -12 ft)

BEACH FILL EQUILIBRATION= NATURAL REDISTRIBUTION OF SAND

Reach Averages	Stations Included	Total Volume Change (cy) (Dune to -12 ft NGVD)	Dry Beach/Surf Zone Volume Chane (cy) (Dune to -5 ft)	Surf Zone/Depth-of-Closure Volume Change (cy) (-5 ft to -12 ft NGVD)
LWF Inlet	5 to 15	-4,000	-19,000	+15,000
USACE East	15 to 40	+7,000	-49,000	+56,000
Town East	40 to 150	-167,000	-282,000	+115,000
Pier	150 to 190	-64,000	-97,000	+33,000
Town West	190 to 290	+14,000	-68,000	+82,000
West Area	290 to 380	+74,000	+18,000	+56,000
Shallotte Inlet	380 to 420	+60,000	-19,000	+79,000
	TOTAL	-80,000	-516,000	+436,000
Central Reach	40 to 290	-217,000	-447,000	+230,000

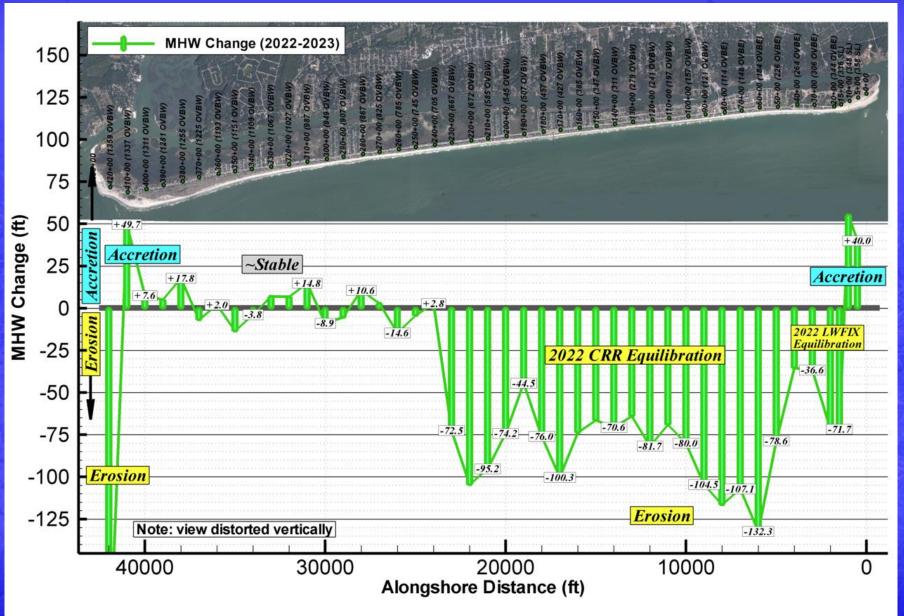
Mean High Water (MHW) Shoreline Change

2000 to 2023

Beach much healthier now

Table 3-4. Historical	Historical MHW Shoreline Change by Reach (2000 to 2021)				
		Historical MHW Change			
Reach Averages	Stations Included	(2000 to 2022) (ft)			
LWF Inlet	5 to 15	+400.6			
USACE East	15 to 40	+174.5			
Town East	40 to 150	+216.4			
Pier	150 to 190	+218.9			
Town West	190 to 290	+157.1			
West Area	290 to 380	+20.8			
Shallotte Inlet	380 to 420	+85.5			
Central Reach	40 to 290	+191.0
