Technical Proposal for:  
Underwater Inspection of Town Pier  
Holden Beach, NC  
June 10, 2026

# Development of an Underwater Inspection Report and Cost Estimates for Repair or Replacement Information Purposes of Town Pier Property Located at 441 Ocean Boulevard West, Holden Beach, NC

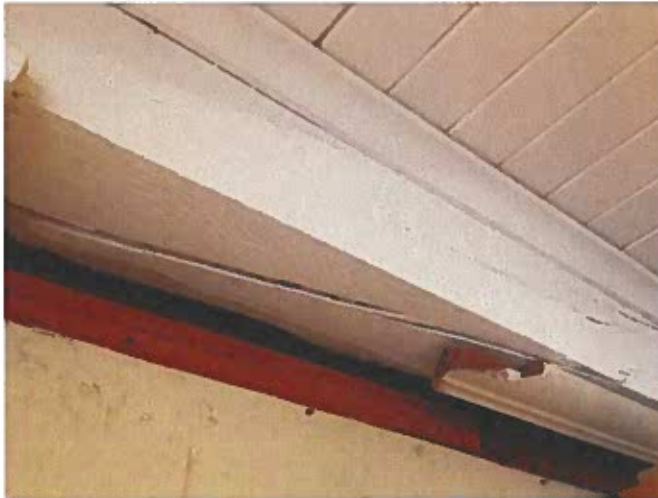
*Steep slope of grain revealed by a large split — this timber was classified non-structural with a partial in-situ failure.*

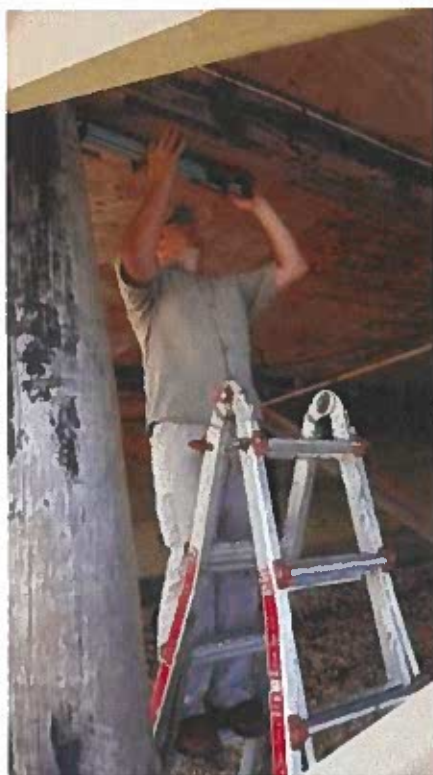
*Resistograph PD Series field deployment — resistance drilling of structural timber elements for relative density profiling and internal condition assessment.*

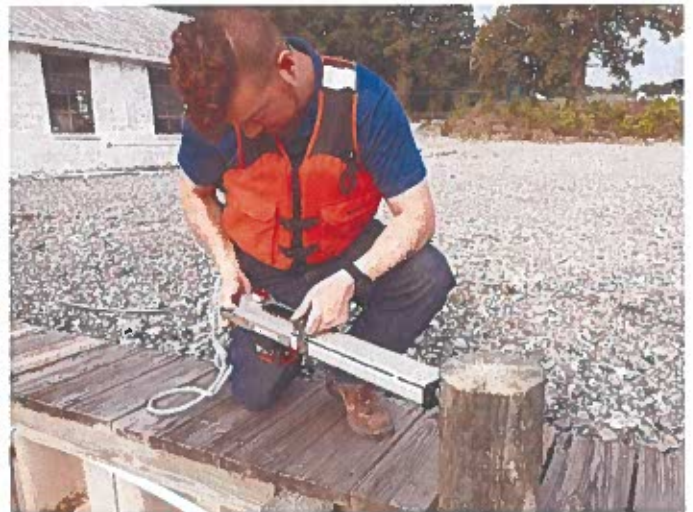
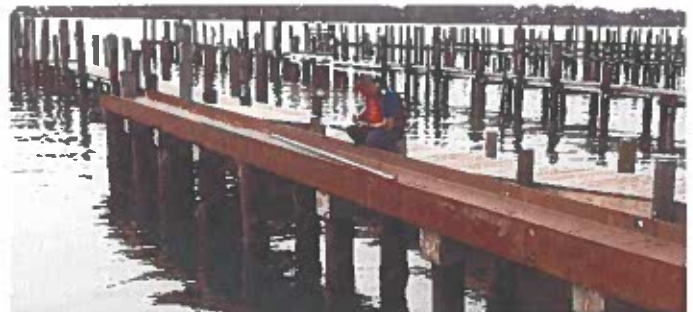
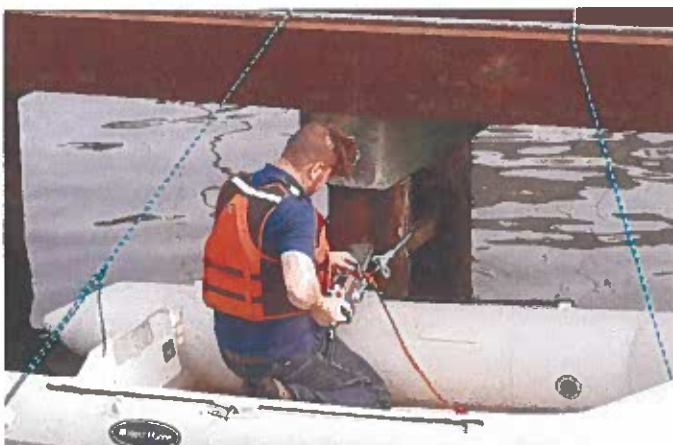
To help detect internal voids and advanced decay without causing further damage to the timber, we use nondestructive tools like a resistance drill, or "resistograph". By slowly advancing a long thin drill bit into the timber, our engineers can observe the resistance readings on the graph in real time. Regions of low or no resistance on the chart signify potential areas of hidden wood decay or marine borer damage. This critical information helps our team identify weak spots and areas of concern within the wooden pile, even if they are not visible from the outside.

Photos of Engineer Dive Inspector, Robert Provencher using the resistance drill at a recent site inspection

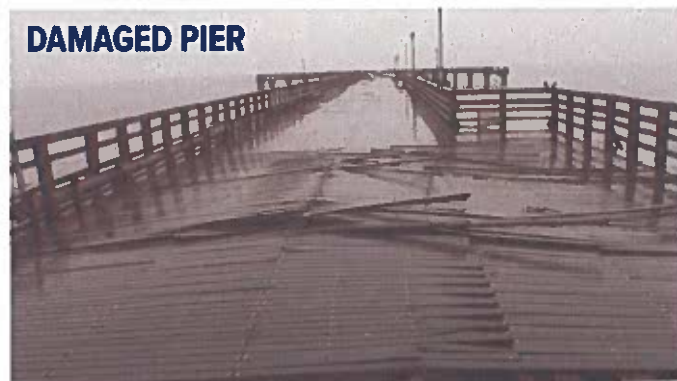
DAMAGED PIER

Following an inspection and condition assessment we designed the replacement of the deck and substructure components including new prestressed, precast concrete beams anchored to the existing concrete pile caps. A new composite / recycled plastic lumber (RPL) deck was designed to replace the existing, damaged timber deck. A new aluminum railing system, aluminum and stainless-steel shade structures and benches constructed from the reclaimed decking of the original pier were also designed and installed.
