## SUMMARY

1234 Main St. Oak Park MI 48237

Tiffany Grant  
Imperative Home Solutions  
248-820-4750

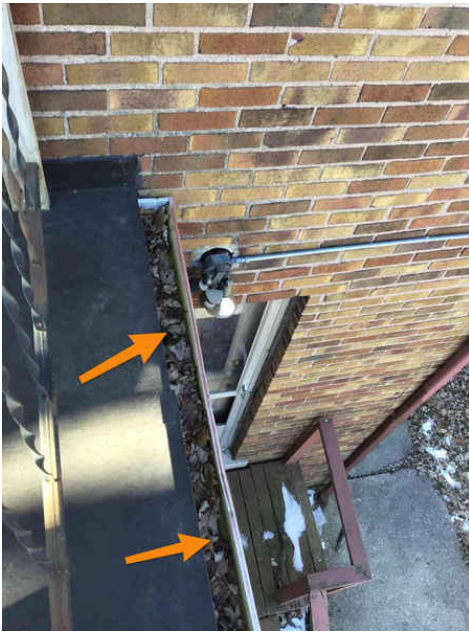
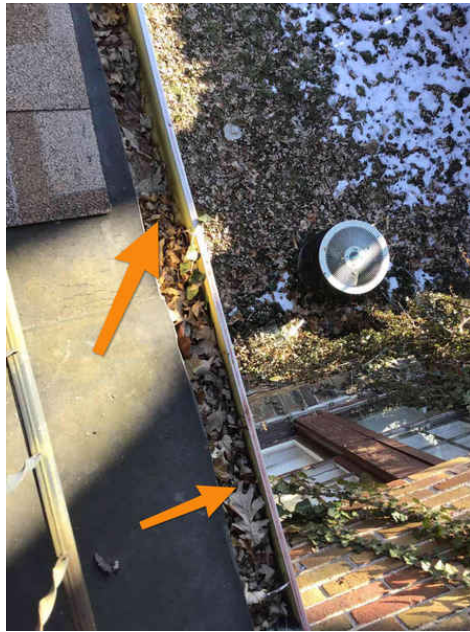
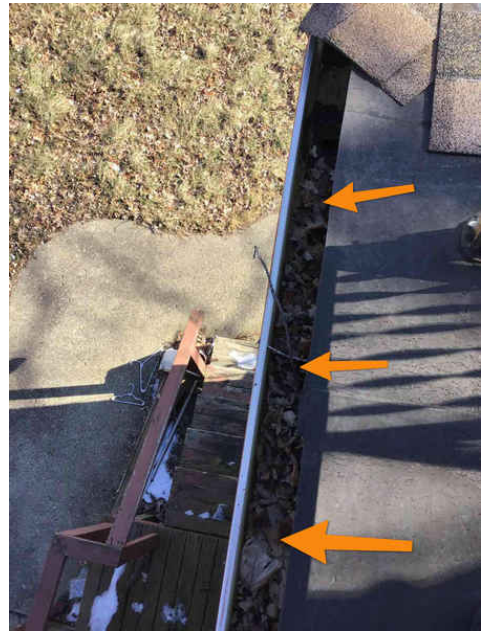
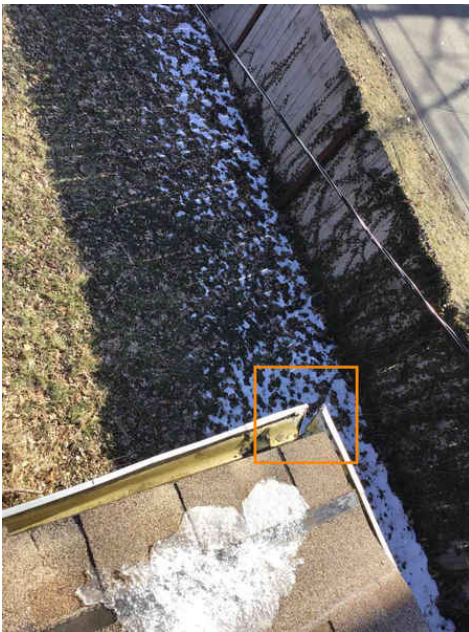
### 2.2.1 Roof Drainage Systems

#### DEBRIS

Debris has accumulated in the gutters. Recommend cleaning to facilitate water flow.

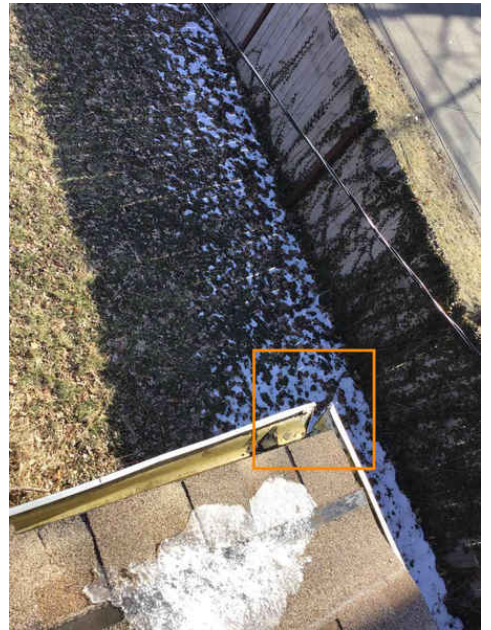
#### 2.2.3 Roof Drainage Systems

##### **GUTTER DAMAGED**

Gutters were damaged. This can result in excessive moisture in the soil at the foundation, which can lead to foundation/structural movement. Recommend a qualified contractor evaluate and repair.

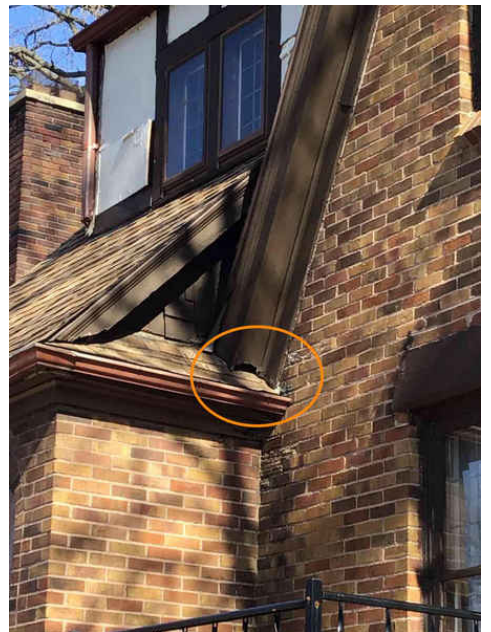
#### 2.2.4 Roof Drainage Systems

##### **GUTTER LEAKAGE**

Gutters were observed to be leaking in one or more areas. This can result in excessive moisture in the soil at the foundation, which can lead to foundation/structural movement. Recommend a qualified contractor evaluate and repair gutters to proper functionality.

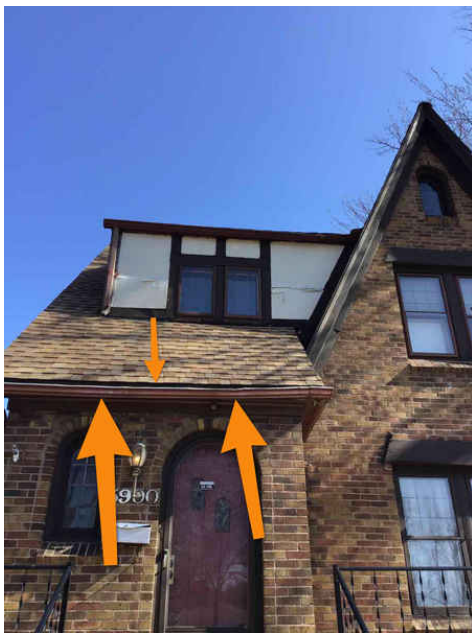
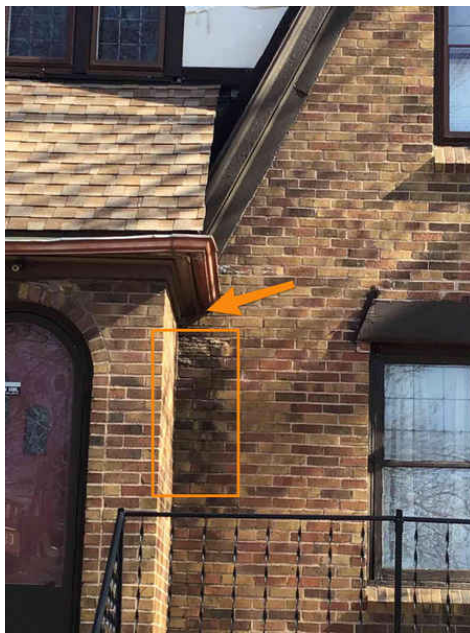
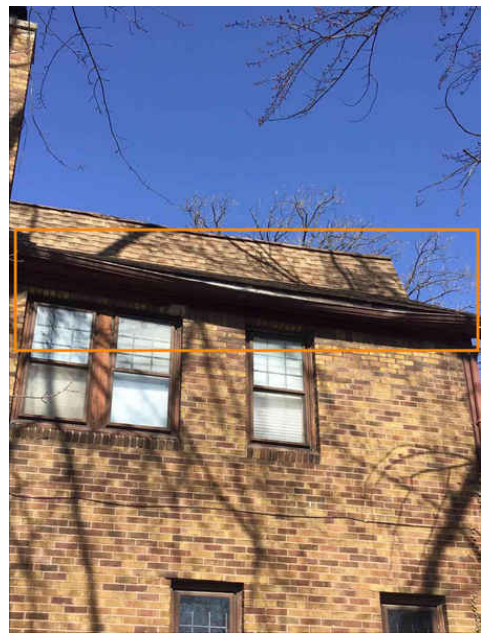
#### 2.2.5 Roof Drainage Systems

##### **GUTTER LOOSE**

The gutter(s) is loose and needs to be re-fastened to fascia and pitched properly.

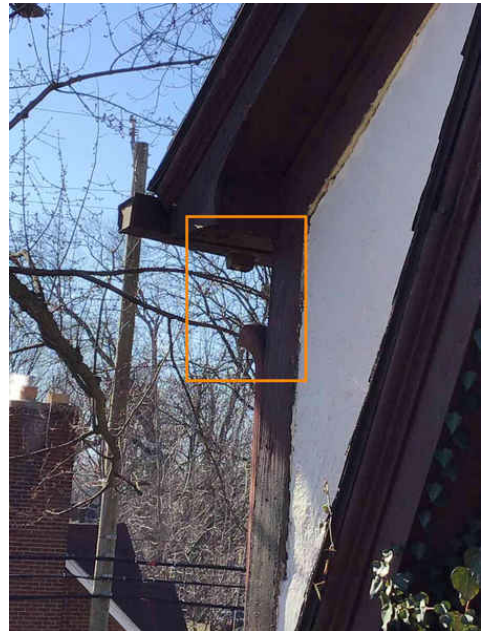
#### 2.2.6 Roof Drainage Systems

### DOWNSPOUT DETACHED

Downspout is not connected to gutter.

Contact a qualified professional.

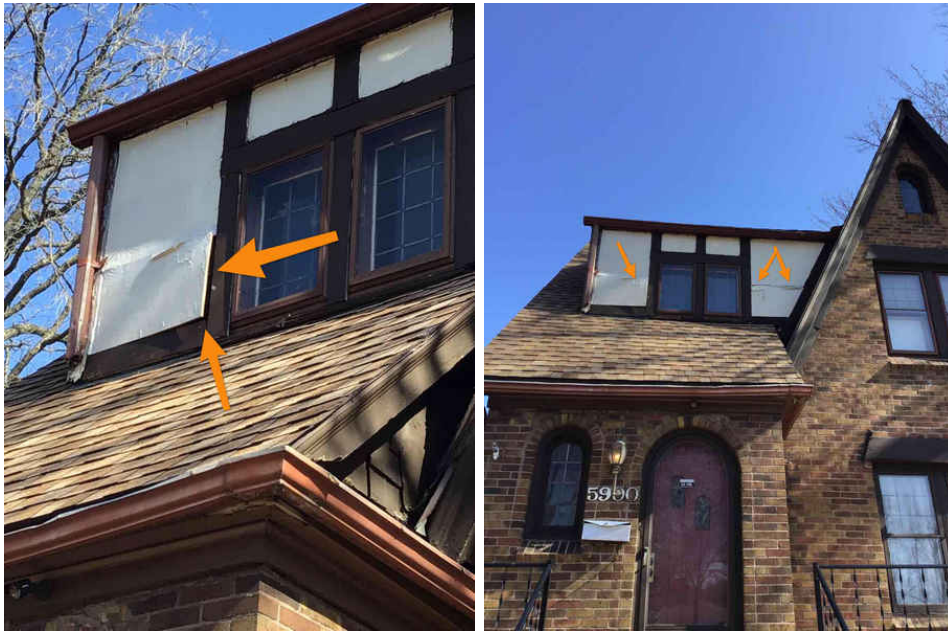
### 3.1.1 Siding, Flashing & Trim

#### **LOOSE BOARDS**

One or more siding boards appear to have been loose, which could result in moisture intrusion. Recommend a qualified siding contractor secure and fasten.

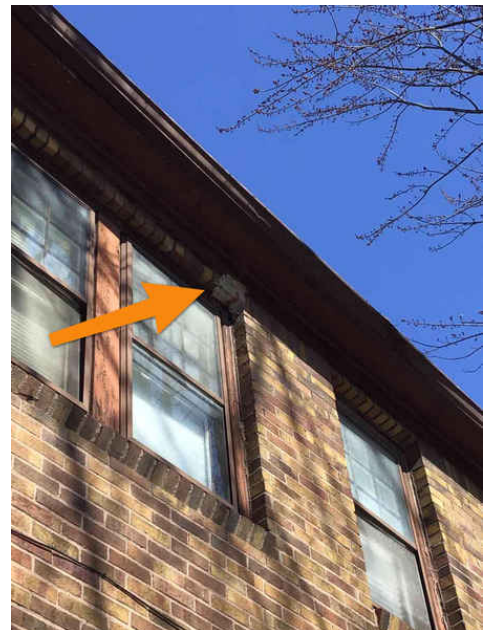
### 3.1.2 Siding, Flashing & Trim

#### **IMPROPER CONSTRUCTION TECHNIQUES**

Improper construction techniques on masonry.

Contact a qualified professional.

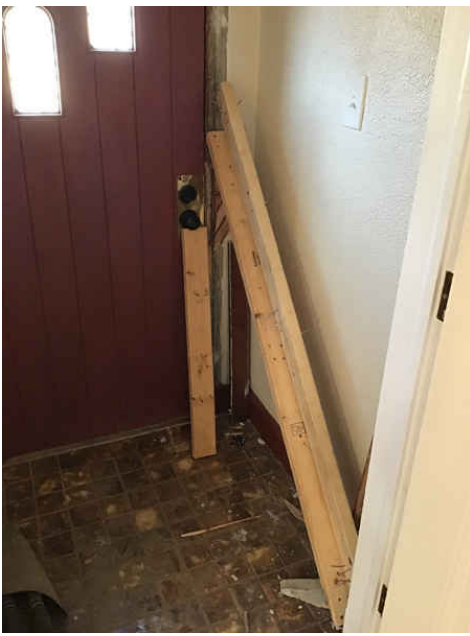
### 3.2.1 Exterior Doors

#### **DOOR SILL/TRIM**

Door sill and/or trim is loose, deteriorated, missing or worn and repair or replacement should be considered.

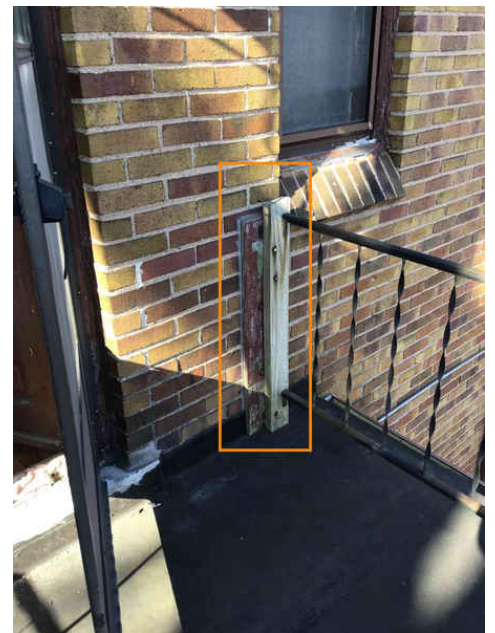
### 3.4.1 Decks, Balconies, Porches & Steps

#### **IMPROPER CONSTRUCTION PRACTICES**

Balcony was observed to have general poor construction for handrails. Recommend qualified deck contractor evaluate.

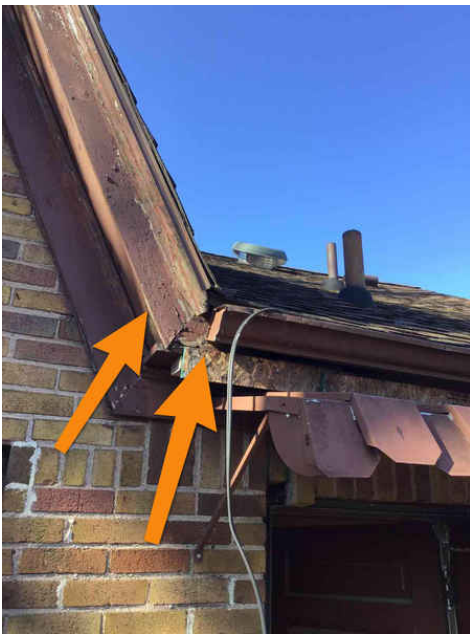
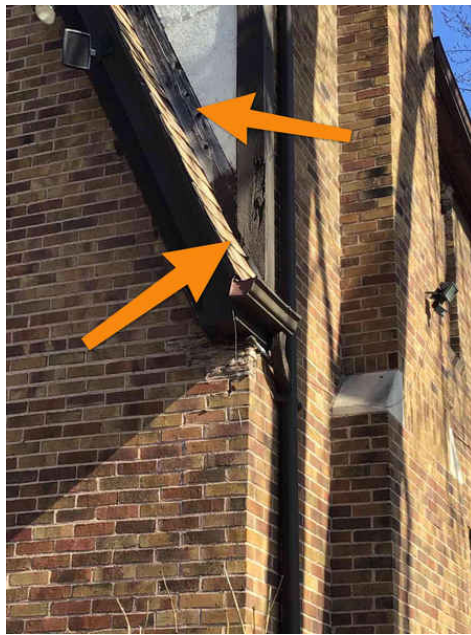
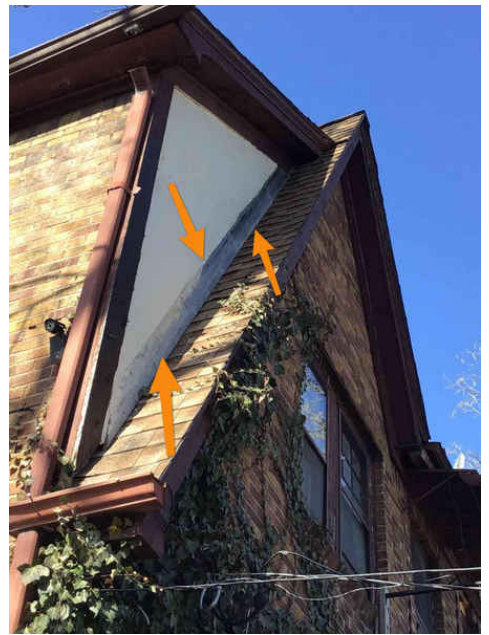
### 3.5.1 Eaves, Soffits & Fascia

#### **FASCIA - ROTTED**

One or more sections of the fascia are rotted. Recommend qualified roofer evaluate & repair.

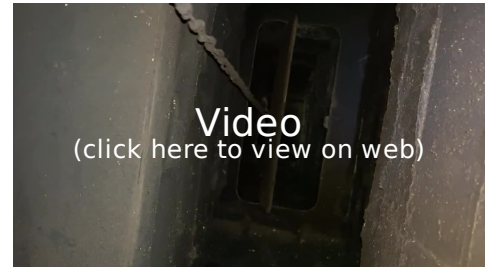
#### 4.3.1 Damper Doors

### **DAMPER INOPERABLE**

Damper would not stay closed once pull chain was released. Recommend a qualified fireplace contractor repair.

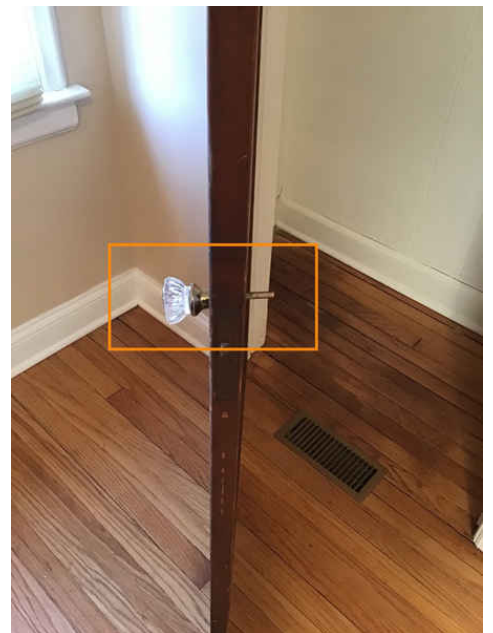
#### 5.1.1 Doors

### **KNOBS**

Door knob missing/broken on upstairs bedroom closet.

Contact a qualified professional.

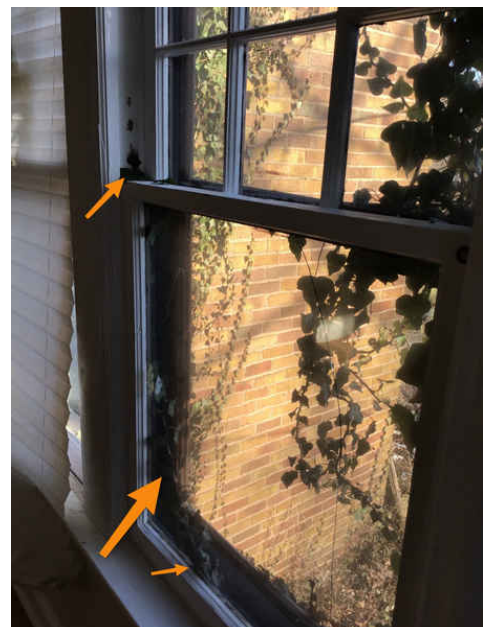
#### 5.2.1 Windows

### **FAILED SEAL**

Observed a failed window seal with vines growing inside of windows. Recommend qualified window contractor evaluate & replace. Cold air coming from outside.

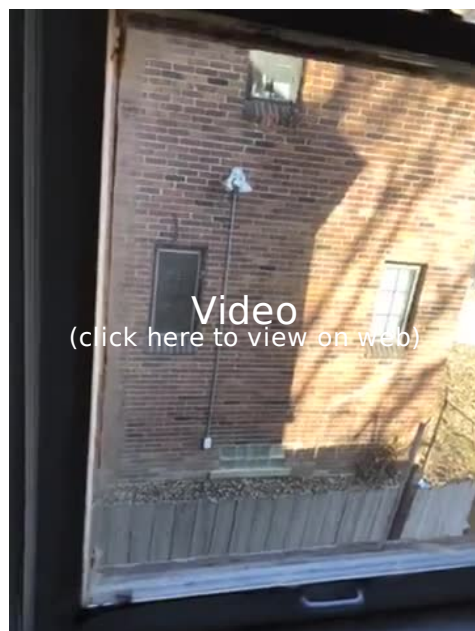
### 5.2.2 Windows

#### **IMPROPER INSTALLATION**

Windows appear to not be operating properly due to substandard installation. Recommend window specialist evaluate.

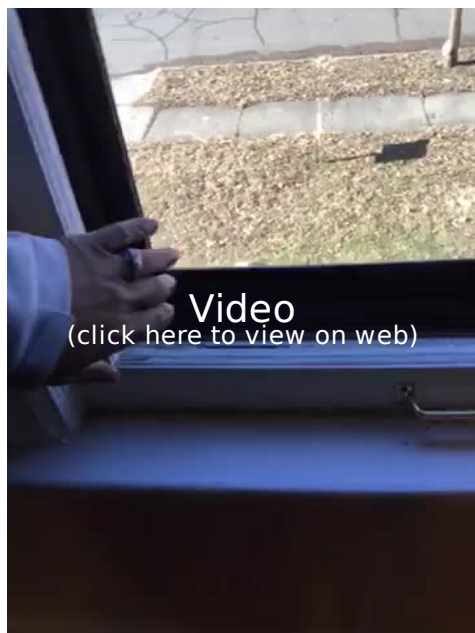
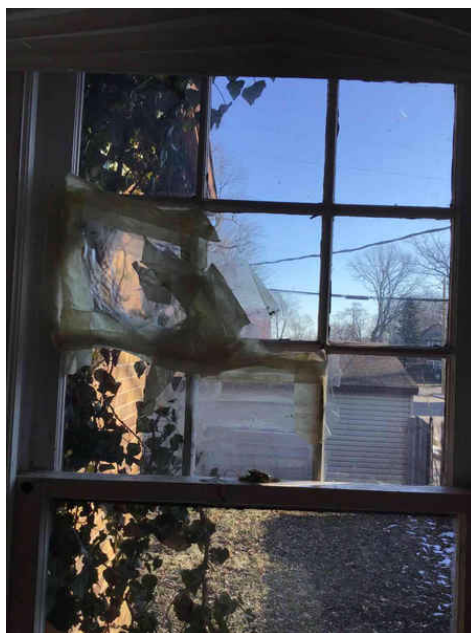
### 5.2.3 Windows

#### **BROKEN**

Broken windows, recommend professional consultation.

Contact a qualified professional.

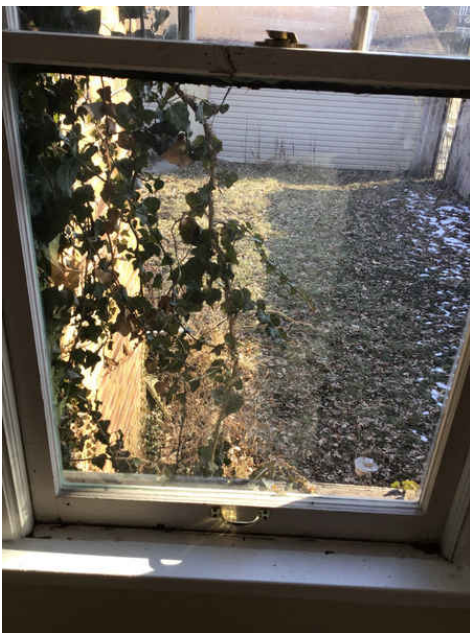
### 5.2.4 Windows

#### **OUTDATED**

Some windows are outdated and require maintenance or replacement.

Contact a qualified professional.

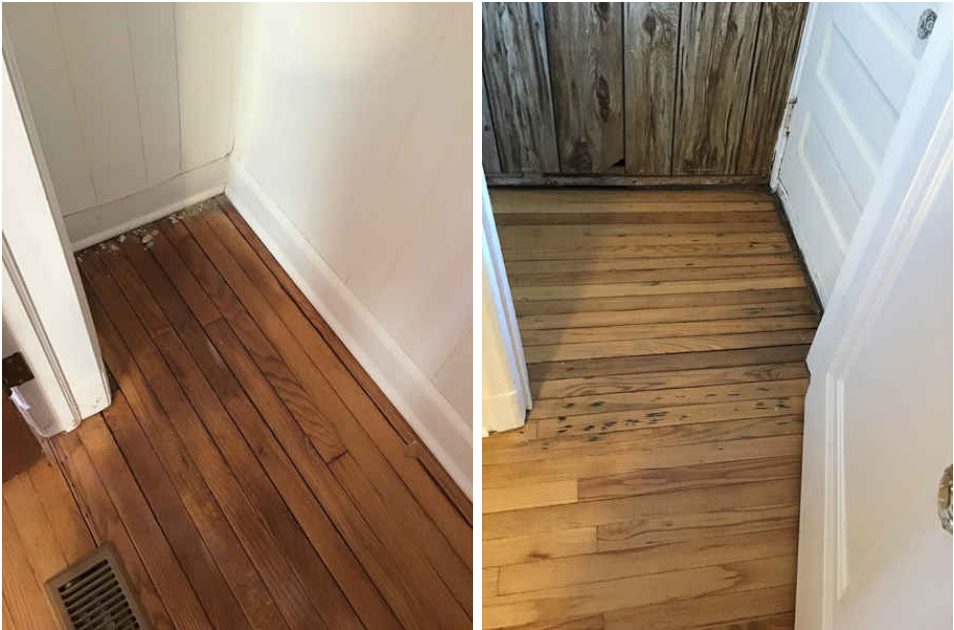
5.3.1 Floors

**MOISTURE DAMAGE**

Floors had areas of visible moisture damage. Recommend a qualified flooring contractor evaluate & repair areas of moisture.

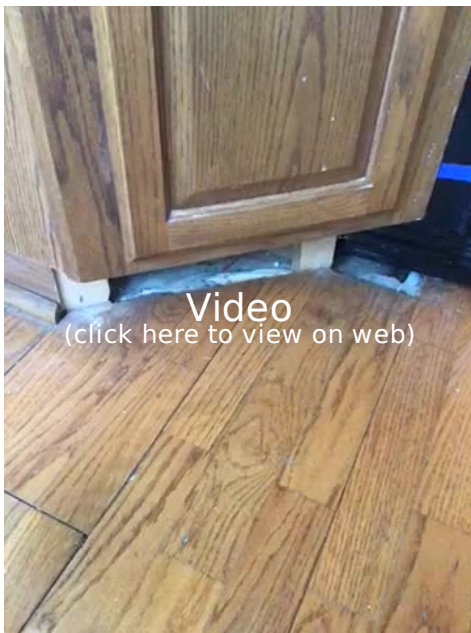
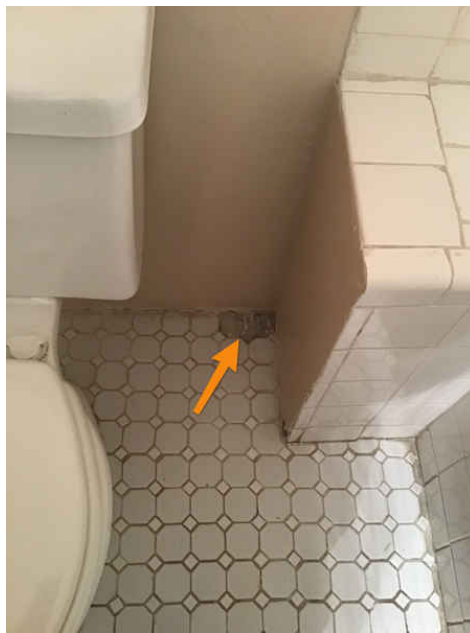
5.3.2 Floors

**TILES MISSING**

One or more floor tiles were missing. Recommend installing/replacing missing tiles.

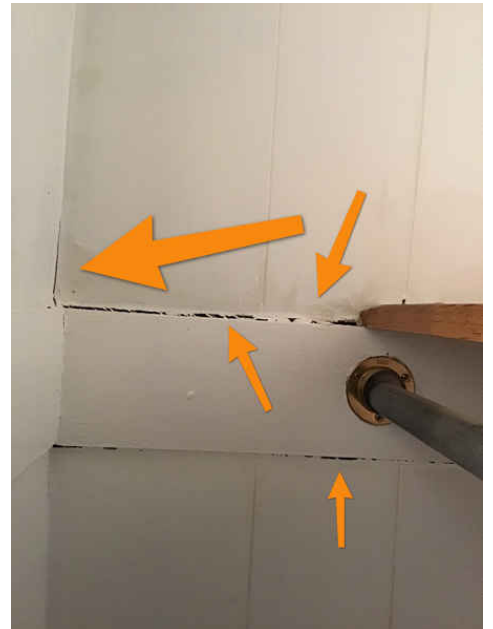
#### 5.4.1 Walls

### MOISTURE DAMAGE

Stains on the walls visible at the time of the inspection appeared to be the result of moisture intrusion. The source of moisture may have been corrected. Recommend further examination by a qualified contractor to provide confirmation.

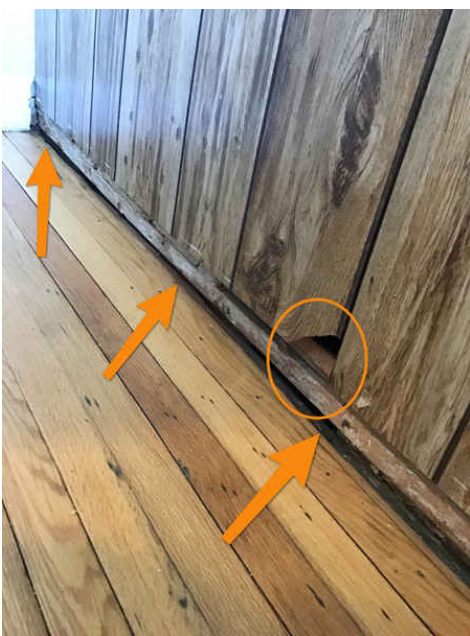
#### 5.4.2 Walls

### IMPROPER BUILDING TECHNIQUES

Improper building techniques. Cut and broken wood beams and observed in walls.

Contact a qualified professional.

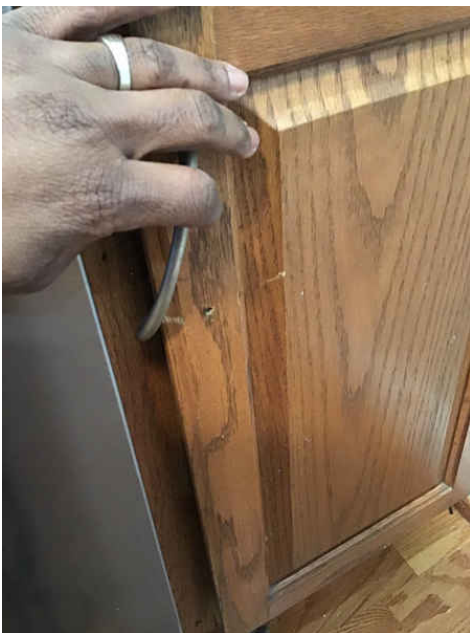
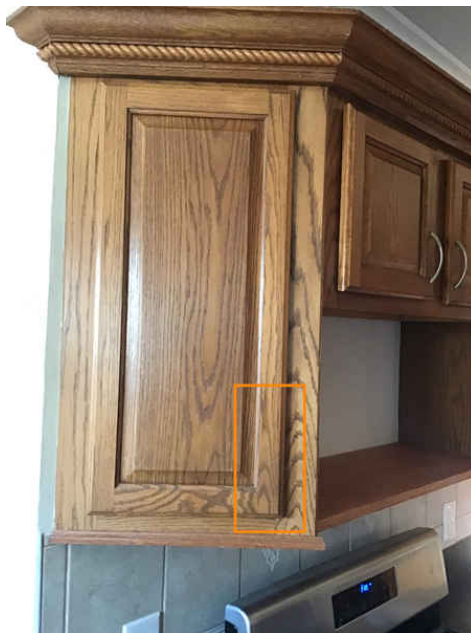
#### 5.7.1 Countertops & Cabinets

### **CABINET HANDLE MISSING/LOOSE**

One or more cabinet handles were missing and or loose.

No handle

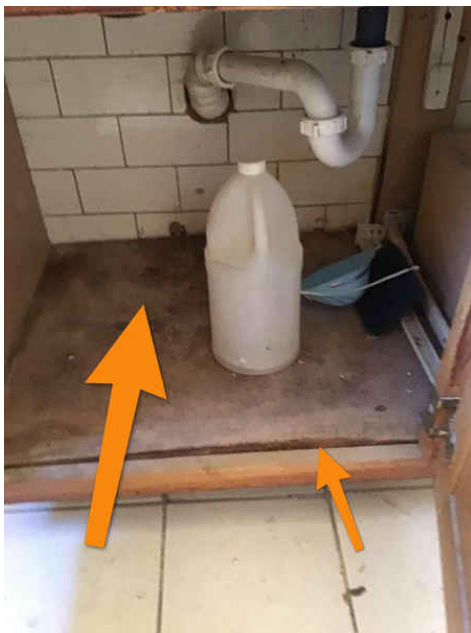
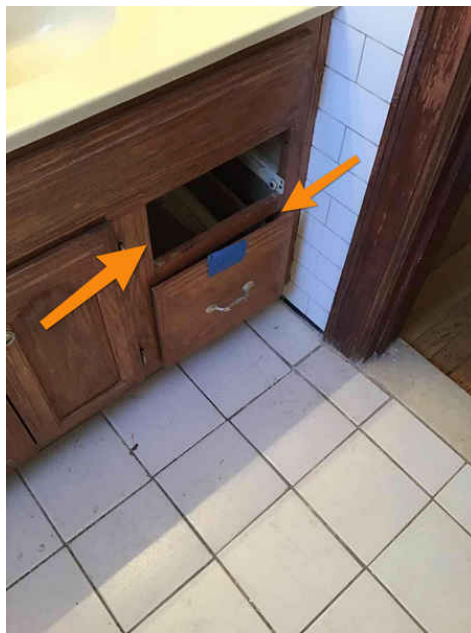
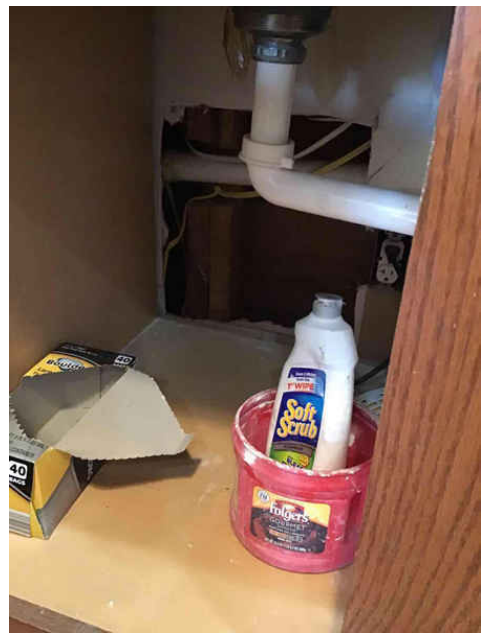
#### 5.7.2 Countertops & Cabinets

### **CABINETS DAMAGED**

Bathroom cabinet had visible damage at time of inspection Hole in wall in lower kitchen cabinet Missing electrical faceplate. Recommend a qualified cabinets contractor evaluate and repair.

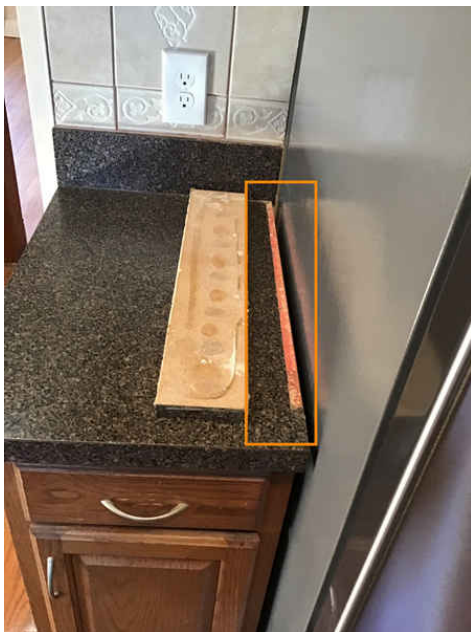
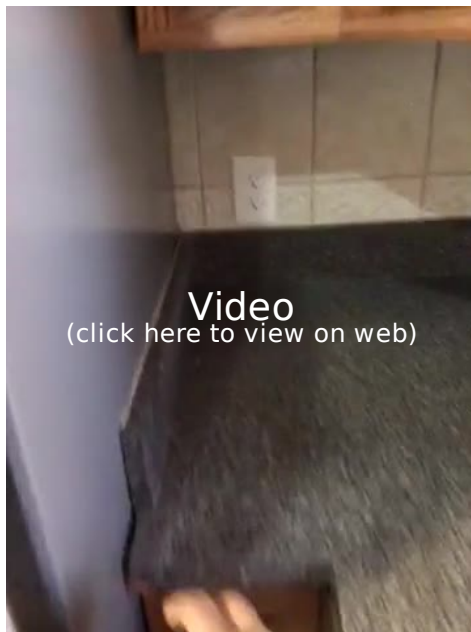
#### 5.7.3 Countertops & Cabinets

### COUNTERTOP NOT SECURED

Kitchen countertop appeared insecure. Recommend qualified countertop contractor evaluate and secure countertop properly.

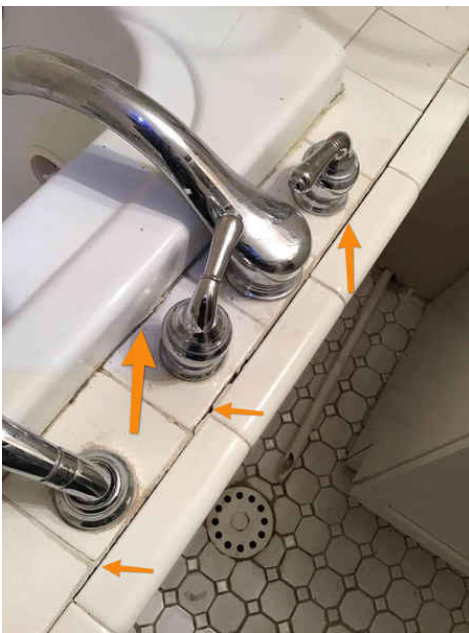
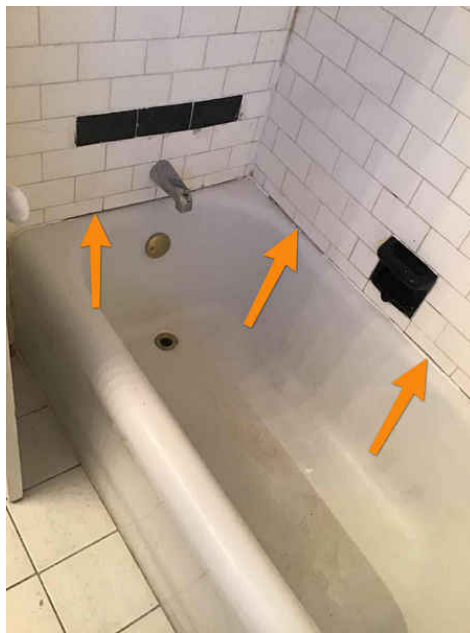
#### 5.7.4 Countertops & Cabinets

### GROUT DETERIORATING

Grout lines were cracked or severely deteriorated. Recommend a qualified contractor repair or replace grout.

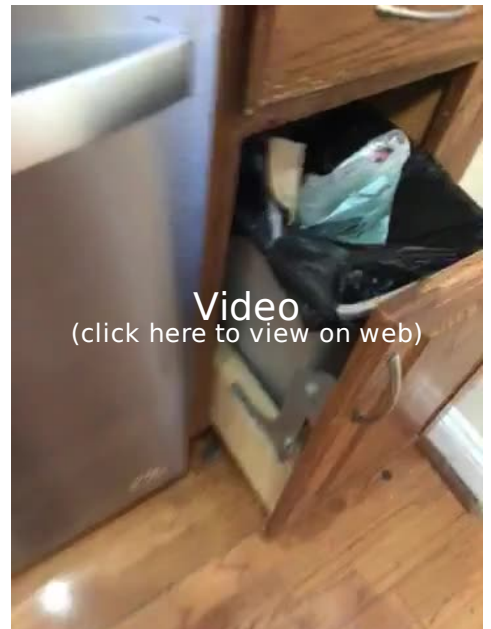
#### 5.7.5 Countertops & Cabinets

### **CABINET DOOR WON'T CLOSE**

Cabinet door won't fully close.

Contact a qualified professional.

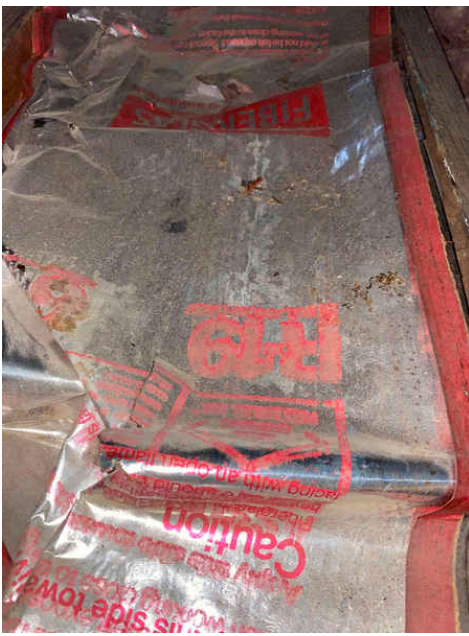
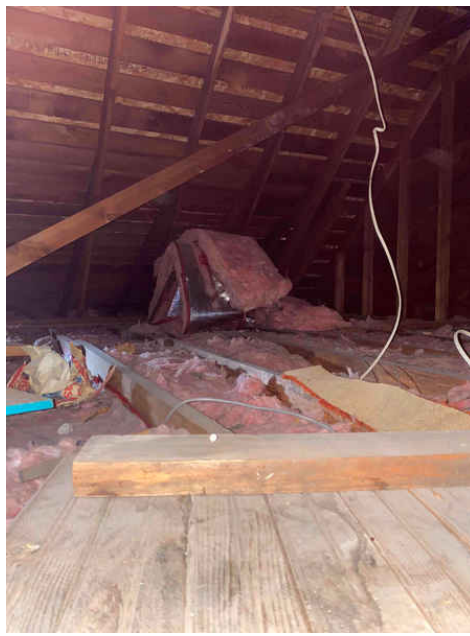
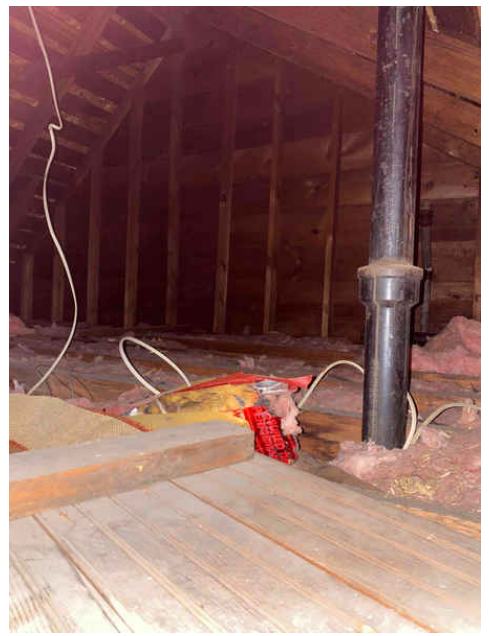
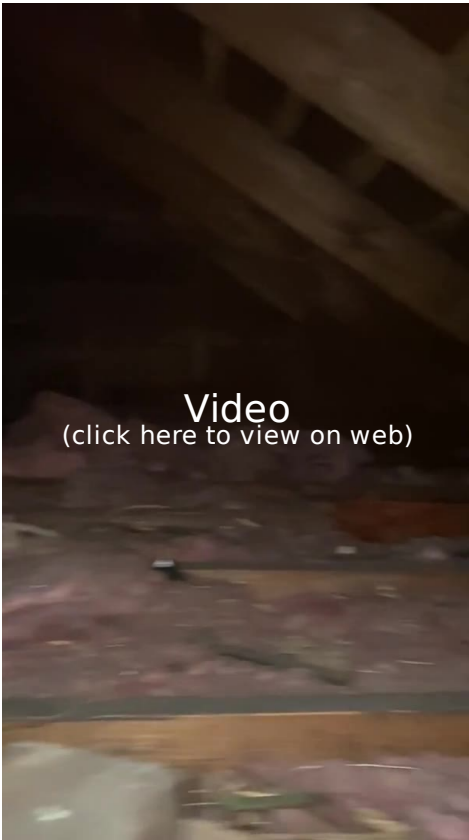
#### 6.1.1 Attic Insulation

### **INSUFFICIENT INSULATION**

Insulation depth was inadequate. Recommend a qualified attic insulation contractor install additional insulation.

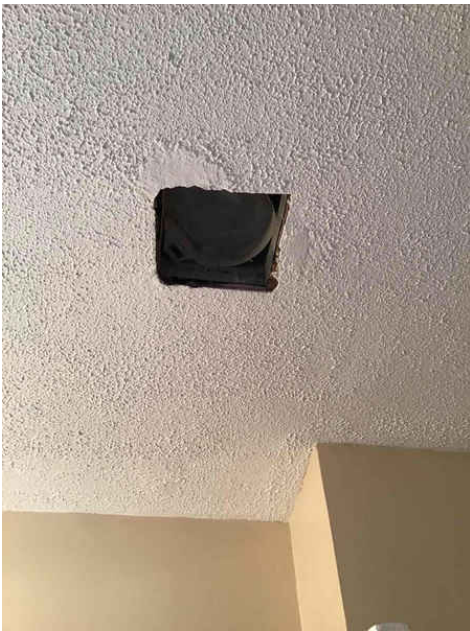
#### 6.4.1 Exhaust Systems

### BATHROOM VENTS INTO ATTIC

Bathroom fan vent is not covered. Recommend a qualified attic contractor property install exhaust fan to terminate to the exterior.

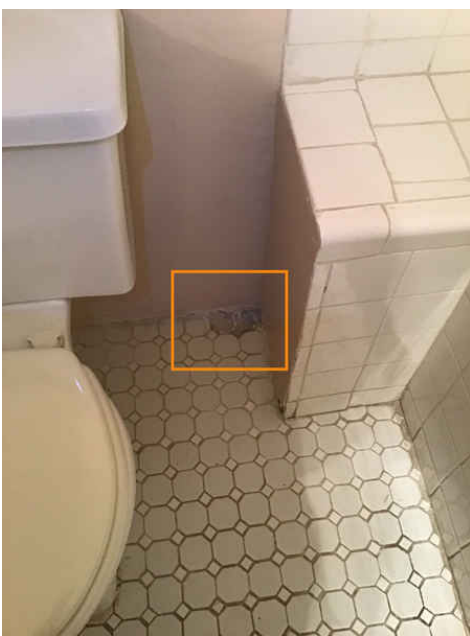
8.3.1 Floor Structure

**TILE**

Broken and chipped floor tiles throughout basement.  
Recommend professional consultation, possible asbestos in tiles

Recommendation  
Contact a qualified professional.

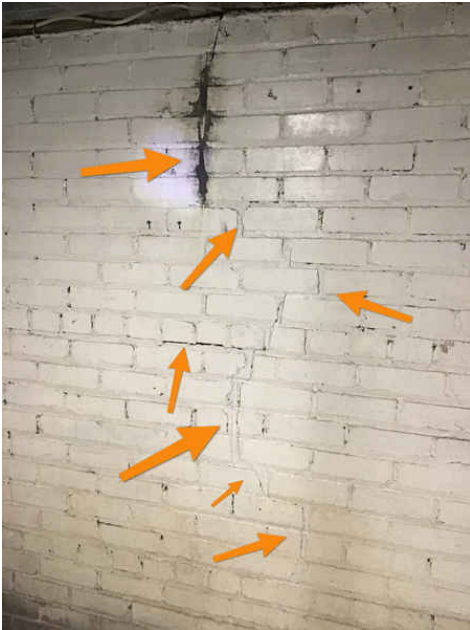
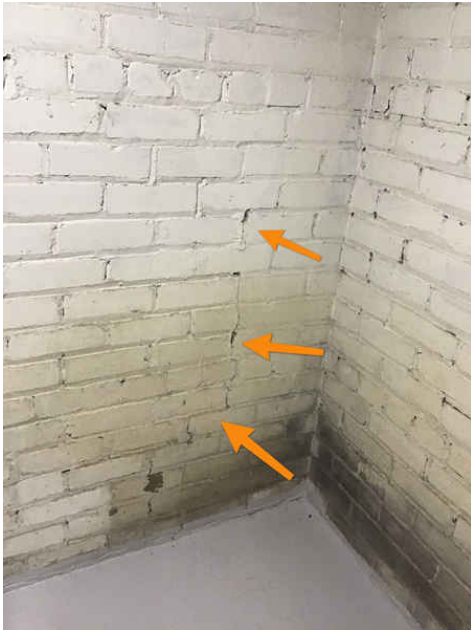
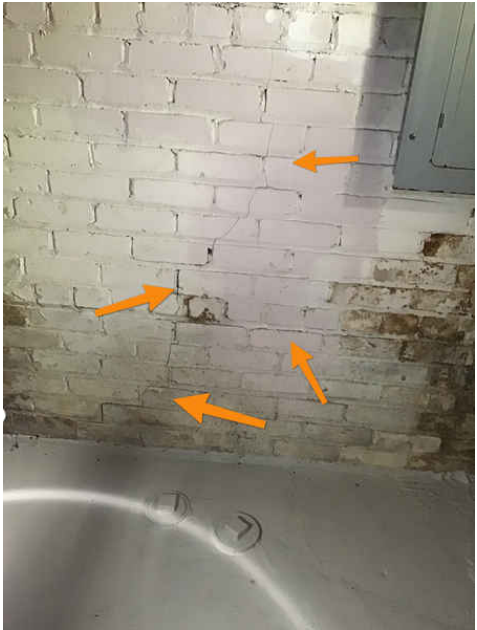
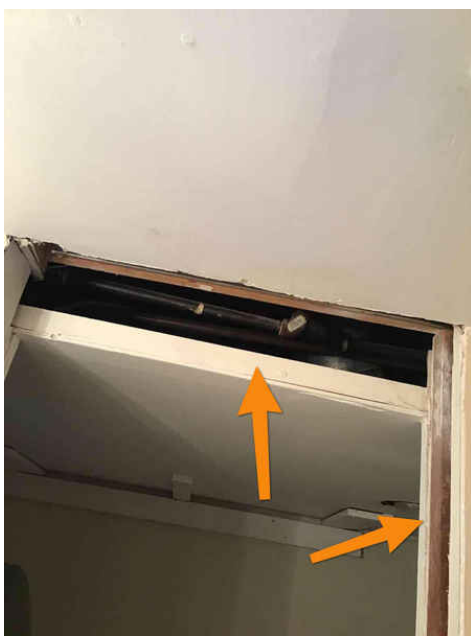
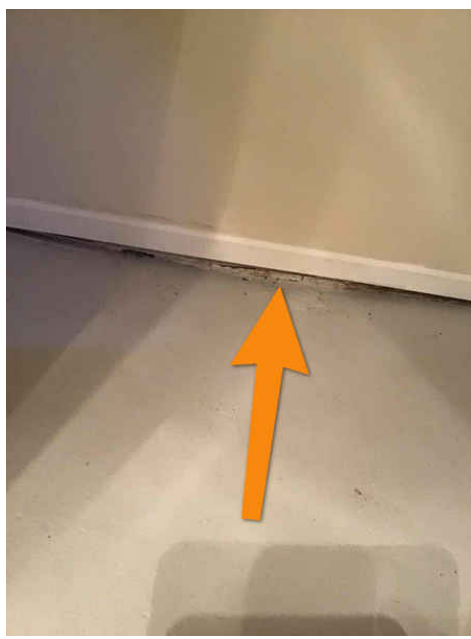
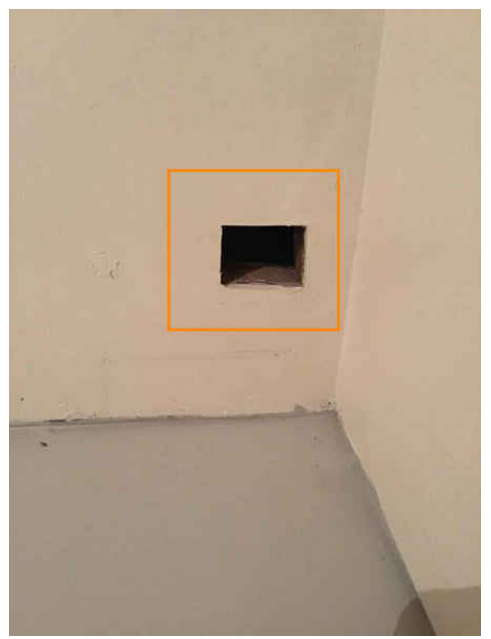
8.4.1 Wall Structure  
**CRACKS - MINOR**

Minor cracking was observed in wall structure. This is common in homes this age. Recommend monitoring.

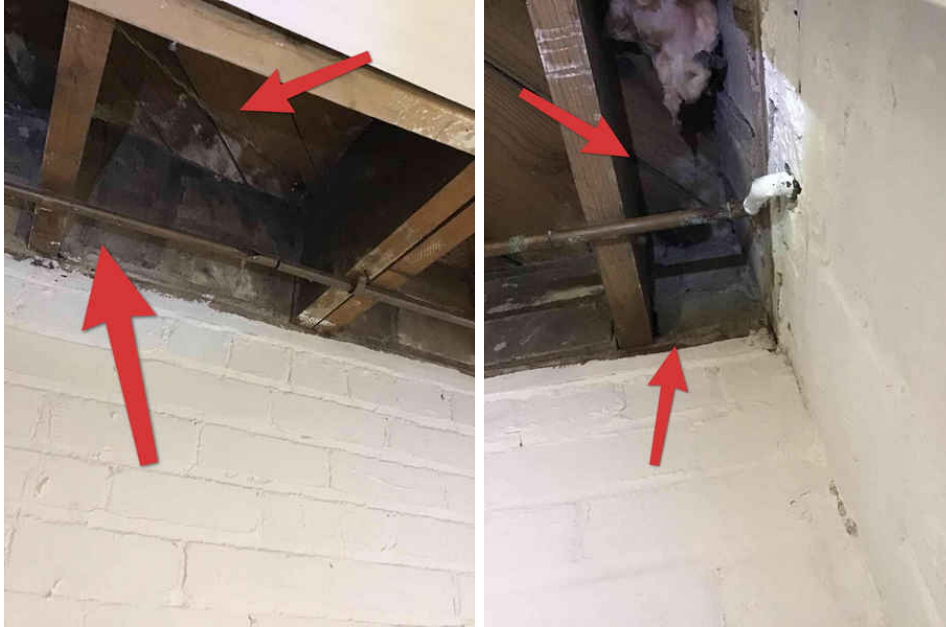
### 8.5.1 Ceiling Structure

## EVIDENCE OF WATER INTRUSION

Ceiling structure showed signs of water intrusion, which could lead to more serious structural damage. Recommend a qualified contractor identify source or moisture and remedy.

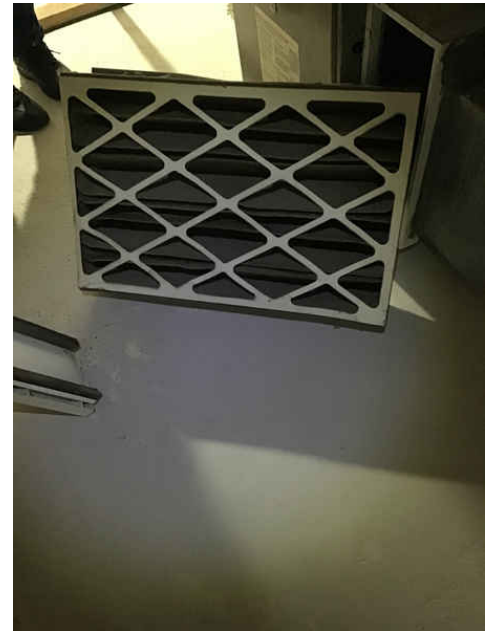
#### 9.1.1 Equipment **FILTER DIRTY**

The furnace filter is dirty and needs to be replaced every 6 months.

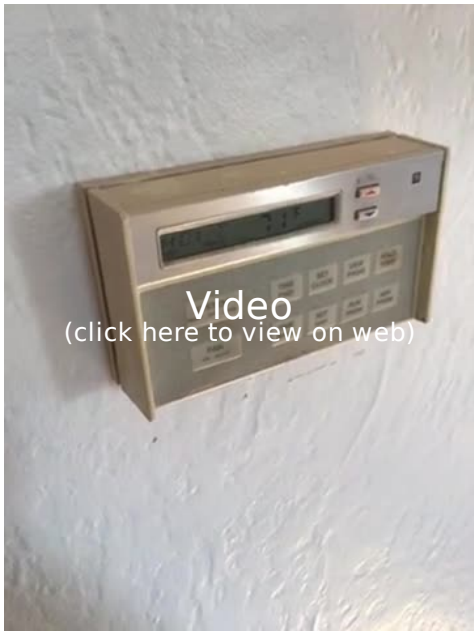
#### 9.2.1 Normal Operating Controls **LOOSE THERMOSTAT**

Thermostat was loose on the wall. Recommend repair or replacement.

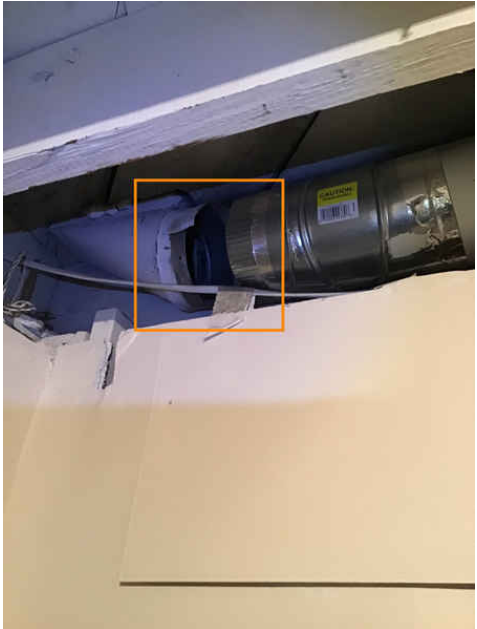
9.3.1 Distribution Systems

**DUCTS NOT SEALED**

Air supply ducts were not properly sealed. Recommend a qualified HVAC contractor seal supply and return ducts for maximum efficiency.

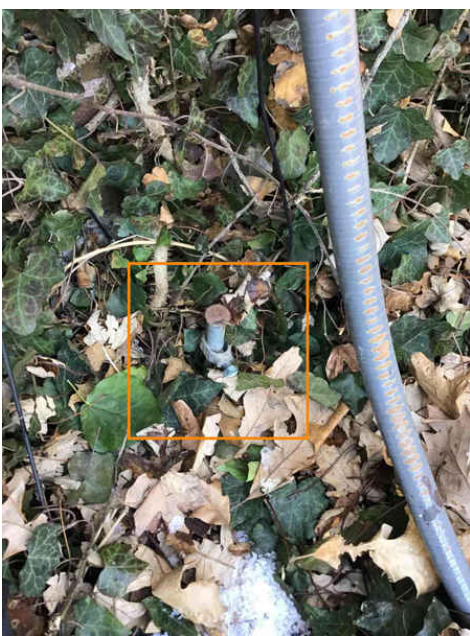
10.2.1 Main & Subpanels, Service & Grounding, Main Overcurrent Device

**NO GROUND WIRE**

Missing ground wire. Recommend qualified electrician evaluate and install.

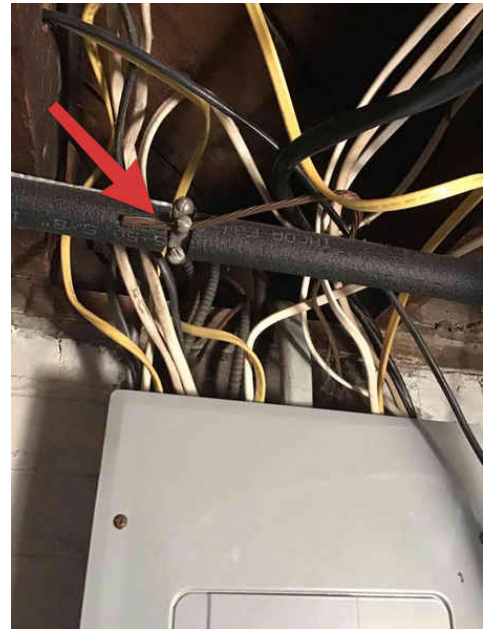
10.2.2 Main & Subpanels, Service & Grounding, Main Overcurrent Device

### **IMPROPER WIRING TECHNIQUES**

Improper wiring techniques. Electrical ground wire connected to gas line, unclear if wire is bonded.

Safety Hazard

Contact a qualified professional.

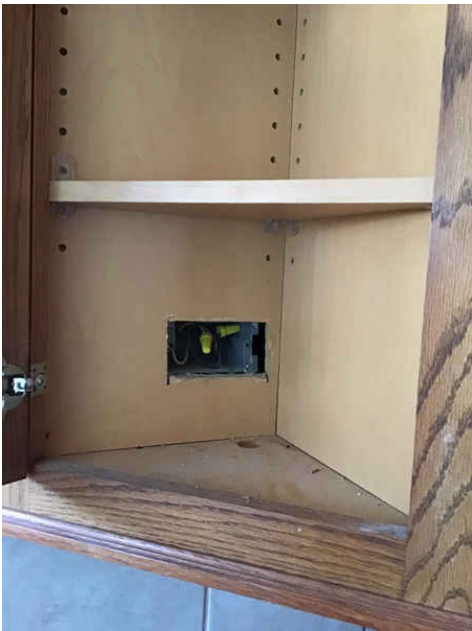
10.4.1 Lighting Fixtures, Switches & Receptacles

### **COVER PLATES MISSING**

One or more receptacles are missing a cover plate. This causes short and shock risk. Recommend installation of plates.

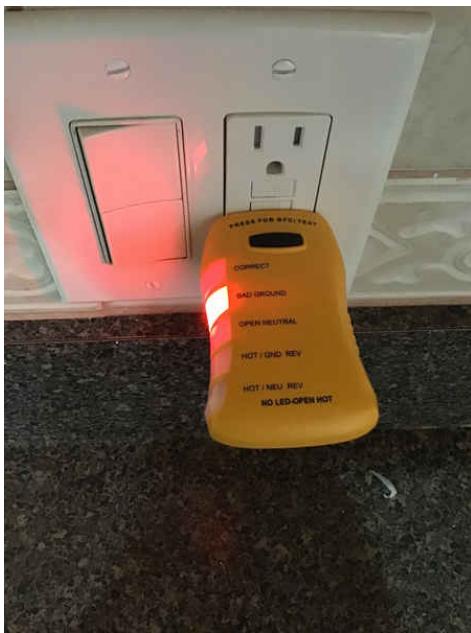
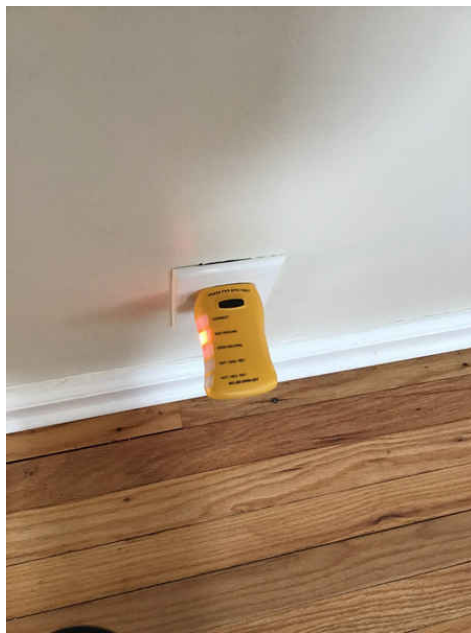
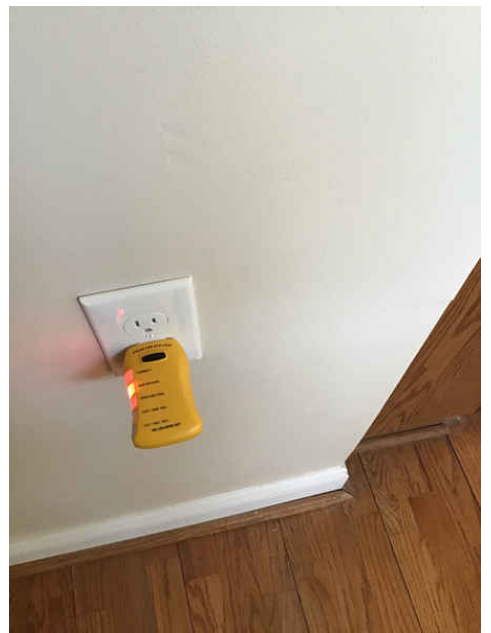
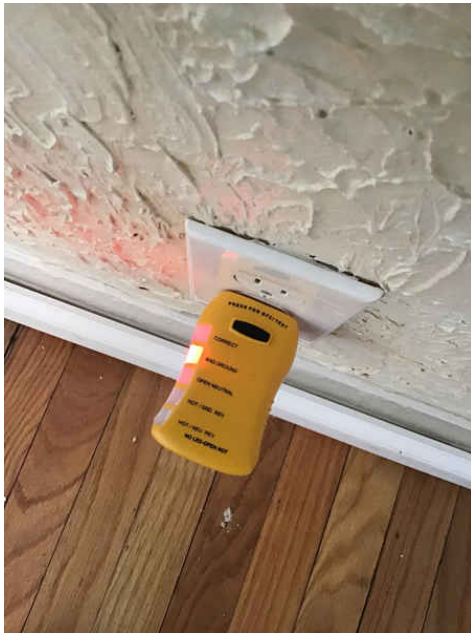
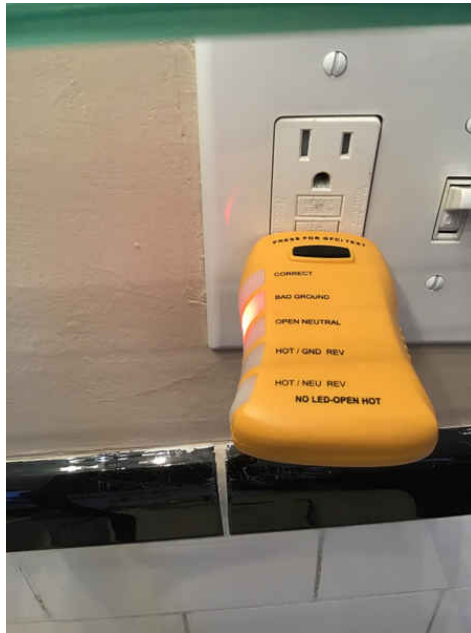
10.4.3 Lighting Fixtures, Switches & Receptacles

**UNGROUNDED RECEPTACLE**

One or more receptacles are ungrounded. To eliminate safety hazards, all receptacles in kitchen, bathrooms, garage & exterior should be grounded.

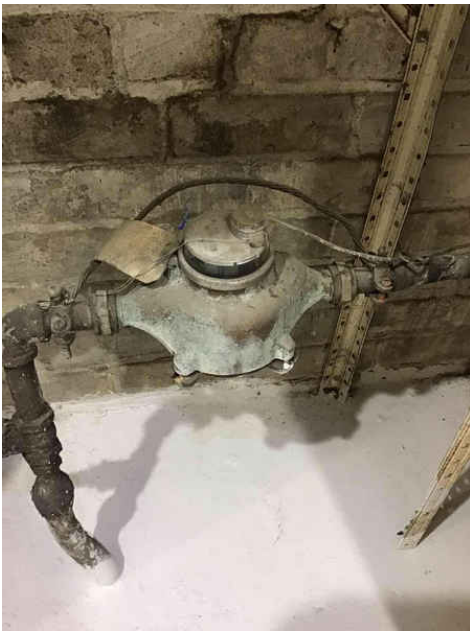
#### 11.1.1 Main Water Shut-off Device

### CORROSION

Water main shut-off shows signs of corrosion. Recommend a qualified plumber evaluate.

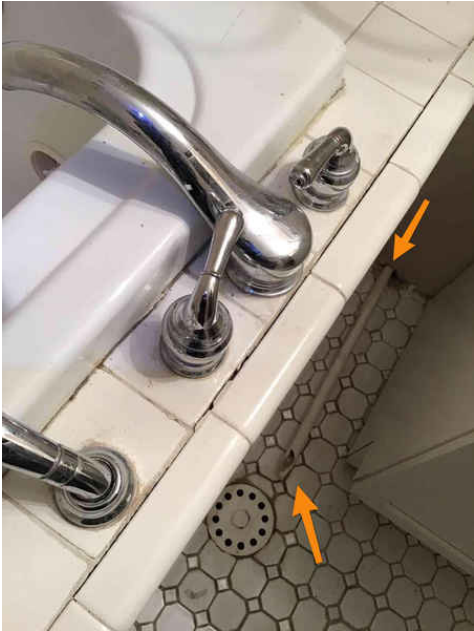
11.2.1 Drain, Waste, & Vent Systems

**IMPROPER CONNECTION**

An improper connection was observed at a drain, waste or vent pipe. Recommend a qualified plumber evaluate and repair.
