Veritas Property Inspection

Inspection Report

[REDACTED]
Lake Elsinore, California 92530

Inspection Date May 24, 2018
Client [REDACTED]
Inspector Nicholas Peres, CPI
P.O. Box 1004
Lake Elsinore, CA 92530
(951) 230-5831
veritasproinspect@gmail.com
Infrared, IAC2 Mold Certified,
interNACHI

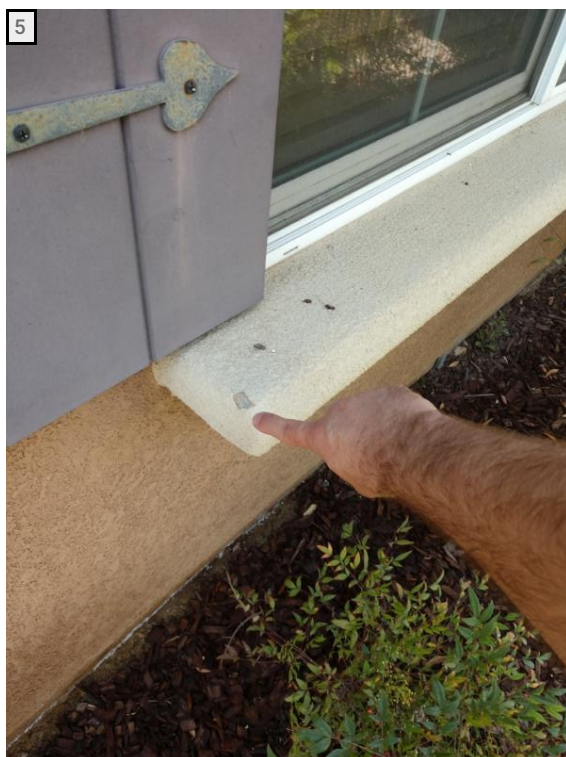
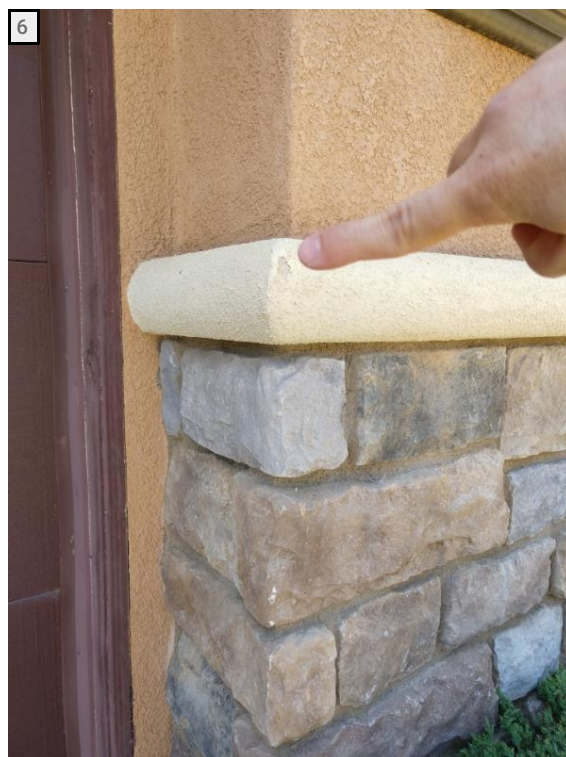
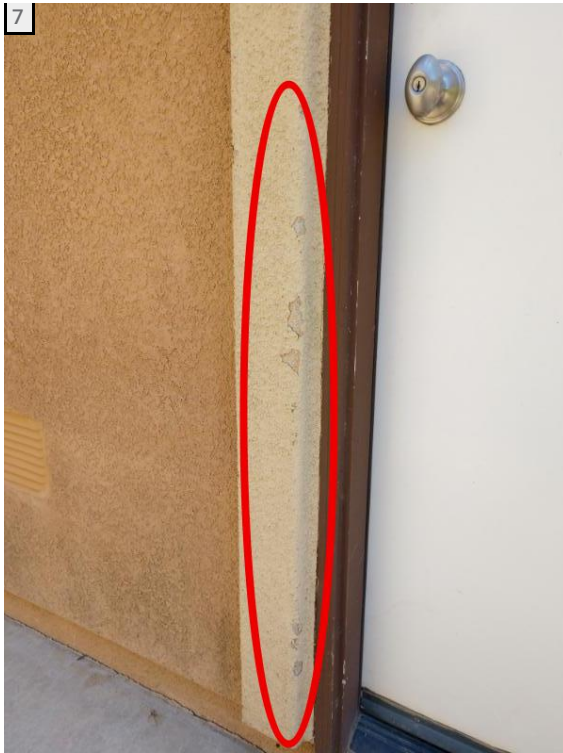
Stucco foam trim has holes or gaps

Location	Exterior: Ground View
Impact	The holes could allow for moisture intrusion which may cause damage to the stucco foam trim and stucco siding over time
Suggested Action	Have repaired and resealed by a qualified person

Noted in several places throughout trim

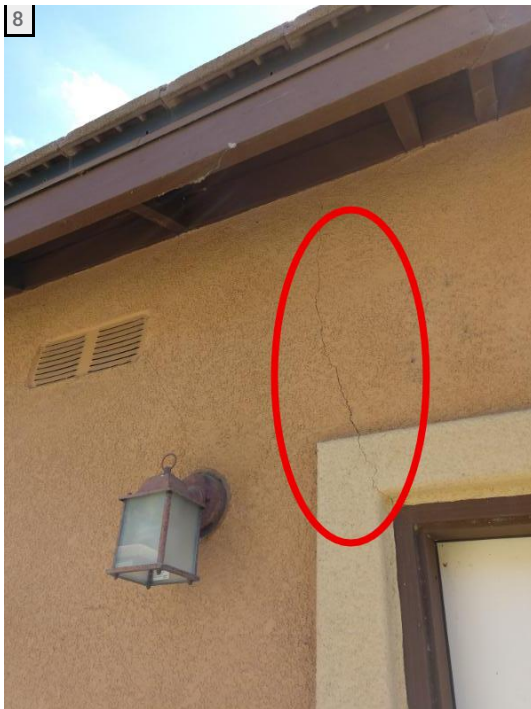
Stucco is cracked

Location	Exterior: Ground View
Impact	Cracked stucco may allow for moisture and insect intrusion
Suggested Action	Have a licensed stucco contractor or qualified person repair the affected areas
Other Information	Observed several affected areas

Noted in several places throughout stucco

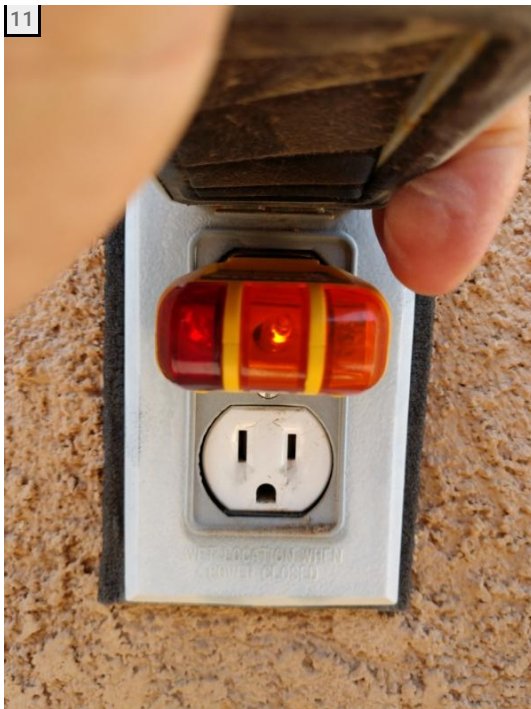
Tester shows open ground

Location	Exterior: Ground View
Impact	An open ground outlet can cause an electrical surge to the appliance resulting in damage or electrical shock
Suggested Action	Have repaired by a licensed electrical technician

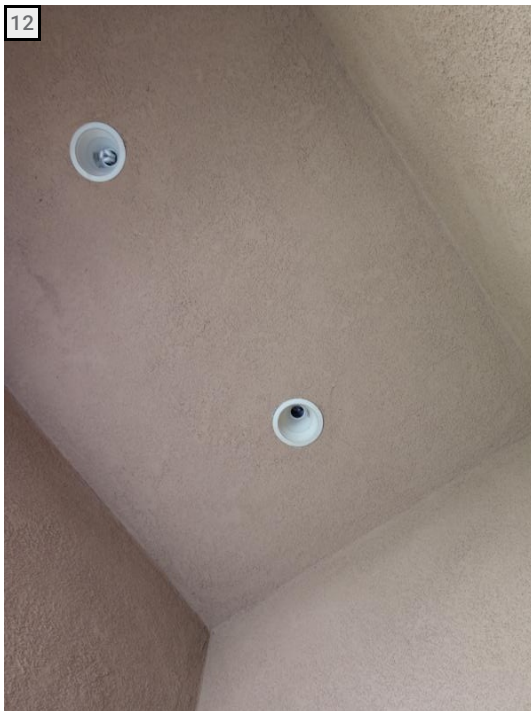
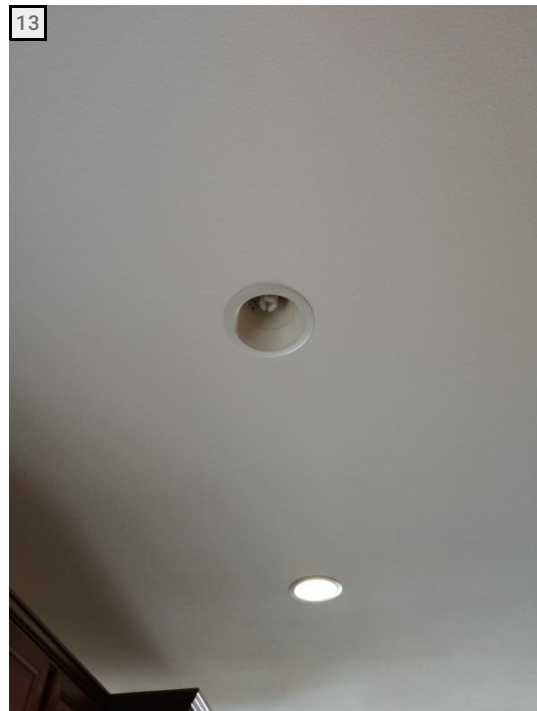
Bulb is burned out

Location	Exterior: Ground View, Kitchen
Suggested Action	Replace the bulb

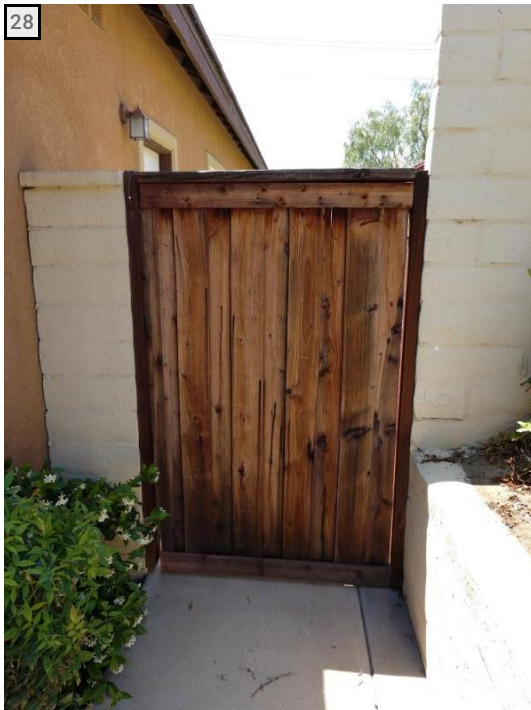
In need of normal staining

Impact Wood gates and fences need to be sealed regularly to prevent premature wear

Suggested Action Have a qualified person re-stain the fence or gate

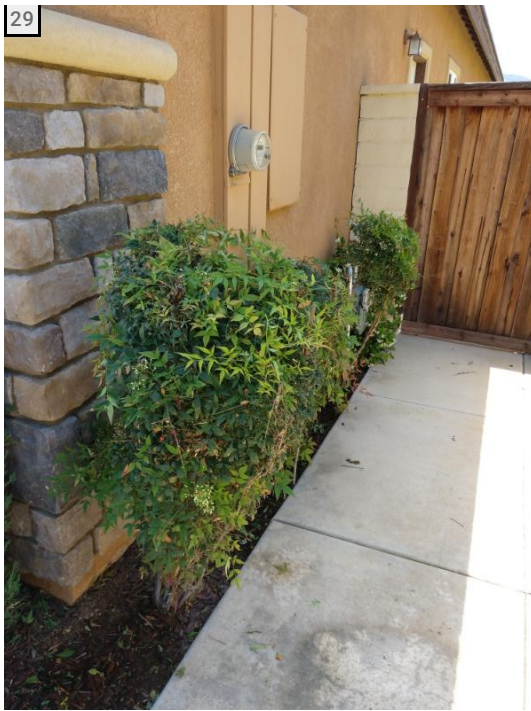
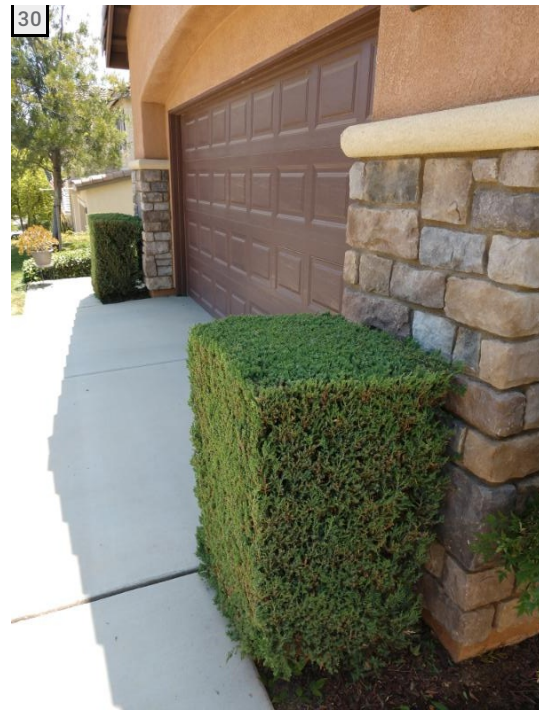
Shrubbbery is in contact with home or siding

Location Exterior: Ground View

Impact The shrubbbery provides an environment where moisture and/or insects could intrude

Suggested Action Regularly trimm the shrubbbery to achieve a clearance of at least 6 - 8 feet

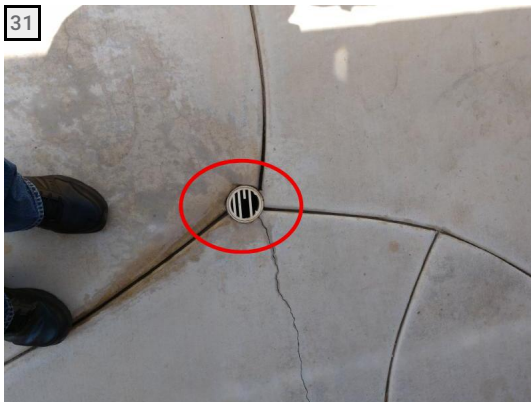
Walkway drainage grate broken

Location	Exterior: Ground View
Impact	Possible trip and fall hazard
Suggested Action	Have a qualified person replace walkway drainage grate

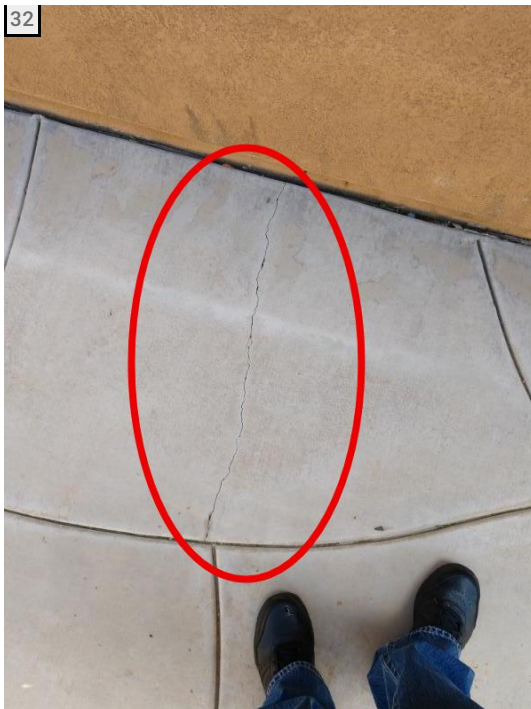
Settling with minor cracks

Location	Exterior: Ground View
Impact	The cracks allow for water intrusion, which may cause the surrounding surfaces to also deteriorate possibly requiring a complete replacement
Suggested Action	Seal the crack(s) with weather-resistant pliable concrete sealer

Noted in several places

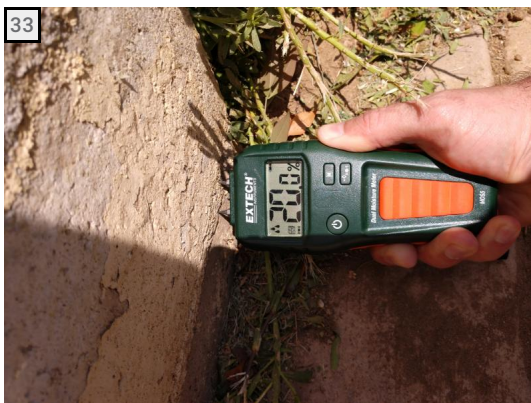
Spalling and efflorescence in block

Location	Exterior: Ground View
Impact	Spalling can eventually lead to significant structural damage Depending on water and soil conditions. The process could take many years
Suggested Action	Monitor for worsening conditions and have evaluated by a qualified person
Other Information	Spalling is flaking off or loss of material in masonry block. Efflorescence is the white powdery appearance of the block surface; this is caused by moisture evaporating and leaving behind visible deposits

Moisture reading

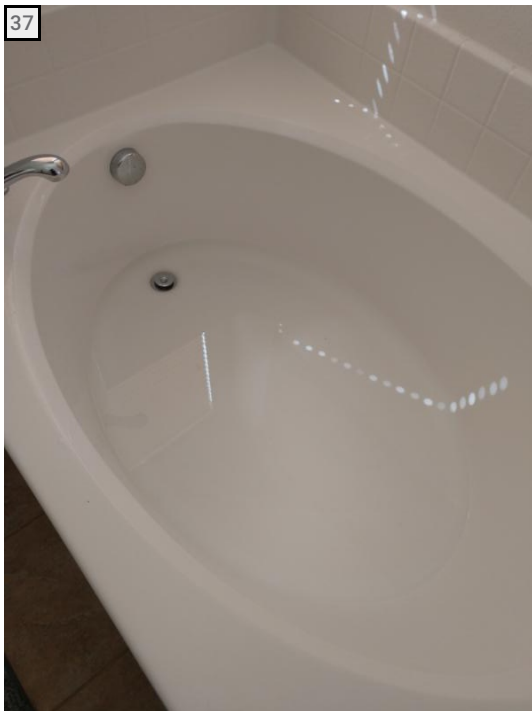
Drains slow

Location	Master Bathroom
Suggested Action	Clear the drain of debris with a rodder (vs. chemical)

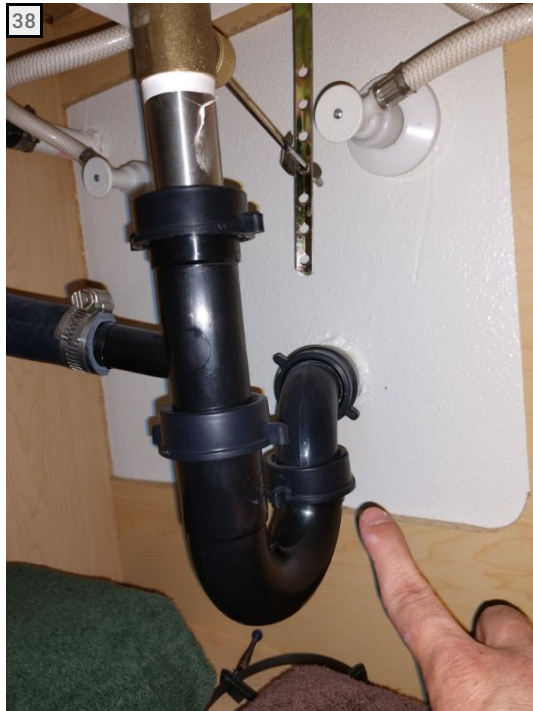
Pipes are leaking at the connecting joint

Location	2nd Bathroom
Impact	The water may damage the surrounding areas
Suggested Action	Have tightened or repaired by a qualified person

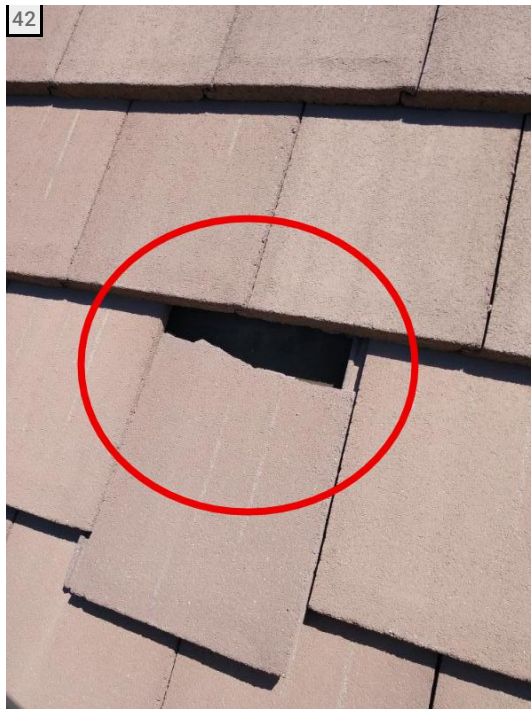
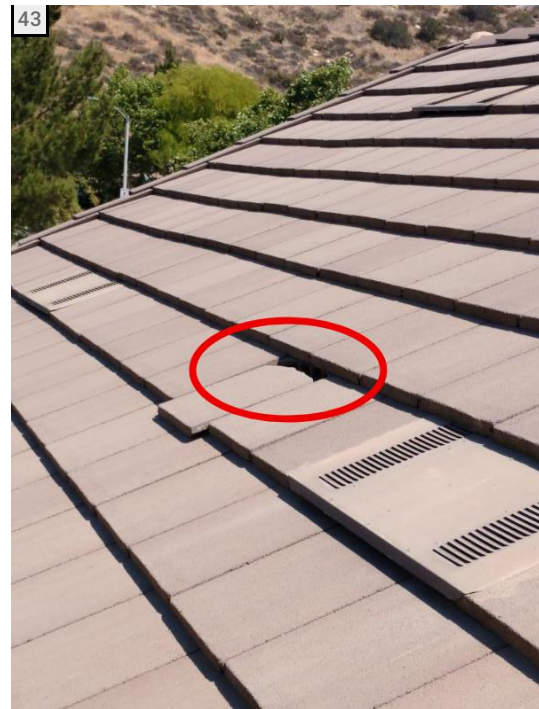
Displaced

Location	Exterior: Roof View
Impact	A displaced tile provides an avenue for runoff to penetrate the roof
Suggested Action	Have repaired by a roofing contractor or qualified person
Other Information	The roofing material can be displaced by some force such as Something heavy thrown on roof, excessive snow, ice or wind

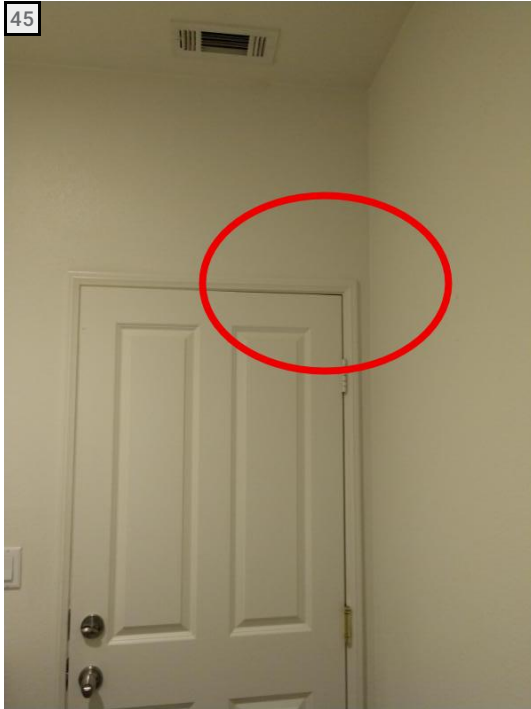
Safety Concern**Self-closing hinge is missing**

Location	Attached Garage
Impact	Without a self closing hinge, the garage door may remain
Suggested Action	Install a self closing hinge

Circled usual location of self closing hinge for reference

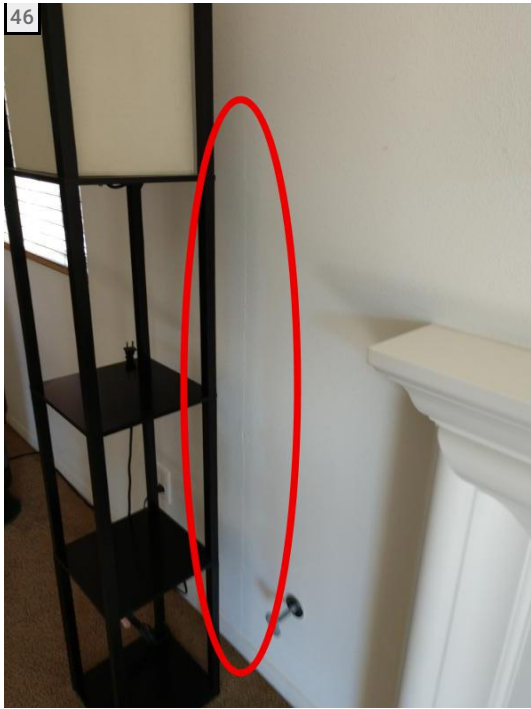
Cosmetic**Drywall has settling cracks**

Location	Family Room
Suggested Action	Repair with drywall tape and drywall compound and repaint
