Rear DP Overheating? Here is one major cause and the corrective actions needed.

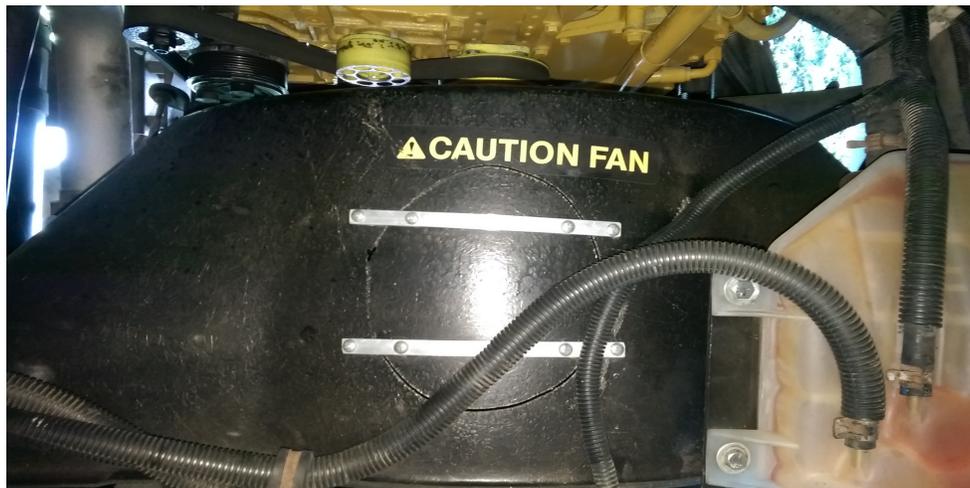
- Take some aluminum strapping $\frac{1}{2}$ " wide X $\frac{1}{8}$ " thick to span the plug in two places as shown in the photo.
- Drill 4 clearance holes for # 10 stainless steel sheet metal screws in the straps as shown. Two are for the plug, other two for the shroud.
- Offset the straps, mark and pilot drill the holes (4) in the plug.
- Install four #10 X $\frac{1}{2}$ " stainless steel sheet metal screws in the plug.
- Align the plug with the access hole and transfer mark the shroud holes.
- Pilot drill and install four more screws.

You know have a access hatch to clean out your CAC/RAD. This should be done every year or 20,000 miles. Besides oil changes, this is one PM you do not want to skip.
