Ehningen: Fire of a high-voltage battery on a test stand

Fast extinguishing success with F-500 - Interesting extinguishing water analysis

A high-voltage car battery burned on an air-conditioning test bench in Ehningen (Baden-Württemberg). The fire was quickly extinguished by the emergency services with the extinguishing agent additive F-500. The article describes the course of action and deals in particular with the topics of extinguishing water retention and extinguishing water analysis.

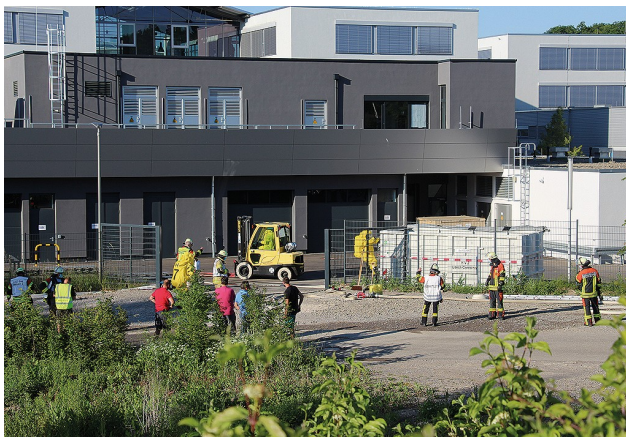
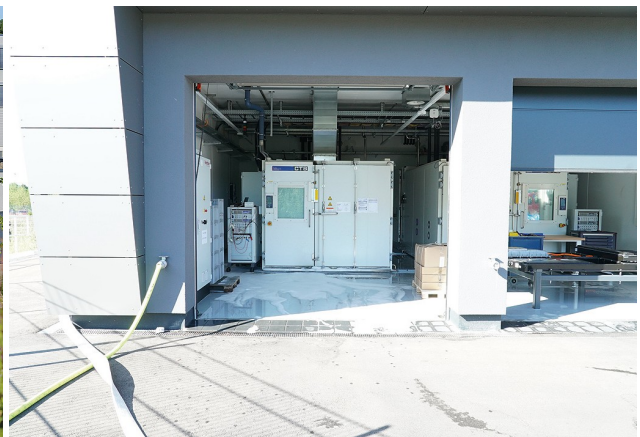
left: Overview of the operation site. Climate chamber 12 is located in the building on the far left (outside the picture). The liquid-tight roll-off trough is next to the company entrance. **right:** View of the climatic chamber 12 affected by the fire with the C feed fitting.

The extinguishing operation was carried out directly via the C feed device on the outside of the test chamber. In this way, the climatic chamber and the

The high-voltage battery, whose housing was completely closed, was flooded. Water with a three-percent admixture of the extinguishing agent additive F-500 was used as the extinguishing agent. Within one minute a successful extinguishing could be achieved and the feedback "fire under control" could be given. An immediate decrease of the temperature in the climatic chamber by about 75 °C to 190 °C as well as a further decrease to about 160 °C within ten minutes could be observed.

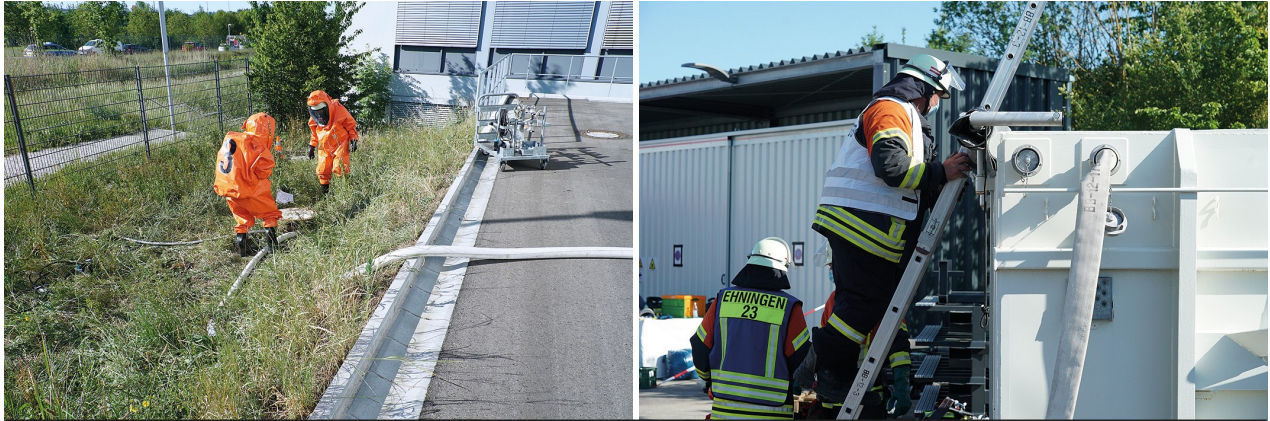
Left: The extinguishing agent mixture was first collected in the underground structural five-cubic-metre collection tank ... **right:** ...and then pumped into the company's liquid-tight roll-off container (here during preparation for the pumping work).

retention", which was led by a platoon leader, had been set up. During the investigation it quickly became clear that the existing structural collection solution with a capacity of five cubic metres would not be sufficient. As an alternative, it was planned to pump the collected extinguishing agent mixture into the company's liquid-tight roll-off trough. After the arrival of the environmental protection platoon at 5.24 p.m., the unit was assigned the following tasks:

The forces of the environmental protection platoon pumped the extinguishing agent mixture from the five-cubic-meter catch basin into the roll-off trough. A total of seven cubic metres of extinguishing agent mixture was involved.

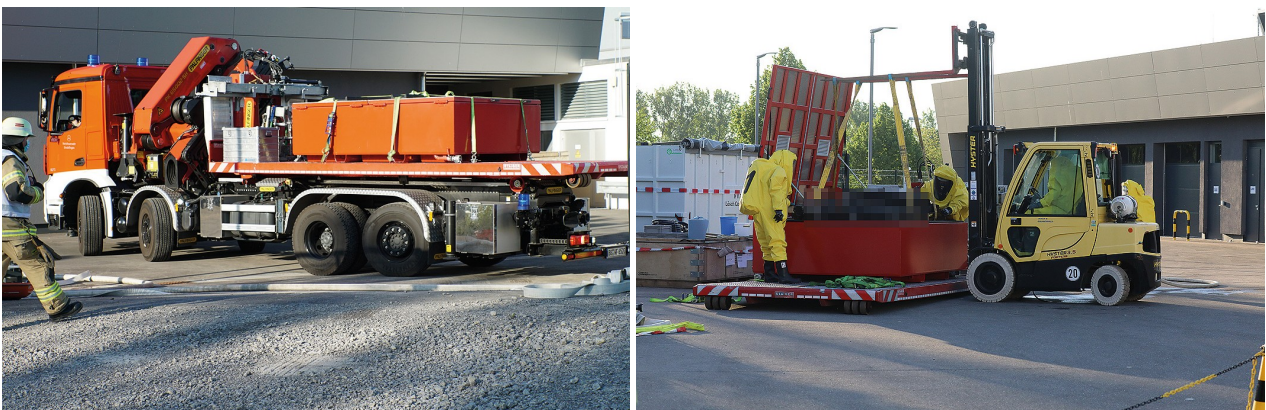
Left: With a WLF, the WF Mercedes-Benz brought a battery salvage container. **right:** By means of a forklift truck, the damaged battery together with the carrier frame was brought into the salvage container.

At 7.30 p.m., the emergency services secured the extinguished battery in a recovery container filled with a water-F-500 mixture at the Mercedes-Benz Sindelfingen plant fire brigade, into which it had been moved by means of a forklift truck. The work took about half an hour. The battery did not ignite again. The work was carried out under chemical protection suits.
