## Case Study — Clogged Fines Chute Under Feeder to Jaw

## Implementation Plan (NWS Turnkey)

## Chute Retrofit Concept Sketch

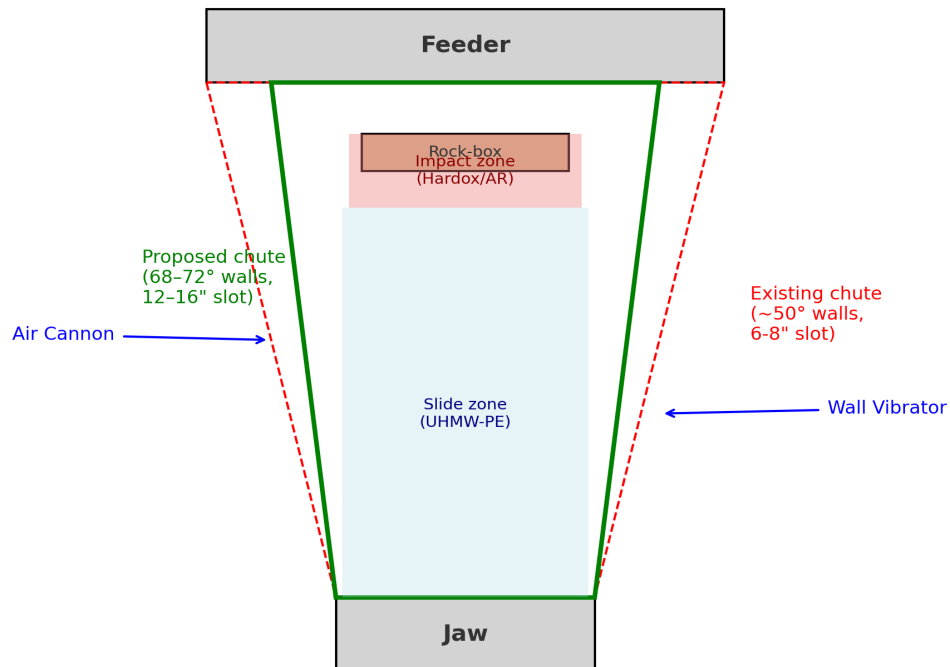
### Chute Retrofit Concept — NWS Solution

Operations & Water Management	Re-aim sprays; install drip-lips, drains, and interlocks.
Flow Aids	Add pneumatic air cannons, knockers, or vibrators at arch zones.
Liner Strategy	Use Hardox/AR at impact; UHMW-PE (TIVAR-88) in slide zones.
Geometry Fix	Steepen walls to 68–72°; widen outlet to $\geq 12"$ ; add rock-box.

- 1" UHMW-PE liner panels with SS fasteners.
- Hardox 450/AR400 plates for impact zones.
- Two air cannons (50–100 L) with valves and PLC I/O.
- One heavy-duty vibrator with VFD.
- Skirt drip-lips, drains, sump hardware.
