### **Extraction Report**

Location: Country Pond, Newton/Kingston, NH

Exotic/Invasive Plant(s): Brittle naiad

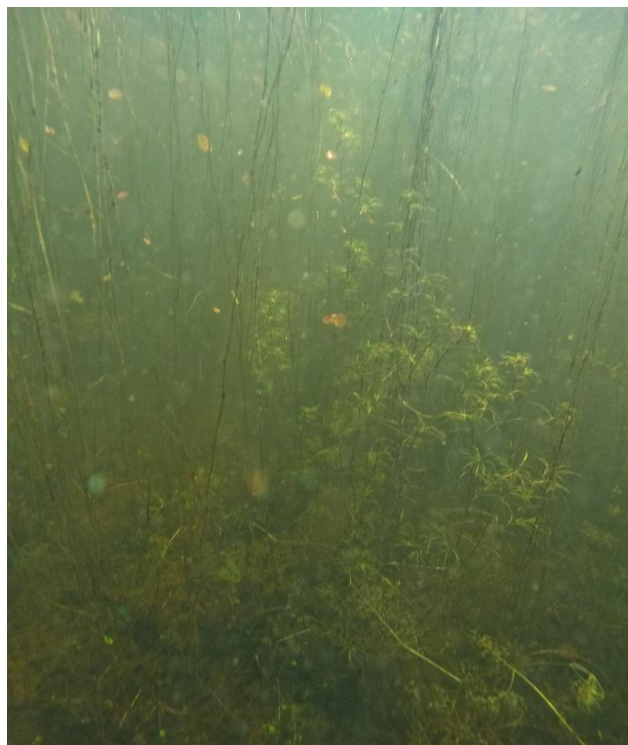
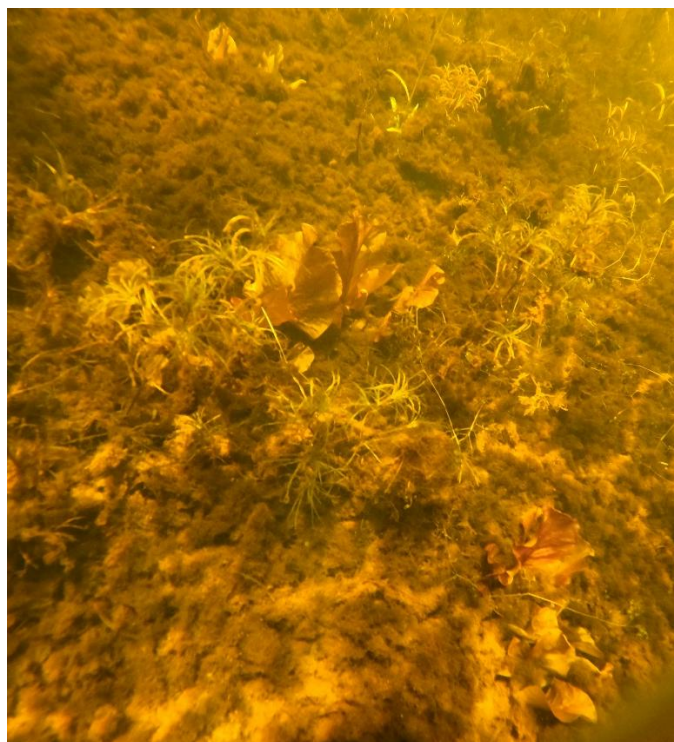
The tall and the short brittle naiad plants in the Lake Road cove. Plants were found both in the lily pad mass on the western side and in the open water.

On the first day, divers started extraction in the cove off Lake Road. Brittle naiad plant grew between six inches and three feet tall in water six feet deep. Plants were tangled in watershield and difficult to extract. Divers determined they'd need to return to this cove several times. Divers transited to Webster Road and the adjoining bridge. At the bridge, plants were extracted from sand and gravel in between granite rocks along the shoreline. There was one one-foot tall, bushy plant in water two feet deep. The remaining plants were small. Divers searched the area in front of the lily pads at the house at the end of Webster Road, where one point was mapped. Divers didn't see any plants, and determined they needed to return and recheck the beach area where people were playing in the water.

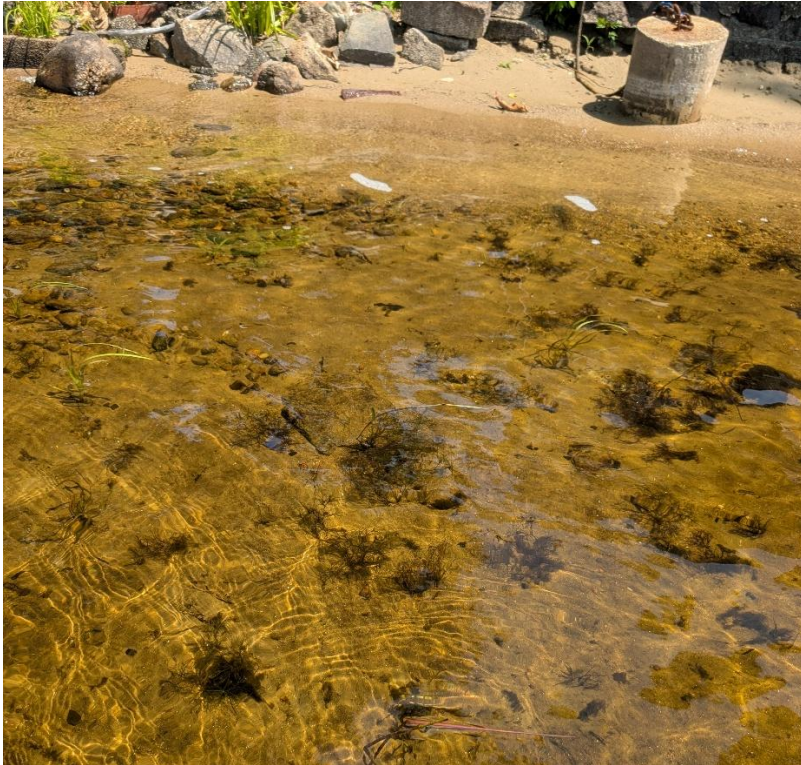
Tiny, bushy plants in the beach area off Marcoux Road. Plants were rooted in the sand but not further out.

Divers moved south to numbers 22 and 24 Marcoux Road. They extracted tiny, bushy plants from the shoreline. Plants were not found beyond water about a foot deep. From there, at the single mark off the Wenmarks Grove Town Beach, divers found small and tiny plants, which looked trampled/pulverized, and amounted to barely anything., along the shoreline and in what appears to be a boat launch area. Divers ended the first day at the boat launch and beach off Sunshine Drive. Brittle naiad plants ranged in size from less than a foot to three feet tall. A small field was visible from the surface in the space behind the black pontoon boat and the jet skis. All plants, native and invasive, were thriving in this area. Plants were rooted amongst underwater ferns and bladderwort. Divers cleared the boat launch and started on the open was area.

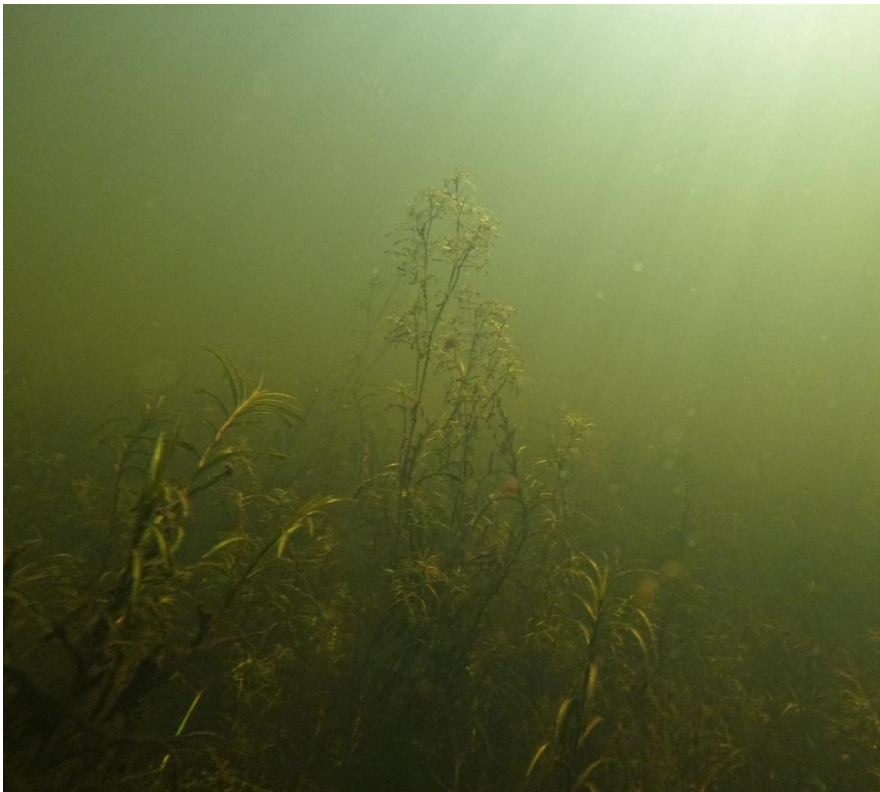
The plants in the Sunshine Drive boat launch area are taller than in most areas and readily seen from the surface.

Divers focused on the Sunshine Drive boat launch and beach on the fourth day. Most of the brittle naiad was extracted from the open water area behind the pontoon boats. Additional clusters were found off the beach side of the red pontoon boat, along the lily pads off the boat launch, and in the areas in front of the lily pads on either side of the beach. Plants were found sporadically along the lily pads and near the floating dock east of the beach.

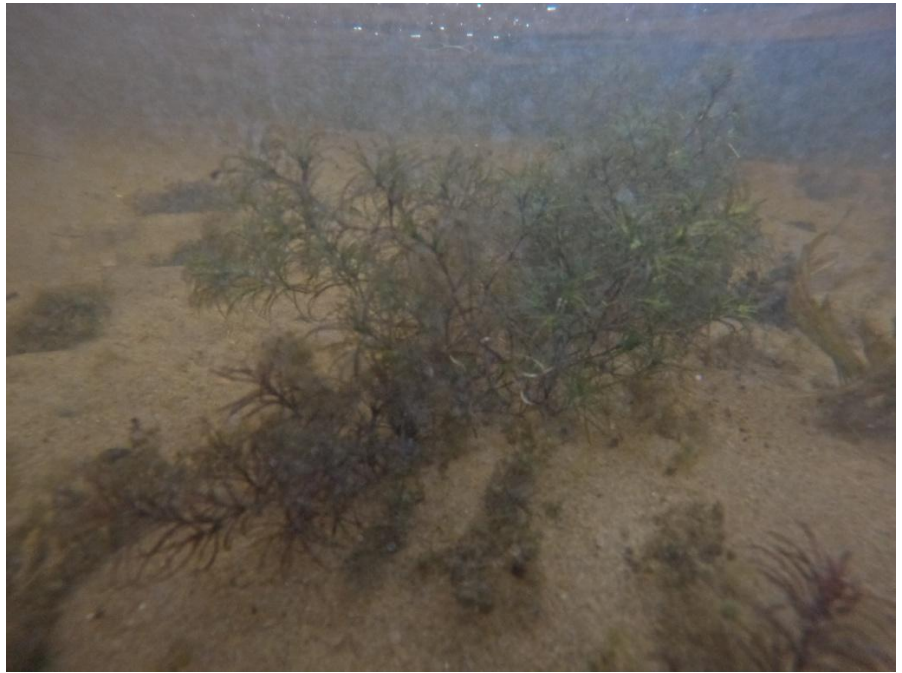
While the tallest plants were found at the end of the single pier, most of the brittle naiad plants at the former Boy Scout Camp property were small and bushy. Plants would root and lay down in the sand. Plants would be as tall as eight inches once fluffed up.

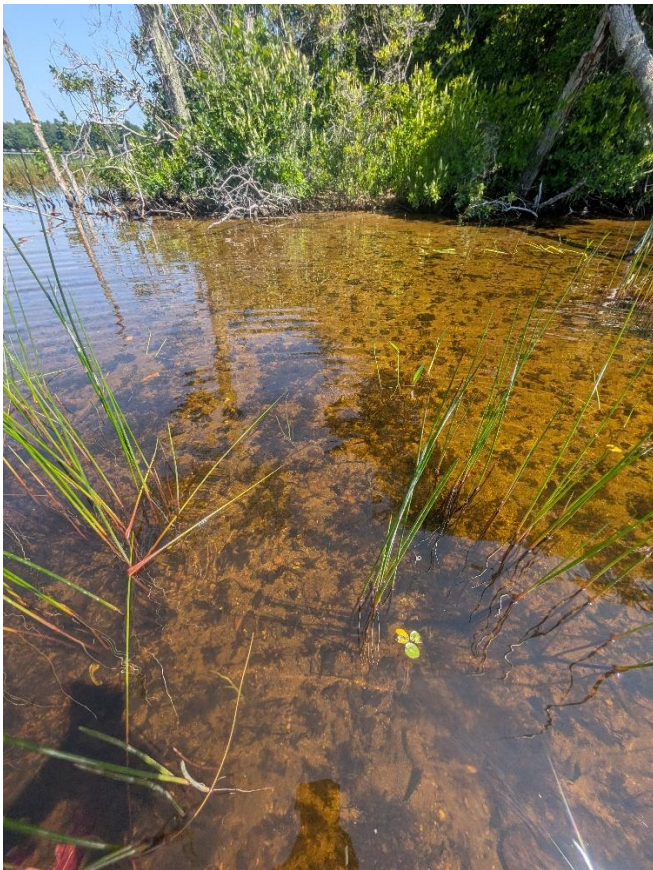
Tiny brittle naiad plants in the sandy area off the point of the island covered in organic decomposing matter.

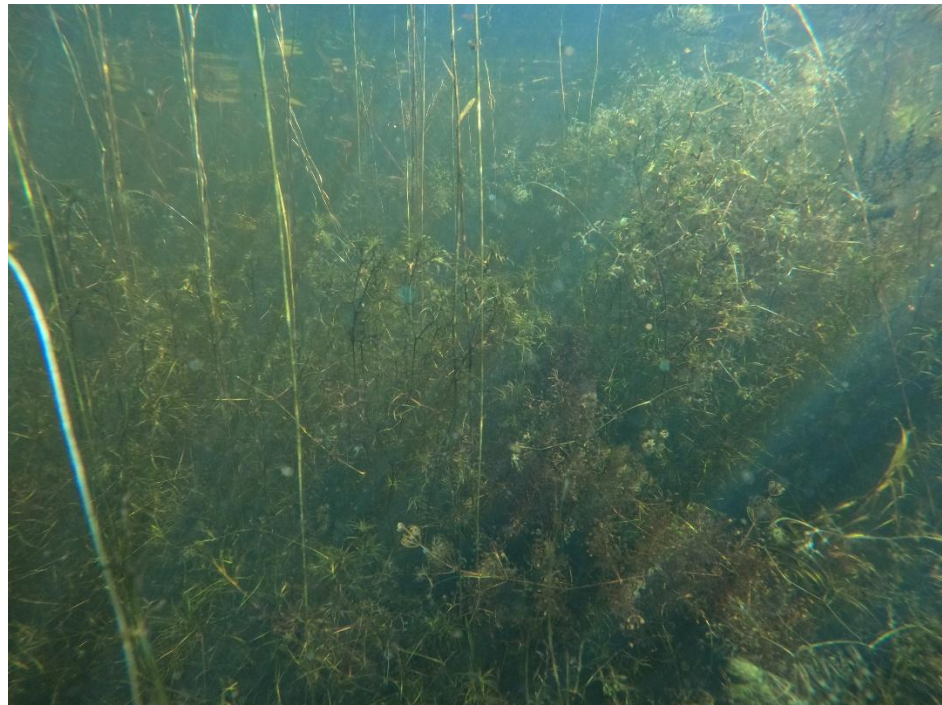
A cluster of tall brittle naiad along the lily pads along the lily pads on the right side of the beach off Sunshine Drive.

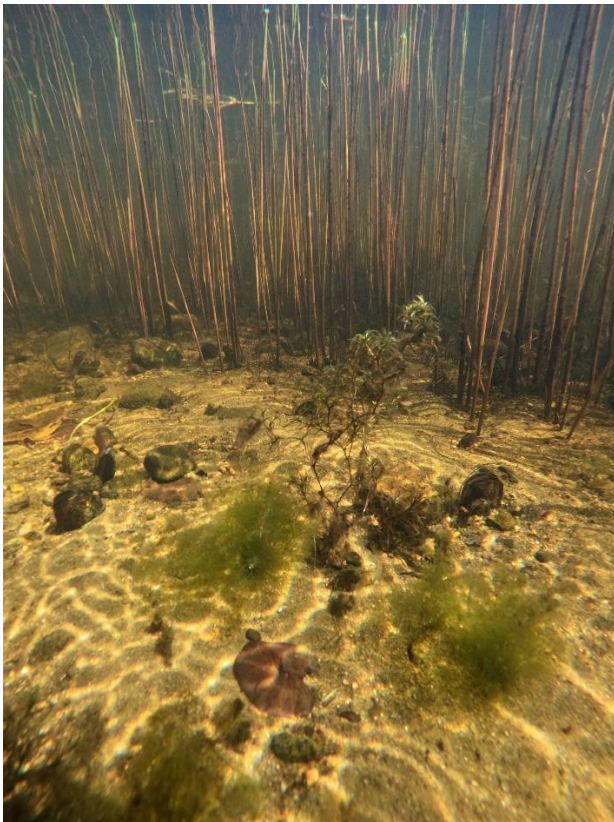
Tiny brittle naiad plant along the shoreline on the northern tip of the island growing in sand and separated from the open water by reeds.

On the fifth day, divers started with the points off the tip of the northern side of the island. One small plant was found on the open water side of the lily pads and reeds, while four were located on the sandy shore of the island. Divers moved to the next point on the island, where at the bottom of the scummy rocky ledge at five feet deep, three two-foot-tall plants were extracted. Further down the shoreline, at the elbow, many small plants no more than eight inches long were extracted from the rocky shore, and six plants a few feet tall, but not all clustered together, were extracted from past the lily pads in open water. Divers crossed the northern part of the lake to the single point off the western branch of Lake Road. One tiny plant on the beach and one, one foot tall, plant further into water were extracted. Across the northern side of the pond, both divers searched for the plant marked north of the former Boy Scout campground, but they didn't find any in the dense watershed.

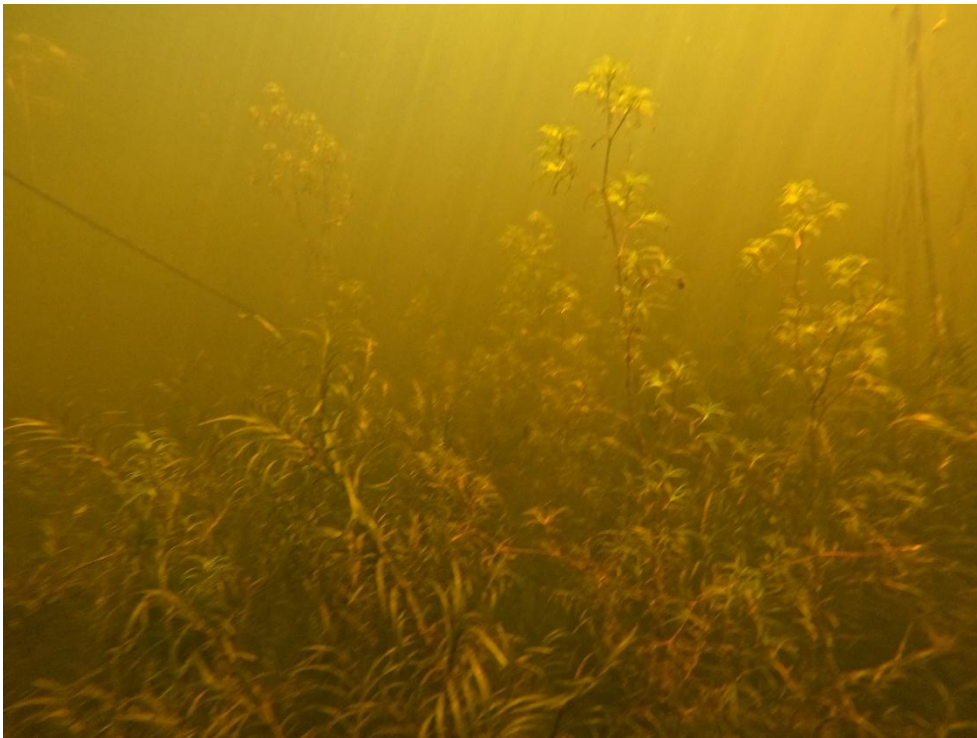
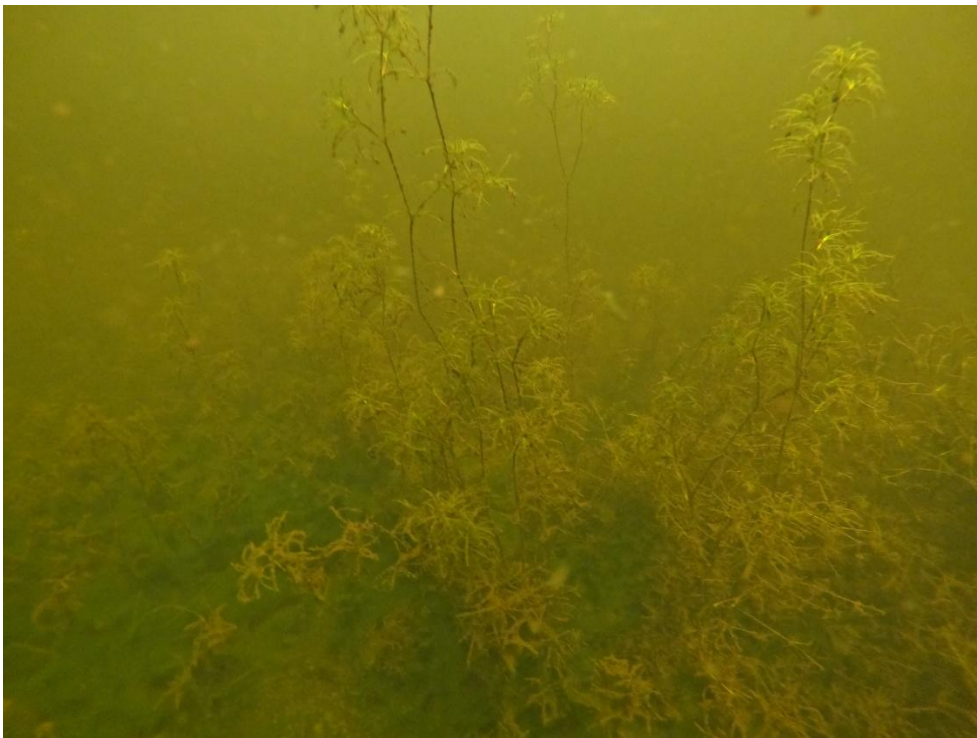
Top & Bottom:

Brittle naiad plants saturated the area in front of the Country Shores Camping Area beach and adjoining lily pads on the eastern side.

On the eighth day, divers focused solely on the Country Shores Camping Area beach and lily pads. They extracted from the open water, the lily pads near the eastern swim line, and farther off along the lily pad line. In the former, divers attempted to find the end of the brittle naiad growth. Brittle naiad growth continued up to 100 feet away from the swim lines eastward and beyond. Throughout this area, plants grew more sparsely in the open water and in a field in the area right up to the lily pads. In the whole area, plants grew larger the nearer to the lily pads they grew. The tall plants were very bushy with tight leaf clusters. Smaller plants had both these leaves and longer, more umbrella-like leaves. Divers extracted until they were silted out.

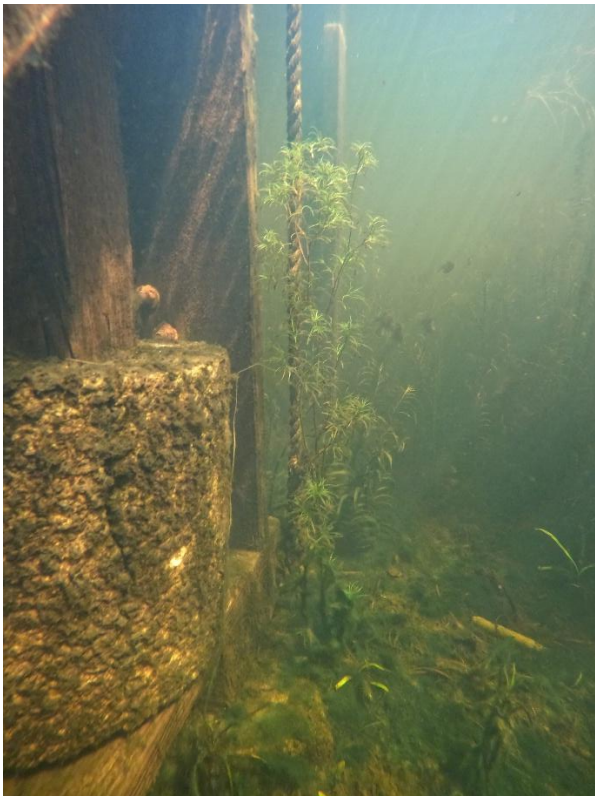
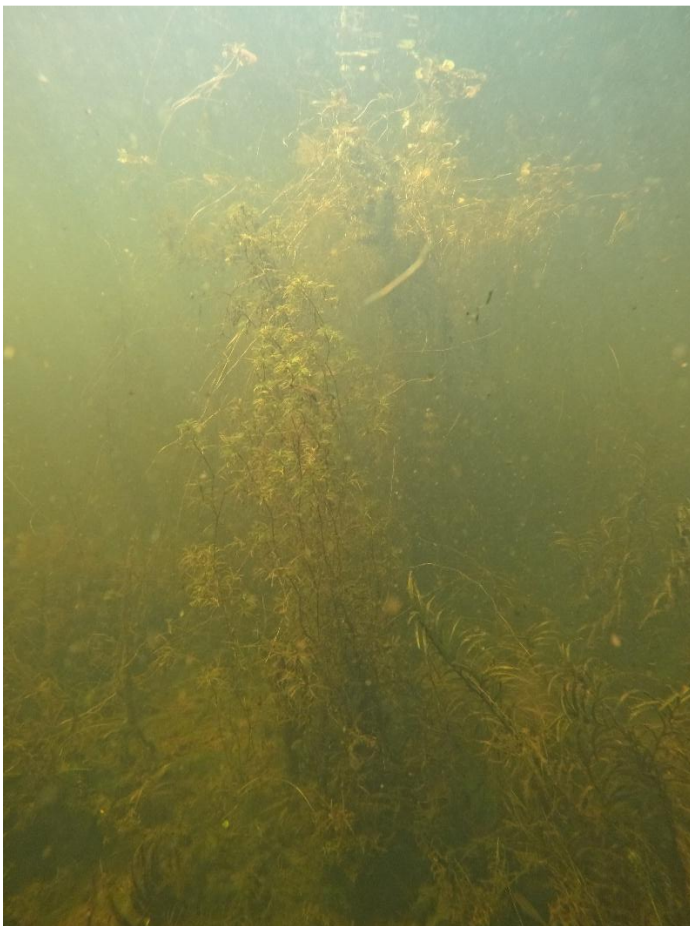
Top & Bottom:

Brittle naiad plants from the far side of Sunshine Drive. In this area, plants grew taller than in other areas. Plants consistently grew along the border of the lily pads and open water, and in one field off to the side of the black pontoon boat at the end of Sunshine Drive.
