BAT ACTIVITY SURVEY FOR

THE OLD MILL

ABERDARON

21st September 2015

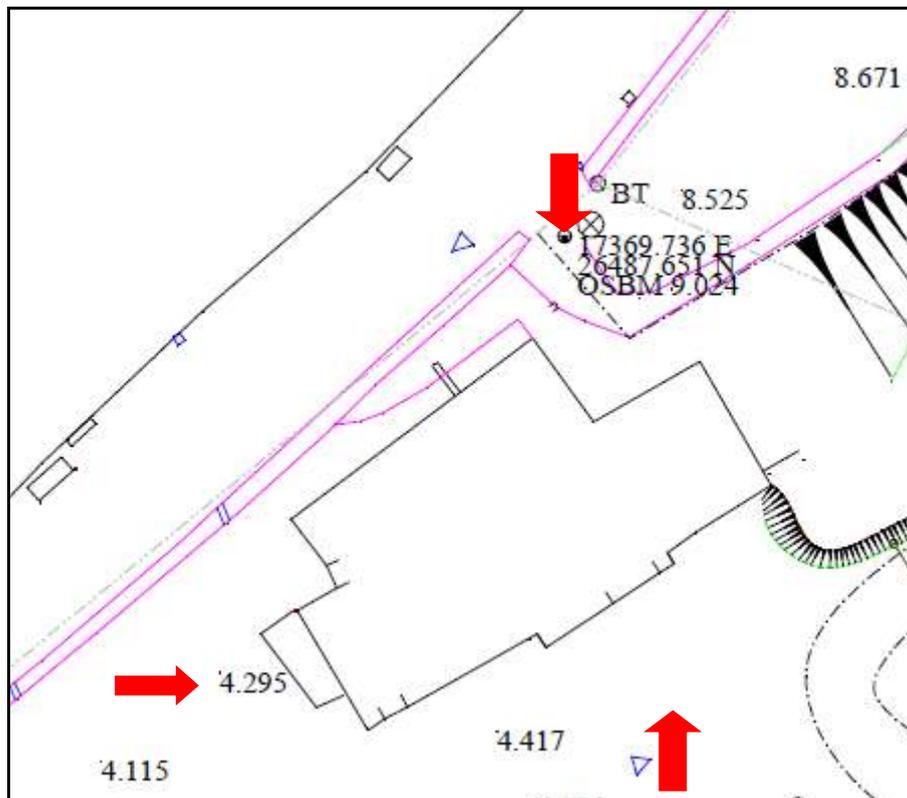
4. SITE PLAN AND SURVEYOR LOCATIONS

A single evening emergence/activity survey was undertaken on the 19th September 2015. The information obtained from the single survey is thought to be sufficient to enable a mitigation plan to be formulated. The survey was carried out by three experienced surveyors. The surveyors were positioned along the north, east and south elevations to ensure all areas were adequately covered.
