PROTECTED SPECIES SURVEY

THE OLD MILL

ABERDARON

21st September 2015

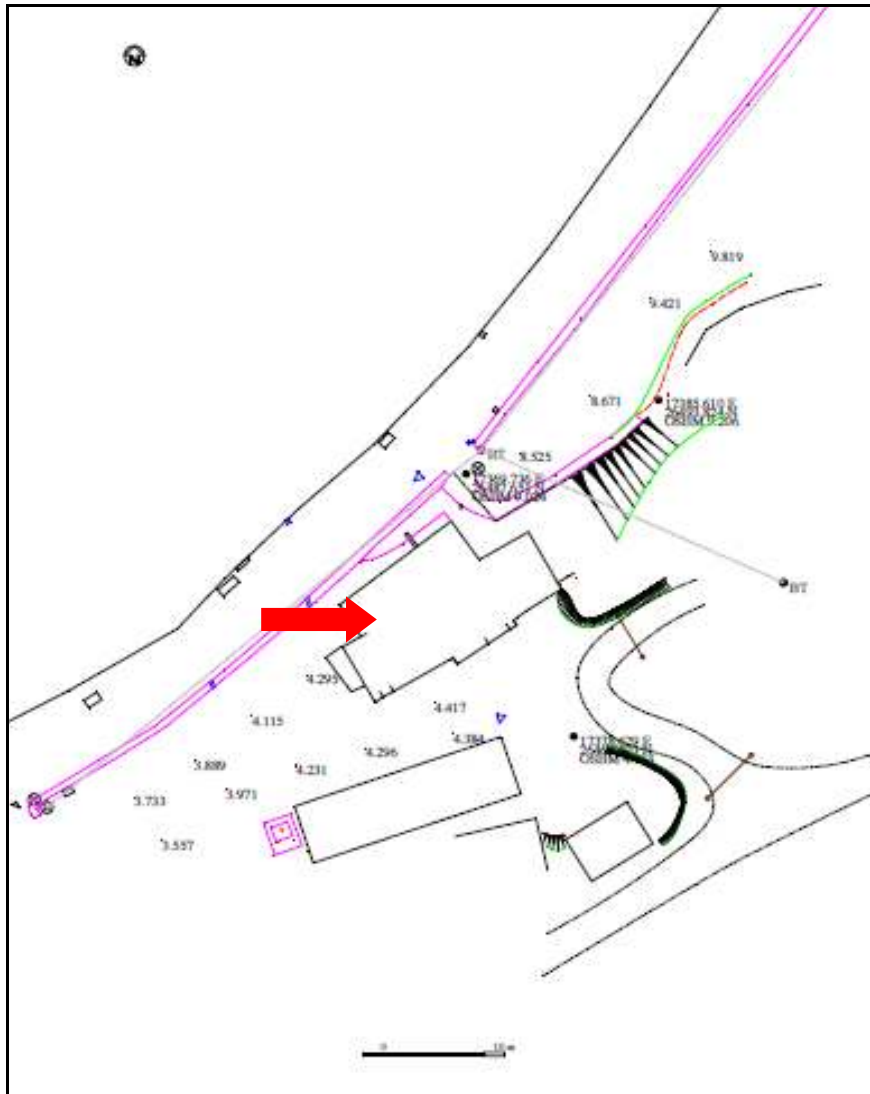
Appendix 1 – Site plan

The site consists of the disused mill/leat etc which is located in the centre of the village opposite the bakery. The surrounding habitat includes a stream, areas of open grassland, trees/scrub and coastal habitat.

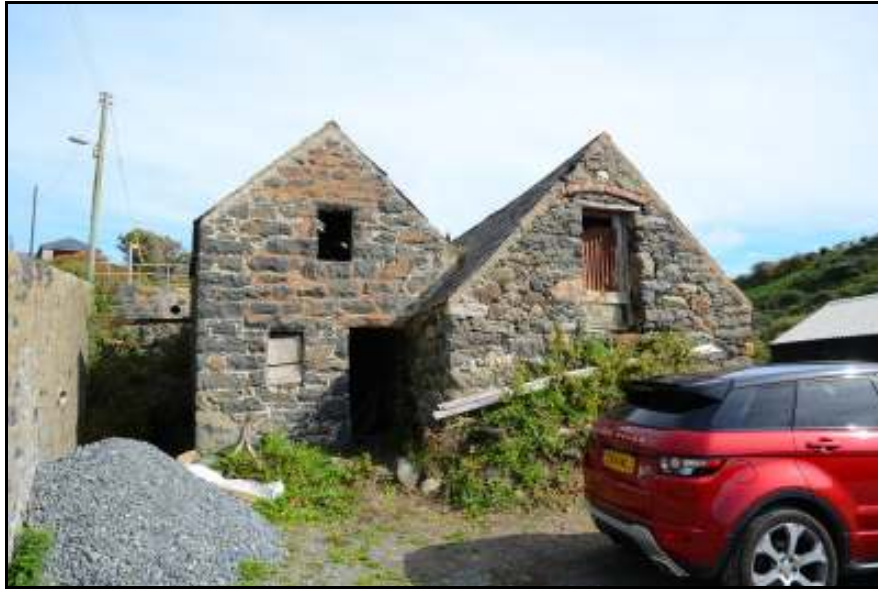
1. West elevation

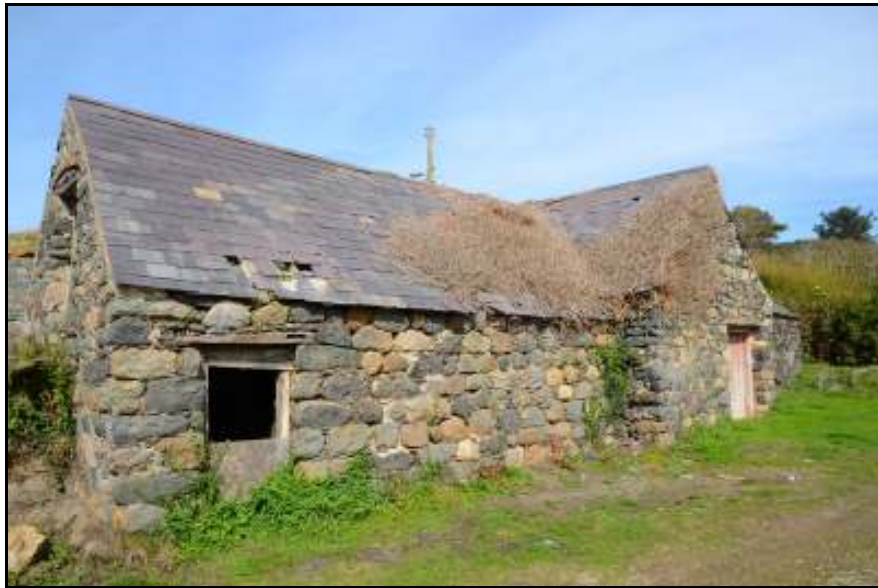
2. South elevation

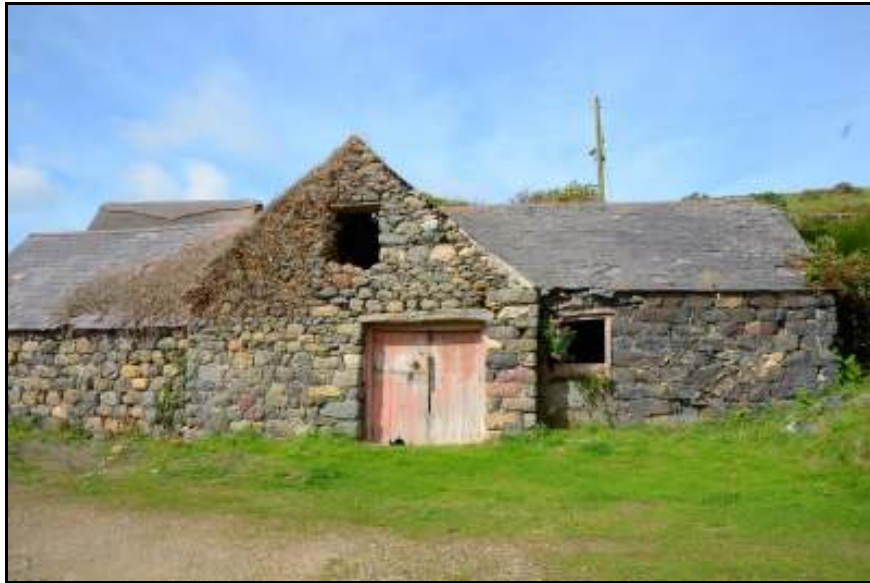
3. South elevation

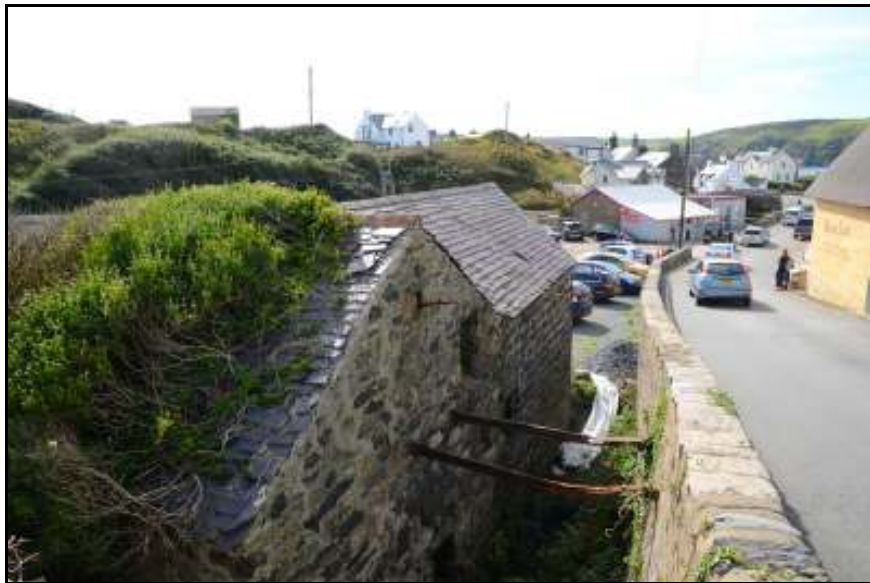
4. North elevation

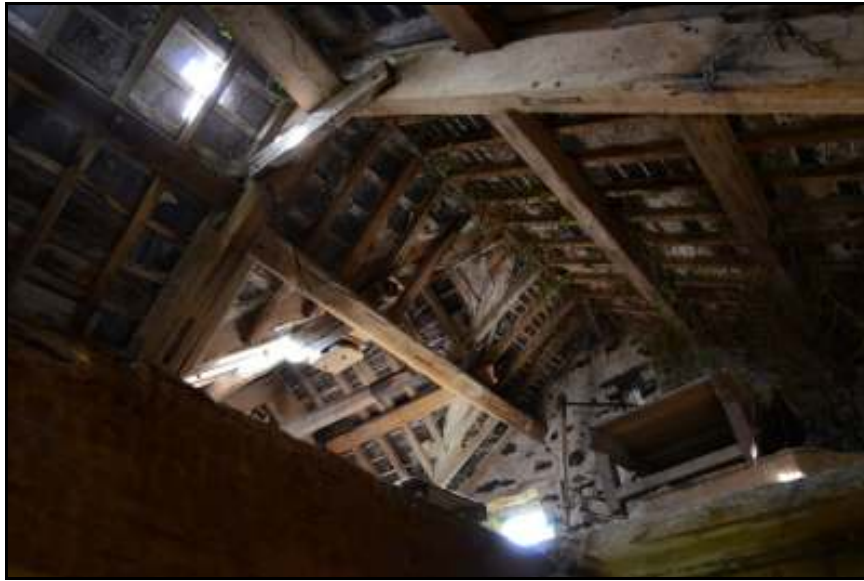
The majority of the timbers appear to be original and some do support open mortise joints although none are very deep. There are a few gaps in and around the side of some of the utilised roof timber joints but no evidence of bats was found in these areas. A lot of the timbers are just damp and decayed, light levels are also quite high in most areas of the building.

Overall the potential of the building to support bats in its current condition is low. The main reasons are levels of light, holes in the roof, airflow, damp etc, the side elevation is also highly illuminated by streetlights (bright led type bulbs).

5. Light and open roof areas

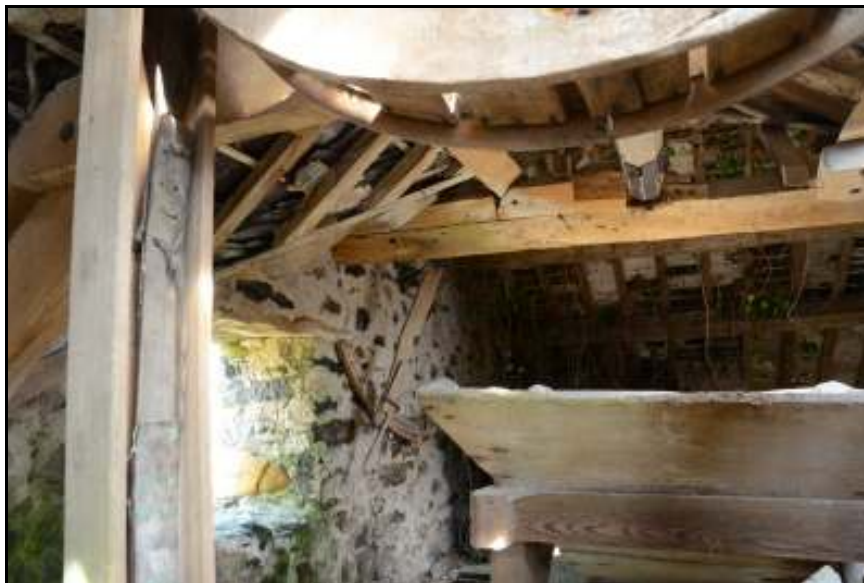
6. High light levels around wheel area

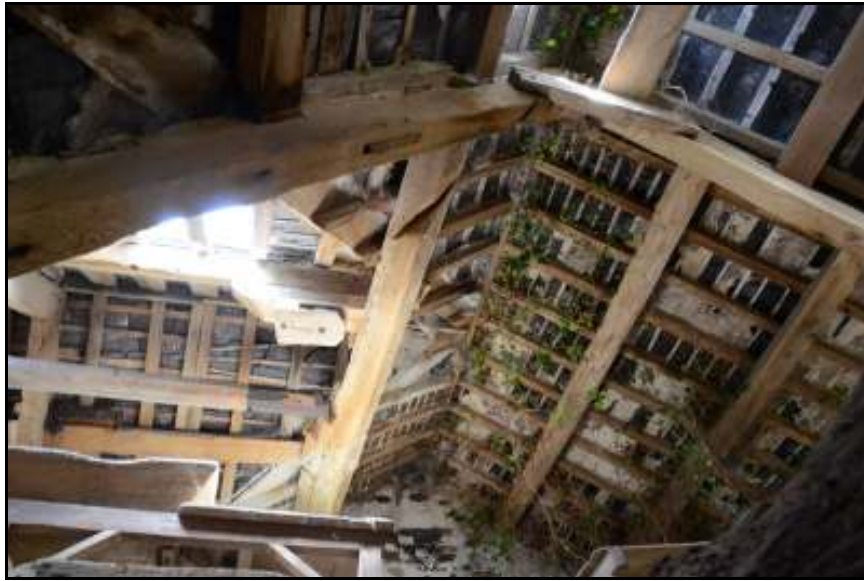
The building has been constructed in a traditional manner with stone walls supporting a pitched and timber framed roof covered with slate (no underfelt). The building is in a poor condition with missing slates, holes in the roof, timber decay, damp in the walls etc. The leat at the rear of the mill has grown over with bramble scrub, ivy growth is also evident within the roof of the main building.

7. Holes in roof and high light levels

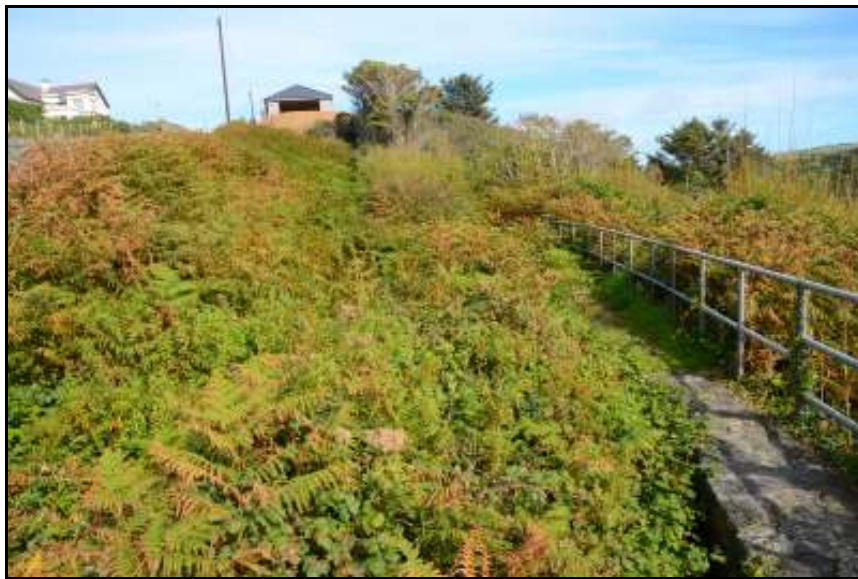
At the time of the survey there was no evidence of badgers (setts, outliers etc) anywhere within the vicinity of the building or within the disused leat (now covered with scrub). Badgers are however a mobile species and the situation could change during the period of any extant planning permission.

8. Leat at the rear is blocked with scrub

Evidence of nesting birds was found throughout the building on wall ledges, crevices and roof timbers etc. A few swallow nests are present as well as nests from blackbird, house sparrow, wren etc. Any works to restore the building will need to take place between October and February inclusive to avoid nesting birds. The same applies to the removal of ivy, scrub or other vegetation either inside/outside of the building or within the leat.

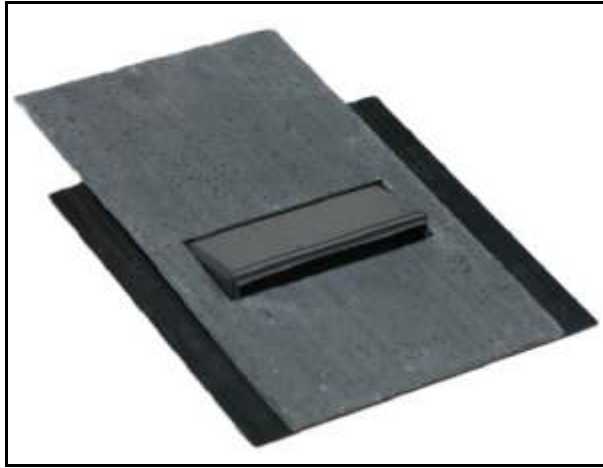
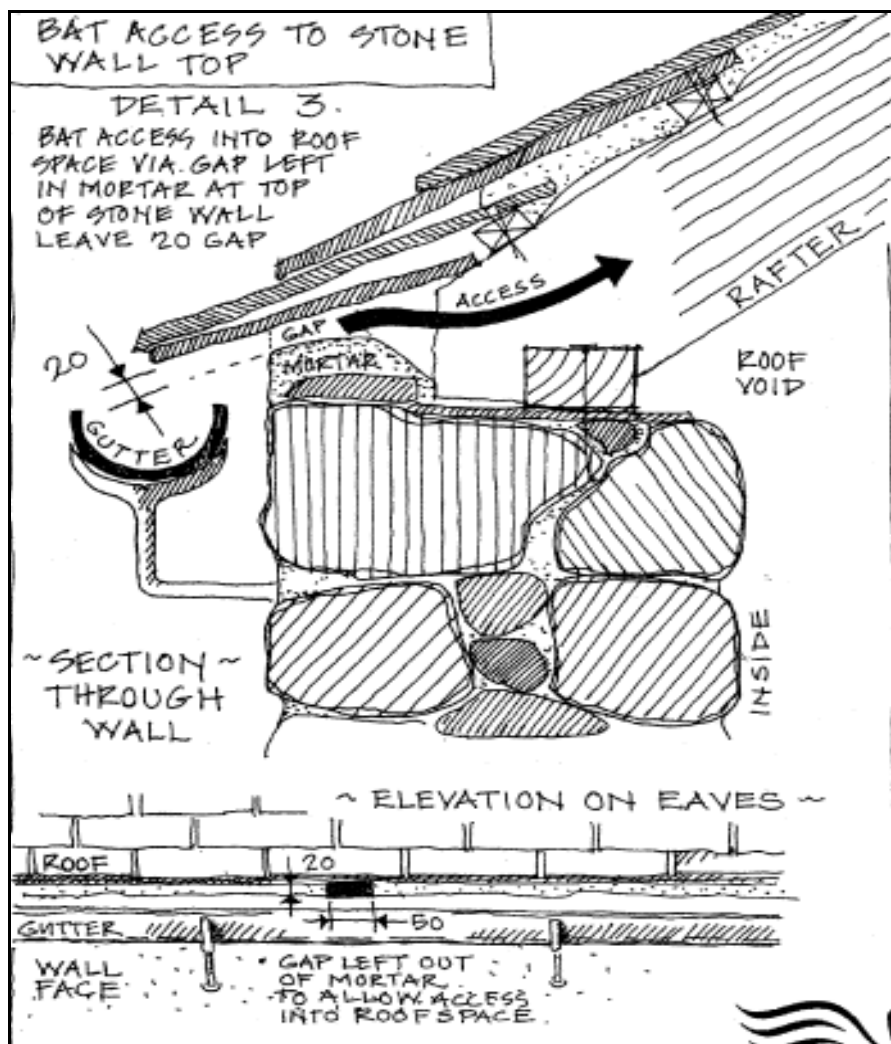
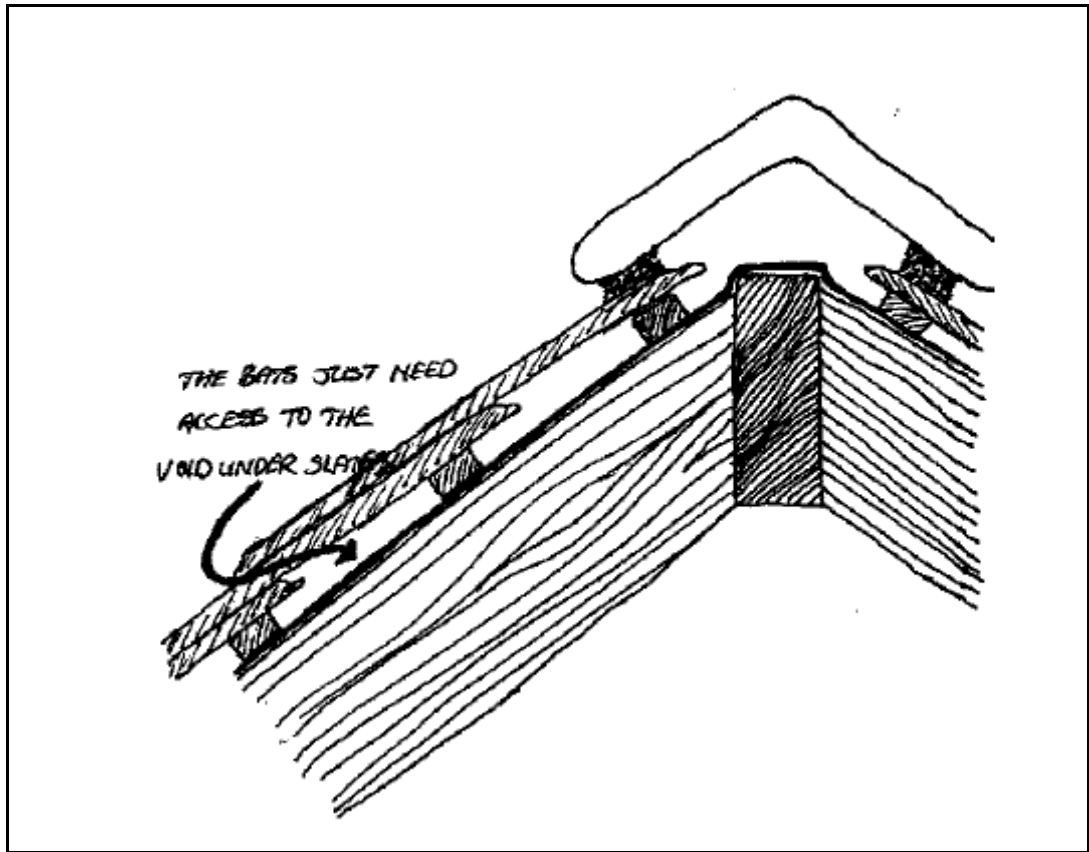
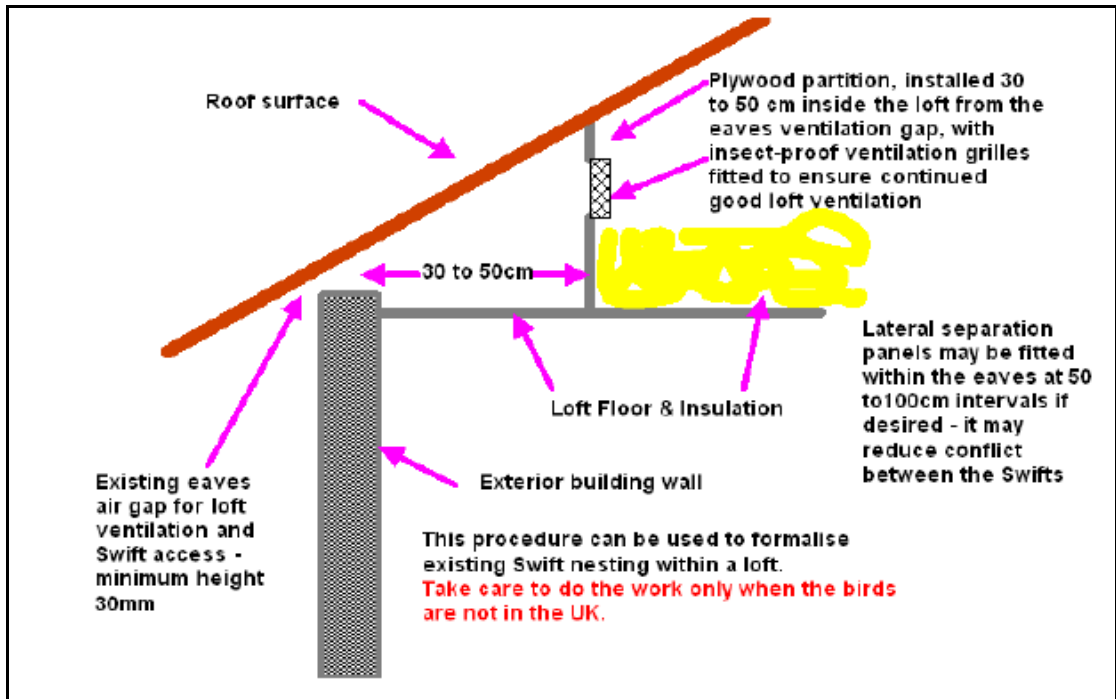
Appendix 3 – Some examples of bat mitigation that can be included after the restoration work has been undertaken.

Slateline bat access tile

The restoration of the building offers the opportunity to create/retain some bat friendly features. Pipistrelle sp. and other crevice dwellers such as Myotis bats will readily take to new/and or restored buildings as long as suitable access points and features are created.

- **If lining the roof use traditional bitumen roofing felt rather than a modern plastic liner.**
- **Create/retain as many gaps as possible of varying size under the eaves leading up to the space above the wall plate.**
- **Ensure all timberwork is only treated using chemicals shown to be safe for bats.**
- **Ensure any external lighting is low level and directional towards the Ground.**
