MELIN ABERDARON

Archaeological Survey

EAS Client Report 2015/13

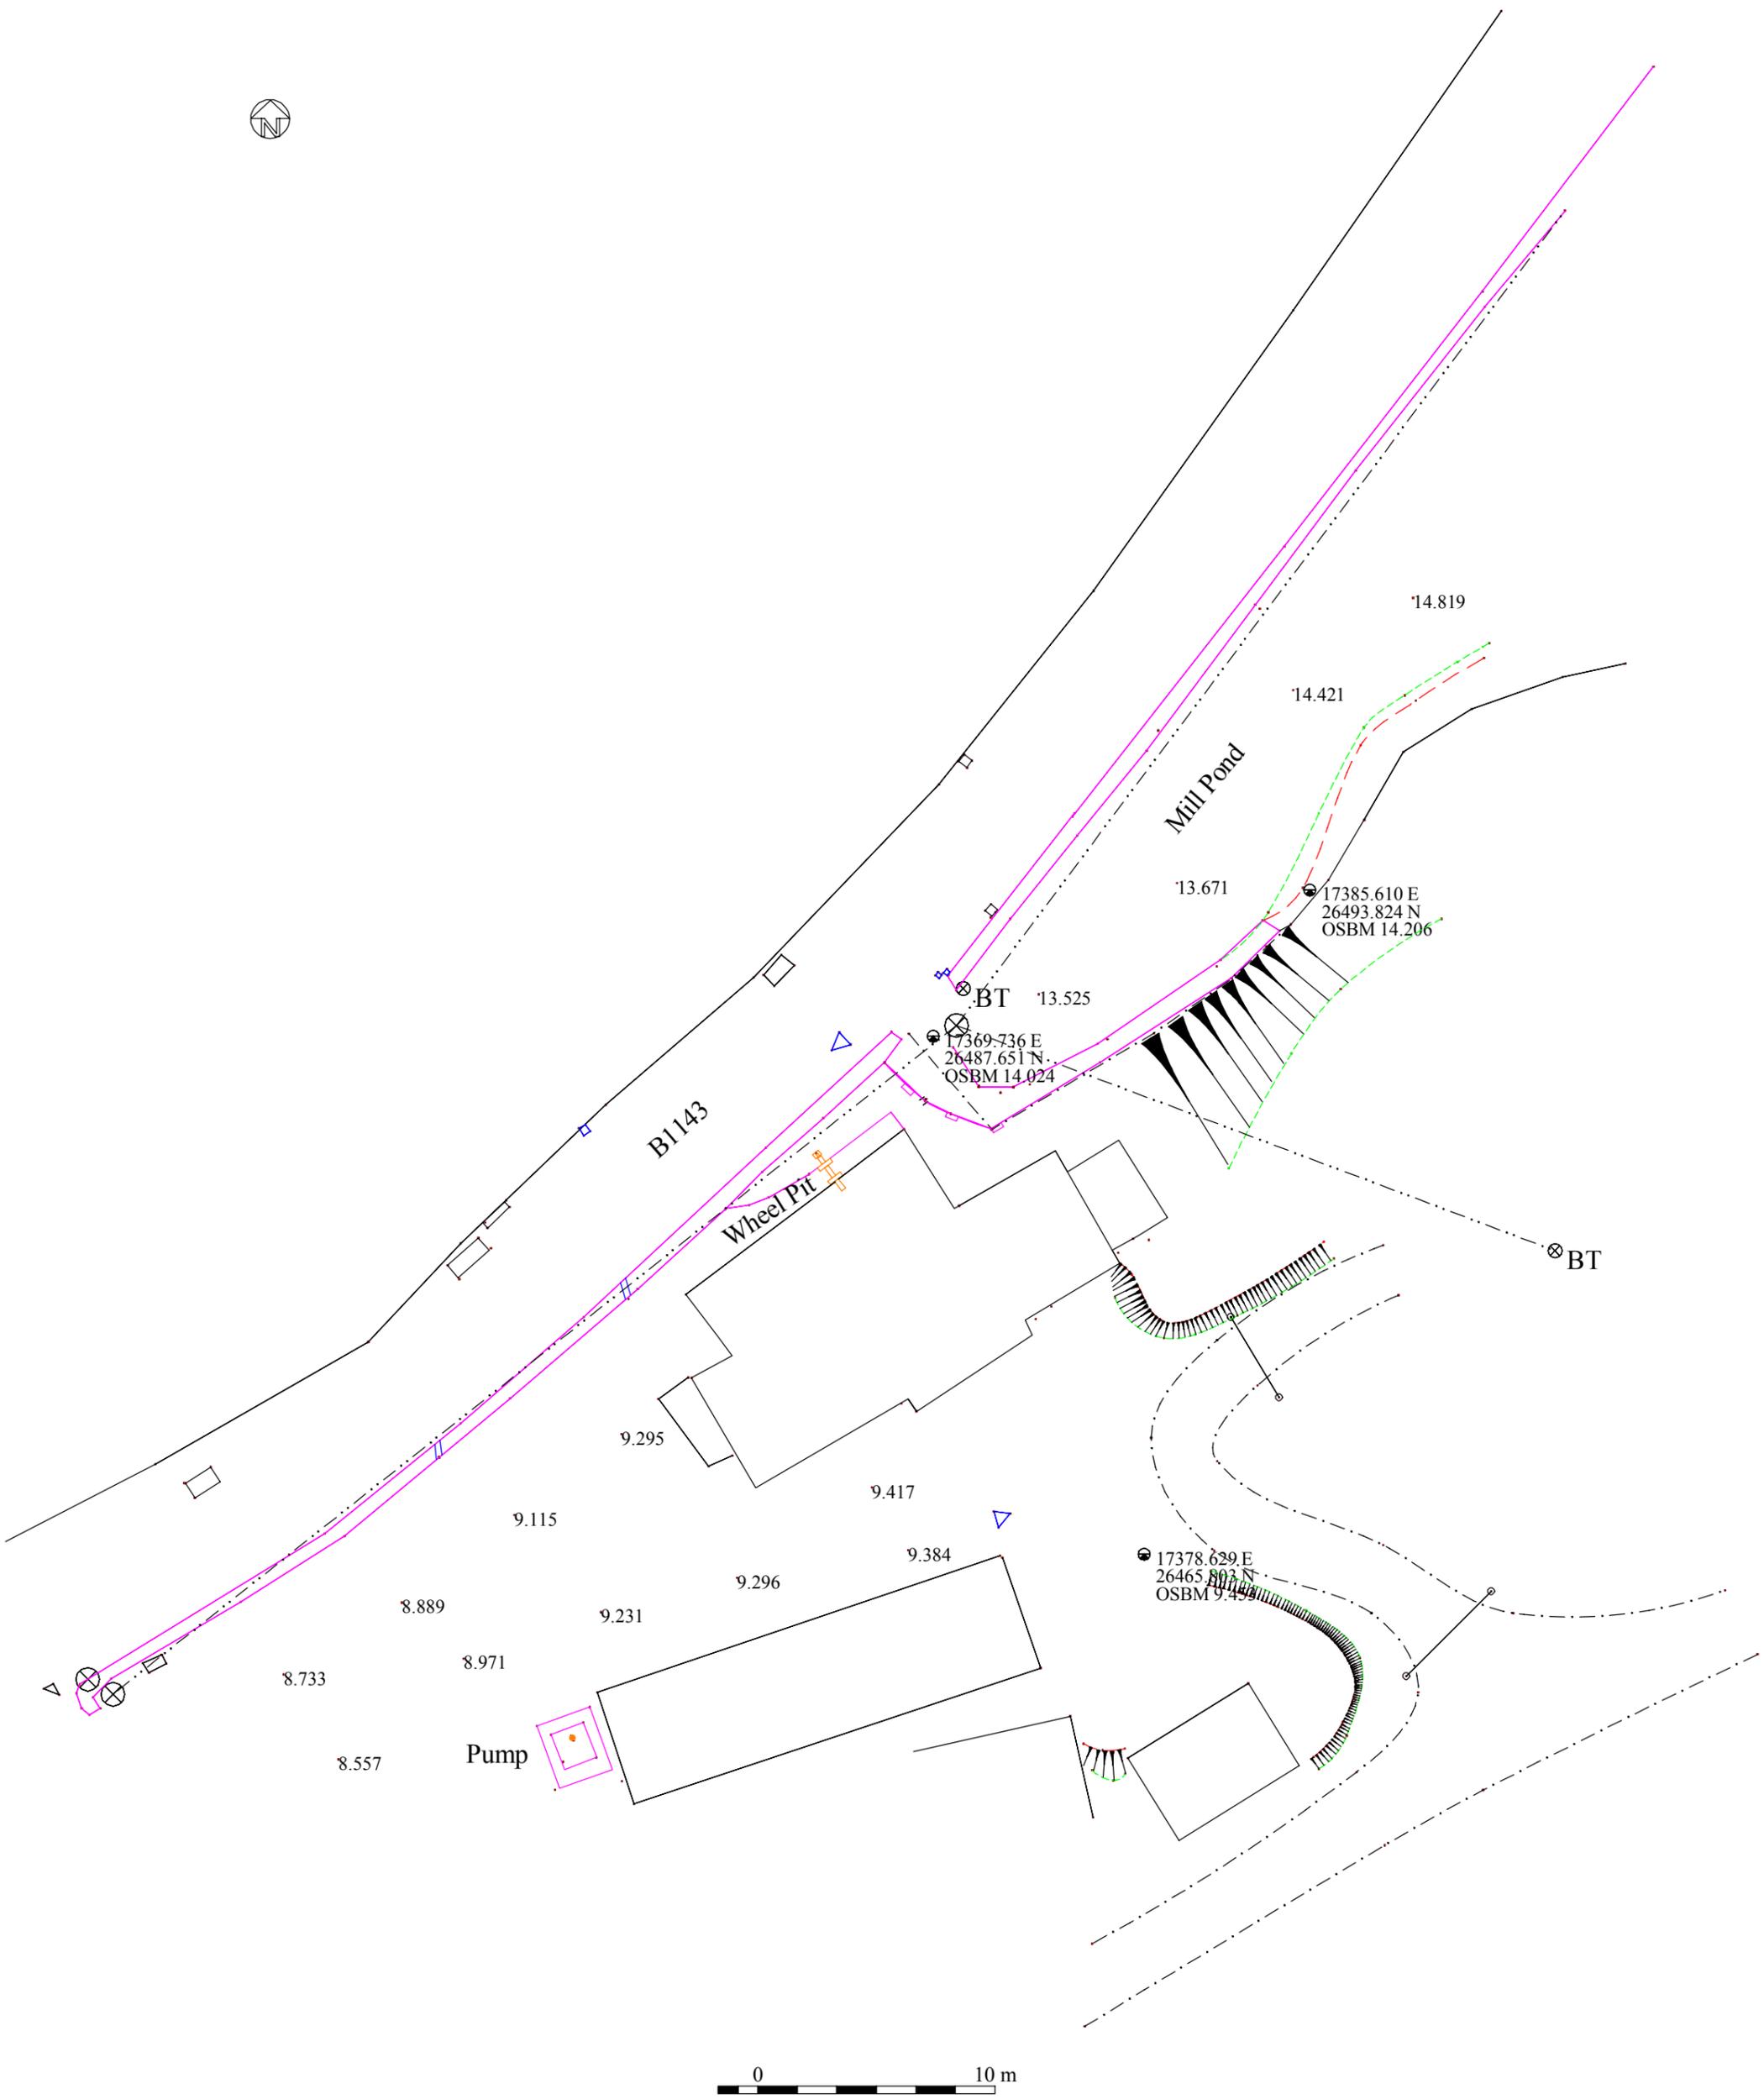
Figure 3: Topographic Survey
Scale 1:250

The mill complex at Aberdaron is composed of a number of elements. (Figures 3-6) At the centre of the complex is the earliest of the surviving buildings which holds most of the machinery and is probably the original mill building. This building is most likely associated with the mill pond and its associated leat, although there is some modern modification to accommodate the footpath running along the southern side of the mill pond. Other buildings in the range include a corn dryer, a range to house the flour dressing machines, a stable and a store. These elements will be discussed separately together with a discussion of the mill machinery and the graffiti found in the building.

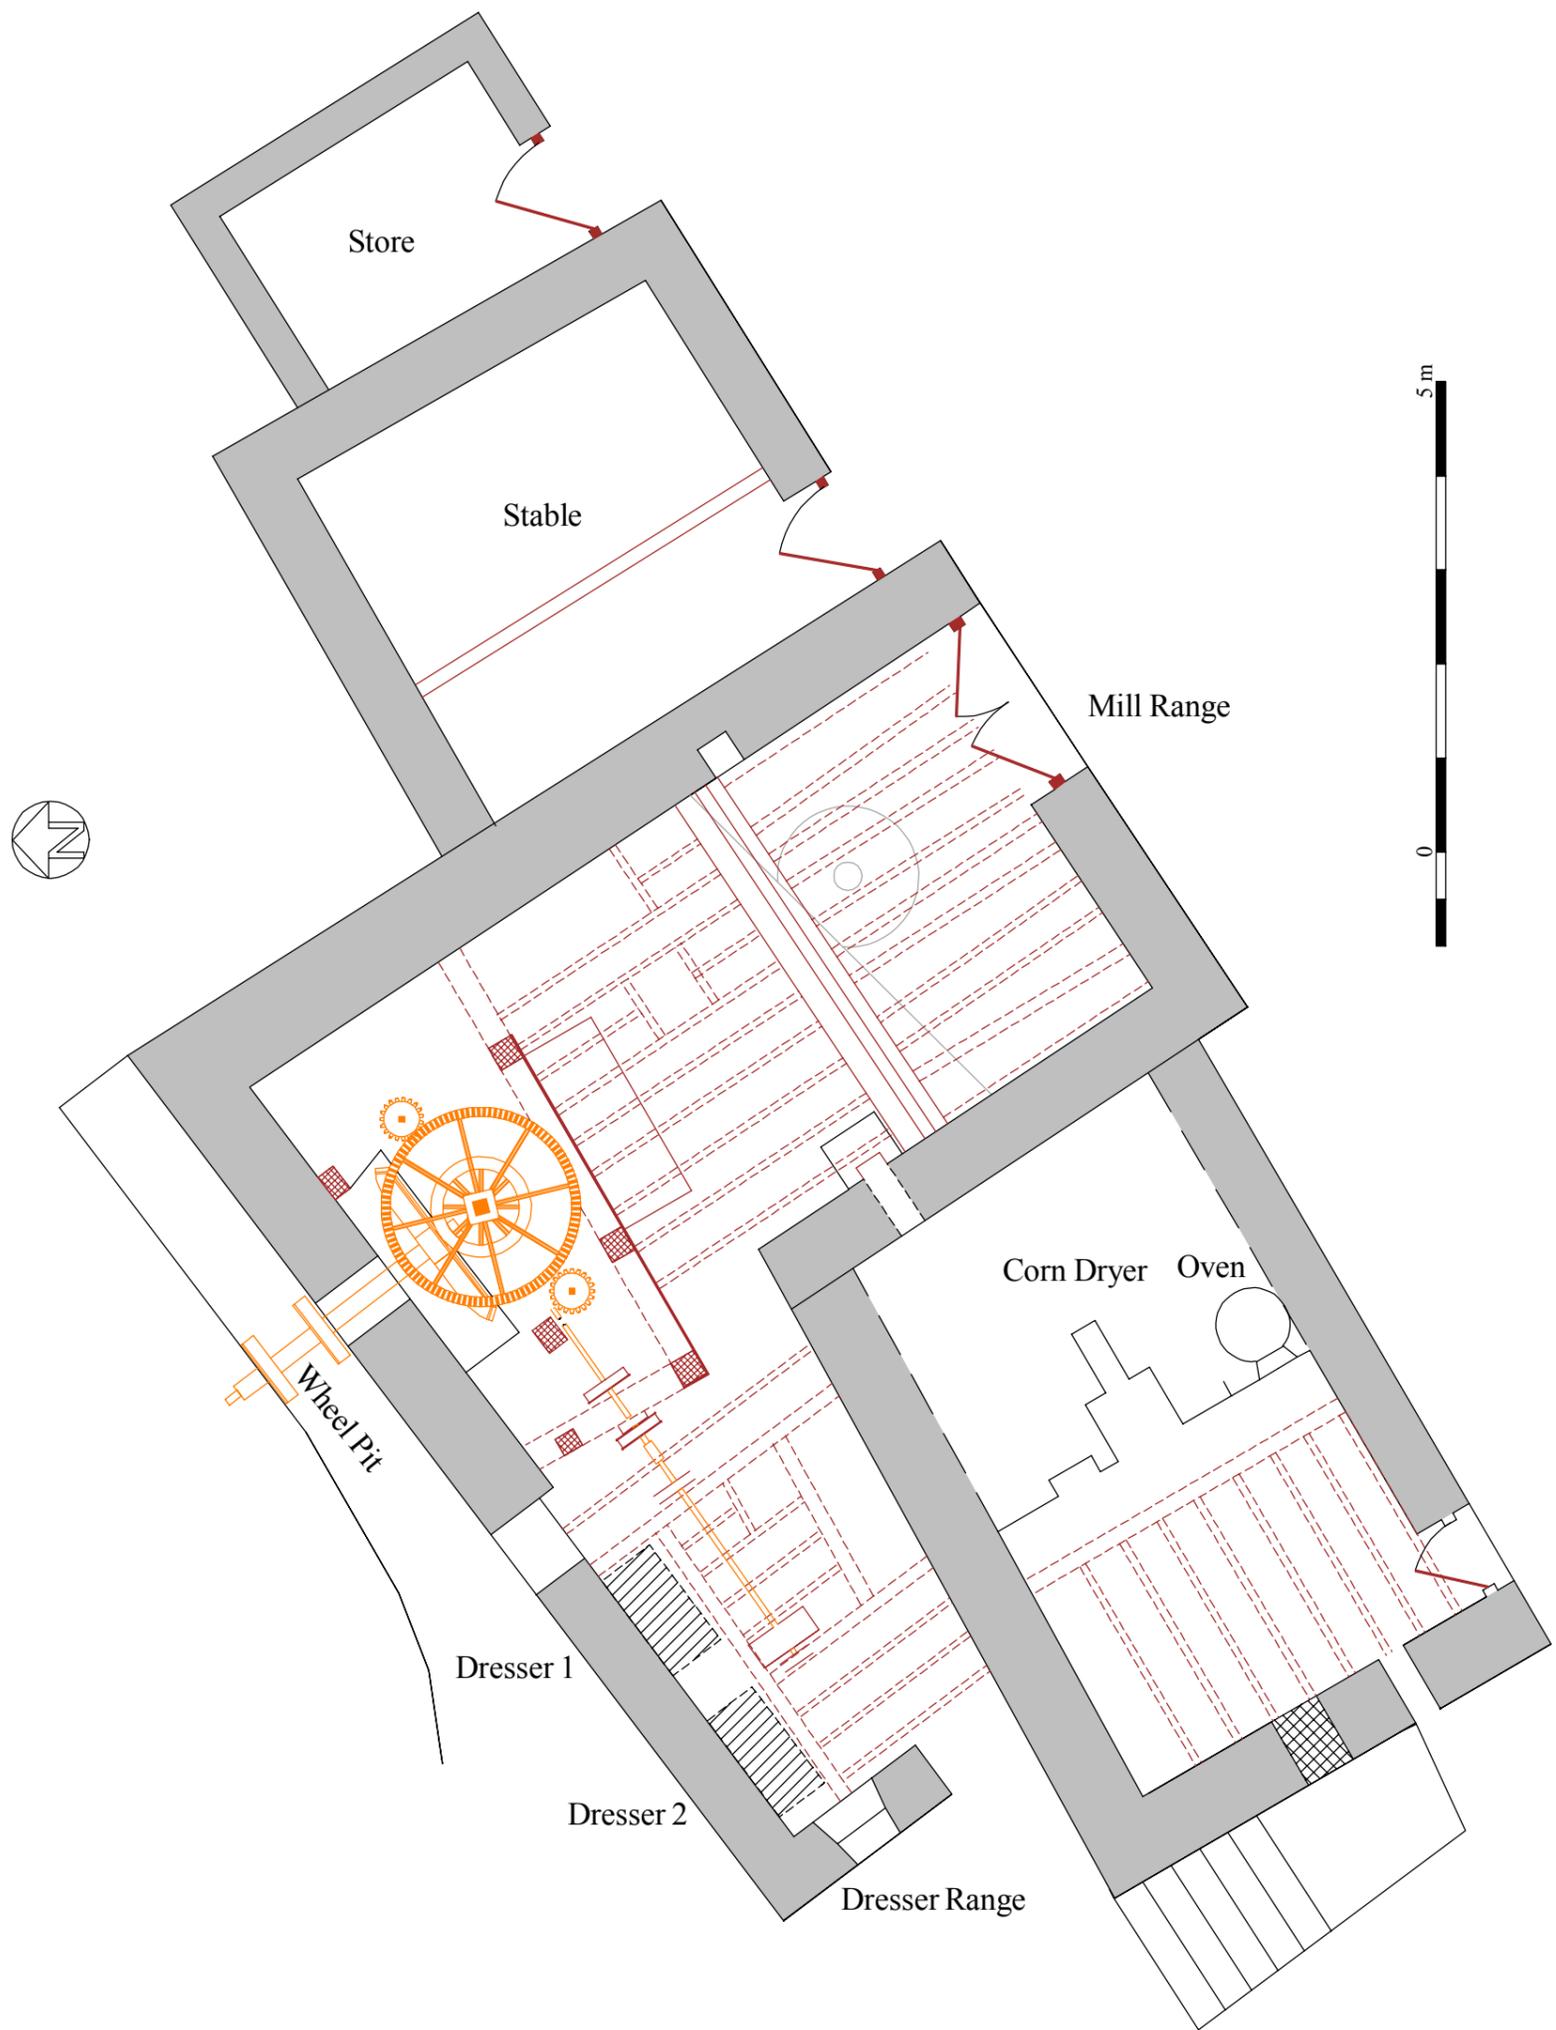
Figure 5: Ground Floor Plan
 Scale 1:75

The plans of the buildings are shown on Figures 5 and 6, and the elevations on Figure 7.

The ground floor can be divided into three zones, the south eastern end, the central area and the north western end occupied by the Hurst Frame and the mill machinery. Set in the floor of the south eastern end of the range, is most of, a worn out runner stone, 1.5 m 4' 11") in diameter (Plate 12). It would appear to be of Anglesey grit having been made of a single slab of rock. The doors to the mill range have a series of blacksmith-made fittings. On the outside of the doors, to the mill range, there is a ring door handle on the upper leaf of the spilt door (Plate 13) with a diamond shaped plate behind. This lifts a simple latch on the inner surface of the door. The rest of the door furniture (Plate 14) also appears to be blacksmith made. The upper door hinges have simple triangular finials whilst the main doors have spade shaped finials. The lintel over the door is wooden with a similar twist to that used on the outside of the building. The series of peg holes on the underside of this timber would suggest it is a re-used timber. There is a small niche in the eastern wall which is of unknown function (Plate 15). Resting against the wall at this end of the building are the outer frames of a dresser (Plate 16)

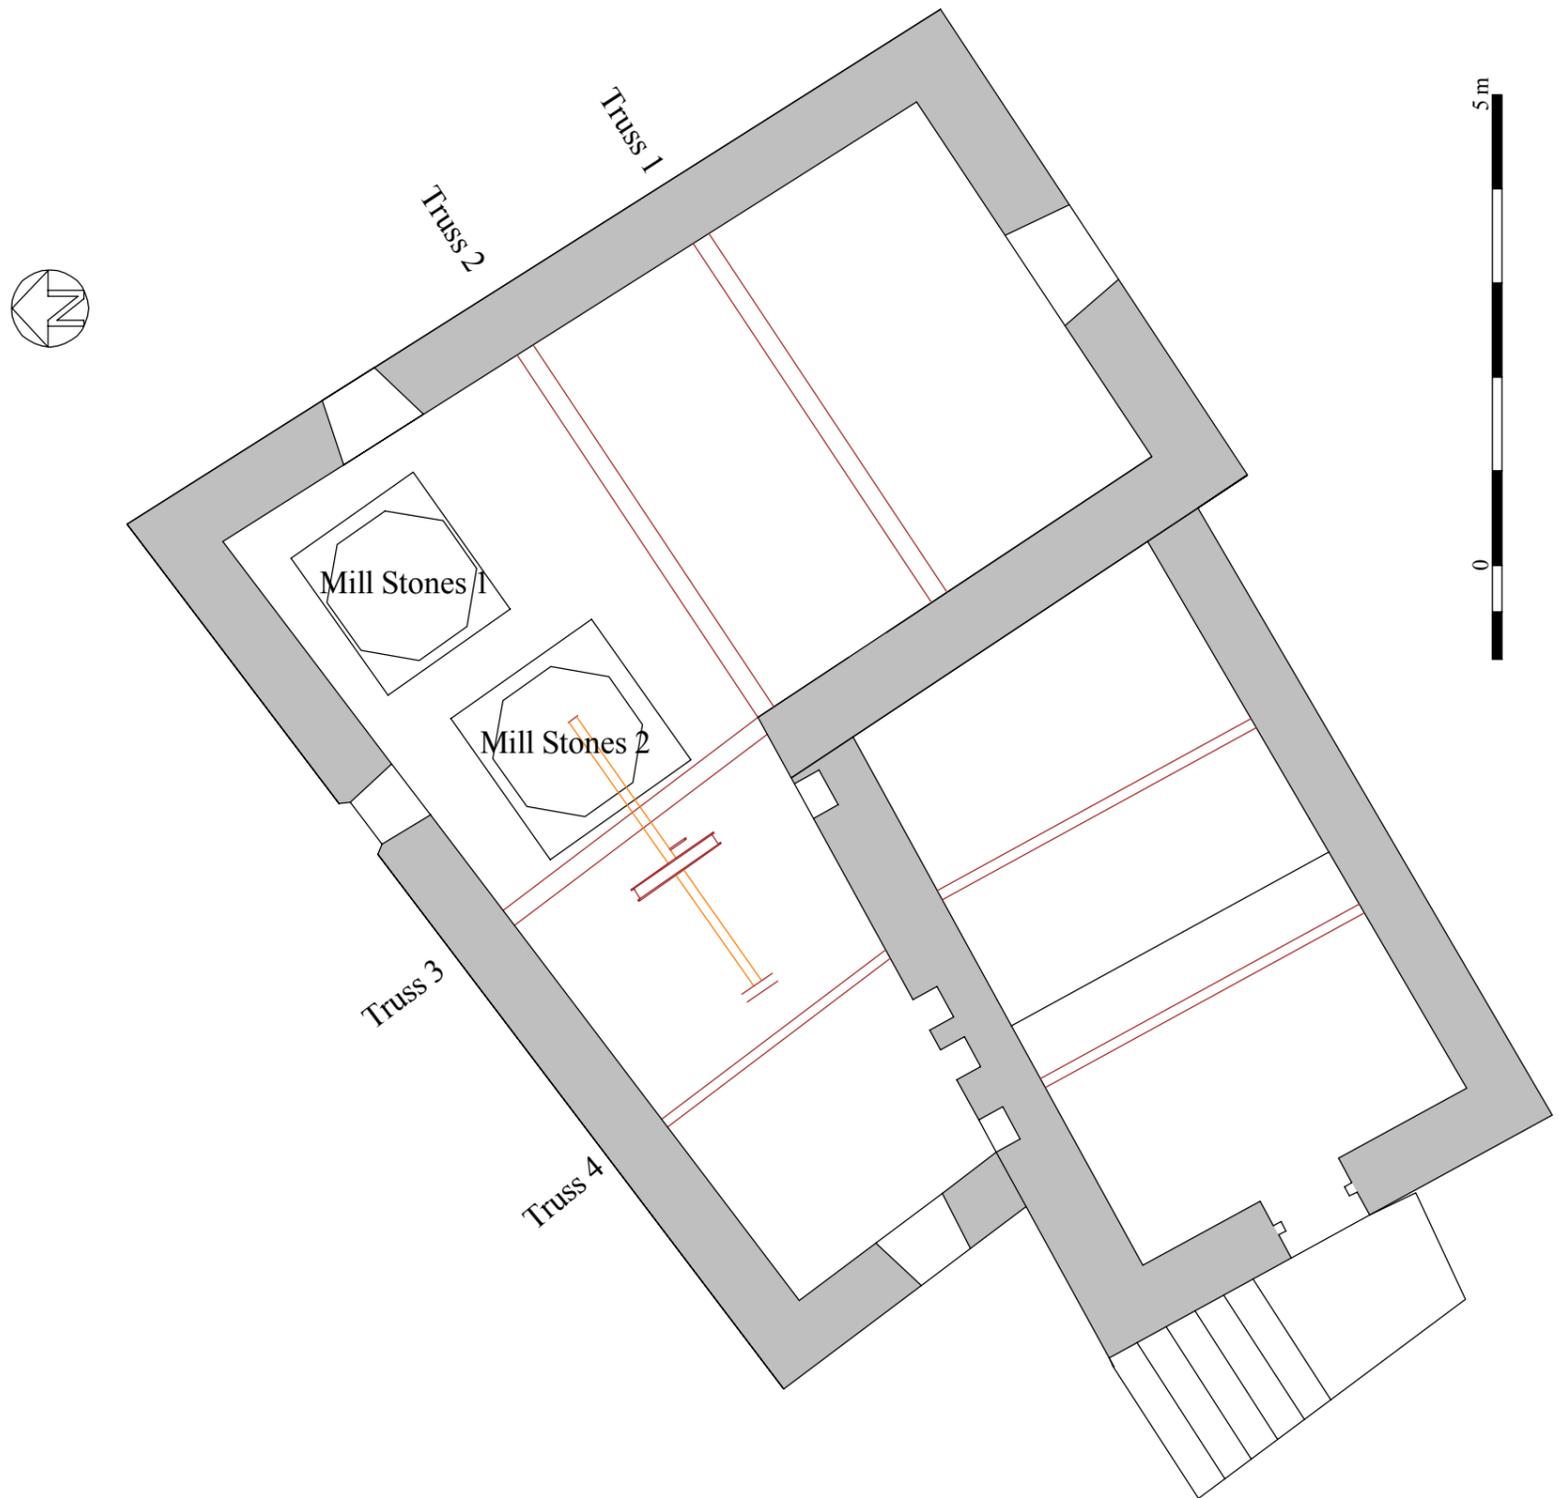
Figure 6: First Floor Plan
Scale 1:75

The tripartite division of the mill range is also reflected on the first (stone) floor (Figure 6). The south eastern end of the range is slightly raised (Plate 22) whilst the middle section is less well preserved than the rest of the floors in this range. It does, however, include the hatch for a sack hoist (Plate 23). The north western end, above the Hurst Frame, has the two sets of stones within their octagonal tuns (Plate 24). There are two trusses crossing the range. Truss 1 defines the division between the south eastern end and the middle section of the range. It is a relative simple truss with raking struts, however there is a windlass attached to the southern side of the truss (Plate 25) and a high collar attached to the northern side supports a longitudinal beam between the two trusses. There is an iron ring on the underside of this beam which is above the hatch (Plate 26). Truss 2 is a simple "A" frame, the western principle rafter, however has been replaced with a softwood round sectioned timber. The replacement of this timber is probably related to the worn slots in the associated timbers to this truss (Plates 27 and 28). These slots would suggest that there was a link between the upper lay shaft and the iron ring above the hatch, suggesting the sack hoist was powered by the upper lay shaft. The iron shackle and chain attached to the upper northern purlin (Plate 29) is probably related to lifting the western runner stone for dressing. The high opening in the north western gable end of the mill range contains the lever to control the penstock and a pegged board which defined the level to which the penstock was opened. There is a runner stone loose in the northern corner of the mill range, although it is somewhat hidden by vegetation growing through the roof. This has an iron band and appears to be of Anglesey gritstone (Plate 30).

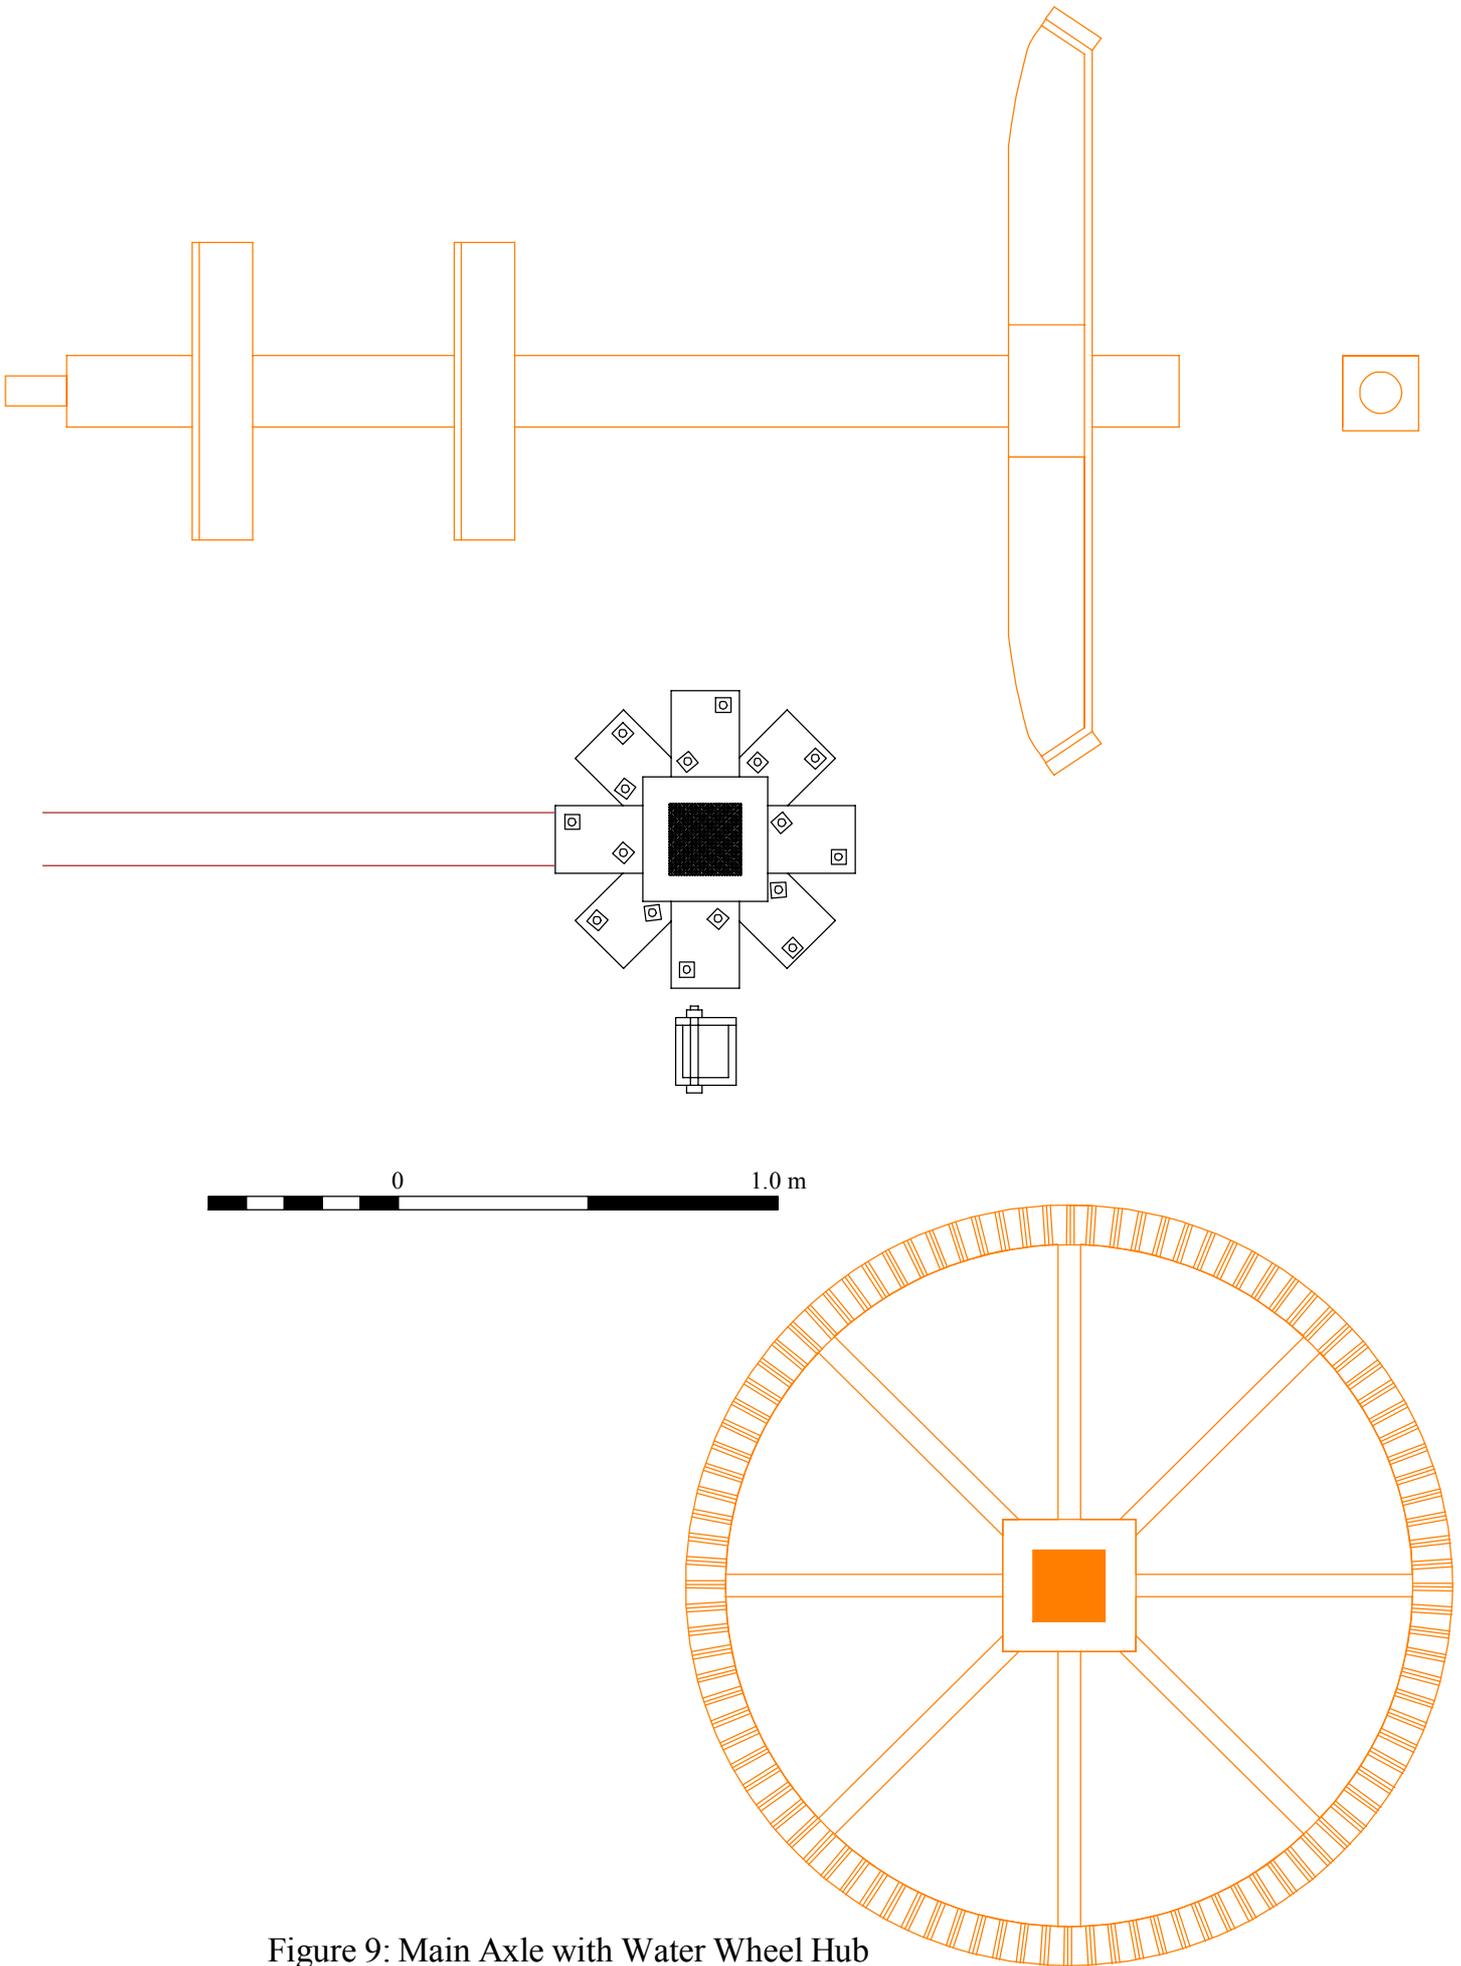
Figure 9: Main Axle with Water Wheel Hub
and Pit Wheel
Scale 1:20

Only the hub of the waterwheel survives (Plates 65 -67, Figures 9 and 10) consisting of the cast iron hub for an eight spoke wheel. Each of the spokes was 0.14 m square and was of wood. One of these survives to a length of 1.35 m, however it is likely that the waterwheel was originally up to 4.8 m (15' 9") in diameter. It is likely that other fittings from the

The axle has a bearing supported by a stone wall at its northern end, unfortunately the top cap of this bearing block is now missing. The axle is of cast iron with a square profile 0.19 m (7 ½") square. It is 2.93 m (9' 7") long, passing through the wall of the mill building. Inside the mill, is the pit wheel which is 2.02 m (6' 7½") in diameter with eight spokes. It is of cast iron construction with 100 teeth set at an angle (Plate 69). Once again the pit wheel is held in place by a series of iron wedges. The axle is then supported by a second bearing block which is mounted in a wooden support. This also holds the toe pot for the main shaft (Plate 70).

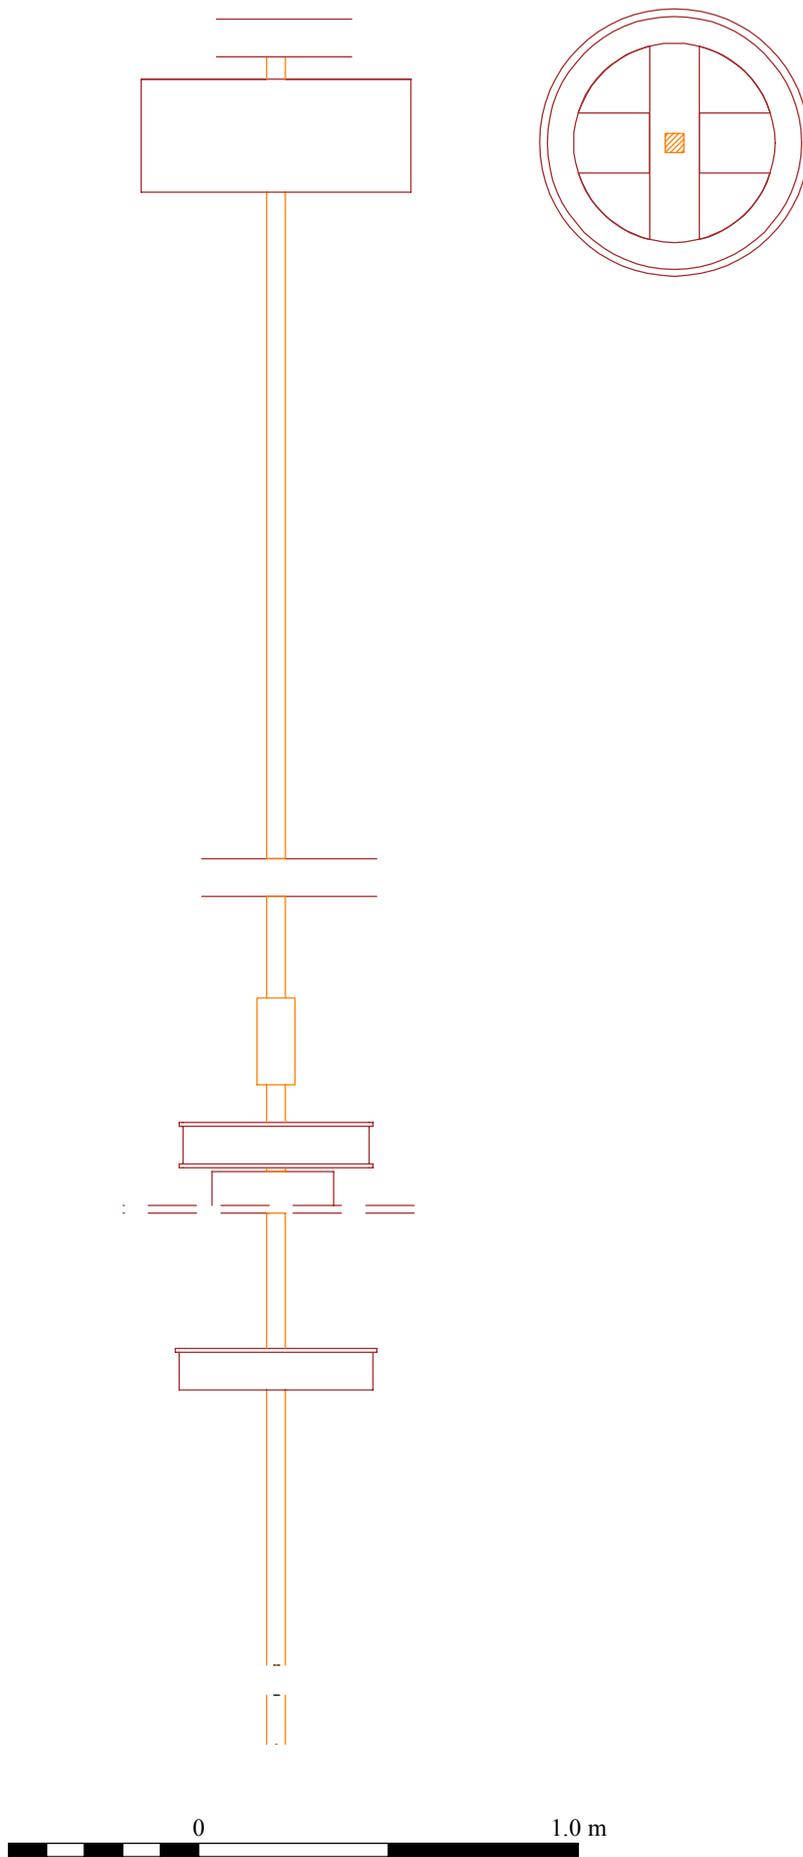
Figure 13: Lower Lay Shaft
Scale 1:20

The ancillary machinery for the mill was powered from one of the lay shafts. The lower lay shaft (Figure 13) had a gear wheel which engaged with the crown ring on the top of the great spur wheel, this is now missing. The shaft is supported at its eastern end by a phosphor bronze bearing mounted on one of the supports for the Hurst Frame (Plate 83). There is one wooden pulley inside the Hurst Frame and two other wheels within the Dresser Range. The wheel within the Hurst Frame is 0.51 m (1' 8") in diameter and 102 mm (4") thick (Plate 84). This was linked to a fan below the Hurst Frame. The lay shaft passes through the wall of the Hurst Frame and a second bearing before it has a second wheel attached (Plate 85). This is of a similar size to that within the Hurst Frame and has a leather belt around the wheel which links it to the upper lay shaft. There is then a third bearing support for the lay shaft. At the western end of the lay shaft is a larger wheel which is 0.71 m (2' 4") in diameter and 0.3 m (1') thick with crossed spokes (Plate 86). This wheel drove the dresser machines by means of a leather drive belt.

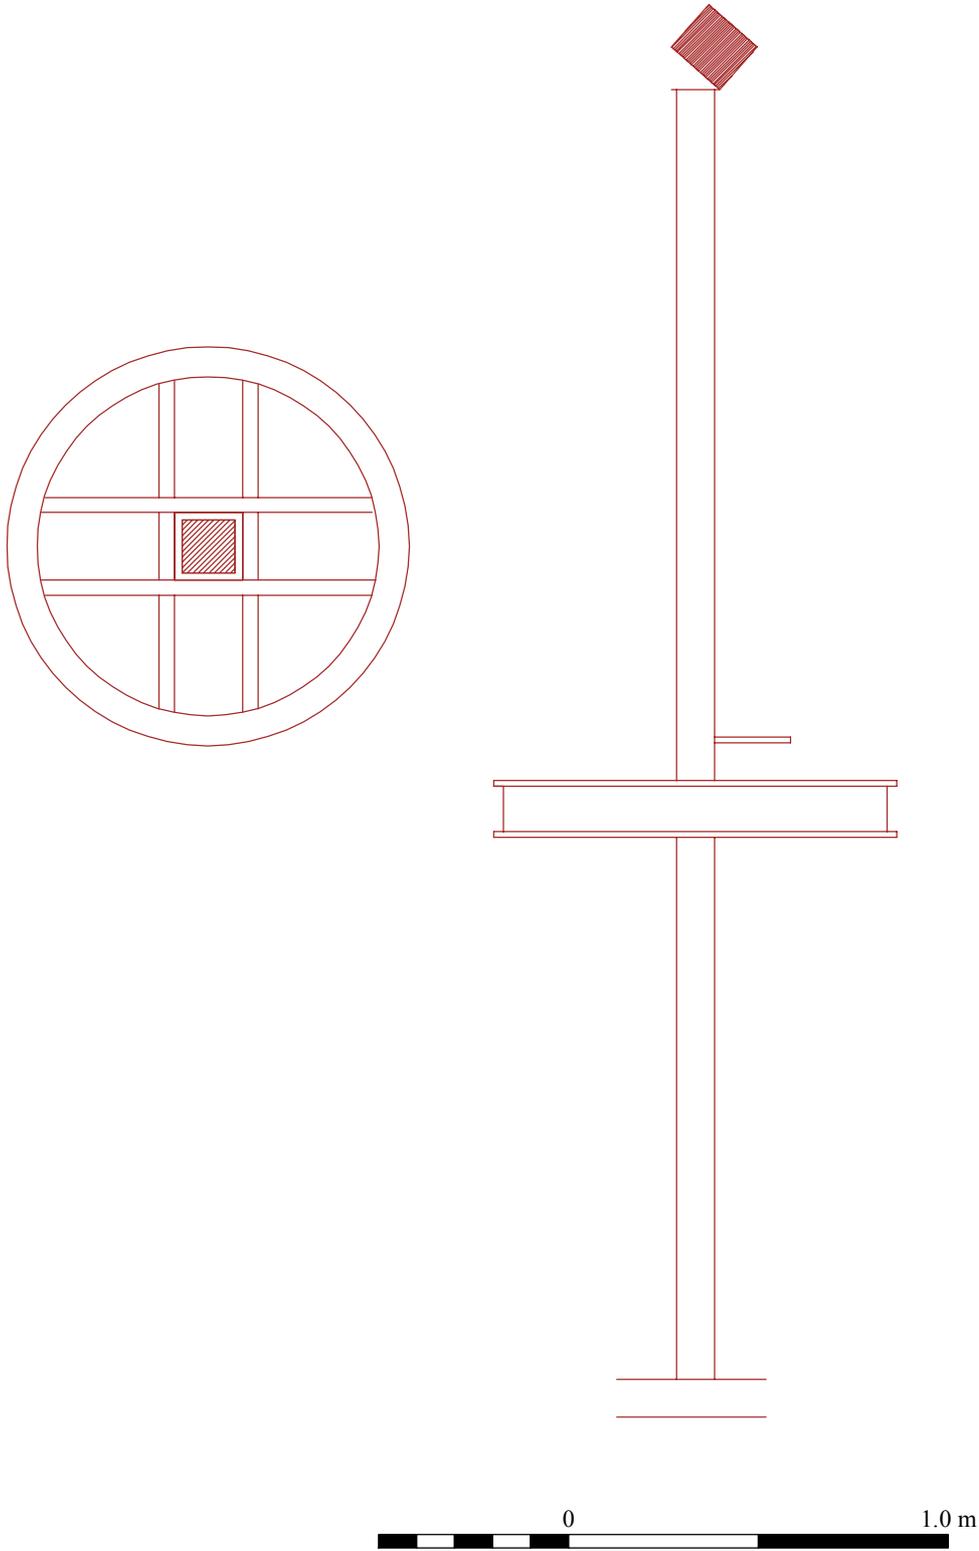
Figure 14: Upper Lay Shaft
Scale 1:20

The upper lay shaft (Figure 14) is driven by means of a leather belt from the lower lay shaft. This belt runs in a wooden protective channel (Plate 96) and then over a pulley wheel with clapsed spokes. This wheel is 1.06 m (3' 6") in diameter and 0.15 m (6") thick (Plate 97). This axle for this wheel runs along the line of the "Dresser Range" and to a point where it is supported by one of the purlins to the mill range. It acted as a sack hoist in two places. Within the "Dresser Range" the shaft is worn above the hatch in this range (Plate 98) and at the eastern end it is reinforced with iron sheeting (Plate 99) which is likely to be the position of the drive for the sack hoist in the mill building. This position is not above the hatch in the mill, however worn slots in the western principle rafter (Plate 27) would suggest a rope or wire ran from the shaft to an iron ring above the hatch (Plate 26) via a pulley wheel (Plate 100) attached to one of the purlins.

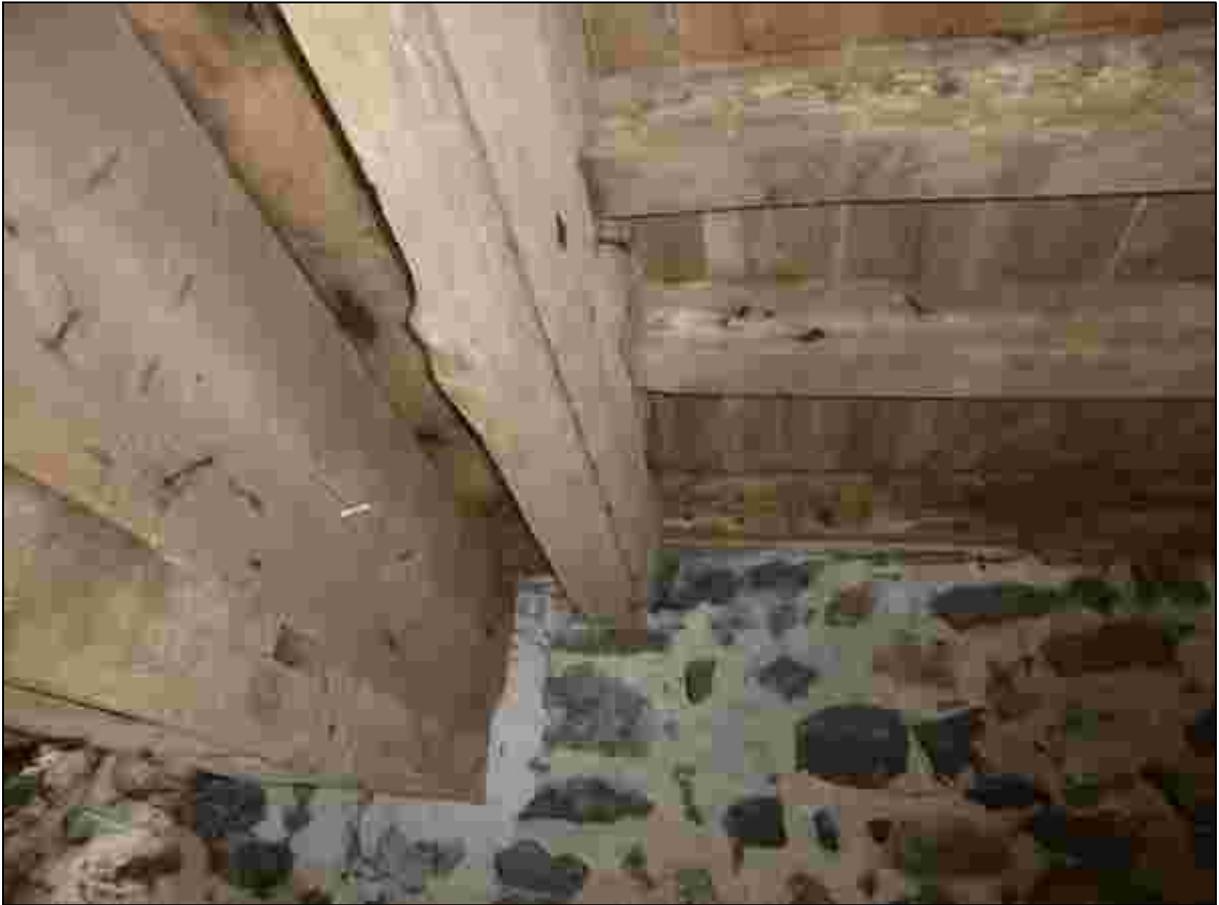
Plate 17: Ceiling joist in the mill range

The division between the south eastern end and the middle section of the range is defined by a slight step in the floor and the two ceiling beams crossing the range (Plate 17). Both of these beams appear to be of re-used timbers with the smaller, southern ceiling beam having a quarter round moulding. The larger, northern, beam has a series of mortice holes on its underside also demonstrating that the beam is re-used. On the western wall there is the remains of a wooden spout (Plate 18) which would have allowed grain from the corn dryer to be transferred to the mill range. The wall of the mill range around this feature appears to have been re-built suggesting the link between the corn dryer and the mill is a secondary feature. Resting on the opposite wall is a wooden slipper (Plate 19) which is probably from the eastern stones on the first floor.

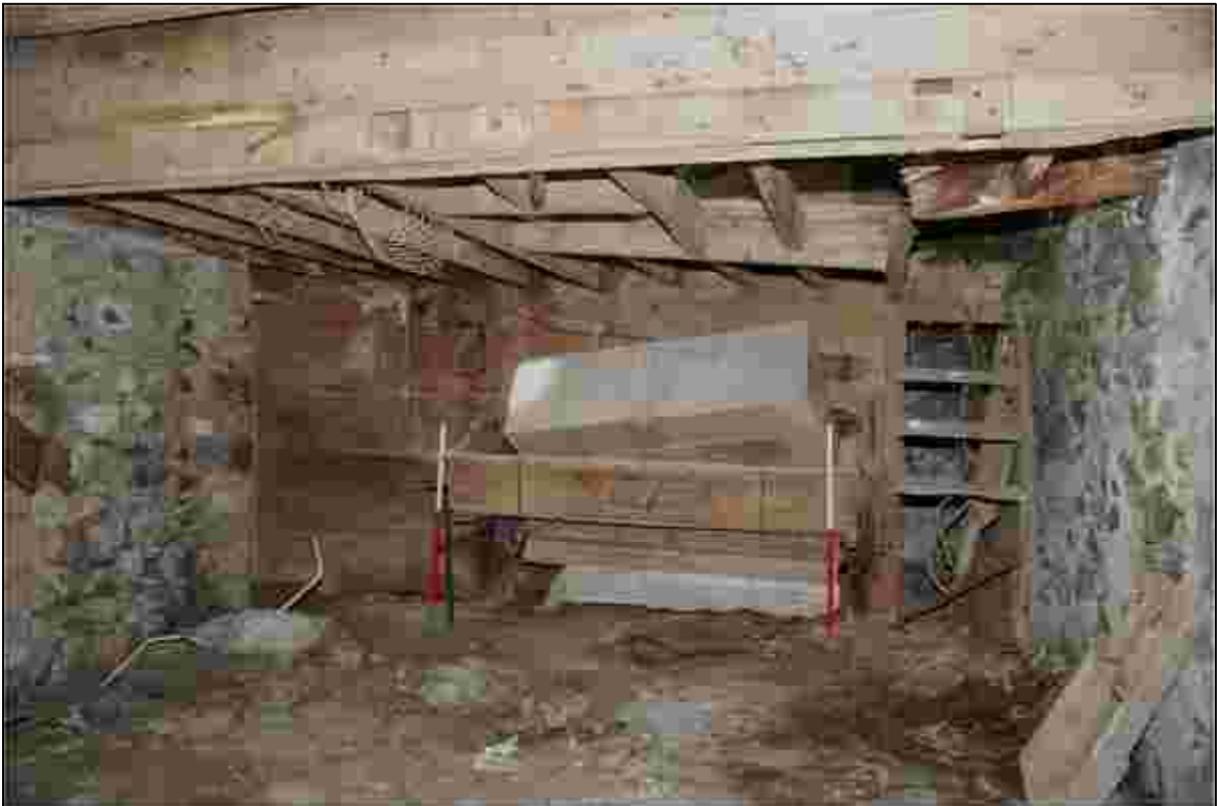
Plate 20: The Hurst Frame and trough in the mill range

The north western end of the range contains the mill mechanism which is contained within, and supported by, the Hurst Frame (Plate 20). The southern side, of which, is completely boarded hiding the machinery behind. At the eastern end is the remains of the wooden ladder to the first floor and the access point to the machinery. Also attached to the Hurst Frame is a wooden trough which served as the receptacle for collecting flour from the eastern stone via a wooden spout (Plate 21). Also sitting within this trough is a second trough which originally sat below the spout from the western stones on the western side of the Hurst Frame.

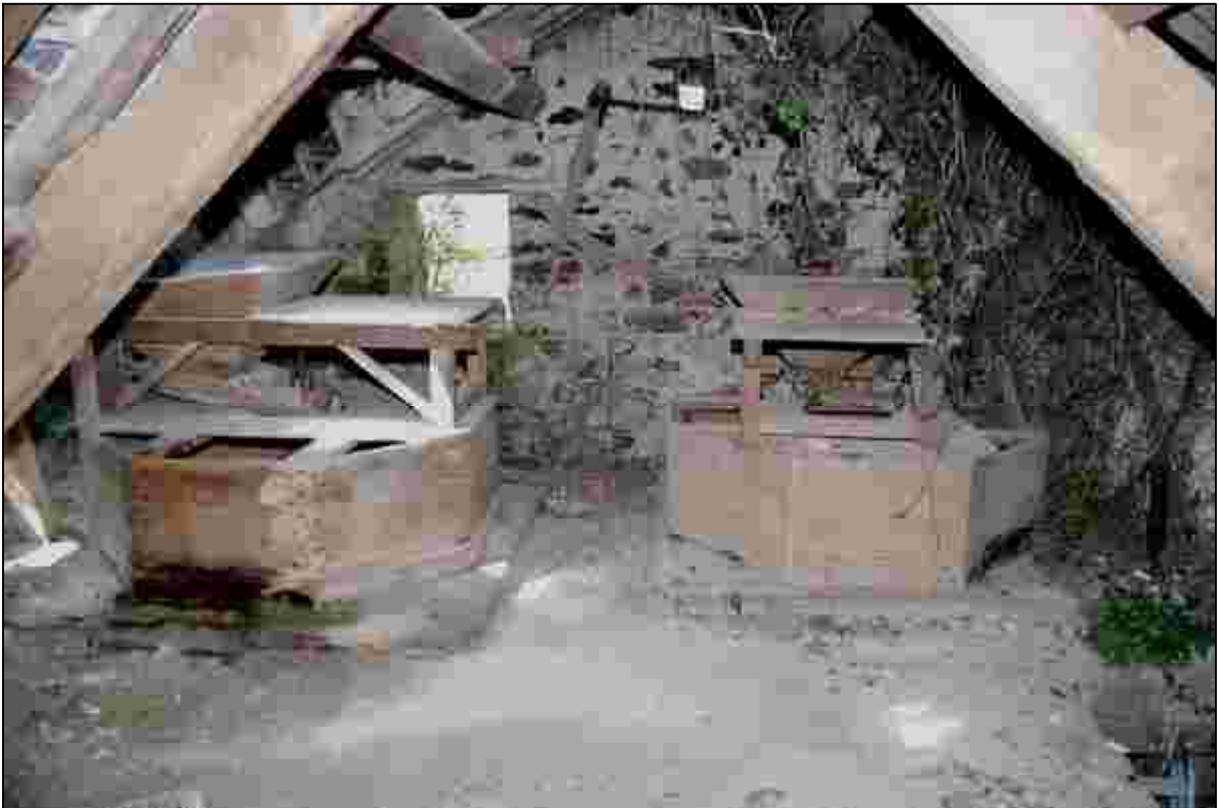
Plate 24: The stone floor of the mill range, looking north west

The quants pass through bed stones and drive the upper (runner stones). The stones are held within octagonal tuns on which are mounted the horses (Plate 24). The horses support both the hopper and the slipper (Plate 79). The slipper only survives *in situ* on the western stones, however the slipper to the eastern stones is likely to be that on the ground floor of the mill range (Plate 19). The end of the slipper was moved by the damsel which is attached to the top of the quant. Once again that in the eastern stones is missing, but is probably resting on the ground floor at the eastern end of the Hurst Frame (Plate 80). The flour from the stones was retained by the tuns and then ran through spouts into troughs on the ground floor. Whilst the wooden spout (Plate 81) and the trough for the eastern stones survive, the spout for the western stones has been replaced by a crude metal tube which has been reinforced with tin cans (Plate 82) and the trough has been moved to sit within the other trough

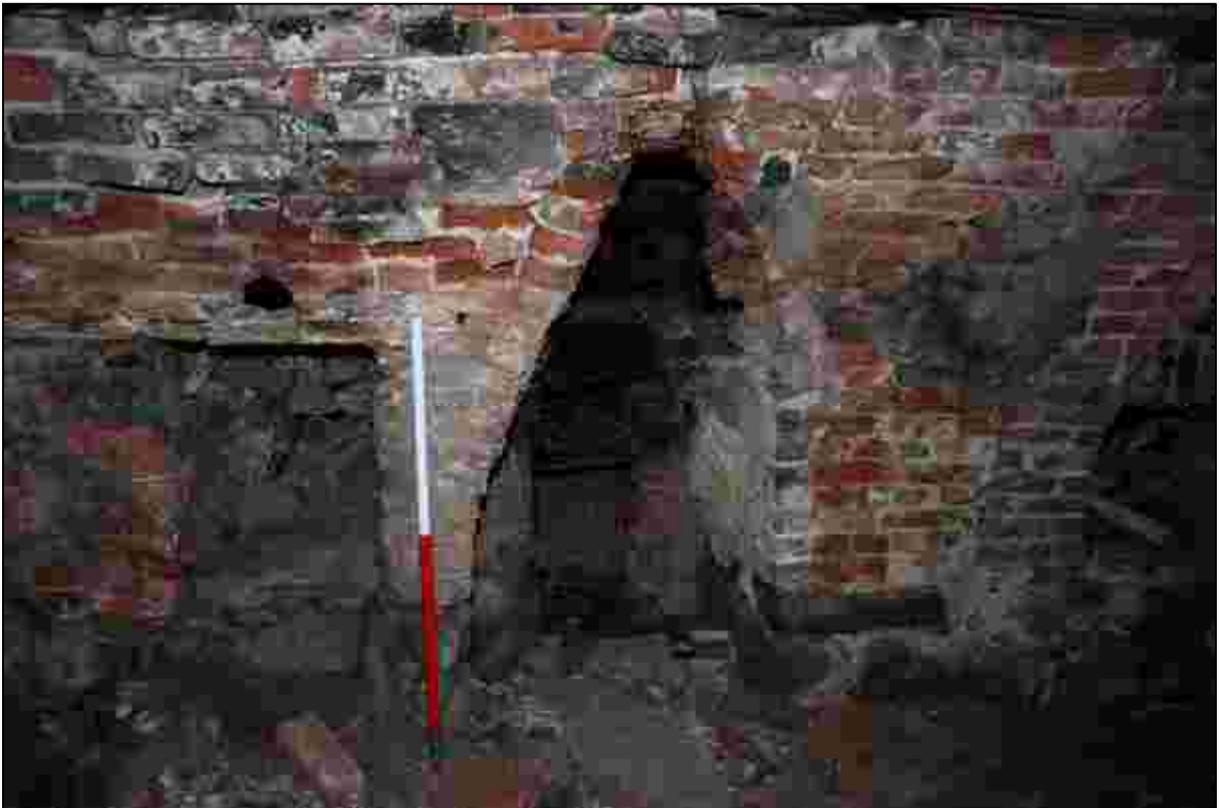
Plate 36: The northern and central opening in the dividing wall of the corn dryer

On the ground floor the building is divided into two spaces. Though the eastern door is the stoke house for the corn dryer. The eastern end of this space has the brick dividing wall with three openings. This wall has a stone base and a brick vault with its top supported by the ceiling beam so that it is 0.60 m overhung. There are three openings in the wall (Plate 35), two of which relate to the use of the building as a corn dryer and the third is an inserted oven. The northern opening probably gave access to the heat chamber for cleaning, it has a rectilinear form and a wooden lintel (Plate 36). The central opening (Plate 36) is formed with
