MELIN ABERDARON

Archaeological Survey

EAS Client Report 2015/13

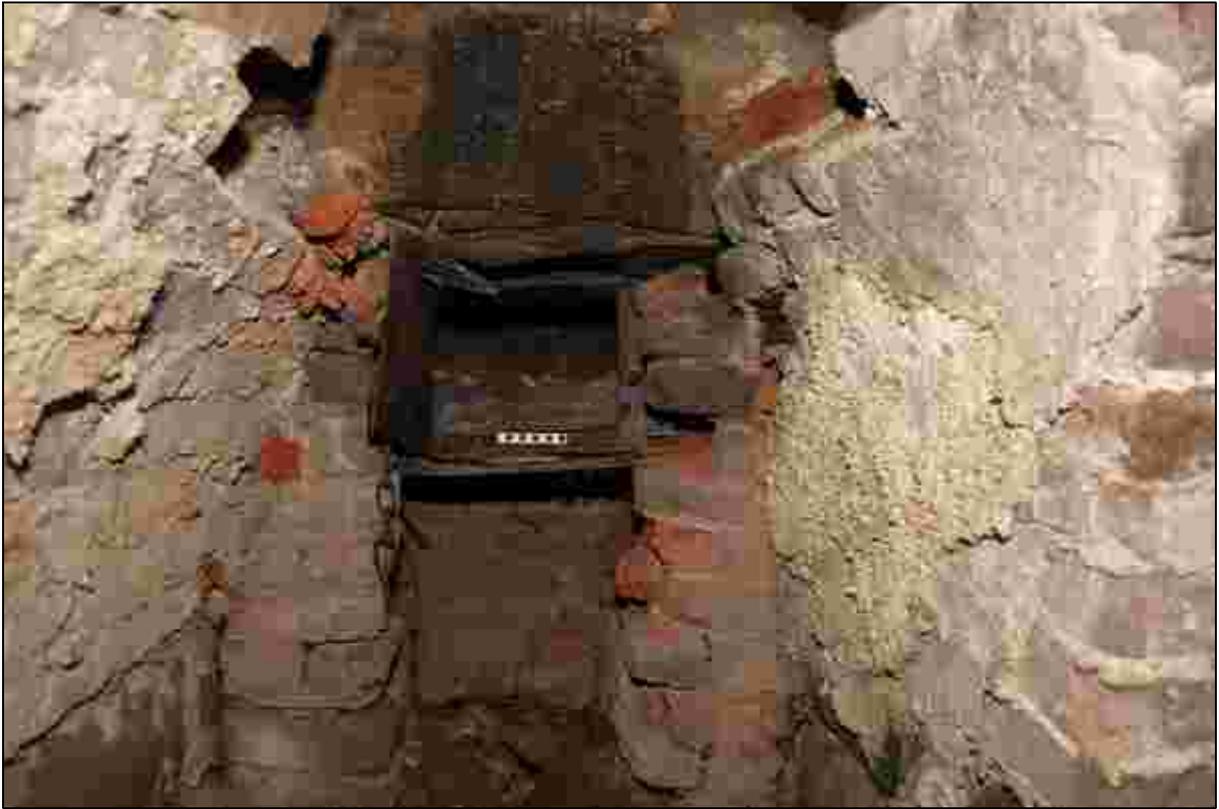
Plate 37: The firebox

a brick, pointed arch and contains the firebox for the corn dryer (Plate 37). The firebox is a metal box with an iron door supported on brick piers. There is an oven (Plate 38) in the southern end of the dividing wall. This is clearly an inserted (later) feature constructed of slightly larger brick than the rest of the dividing wall. The oven itself is approximately 0.78 m in diameter. There is a block window in the western gable wall (Plate 39). It is likely that this was blocked when the external flight of stairs was added to the building. The door to the ground floor (Plate 40) has blacksmith made fittings with iron pintels and strap hinges. The latch was in wood. This end of the building also contains the shafts from a horse drawn cart (Plate 41).

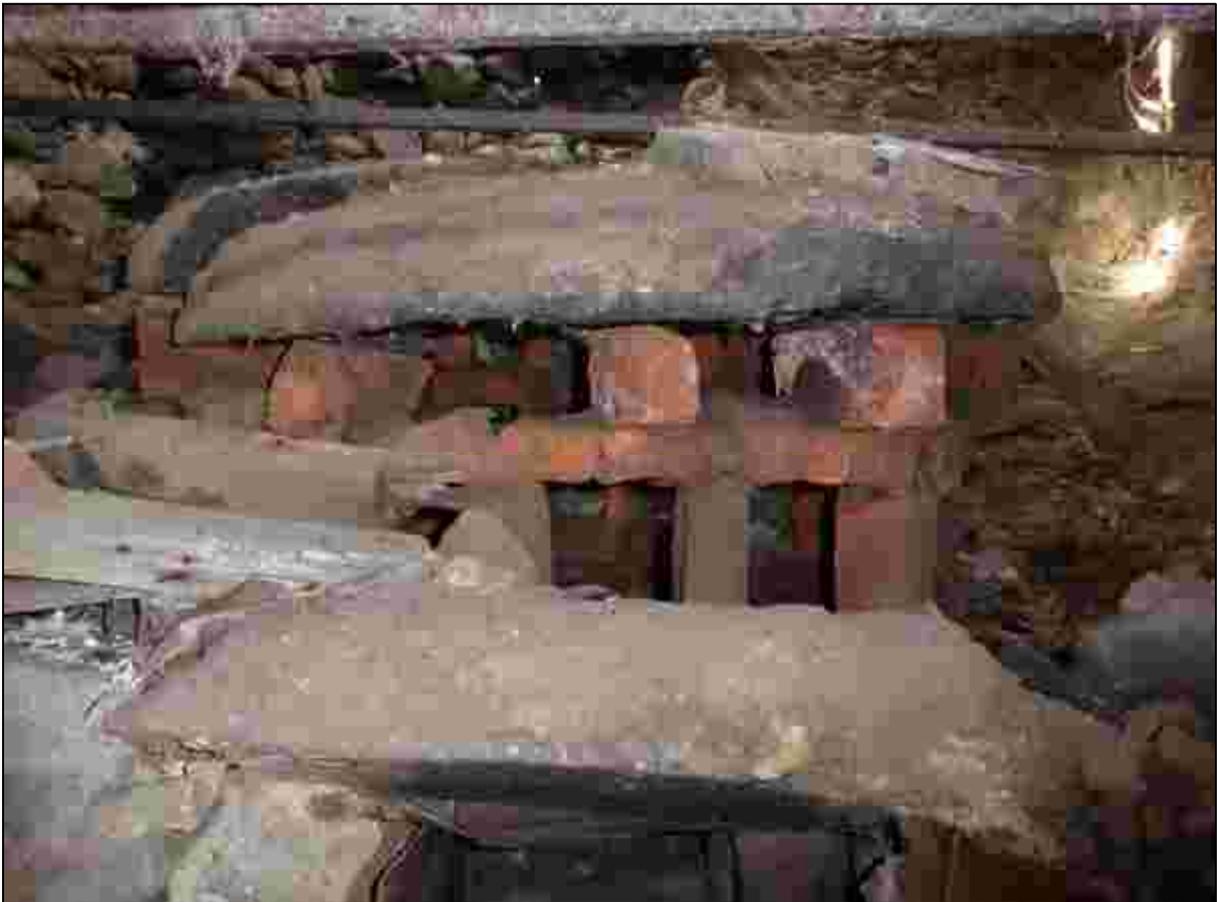
Plate 42: Perforated stack behind the firebox

Behind the firebox the heat was transferred to the heated chamber by means of a highly perforated brick tube (Plate 42) surmounted by a re-used millstone. This allowed the heat from the firebox to be distributed evenly through the heated chamber below the drying floor. The walls of this chamber slope inwards (Plate 43) which is also assumed to be a feature to allow the even distribution of heat to the drying floor.

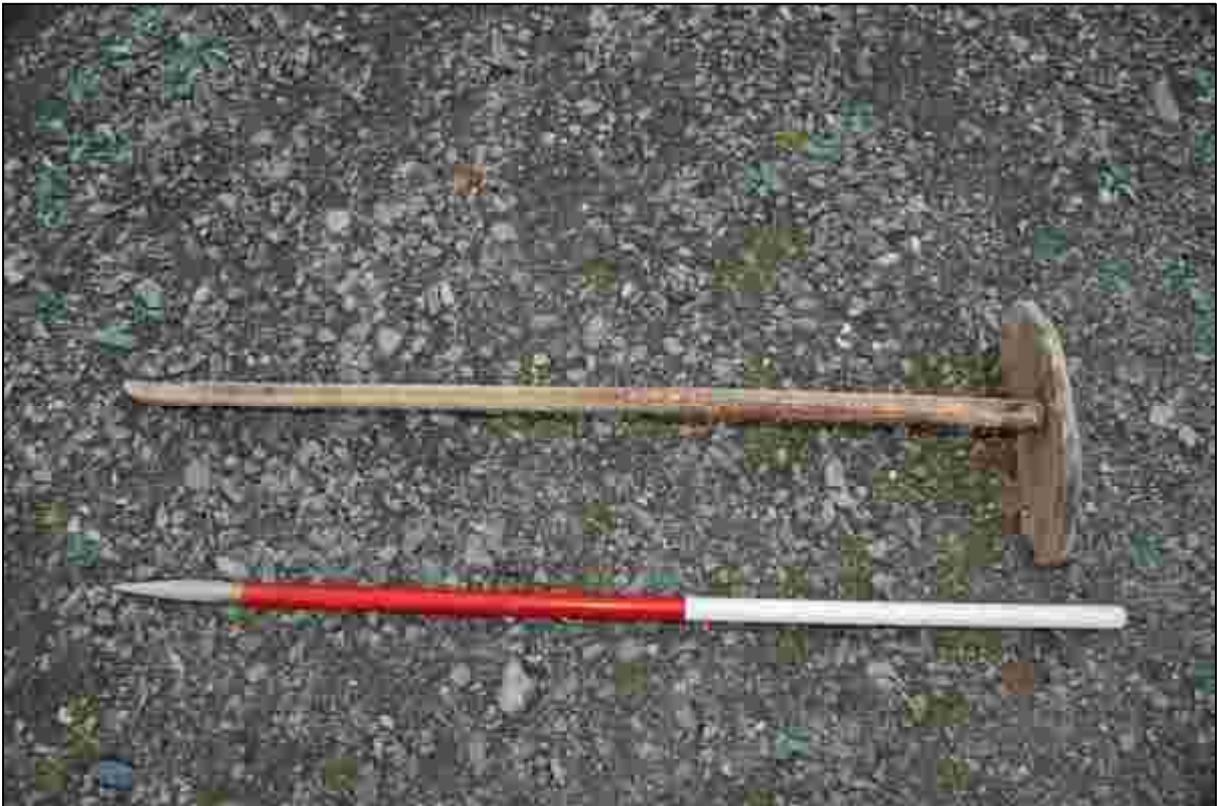
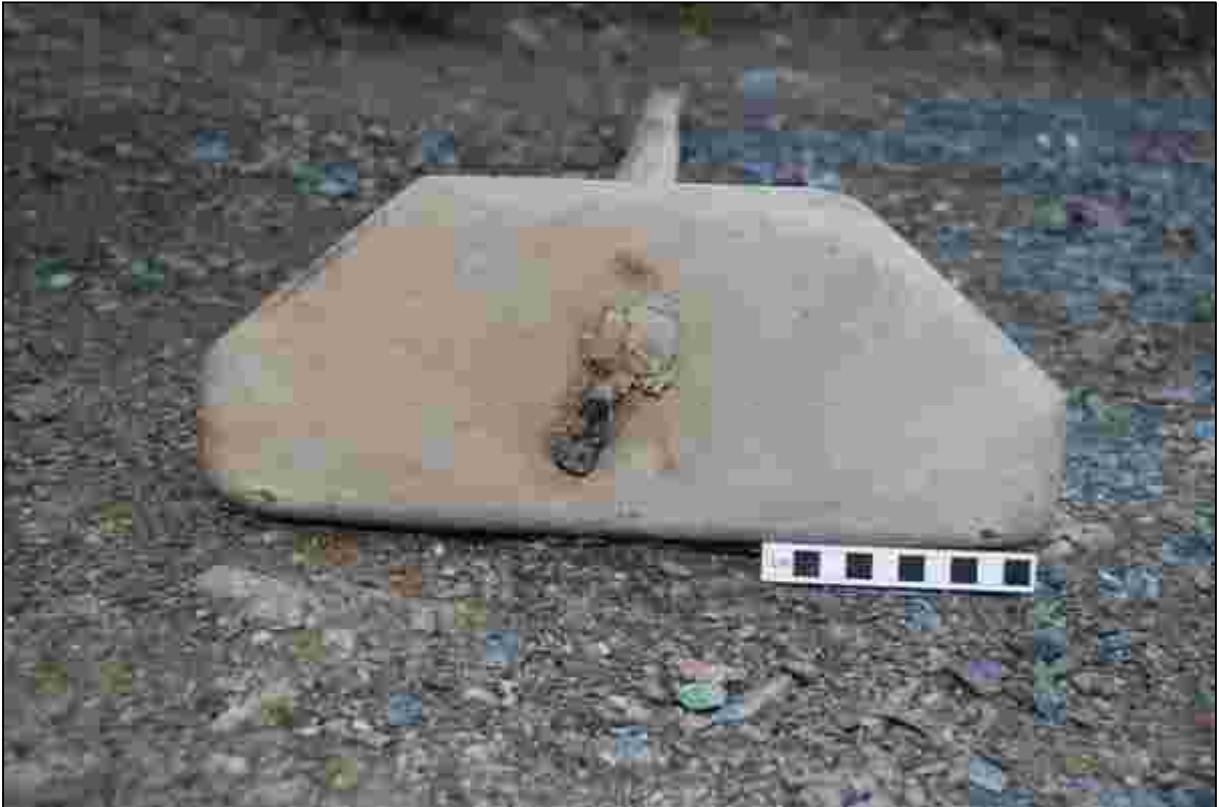
Plate 48: Tool from the corn dyer

Tucked behind one of the principle rafters in the roof was one of the tools which was used to spread the grain over the heated floor (Plates 48 and 49). This was a relatively simply made "pusher" consisting of a simple handle with a head nailed on the end. This head has a felt strip along its longest edge which presumably was designed to reduce scratching whilst moving the grain on the heated floor. Also on the first floor of the corn dryer is a set of wooden steps (Plate 50), these are not from the corn dryer itself, however, it is likely that they were originally from the "Dresser Range".

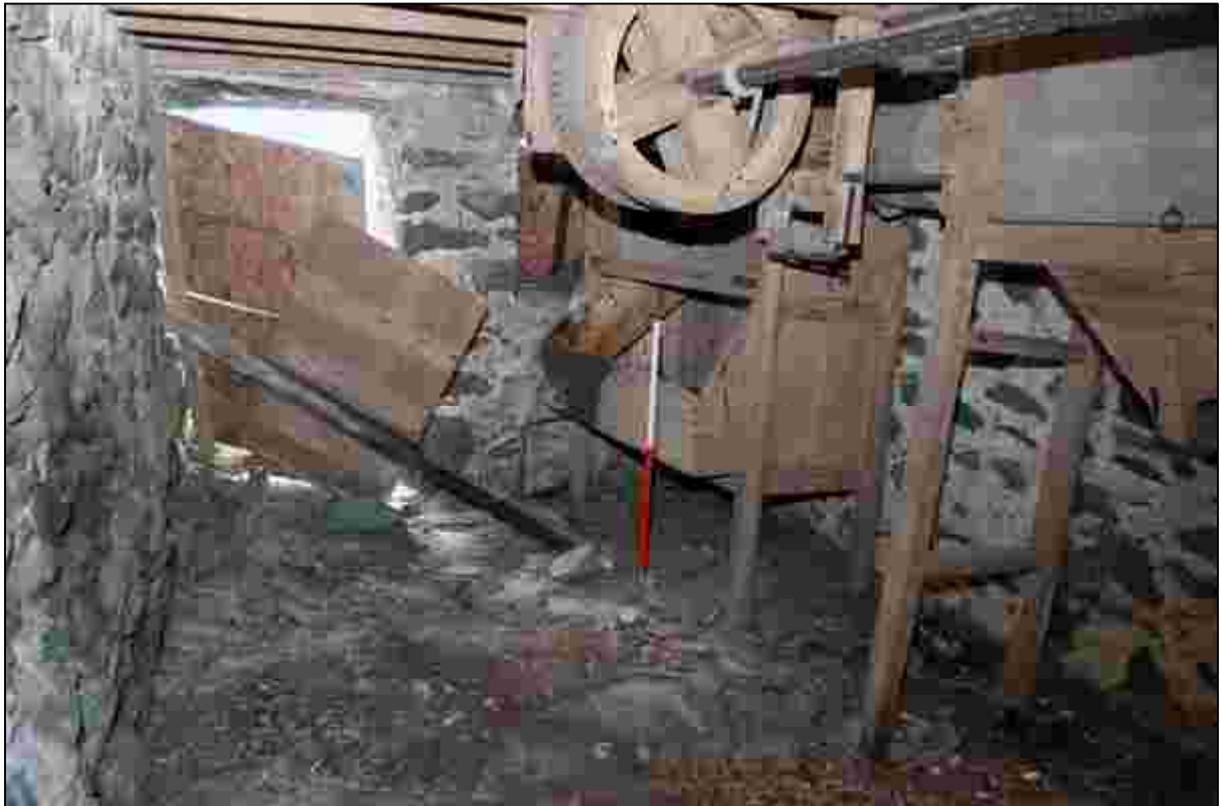
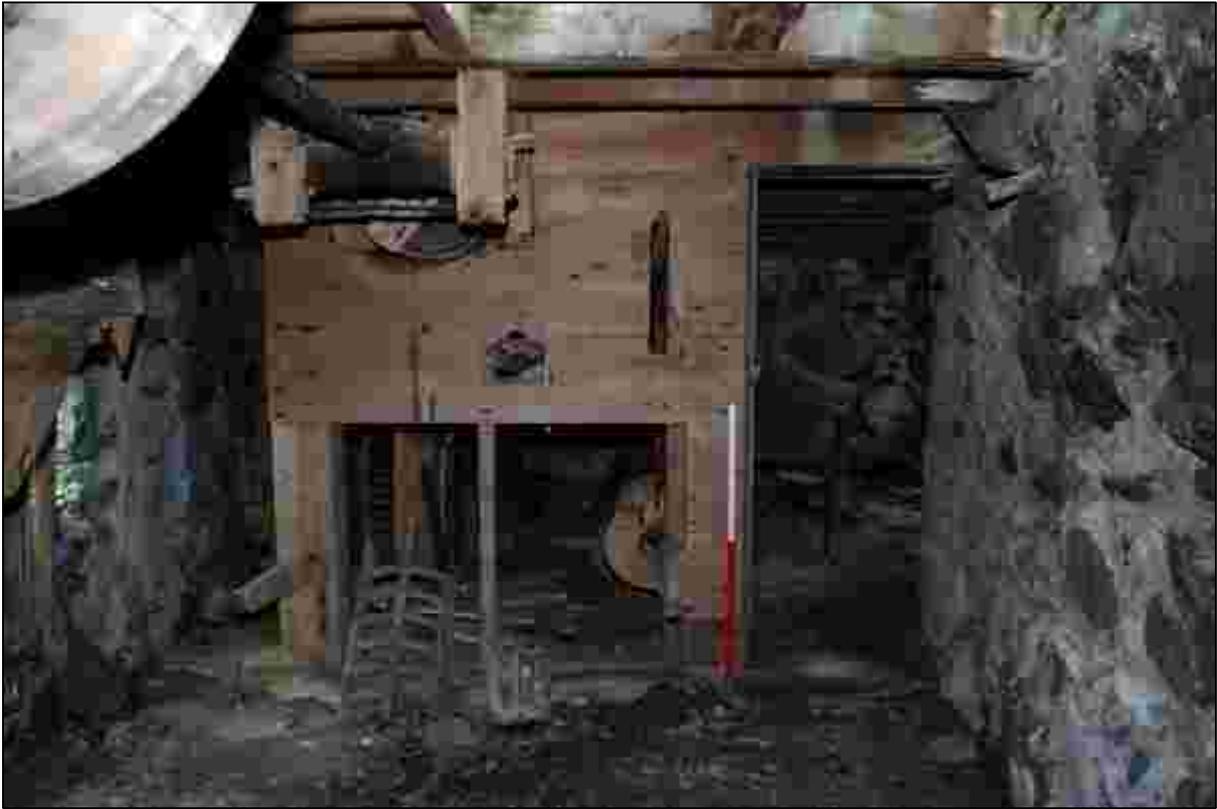
Plate 54: Ground floor of the “Dresser Range”, looking south west

On the ground floor the range runs south and west from the Hurst frame (Plates 54 and 55), containing the two dresser machines and the lower lay shaft.

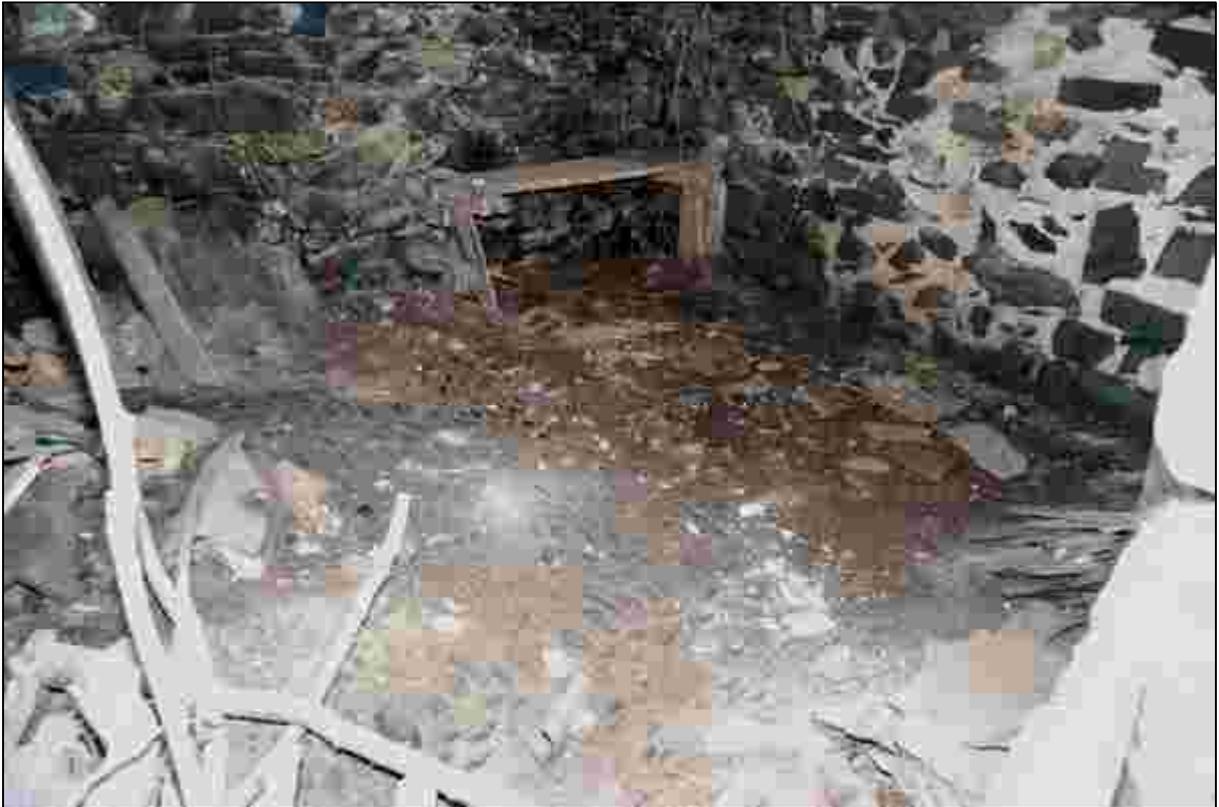
Plate 61: The floor of the stables

This single storied range has a cobbled floor (Plate 61) with a central drain running along the length of the building. There are a few fittings surviving within the stables, these consist of a wooden bench in the north western corner (Plate 62) and two wooden pegs on the western wall. One of these pegs holds a horse collar (Plate 63) whilst the other hold part of the harness from a cart (Plate 64).

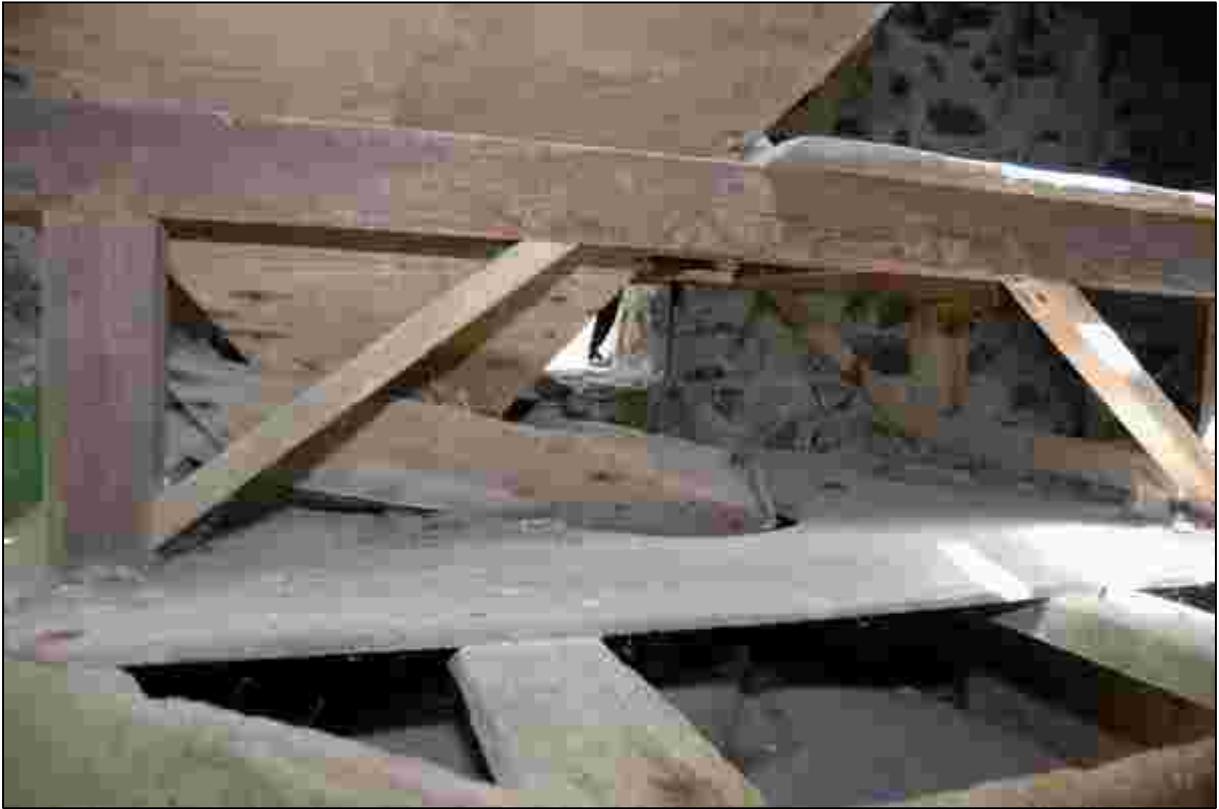
Plate 79: Hopper and slipper for the western stones

The quants pass through bed stones and drive the upper (runner stones). The stones are held within octagonal tuns on which are mounted the horses (Plate 24). The horses support both the hopper and the slipper (Plate 79). The slipper only survives *in situ* on the western stones, however the slipper to the eastern stones is likely to be that on the ground floor of the mill range (Plate 19). The end of the slipper was moved by the damsel which is attached to the top of the quant. Once again that in the eastern stones is missing, but is probably resting on the ground floor at the eastern end of the Hurst Frame (Plate 80). The flour from the stones was retained by the tuns and then ran through spouts into troughs on the ground floor. Whilst the wooden spout (Plate 81) and the trough for the eastern stones survive, the spout for the western stones has been replaced by a crude metal tube which has been reinforced with tin cans (Plate 82) and the trough has been moved to sit within the other trough

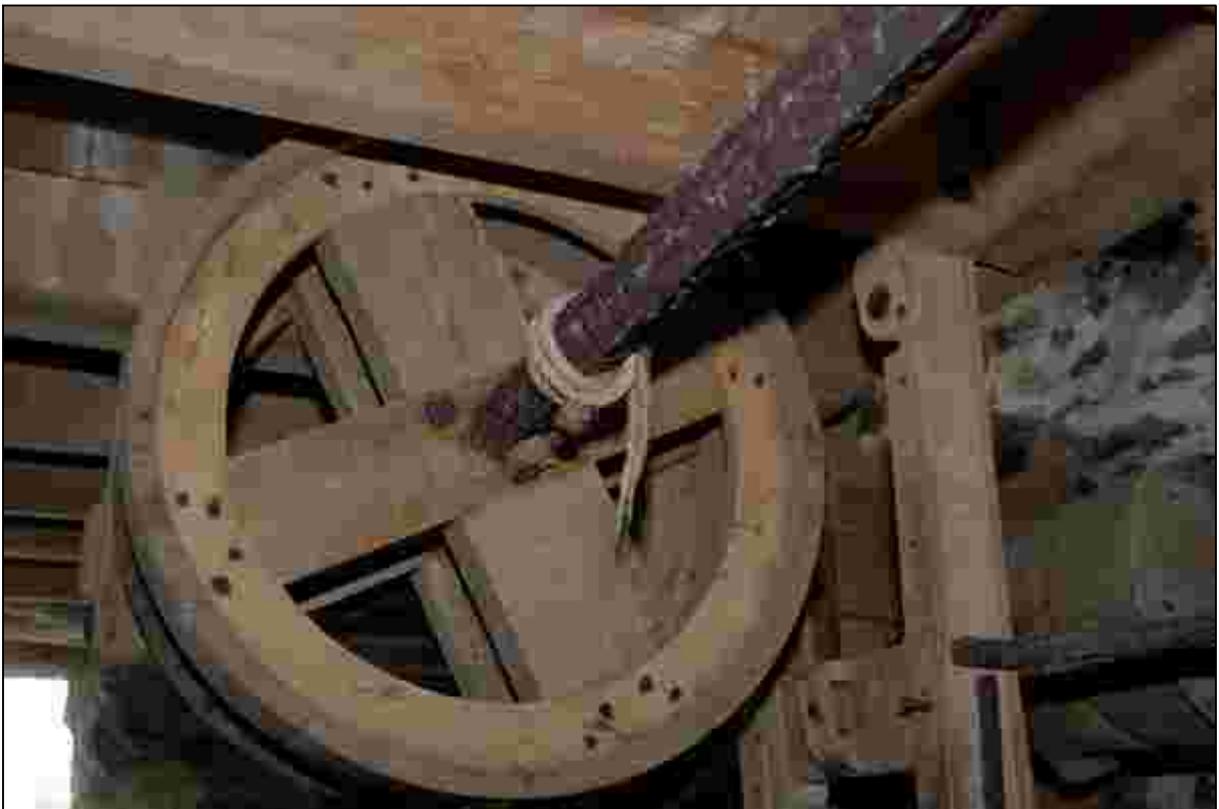
Plate 86: The western pulley wheel on the lower lay shaft

The ancillary machinery for the mill was powered from one of the lay shafts. The lower lay shaft (Figure 13) had a gear wheel which engaged with the crown ring on the top of the great spur wheel, this is now missing. The shaft is supported at its eastern end by a phosphor bronze bearing mounted on one of the supports for the Hurst Frame (Plate 83). There is one wooden pulley inside the Hurst Frame and two other wheels within the Dresser Range. The wheel within the Hurst Frame is 0.51 m (1' 8") in diameter and 102 mm (4") thick (Plate 84). This was linked to a fan below the Hurst Frame. The lay shaft passes through the wall of the Hurst Frame and a second bearing before it has a second wheel attached (Plate 85). This is of a similar size to that within the Hurst Frame and has a leather belt around the wheel which links it to the upper lay shaft. There is then a third bearing support for the lay shaft. At the western end of the lay shaft is a larger wheel which is 0.71 m (2' 4") in diameter and 0.3 m (1') thick with crossed spokes (Plate 86). This wheel drove the dresser machines by means of a leather drive belt.

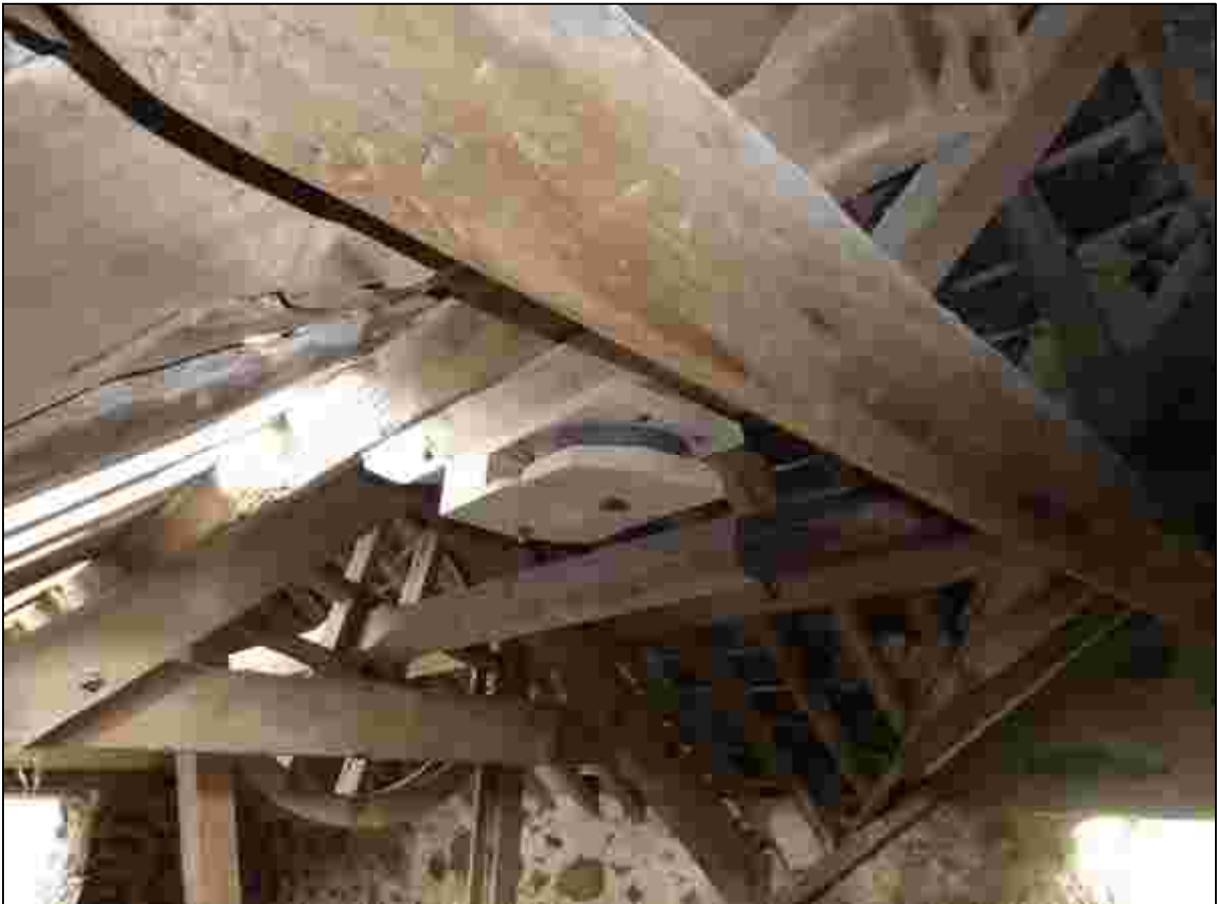
Plate 100: Pulley wheel, part of the sack hoist mechanism

The upper lay shaft (Figure 14) is driven by means of a leather belt from the lower lay shaft. This belt runs in a wooden protective channel (Plate 96) and then over a pulley wheel with clapsed spokes. This wheel is 1.06 m (3' 6") in diameter and 0.15 m (6") thick (Plate 97). This axle for this wheel runs along the line of the "Dresser Range" and to a point where it is supported by one of the purlins to the mill range. It acted as a sack hoist in two places. Within the "Dresser Range" the shaft is worn above the hatch in this range (Plate 98) and at the eastern end it is reinforced with iron sheeting (Plate 99) which is likely to be the position of the drive for the sack hoist in the mill building. This position is not above the hatch in the mill, however worn slots in the western principle rafter (Plate 27) would suggest a rope or wire ran from the shaft to an iron ring above the hatch (Plate 26) via a pulley wheel (Plate 100) attached to one of the purlins.

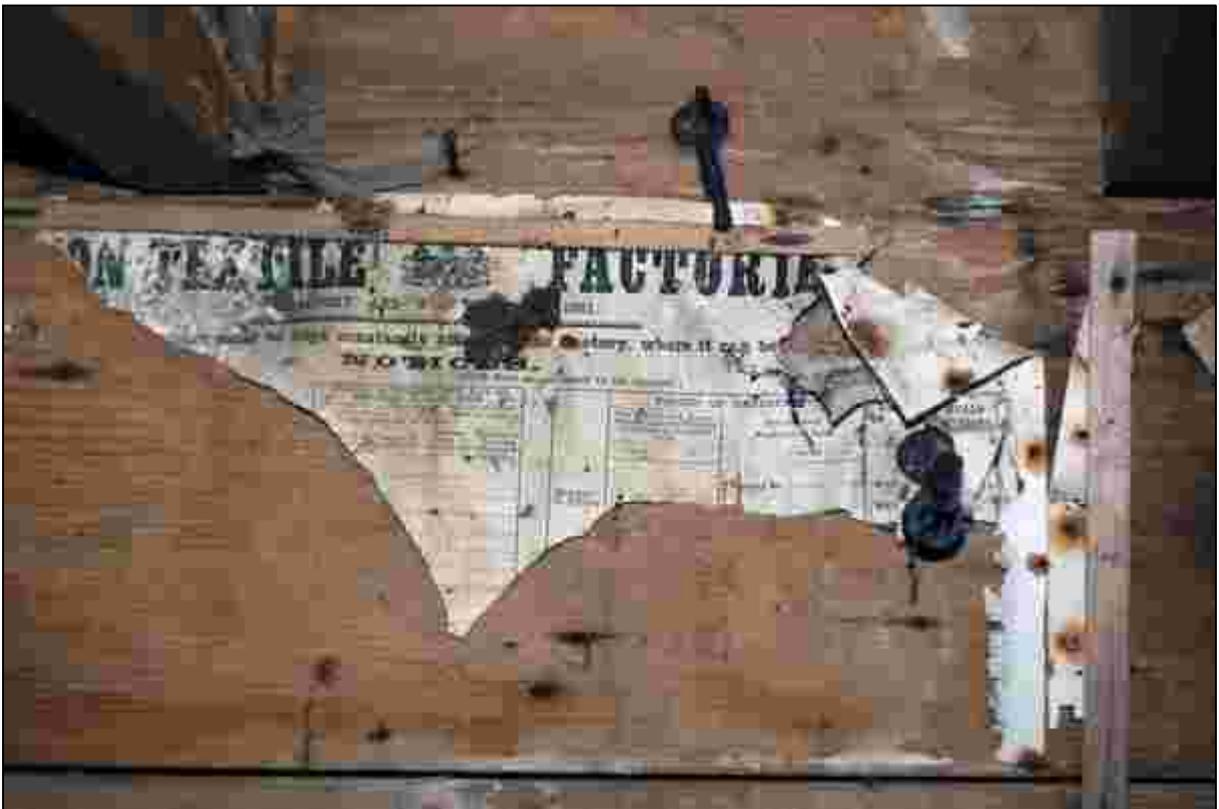
Plate 106: 1901 Factory and Works Act record

The eastern end of the Hurst frame would appear to be a concentration of the graffiti presumably representing a convenient surface for taking notes (Plate 103). Amongst the somewhat worn graffiti two dates can be determined 1851 (Plate 104) and 1881 (Plate 105), both in pencil. There is also a clear “E” and a signature adjacent to the 1881 date (Plate 105). This area also the remains of an official record sheet for the 1901 Factories and Works Act recording the hours worked by the employees (Plate 106).
