COLD-PLUS®

Cold-Plus; University of Colorado - Colorado Springs

Status Report 10.30.18

ATMS was hired to take readings on rooftop package unit #17 on Colorado Campus building 100. The purpose of this was to take samplings of equipment performance before and after installing Cold-Plus compressor additive.

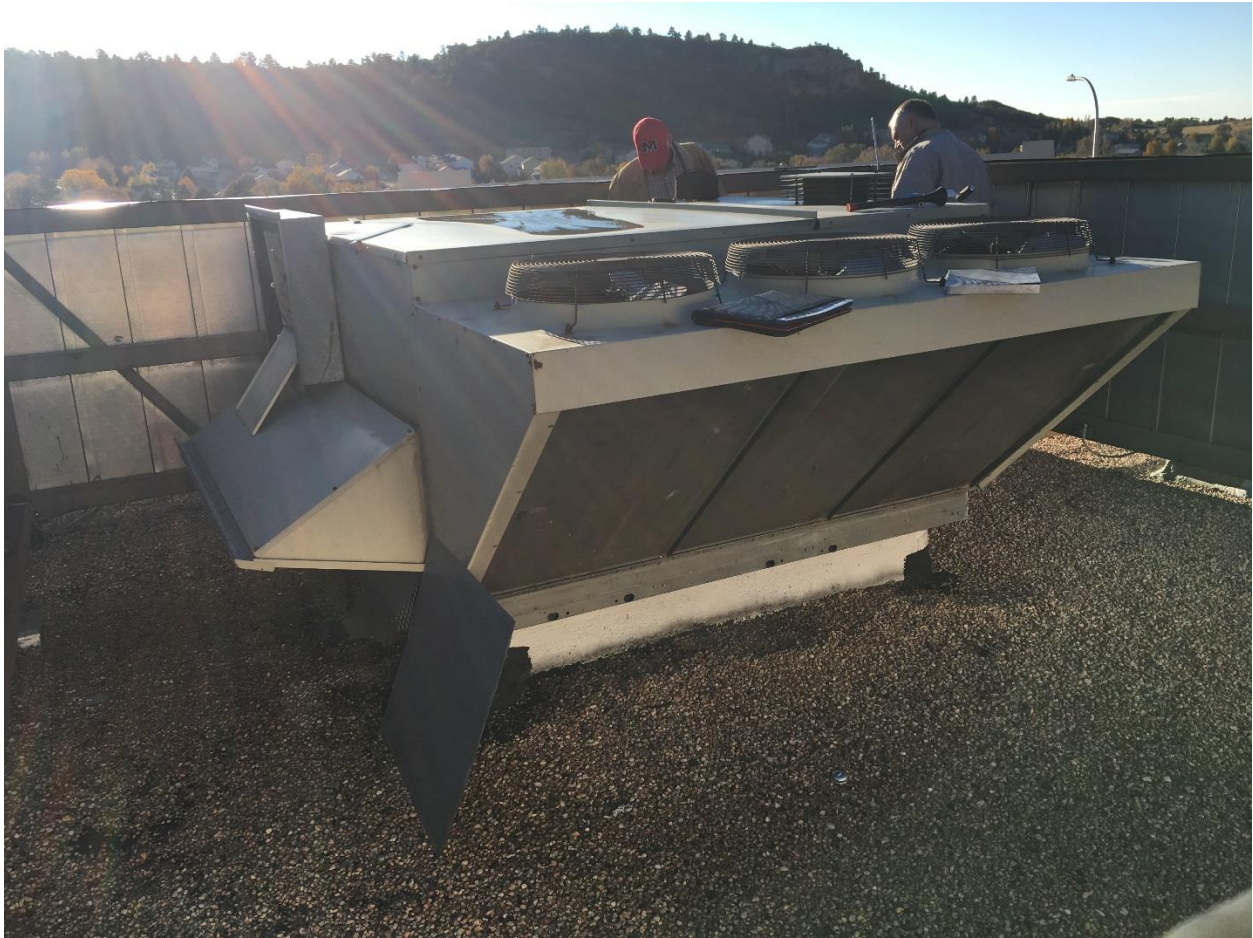
Upon an initial inspection of the equipment ATMS discovered this unit to be a very old unit in poor repair and low performance. Understanding that this unit was intentionally selected for testing, we concluded that most of the equipment on the campus of UCCS was of similar age and condition. Our goal is to determine what the average energy savings would be across all the campus equipment.

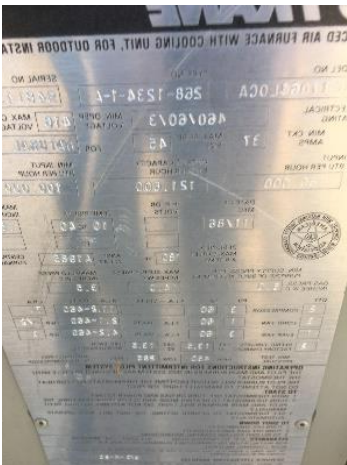
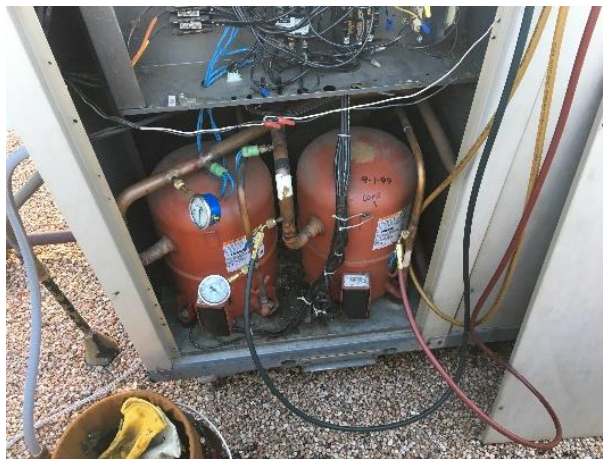
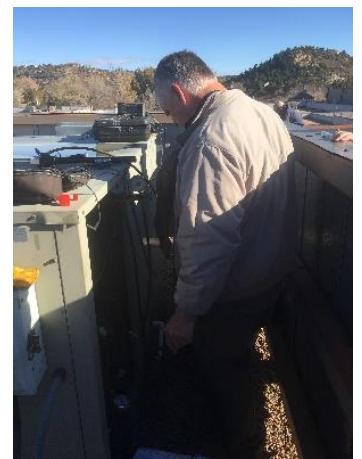
We were assigned an old 1988 15-ton, Trane three phase 460V air conditioner:

Model: BYC170G4LOCA

Type: 268-1234-1-A

Serial: S48143704D

R22 refrigerant

2 Circuits
