Hamlet Home Inspections Inc.

Residential Inspection Report

1 Smith Street, Long Island, NY

Inspected on Thu, Oct 21 2021 at 1:31 PM

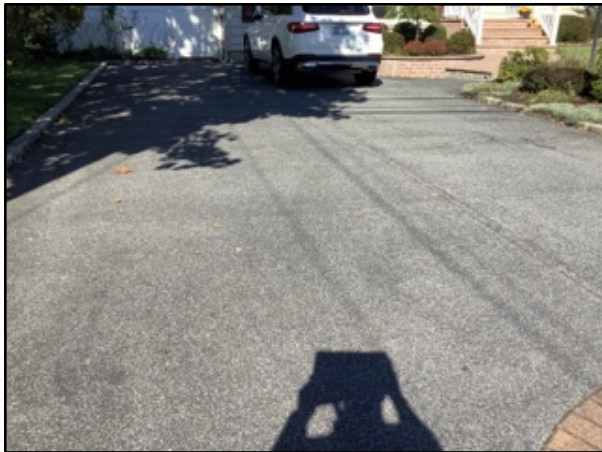
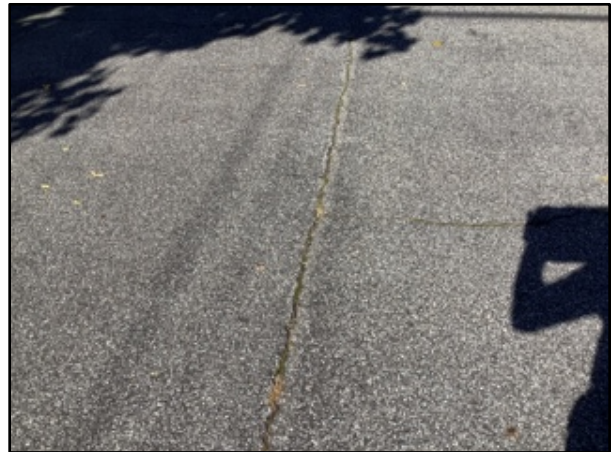
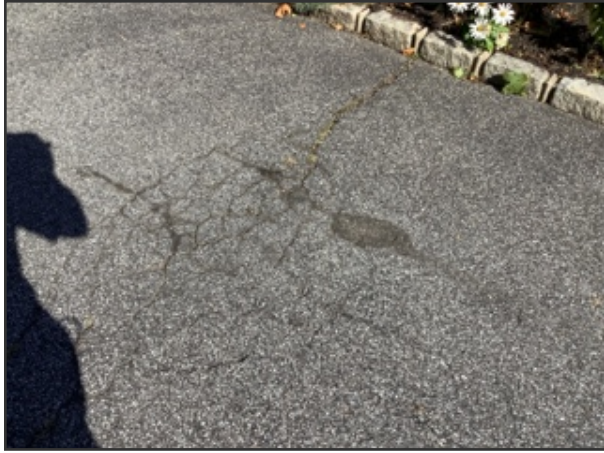
Asphalt
Condition: Repair or Replace

Asphalt will naturally start to crack over time, seal coat and repair as needed.

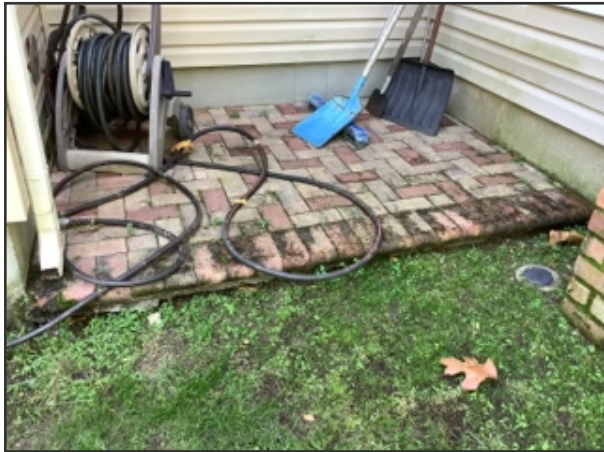
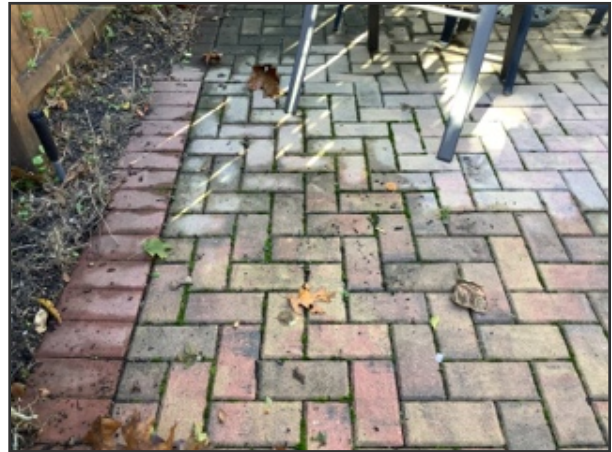
Condition: Repair or Replace

Both patios are not draining well and patio on west side of home has a noticeable dip with accumulated run off from rain. These areas should be graded to prevent further damage

1) Both patios are not draining well and patio on west side of home has a noticeable dip with accumulated run off from rain. These areas should be graded to prevent further damage

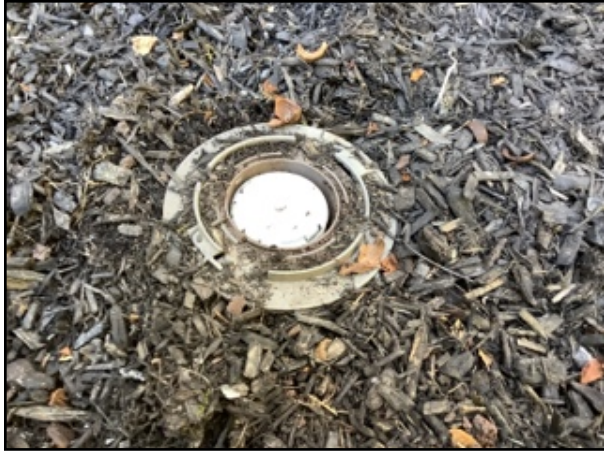
Figure 5-1

Termite stations, no visible activity at time of inspection .
Gutter in front of home missing extension .

2) Termite stations, no visible activity at time of inspection .
Gutter in front of home missing extension .

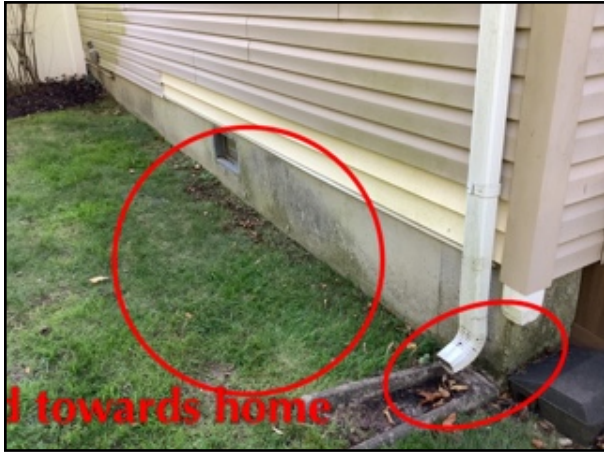
Figure 6-1

East facing foundation wall showing signs of excessive moisture, splash block drains towards home and the grounds grading is allowing water run towards house in this area.

Where splash block is located there is pooling water in interior in crawlspace .

3) East facing foundation wall showing signs of excessive moisture, splash block drains towards home and the grounds grading is allowing water run towards house in this area. Where splash block is located there is pooling water in interior in crawlspace .

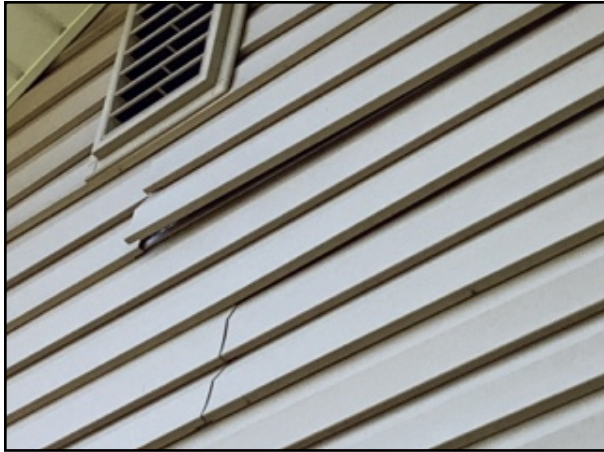
Figure 11-1

Comment 11:
Loose and missing siding on east side of home.

6) Loose and missing siding on east side of home.

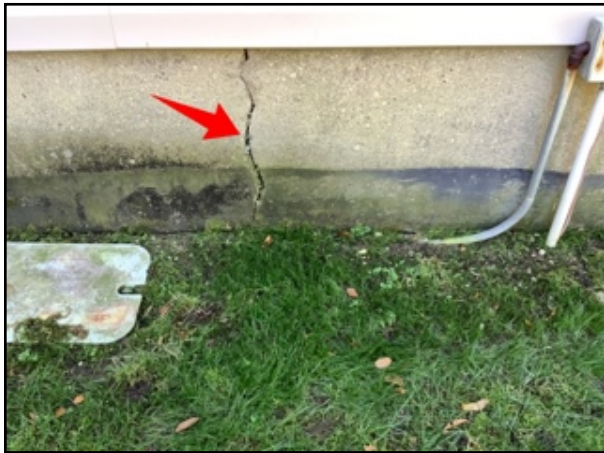
Figure 12-1

Comment 12:
There are a few settling cracks noticed , recommend tuck pointing and monitor to see if it continues . This crack at exterior of Home is up to 1/2 inch wide and there are signs of excessive moisture

7) There are a few settling cracks noticed , recommend tuck pointing and monitor to see if it continues . This crack at exterior of Home is up to 1/2 inch wide and there are signs of excessive moisture

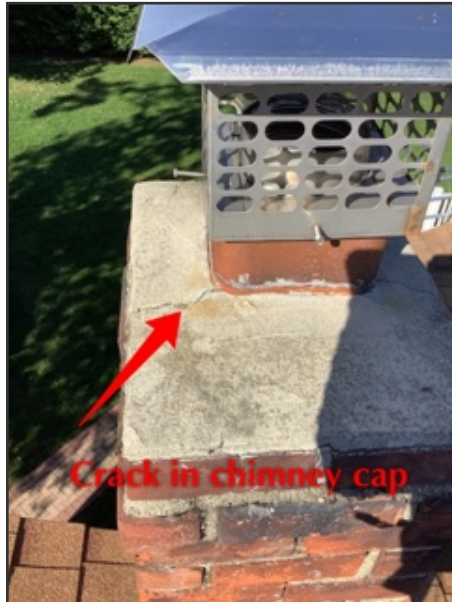
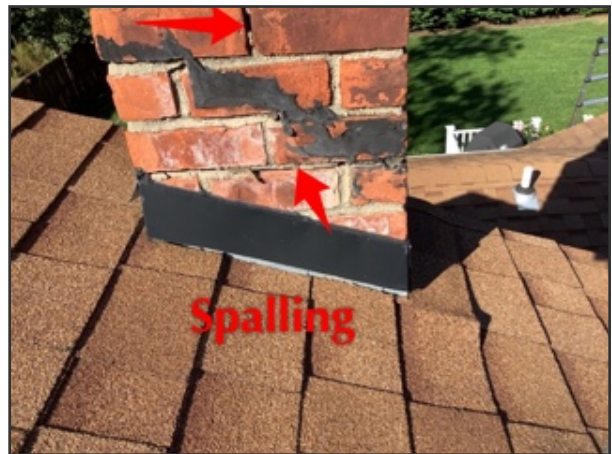
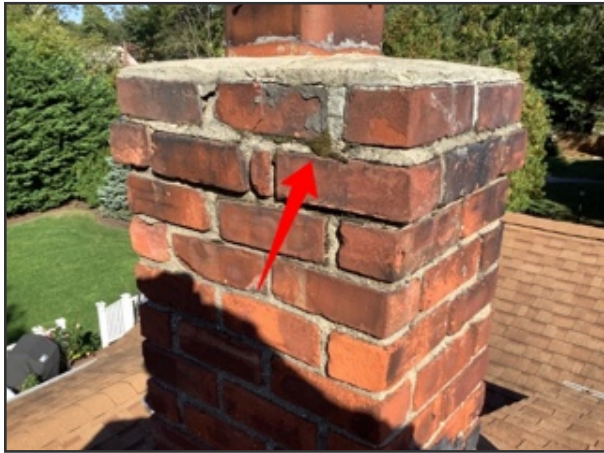
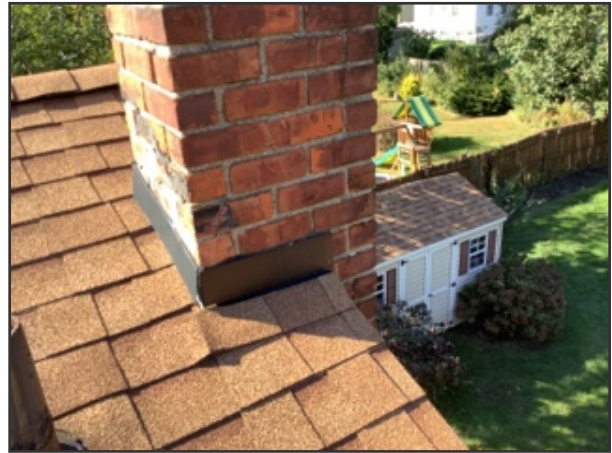
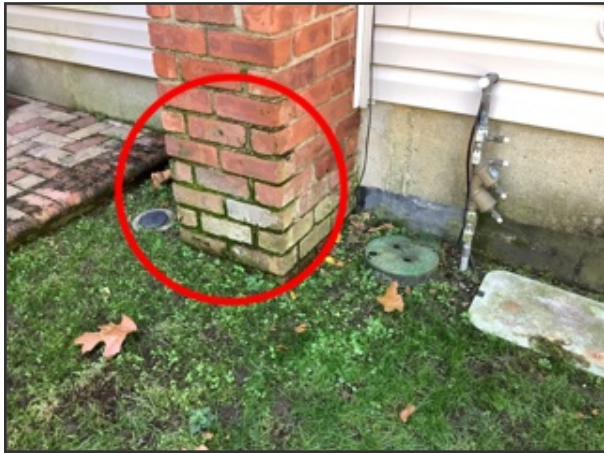
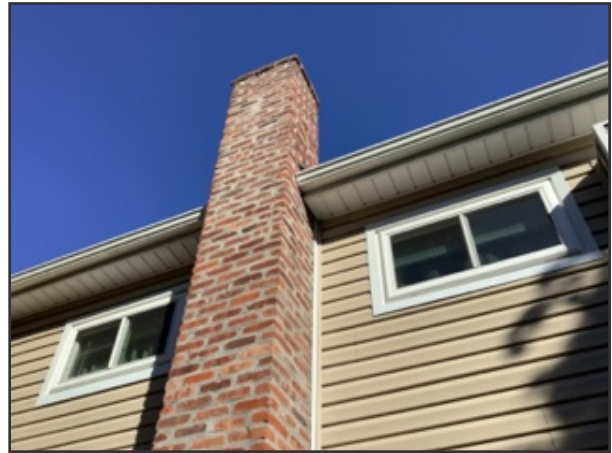
Condition: Repair or Replace

Comment 14:
Chimney cap cracking, spalling in many places, tuck pointing recommend .

9) Chimney cap cracking, spalling in many places, tuck pointing recommended.

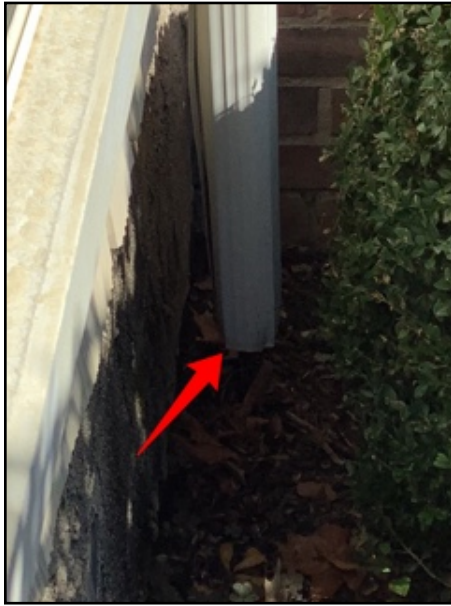
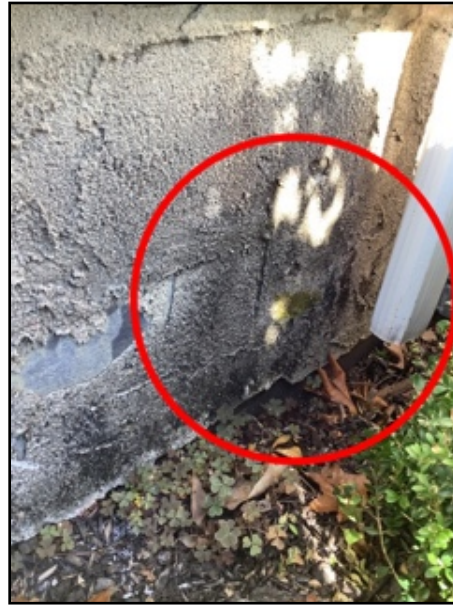
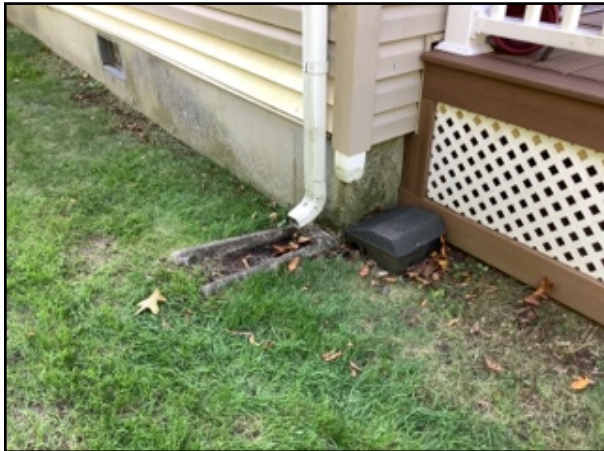
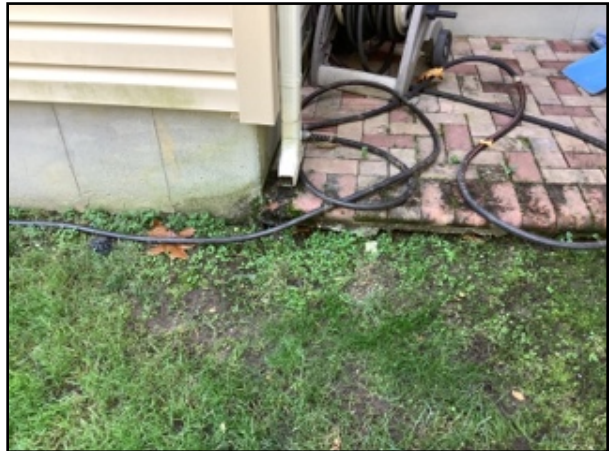
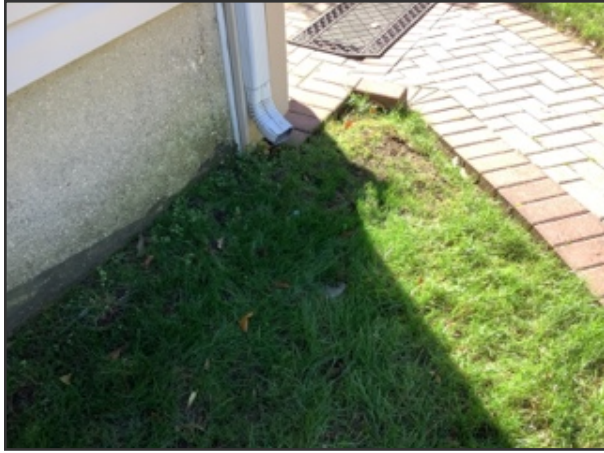
Condition: Repair or Replace

Down spout for gutters are either missing or and draining to close to home. Gutter extensions recommended

10) Down spout for gutters are either missing or and draining to close to home. Gutter extensions recommended

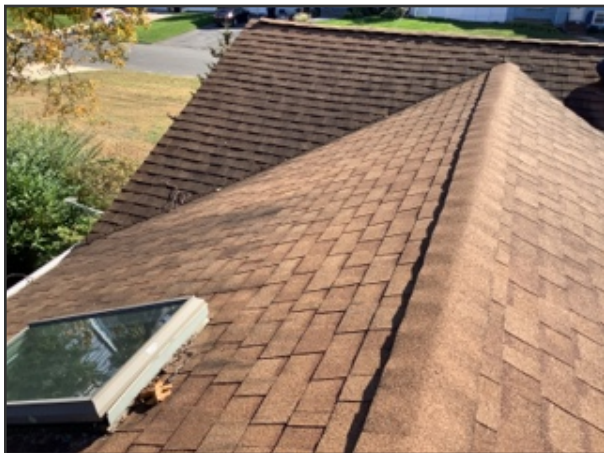
Figure 16-1

North facing side of skylight roof is raised and there is fungi mold growth indicating excessive moisture retention.

11) North facing side of skylight roof is raised and there is fungi mold growth indicating excessive moisture retention.

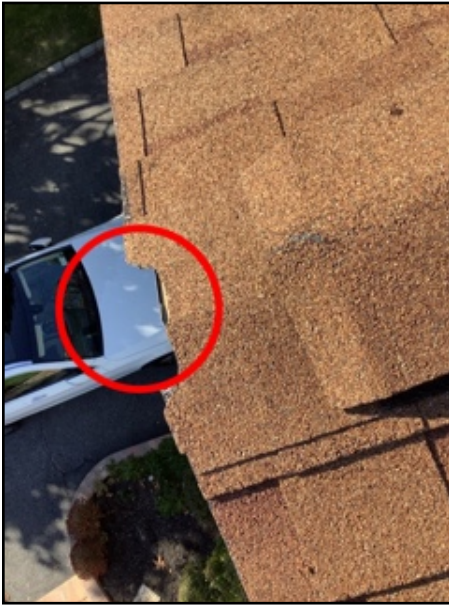
Figure 18-1

Ridge tile missing, water can get behind and into structure .

12) Ridge tile missing, water can get behind and into structure .

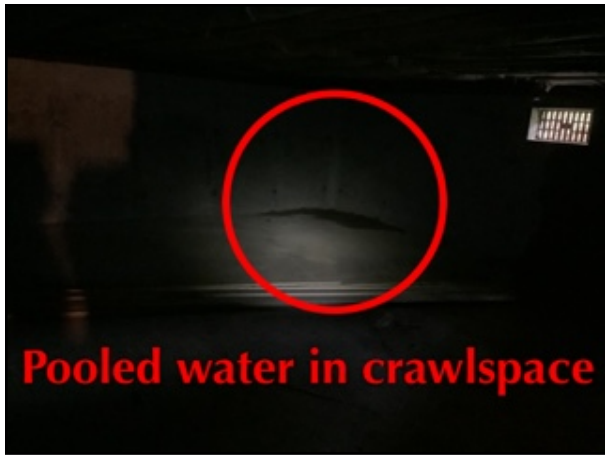
Figure 22-1

Moisture intrusion in crawlspace at point where splash block is sloped towards home.

15) Moisture intrusion in crawlspace at point where splash block is sloped towards home.
