## How To Front Door Disassembly

VCV front door disassembly is one important component of restoring our vans. This “How to” shows how I would disassemble the doors. If you have any suggested improvements, please forward any ideas to me and I will include them. Thank you in advance.

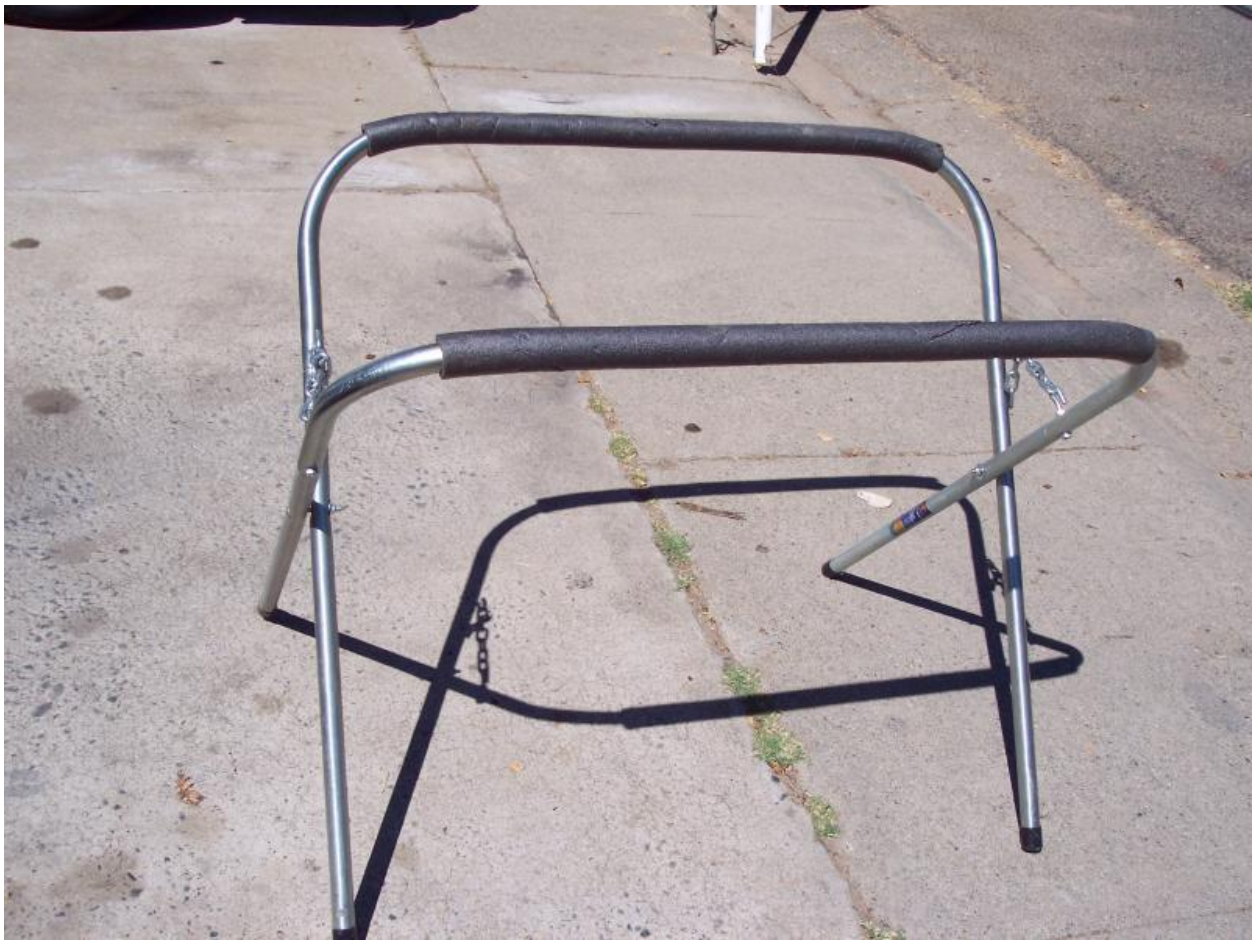
It is very helpful if you have one of these. Body shops use them as a portable stand. They can hold about 500 lbs. and come in real handy. You can of course use a table instead. If you do, I advise padding it heavily with a moving blanket, plenty of towels or other heavy padding. The door can slide around and there’s no sense in having the door get more damaged because it’s sliding around or fell off the table.

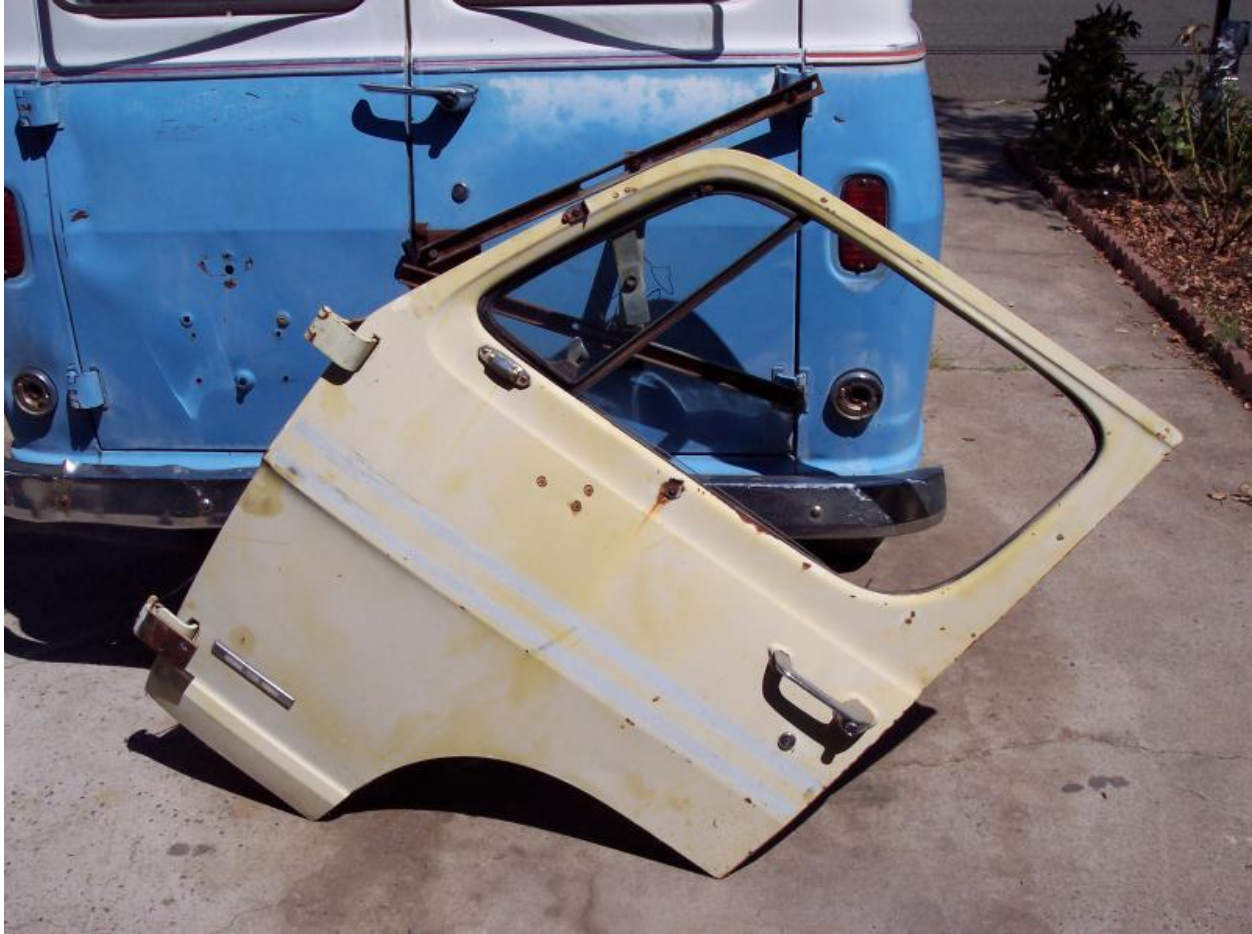
Pic 0192

So, here's one of the doors I'll show. I pulled this one off of a van in the boneyard back in the day when they actually showed up there from time to time. It's had the mirrors removed. This is most likely a 1967 door since there is a lock cylinder below the door handle but no reflector hole like the 68-70 models have. 1st Gen (64-66) doors have the lock in the button of the handle. Notice on this one that the Junior West Coast (JWC) Style mirrors probably did not come on this door but has a provision for it. Notice the three screw holes in the door where the lower mirror mount would be. I think GM just installed different mirrors and plugged those holes with screws. They did have a bracket on the inside that had threaded fittings. In the background is my 65 GMC HandiBus Custom that continues to wait patiently for me to get to apply some lovin to it.

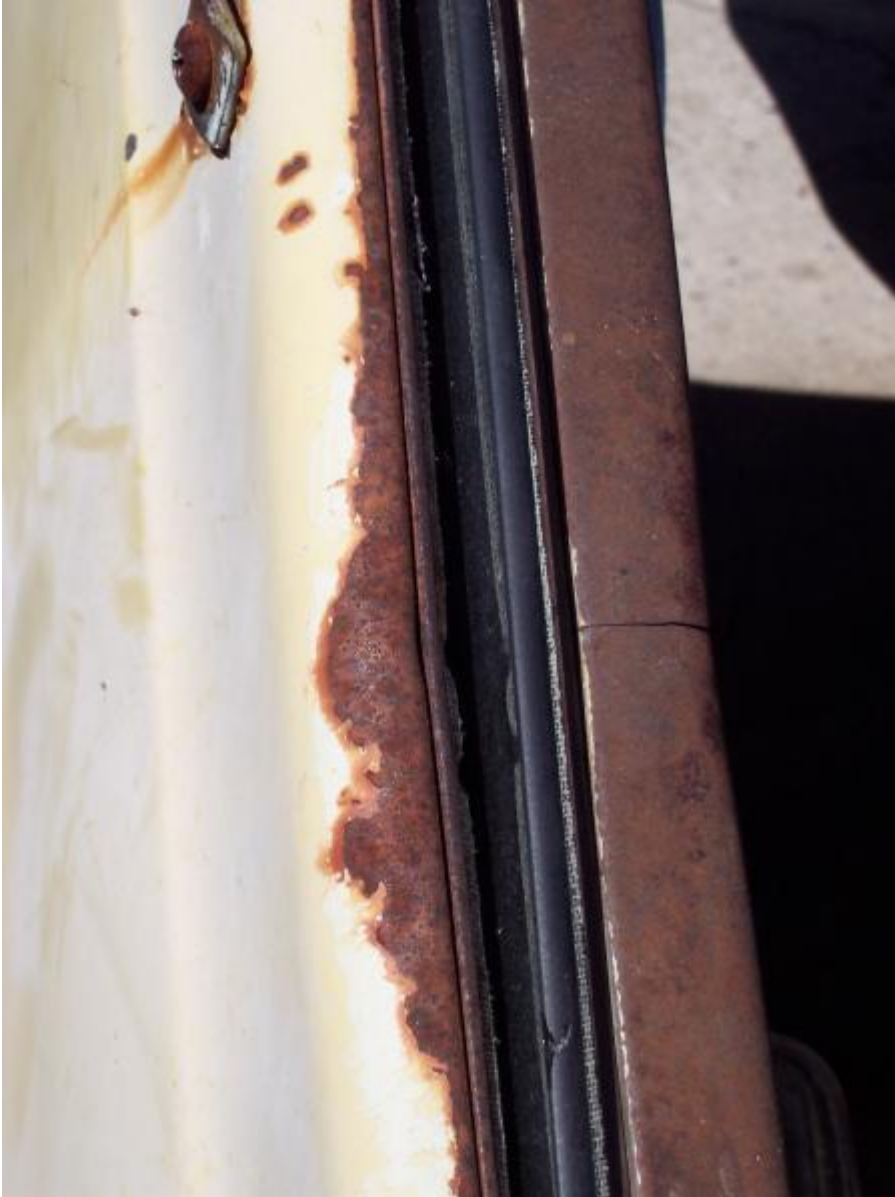
Pic 0191

Here's the interior side of the door. You can see the speaker installation which unfortunately means a fat hole in the door. There's also some hits around the window. Notice the 1st gen door pull which means at least that has been replaced. Some of these hits and other damage should be considered before you spend too much time and money on a door. It's also good to be aware of these issues if you are considering the purchase of a used replacement door. Since most of these hits, holes, dings and cracks are the inside, and since there's not too many of these available for replacement, this door is worth keeping.

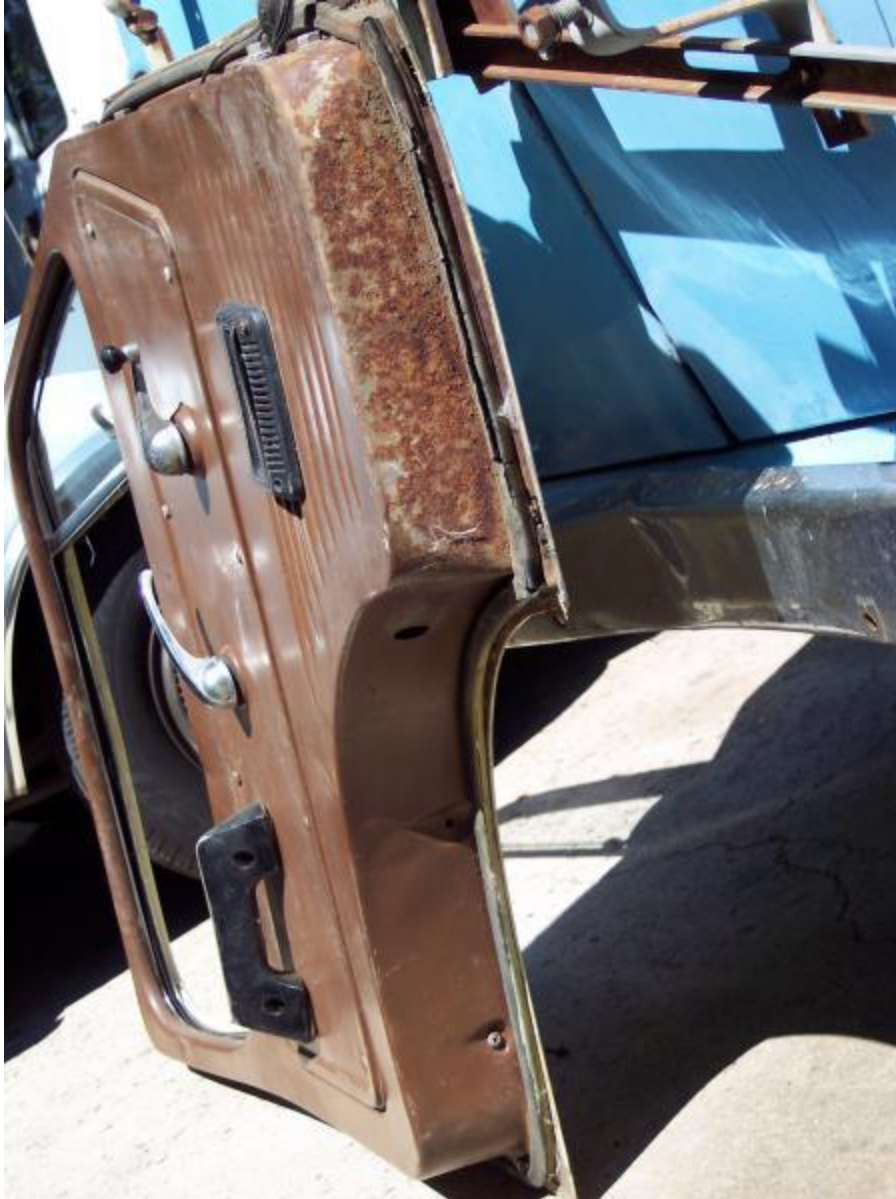
Pic 0194

This pic shows the hinge end of the door. Notice the extra-large flat washers through the bolts holding the lower hinge. They've also improvised a door stop check swing with that side door fabric strap. That probably happened after the original door stop broke off. The spot where it used to be also has seen better days judging from that hole. There's more creases in the door above and below that hole where they may have used wood or something else to prop the door open and then forced it in the closed direction accidentally. Oh, my poor VCV door! Why have they abused you so?

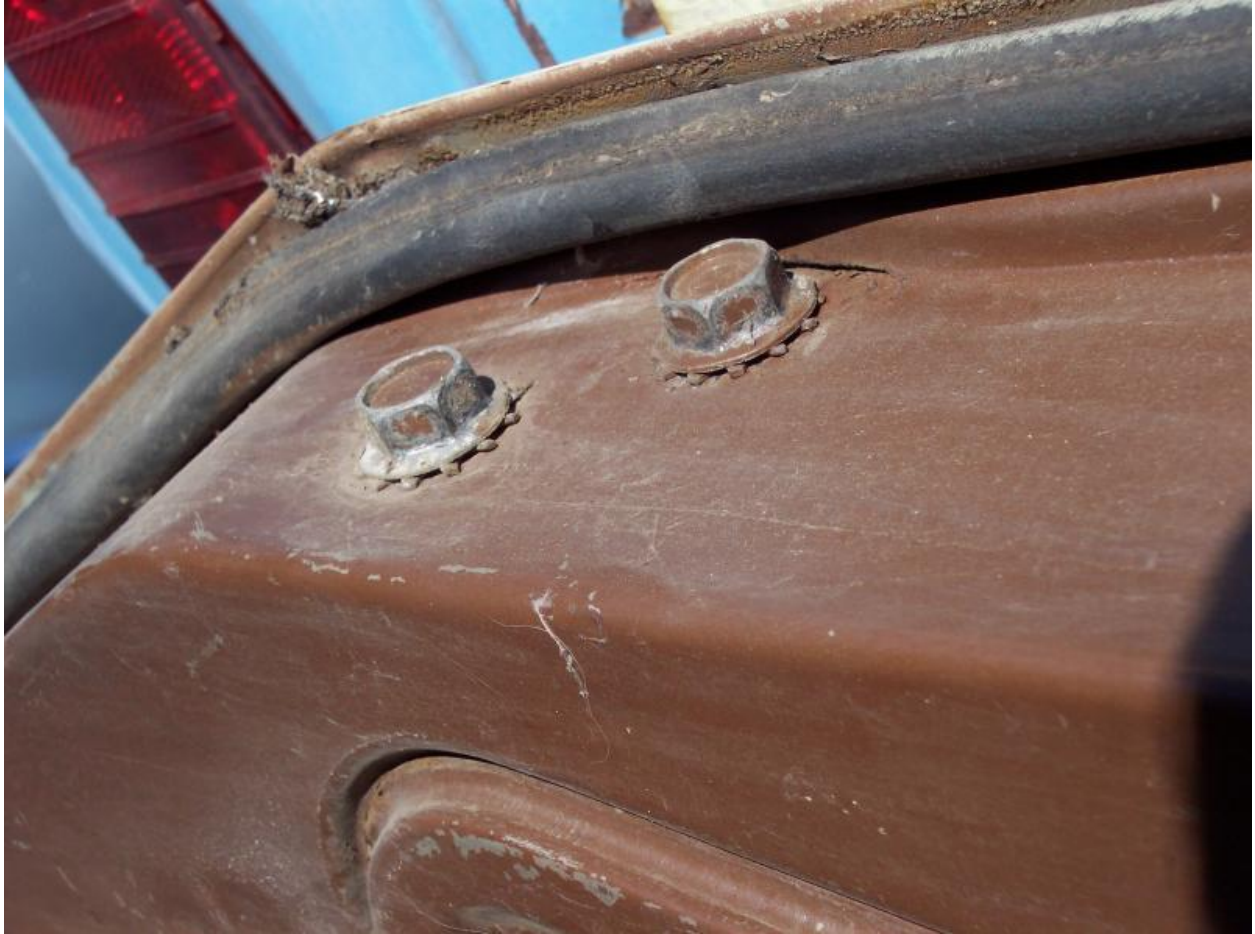
Pic 0195

This shows the bottom of the door and the rust spots common for these. This one is not rotted through but could sure use some attention. It's best to give these doors a good looking over before you commit to something.

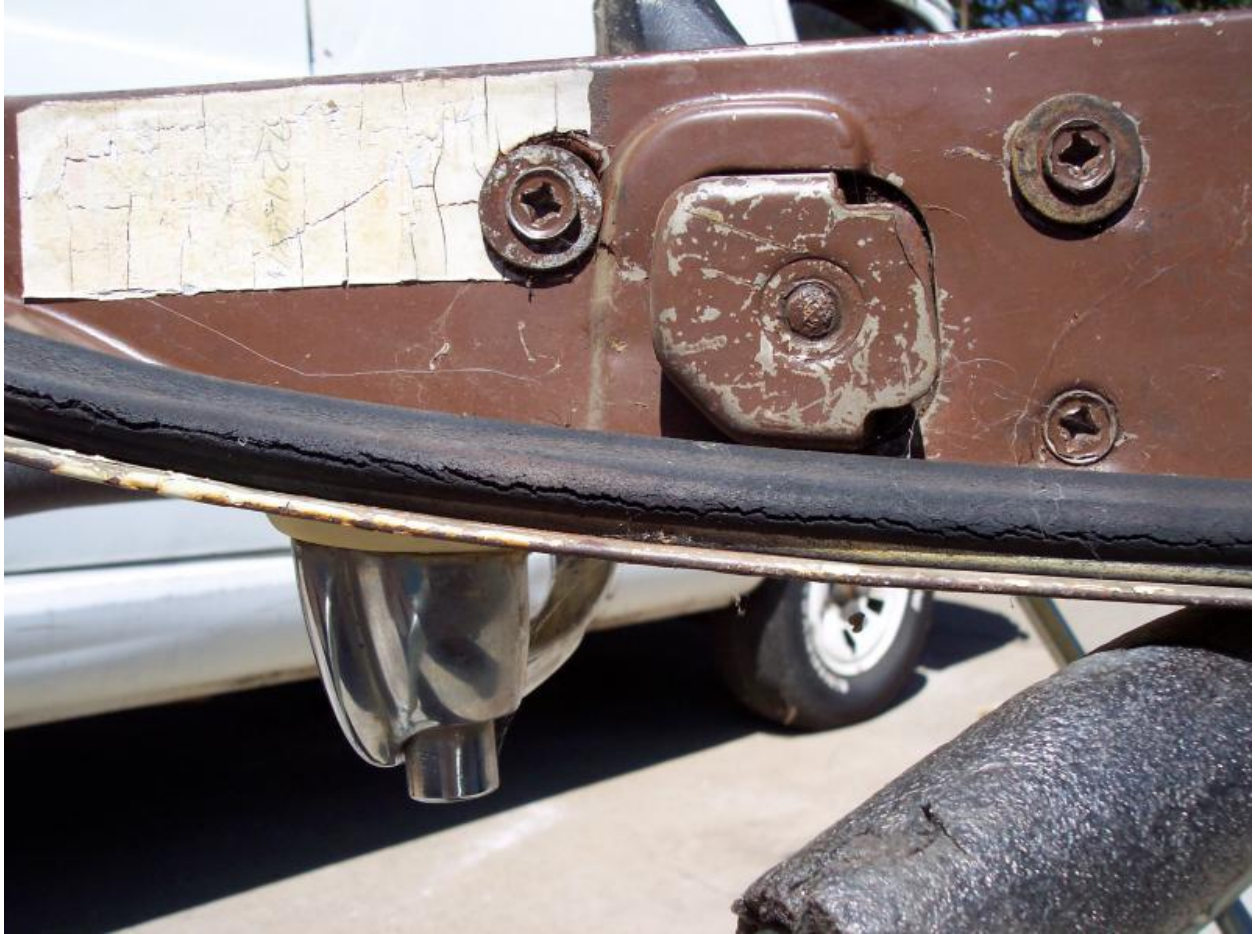
Pic 0199

This is a shot of the upper hinge bolts. Notice the cracks around the bolts, more evidence that this door has been stressed from plenty of time and weight. This can happen because someone enters and exits the van by leaning on the door. These doors are already way too heavy for those hinges. Please consider not leaning on these doors when getting into and out of your VCV.

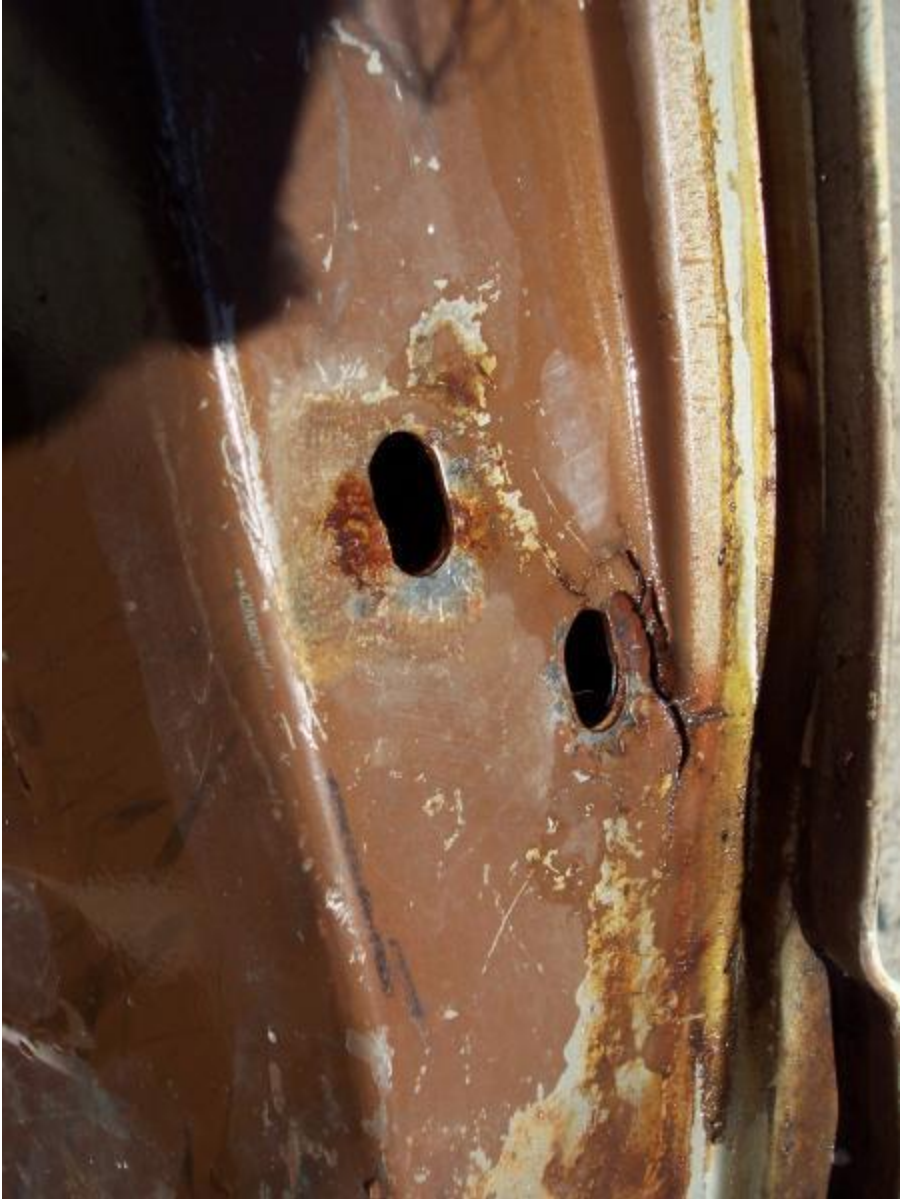
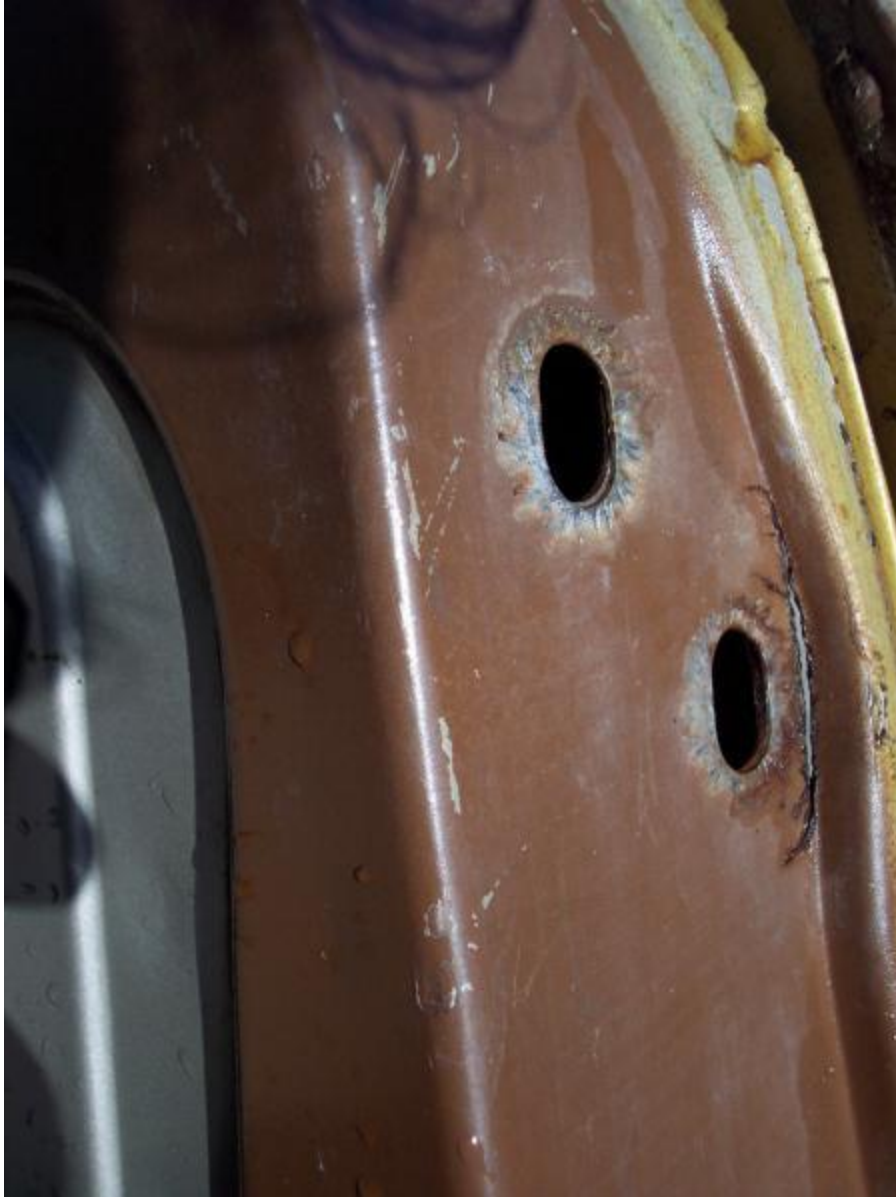
Pic 0200

So on to the disassembly. Even if the door is not to be used, there's plenty of parts to harvest. Start with removing the bolts holding the hinges in place. Preferred is a  $\frac{1}{2}$ ' Drive ratchet with  $\frac{9}{16}$ " socket. The bolt threads protrude through the hinge on the inside and the exposed threads may be rusty. If the bolt doesn't come out with even pressure then don't force it. Hit the inside threads with penetrating oil, run the bolt back in and work it back and forth. No sense in breaking off the bolt or damaging the threads any more than necessary. It's likely those bolts have not been removed since they were installed back at the factory.

This shows the metal fatigue near the hinge attachment area. This will require some welding to make right.

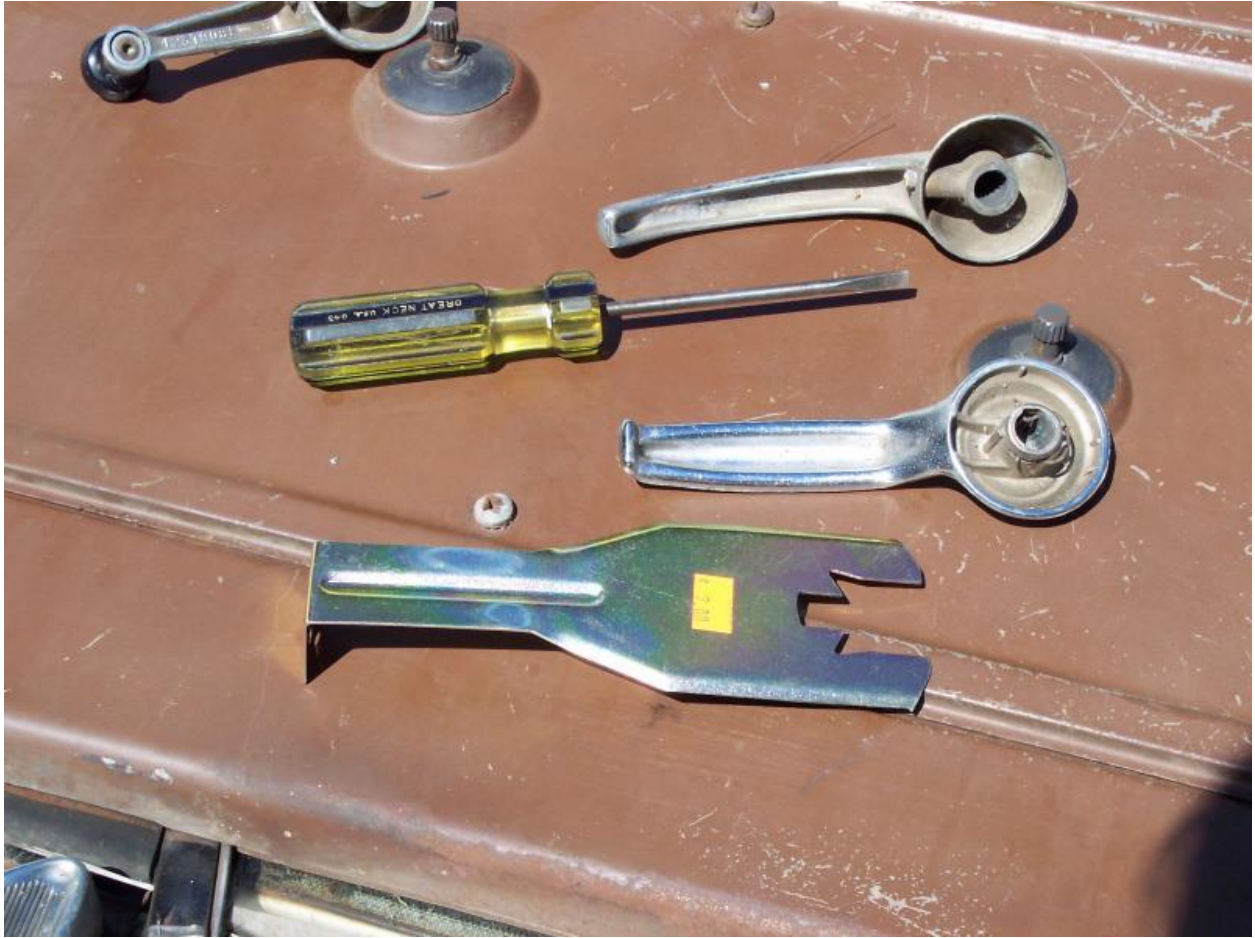
Pic 0201

To remove the window crank handle, loosen the screw with a flat blade screwdriver and then pull the handle off. There's no need to completely remove the screw from the handle.

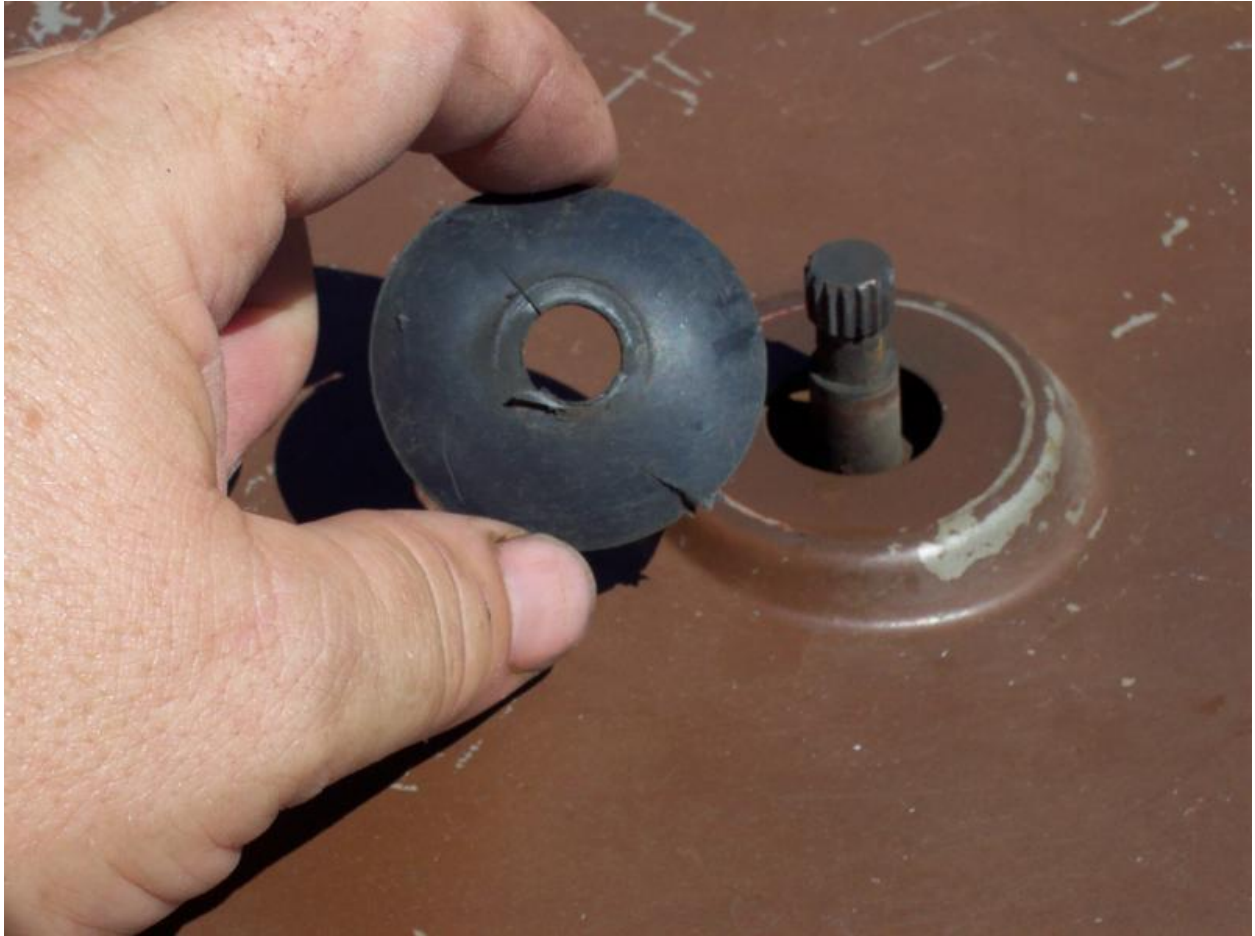
Pic 0203

There's that clip that likes to jump, hide and disappear until you buy a box of them.

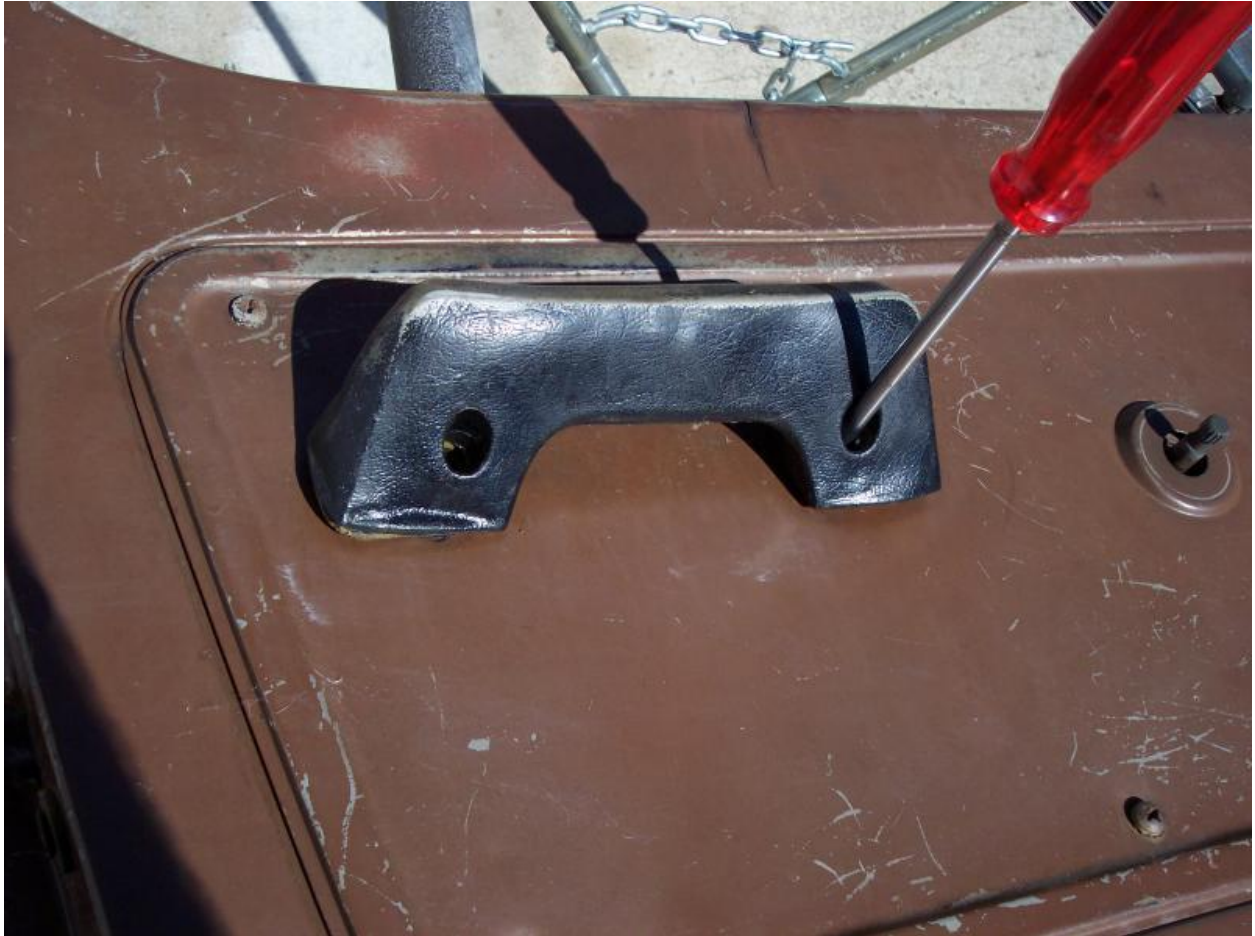
Pic 0204

If they are still there, save these plastic pieces. Even if they are cracked like these. You can reuse them and they help deflect air coming into the van at speed. Every little bit helps. Once the handle are in place, you cant tell they are cracked anyway.

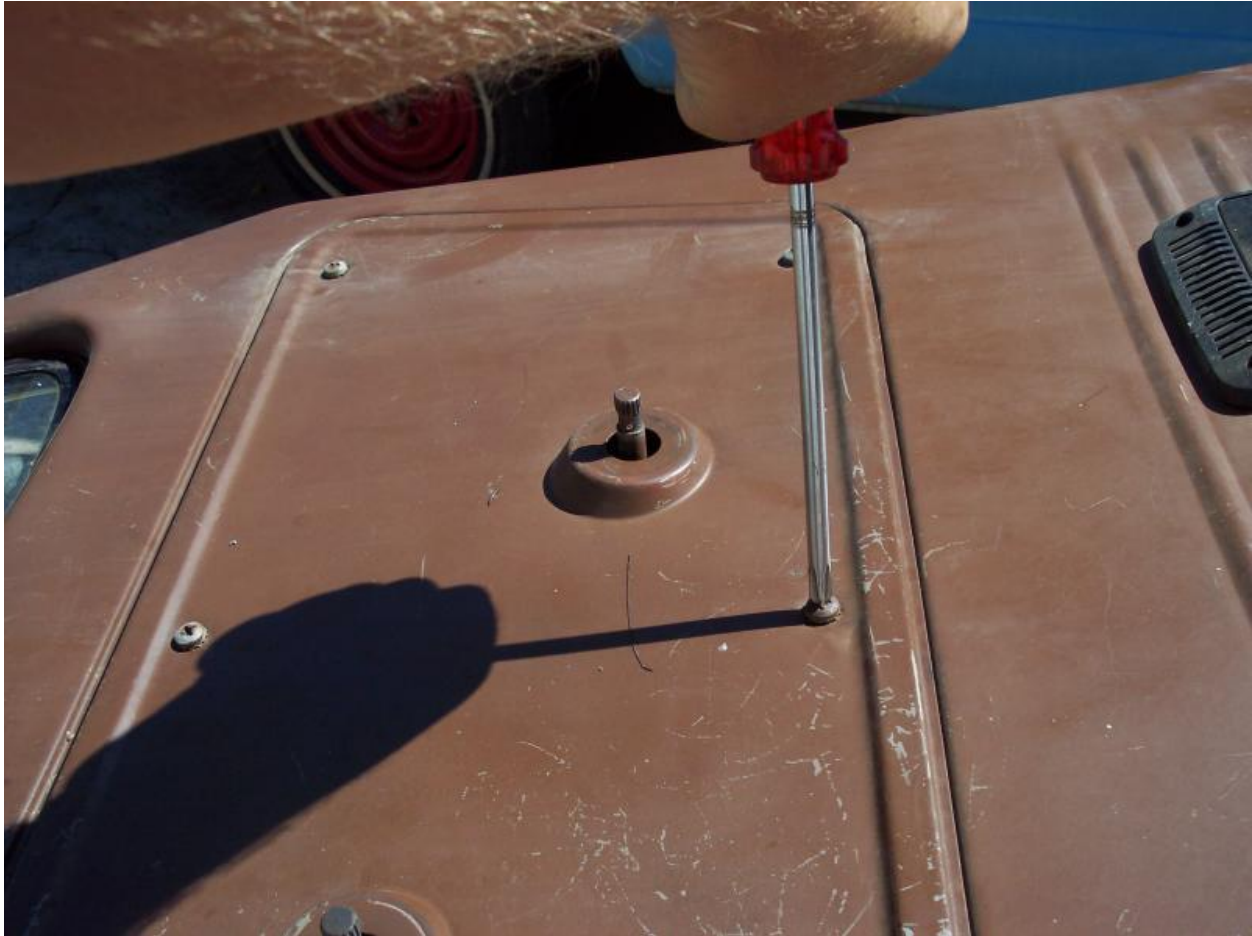
Pic 0205

Next, remove the two screws holding the door pull onto the door. Be sure to use a #3 Phillips screwdriver. They will fit better and cause less damage to the screws.

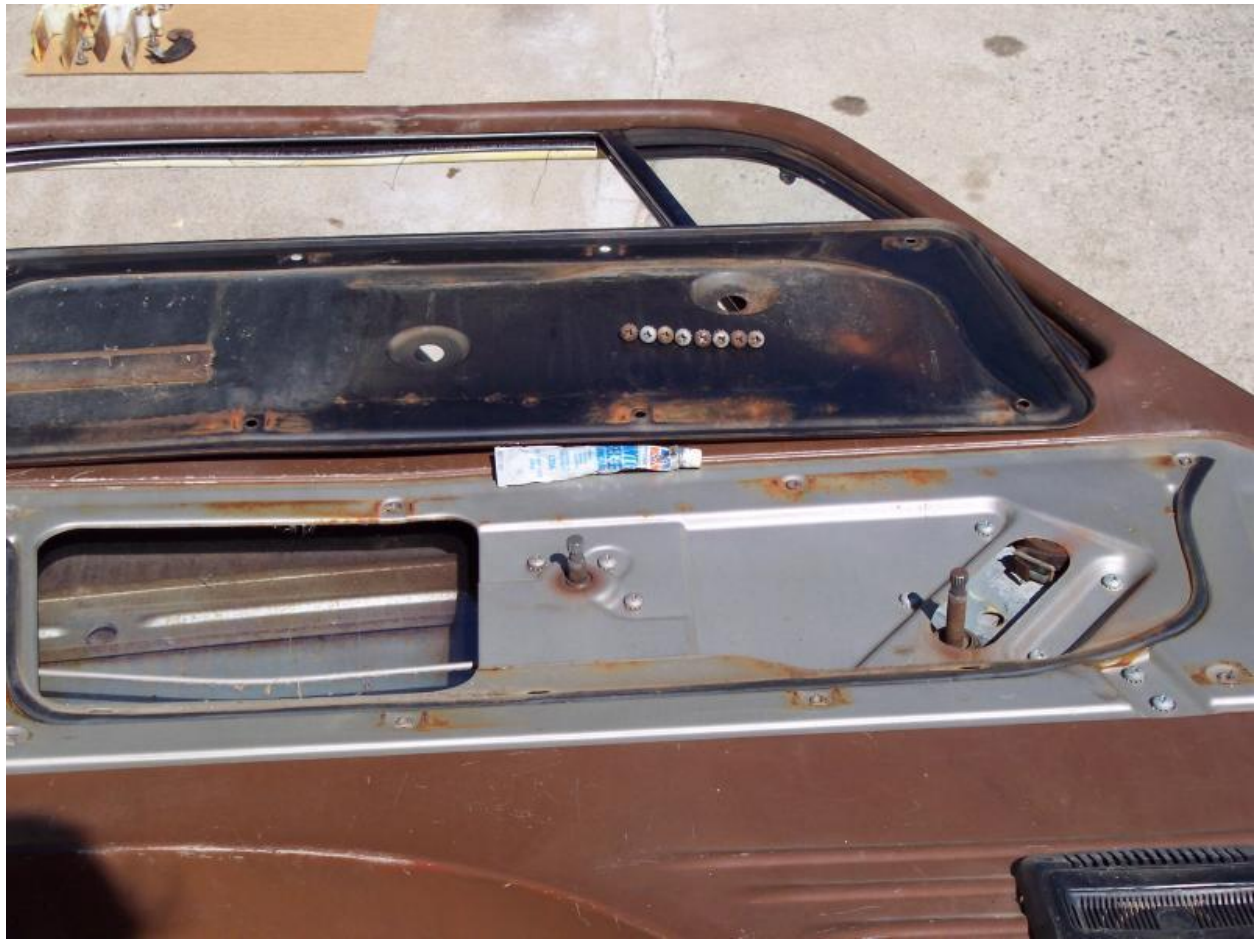
Pic 0206

Now remove the screws holding the door panel to the door. Here's where that #3 screwdriver really comes in handy. Make sure the screwdriver is lined up square on the screw and that you are pushing down with enough force to keep the driver from slipping on the fastener. Try not to push down so much that you tweak the exterior door sheet metal. Some of these instructions may seem like overkill to many who know their way around something as basic as a screwdriver but since this tutorial is for everyone, please excuse some of my comments. Besides, a little simple care can prevent damage that takes a lot of fixing later.

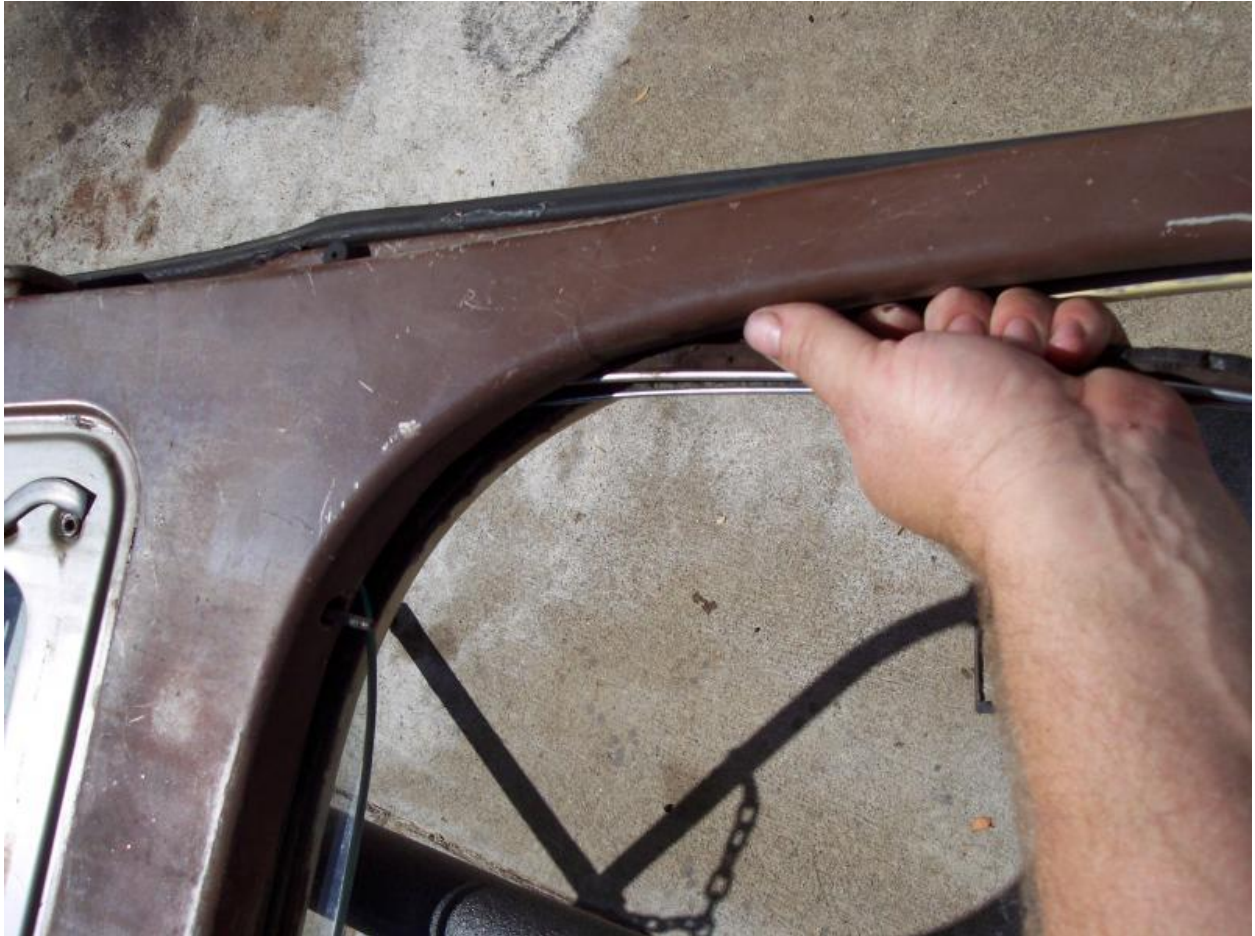
Pic 0208

Pull the window seal from the door starting at the wing (vent) window.

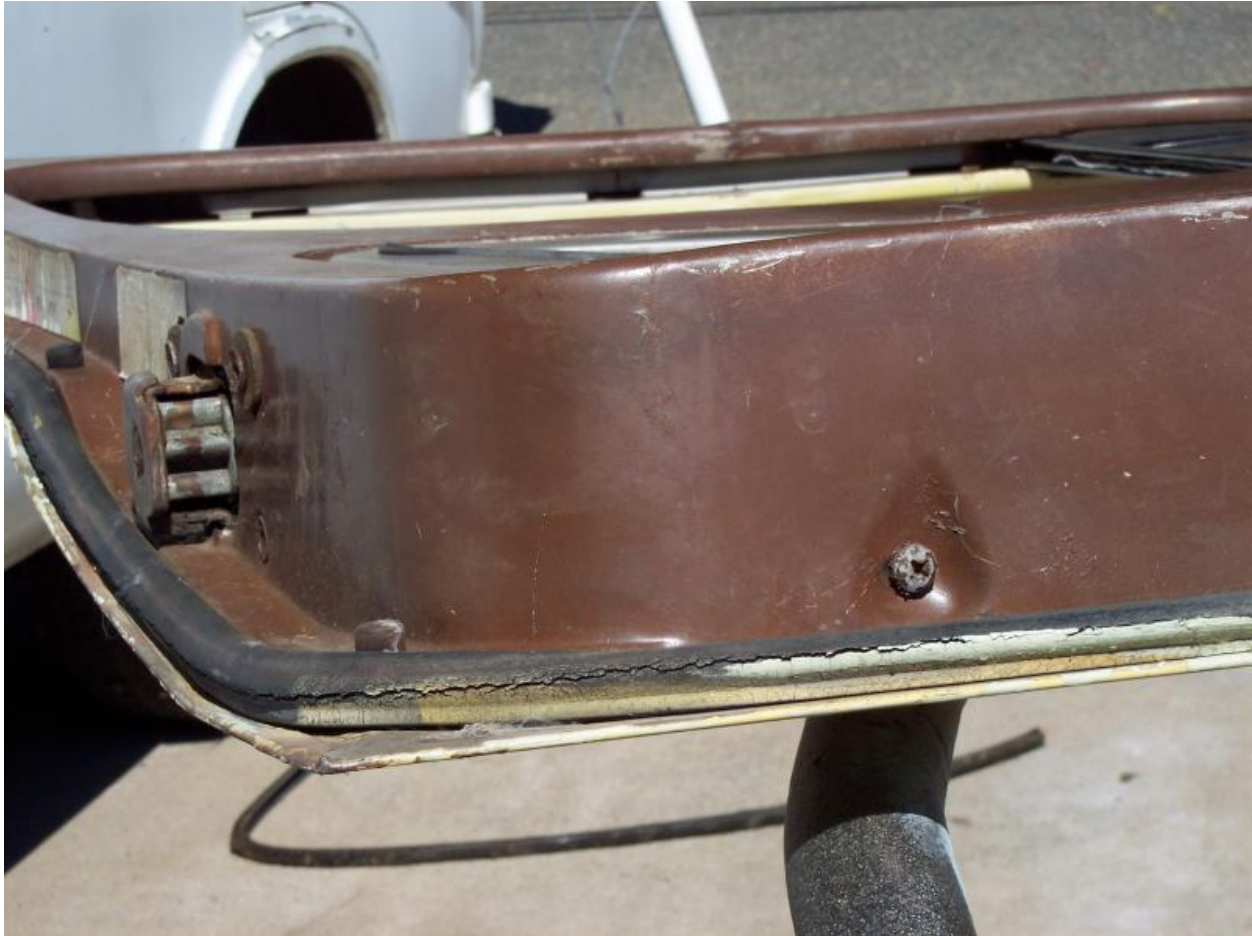
Pic 0211

Now comes the rear door glass guide removal. At this point, if you don't have a #3 phillips screwdriver, stop what you're doing and go buy one. If you are feeling that lucky then go but a lottery ticket and proceed with what ever tool you have, maybe a bear skin, rock hammer and stone knife.

This glass guide is very likely to give you the greatest problems. If it's already broken then save all the pieces possible so you repair it. If it's not broken the do yourself a favor and take your time removing it. Don't be like other idiots (me!) and rush things at this point.

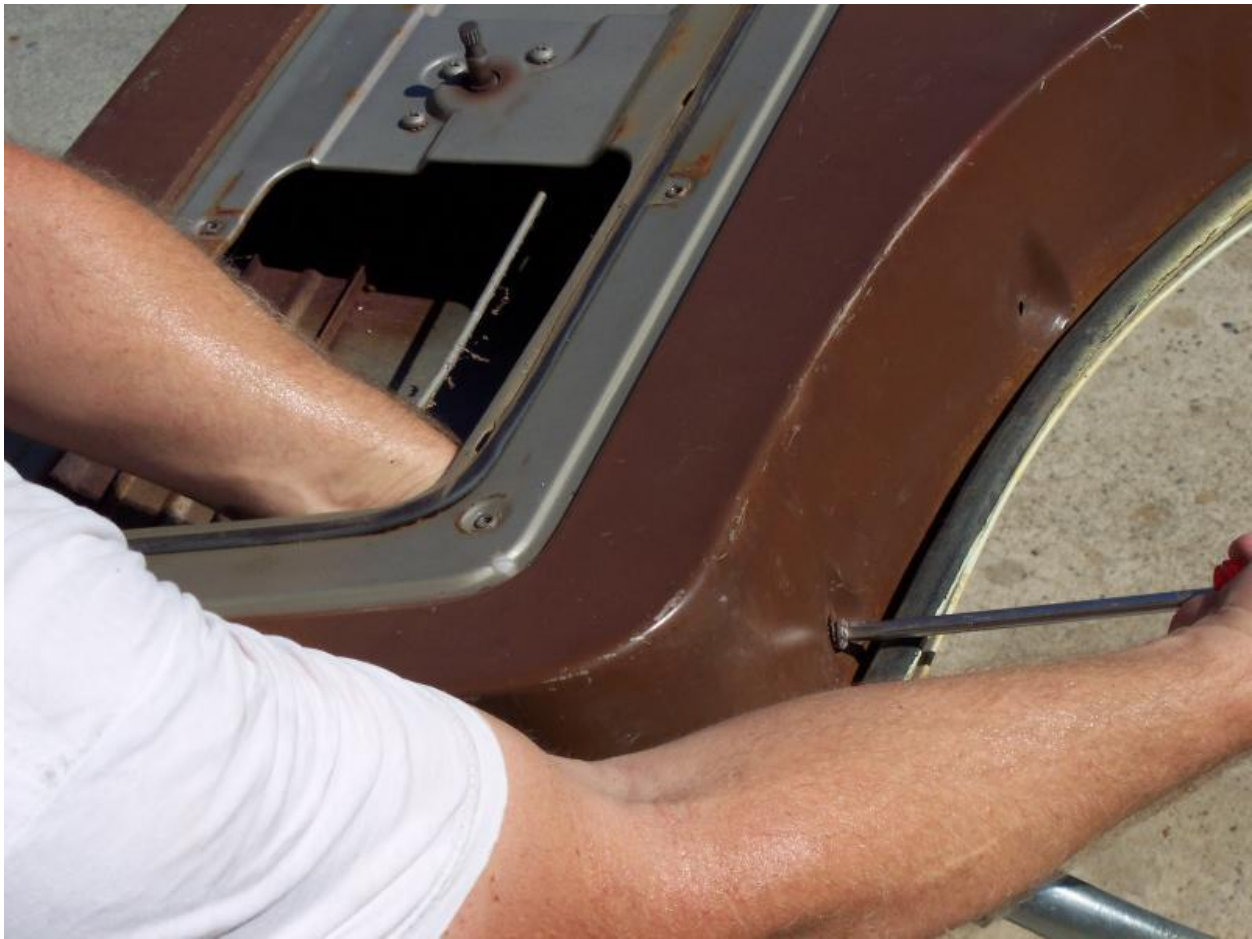
Pic 0214

Here comes the tough one. This screw holds on the bottom of the latch side glass guide channel. It is very likely rusted, frozen, or stuck. And this is if you are lucky. If you are not lucky then it's already broken and you'll have to deal with repairing it later. You are still going to need this screw removed and with as little damage to it and everything around it as possible. So, again, this screw will likely give you the most trouble of any other screw so far. Don't rush this removal. Take your time, you'll be happy you did. If you are at a stopping point now, then please stop, lube the inside part of that screw with the best penetrating oil you have and tackle it later. Personally, I always like Mopar Heat Riser Solvent which contained Butyl Cellusolv. I'm not even sure it is still available. Back in the day, it would consistently do the best job at loosening stuck hard, rusted parts. It also worked better than Raid at killing Black Widow spiders. Anyway, that screw extends beyond the square nut it is threaded into. That means that rust is on a portion of the threads that has been exposed. The screw is stuck in the nut which holds the bottom part of the channel onto the door. Plan on spending whatever time it takes to remove this screw by working it back and forth until it complies with your wishes. Do not give into the temptation of forcing it lest you pay the penalty. Having been appropriately warned, we may proceed.

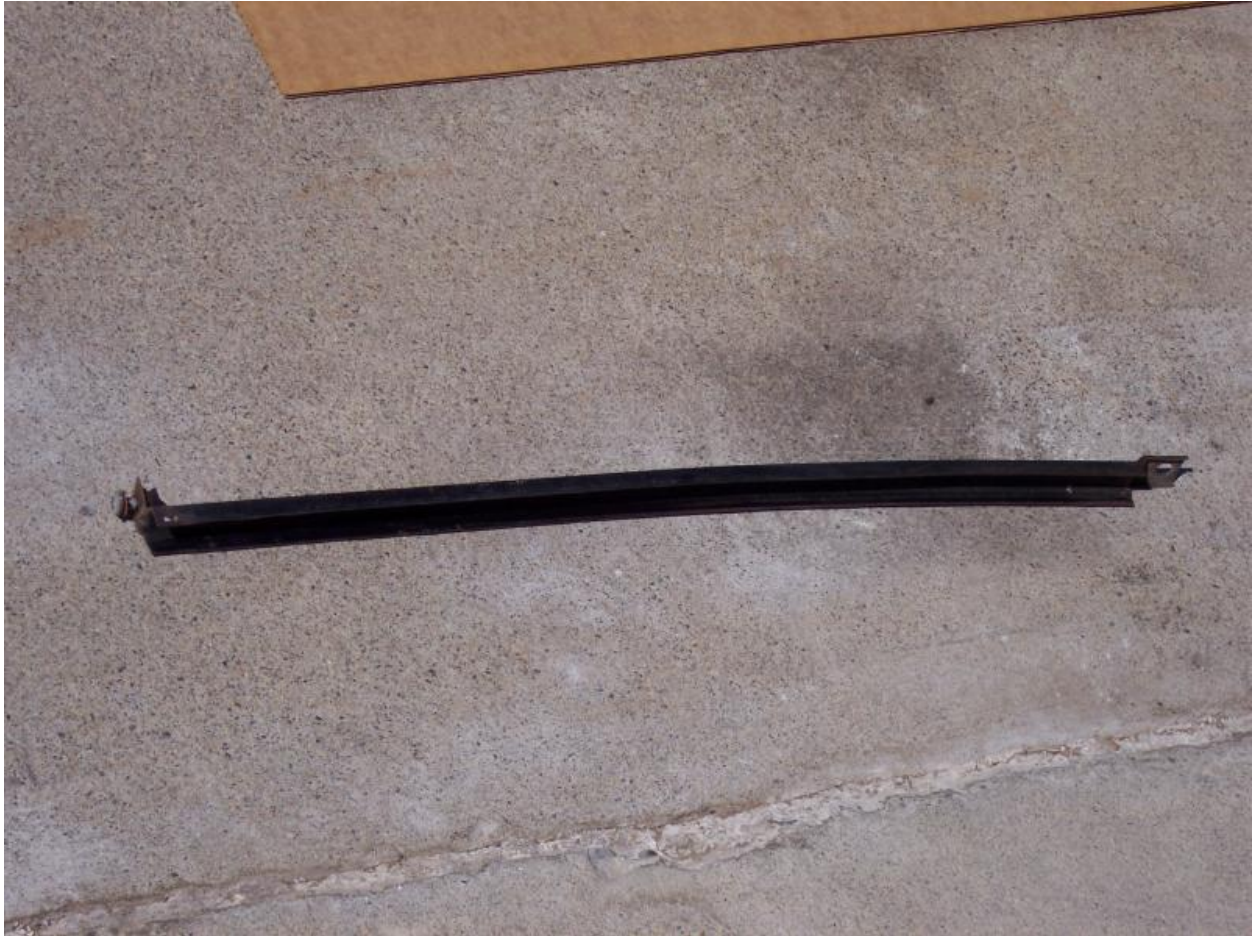
Pic 0215

This is the ideal position I have found for working loose this fastener. One hand inside to hold the bottom of the door glass channel and one hand working the screwdriver. You must hold the bottom of the channel while working the screwdriver. If not, the channel will spin, tweak, break and cause VCV heartbreak. Once you feel the screw moving while the bottom of the channel is not, then you have a chance at success. This just means that you can work that screw back and forth until it comes out clean. Take whatever time is required because I have none of these to sell, only plenty to repair. Pick a hot day, plan to sweat and chant something like "I love my VCVan". It can't hurt more than the door edge biting into your arm.

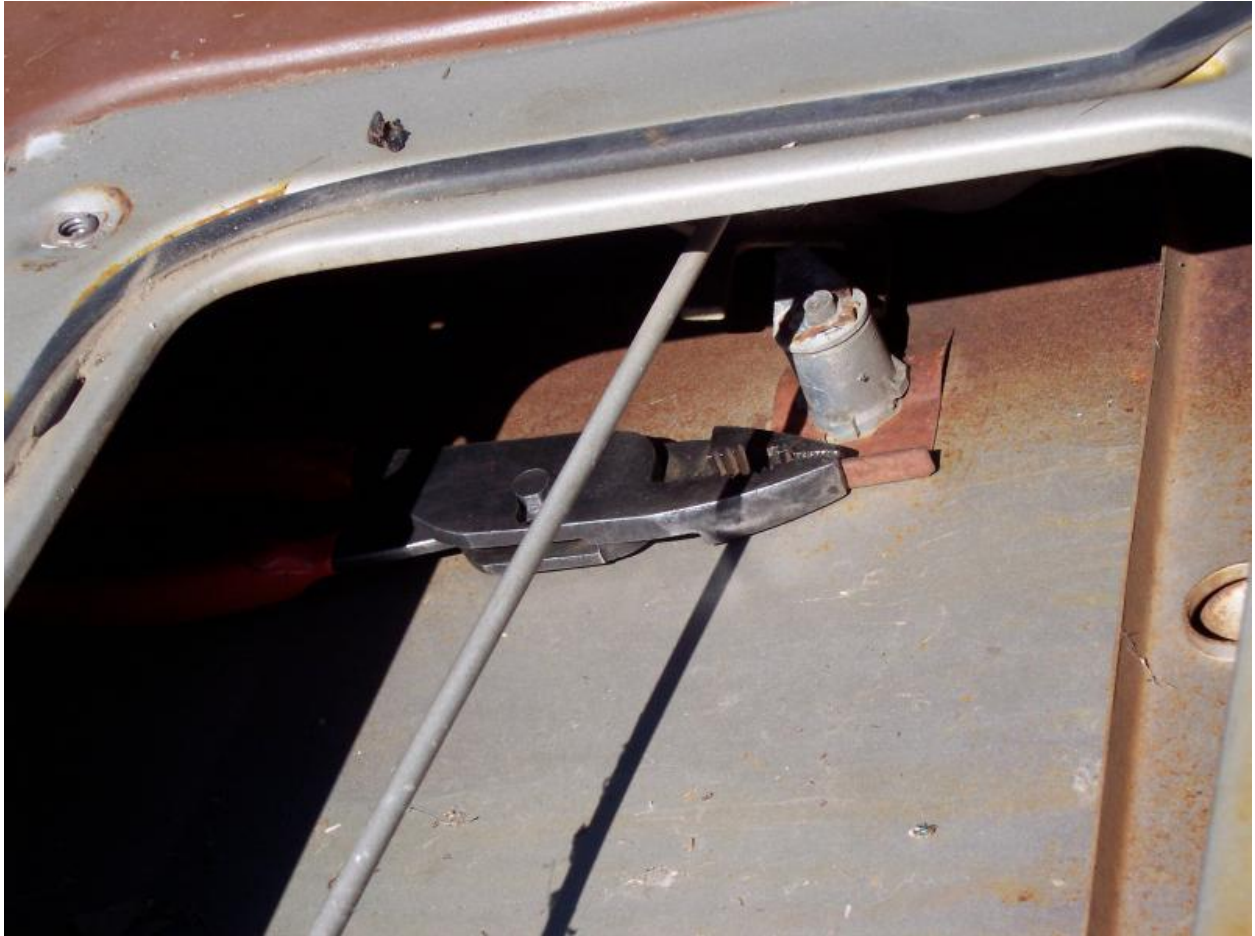
Pic 0216

This is the piece removed. Keep it someplace safe because you'll need it. This piece works on either the driver's or passenger's side door. A treasured piece for those who want their door glass to stay in place.
