## How To Front Door Disassembly

VCV front door disassembly is one important component of restoring our vans. This “How to” shows how I would disassemble the doors. If you have any suggested improvements, please forward any ideas to me and I will include them. Thank you in advance.

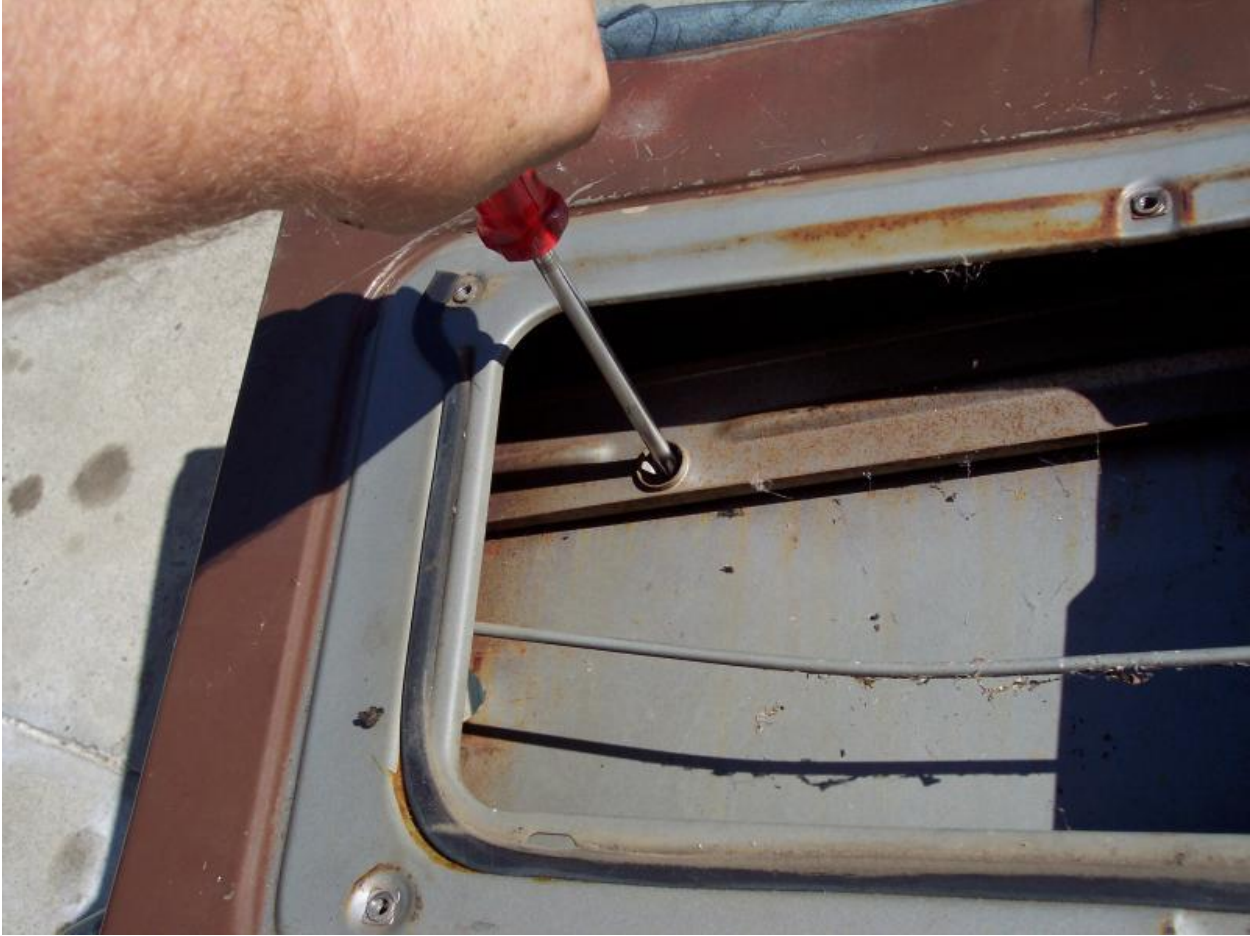
Pic 0217

Pull The door locks by removing the clip. Rock the clip back and forth and catch the lock mechanism in case it wants to fall. There's a round gasket around that lock that will come out in pieces. Check Clark's Corvair for replacements.

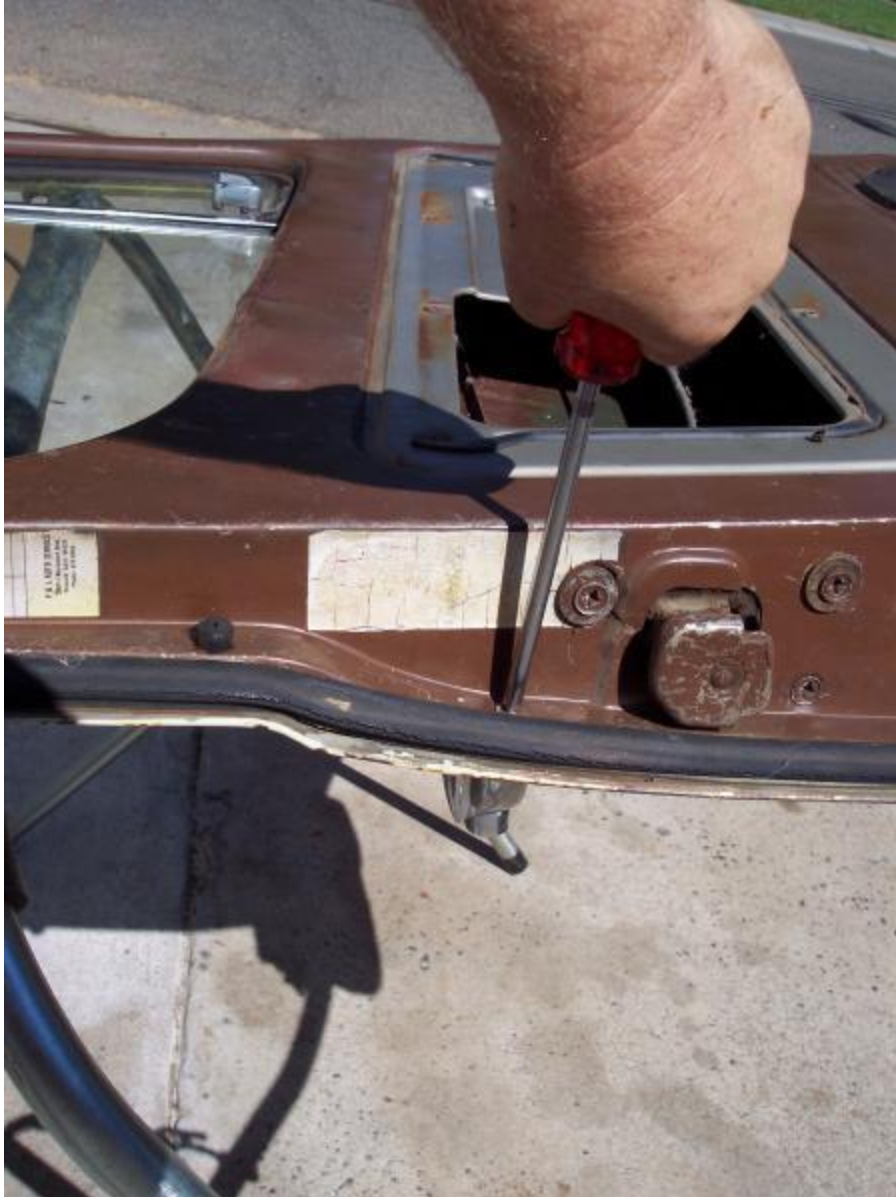
Pic 0218

Remove the two door handle screws. One is on the inside of the door panel..

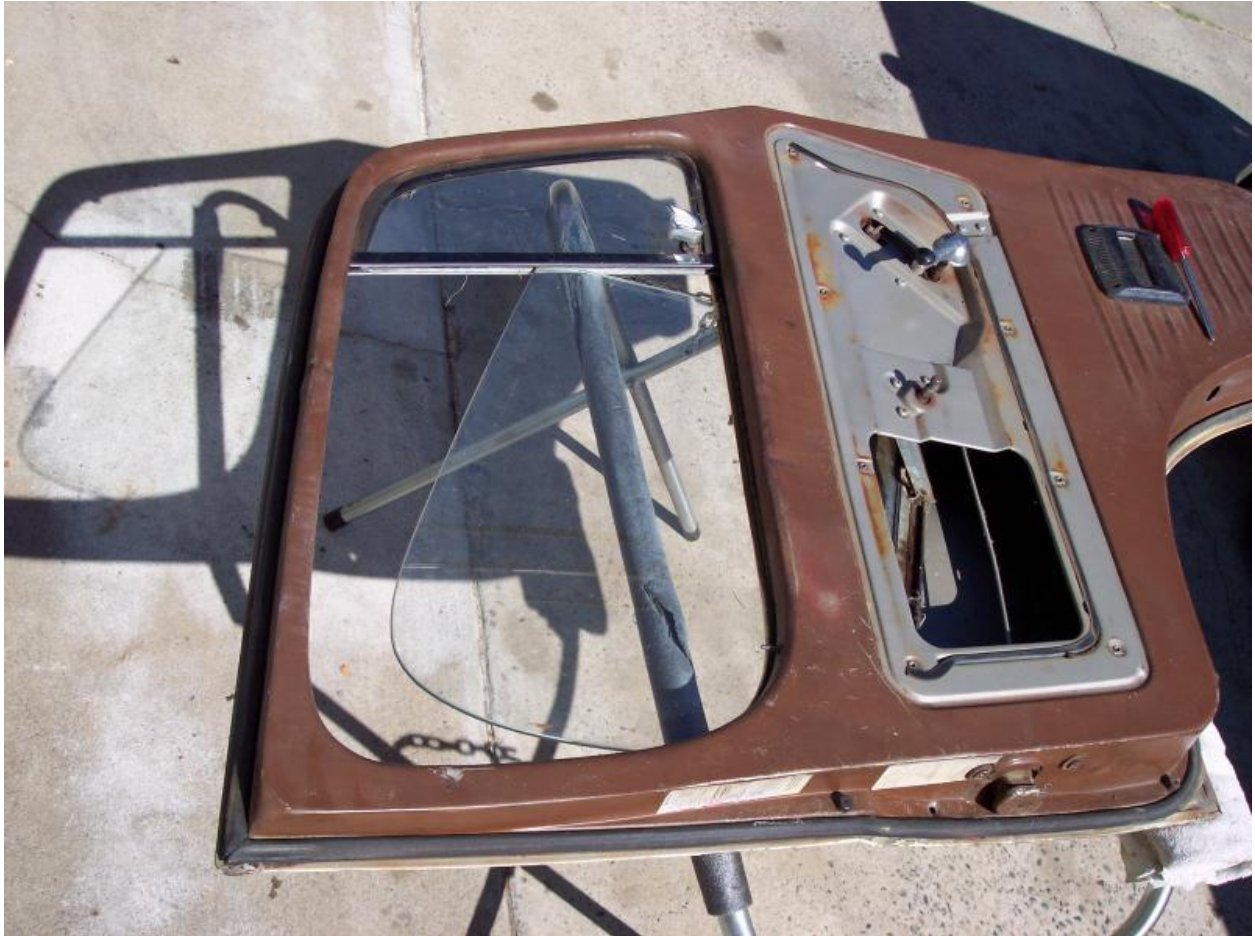
Pic 0219

One is on the outside. The

door handle should come right off.

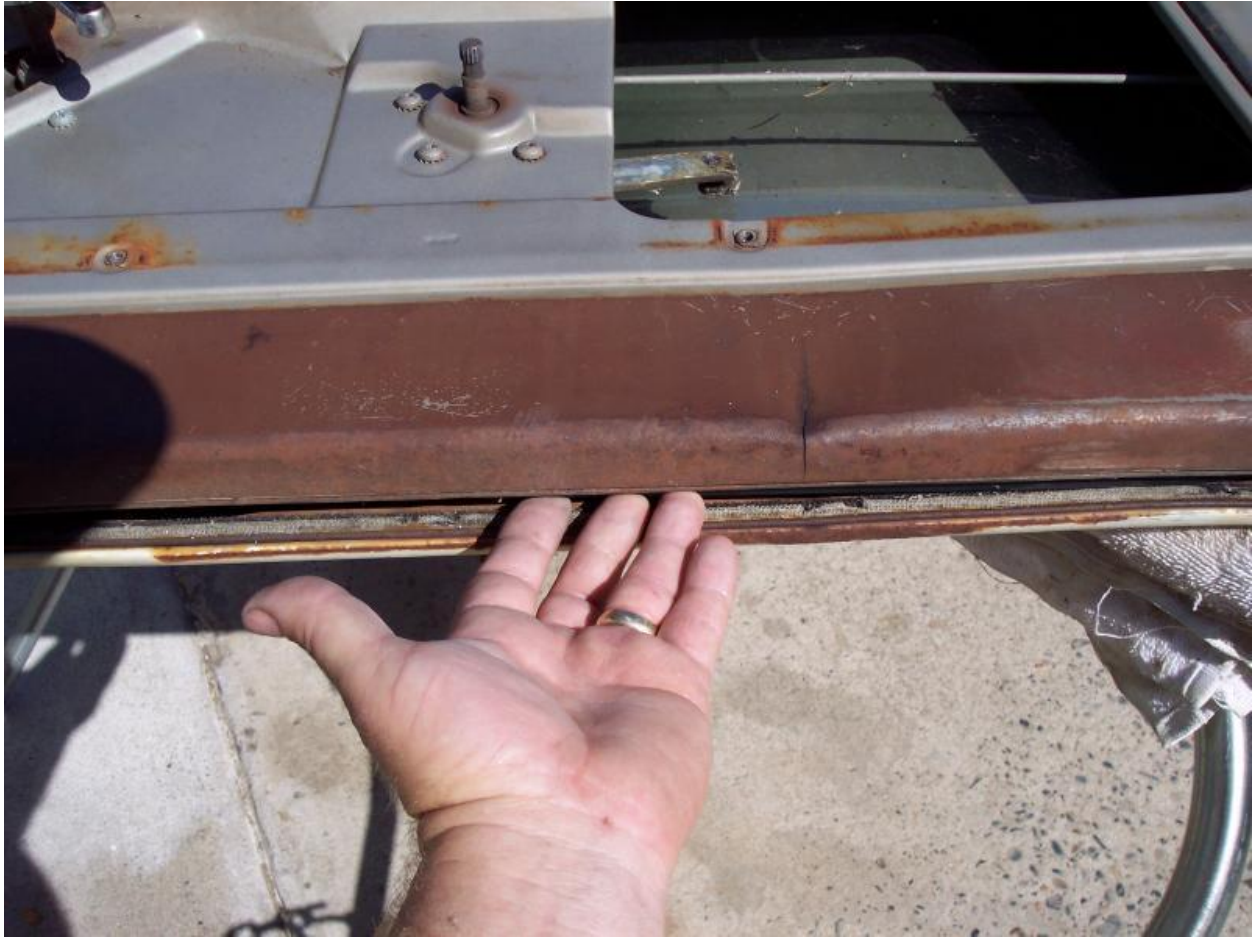
Pic 0220

Position the glass as shown tilting the latch end up. The window regulator can start in the mid position but be ready to reattach the window crank handle if you need to move it some to disengage the regulator from the bottom the glass guide. Now carefully lower the glass down into the door while you remove the window seals. Try not to shake the door around too much during this next operation or you may scratch the glass which is loos in the door.

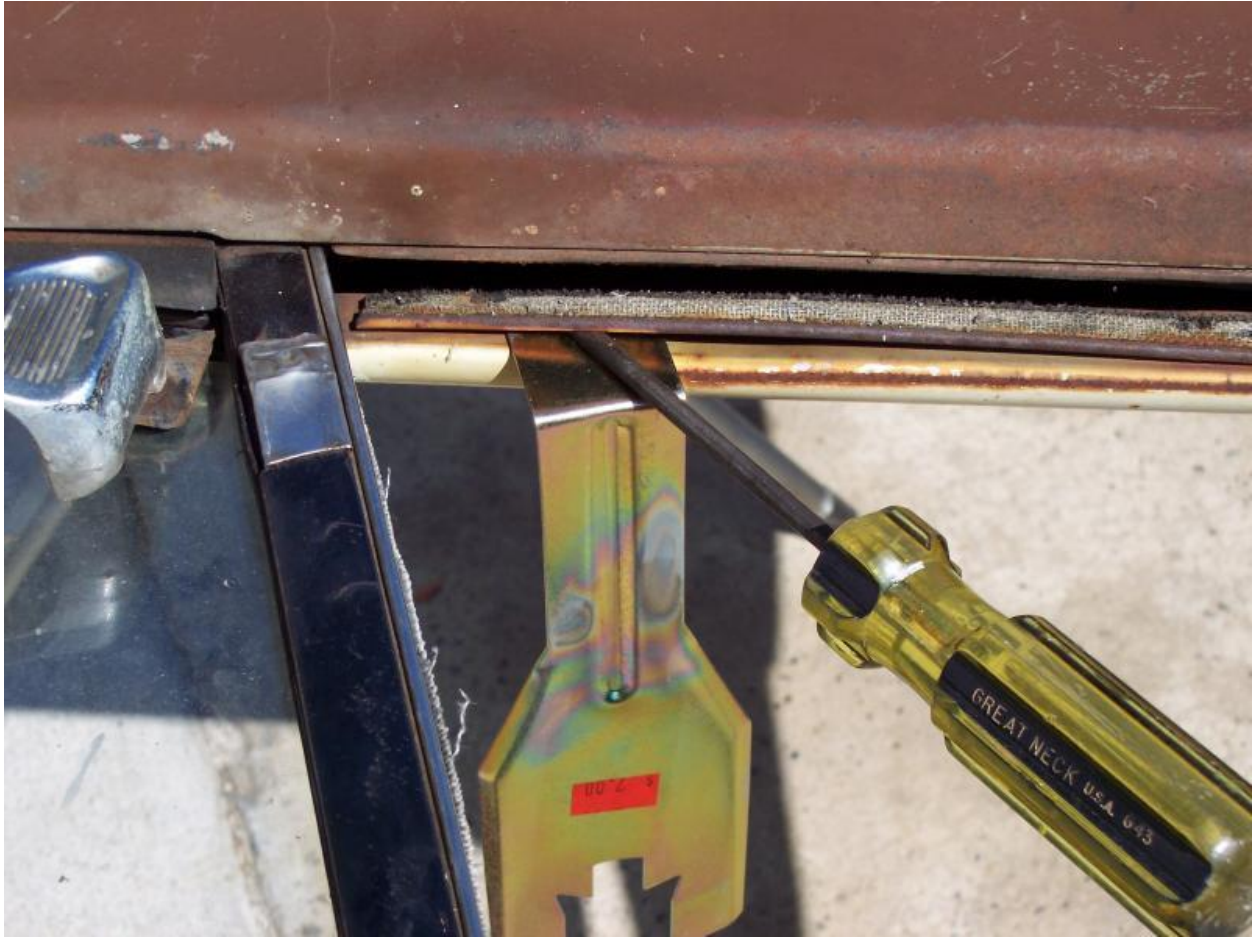
Pic 0221

Remove the window seals before the glass is removed the door.

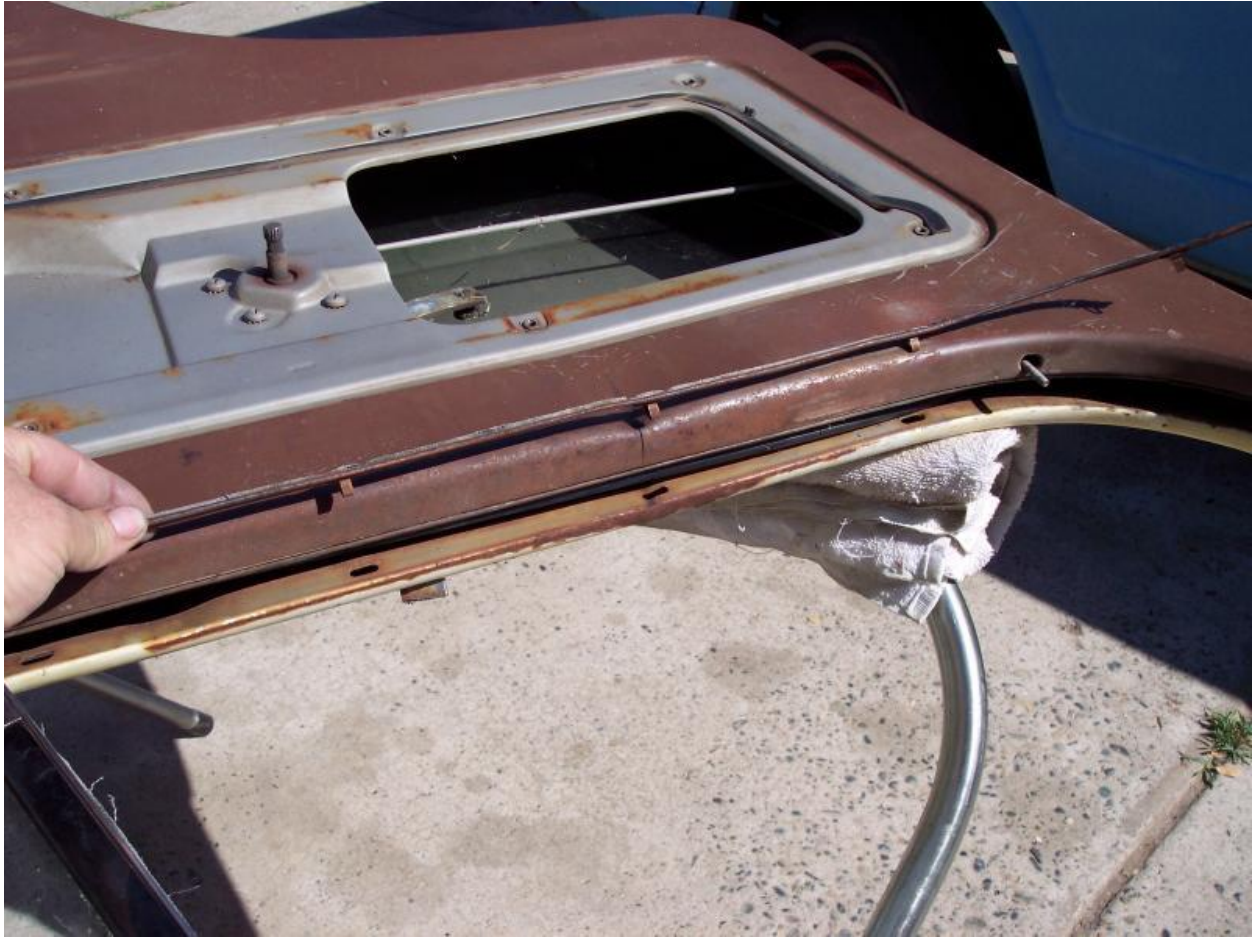
Pic 0222

Remove the glass seal with a tool to protect the door but allows you to pry the seal away.

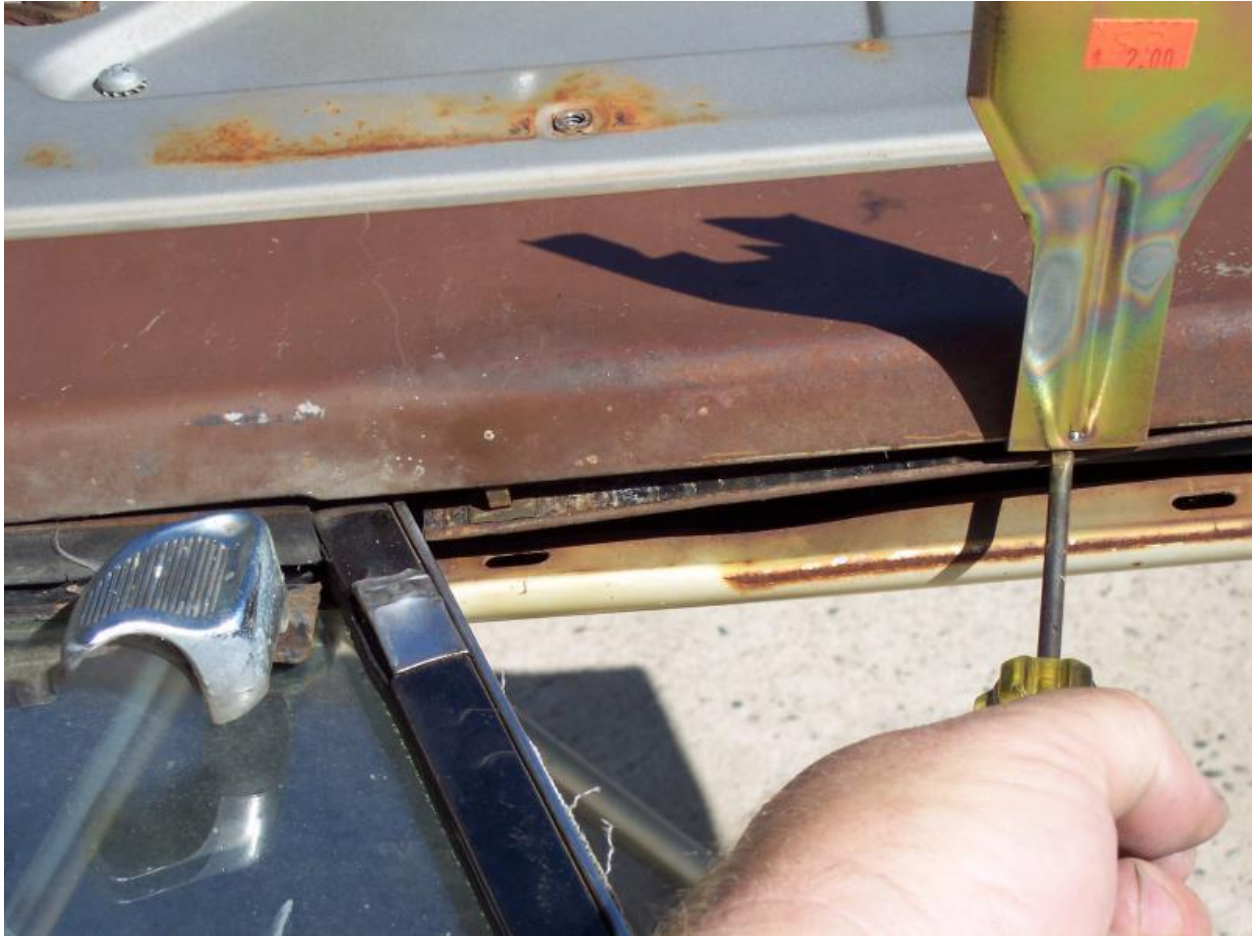
Pic 0223

This shows the seal removed and the clips that hold it to the door.

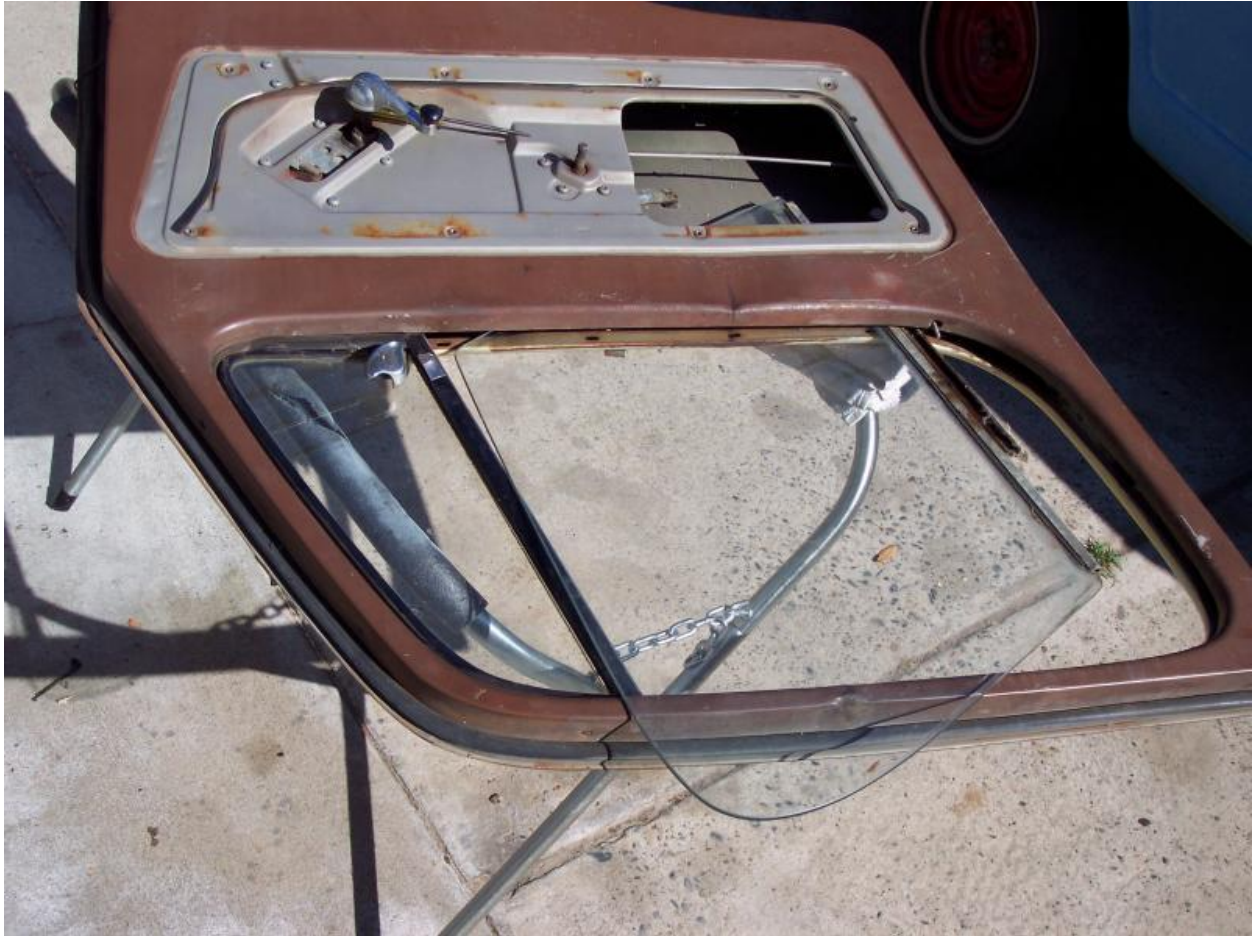
Pic 0224

Remove the seals from both sides.

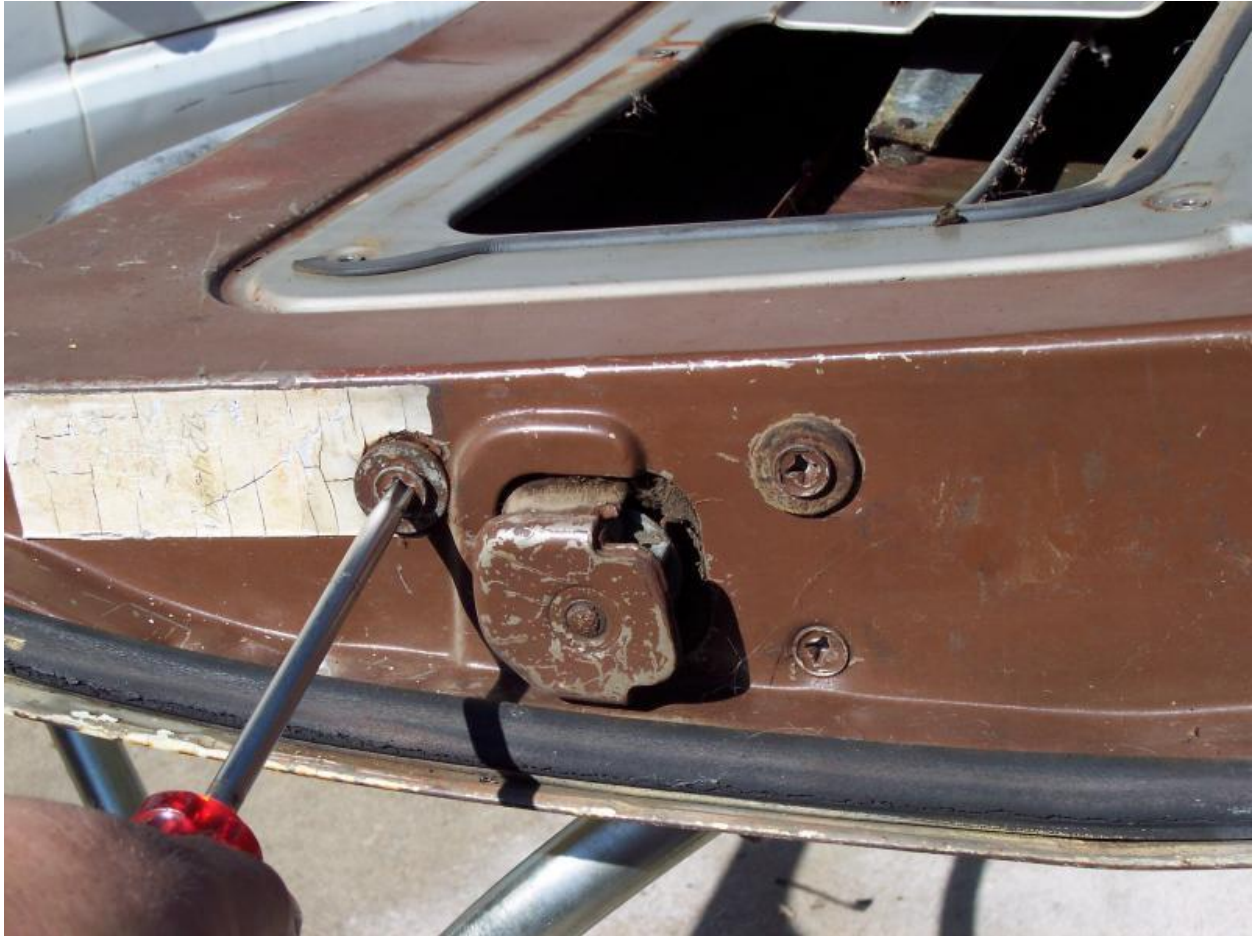
Pic 0226

Now remove the three door latch mechanism screws.

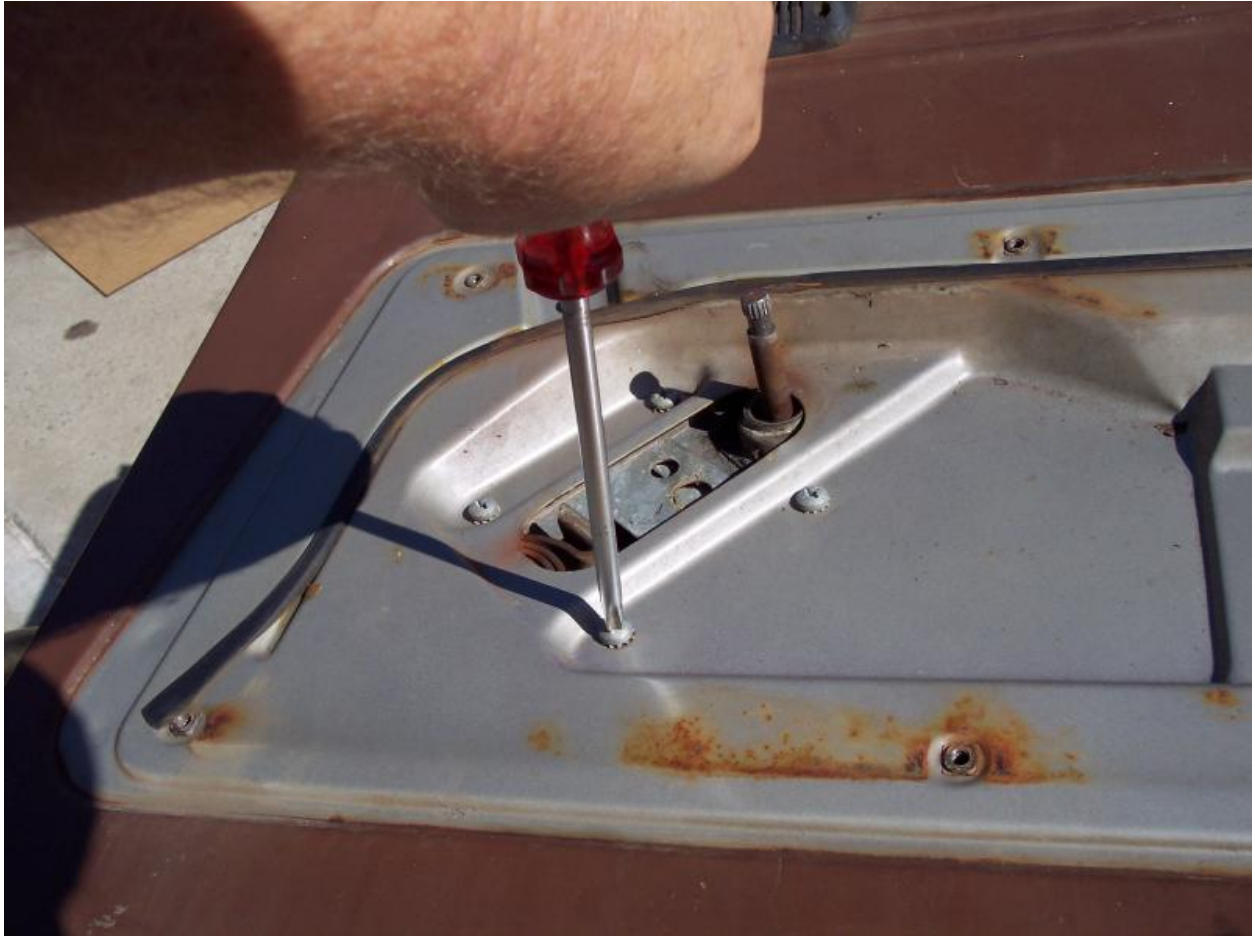
Pic 0228

This is the latch and mechanism removed.

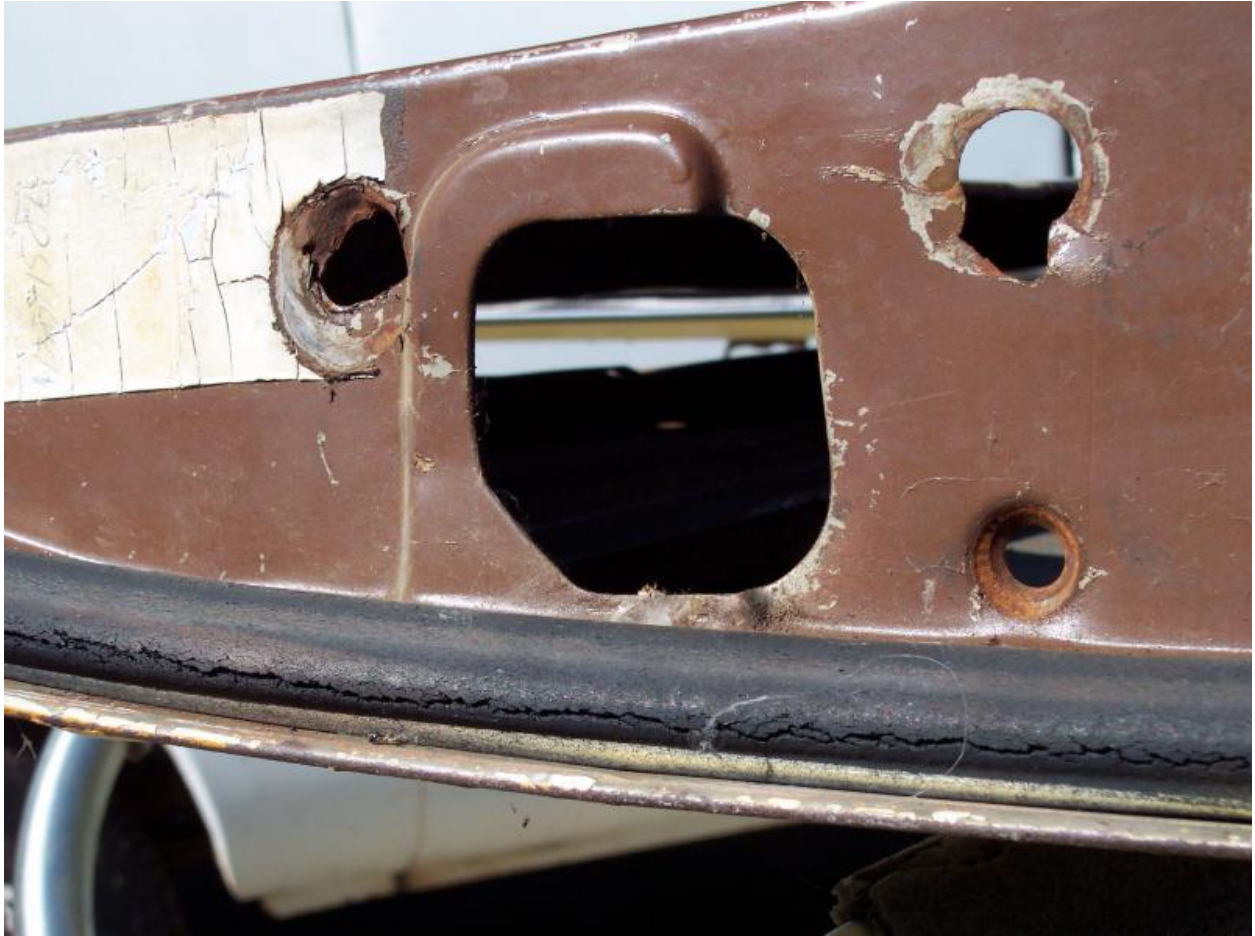
Pic 0229

Now remove the four window regulator mounting screws.

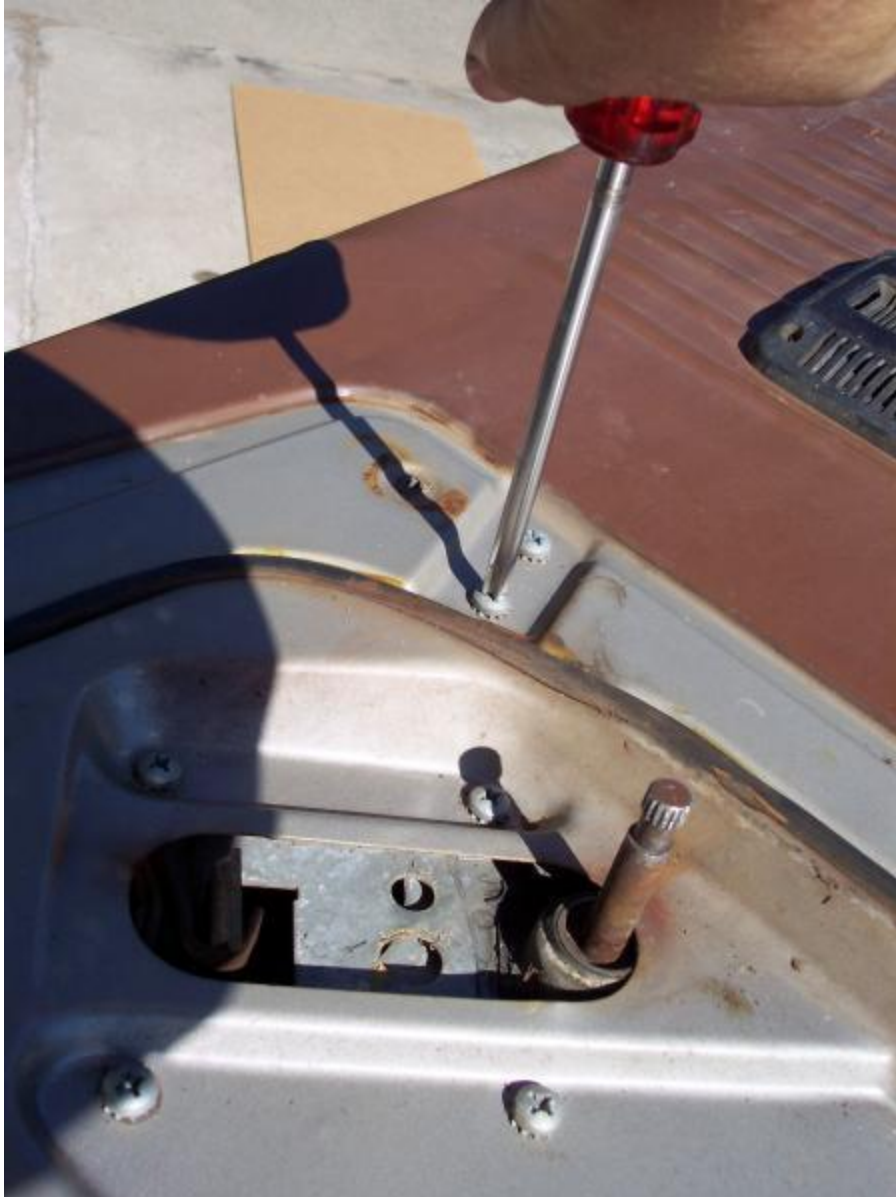
Pic 0230

Here you see the damaged are around the door latch. Repair patch panels are available from 108VG.  
(Shameless Self advertising)

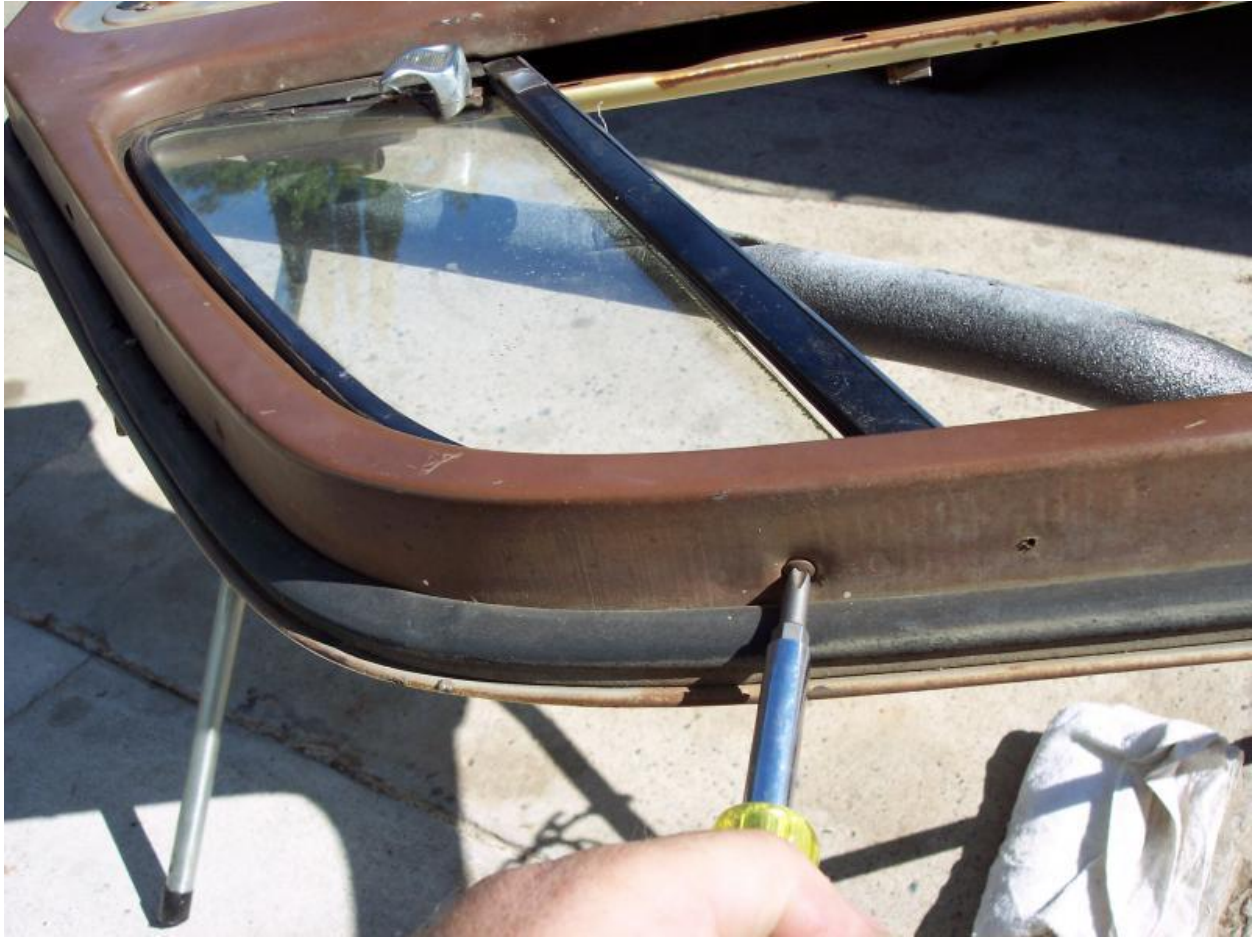
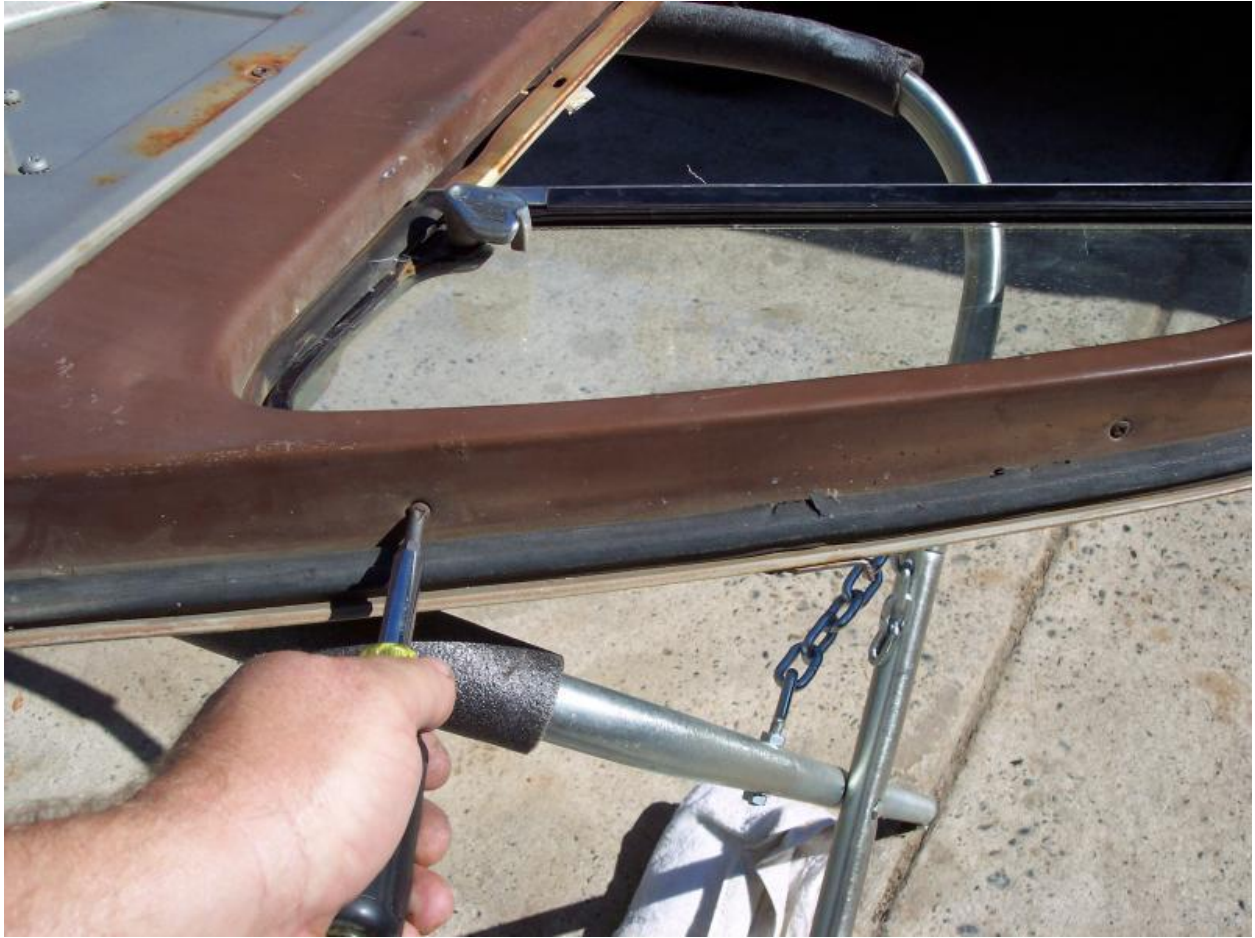
Pic 0231, Pic 0232

Remove the two screws

holding the bottom of the vent window

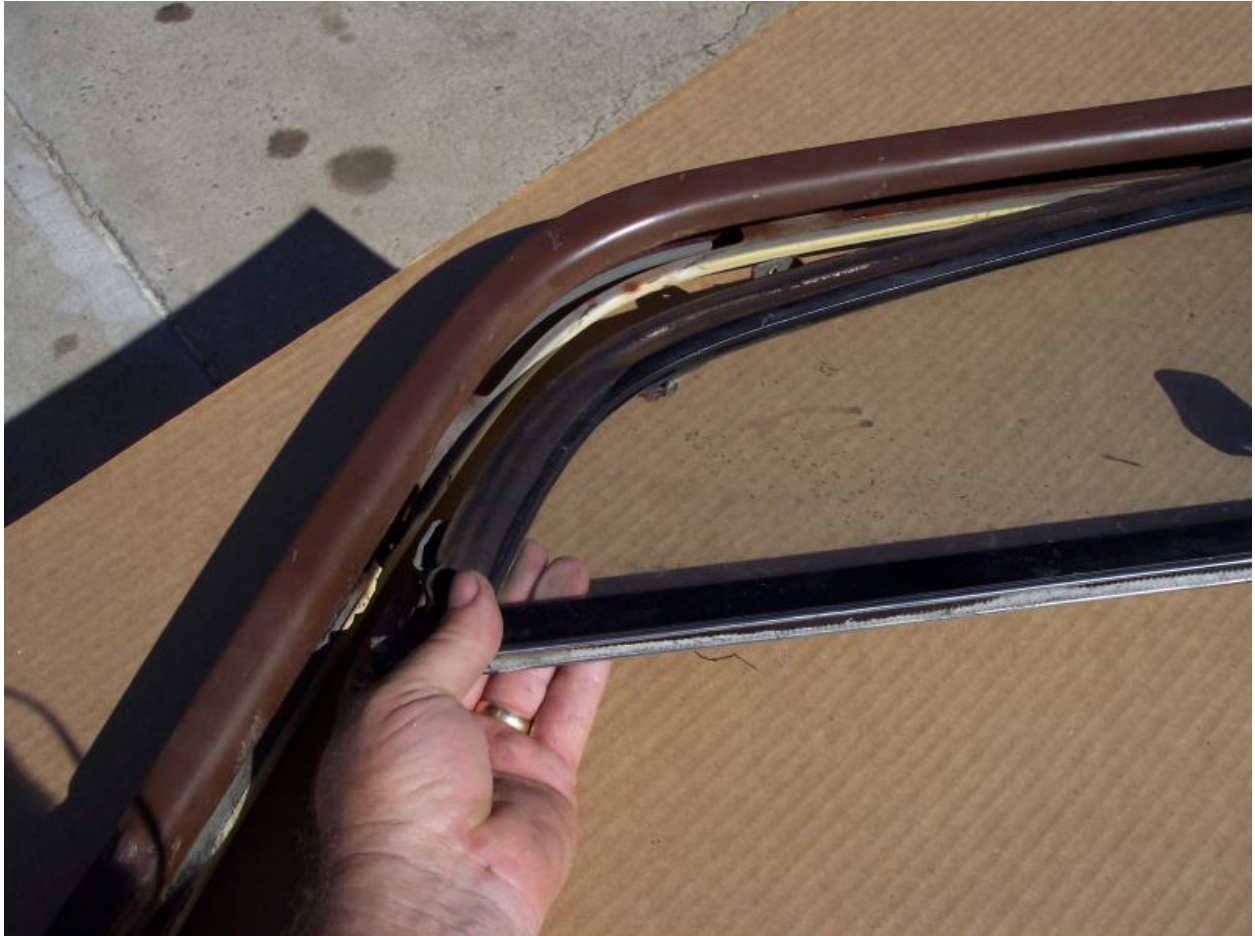
Pic 0233

There's three more screws holding the vent window on to the door. Use a #2 Phillips on these.

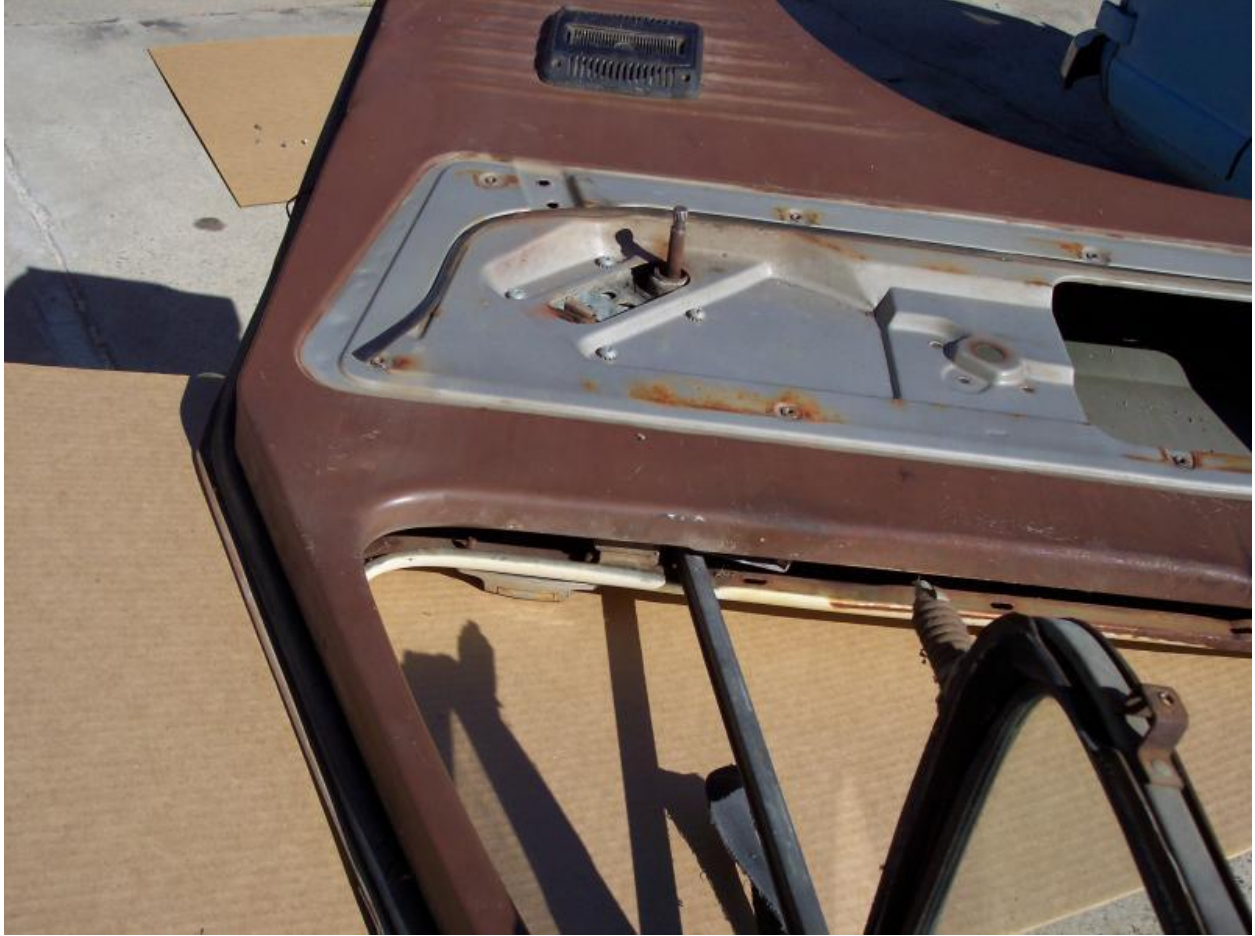
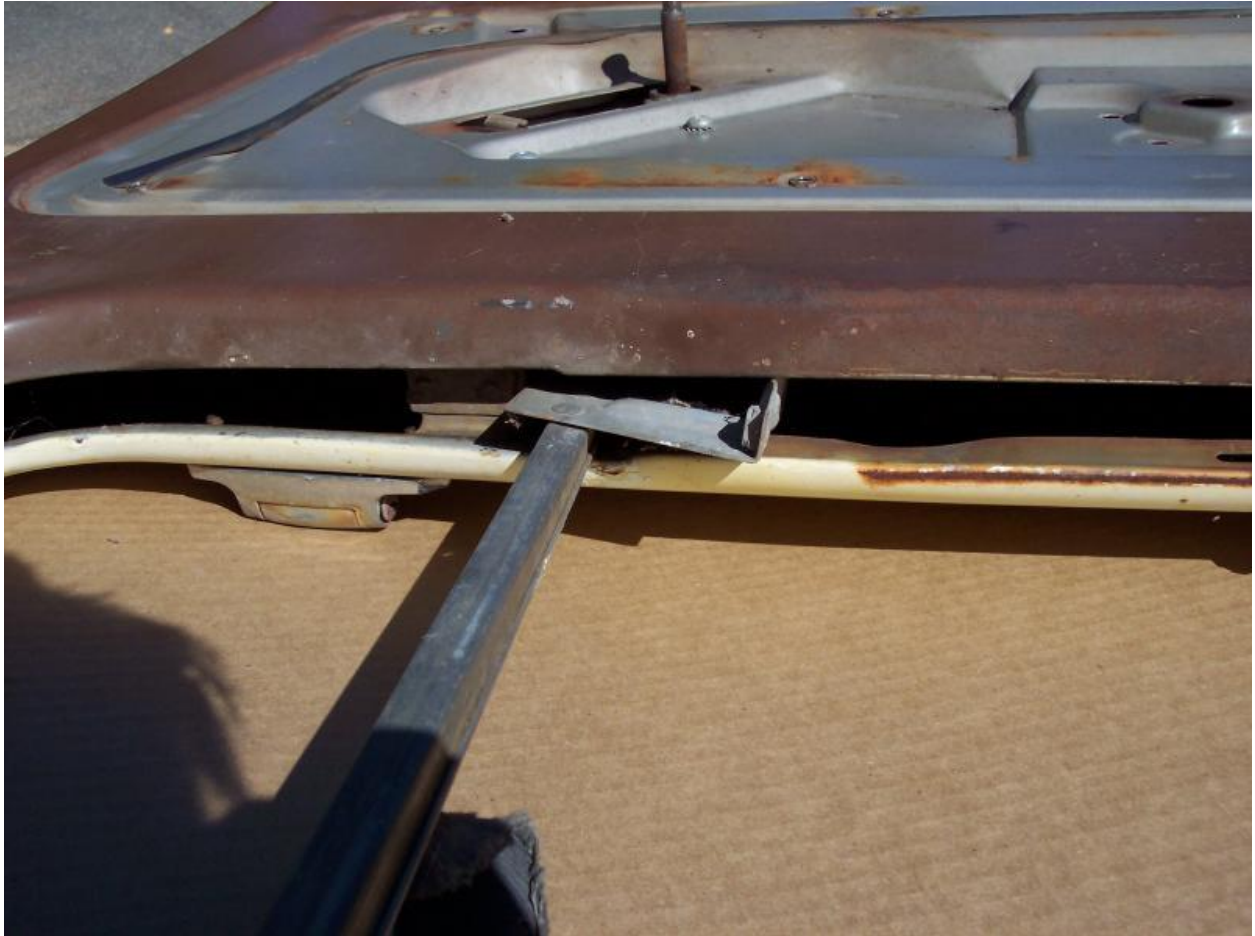
Pic 0234, Pic 0235

Then pull the wing window away from the door in this direction.

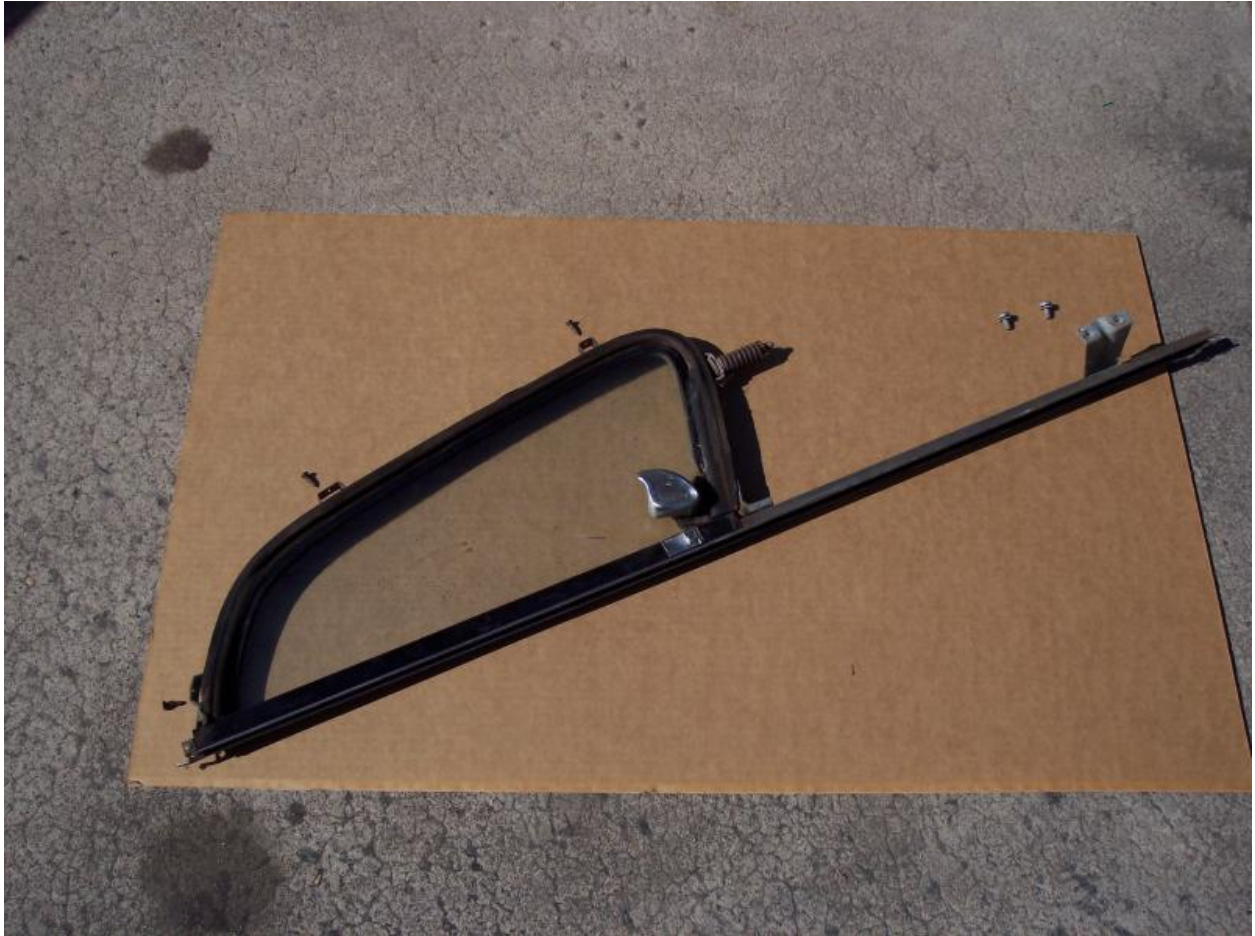
Pic 0236

Once the vent window is most of the way out, you will need to rotate it 90 degrees to allow the lower mount to clear the window gap. It usually comes out easier along this position of the opening.

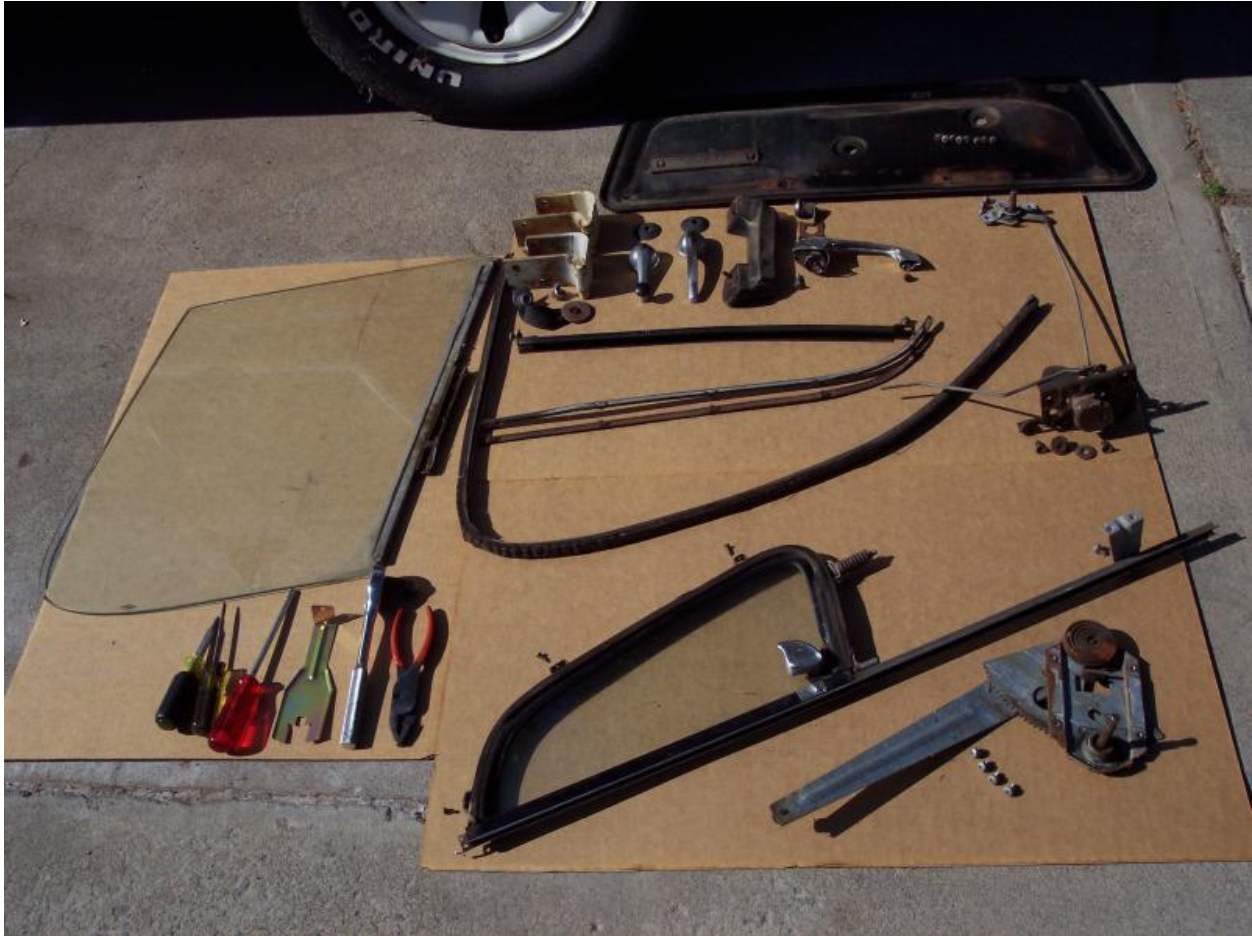
Pic 0237

Here's the vent window removed with the attaching screws nearby.
