How To: ID and Repair Shift Linkage Play

This “How To” covers mostly the 3 speed manual transmission equipped 1st and 2nd gen VCVs. The shift lever and related parts we have can take a lot of abuse over a 50+ year period and many areas can cause excessive looseness and more difficult shifting. I’ll start with the lever and move down towards to the transmission. The first checks are done with the engine off and in gear. I advise reading the entire article before starting any disassembly.

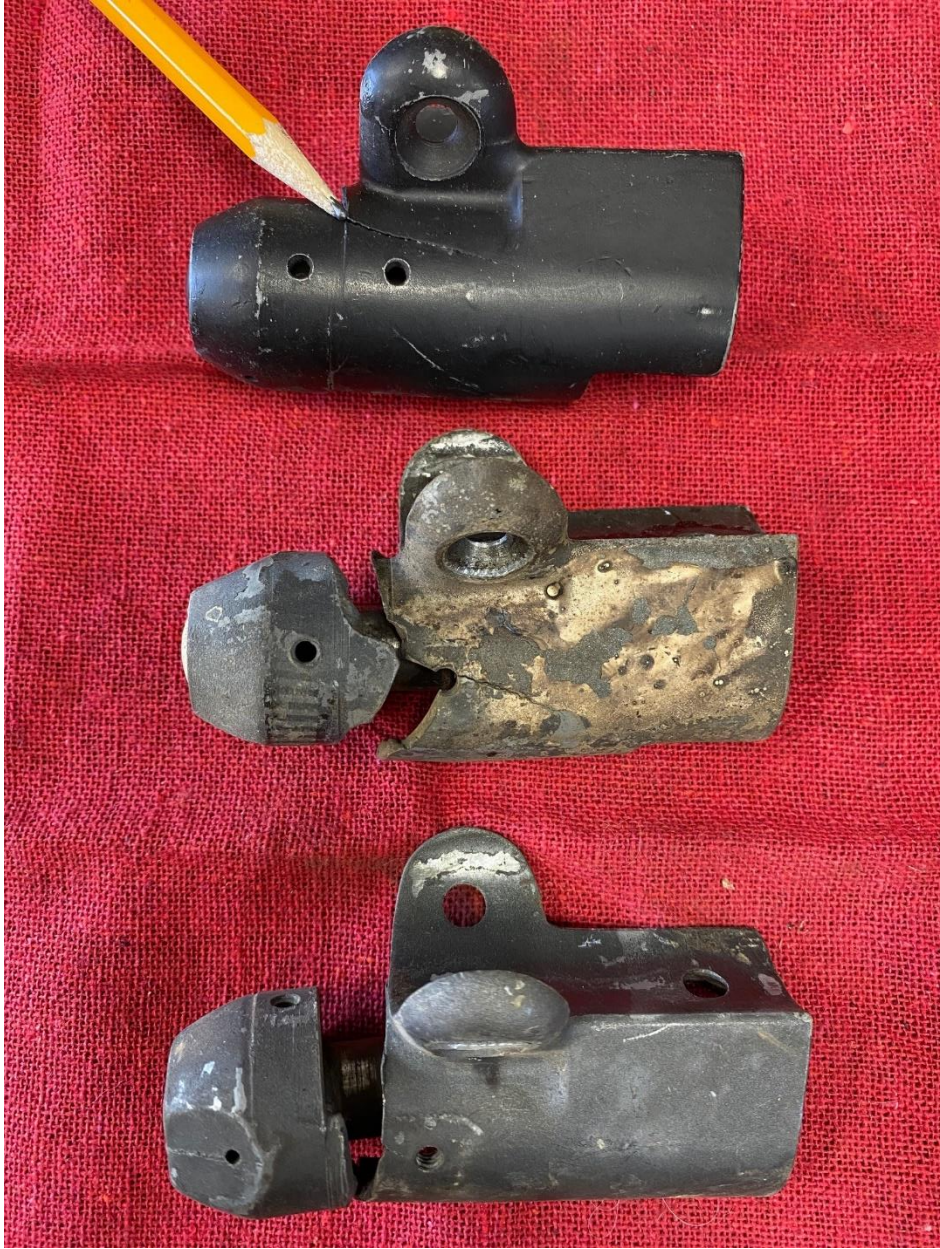
On 1st gen vans, the upper shift shaft retainer (or whatever you call it) will crack and cause looseness. This is the piece that mounts on the steering column tube and holds the upper part of the shift shaft in place. Excessive force (and weak design) causes these to crack. These pieces fail at that ridge line near the top. This failure is obvious when seated in the van. If you have to remove one of these, it’s some work. You usually have to remove the steering wheel, column, rubber floor boot and other items. It can be a lot of work and the subject of a different “How To”. Currently we have no replacement for these upper shifter pieces and believe me, we have tried. Unfortunately, the cost to repop these was just way too expensive so if anyone has a spare, it’s worth keeping. I’ve seen hose clamps wrapped around the steering column to try and hold these together. If you have one that’s too far gone, one alternative is a Lokar cable type shifter and an automatic transmission. Not exactly a quick or inexpensive fix. Every now and then, I run into a spare. Contact me if you can’t find one anywhere else. My advice is to not force the shift lever, too many hard to find or hard to install parts can break. Fix the hard shifting and play before it becomes a catastrophic failure like these

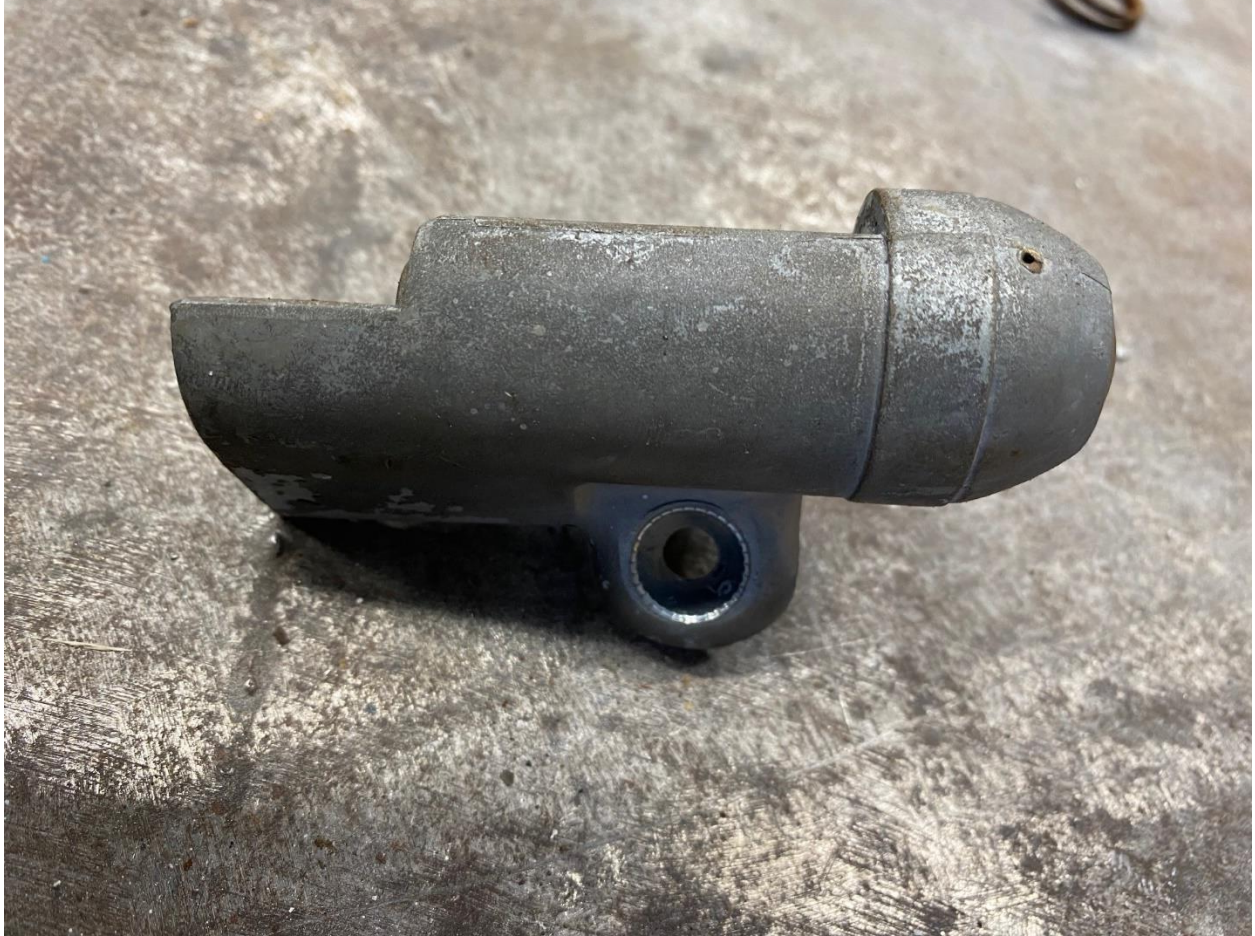
Below is one in good shape.

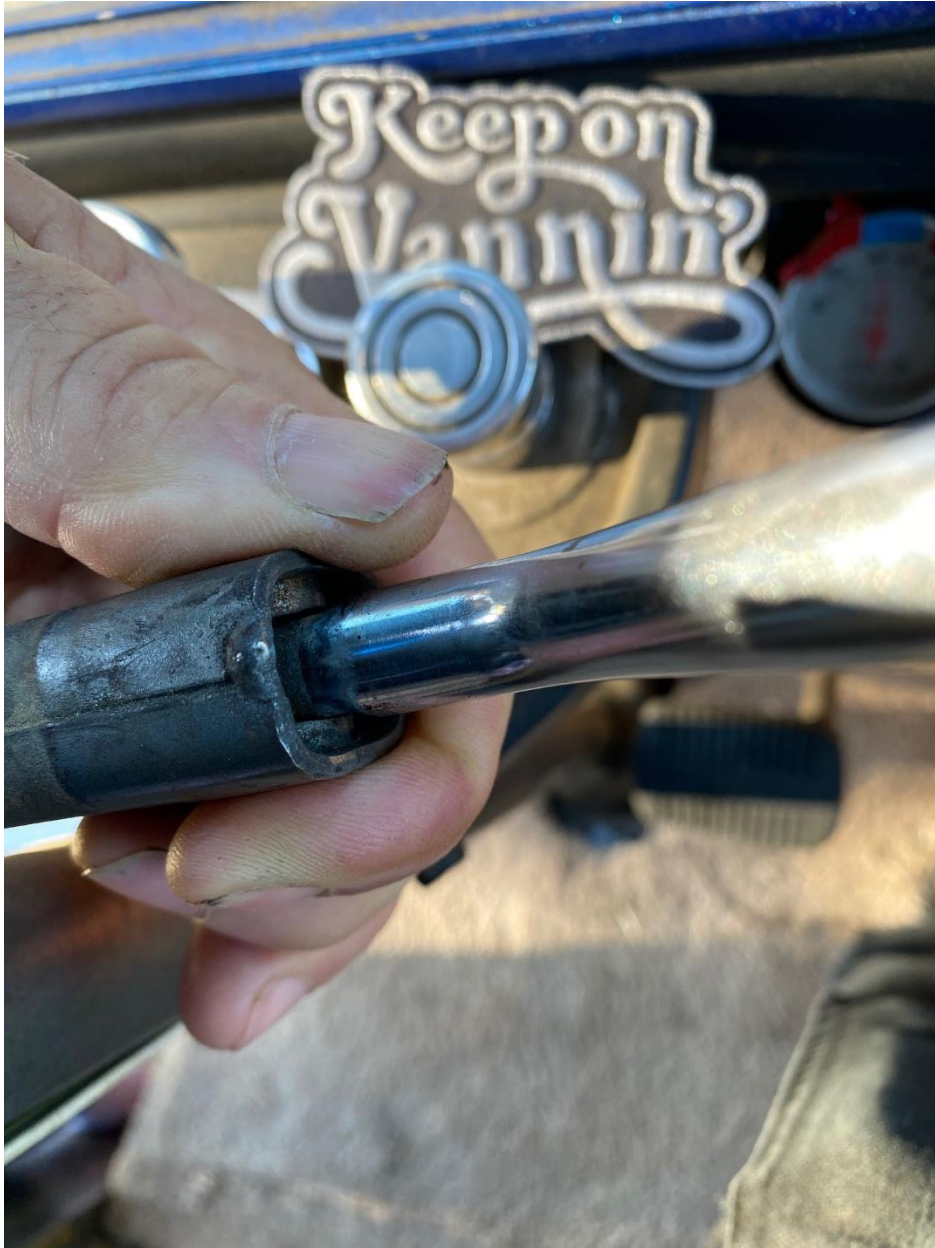
Check for looseness at the shift lever pivot point by first carefully pulling back the rubber boot at the base of the shift lever. Be sure not to catch the boot on the pin during removal. Warm up the boot with a hair dryer if it's cold out or it seems like it's wanting to rip. Once the boot is pulled back, you'll see the pin that holds the lever in place. Grip the lever pin like so. Your thumb should be on the top of the pin and your first finger should be on the lower part of the pin and socket.

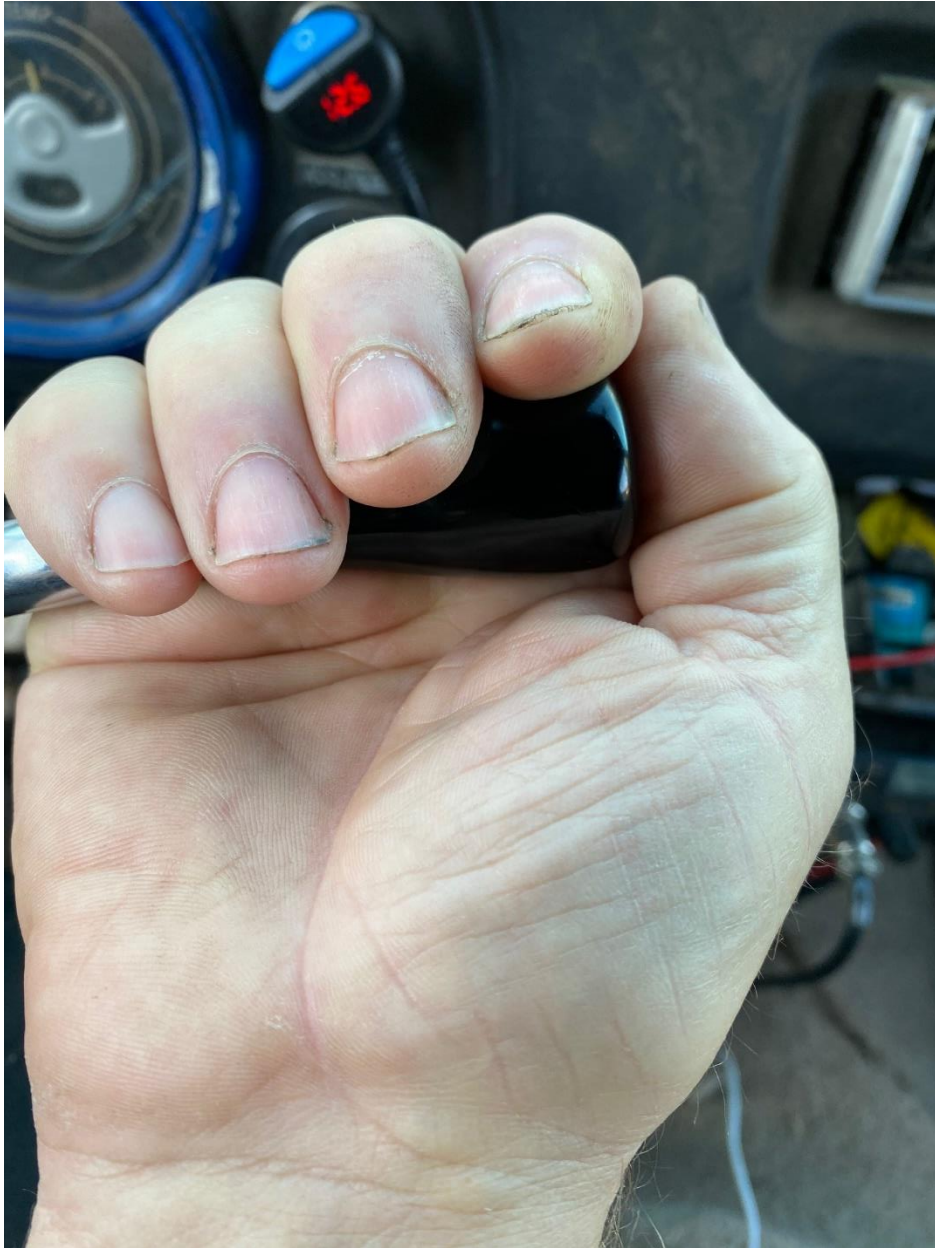
Now grip the other end of the lever like the picture below and give it a gentle twist back and forth.

There should be only minor movement at the lever while twisting. You should feel no movement at the pin. The pin should not be loose at all or rocking in the mounting hole.

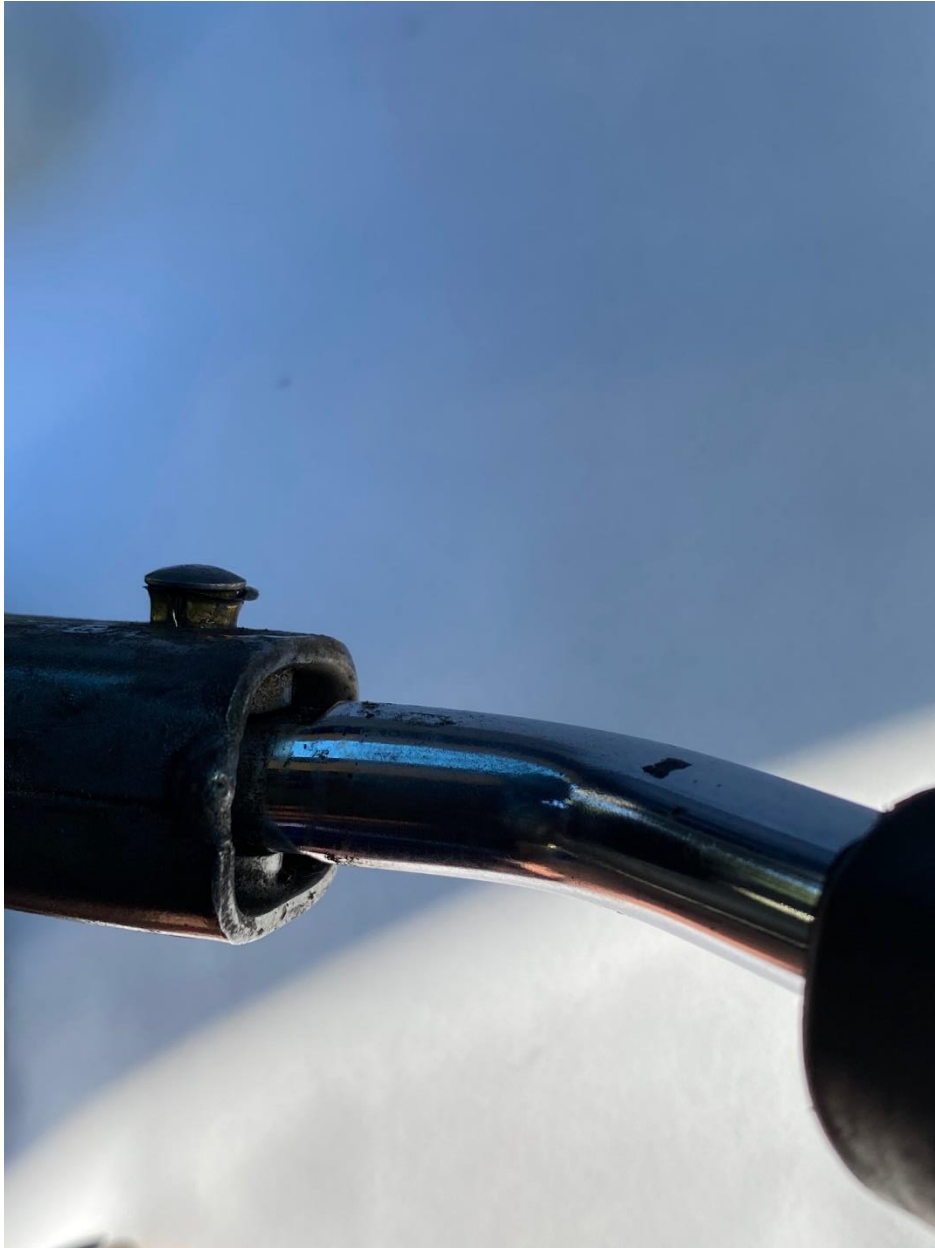
This pin is loose and backing out. The bottom part of the pin no longer contacts the lower part of the lever mount. Since the rubber boot will tend to keep the pin from backing out all the way, the pin rides partially backed out. This wears away the upper mounting hole over time. This then makes for even more play. It happens over time and slowly gets worse.

There are several ways to try and fix this. The first thing you can try is to pull the pin and wrap some shim stock or aluminum foil around the pin splines located near the top of the pin. The splines on the pin are the only thing holding the pin in place. The lower part holds the pin steady but I don't think

there's much on the bottom part of the pin that holds it in place. If you do use something like foil, try to use just a single wrap around the splines. If more than one layer is required, then try the heavy-duty foil which is a little thicker. I haven't found any replacement splined pins for this yet, has anybody? The local hardware store had some tapered pins and also some cylindrical pins that were the same size but if the hole is enlarged, it's still going to be a problem.

Other fixes I've seen are to install a small bolt and self-locking nut. This works but then the rubber boot doesn't fit over it anymore. I've thought of tapping the holes and installing a stainless pan head screw. With the correct bolt, the boot would probably fit again. I'm open to hearing ideas on how to make durable repairs that don't involve too much modification.

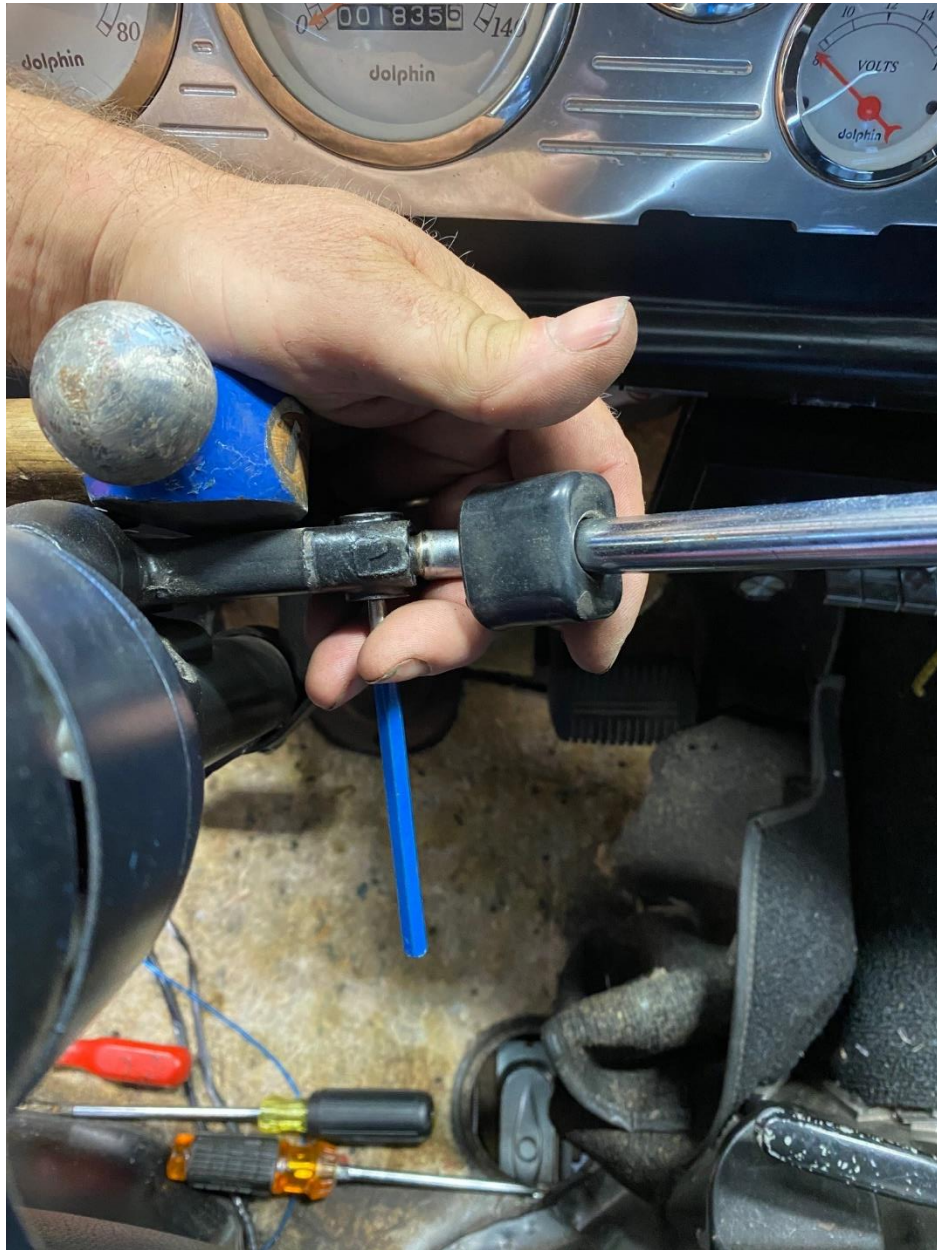
This is how I prepare to hammer the pin out.

Hold a big ball peen hammer or similar weight on the top of the shift lever shaft while holding a pointed punch on the bottom of the pin. This keeps the upper shift lever shaft from taking too much punishment while removing the pin. Before using a hammer on the punch, wrap the ball peen hammer

in a cloth to protect the shift lever shaft. This pic was used to show the proper positioning of the tools and how to hold them.

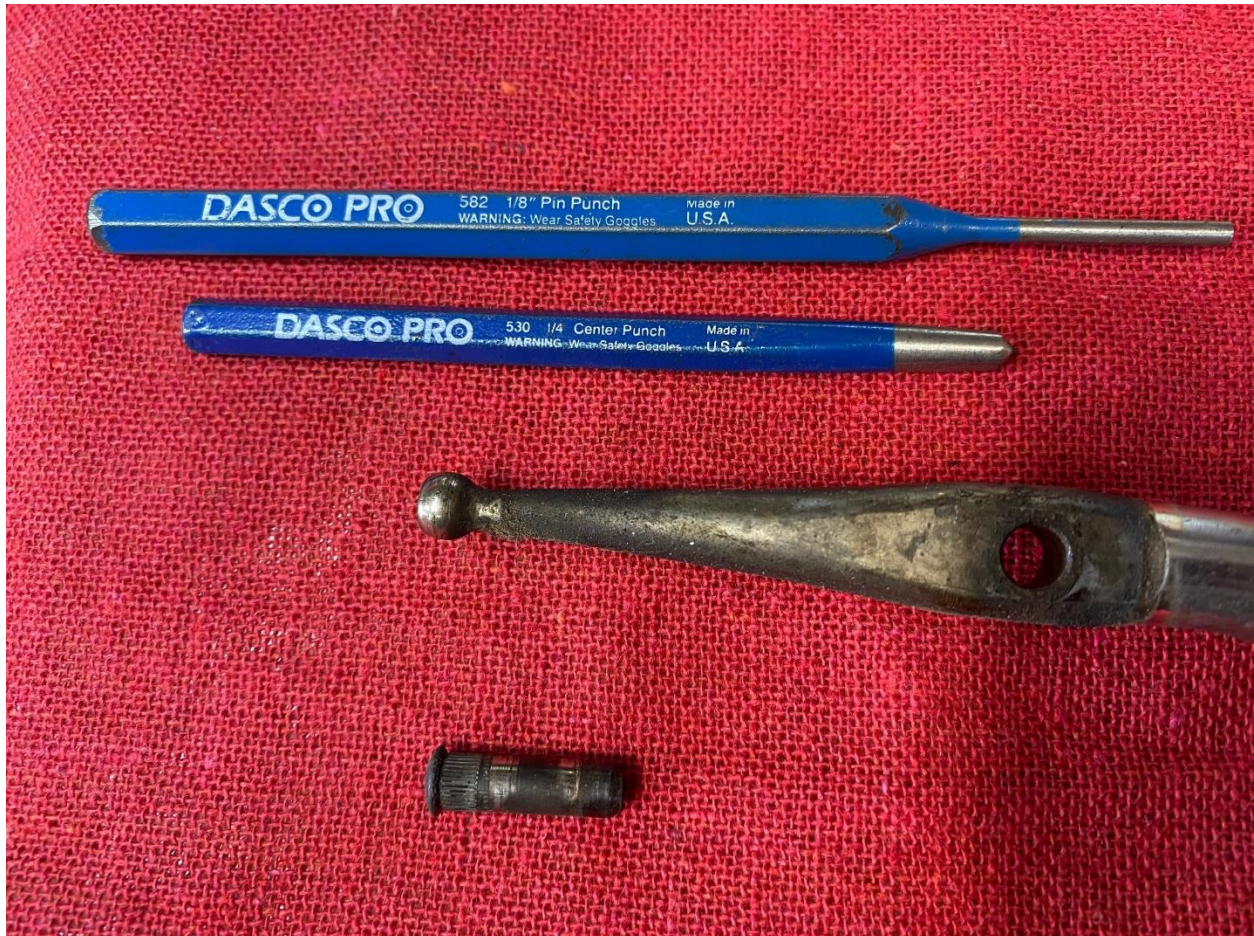
This shows the pin removed, the shift lever end and the two punches that I recommend. The center punch is pointed and is better suited for starting to drive the pin out. The longer pin punch is better for driving the pin the rest of the way out.

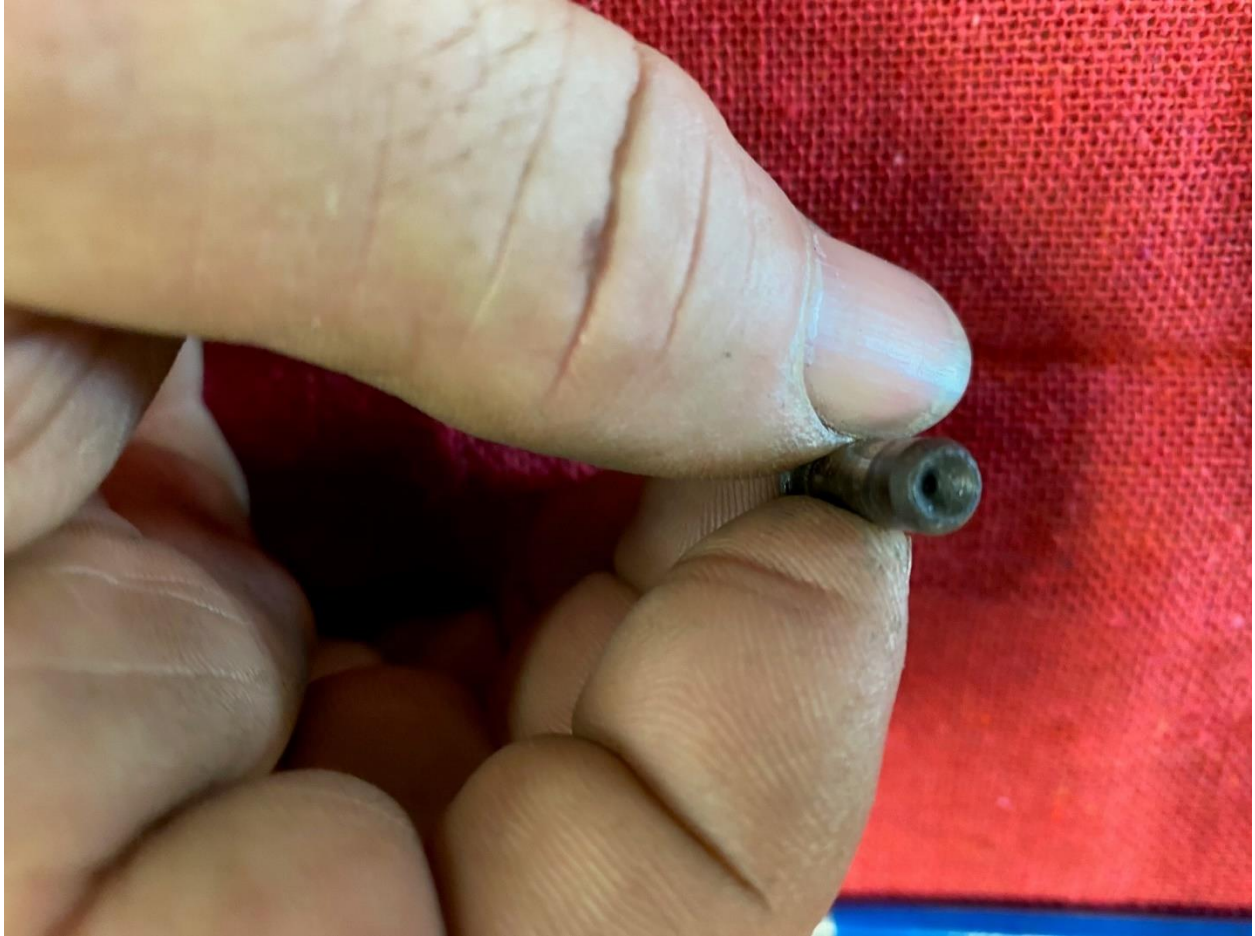
Below is a view of the bottom of the pin. Note how a pointed punch will fit nicely in the base.

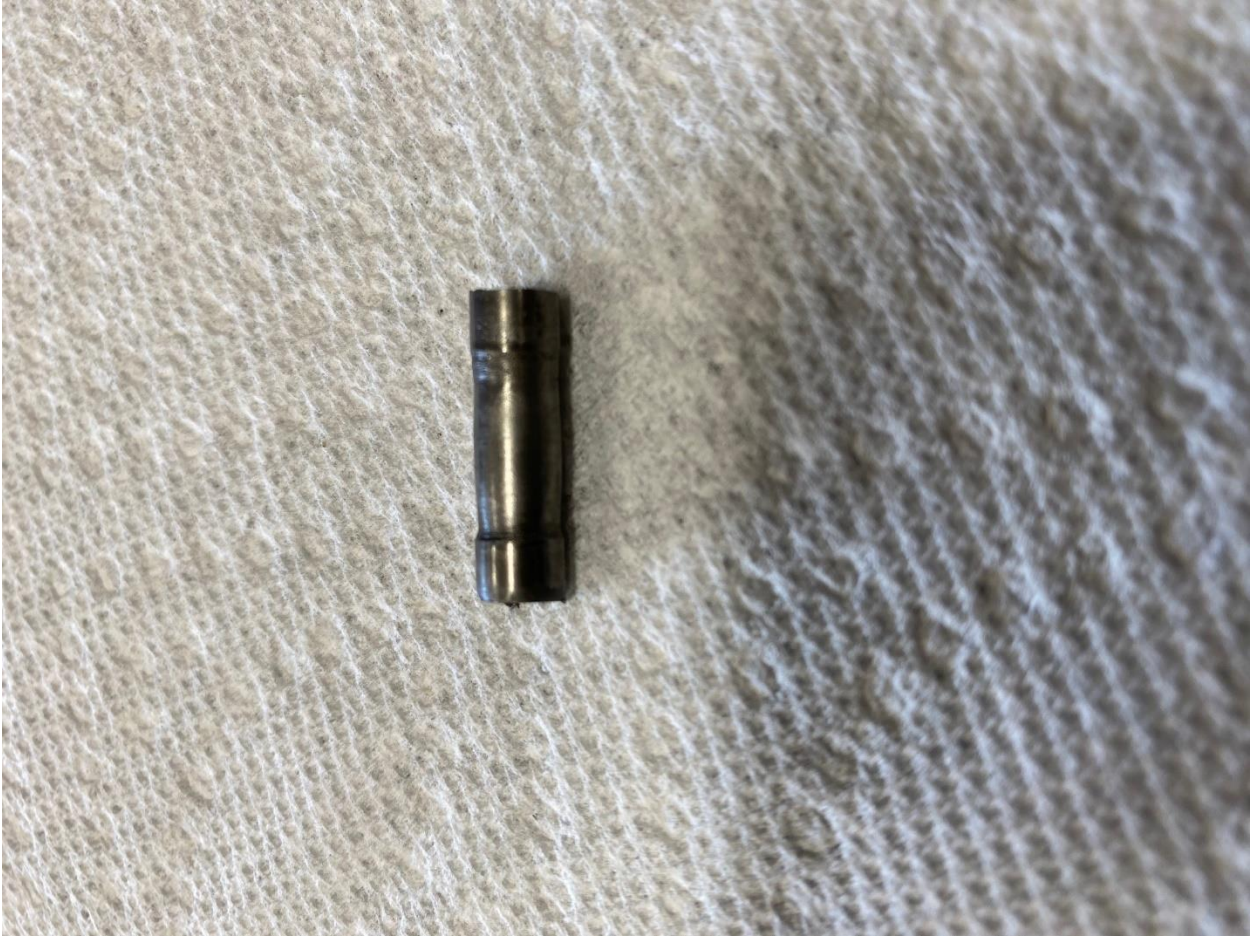
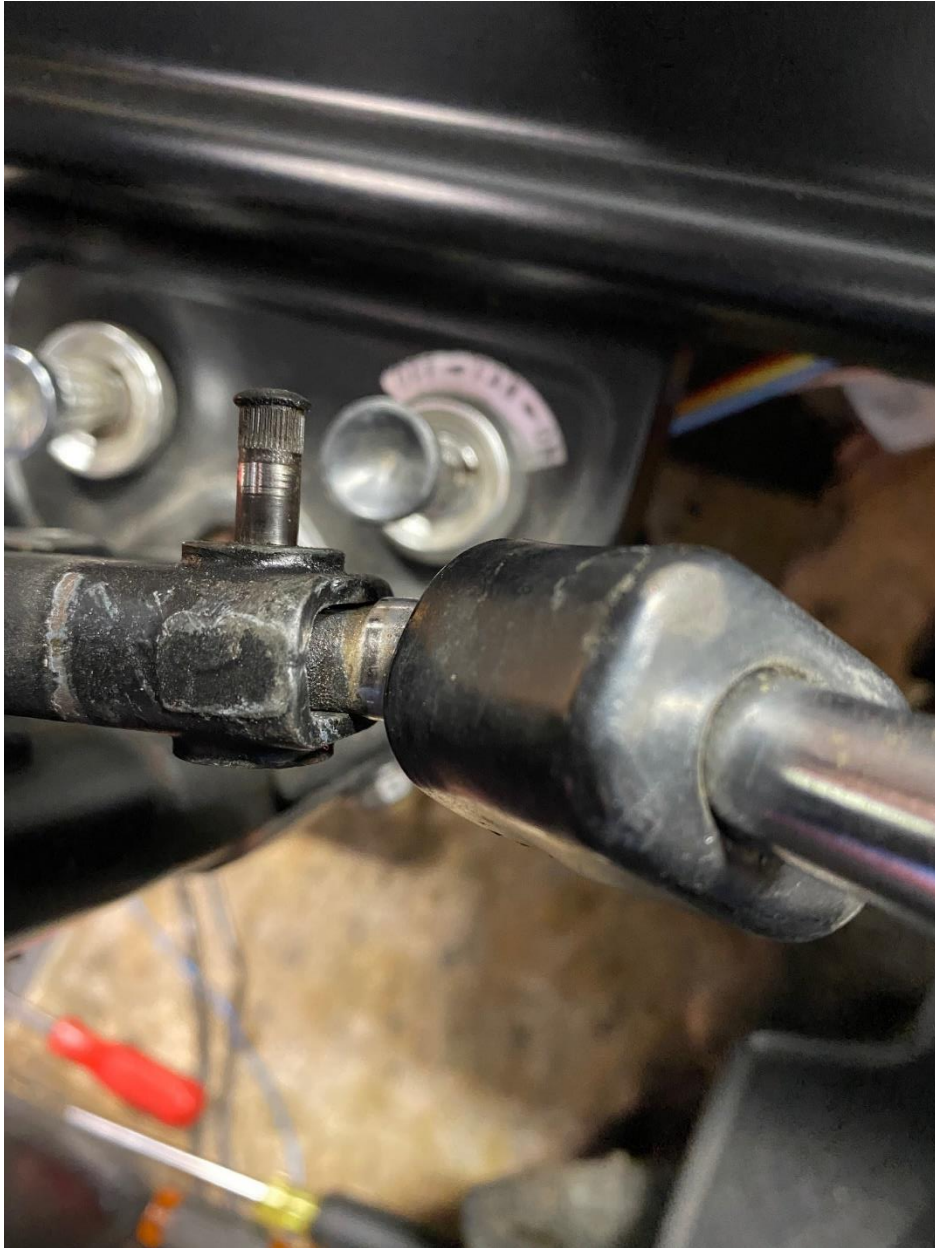
Sometimes on first gens, a different pin is used. I've seen one like the pic below. These are shorter and have no splines. They are shaped like a smooth cylinder and are much tougher to remove. Once you start banging away on this pin, you'll think you're trying to push it the wrong way. Be sure you have a well-fitting pin punch and are backing up the shift lever with as big a weight as possible. I wish I had a small pin press that fit neatly around the lever. That way I could press these out instead of hammer them out. When I have run into these types of pins, it has taken me a lot more hammering than I wanted to. Luckily, I don't run into these as often.

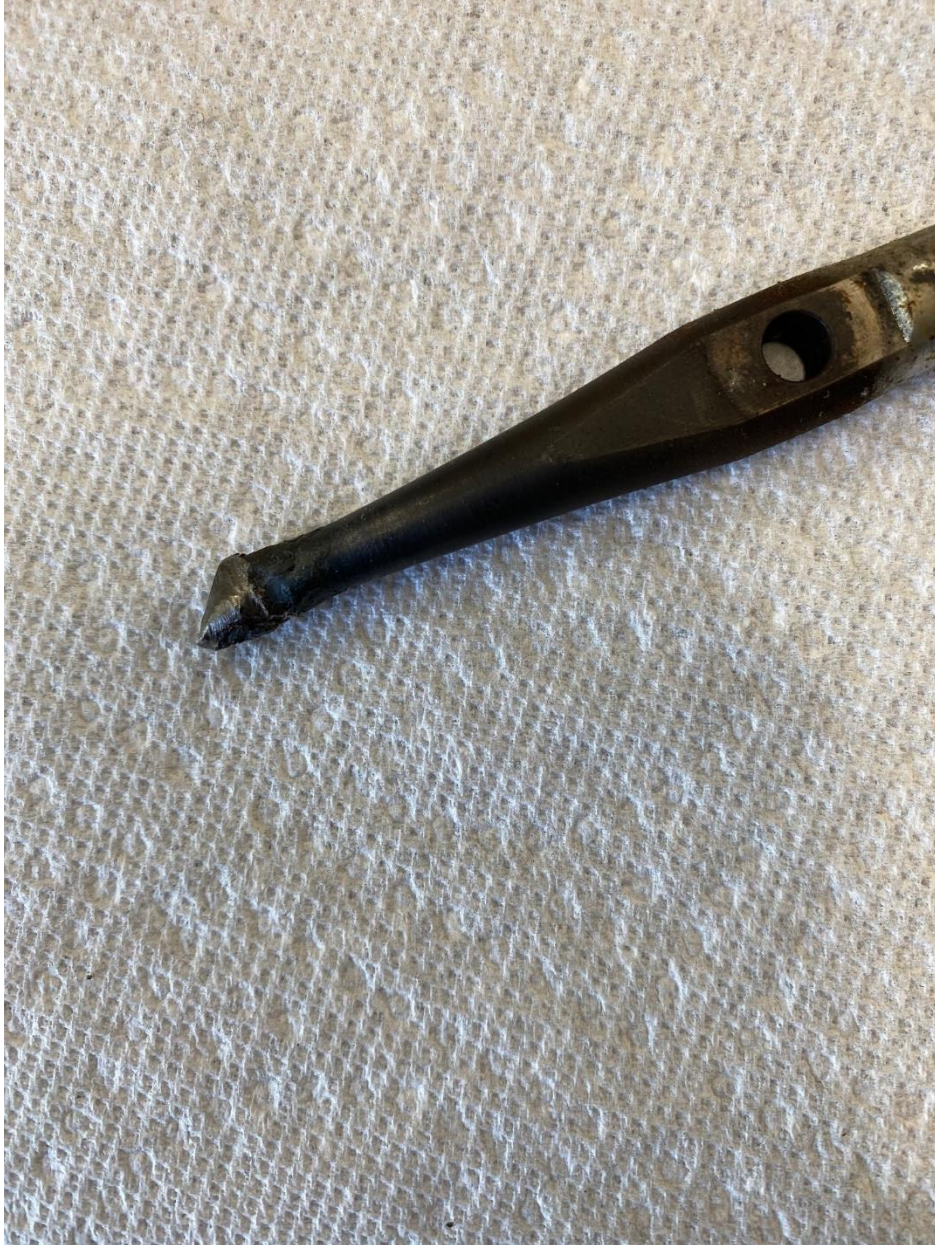
Once the shift lever is removed, check to see if the ball end is in place. One of the previous pics (with the pin punches) shows the ball on the end is unbroken. If the ball is missing, check the socket to see if the broken ball end is there. These broken ball ends on the shifter are another common source of

looseness. This part breaks when too much force is used on the lever. The fix is to replace the lever or take it to a welder and see if they are willing to try a fix. Below pic shows one I pulled out that was repaired. It's a lot easier to weld material onto the end than it is to reshape the end into a ball. Maybe a ball bearing can be welded on the tip?

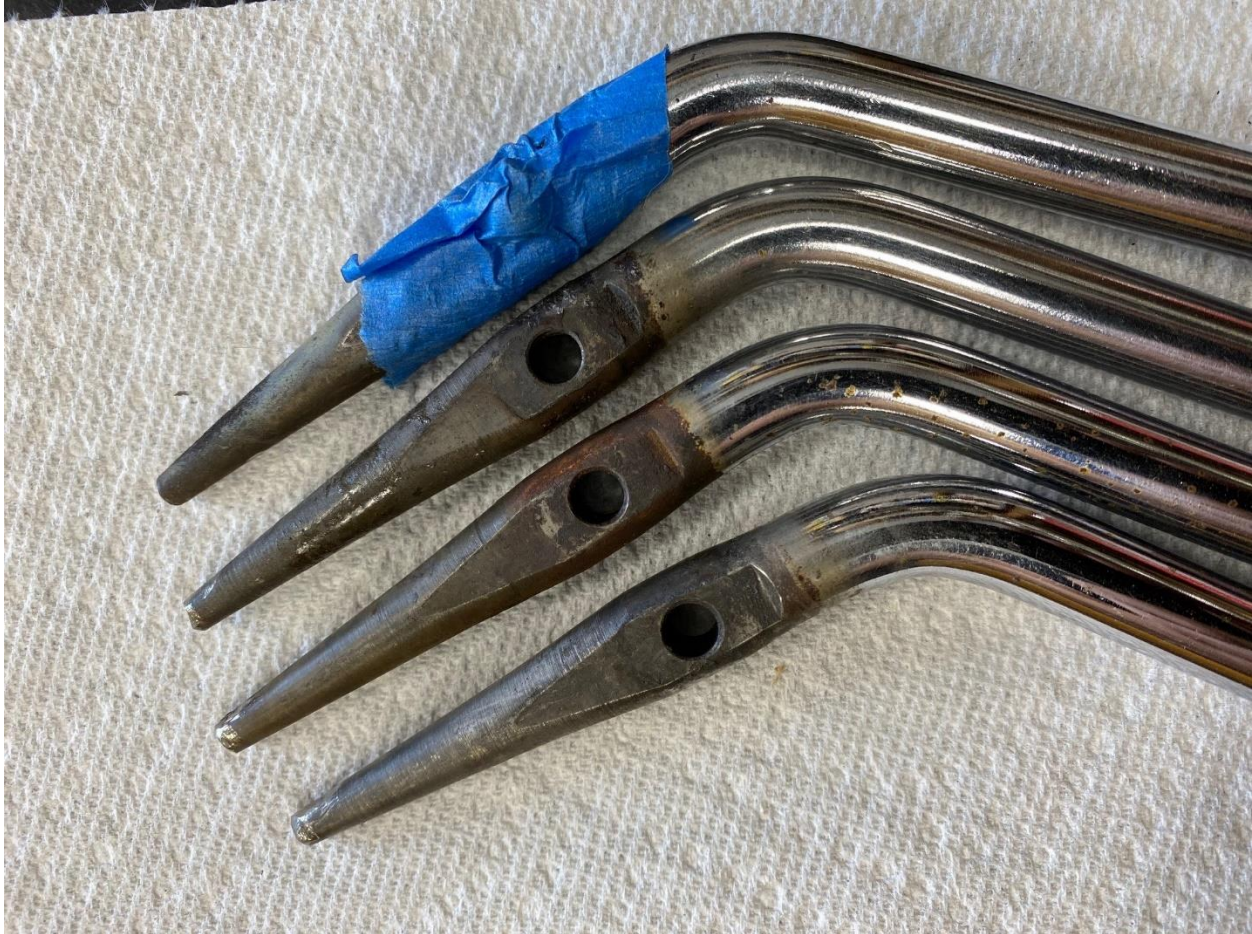
Below pic shows a bunch of shift levers with broken ends.

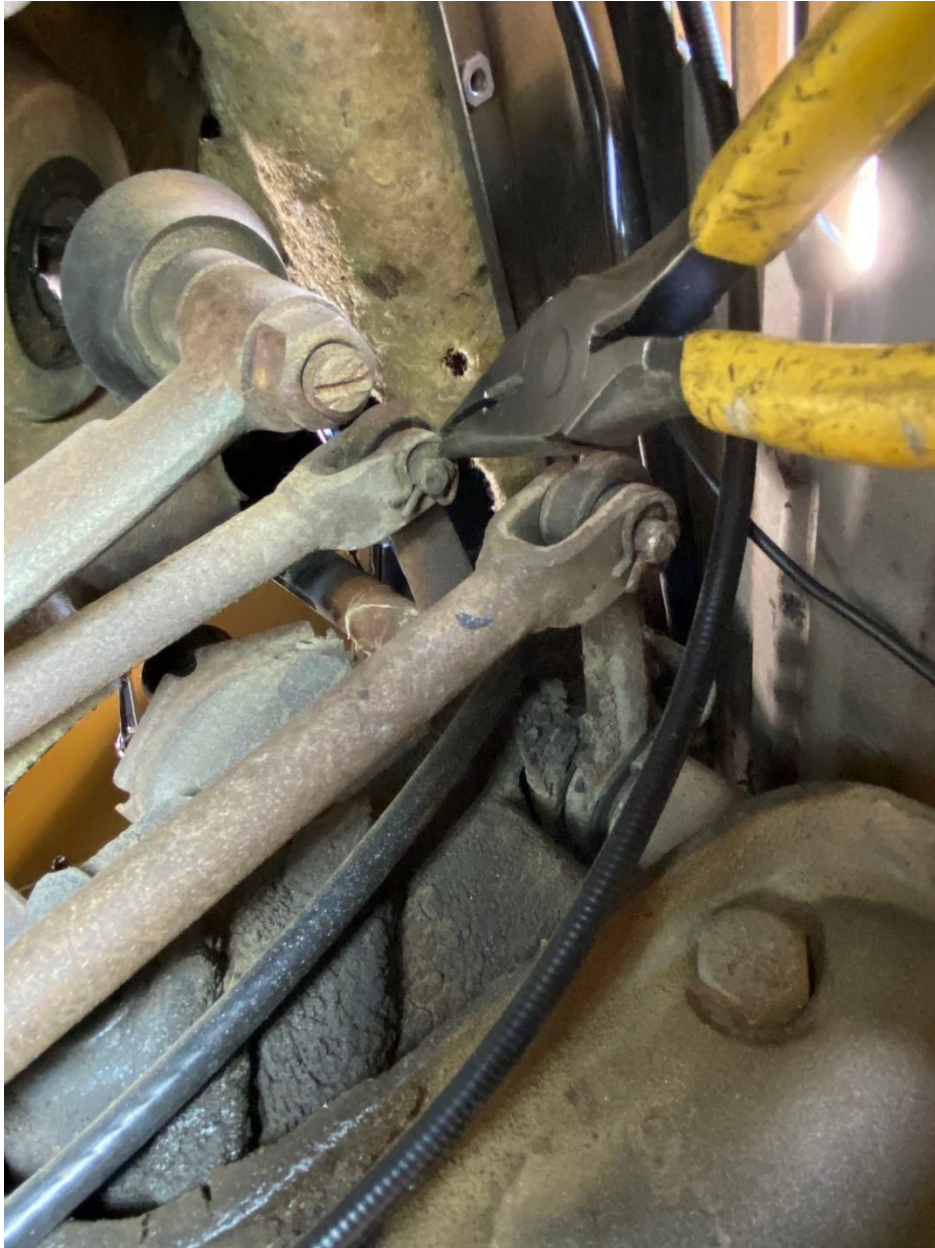
Remove the belly pan to access the levers. Pull the retaining clip and remove the pin and bushings for closer inspection. When you pull the retaining clip, the pin and bushings can fall out so be sure they don't get away from you. The 1st gens have a U shaped rod end and the 2nd gens have the pin built into the end of the rods which makes them more difficult to remove.

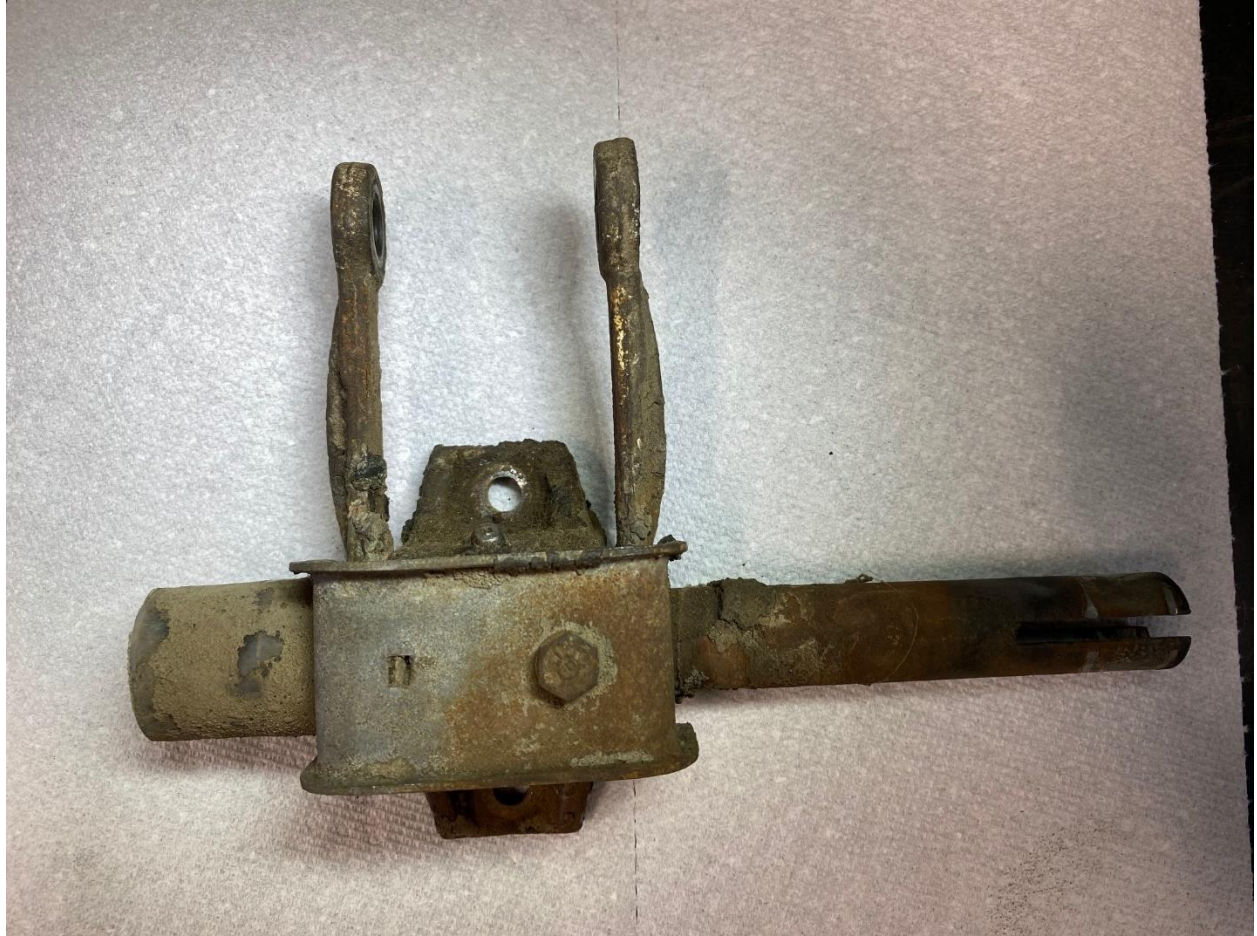
looseness and the repairs that can be done to correct them without as much effort as pulling and repairing the lower shift mechanism. Below is a pic of 1st gen shift mechanism removed. The Chevy casted ones do not have a grease fitting. The GMC casted ones do have a grease fitting. You can just see it near the bolt hole. This is typically overlooked and not greased. If you have looseness, in the shift lever, it's usually not caused by this piece. Issues here will cause increased effort while shifting but not really looseness. If you have a shift mechanism that looks like this then at some point, it needs to be removed, properly cleaned and re-bushed. If you try to push grease into this fitting that looks like this, you may make the shifting worse. The ones I've serviced had a lot of hardened grease in there. If you try to push more wheel bearing type grease in there it can push the hardened grease into the mechanism. If you have high effort shifting and believe it's coming from here, disconnect the shift lever pins before you remove the shift lever, then move the shift lever with the long shift rods disconnected. Then you'll be able to feel the effort required for that portion of shifting. If you aren't going to tackle the removal and cleaning of this mechanism right now then I would only use a light oil or lubricant like WD40. Push the WD40 in through the grease fitting if equipped. This is the best way to lube the mechanism and get a WD40 shower all at the same time. Spray into the mechanism from the top also while an assistant moves the lever through the gears. This lube is only a temporary fix but will help loosen the hardened grease. Unfortunately, it will also attract much more dirt. The cylinder shape on the end is a plastic cover that goes over the spring mounted in the base. If yours is missing, there's a good chance it's sitting in the frame rail. This cover helps keep dirt from getting into the spring area and lower part of the mechanism.

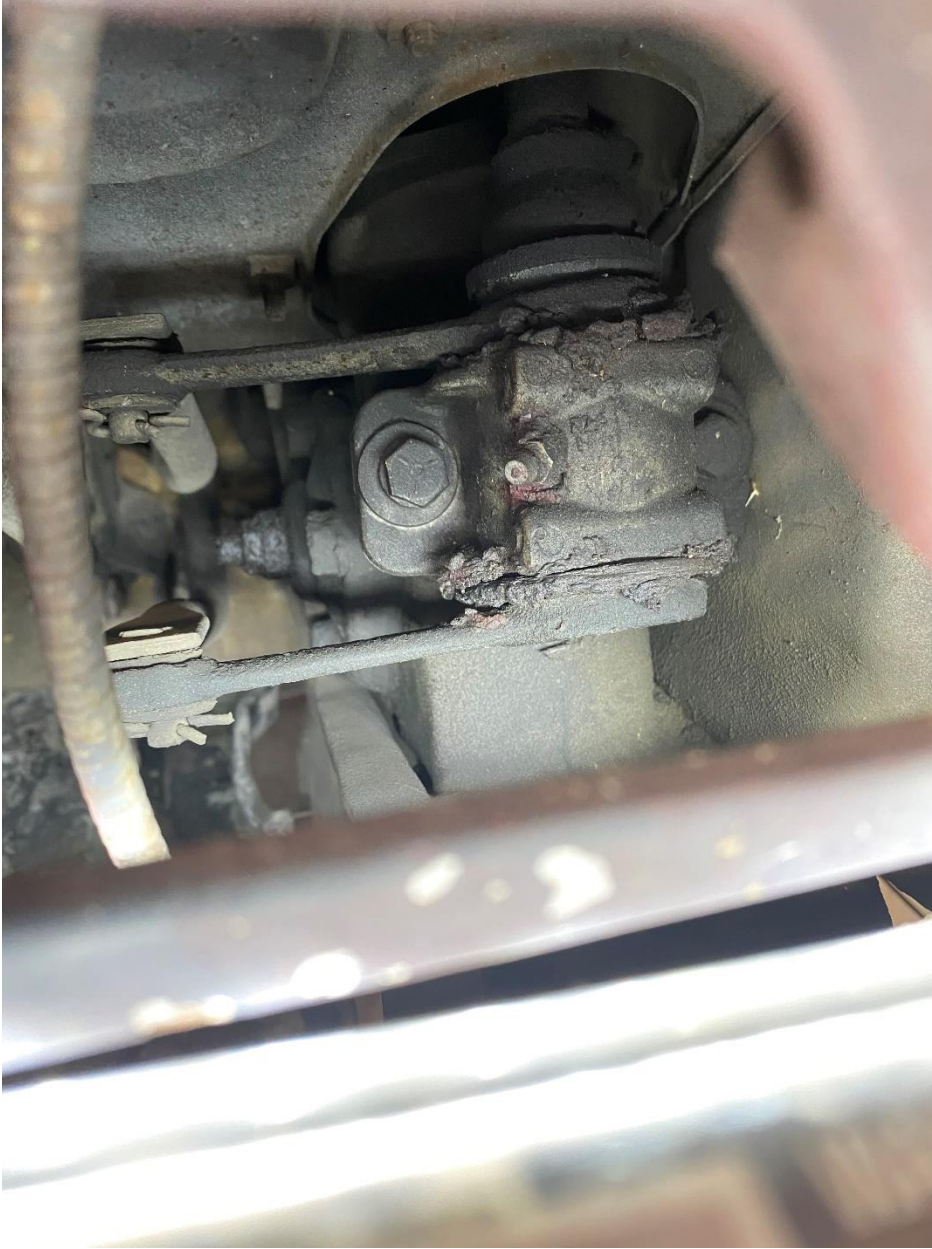
The pic below shows the 2nd Gen VCVs shift mechanism. The 2nd gens have a flat spot on the main body that (I believe) is intended for a grease fitting but I have never seen one installed from the factory. It comes from the factory not even drilled or tapped for a fitting. (WTH!) If you have opportunity to remove one, I advise installing a grease fitting as shown.

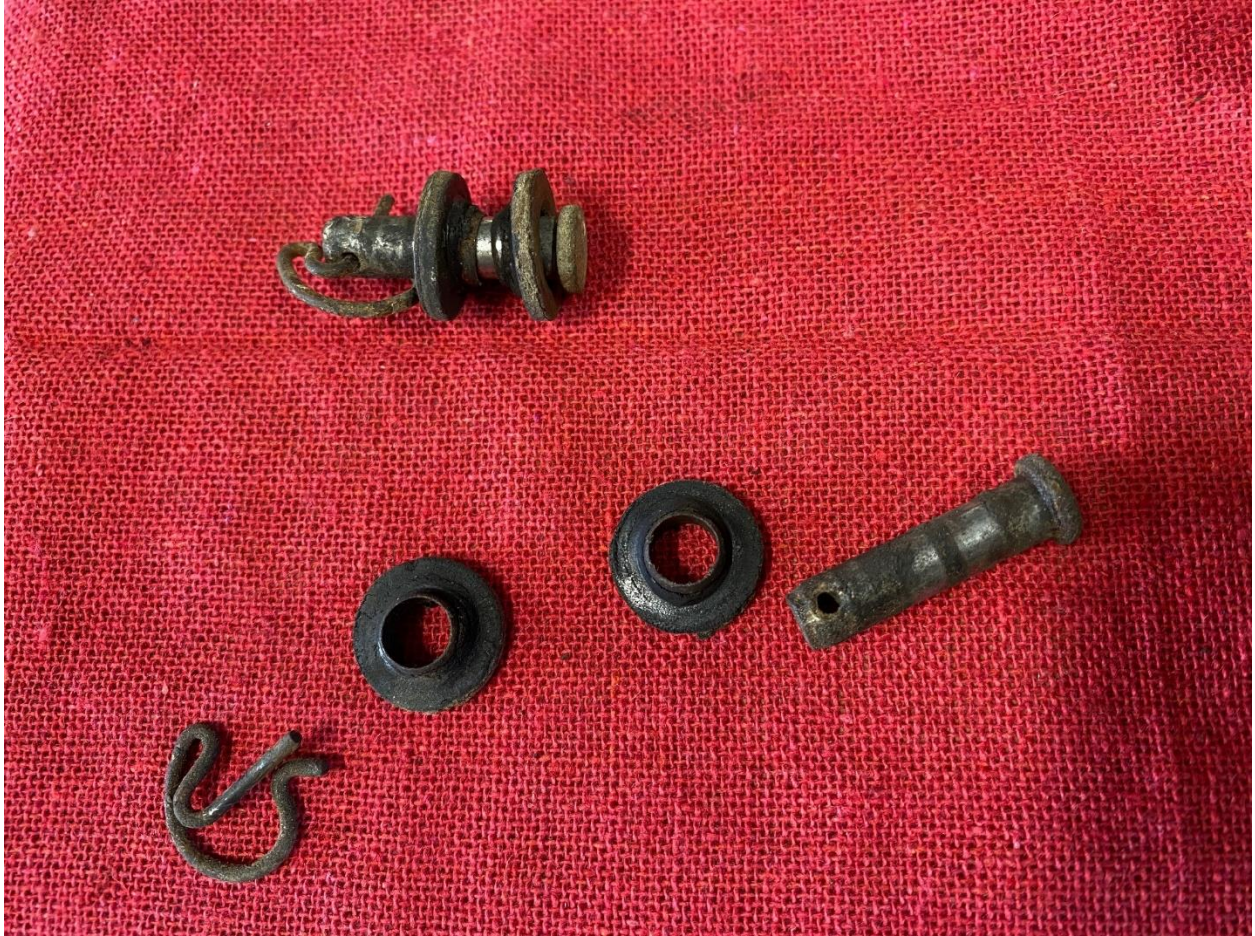
Below is a view of the pins, bushings and retaining clips once removed. You can see the rubber cladding is worn and cracked.

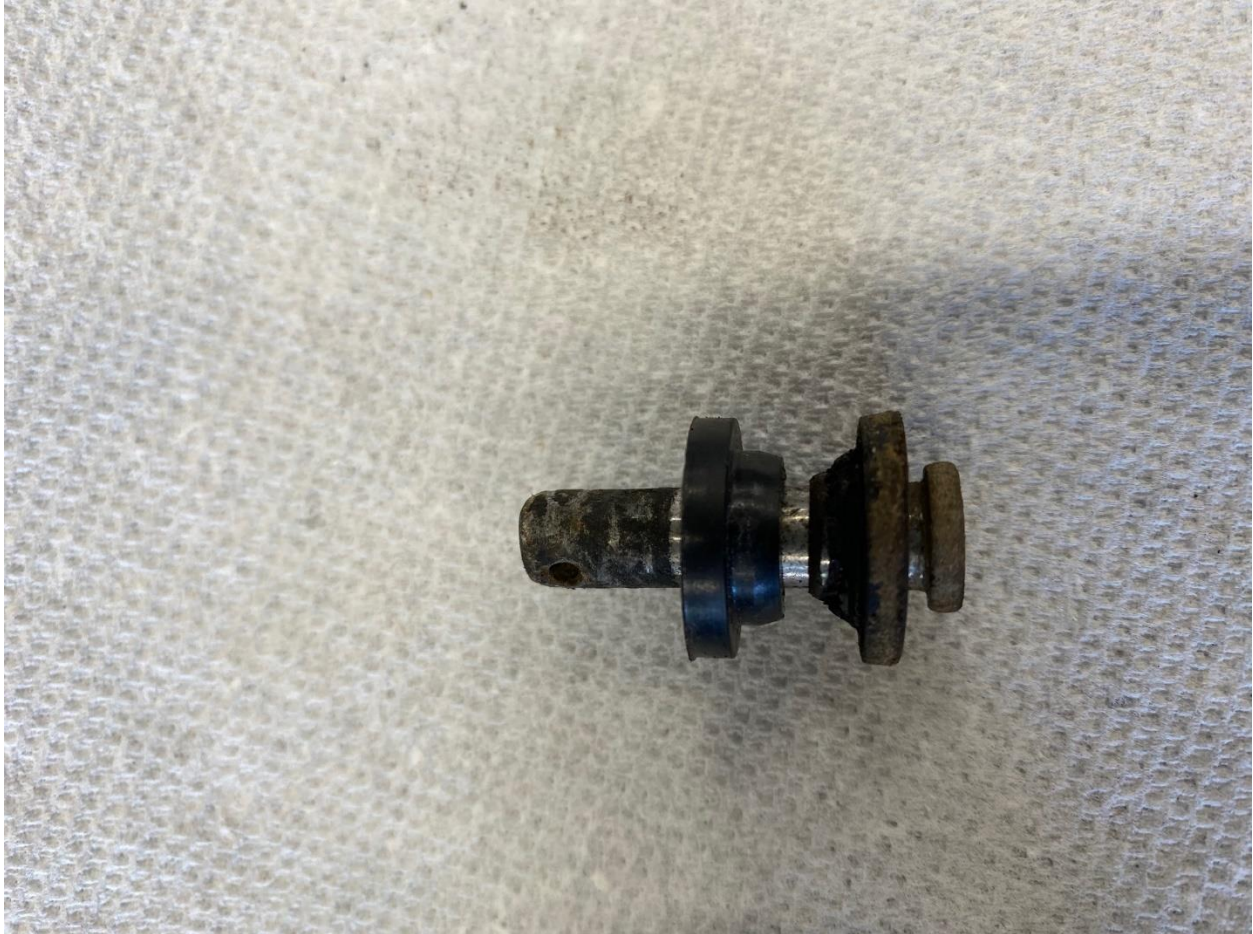
The pic below shows a new bushing next to an old one. The new bushing is much more squared off and will result in much less looseness. I'm having trouble locating these bushings, any help is appreciated. There was a couple of Hurst Shift Arm Bushing Pit Pack kits available but they didn't fit the 1st gen shift arm I was working on. I'm looking for replacement bushings.
