How To: ID and Repair Shift Linkage Play

This “How To” covers mostly the 3 speed manual transmission equipped 1st and 2nd gen VCVs. The shift lever and related parts we have can take a lot of abuse over a 50+ year period and many areas can cause excessive looseness and more difficult shifting. I’ll start with the lever and move down towards to the transmission. The first checks are done with the engine off and in gear. I advise reading the entire article before starting any disassembly.

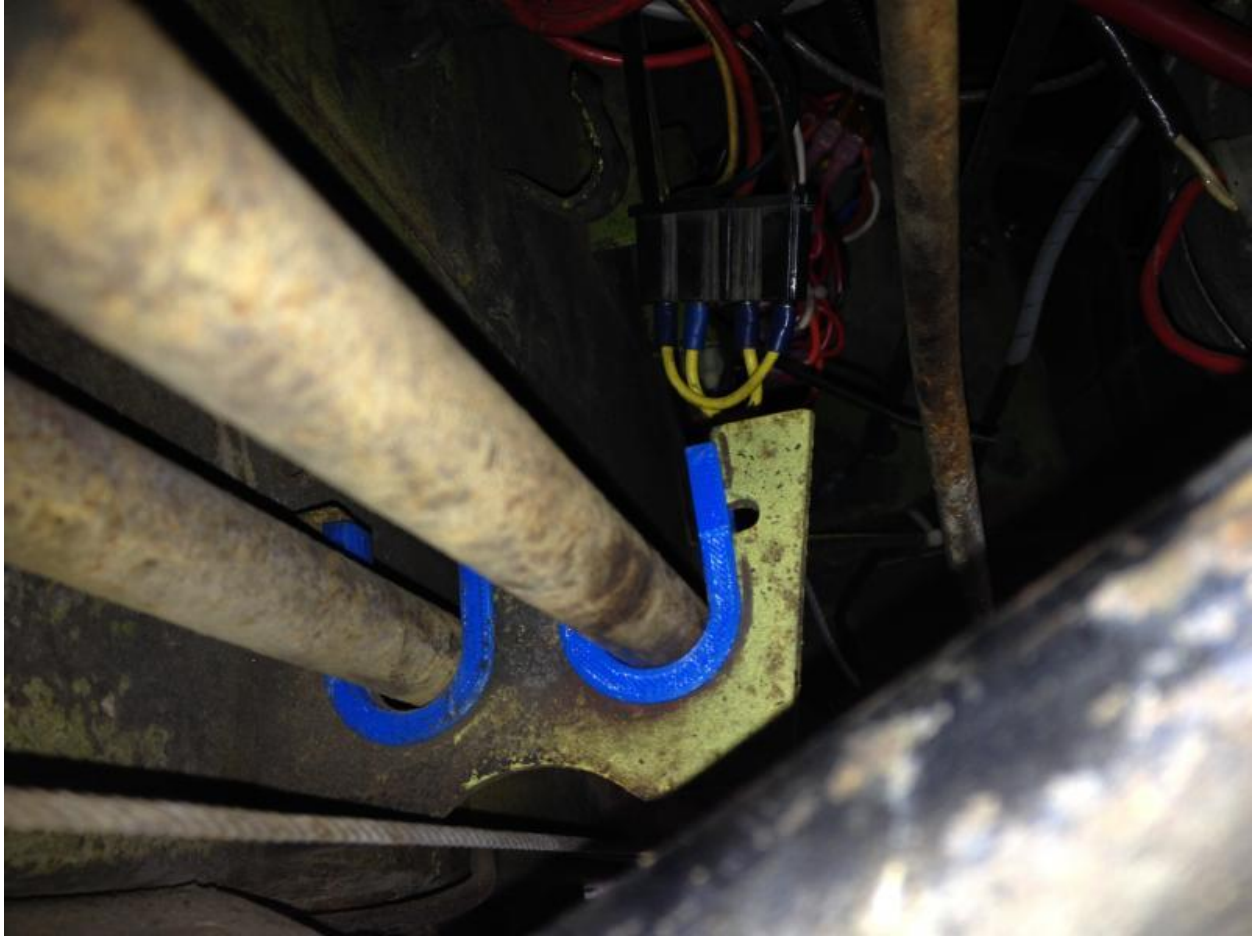
Below shows the U-shaped bushing installed. These long shift rods are hollow and move around if there's no bushing installed. I have installed several sets and have not had to disconnect the linkage at either end. There's some effort involved but they can snap in place without having to remove the rods. Use good judgement in you think you're putting too much force on the rods and disconnect the linkage if you must.

The next area for tighter shifting is the U bushings that help support the long shift rods. These are located below the driver's seat and can be seen from below. From the factory, these were made of a phenolic type material that would crack, break and fall away. In all my years of boneyarding, I've only ever seen one partial piece on a van. From that one partial piece was recreated the 3D printed bushing I have available today. Many thanks to Lucky Chuck for his CAD renderings of this bushing. Much trial and error were involved to produce a usable bushing. The way I figure, I'll never, ever break even on that item but it's just one more crazy way I demonstrate my VCVanatacism. Clearly, an affliction.

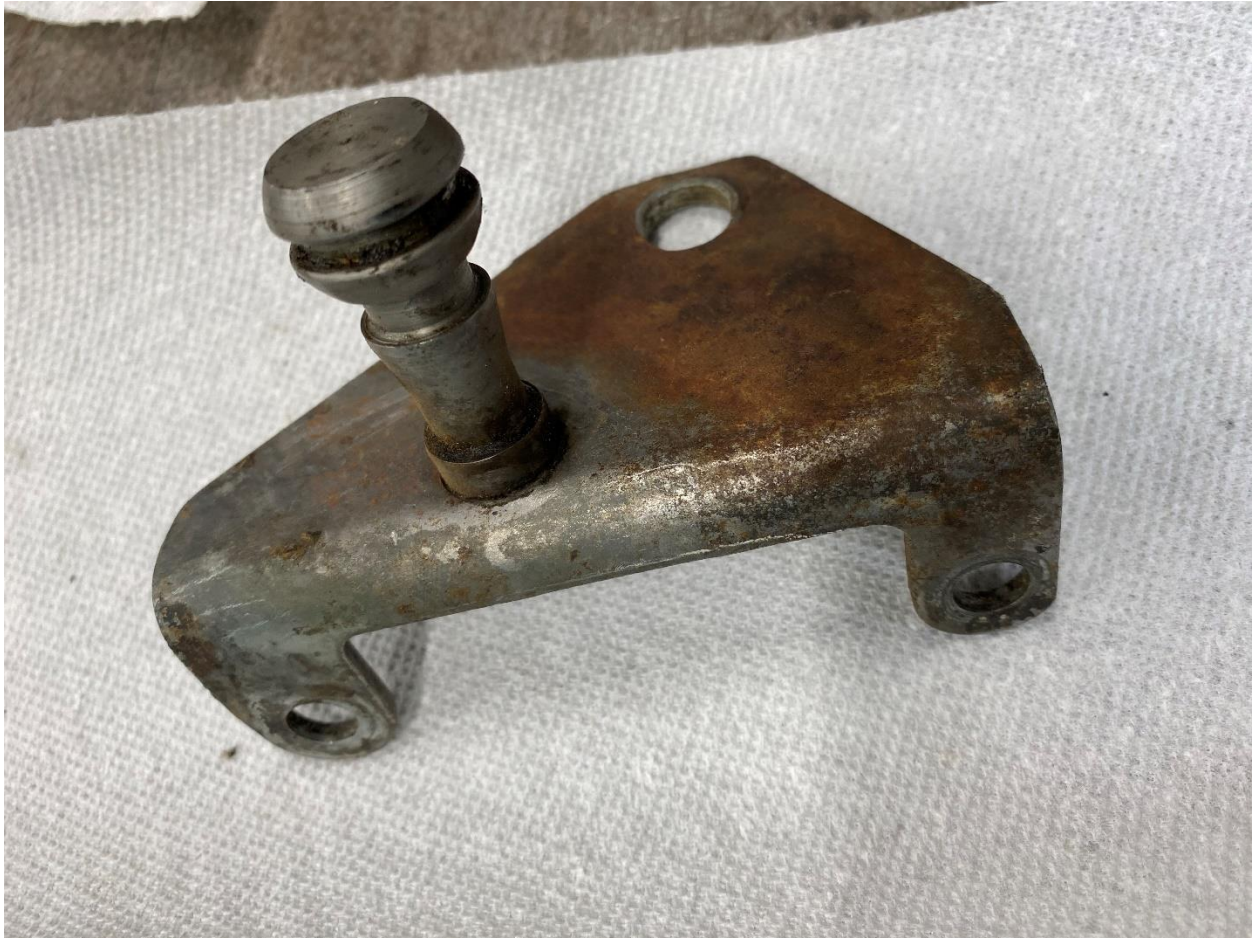
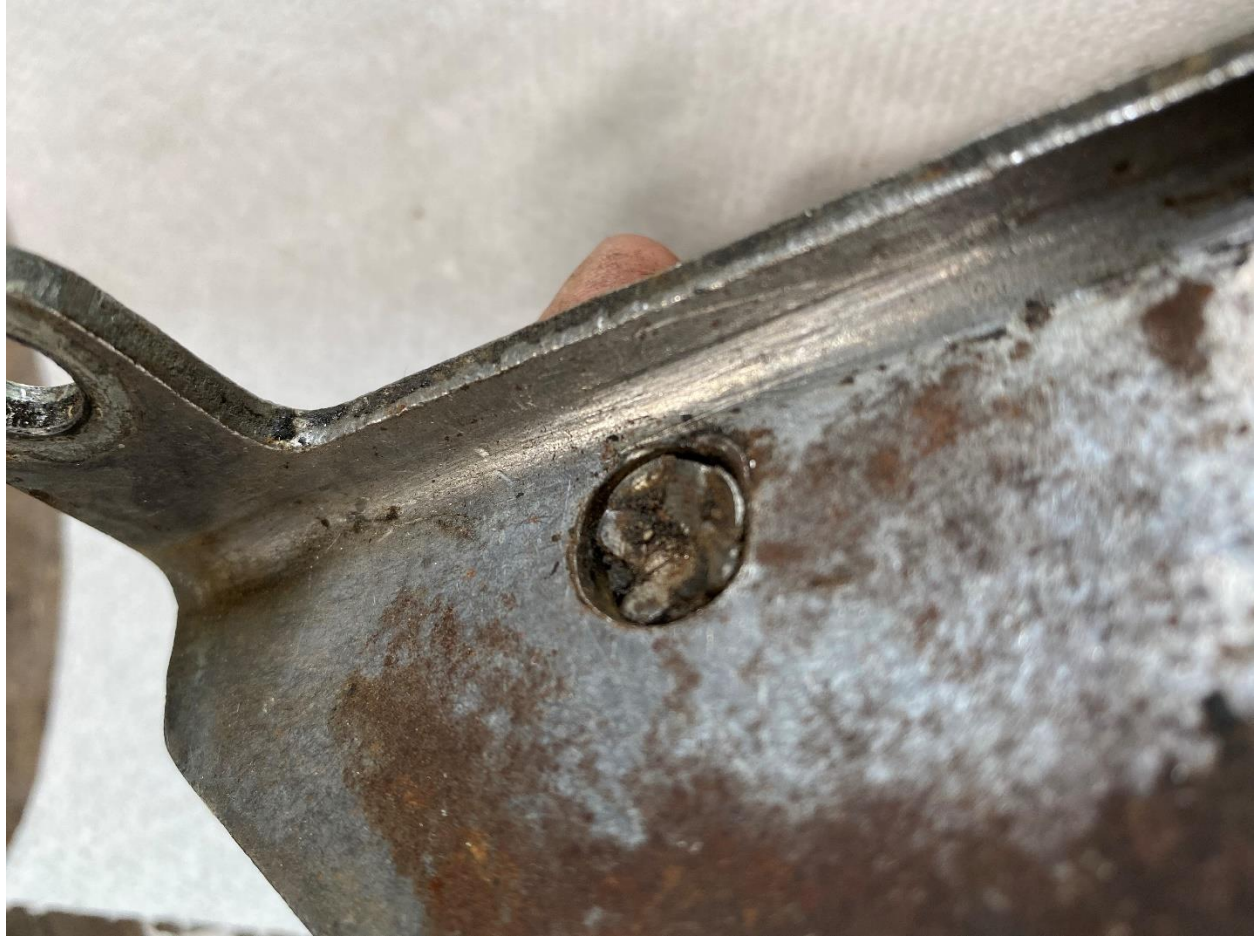
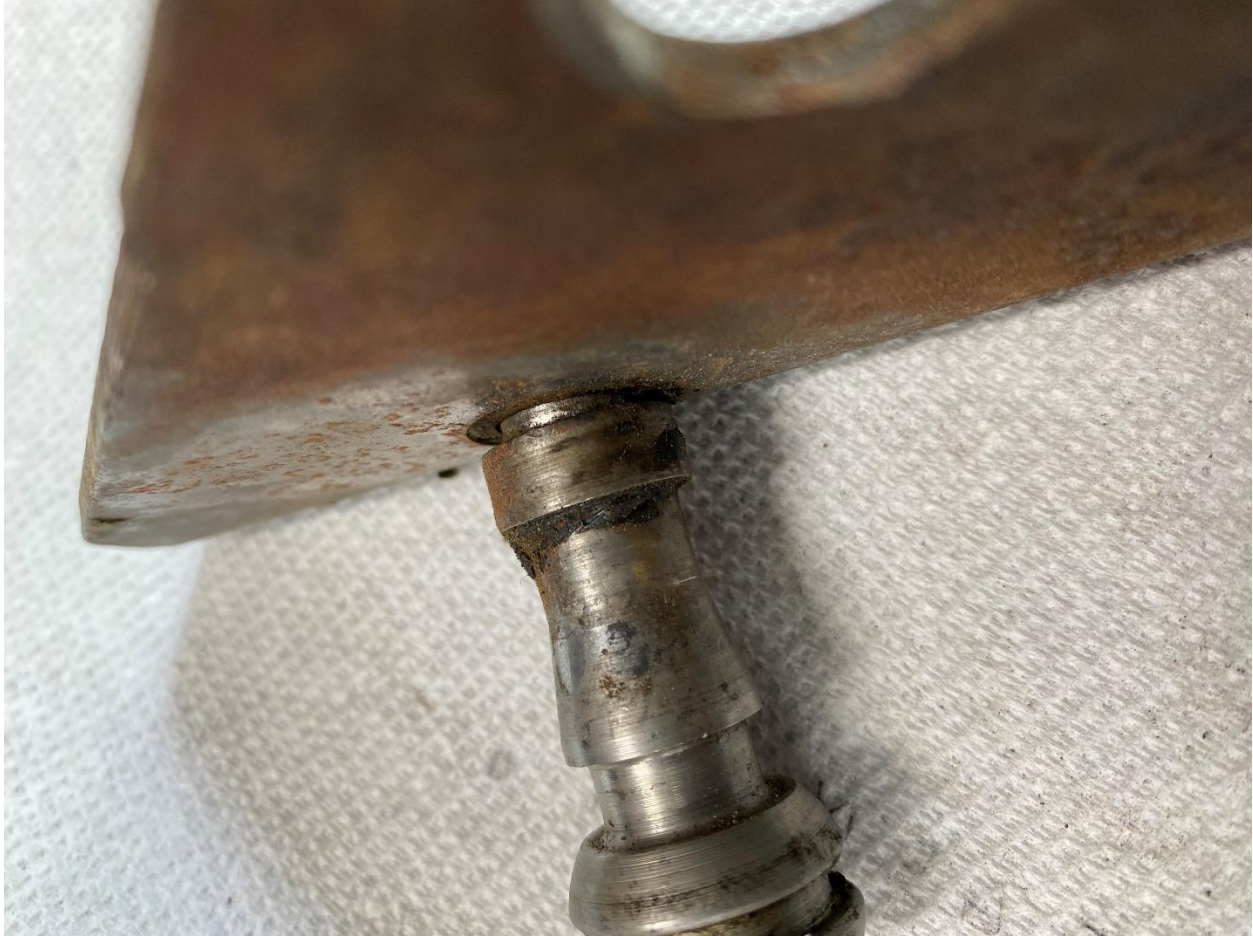
Have an assistant operate the lever and clutch pedal. Observe all points for excessive play. Inspect the clutch "Z bar" where the bracket mounts to the bell housing. This bracket has a ball stud that rides inside the Z bar. It's slightly different than the illustration on the 2nd gens. Sometimes the ball end comes loose from the bracket at the engine and less commonly at the frame end. The pic below shows the ball end bracket and how the ball is swedged into the bracket. This one is coming loose.

Once the ball end gets this loose, the clutch play increases quite a bit. If left unrepaired, it will break off and the ball may drop onto the road. Good luck finding that again. One indication of this failure is that clutch pedal play increases to maximum. (You've just lost your ball, stud.) The fix here is to remove the bracket (before it breaks), clean it up and weld that ball onto the bracket. It would be a good time to clean the Z bar and components at this time also. Once repaired, it should then be good to go for at least another 50 years.
