## How To: ID and Repair Shift Linkage Play

This “How To” covers mostly the 3 speed manual transmission equipped 1<sup>st</sup> and 2<sup>nd</sup> gen VCVs. The shift lever and related parts we have can take a lot of abuse over a 50+ year period and many areas can cause excessive looseness and more difficult shifting. I’ll start with the lever and move down towards to the transmission. The first checks are done with the engine off and in gear. I advise reading the entire article before starting any disassembly.

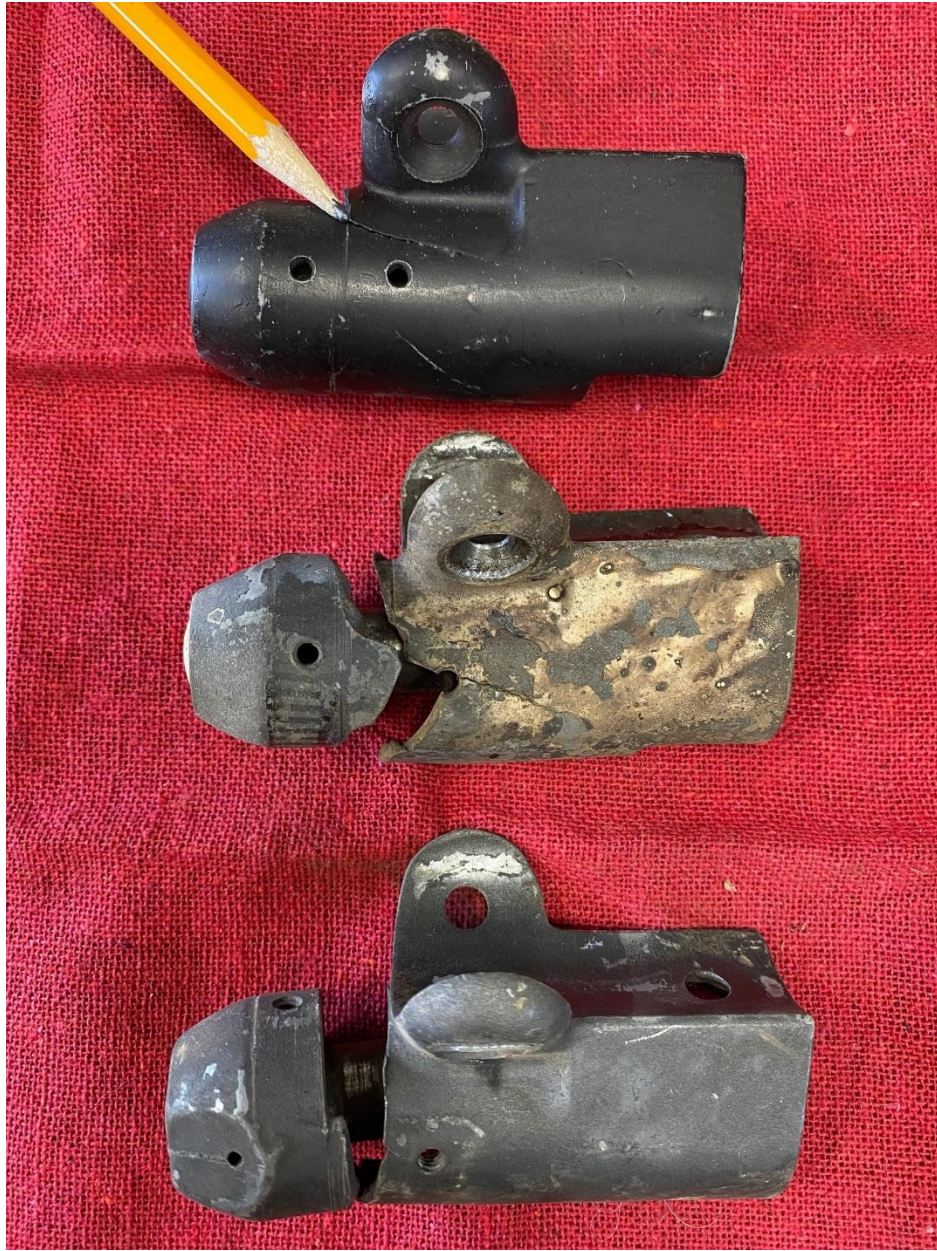
On 1st gen vans, the upper shift shaft retainer (or whatever you call it) will crack and cause looseness. This is the piece that mounts on the steering column tube and holds the upper part of the shift shaft in place. Excessive force (and weak design) causes these to crack. These pieces fail at that ridge line near the top. This failure is obvious when seated in the van. If you have to remove one of these, it’s some work. You usually have to remove the steering wheel, column, rubber floor boot and other items. It can be a lot of work and the subject of a different “How To”. Currently we have no replacement for these upper shifter pieces and believe me, we have tried. Unfortunately, the cost to repop these was just way too expensive so if anyone has a spare, it’s worth keeping. I’ve seen hose clamps wrapped around the steering column to try and hold these together. If you have one that’s too far gone, one alternative is a Lokar cable type shifter and an automatic transmission. Not exactly a quick or inexpensive fix. Every now and then, I run into a spare. Contact me if you can’t find one anywhere else. My advice is to not force the shift lever, too many hard to find or hard to install parts can break. Fix the hard shifting and play before it becomes a catastrophic failure like these

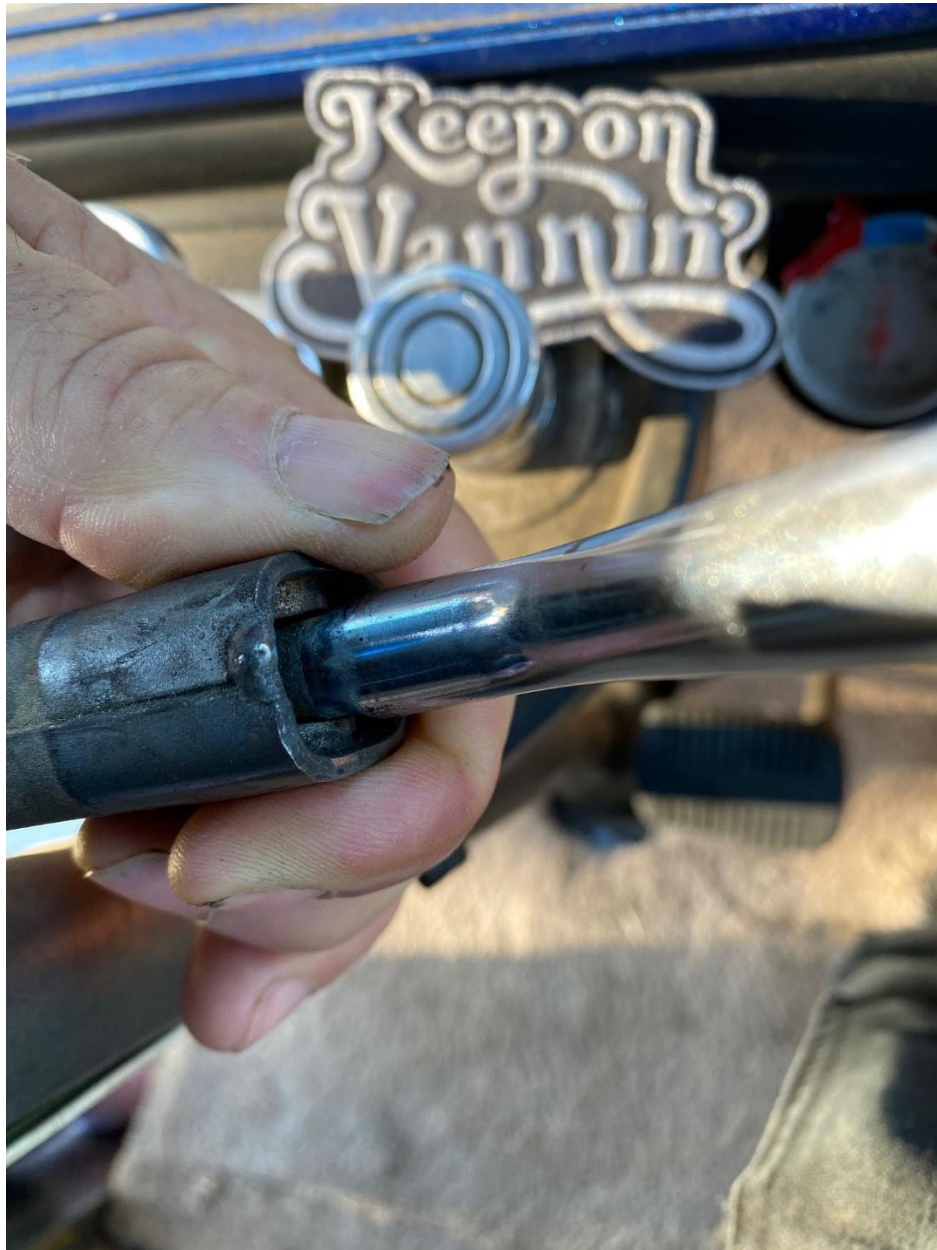
**Check for looseness** at the shift lever pivot point by first carefully pulling back the rubber boot at the base of the shift lever. Be sure not to catch the boot on the pin during removal. Warm up the boot with a hair dryer if it's cold out or it seems like it's wanting to rip. Once the boot is pulled back, you'll see the pin that holds the lever in place. Grip the lever pin like so. Your thumb should be on the top of the pin and your first finger should be on the lower part of the pin and socket.

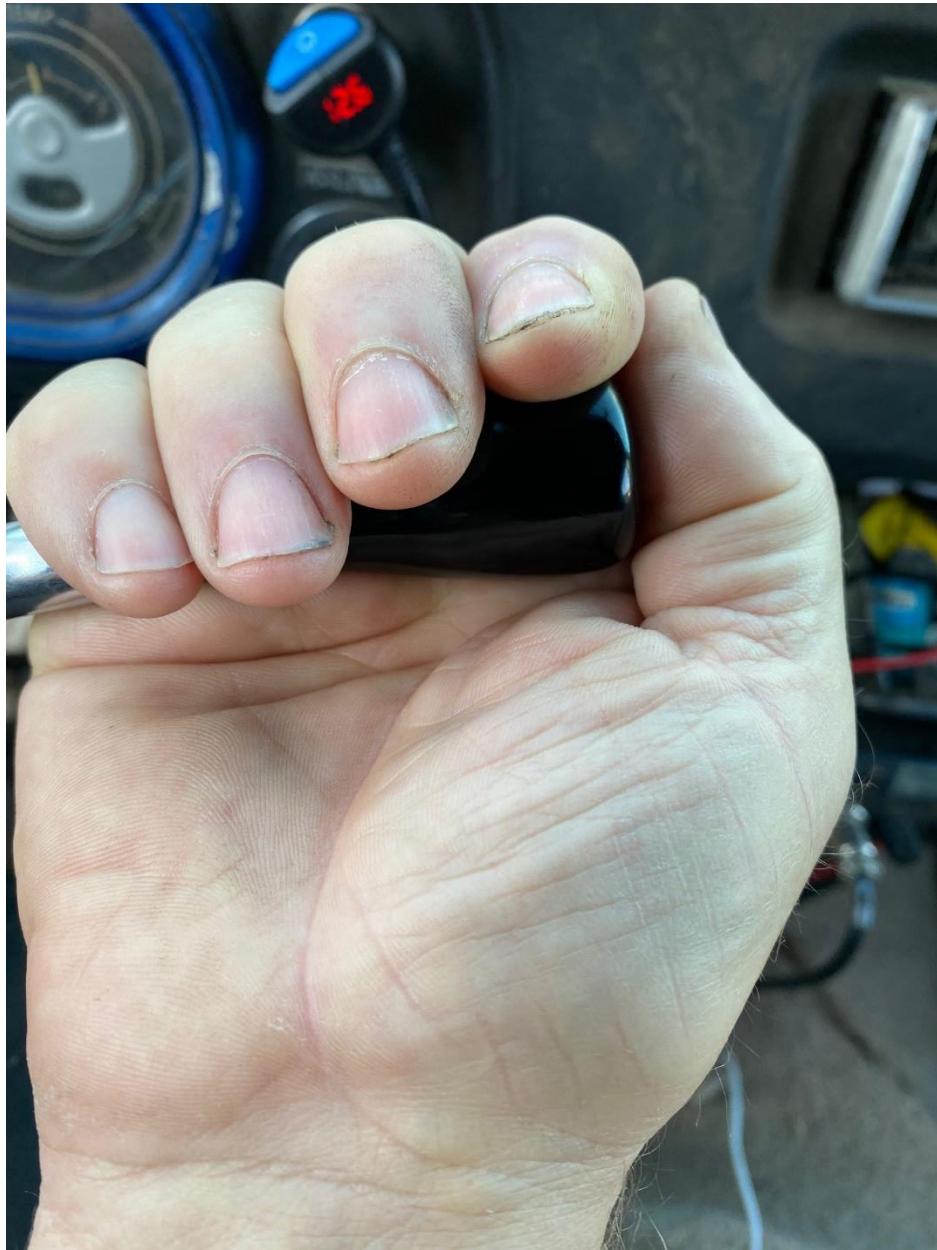
Now grip the other end of the lever like the picture below and give it a gentle twist back and forth.

There should be only minor movement at the lever while twisting. You should feel no movement at the pin. The pin should not be loose at all or rocking in the mounting hole.

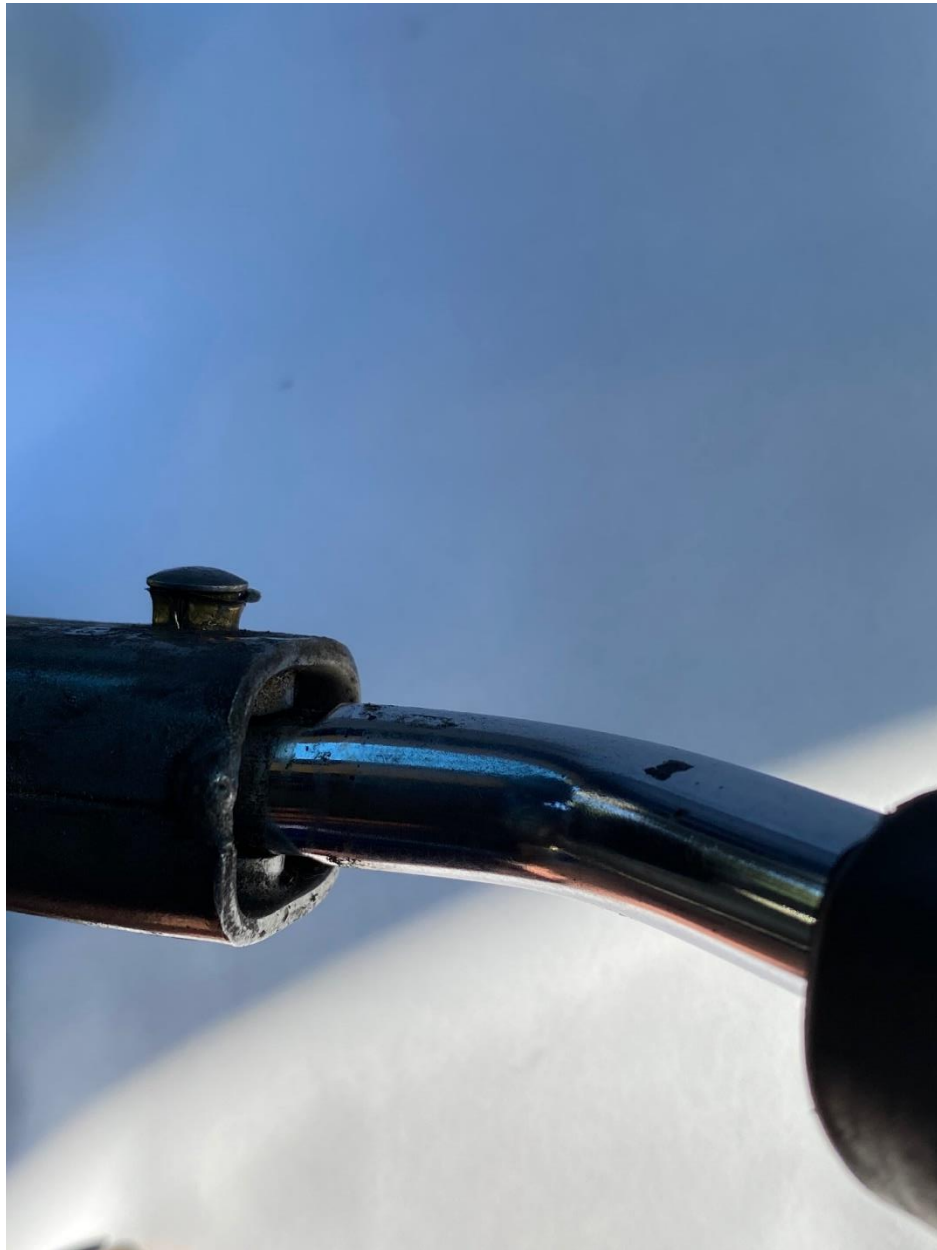
This pin is loose and backing out. The bottom part of the pin no longer contacts the lower part of the lever mount. Since the rubber boot will tend to keep the pin from backing out all the way, the pin rides partially backed out. This wears away the upper mounting hole over time. This then makes for even more play. It happens over time and slowly gets worse.

There are several ways to try and fix this. The first thing you can try is to pull the pin and wrap some shim stock or aluminum foil around the pin splines located near the top of the pin. The splines on the pin are the only thing holding the pin in place. The lower part holds the pin steady but I don't think

there's much on the bottom part of the pin that holds it in place. If you do use something like foil, try to use just a single wrap around the splines. If more than one layer is required, then try the heavy-duty foil which is a little thicker. I haven't found any replacement splined pins for this yet, has anybody? The local hardware store had some tapered pins and also some cylindrical pins that were the same size but if the hole is enlarged, it's still going to be a problem.

Other fixes I've seen are to install a small bolt and self-locking nut. This works but then the rubber boot doesn't fit over it anymore. I've thought of tapping the holes and installing a stainless pan head screw. With the correct bolt, the boot would probably fit again. I'm open to hearing ideas on how to make durable repairs that don't involve too much modification.

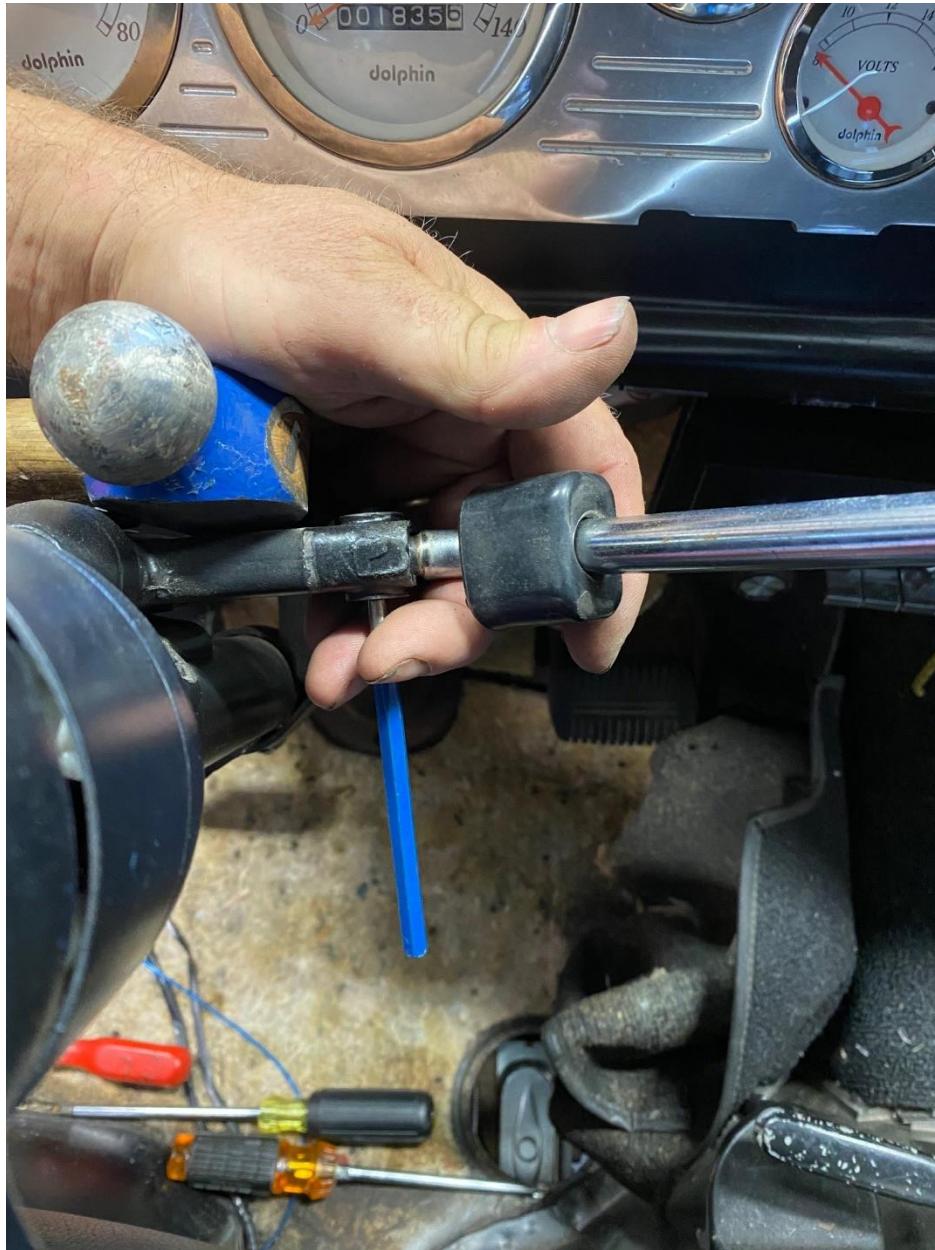
This is how I prepare to hammer the pin out.

Hold a big ball peen hammer or similar weight on the top of the shift lever shaft while holding a pointed punch on the bottom of the pin. This keeps the upper shift lever shaft from taking too much punishment while removing the pin. Before using a hammer on the punch, wrap the ball peen hammer

in a cloth to protect the shift lever shaft. This pic was used to show the proper positioning of the tools and how to hold them.

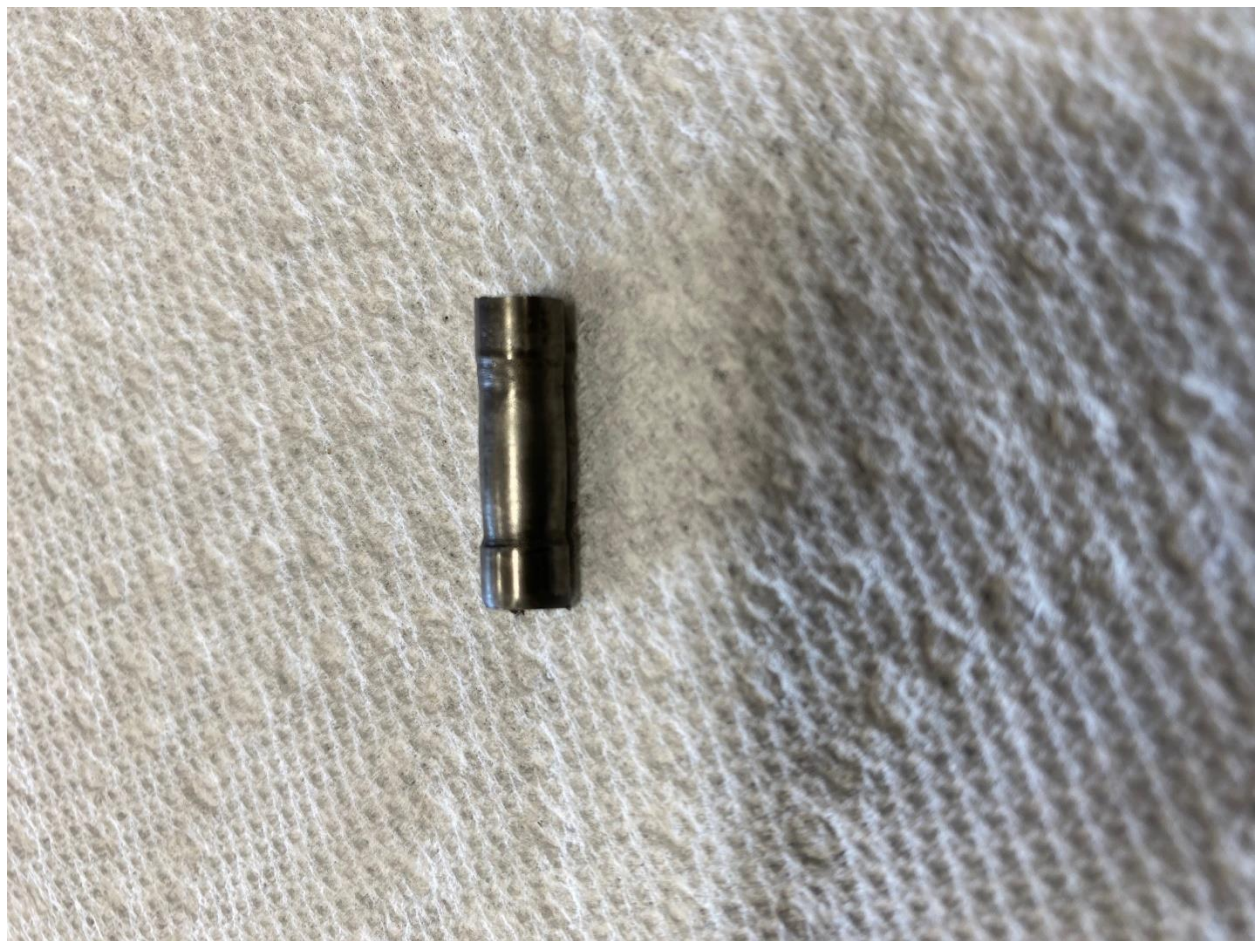
Sometimes on first gens, a different pin is used. I've seen one like the pic below. These are shorter and have no splines. They are shaped like a smooth cylinder and are much tougher to remove. Once you start banging away on this pin, you'll think you're trying to push it the wrong way. Be sure you have a well-fitting pin punch and are backing up the shift lever with as big a weight as possible. I wish I had a small pin press that fit neatly around the lever. That way I could press these out instead of hammer them out. When I have run into these types of pins, it has taken me a lot more hammering than I wanted to. Luckily, I don't run into these as often.

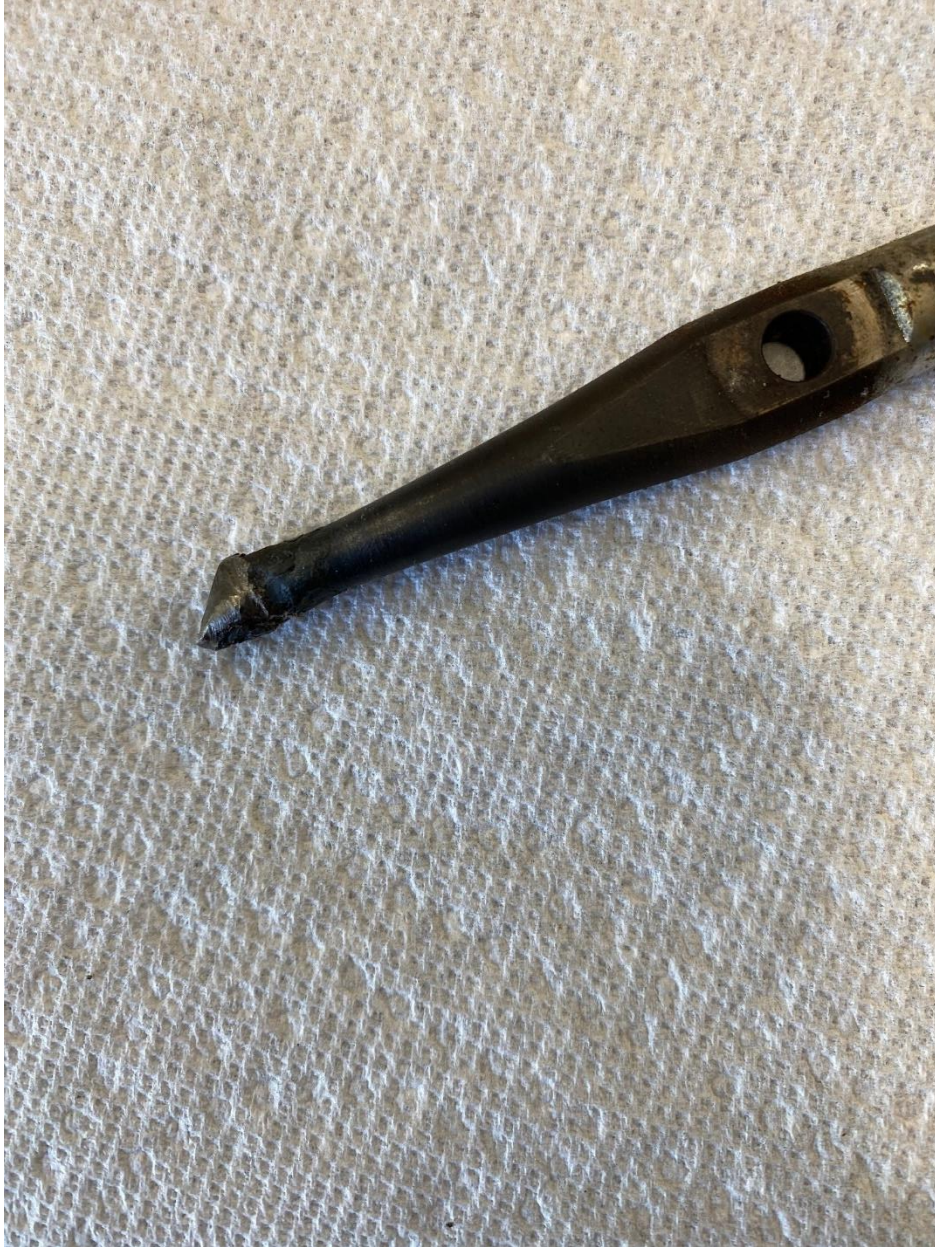
Once the shift lever is removed, check to see if the ball end is in place. One of the previous pics (with the pin punches) shows the ball on the end is unbroken. If the ball is missing, check the socket to see if the broken ball end is there. These broken ball ends on the shifter are another common source of

looseness. This part breaks when too much force is used on the lever. The fix is to replace the lever or take it to a welder and see if they are willing to try a fix. Below pic shows one I pulled out that was repaired. It's a lot easier to weld material onto the end than it is to reshape the end into a ball. Maybe a ball bearing can be welded on the tip?

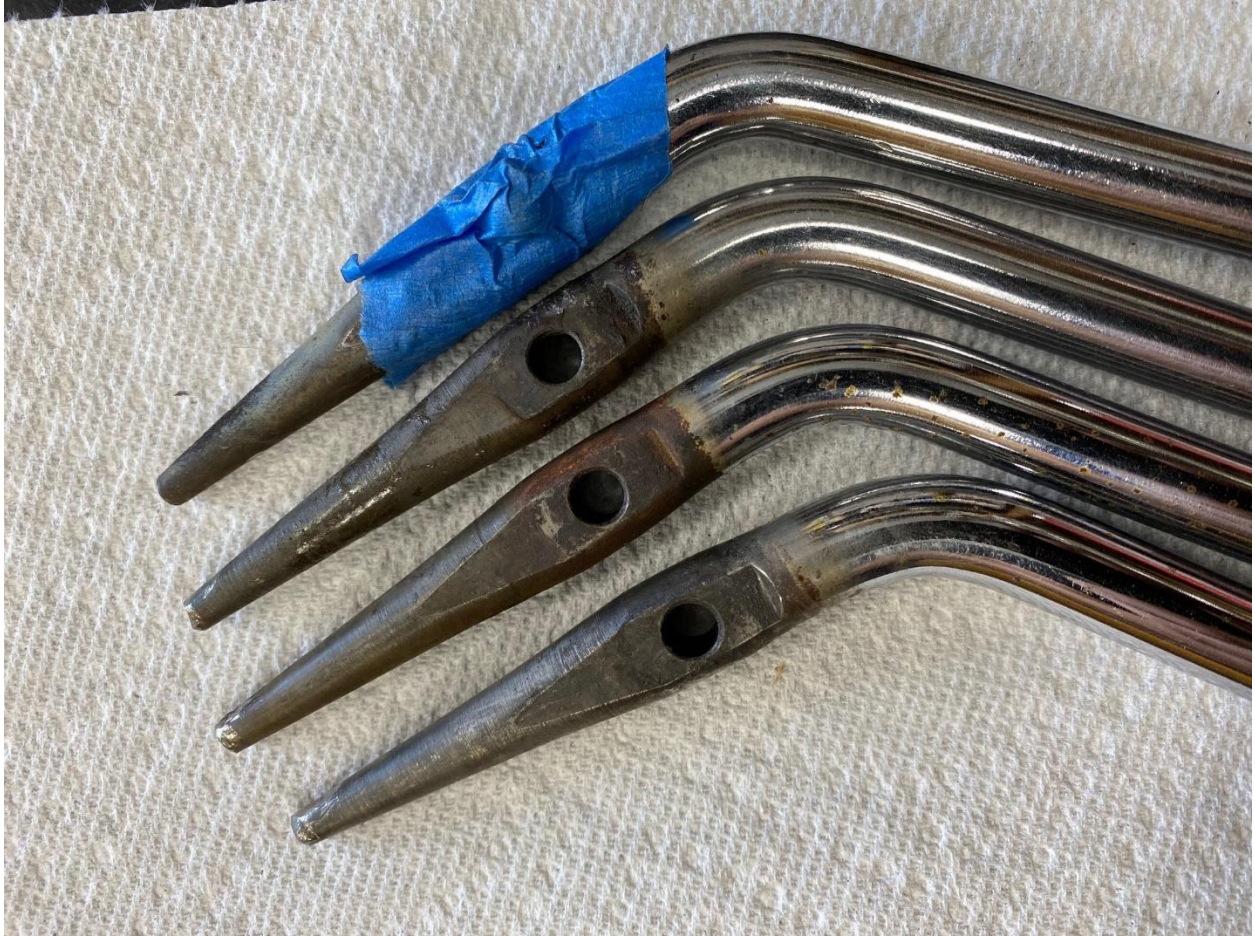
Below pic shows a bunch of shift levers with broken ends.

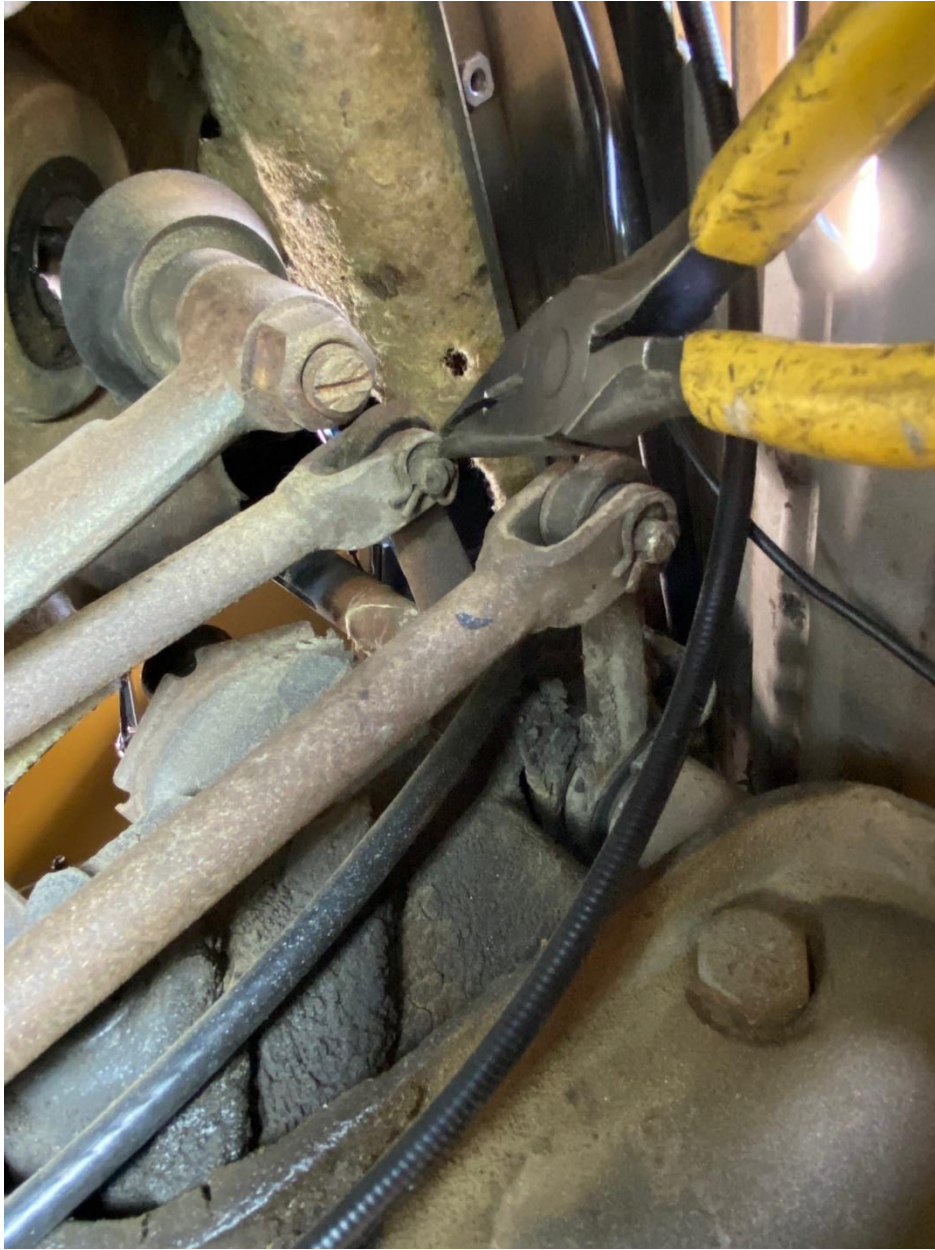
Remove the belly pan to access the levers. Pull the retaining clip and remove the pin and bushings for closer inspection. When you pull the retaining clip, the pin and bushings can fall out so be sure they don't get away from you. The 1<sup>st</sup> gens have a U shaped rod end and the 2<sup>nd</sup> gens have the pin built into the end of the rods which makes them more difficult to remove.

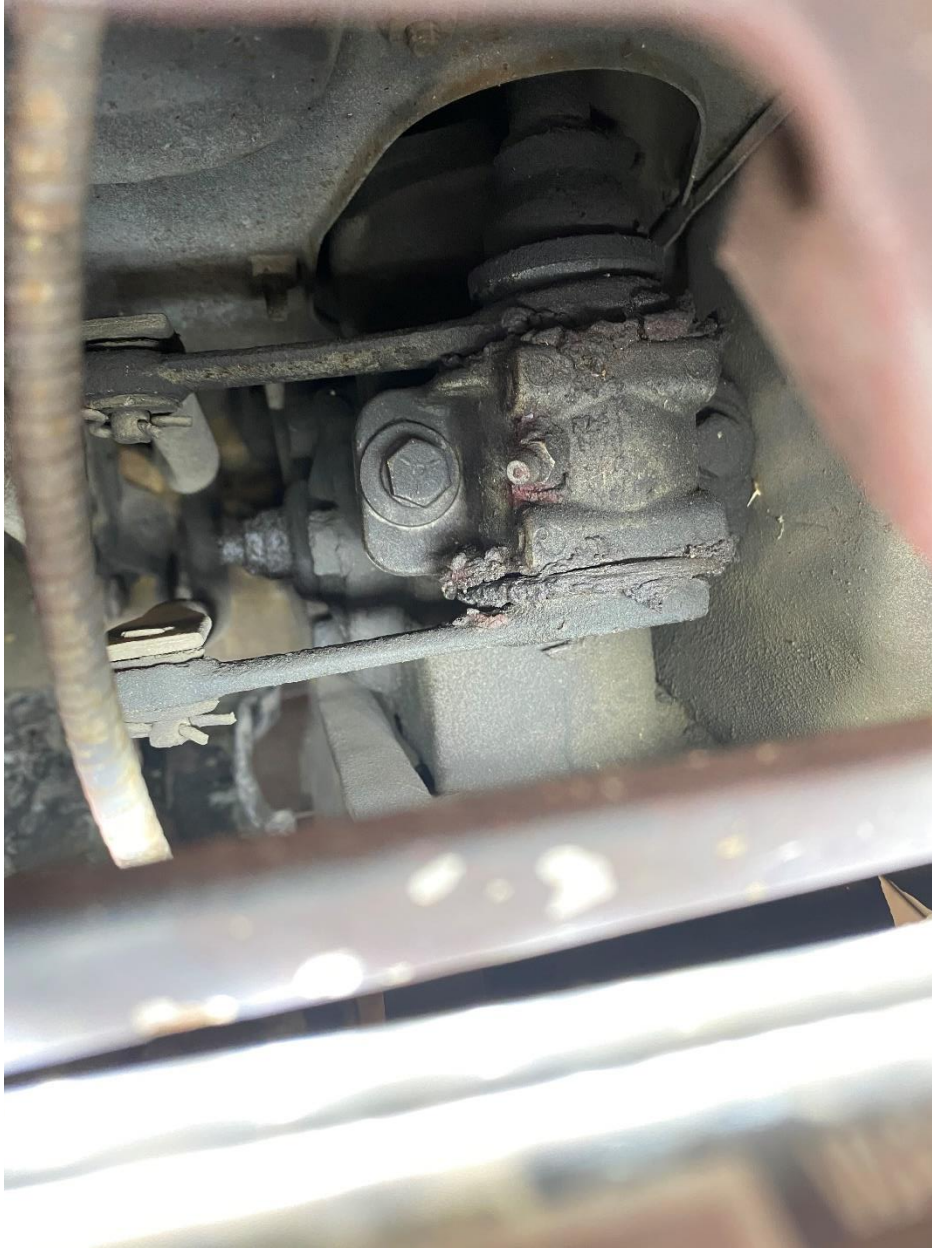
The pic below shows the 2<sup>nd</sup> Gen VCVs shift mechanism. The 2<sup>nd</sup> gens have a flat spot on the main body that (I believe) is intended for a grease fitting but I have never seen one installed from the factory. It comes from the factory not even drilled or tapped for a fitting. (WTH!) If you have opportunity to remove one, I advise installing a grease fitting as shown.

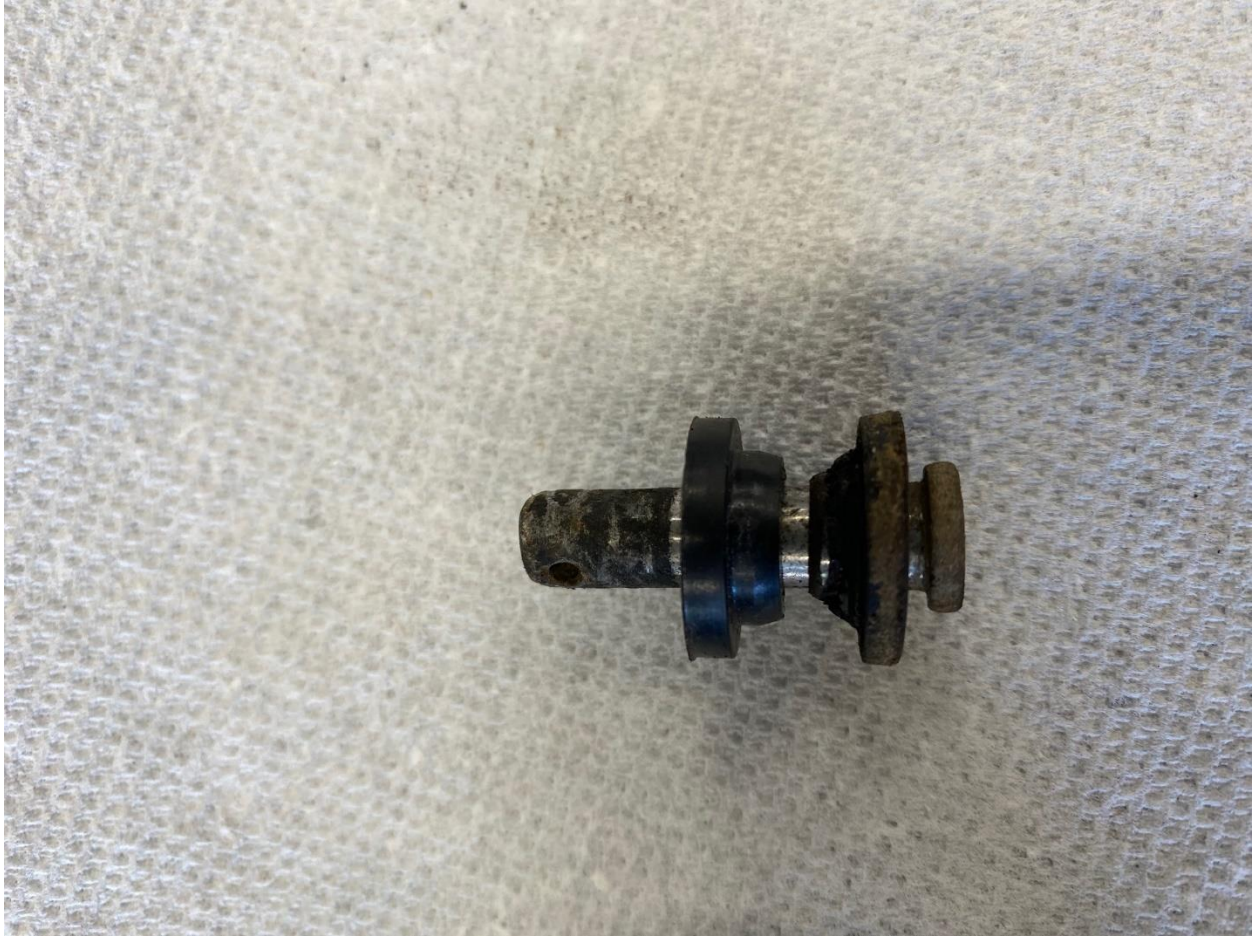
The pic below shows a new bushing next to an old one. The new bushing is much more squared off and will result in much less looseness. I'm having trouble locating these bushings, any help is appreciated. There was a couple of Hurst Shift Arm Bushing Pit Pack kits available but they didn't fit the 1<sup>st</sup> gen shift arm I was working on. I'm looking for replacement bushings.

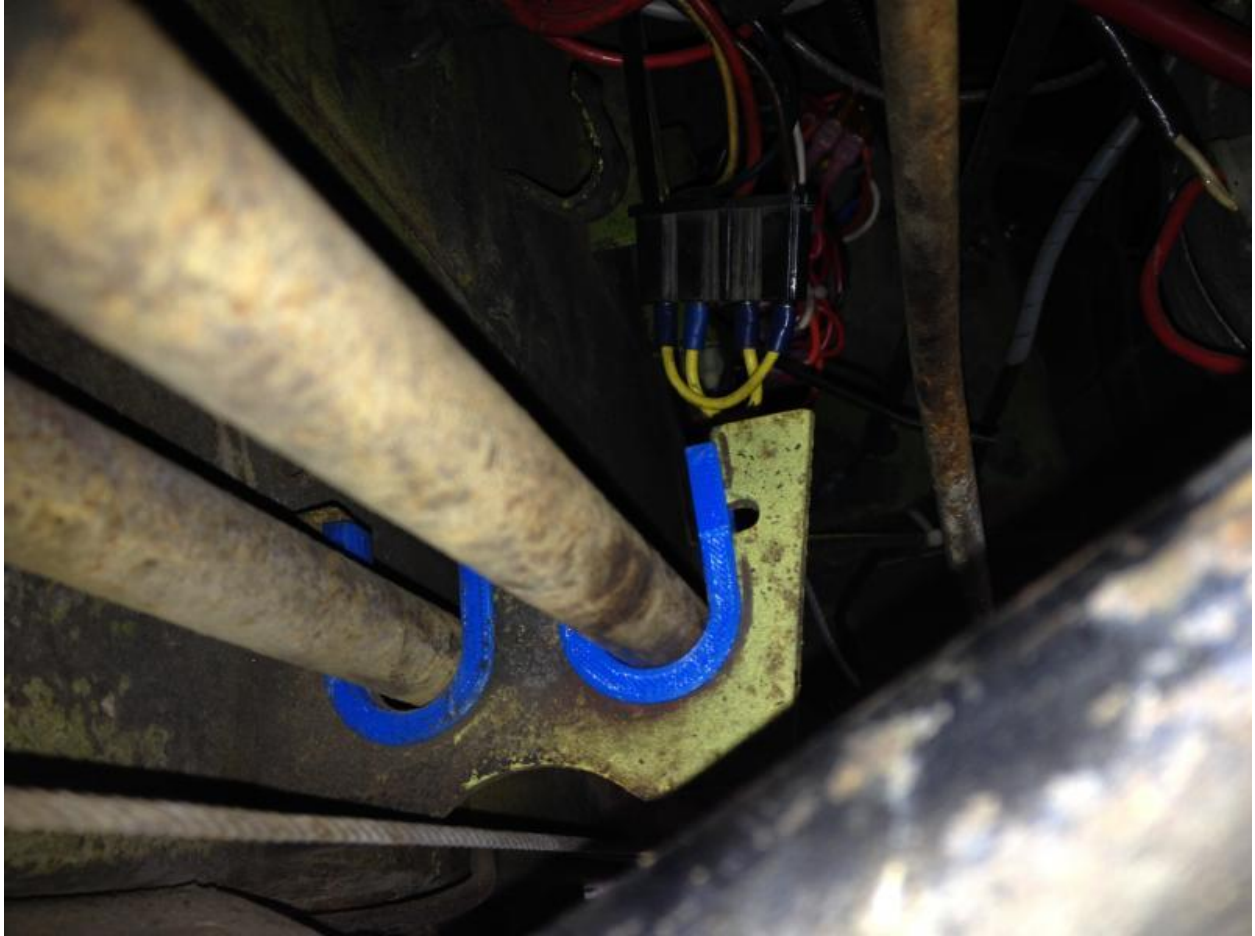
Below shows the U-shaped bushing installed. These long shift rods are hollow and move around if there's no bushing installed. I have installed several sets and have not had to disconnect the linkage at either end. There's some effort involved but they can snap in place without having to remove the rods. Use good judgement in you think you're putting too much force on the rods and disconnect the linkage if you must.

The next area for tighter shifting is the U bushings that help support the long shift rods. These are located below the driver's seat and can be seen from below. From the factory, these were made of a phenolic type material that would crack, break and fall away. In all my years of boneyarding, I've only ever seen one partial piece on a van. From that one partial piece was recreated the 3D printed bushing I have available today. Many thanks to Lucky Chuck for his CAD renderings of this bushing. Much trial and error were involved to produce a usable bushing. The way I figure, I'll never, ever break even on that item but it's just one more crazy way I demonstrate my VCVanatacism. Clearly, an affliction.
