Subject Facility: **North Country Environmental Services, Inc., 581 Trudeau Rd, Bethlehem**
Permit No DES-SW-SP-03-002
Solid Waste Facility Inspection Report

On September 9, 2025, the New Hampshire Department of Environmental Services conducted a focused landfill cover inspection at the subject solid waste facility. The inspection was conducted to determine compliance with landfill cover requirements in RSA 149-M, the New Hampshire Solid Waste Rules Env-Sw 100-2000, and the facility permit.

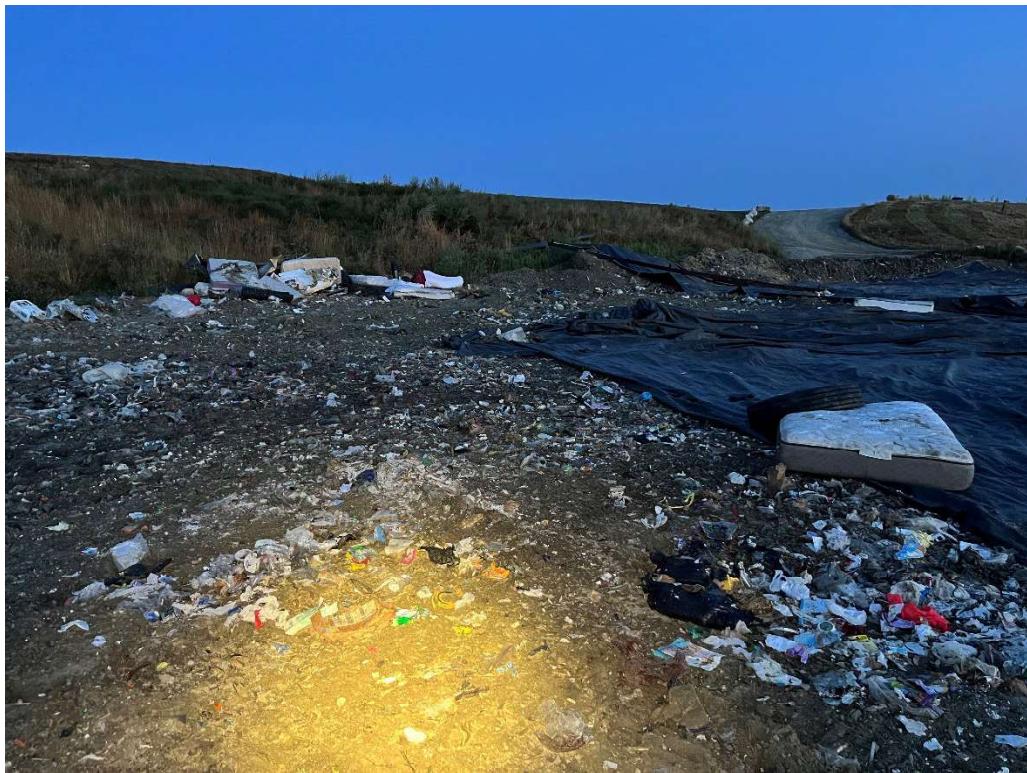
IMG_1662

Env-Sw 806.03(c): At landfills receiving municipal solid waste, Env-Sw 806.03(c) requires cover material to be placed over all exposed waste no less frequently than at the end of each operating day. During the inspection, incomplete cover application was observed at the working face (IMG_1662, IMG_1663, IMG_1666, IMG_1667).

Corrective Action: Immediately place adequate cover material over all waste at the facility and submit photos to NHDES showing cover application. Note: On September 9, 2025, the facility submitted photos to NHDES showing appropriate cover application in the areas noted in this report.
