**Re: NCES Repeated Enforcement Request**

**SUBJECT: Hydrogeological Opinion  
Release Events at the NCES Landfill Site  
Bethlehem, New Hampshire**

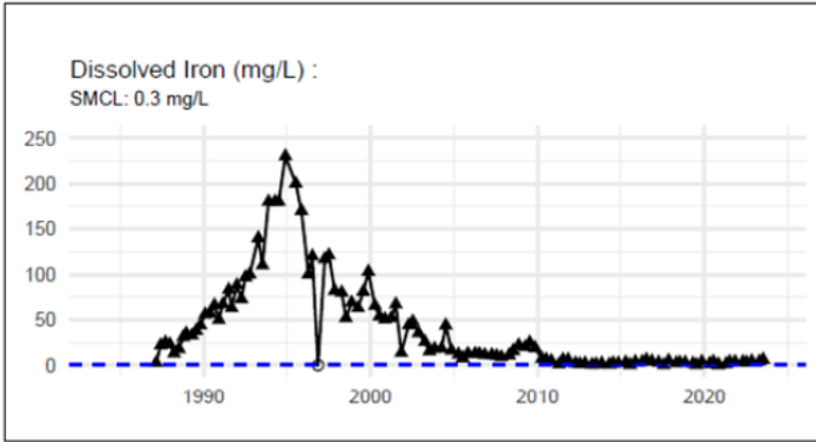
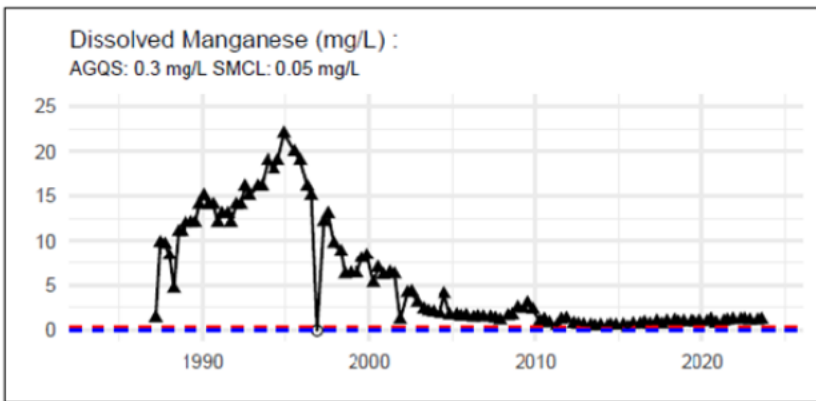
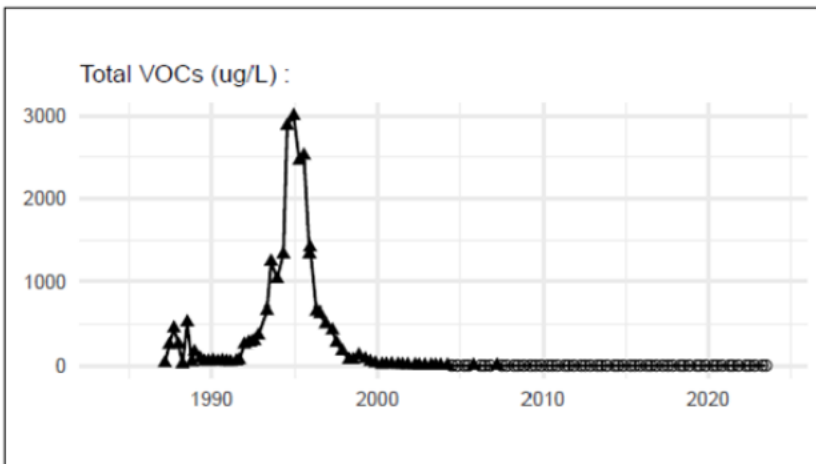
SIZE	CALEX PROJECT	DWG NO	REV
		<b>Figure 1</b>	
Drawn By:	March 2024	SHEET

Notes: Plots taken from Page 283/483 of July "2023 Tri-Annual/2023 Annual Water Quality Monitoring Results", August 2023, SHA.

## Example Trend Plots from B-103D for Releases from Sanco Landfill Excavation

These historical analytical data show that historical releases from the old landfill flowed downgradient with the groundwater and dissipated, such that the groundwater data returned to “background” conditions in some wells. In B-103D illustrated in **Figure 1**, the iron and manganese returned to background a bit after 2010. For VOCs, the return to background appeared to occur mostly prior to 2000, as illustrated in **Figure 1**. These trend plots clearly illustrate the slug of contaminants that were released into groundwater during Sanco landfill removal activities that dissipated over time.

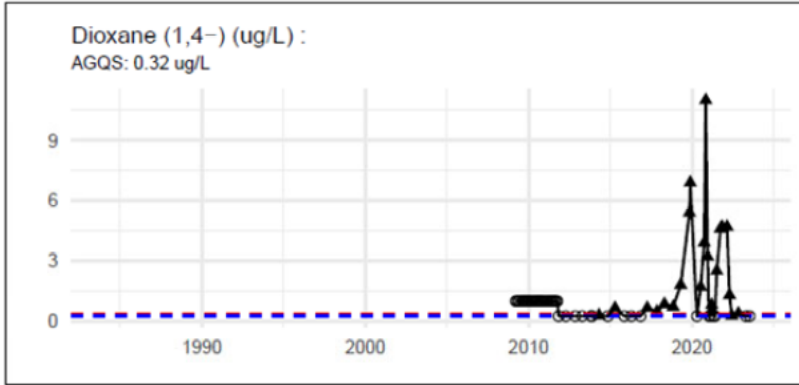
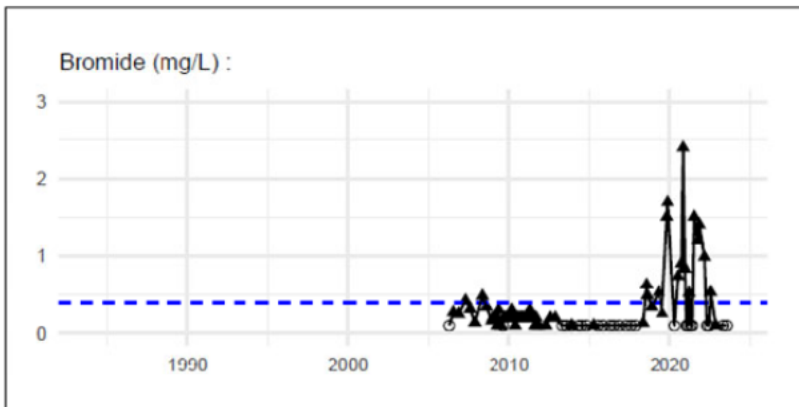
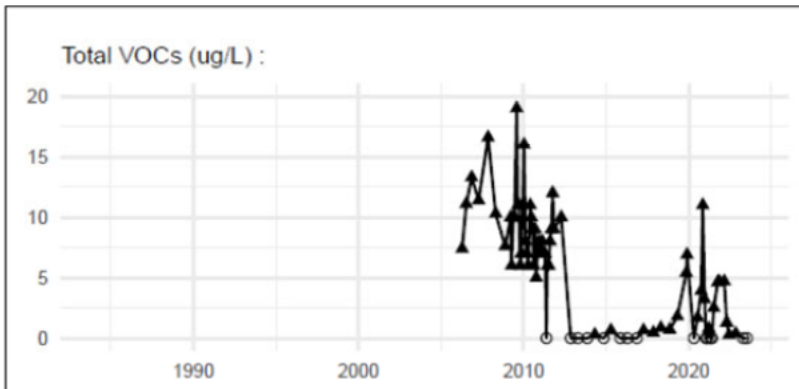
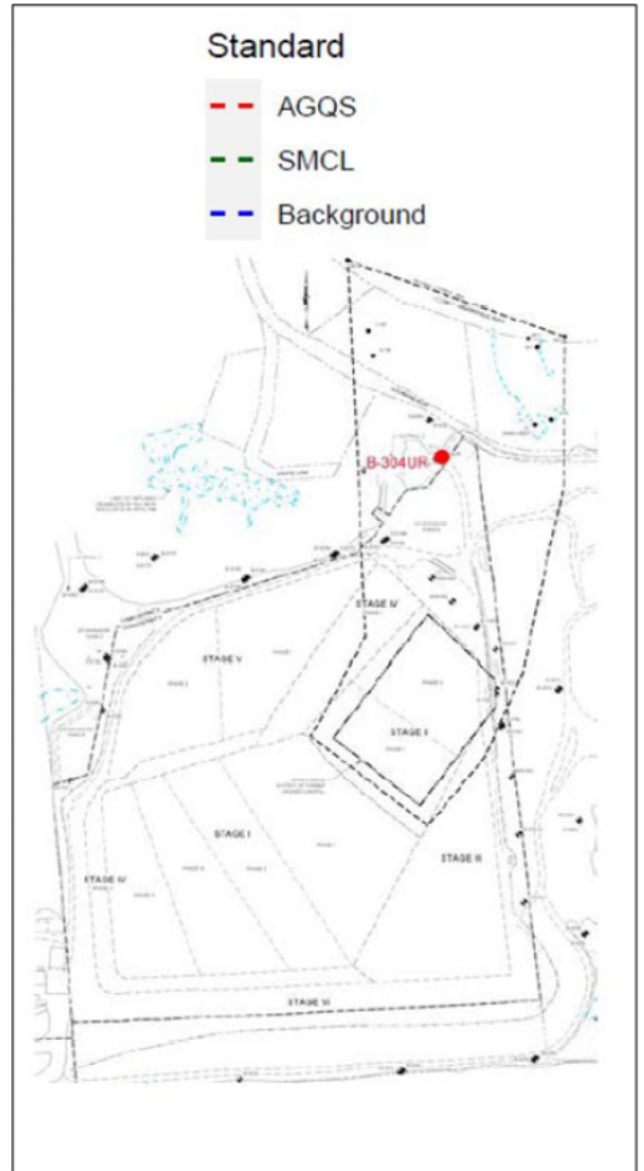
SIZE	CALEX PROJECT	DWG NO	REV
		<b>Figure 2</b>	
Drawn By:	March 2024	SHEET

Notes: Plots taken from Page 269/483 of July "2023 Tri-Annual/2023 Annual Water Quality Monitoring Results", August 2023, SHA.

## Example Trend Plots from B-304UR for Releases from Post – 1996 Waste Disposal Operations

illustrating the dissipation of an apparent spike of VOCs and 1,4 dioxane in the mid 2000s to early 2012 timeframe while B-304UR (pg. 269/483) showed high VOCs and low detections of bromide in the subject timeframe. **Figure 2** illustrates some of the trend plots for B-304UR taken from the Report, pg. 269/483.

The Site plan on **Figure 2** identifies the location of B-304UR as a red dot which is located about halfway down into the GMZ. In looking at the analyte plots of **Figure 2**, one sees large spikes of VOC detections in the mid 2000s until about 2012 or 2013, while the apparent smaller detections of bromide are driven by the different plot scales (mg/l versus ug/l) of the results. The 1,4 dioxane plot shows consistent detections in the same timeframe. These data, (and the other wells listed by NHDES) showing spikes in VOCs comingled with bromide detections, indicated to NHDES that these release(s) were not from the old landfill, but had instead occurred from the operating landfill.

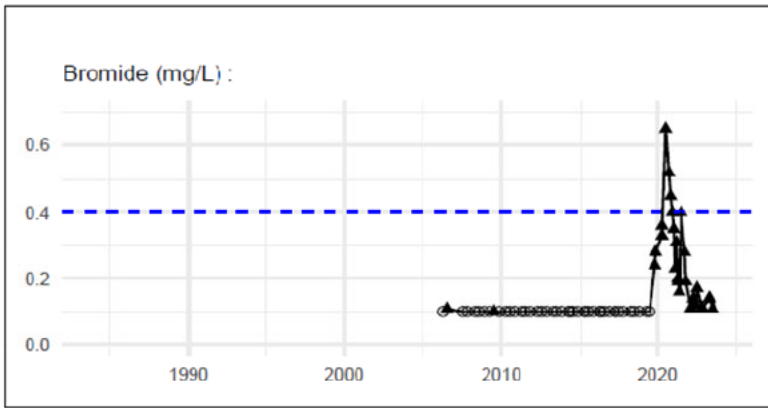
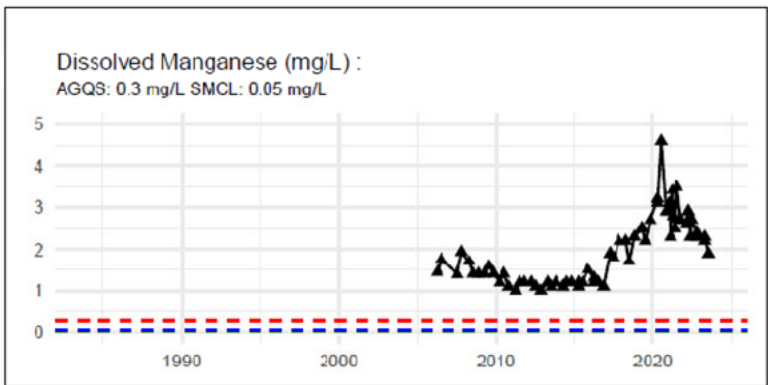
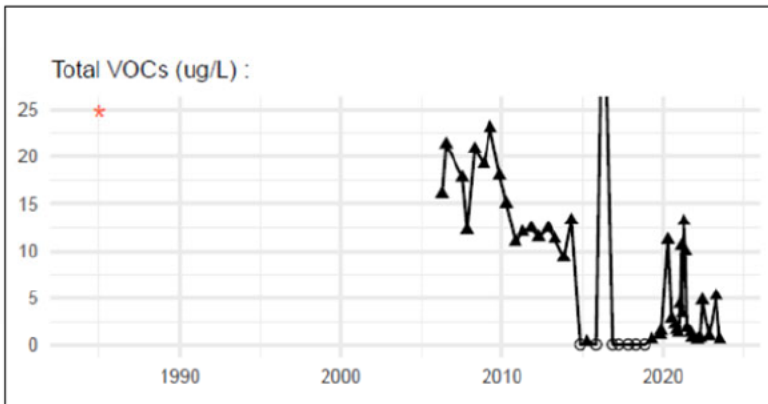
Notes: Plots taken from Page 270/483 of July "2023 Tri-Annual/2023 Annual Water Quality Monitoring Results", August 2023, SHA.

**Figure 3** illustrates some trend plots from B-304DR, a well located within the GMZ and near B-304UR that was illustrated in **Figure 2**. The plots show spikes in bromide detections very clearly beginning prior to 2020 and falling off sharply. The manganese plot in **Figure 3** shows a broad

spike around the same period, but still remaining above standards, while the VOCs plot shows a similar discrete timeframe of detections. These data suggest impacts from releases from the operating landfill since the bromide is commingled in the groundwater. These same trend observations are also illustrated in **Figure 2** for the same 2018 to 2023 timeframe.
