SITE VISIT REPORT	New Hampshire Department of Environmental Services Waste Management Division P.O. Box 95, 29 Hazen Drive Concord, NH 03302-0095 Phone: 603-271-2925 Fax: 603-271-2456
---	--------------------------	---

Visit Information			
Date of Visit	May 10, 2021	NHDES Staff Conducting Site Visit	Jaime Colby, NHDES-SWMB James O'Rourke, NHDES-WMD
Time Arrival / Departure	10:00 AM – 12:30 PM	Weather	Sunny, 55-60°F
Purpose of Site Visit	Follow-up on leachate spill reported on May 3, 2021		
Photos Taken: <input checked="" type="checkbox"/> Yes <input type="checkbox"/> No (If yes, see photo log, Attachment A)			
Samples Collected: <input type="checkbox"/> Yes <input checked="" type="checkbox"/> No (If yes, see sample collection log)

Attachment A - Photograph Log

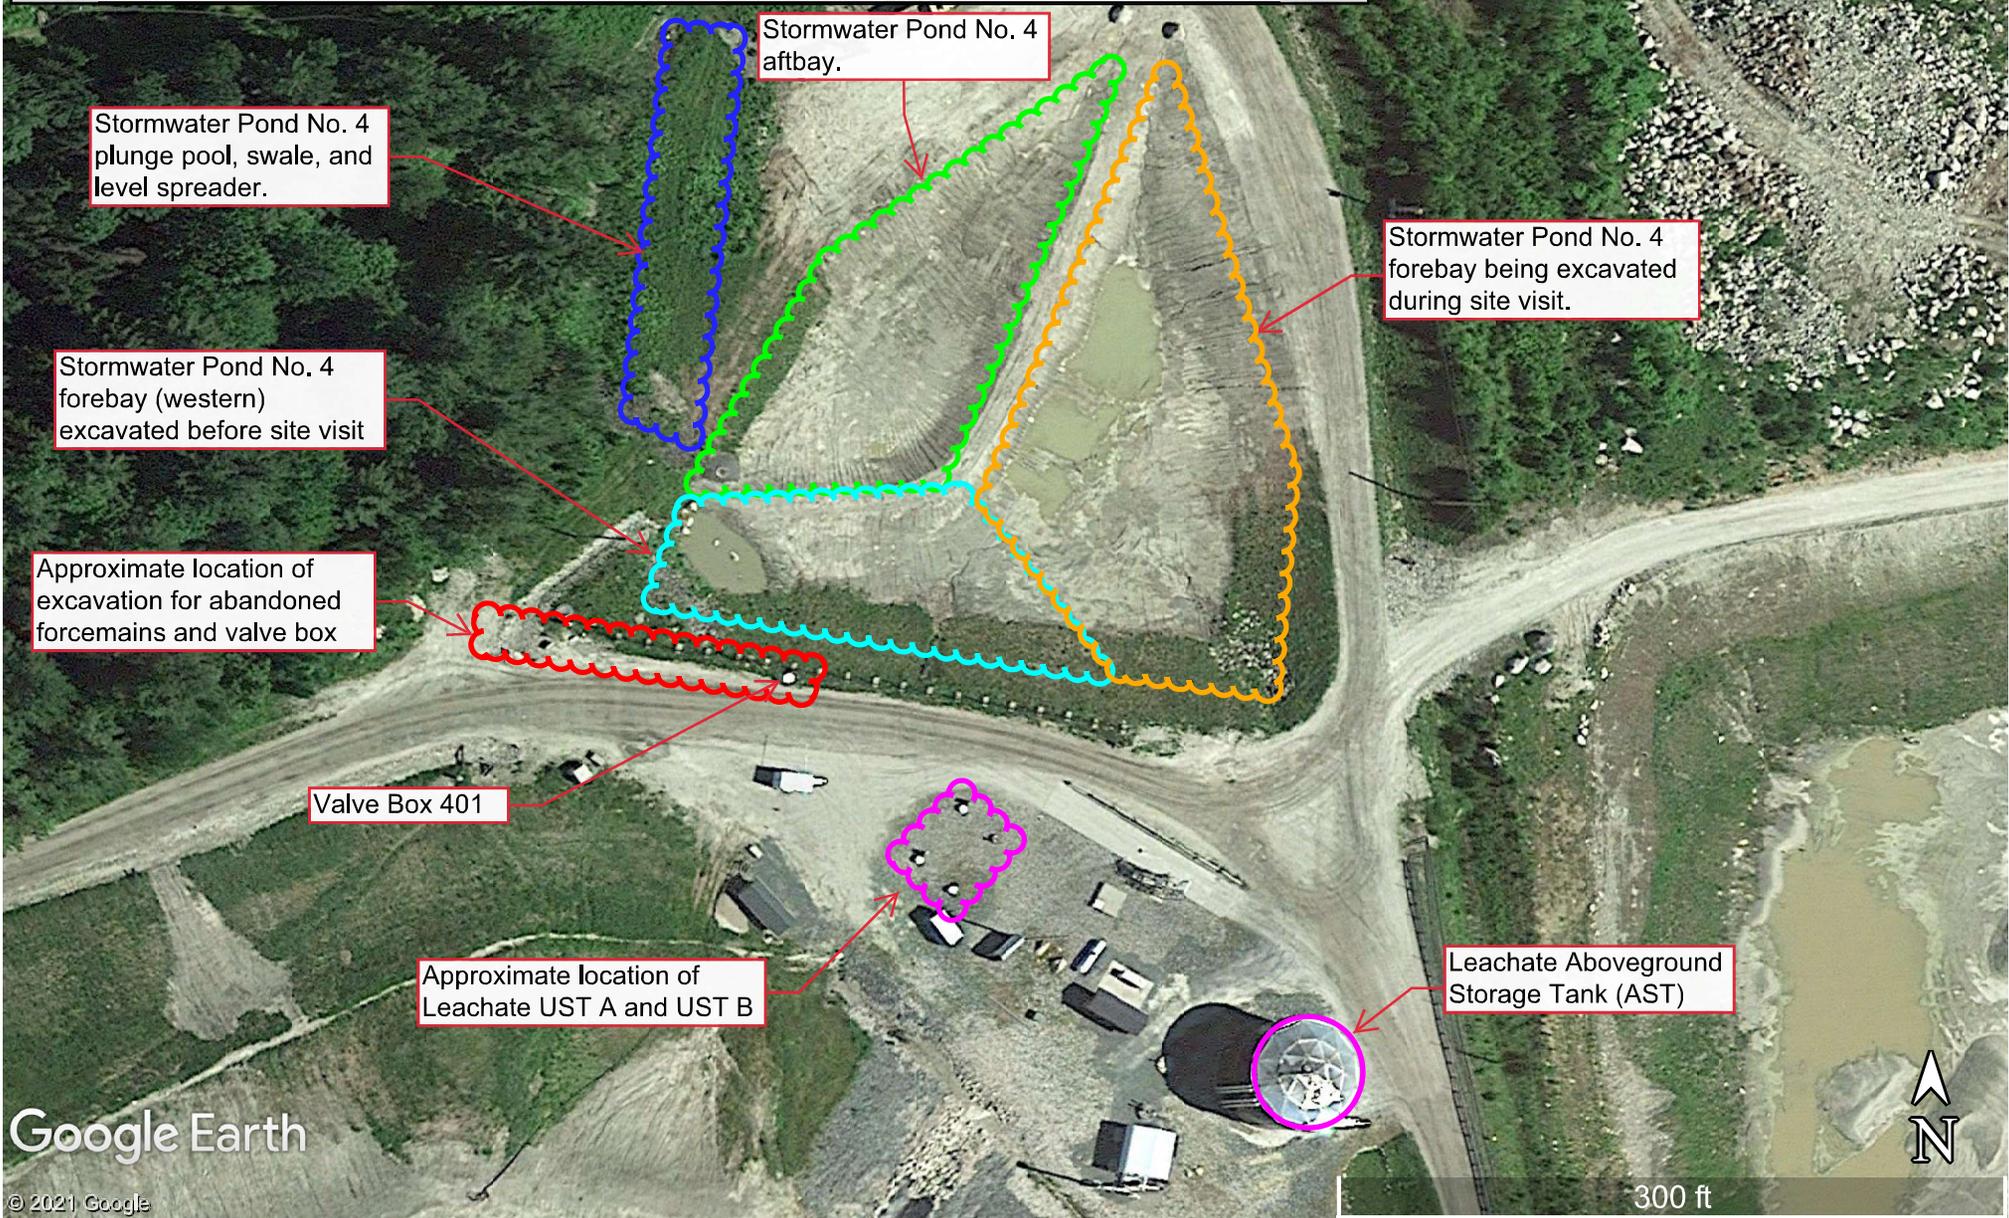
Figure No. 1: Field Sketch

Note: The locations of NHDES staff observations indicated on this field sketch should be considered approximate. The field sketch area is focused on the northeast portion of the facility showing the leachate storage system and Stormwater Pond No. 4. Observations were made during a site visit on May 10, 2021.

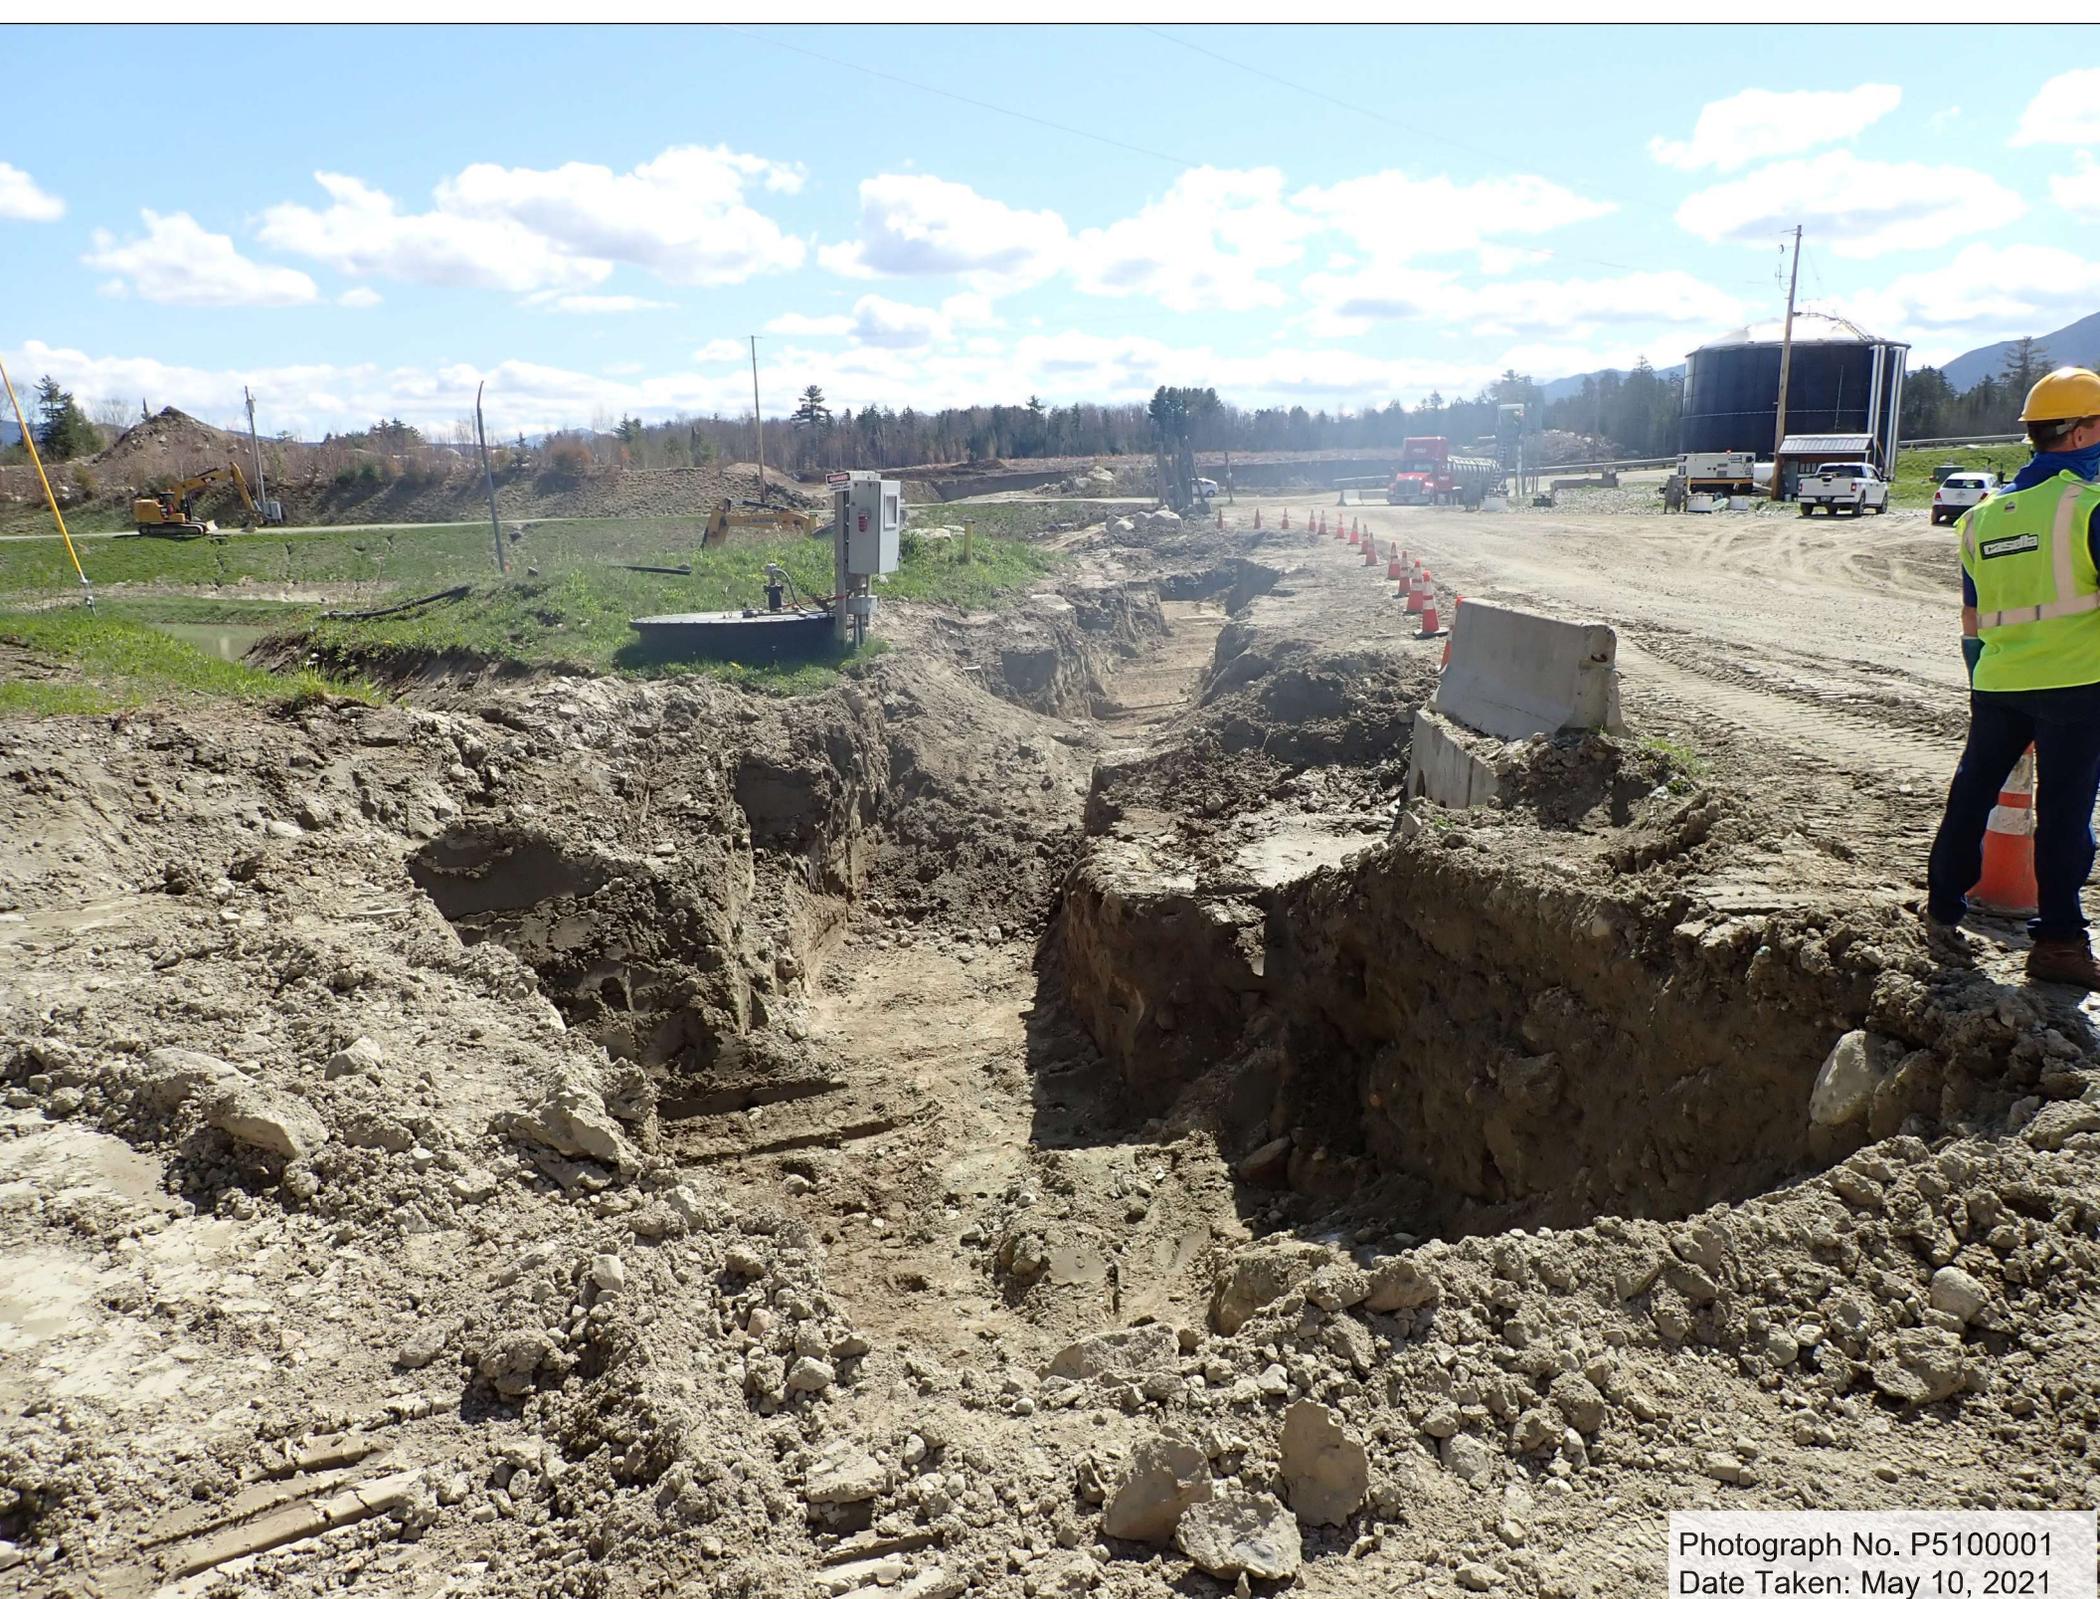
Photograph No. P5100001
Date Taken: May 10, 2021

NHDES observed an open excavation where valve box 401 and two forcemains running west were removed. See photographs P5100001 through P5100004. NHDES did not observe any apparent staining in the excavation, and Tim White reported that soil samples had been taken from the excavation and sent for laboratory analysis of leachate indicator parameters (metals, volatile organic compounds (VOCs), and Total Kjeldal Nitrogen (TKN)). The results of the analytical testing were expected late Monday, May 10, or sometime Tuesday, May 11.

Photograph Information			
Date of Photographs	May 10, 2021	Photographer	J. Colby, NHDES-SWMB
Camera Used	Olympus Tough TG-6		
Photograph Number	Description		
P5100001	Excavation to remove valve box 401 and forcemains, looking east		
P5100002	Excavation to remove valve box 401 and forcemains, looking east		
P5100003	Excavation to remove valve box 401 and forcemains capped in place – one to the former leachate evaporator and one to UST A – looking northeast		
P5100004	Excavation to remove valve box 401 and forcemains capped in place, looking west		
P5100005	Excavating sediments from Stormwater Pond No. 4, looking northeast		
P5100006	Looking down southern manhole of UST A, Stage III discharging		
P5100007	Looking down southern manhole of UST A, Stage III discharging		
P5100008	Leachate loadout structure, pad and AST, looking southeast		
P5100009	Stormwater Pond No. 4 level spreader and swale, looking north

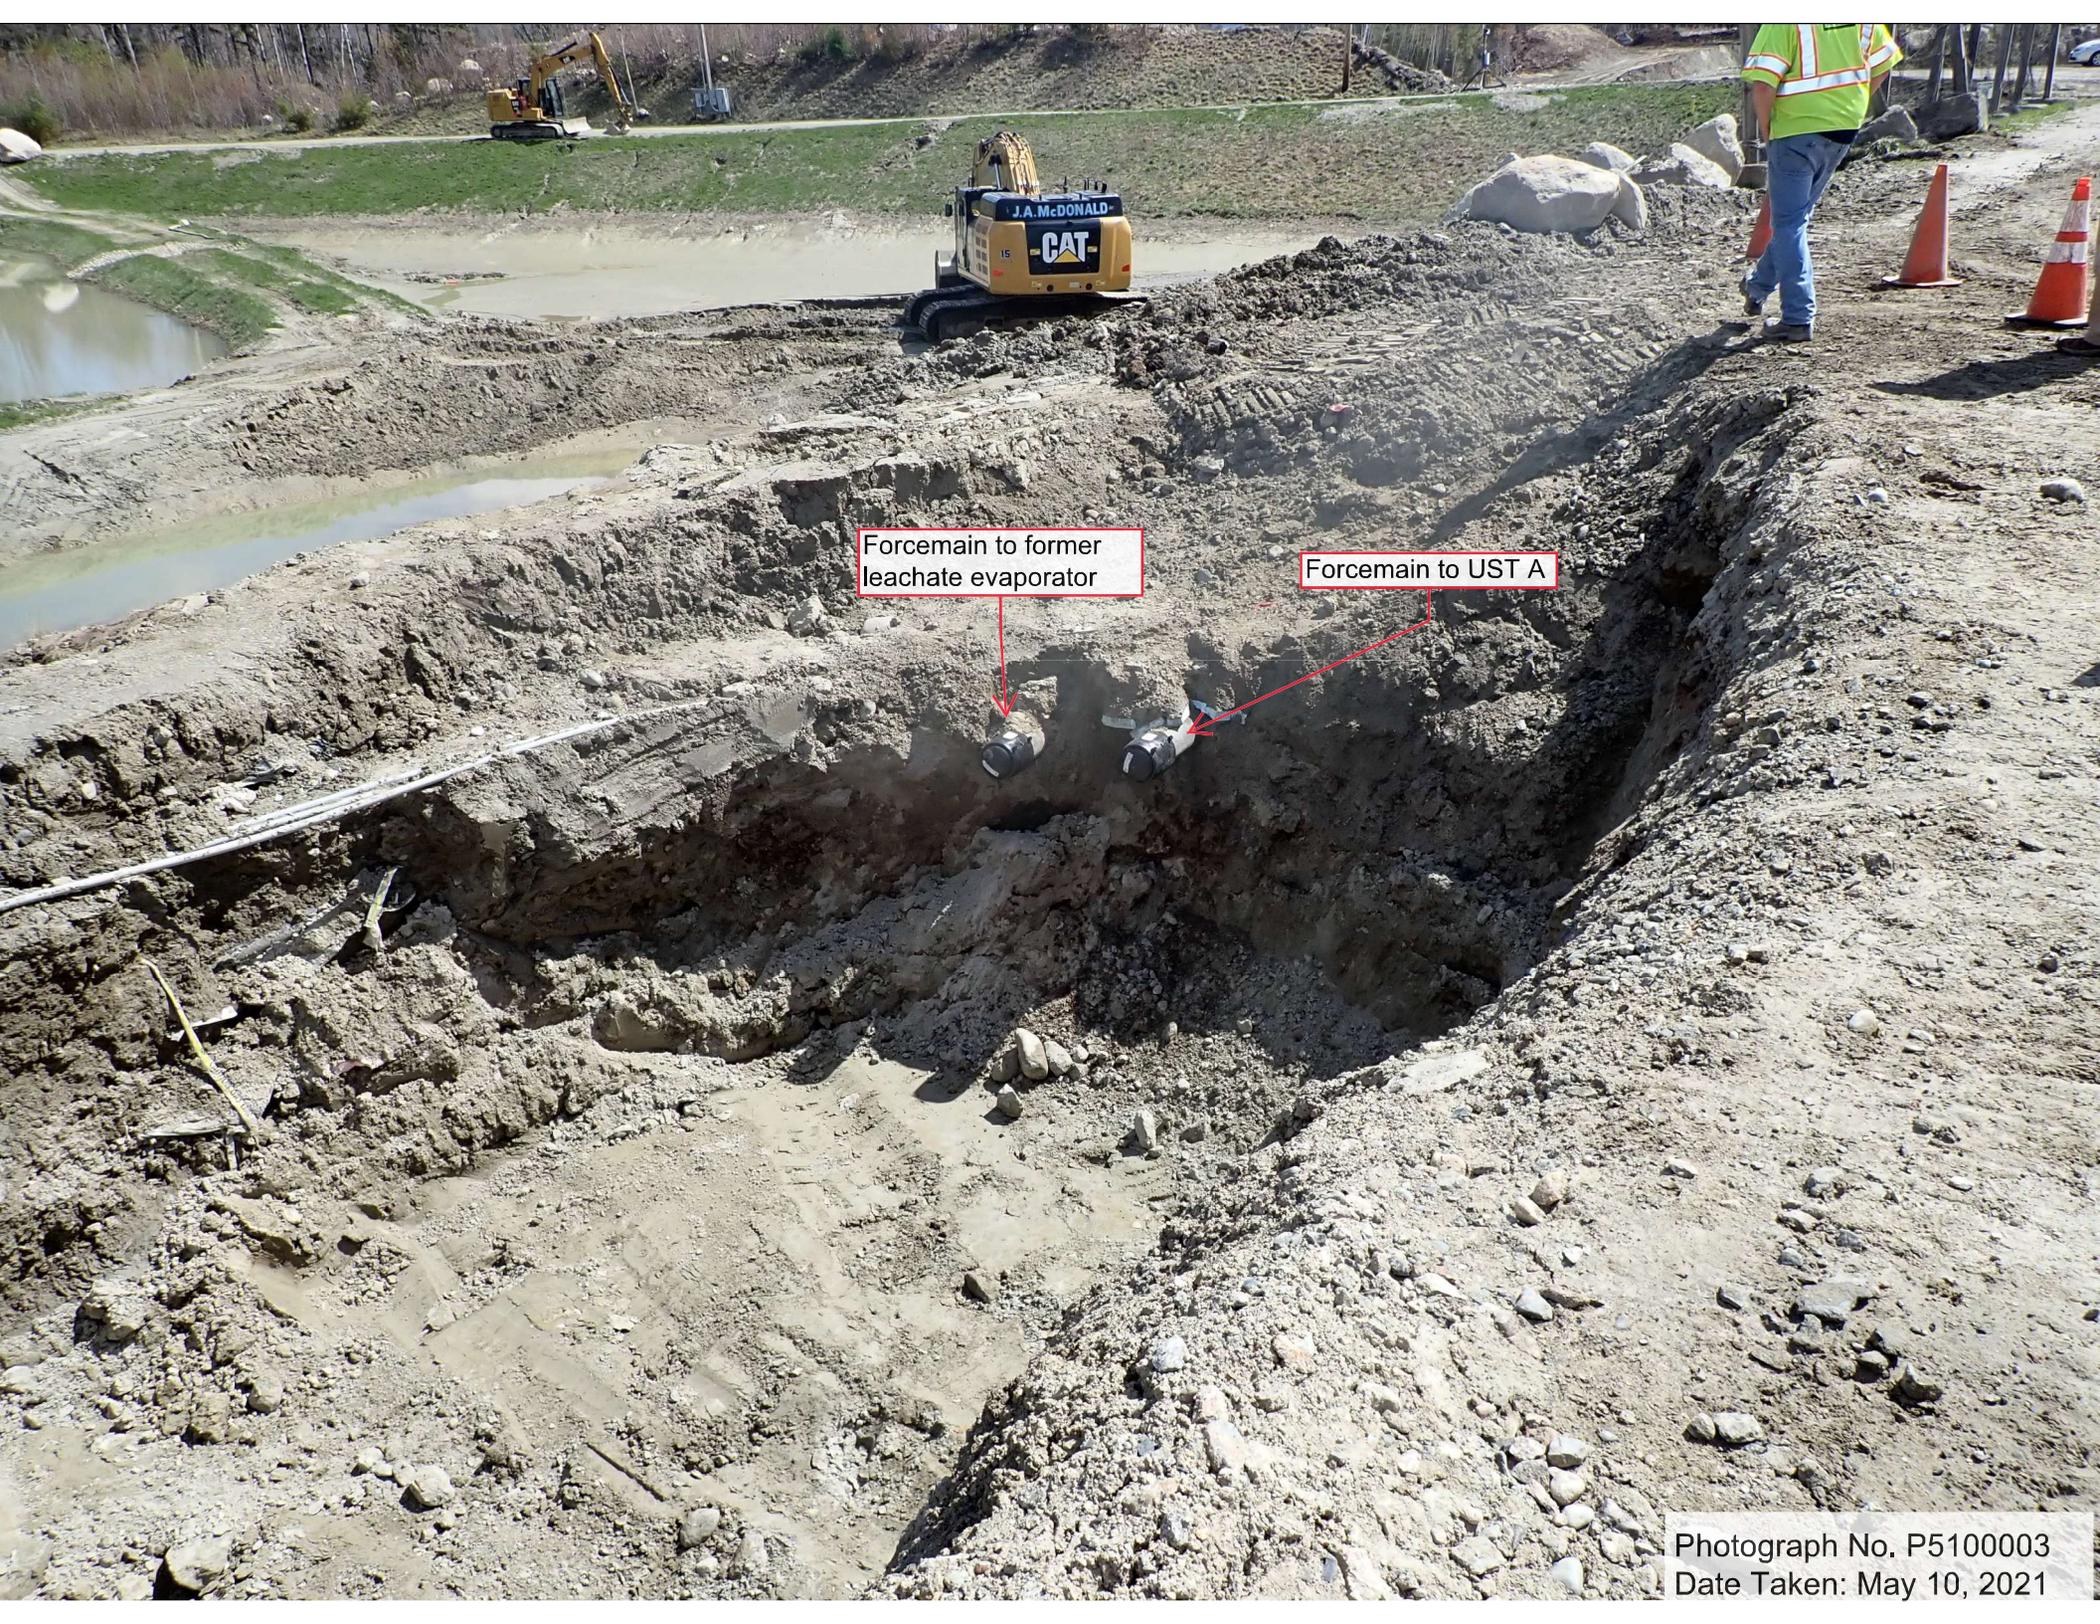
Forcemain to former
leachate evaporator

Forcemain to UST A

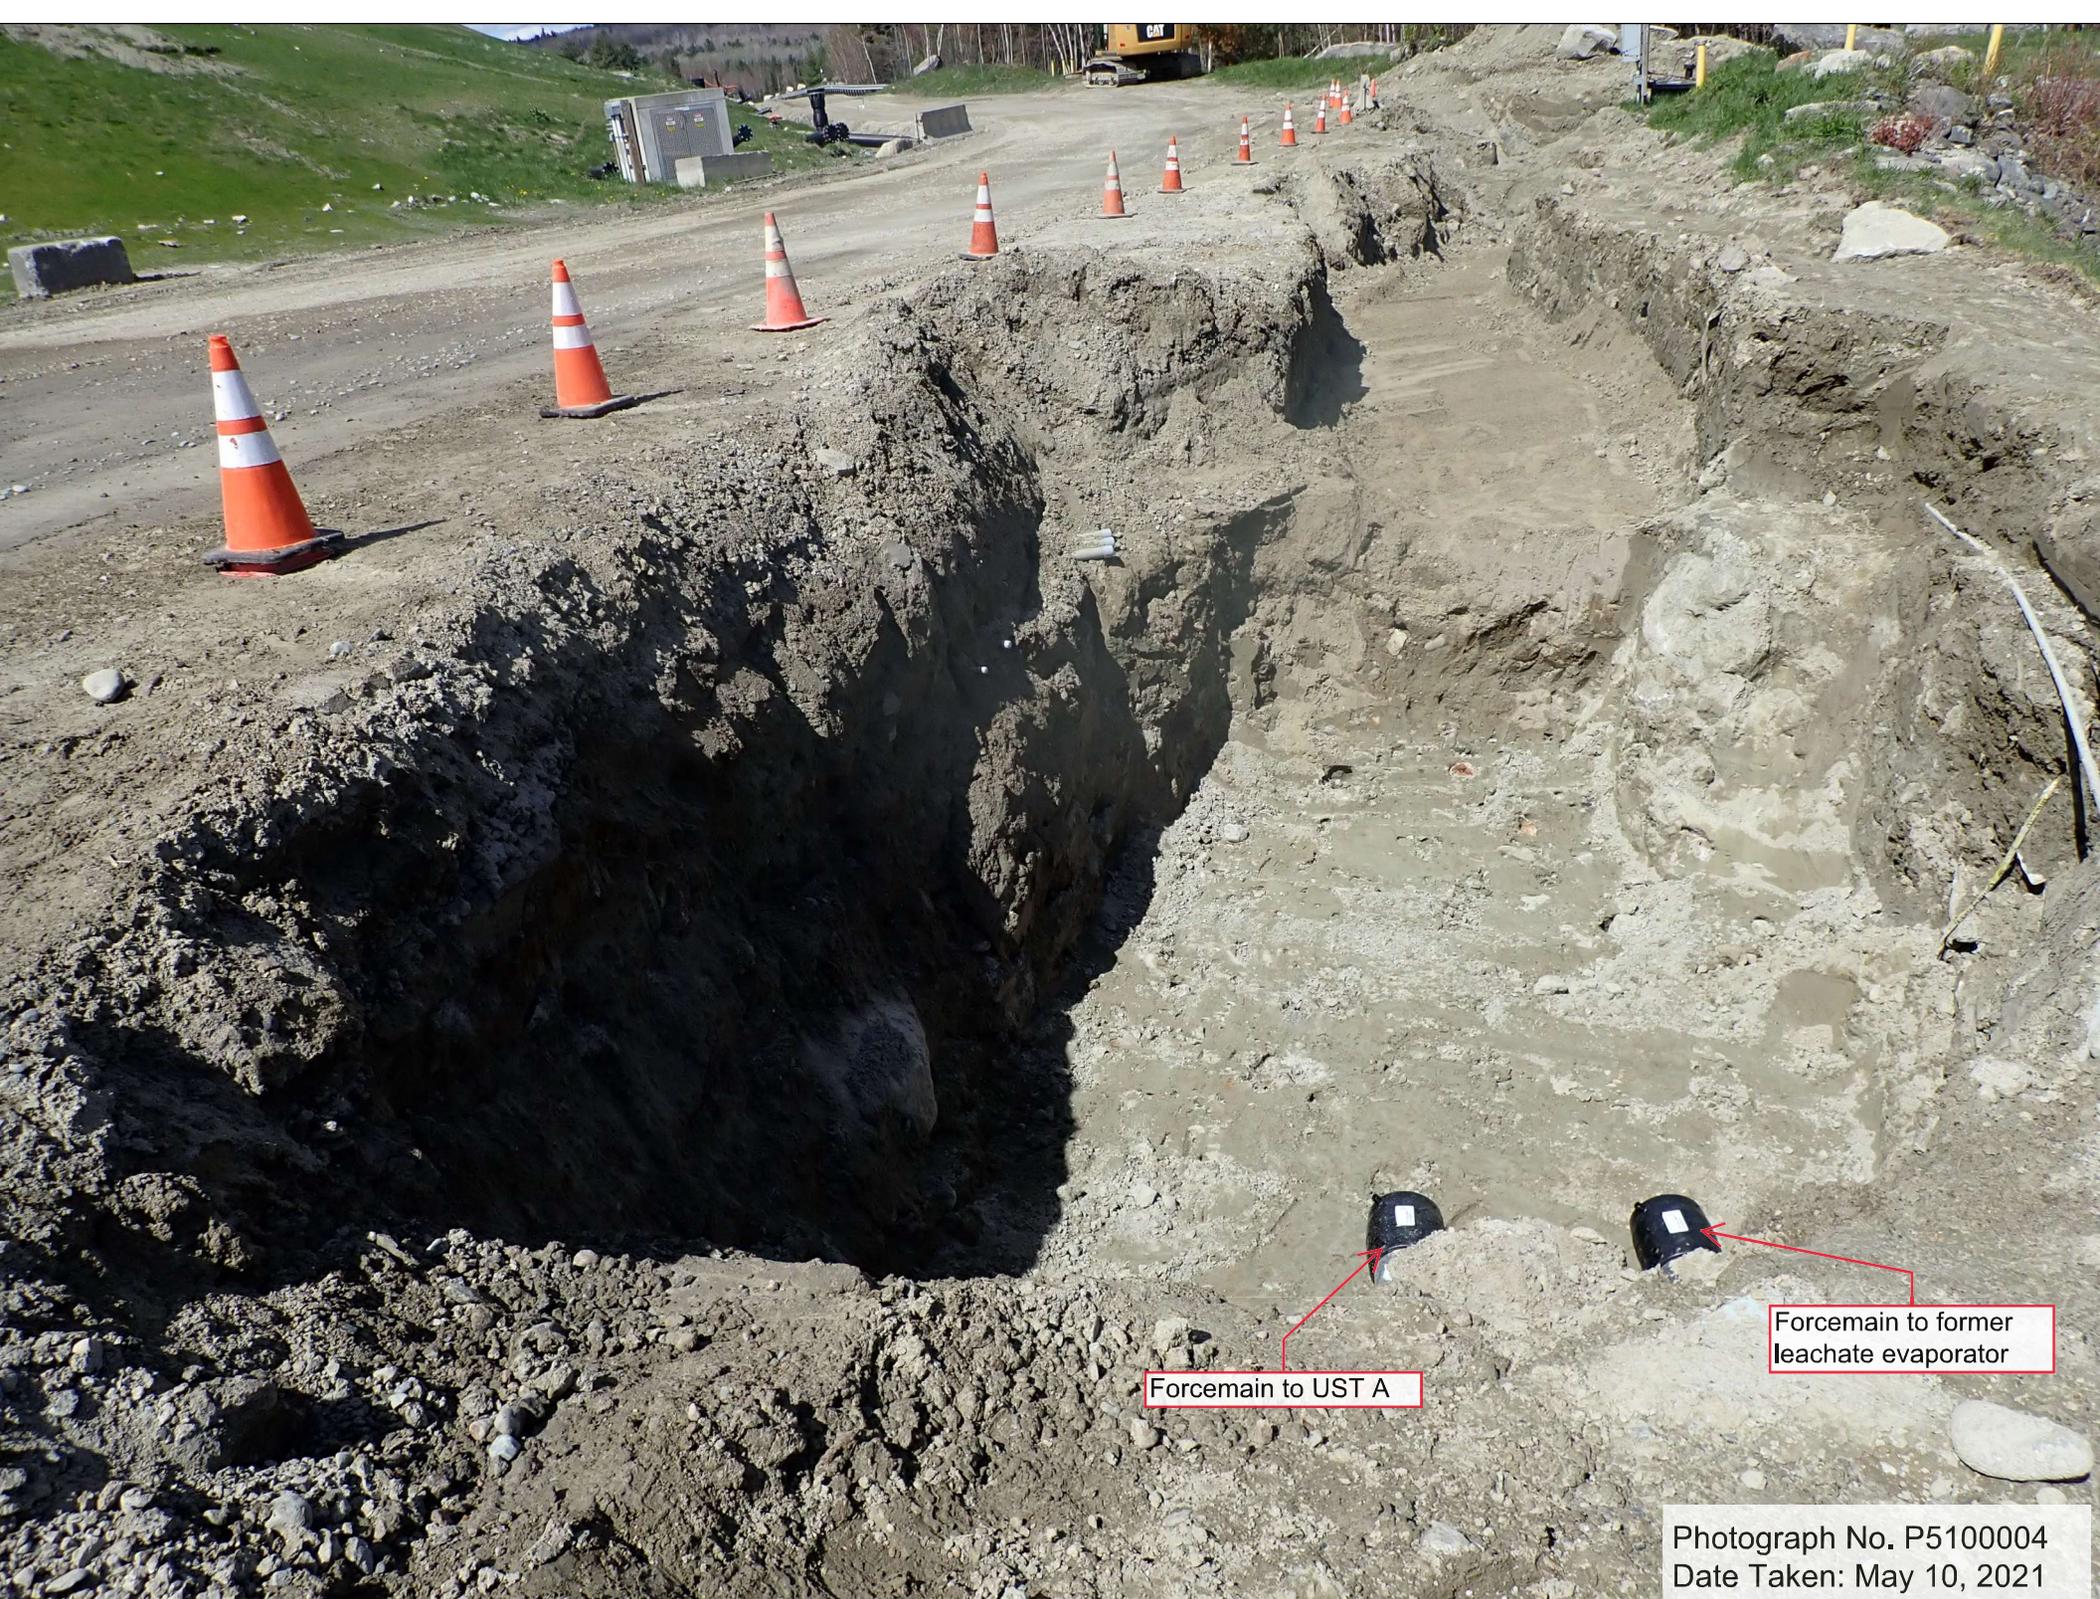
Photograph No. P5100004
Date Taken: May 10, 2021

Forcemain to UST A

Forcemain to former leachate evaporator

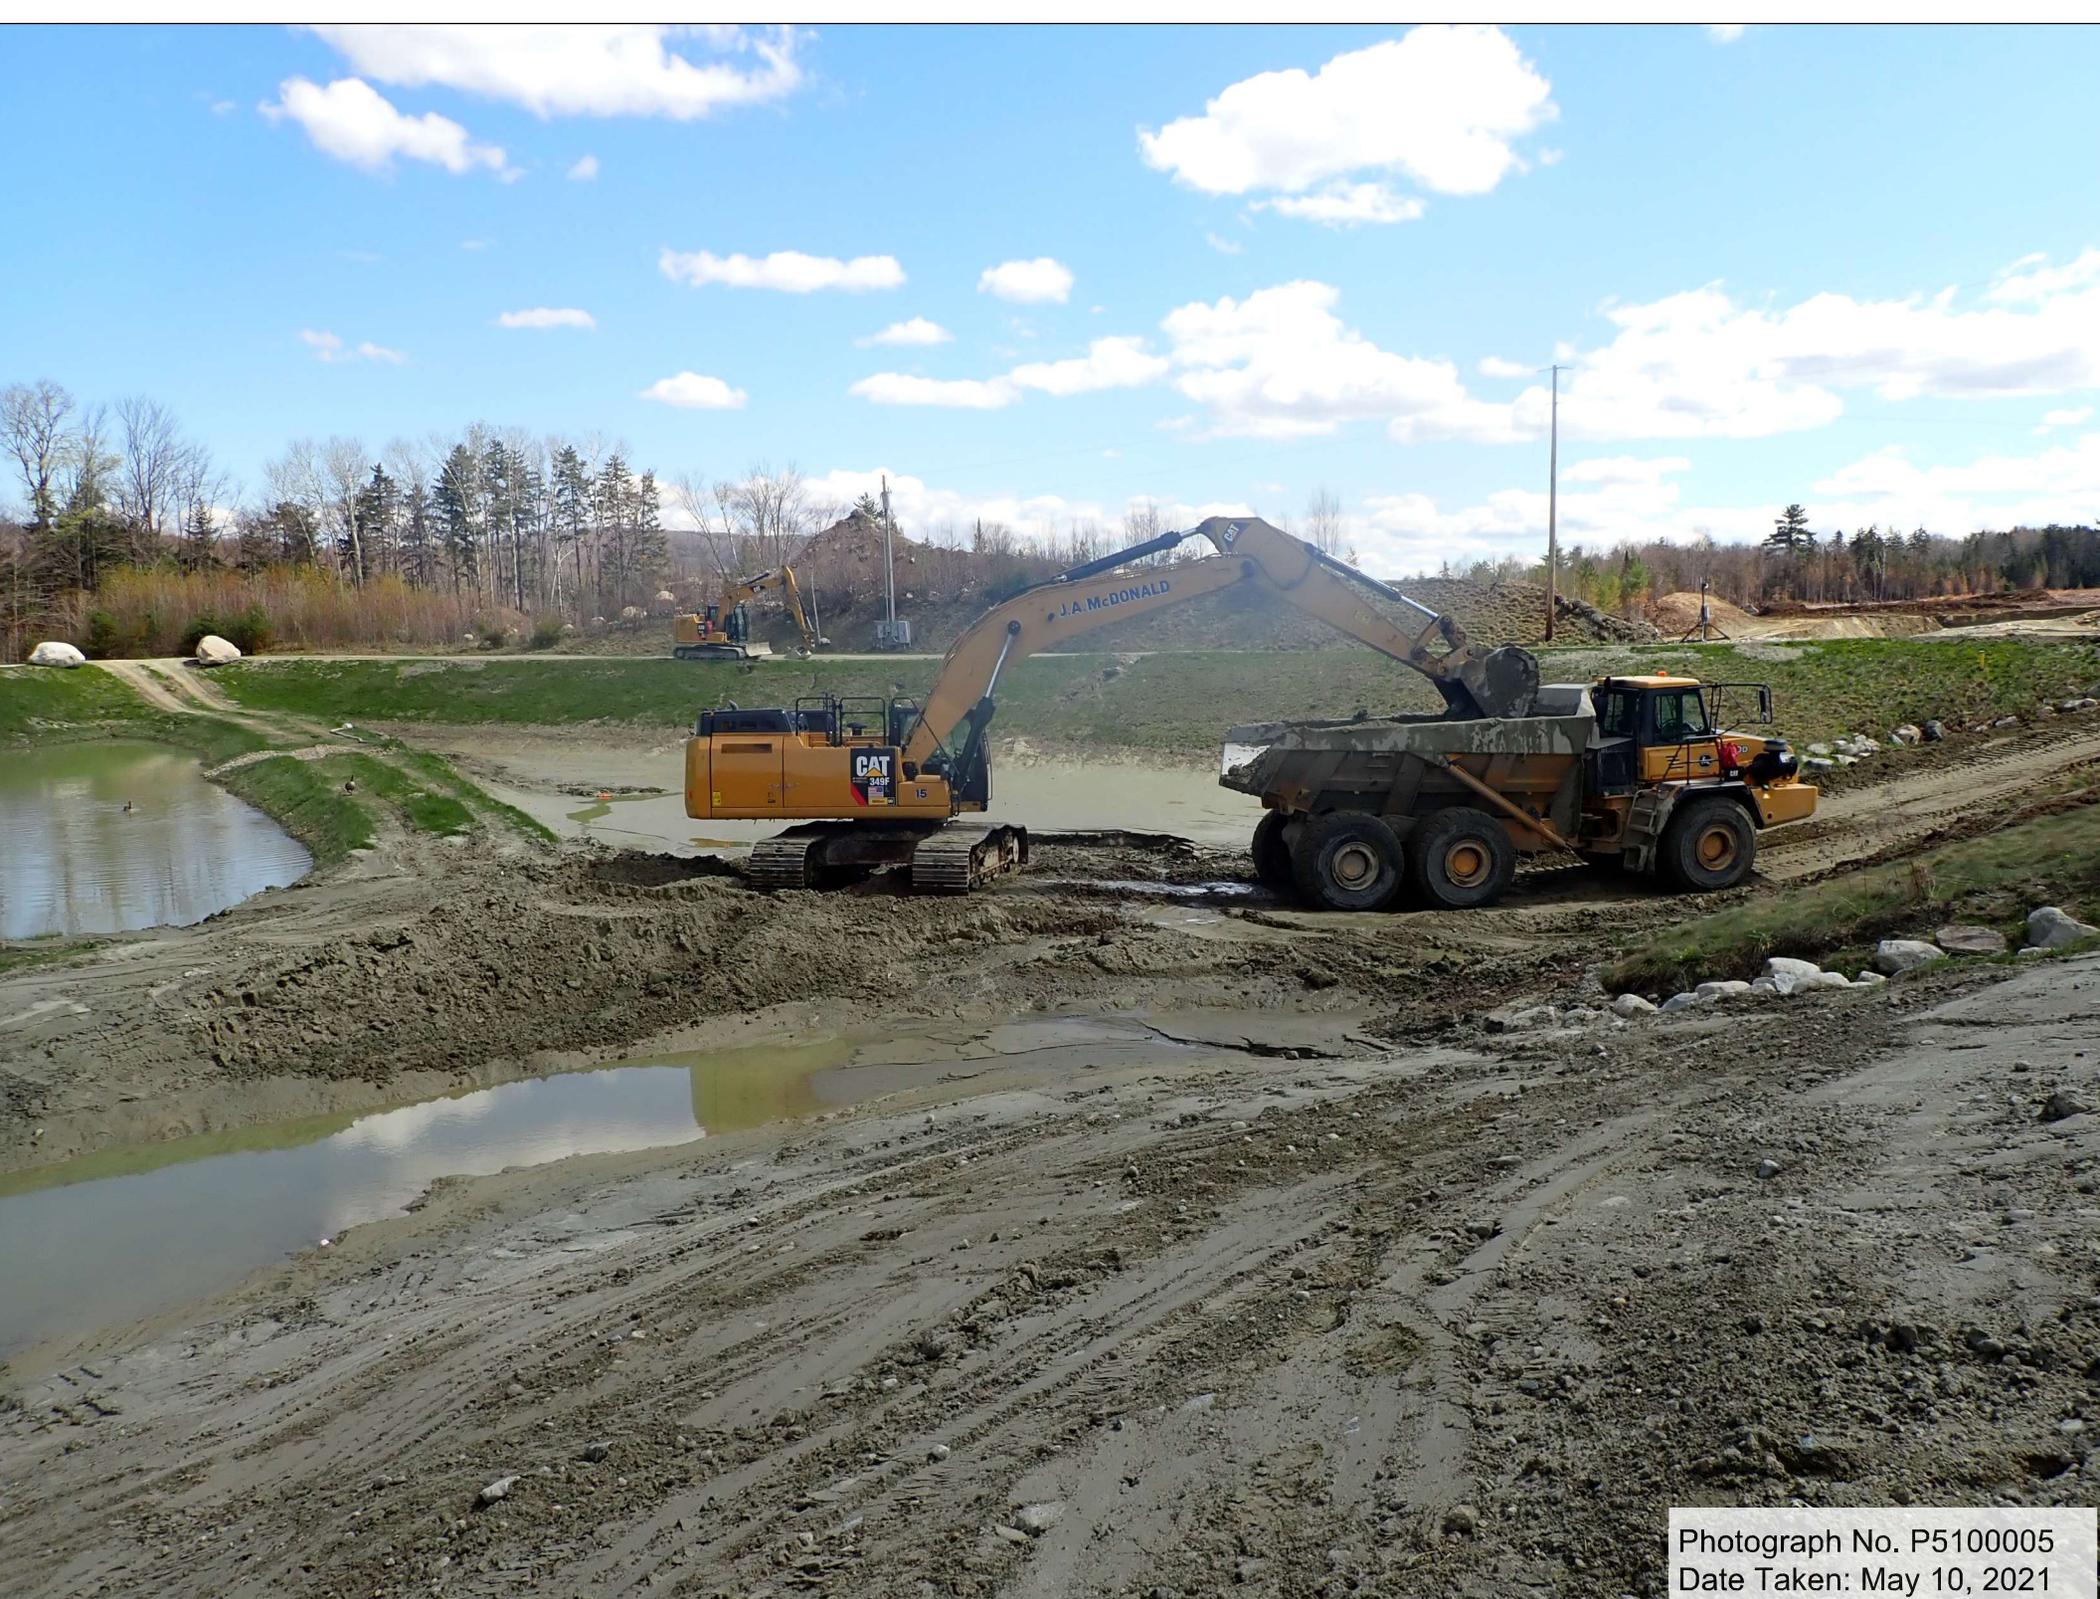
Photograph No. P5100005
Date Taken: May 10, 2021

NHDES observed sediment removal activities from the forebay of Stormwater Pond No. 4. See photographs P5100005 and P5100010. NCES representatives stated that, during the prior week, liquid in the forebay was pumped out of the pond directly into tanker trucks or into the leachate storage system, and the western portion of the forebay was excavated to natural grades. Excavation activities were occurring in the southeastern portion of the forebay at the time of NHDES' site visit.

NHDES observed standing water in the Stormwater Pond No. 4 aftbay, and downstream of the aftbay outlet structure and level spreader. See photographs P5100005 and P5100009 through P5100011. Joe Gay stated that NCES also intends to pump water out of and remove sediment from the aftbay.

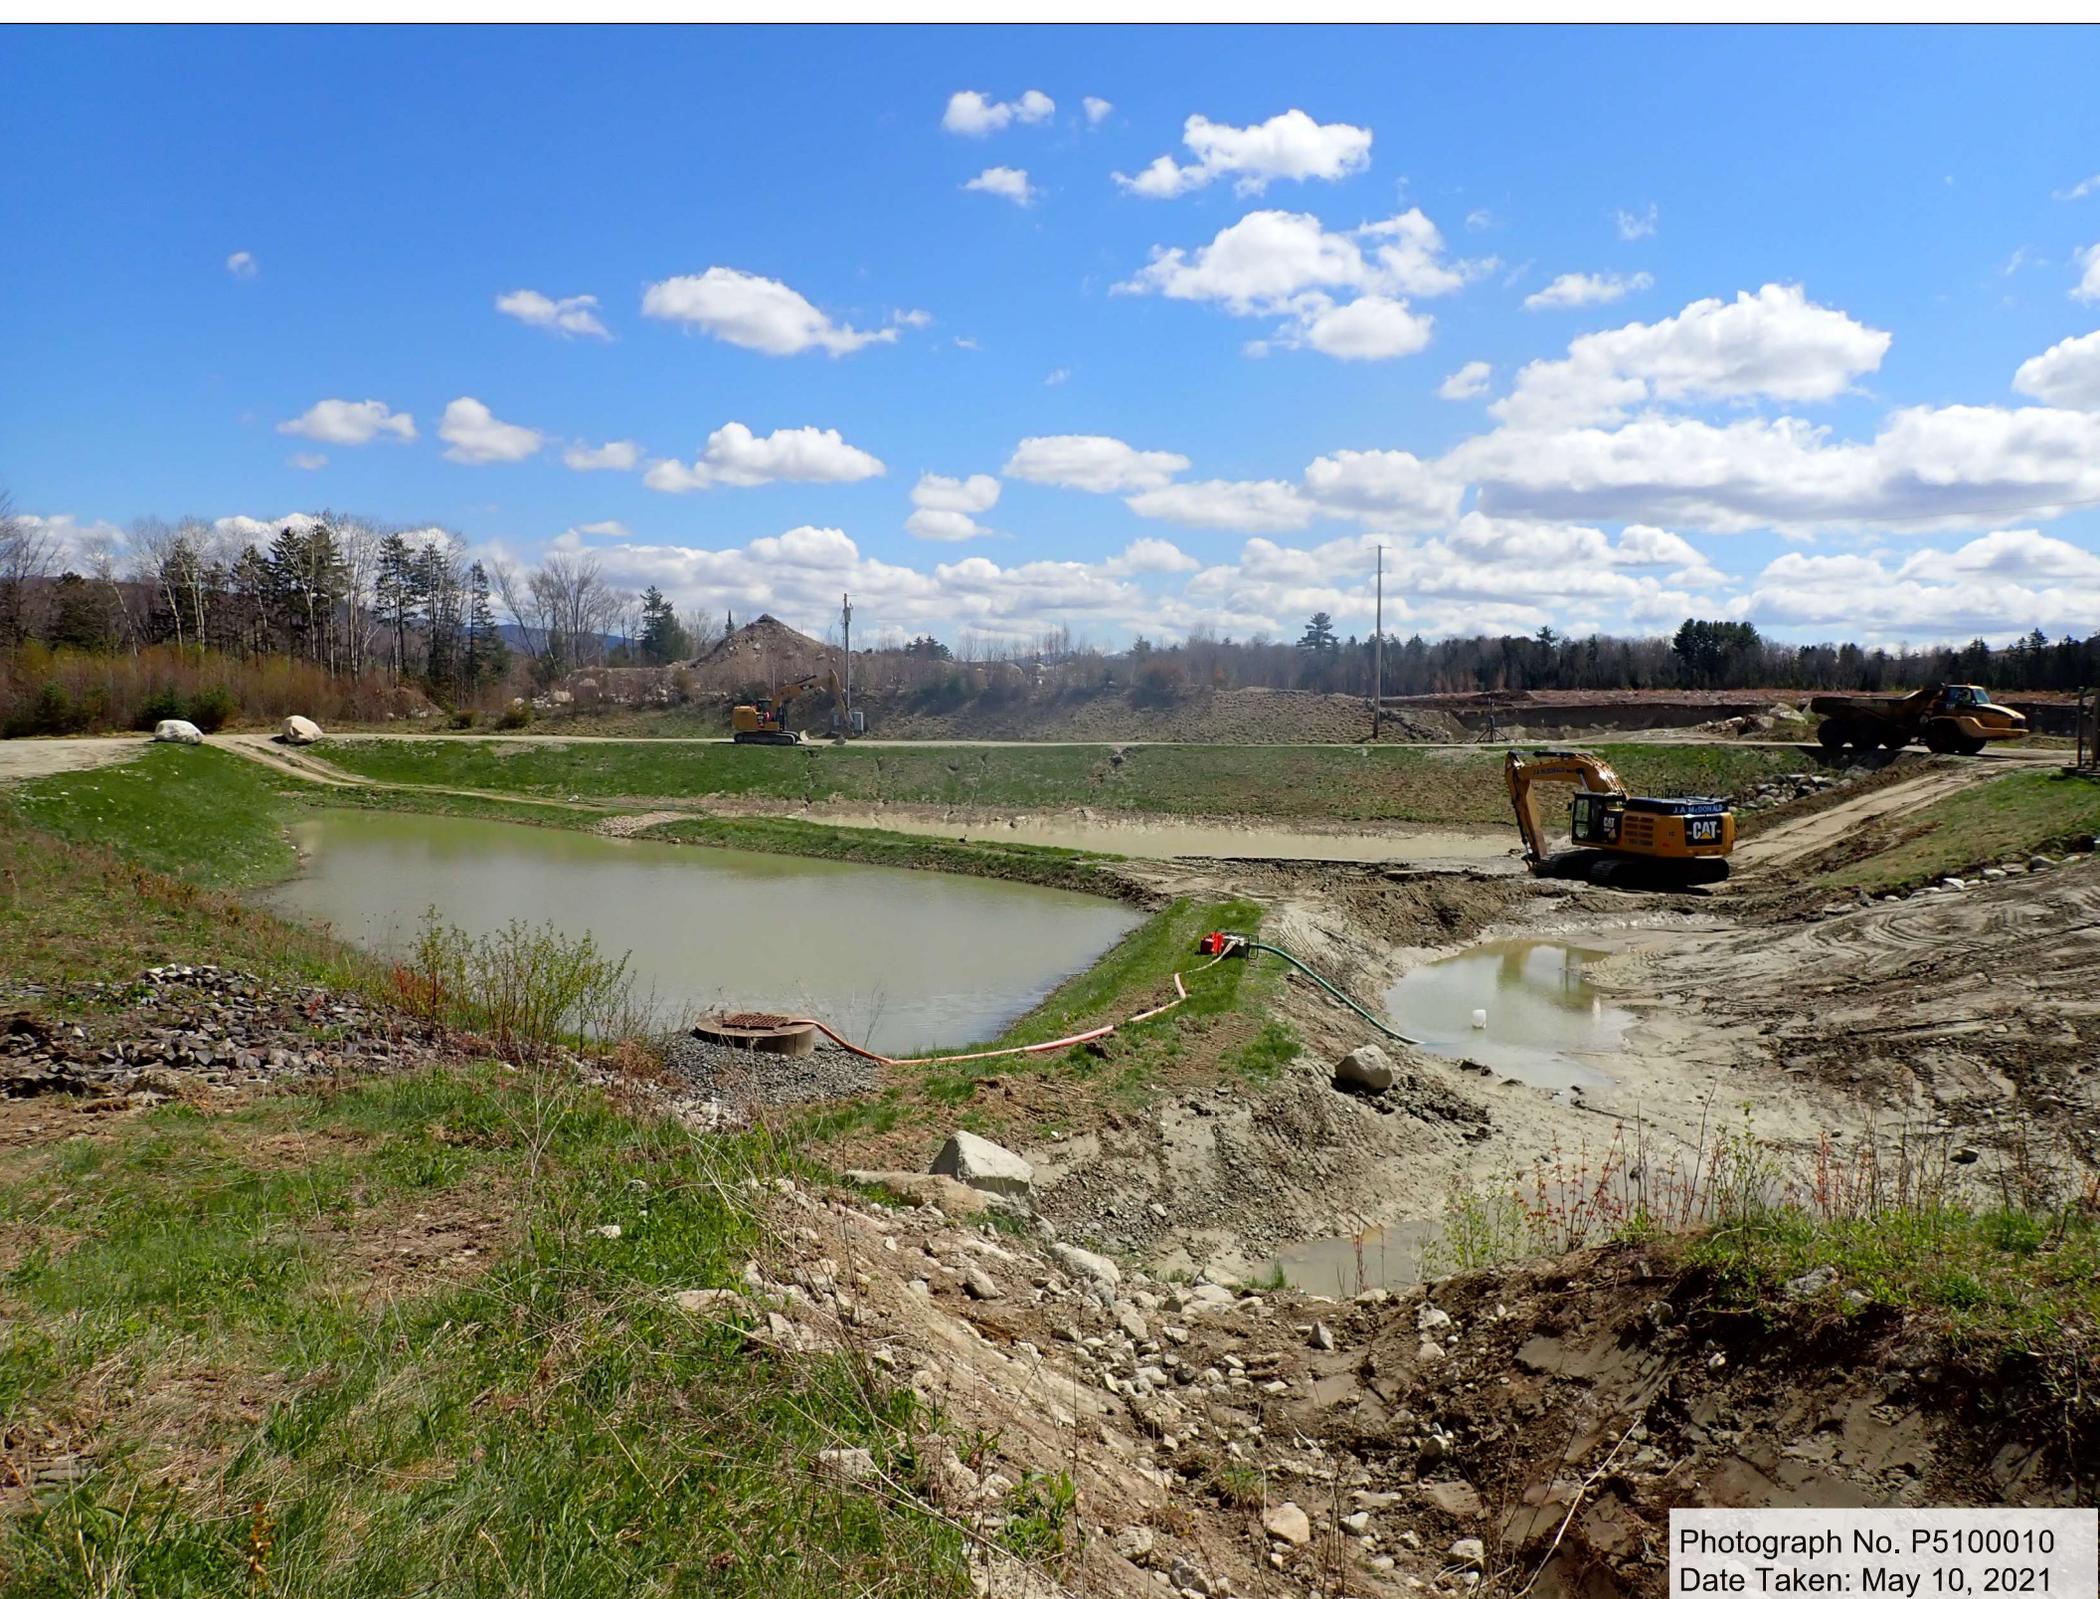
Photograph No. P5100010
Date Taken: May 10, 2021

P5100010	Stormwater Pond No. 4, looking east-northeast		
P5100011	Stormwater Pond No. 4 level spreader and swale, looking north
