SITE VISIT REPORT	New Hampshire Department of Environmental Services Waste Management Division P.O. Box 95, 29 Hazen Drive Concord, NH 03302-0095 Phone: 603-271-2925 Fax: 603-271-2456
---	--------------------------	---

Visit Information			
Date of Visit	May 10, 2021	NHDES Staff Conducting Site Visit	Jaime Colby, NHDES-SWMB James O'Rourke, NHDES-WMD
Time Arrival / Departure	10:00 AM – 12:30 PM	Weather	Sunny, 55-60°F
Purpose of Site Visit	Follow-up on leachate spill reported on May 3, 2021		
Photos Taken: <input checked="" type="checkbox"/> Yes <input type="checkbox"/> No (If yes, see photo log, Attachment A)			
Samples Collected: <input type="checkbox"/> Yes <input checked="" type="checkbox"/> No (If yes, see sample collection log)

Attachment A - Photograph Log

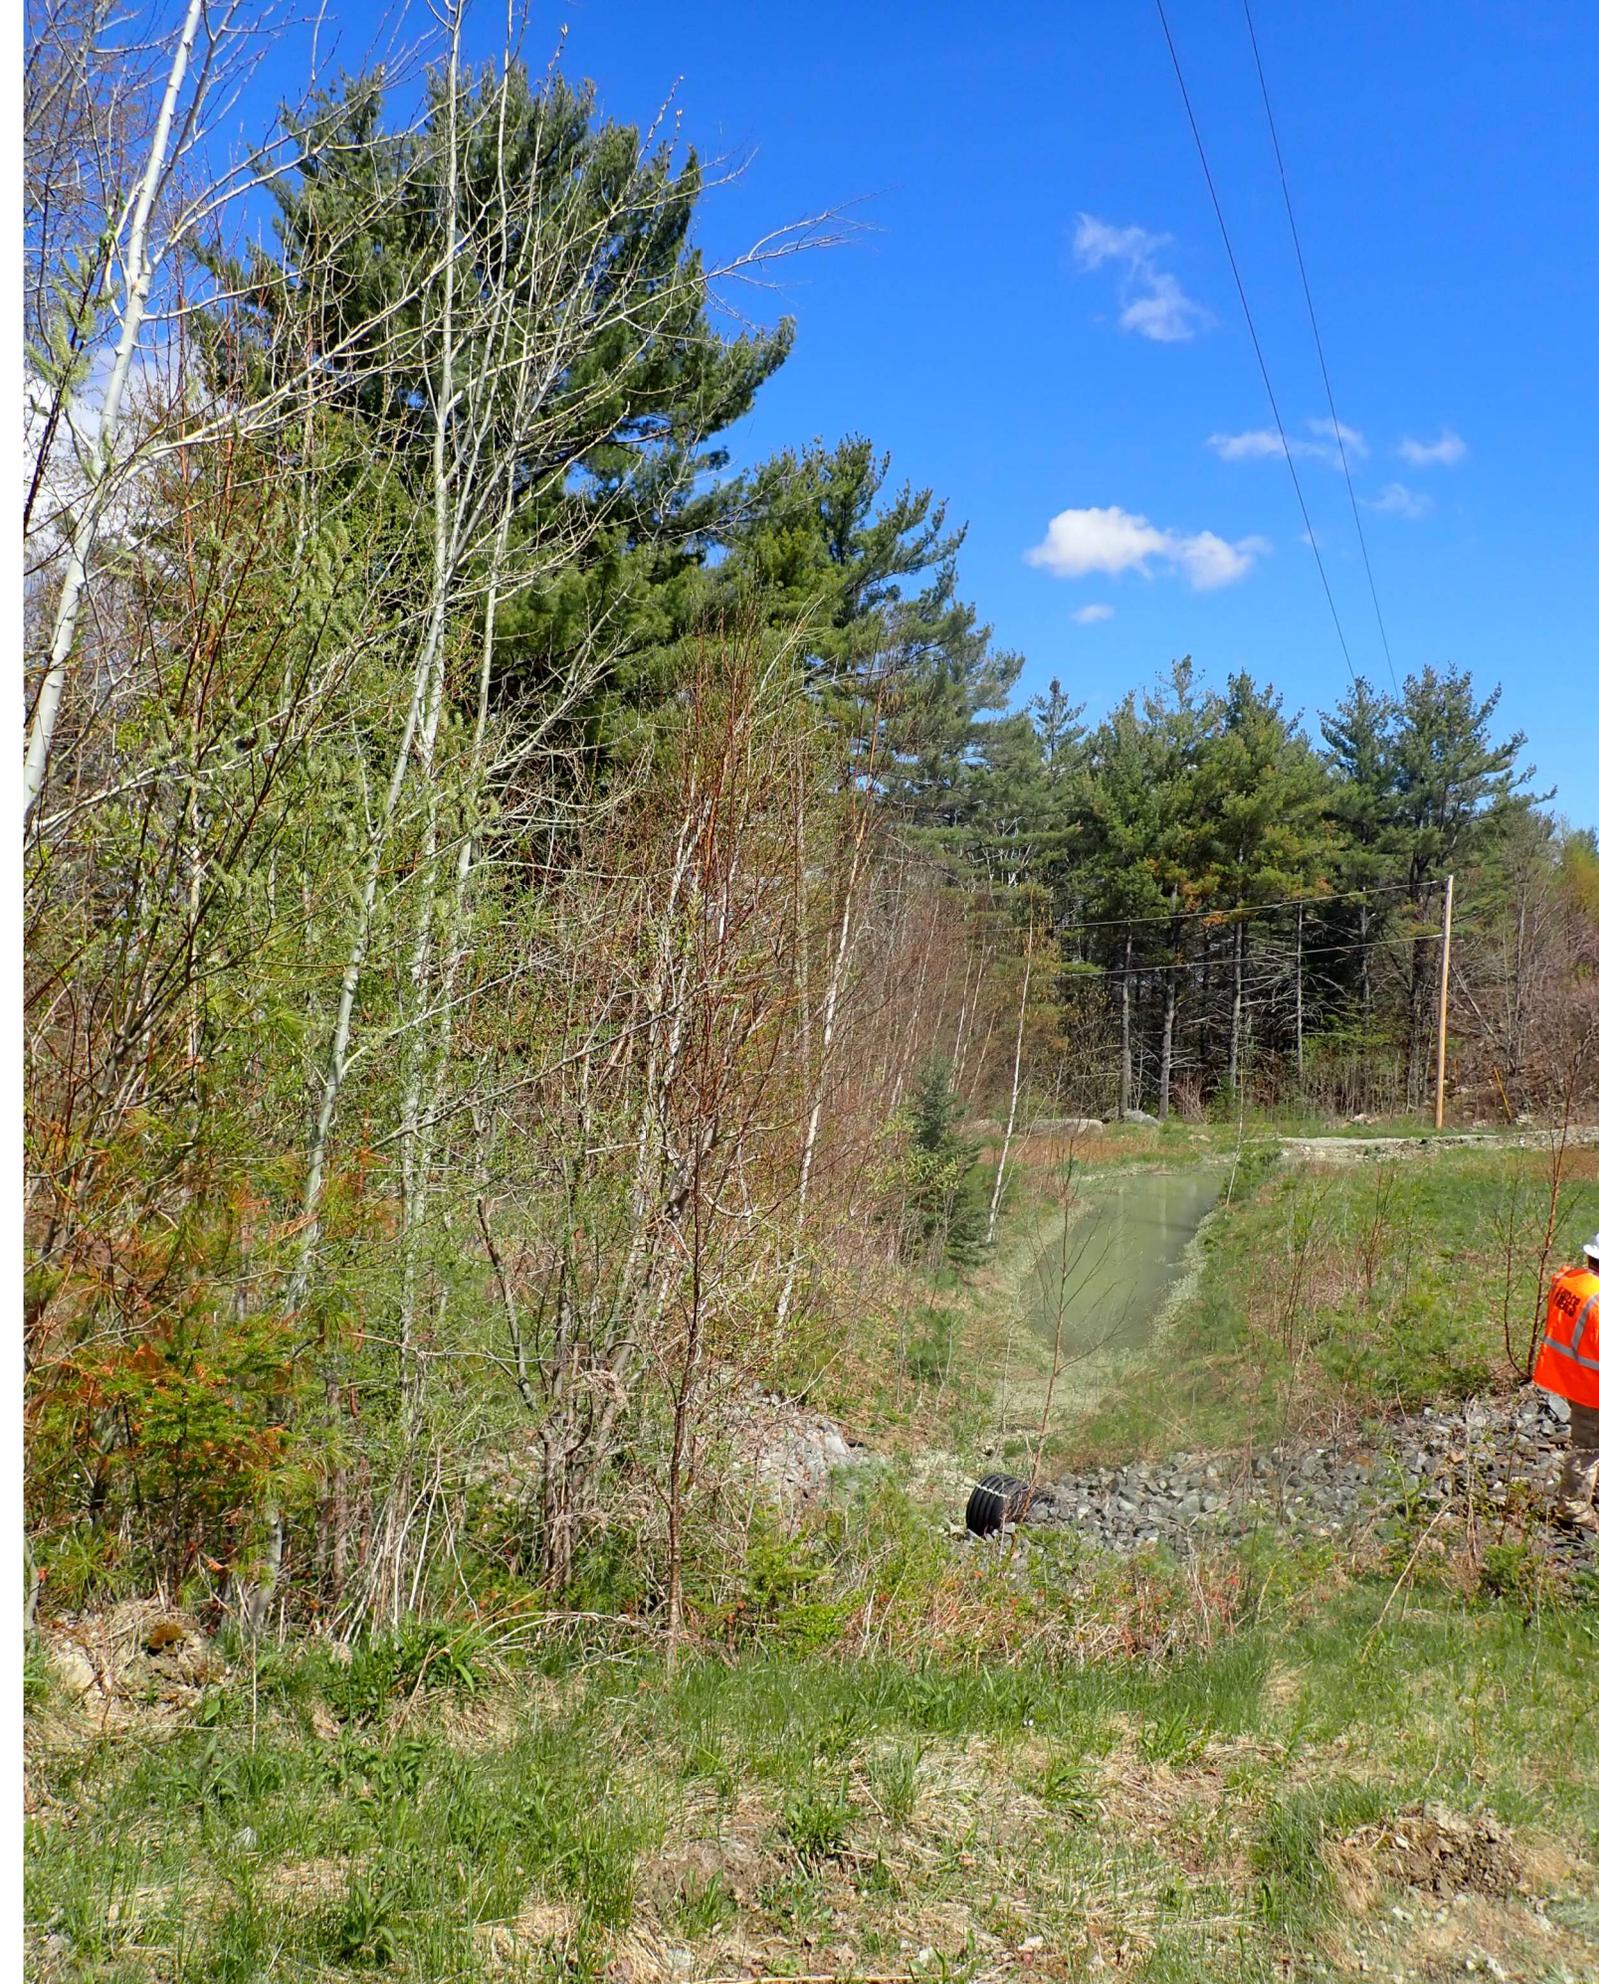
Photograph No. P5100011
Date Taken: May 10, 2021

NHDES observed standing water in the Stormwater Pond No. 4 aftbay, and downstream of the aftbay outlet structure and level spreader. See photographs P5100005 and P5100009 through P5100011. Joe Gay stated that NCES also intends to pump water out of and remove sediment from the aftbay.

P5100010	Stormwater Pond No. 4, looking east-northeast		
P5100011	Stormwater Pond No. 4 level spreader and swale, looking north
