Water Front- Peter Mantius

# Ontario Landfill Systems Damaged by November Landslide Won't Be Fixed for Another Two Months, Casella Tells DEC

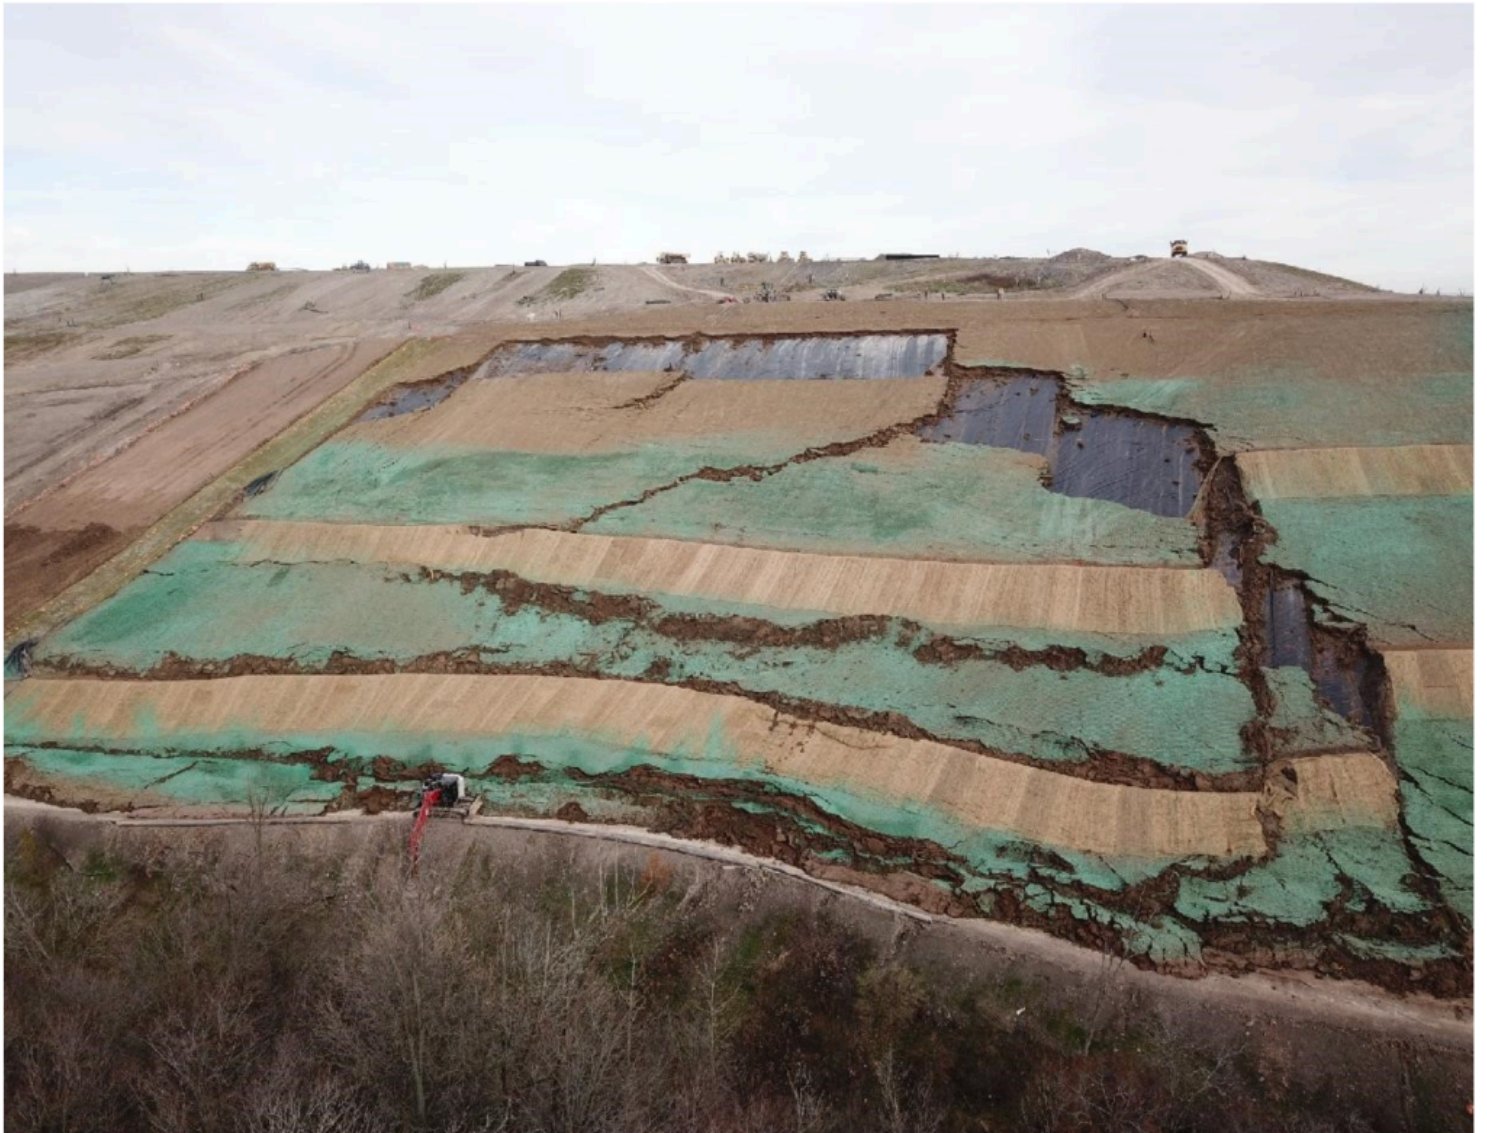
**On the afternoon of Nov. 15, 2023, a two-foot-thick layer of soil slid down a 3.5-acre section of the Ontario County Landfill's southeastern face, tearing a liner and destroying conduits designed to collect gas and leachate.**

The incident destroyed a lateral line connecting several gas extraction wells and a force main pipe that collects liquids from leachate extraction wells. Barring extreme weather emergencies, both conduits will be replaced within two months, Casella said.

"Comprehensive plans are being developed to address ... the repair of the torn liner and the installation of a new vacuum lateral (for gas collection), a new force main (for leachate), and enhanced stormwater management infrastructure," Casella wrote in a [Feb. 9 letter](https://waterfrontonline.files.wordpress.com/2024/03/aafeb9casella) (<https://waterfrontonline.files.wordpress.com/2024/03/aafeb9casella>

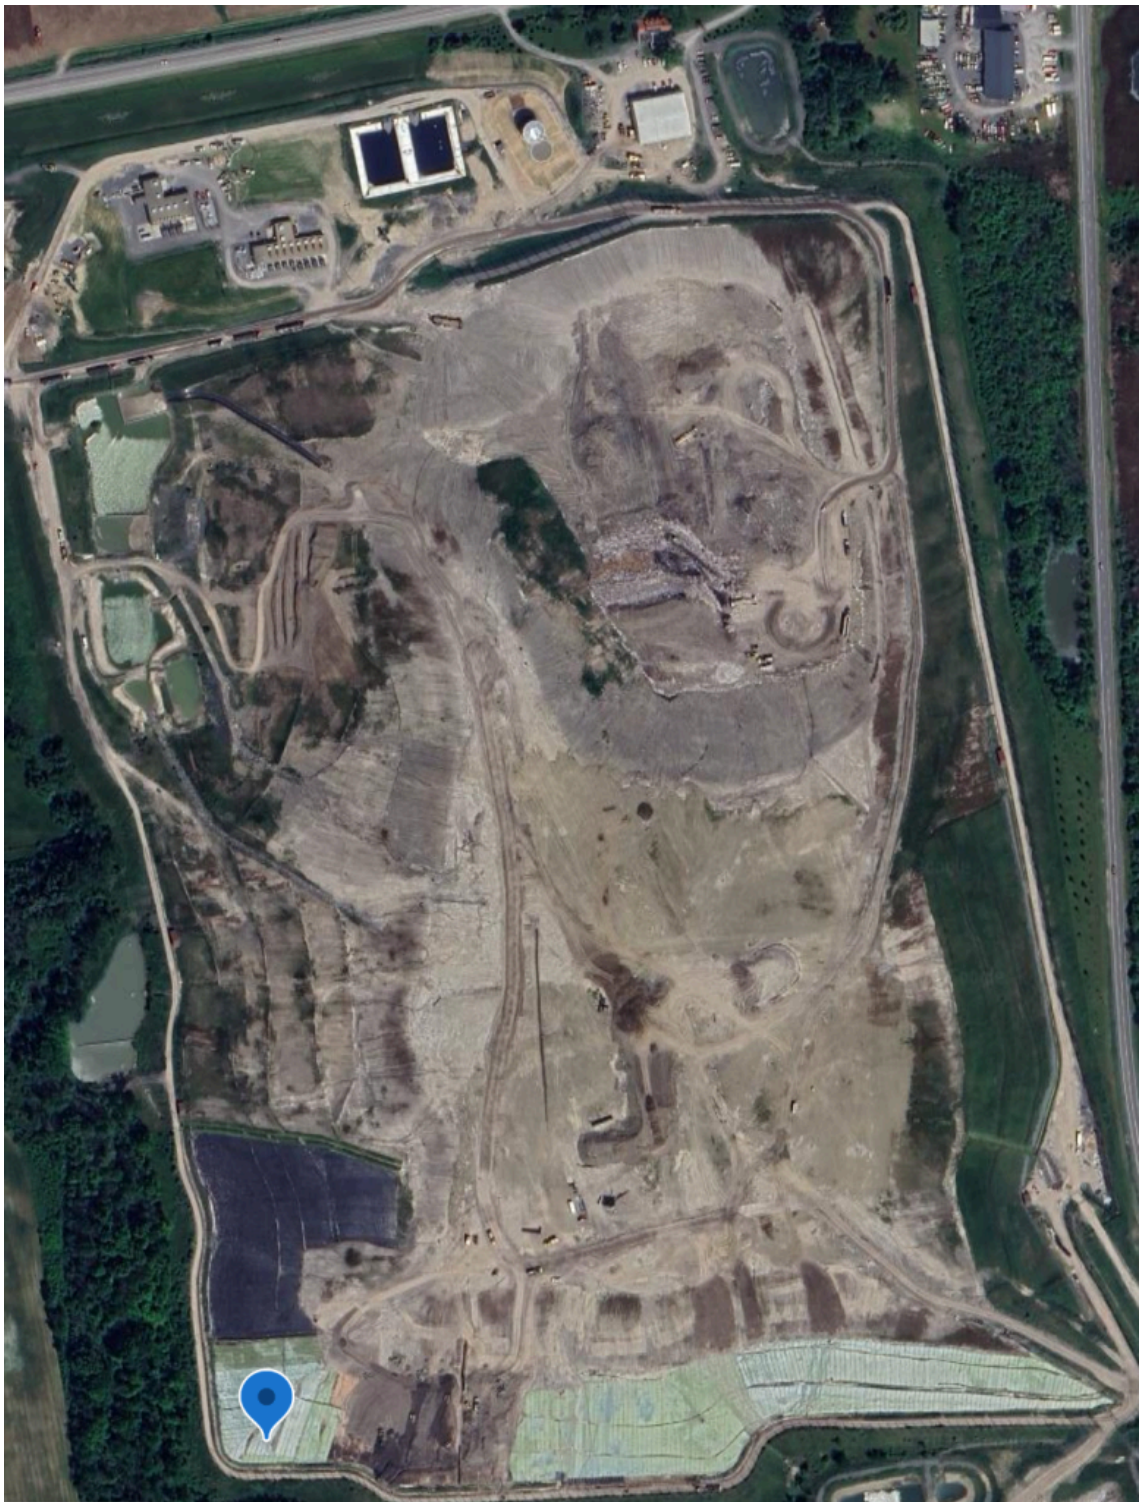
**The blue marker shows the location of the November 2023 landslide at the Ontario County Landfill.**

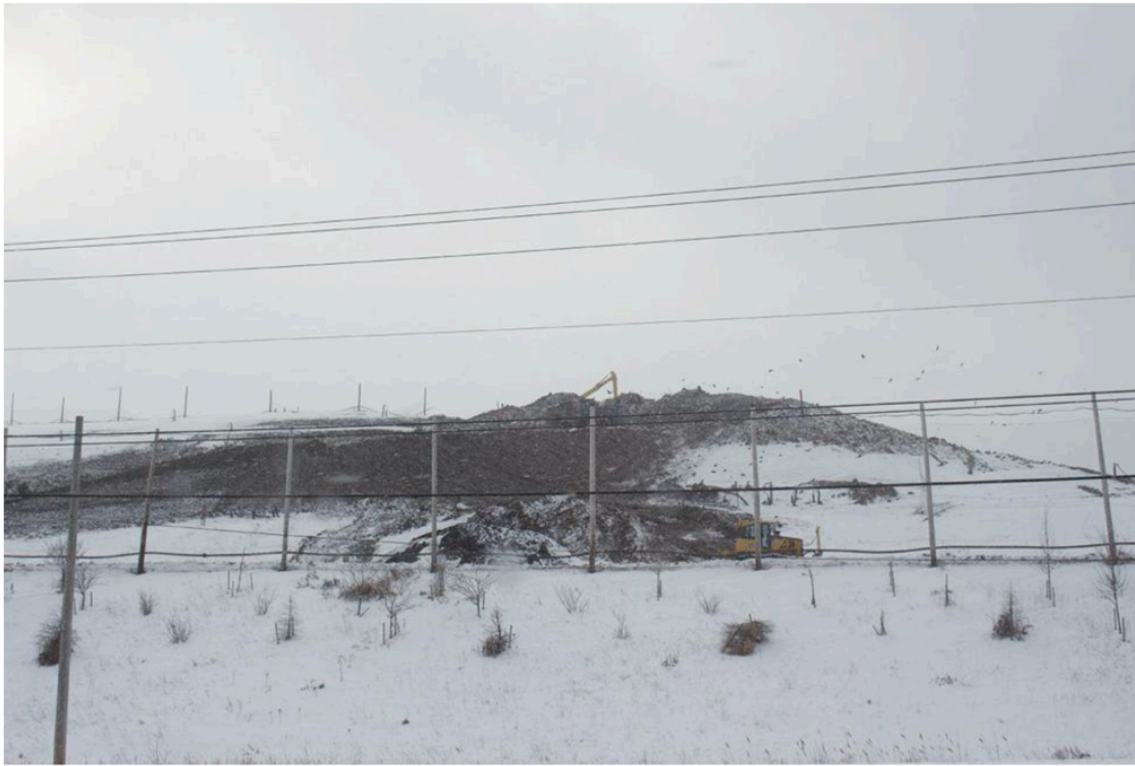
In February 2021, local officials and neighbors of the landfill reported an apparent "blowout" (<https://waterfrontonline.files.wordpress.com/2024/03/smilandslidefeb2021news.pdf>) or slope failure on the northeast corner of Seneca Meadows.

**The Finger Lakes Times ran this photo of unannounced activity at SMI in 2021 that some observers called a ‘blowout,’ while landfill officials called it ‘normal operations.’**

“The work at the site was frantic,” Churchill said of the unannounced activity in 2021. “The repair/patch was completed in short order. Today that area has a huge green liner covering it. I refer to it as the great green band-aid.”

But Kyle Black, the manager at SMI, recently reiterated what he said at the time. “It was normal waste filling operations,” he said last week. “There was some movement of the sub grade and the soil had to be treated.”

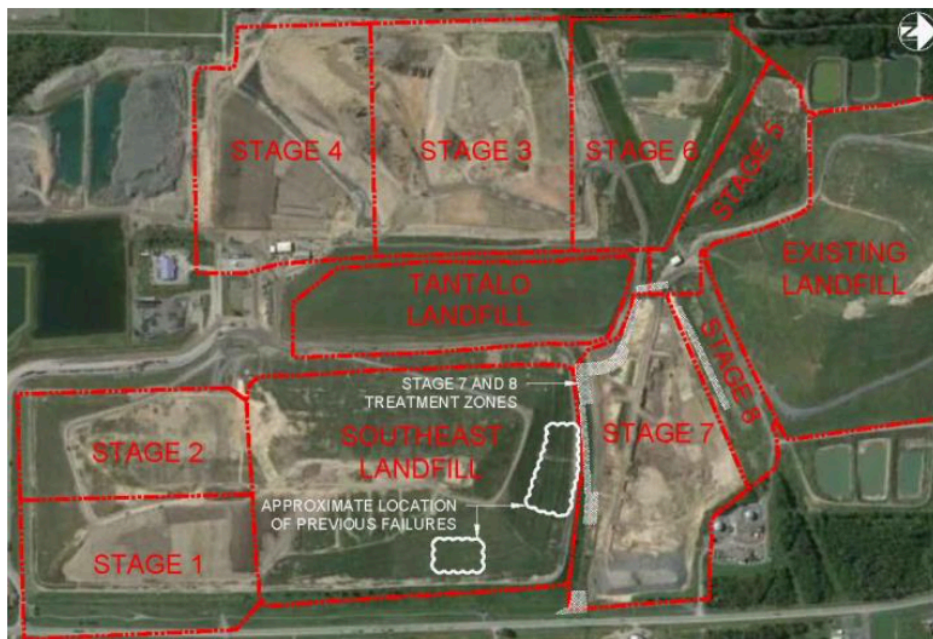
In 2004, SMI did experience “two slope failures,” according to the study by Daniel Ruffing of Geo-Solutions Inc. and others. It cited an engineer’s conclusion that they were caused by “soft clayey deposits that did not have sufficient shear strength to resist the weight of the berm.”

A site map of Seneca Meadows included in a 2017 study outlines in white the areas of two “slope failures” in 2004.

In response, the landfill began “a series of recent projects” experimenting with mixtures of cement and soil to improve its bearing capacity. “Up to this point, soil mixing at this facility has been successful,” the authors concluded.
