Orinda Downs HOA

Level 1 Reserve Study

Report Period - 6/1/2020 to 5/31/2021

Client Reference Number	20467
Property Type	Single Family Homes
Number of Units	154
Fiscal Year End	5/31
Type of Study	Full Study
Date of Site Visit	2/18/2020
Prepared By	Eric Phillipps
Analysis Method	Cash Flow
Funding Goal	Full Funding

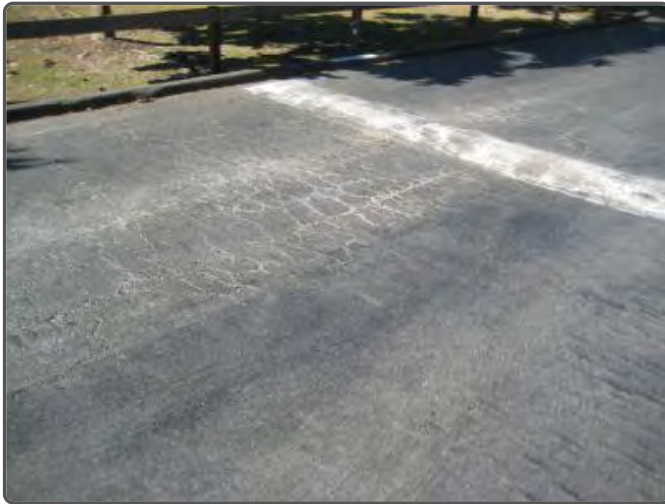
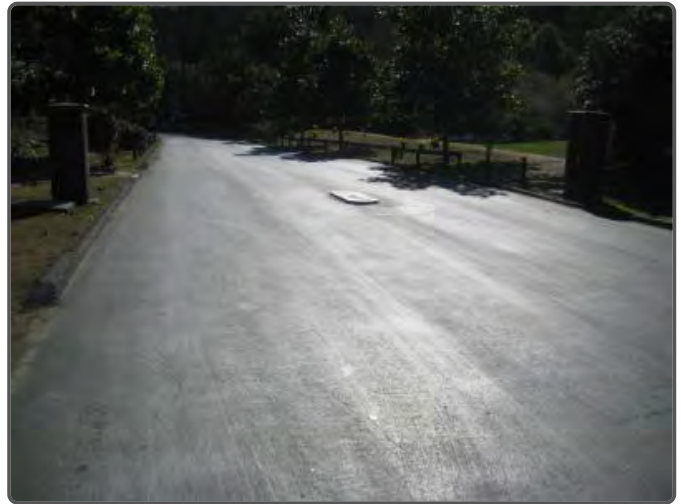
Areas of cracking and deterioration observed. This component typically has an approximate life of 30-40 years. At this time, we recommend the association bring in an asphalt consultant to professionally evaluate the asphalt and develop a scope of work and timeline for future resurfacing/overlay maintenance (major rehab.). The remaining useful life is based on the assumed age.

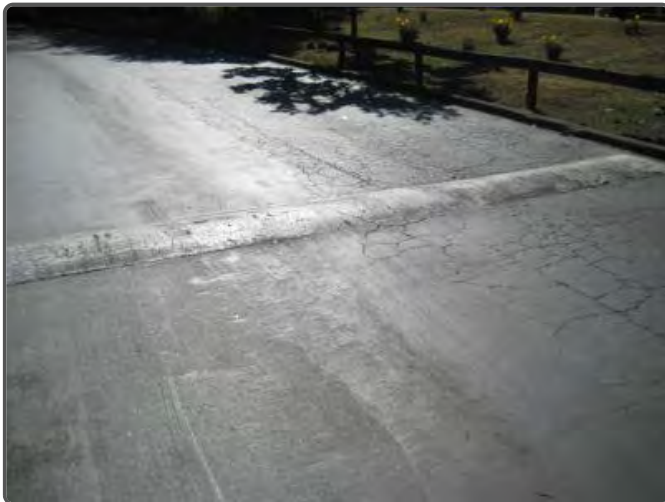
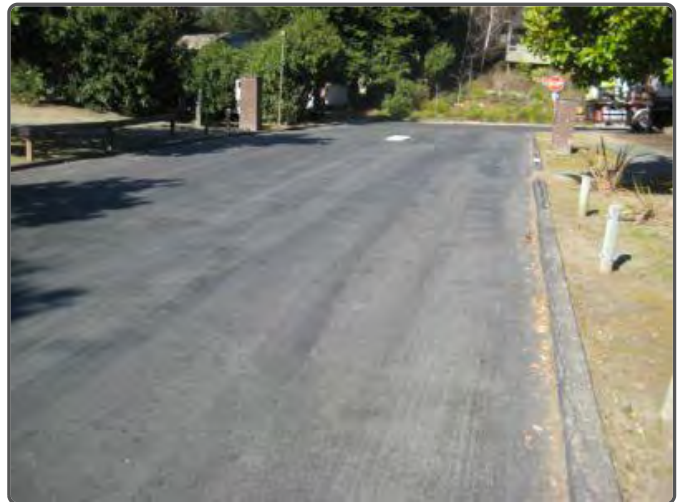
Regular cycles of preventive maintenance (repair/seal coating/stripping) is key to extending the typical useful life cycle of asphalt. This component has an approximate life of 4-6 years and should be completed within 6 months to a year after major rehabilitation projects (see previous component #401).

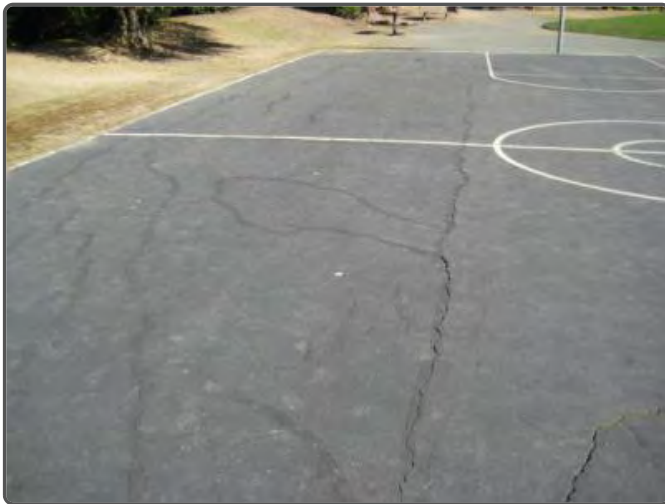
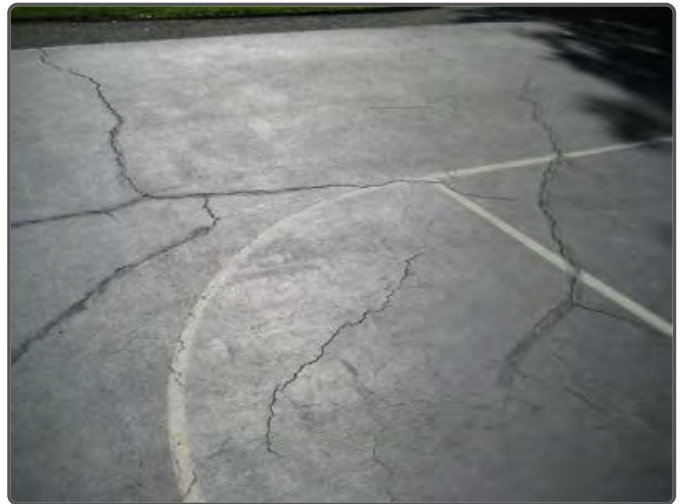
Areas of significant cracking observed. This component typically has an approximate life of 30-40 years, but preventive maintenance (see next component) may prolong typical useful life before major rehabilitation may be needed (resurfacing, overlay, etc.).

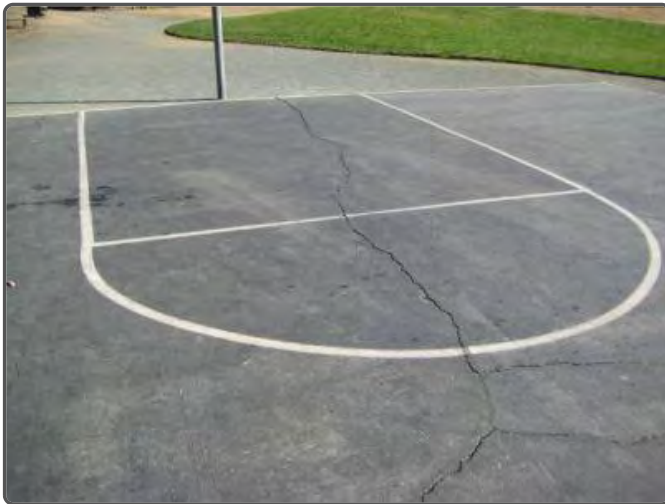
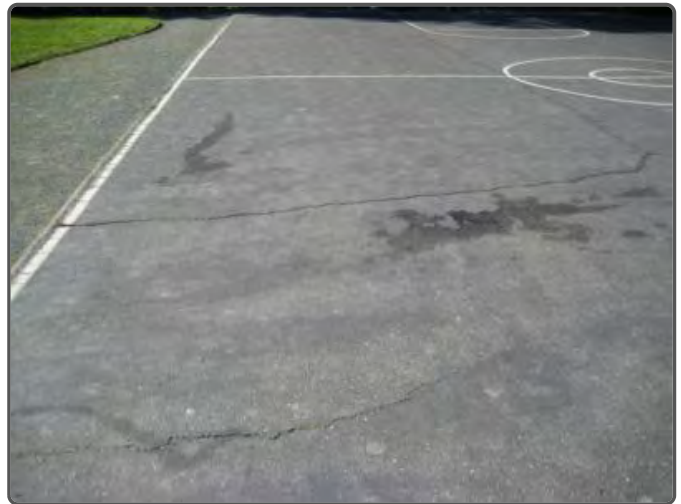
Regular cycles of preventive maintenance (repair/seal coating/stripping) is key to extending the typical useful life cycle of asphalt. This component has an approximate life of 4-6 years and should be completed within 6 months to a year after major rehabilitation projects (see previous component #403).

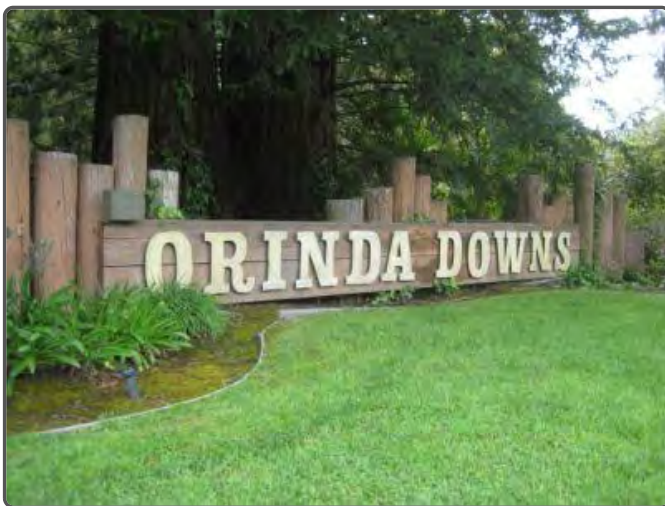
Comp # 801 **Wood Signs - Repair**

Although the community sign and park sign are long lasting, they will require significant cycles of repair and upgrades. If at some point, total replacement is required, funding may be adjusted in reserve study updates.

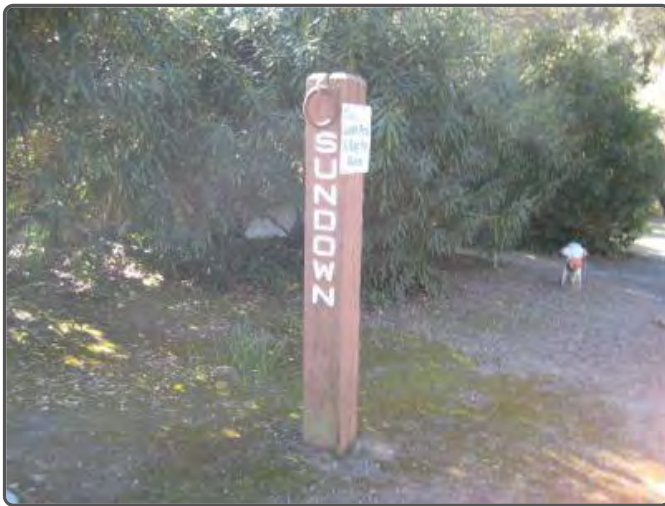
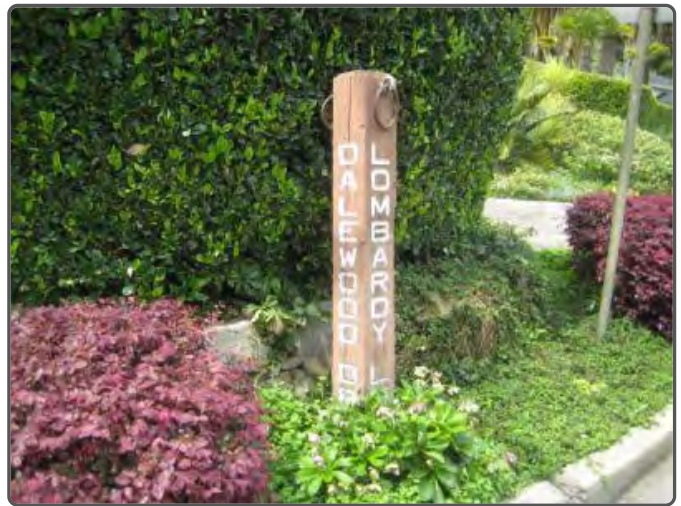
Comp # 802 **Sign Posts - Replace**

The majority of wood sign posts appeared in stable condition. This component has an approximate useful life of 25-35 years. The remaining useful life is based on assumed age.

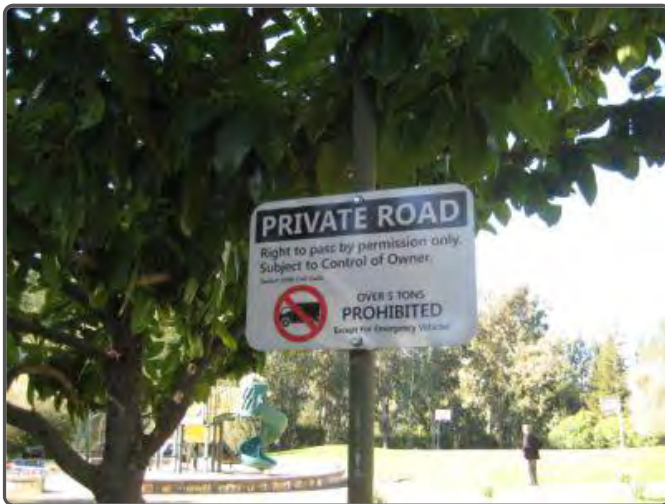
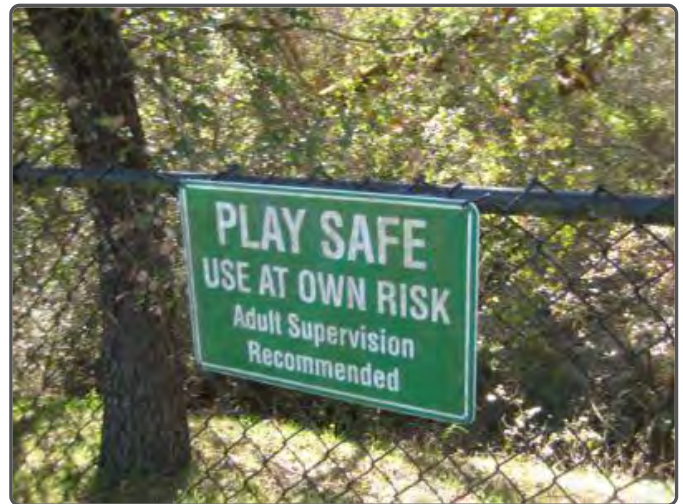
Comp # 803 **Metal Signage - Replace**

Best to plan for regular cycles of signage replacement. This component has an approximate life of 15-25 years.

Remaining useful life is based on the assumed age.

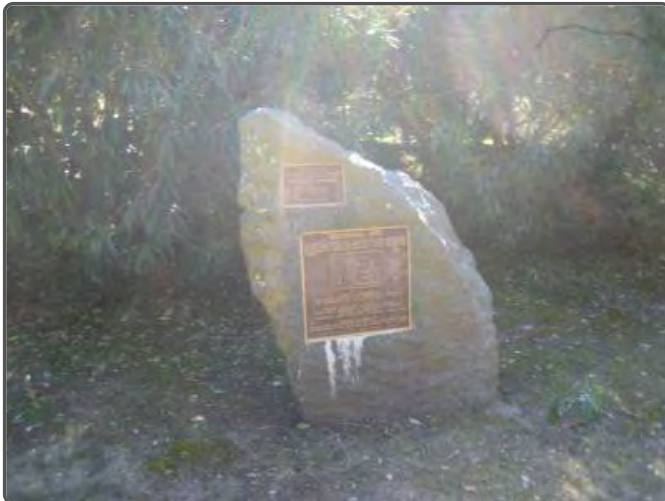
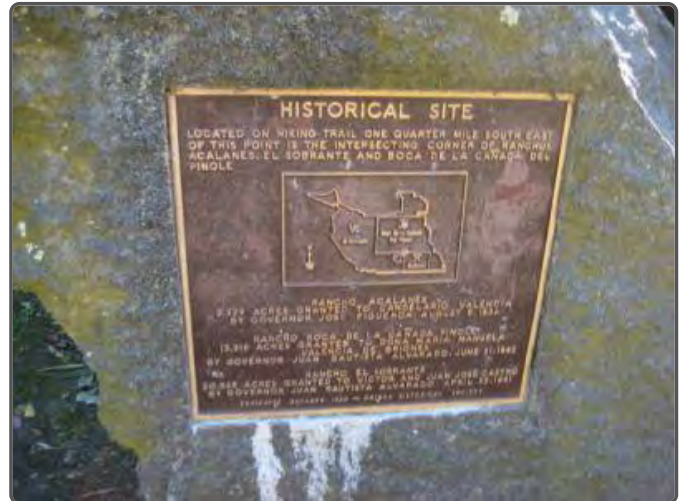
Comp # 804 Historical Monument - Replace (Not Funded)

The historical monument should have an extended life that last well beyond the cope of a reserve study. Therefore, reserve funding is not required at this time.

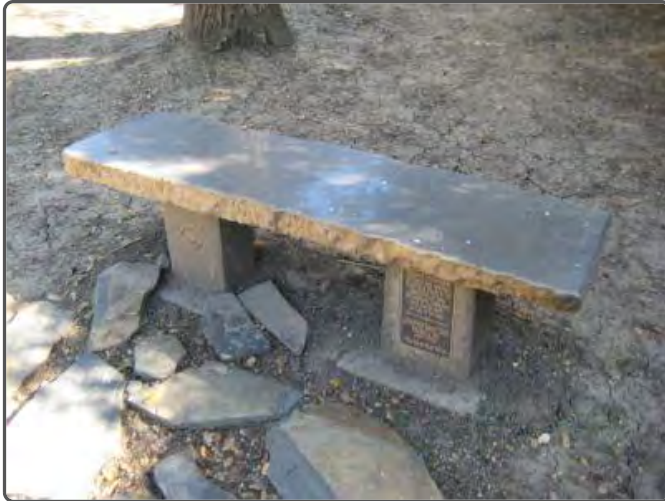
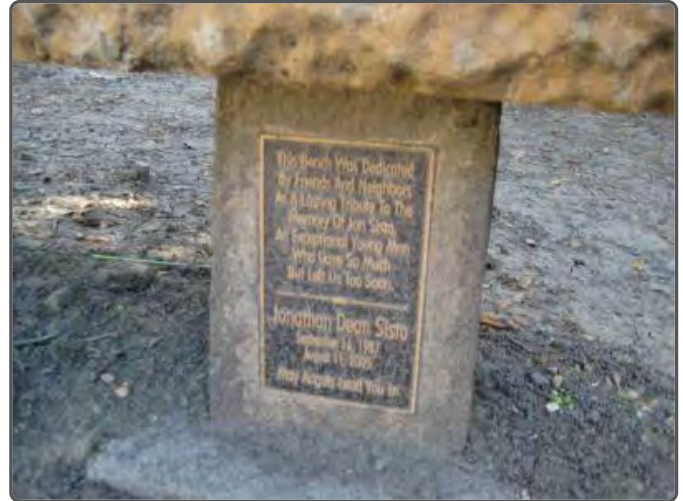
Comp # 805 **Bench Monument - Replace (Not Funded)**

The bench monument should have an extended life that last well beyond the cope of a reserve study. Therefore, reserve funding is not required at this time.

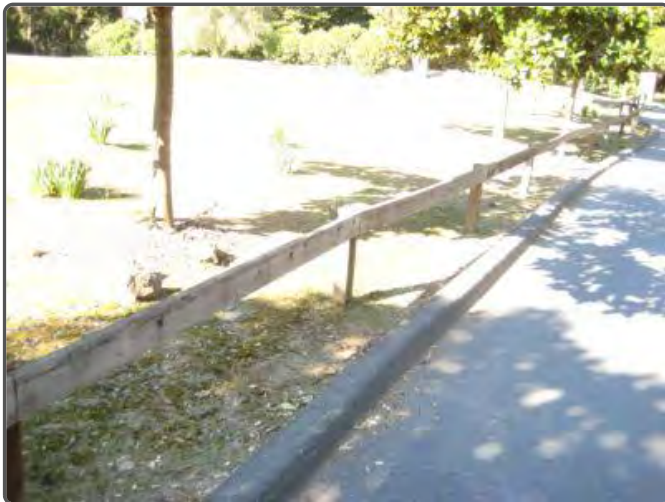
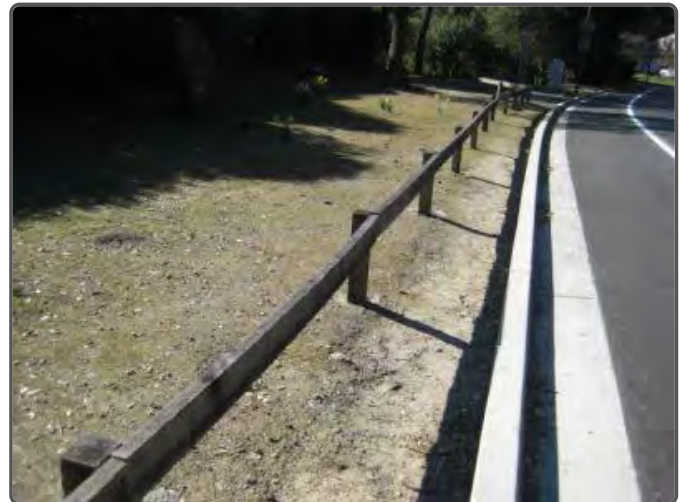
Comp # 1001 **Wood Post & Rail Fencing - Replace**

The wood post and rail fencing appeared in generally stable condition and was reportedly last repaired in 2014. This component typically has an approximate useful life of 15-25 years. The remaining useful life is based on the prior repair cycle.

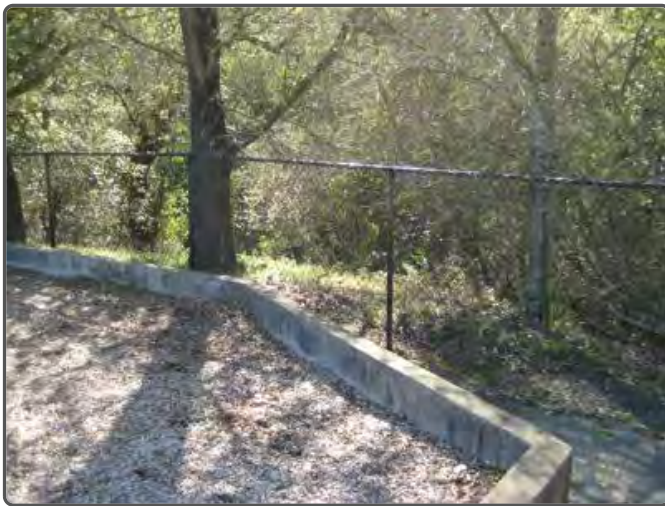
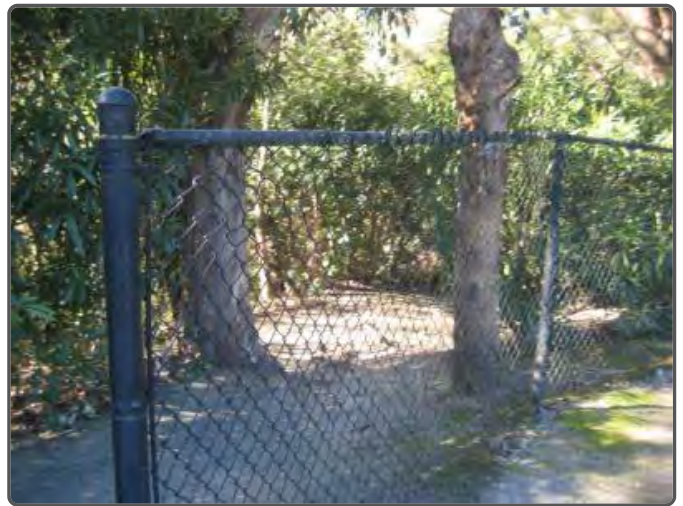
Comp # 1002 **Chain Link Fencing - Replace**

Although there were some areas of damage, the majority of vinyl coated chain link fencing appeared in stable condition. This component has an approximate useful life of 35-45 years. The remaining useful life is based on the assumed age.

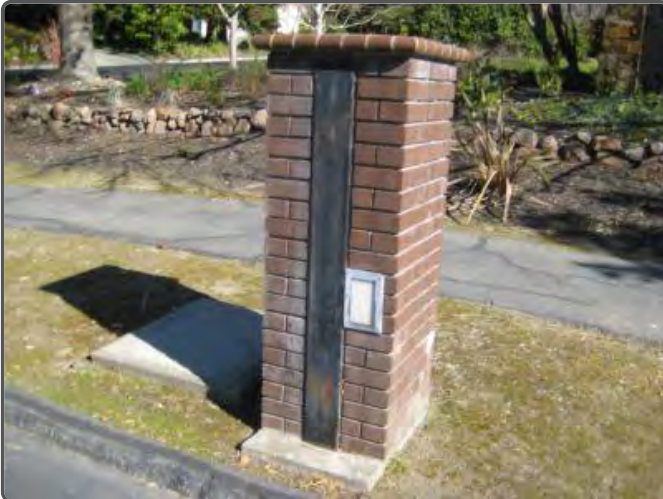
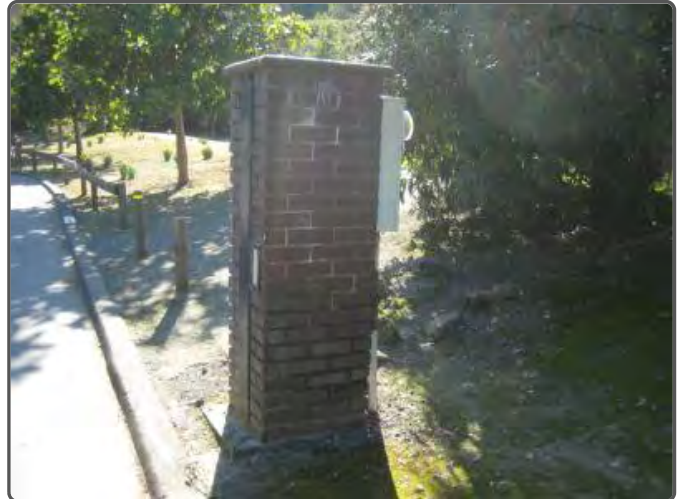
Comp # 1003 **Gate Pillars - Replace (Not Funded)**

Since the gate was removed, there is no expectation to replace the gate pillars. Therefore, reserve funding is not required at this time.

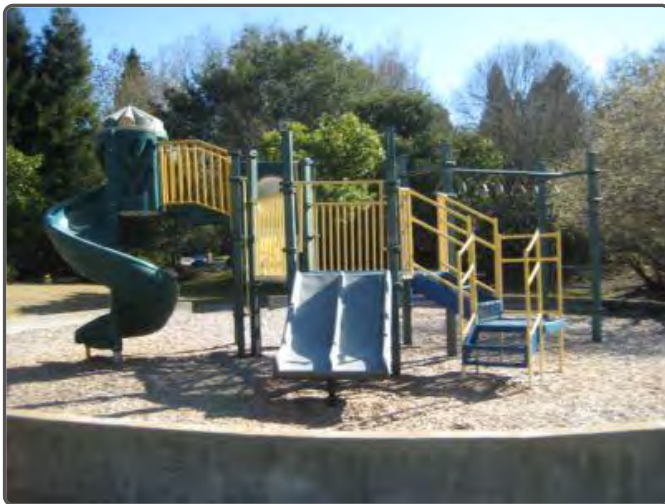
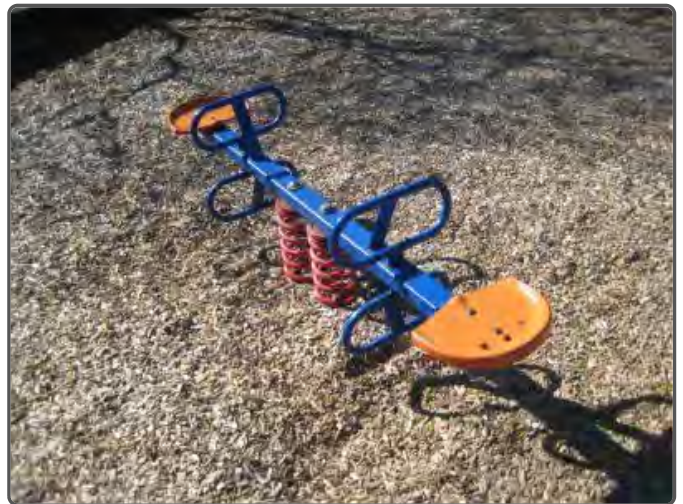
Comp # 1301 **Play Structures - Replace**

The play equipment was reportedly replaced around 2008-2010. This component has an approximate useful life of 15-25 years. The remaining useful life is based on the installation date.

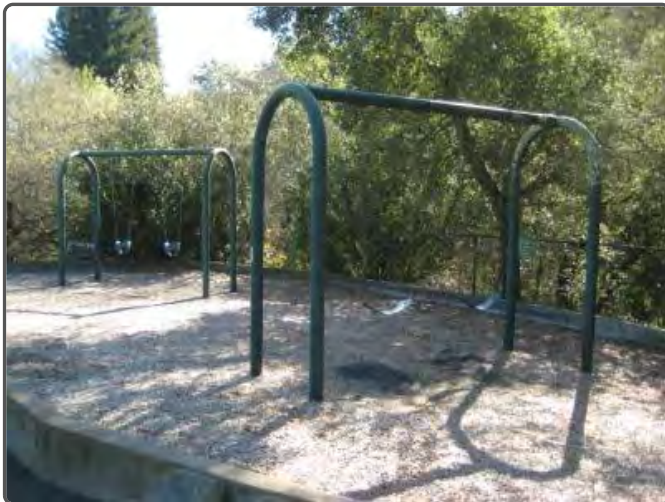
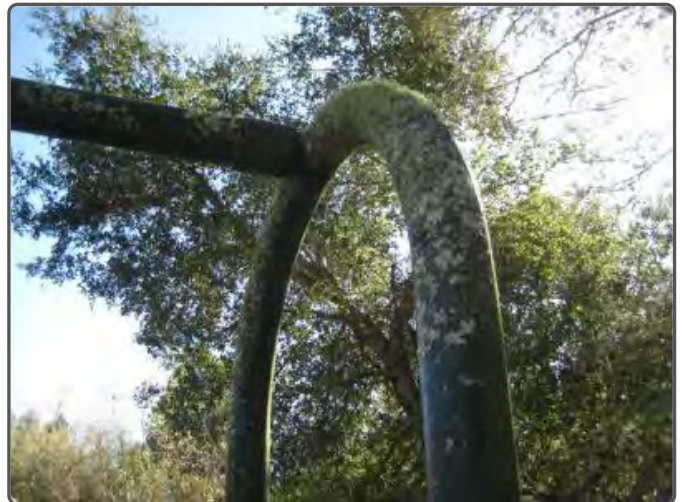
Comp # 1302 **Swing Sets - Replace**

Although the structures are sturdy and long lasting, best to plan for eventual replacement. The swing sets were reportedly replaced around 2008-2010. This component has an approximate useful life of 25-35 years. The remaining useful life is based on the installation date.

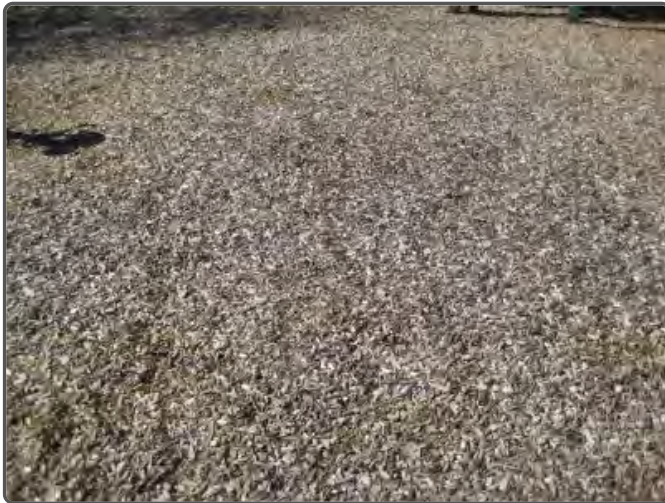
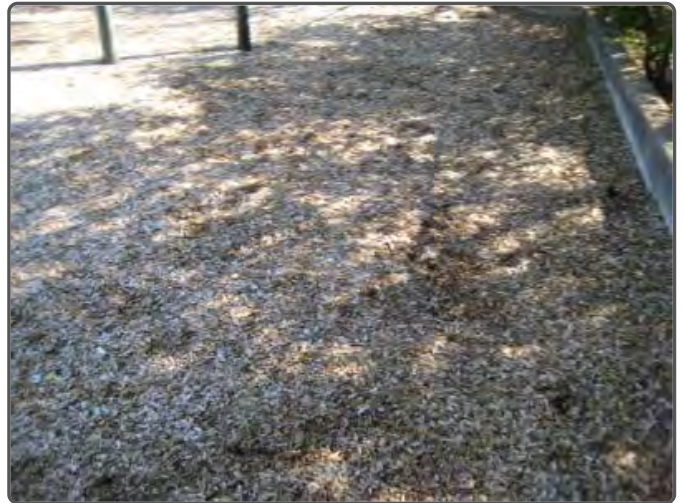
Fair coverage observed. Best to plan for regular cycles of replenishment at roughly the time frame indicated.

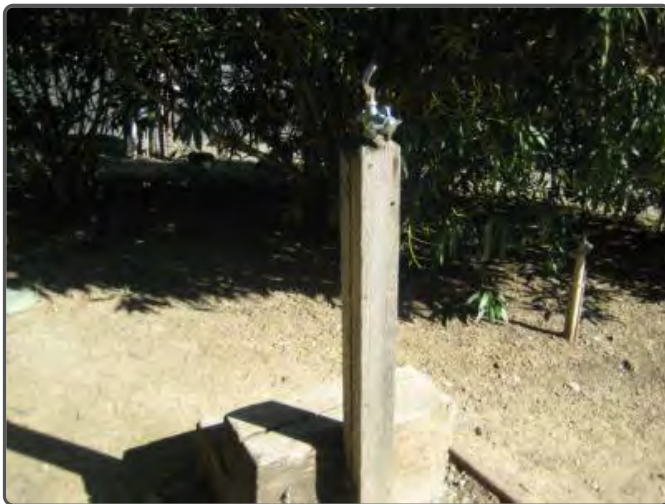
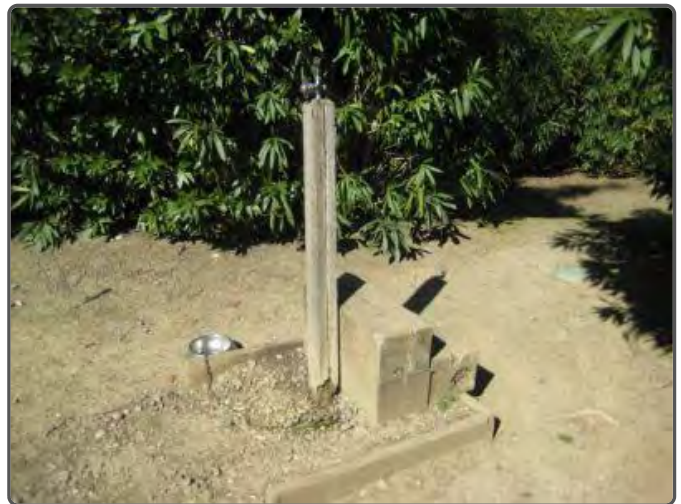
Comp # 1304 **Drinking Fountain - Replace**

Functional condition assumed. This component has an approximate useful life of 15-25 years. The remaining useful life is based on the assumed age.

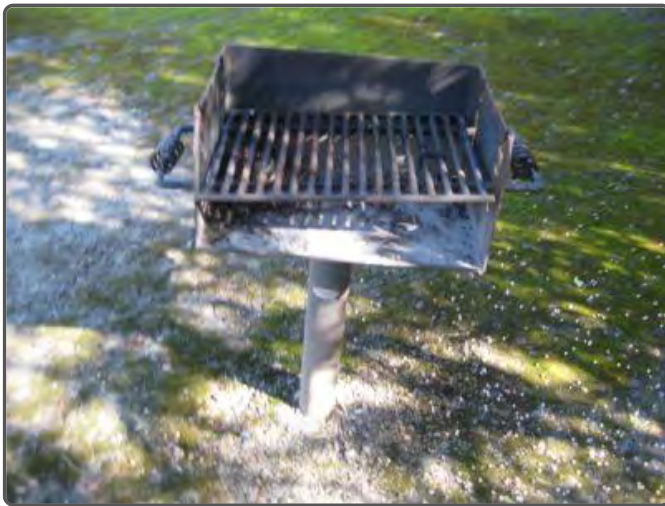
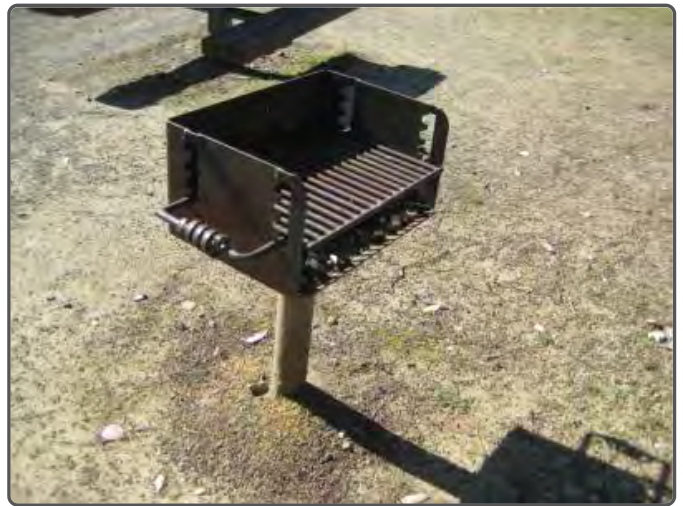
Comp # 1305 **Barbecues - Replace**

Although long lasting, metal barbecues will require eventual replacement. This component has an approximate useful life of 35-45 years. The remaining useful life is based on the assumed age.

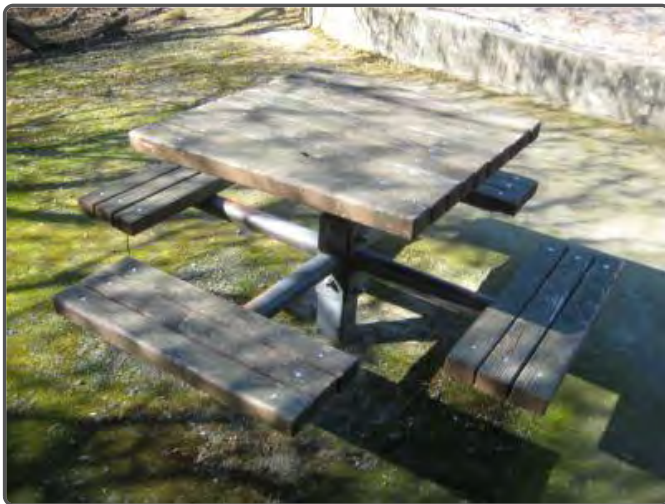
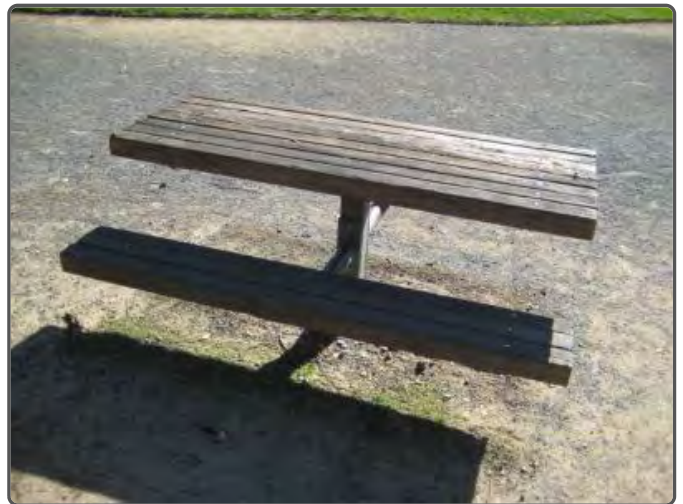
Comp # 1306 **Picnic Tables - Replace**

Although the metal base is long lasting, wood seats and table top will eventually deteriorate. This component has an approximate useful life of 20-30 years. The remaining useful life is based on the assumed age.

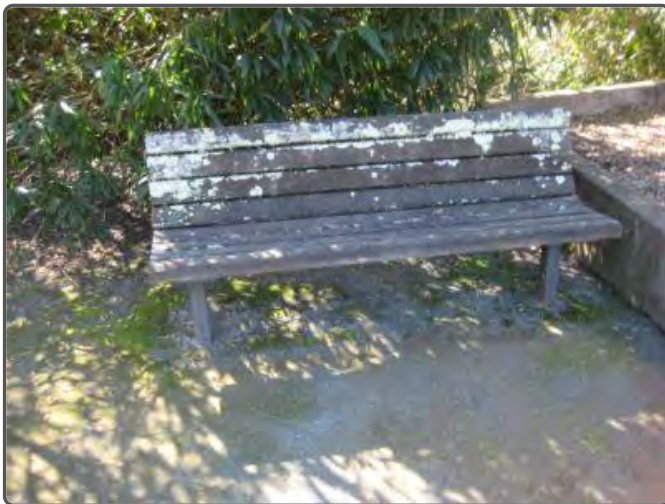
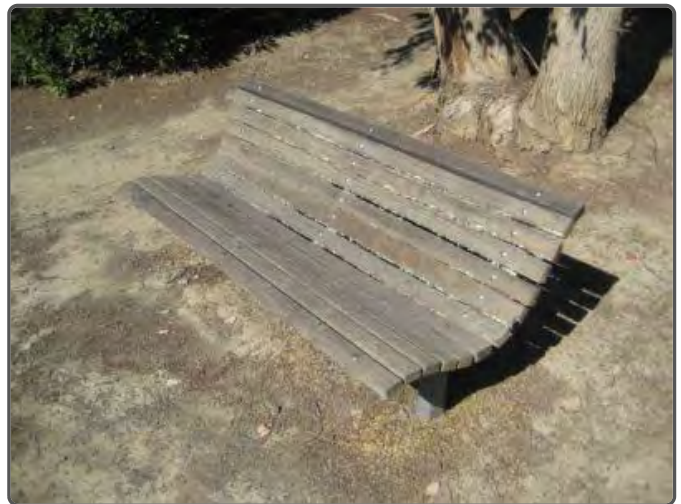
Comp # 1307 **Benches - Replace**

Wood benches appear to be approaching the end of their life span. This component has an approximate useful life of 15-25 years. The remaining useful life is based on the current condition.

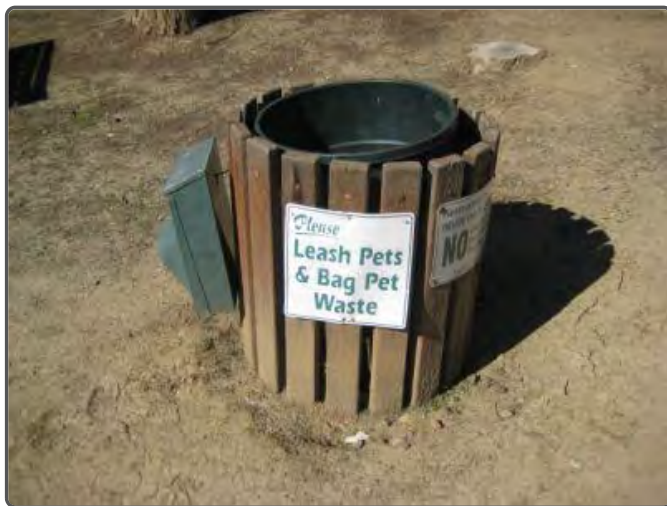
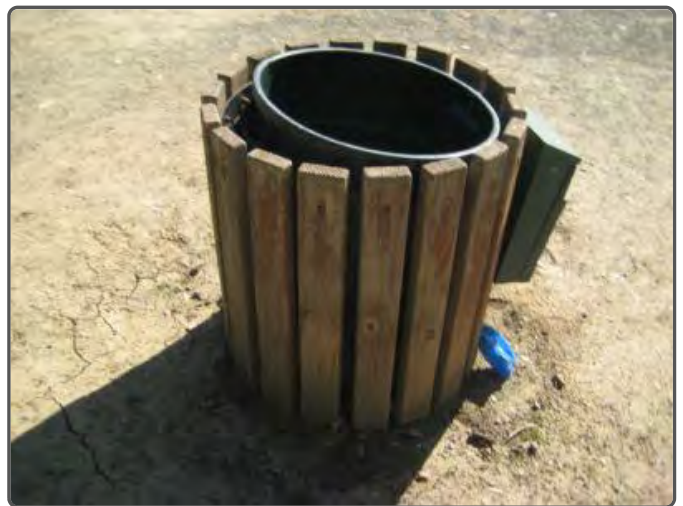
Comp # 1308 **Trash Receptacle Enclosure - Replace**

Trash receptacles receive more use/abuse than other components. This component has an approximate useful life of 10-20 years. The remaining useful life is based on assumed age.

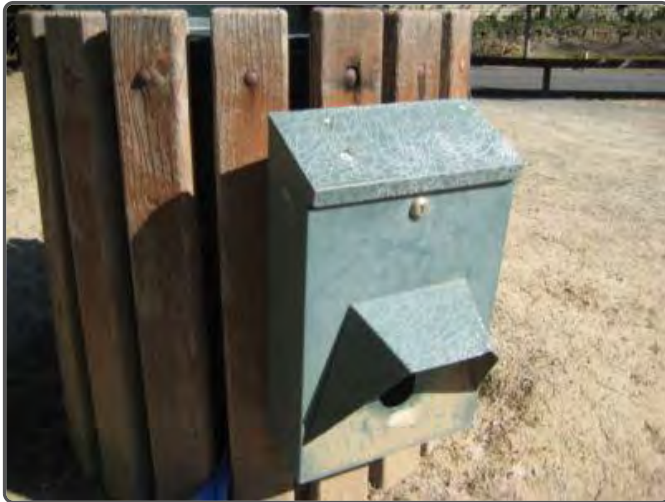
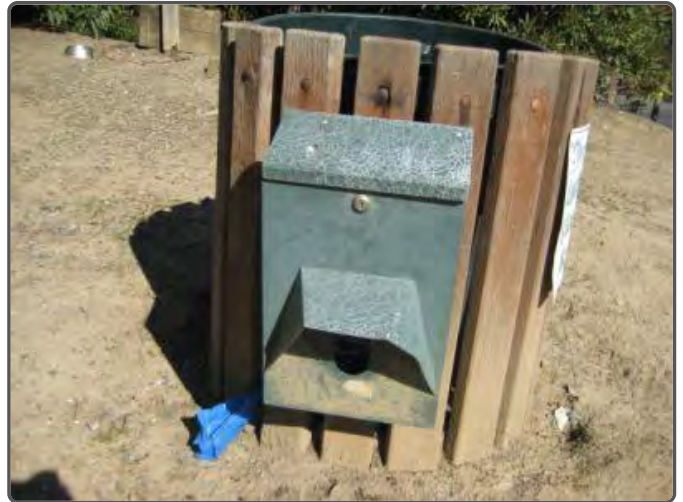
Comp # 1309 **Pet Station - Replace (Not Funded)**

Smaller cost item to replace, plan to maintain as general operating/maintenance expense.

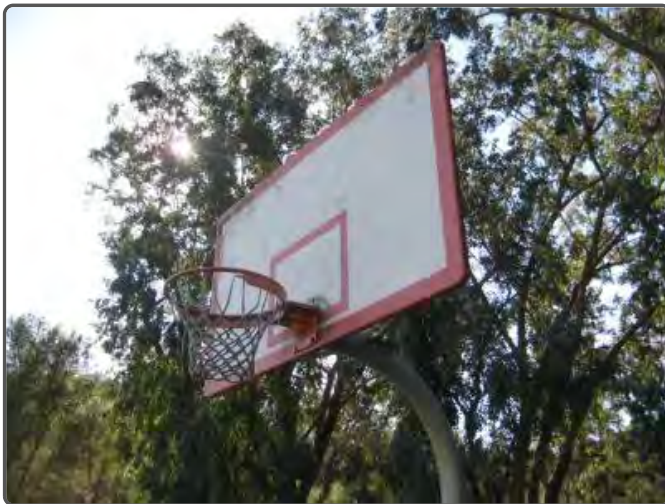
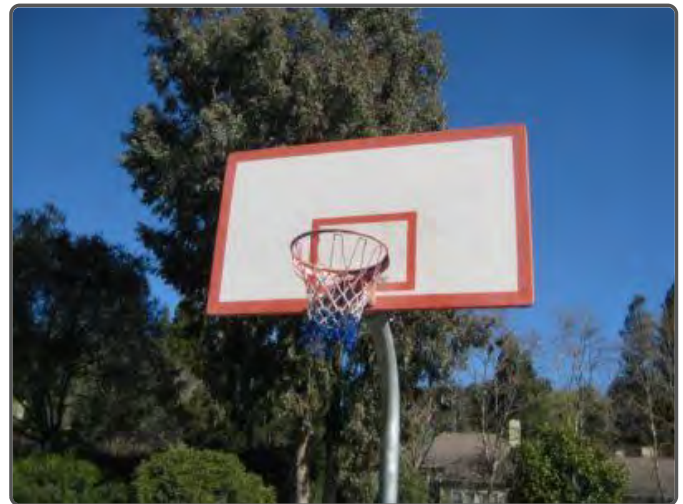
Comp # 1310 **Basketball Equipment - Replace**

Although the poles will have extended life, backboard, hoop and net will require cycles of replacement. This component has an approximate useful life of 15-25 years. The remaining useful life is based on assumed age.

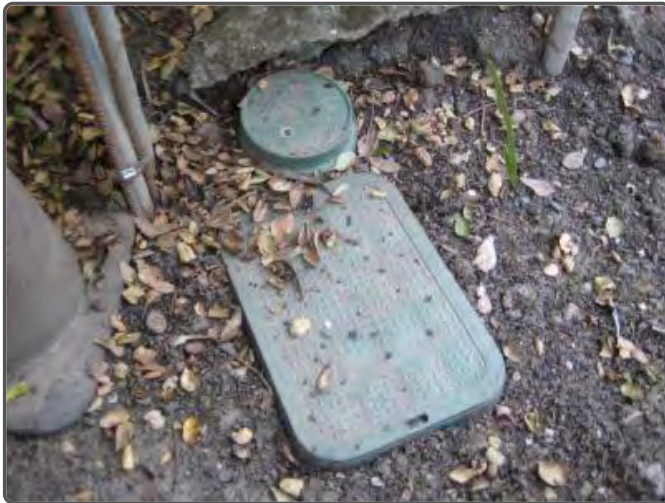
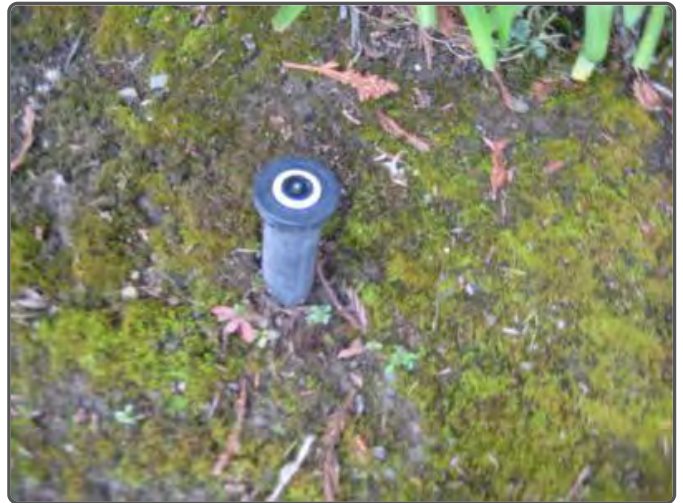
Although difficult to predict timing and scope of work, best to plan for regular cycles of irrigation upgrades.

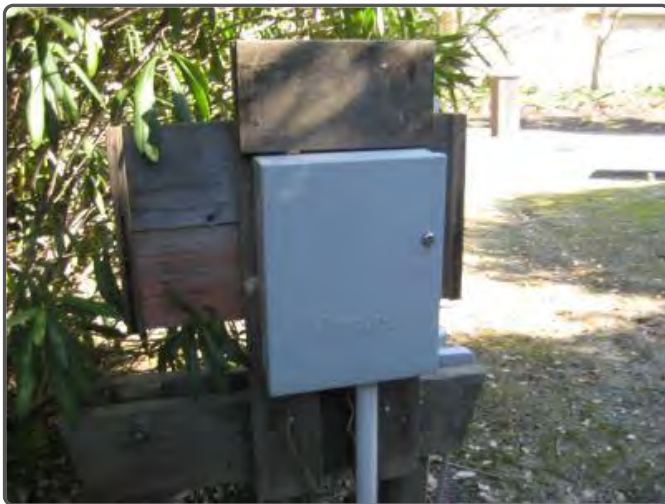
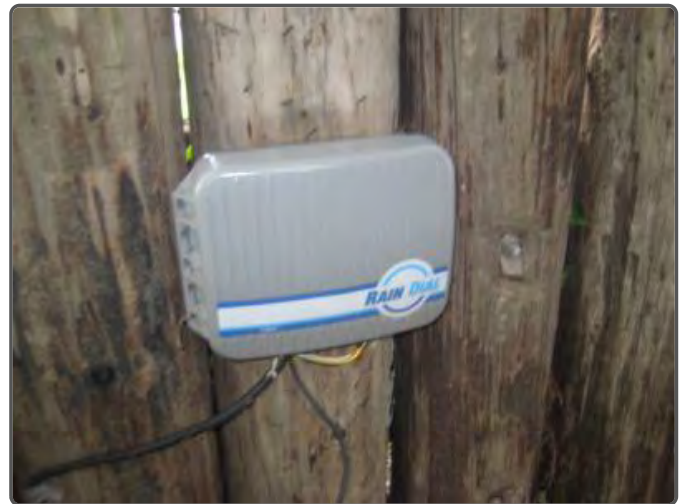
Comp # 1702 **Irrigation Controllers - Replace**

Functional condition assumed, no problems reported. This component has an approximate useful life of 10-20 years. The remaining useful life is based on the assumed age.

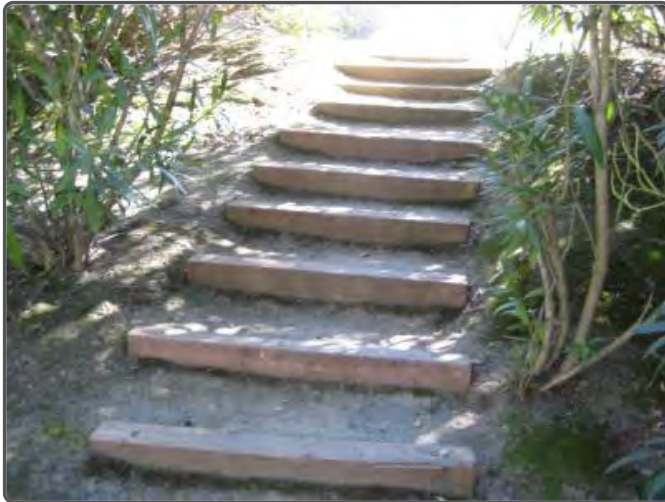
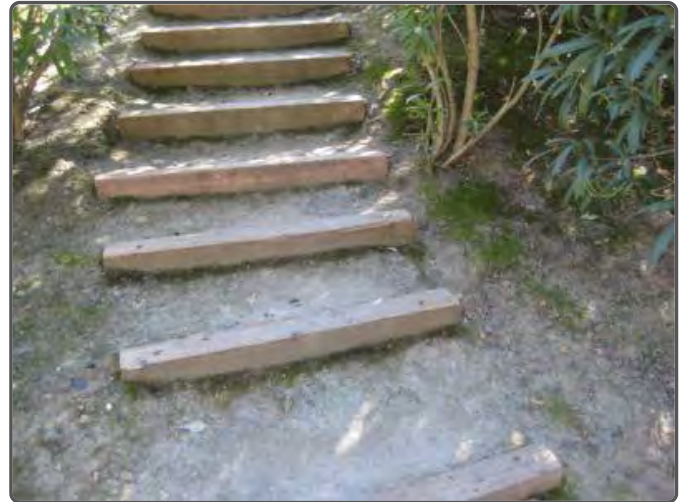
Comp # 1801 **Railroad Tie Steps - Replace (Not Funded)**

Smaller cost item to replace, plan to maintain as general operating/maintenance expense.

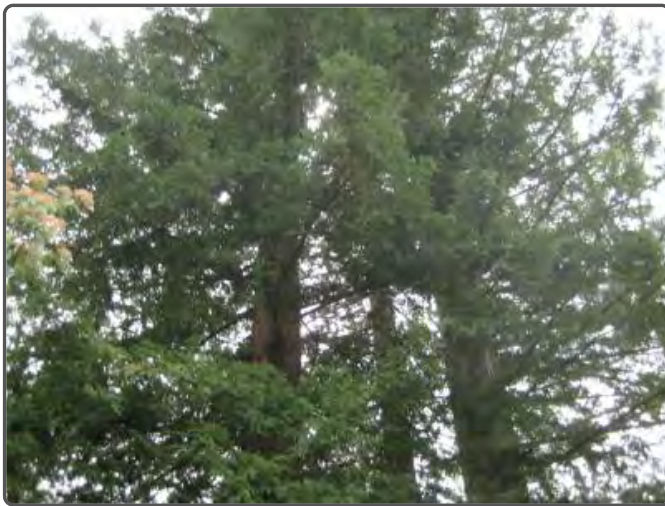
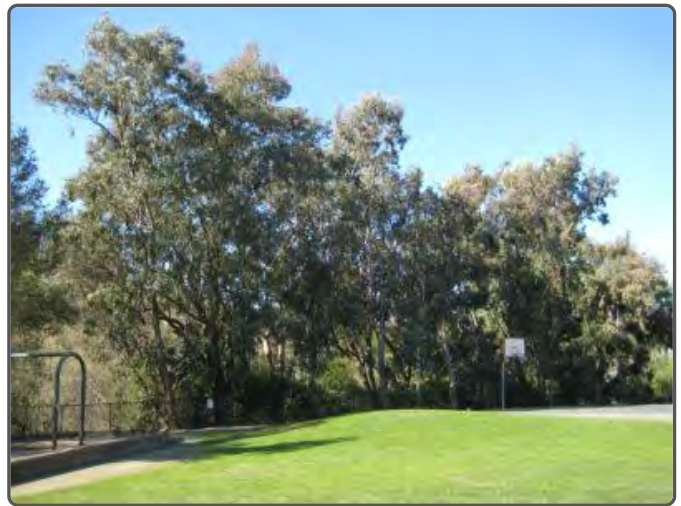
This component represents a reserve allowance for regular cycles of significant tree maintenance expenses. Monitor expenses closely and adjust as needed in reserve study updates.
