Montana Department of Transportation

To: Bob Vosen, P.E. – Missoula District Administrator  
From: Stan Brelin II, P.E. – Traffic Operations Engineer *SB*  
Date: August 8, 2023  
Subject: Intersection Traffic Control Study  
US 93 & Adams Street – Lakeside

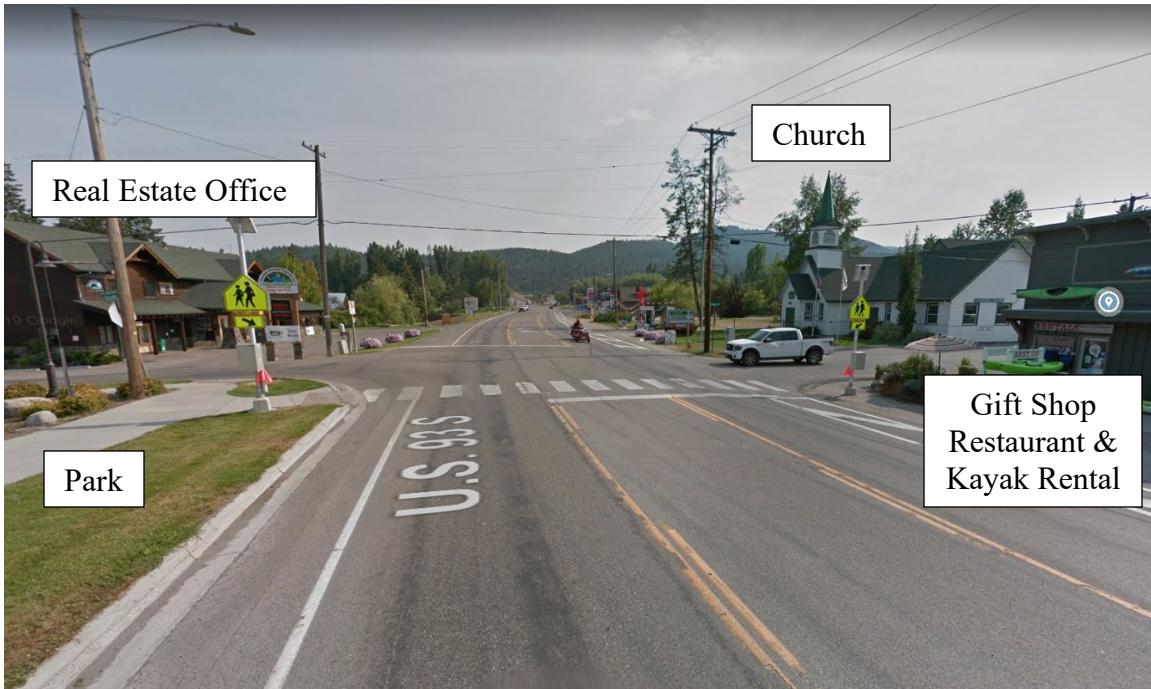
**Figure 3: Street View of Intersection**

Currently the only traffic control on Adams Street is a stop sign for both the east and west legs of the intersection. US 93 traffic is uninterrupted except when a pedestrian utilizes the rectangular rapid flashing beacons (RRFB). The crosswalk is located on the northern leg of the intersection and is continental in style. Shark teeth were installed in 2023 along with restriping the crosswalk on US 93. There are no pavement markings on Adams Street. A real estate office occupies the southeast corner of the intersection whereas a church is on the southwest corner. On the northside of the intersection there is a park on the east side of US 93 and a building occupied by kayak rental business, gift shop, and restaurant on the west side of US93.

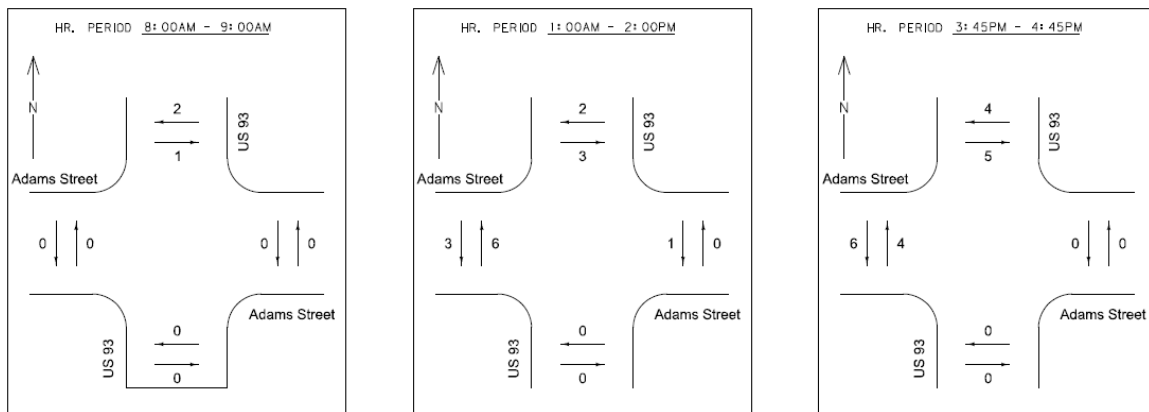
**Figure 8: Pedestrian Peak Hour Volumes for October 6, 2021**

Pedestrian activity was observed in October of 2021 and August of 2022. Figures 8 through 11 show the morning, midday, and afternoon peak pedestrian volumes for October 6, 2021, October 7, 2021, August 9, 2022, and August 30, 2022. A significantly higher volume of pedestrians was observed during the summer.

Pedestrian volumes during the month of October were consistent from day to day. Approximately 6 pedestrians were observed crossing US 93 during the peak hours on average. About 8 pedestrians were observed during the peak hours crossing the west leg of Adams Street on average. Normally there were no pedestrians observed crossing the east leg of Adams Street.

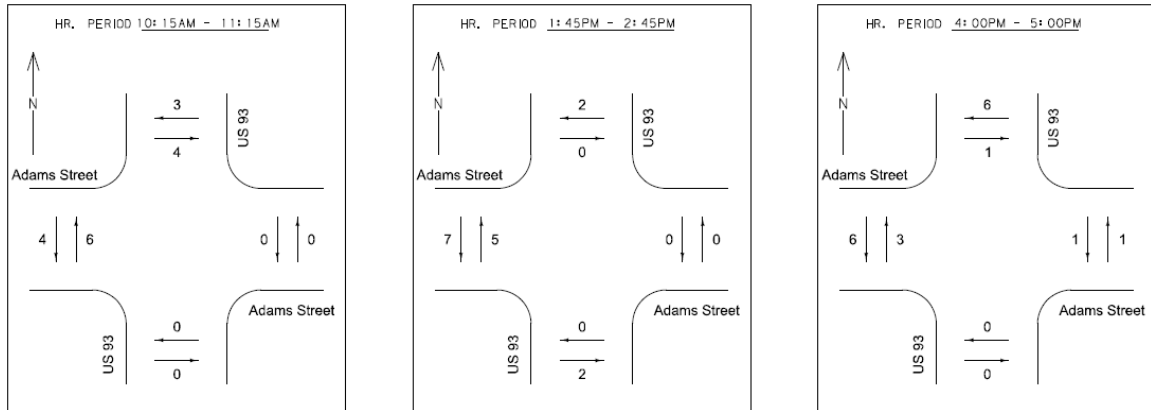
**Figure 9: Pedestrian Peak Hour Volumes for October 7, 2021**

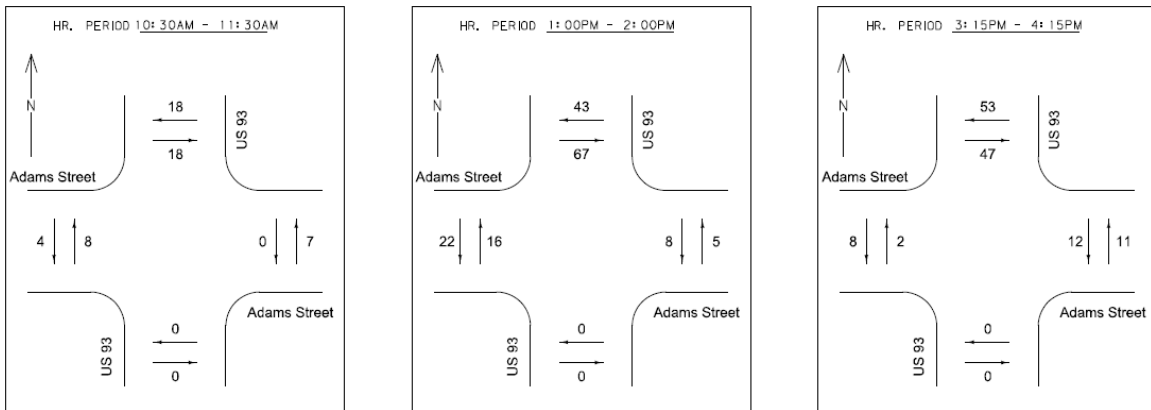
**Figure 10: Pedestrian Peak Hour Volumes August 9, 2022**

Between the beginning of August and the end of August there was some fluctuation in pedestrian volumes. Total pedestrian volumes during the peak hours were on average twice as much on the 9<sup>th</sup> of August in comparison to the 30<sup>th</sup> of August. There were no events and both days were Tuesdays. Temperatures were eight degrees cooler on the 30<sup>th</sup> compared to the 92-degree day observed on the 9<sup>th</sup>.

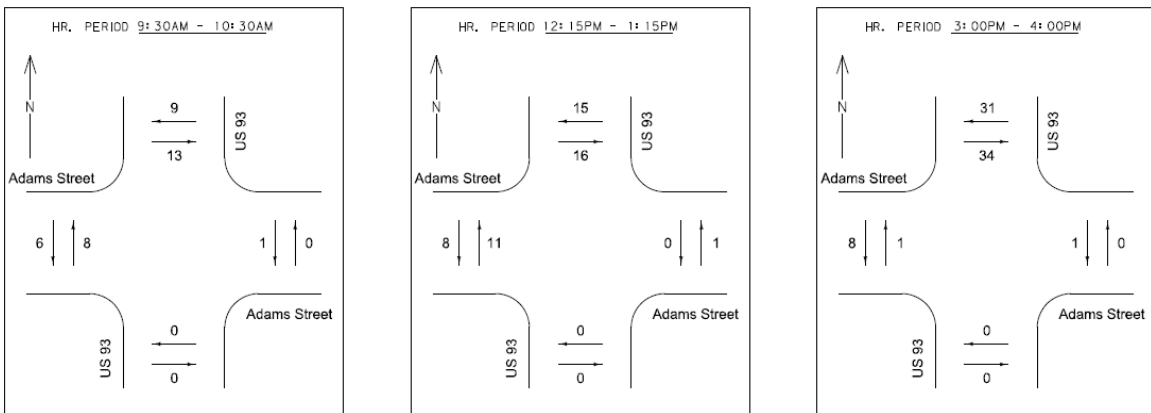
**Figure 11: Pedestrian Peak Hour Volumes August 30, 2022**

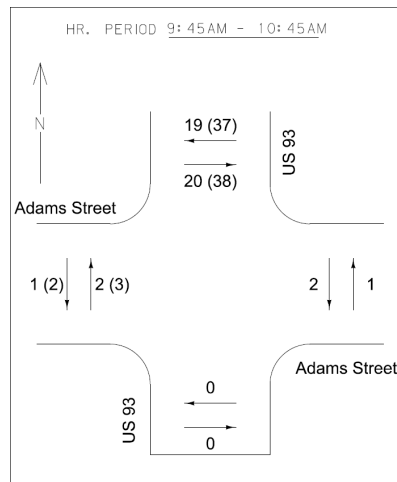
**Figure 12: Peak School Age Children Pedestrian Crossings**

Pedestrian volumes were not adjusted to account for child pedestrians except for October 8, 2021. On this date there were 36 school aged children observed crossing the northern leg of the intersection during the peak hour in Figure 12. It was estimated that a child pedestrian would need 14-second to cross the 46-foot-wide road surface plus an additional 3-seconds for perception reaction time. The total time a school aged-child pedestrian would require is 17-seconds. When these children were observed crossing US 93 there was one adult present and the lead child had an orange flag to wave while crossing with the RRFB activated.
