Impacts of Pressure Monitoring and Leak Detection on Non-Revenue Water Loss

The Sound Choice
for Leak Detection.™

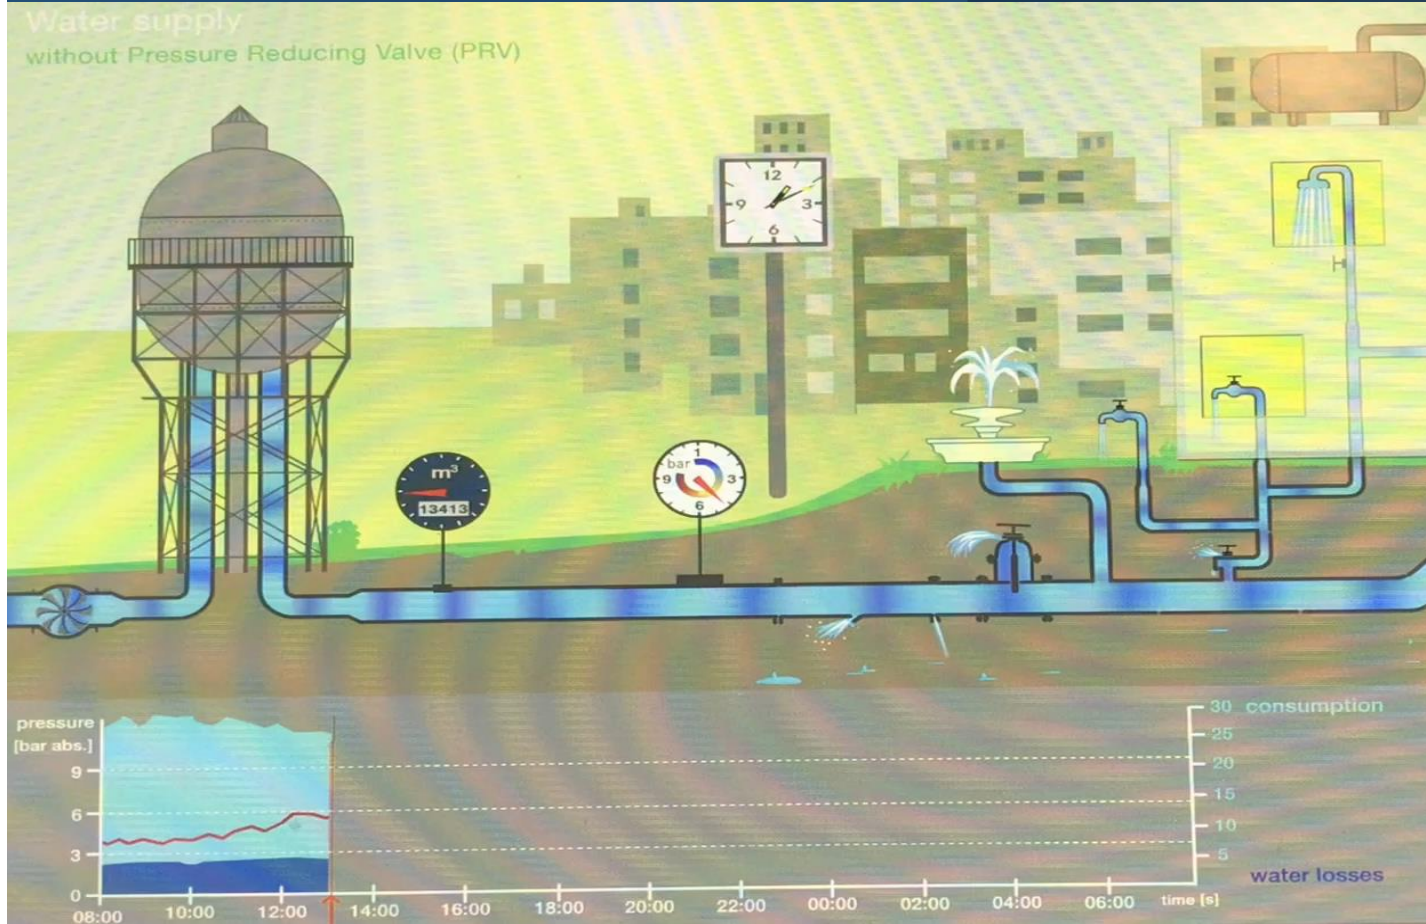
No Pressure Control

Water supply
without Pressure Reducing Valve (PRV)

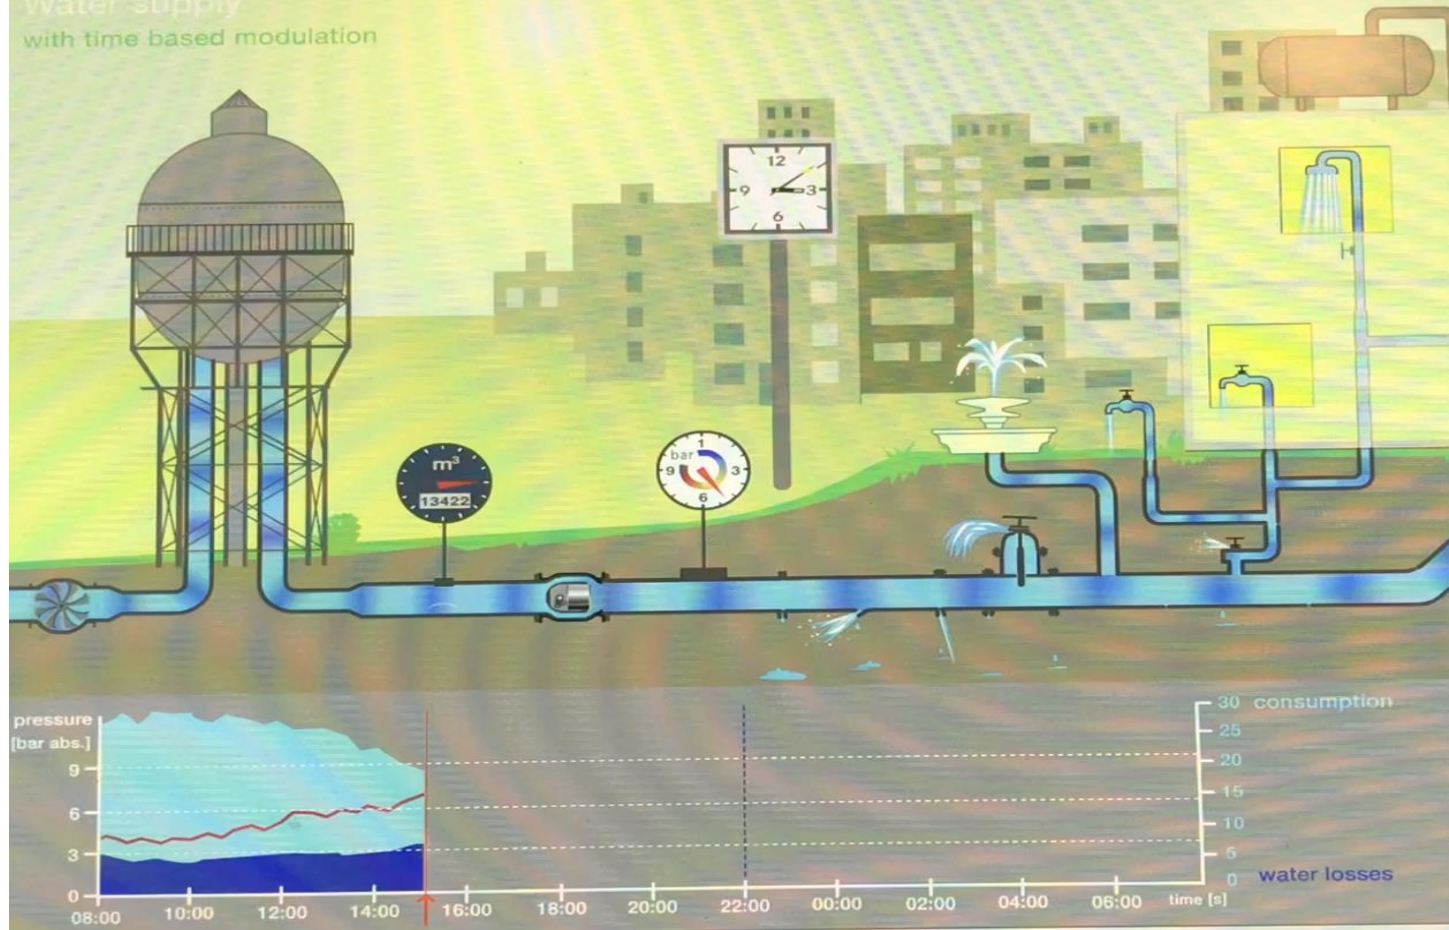
Timed Control

Water supply
with time based modulation

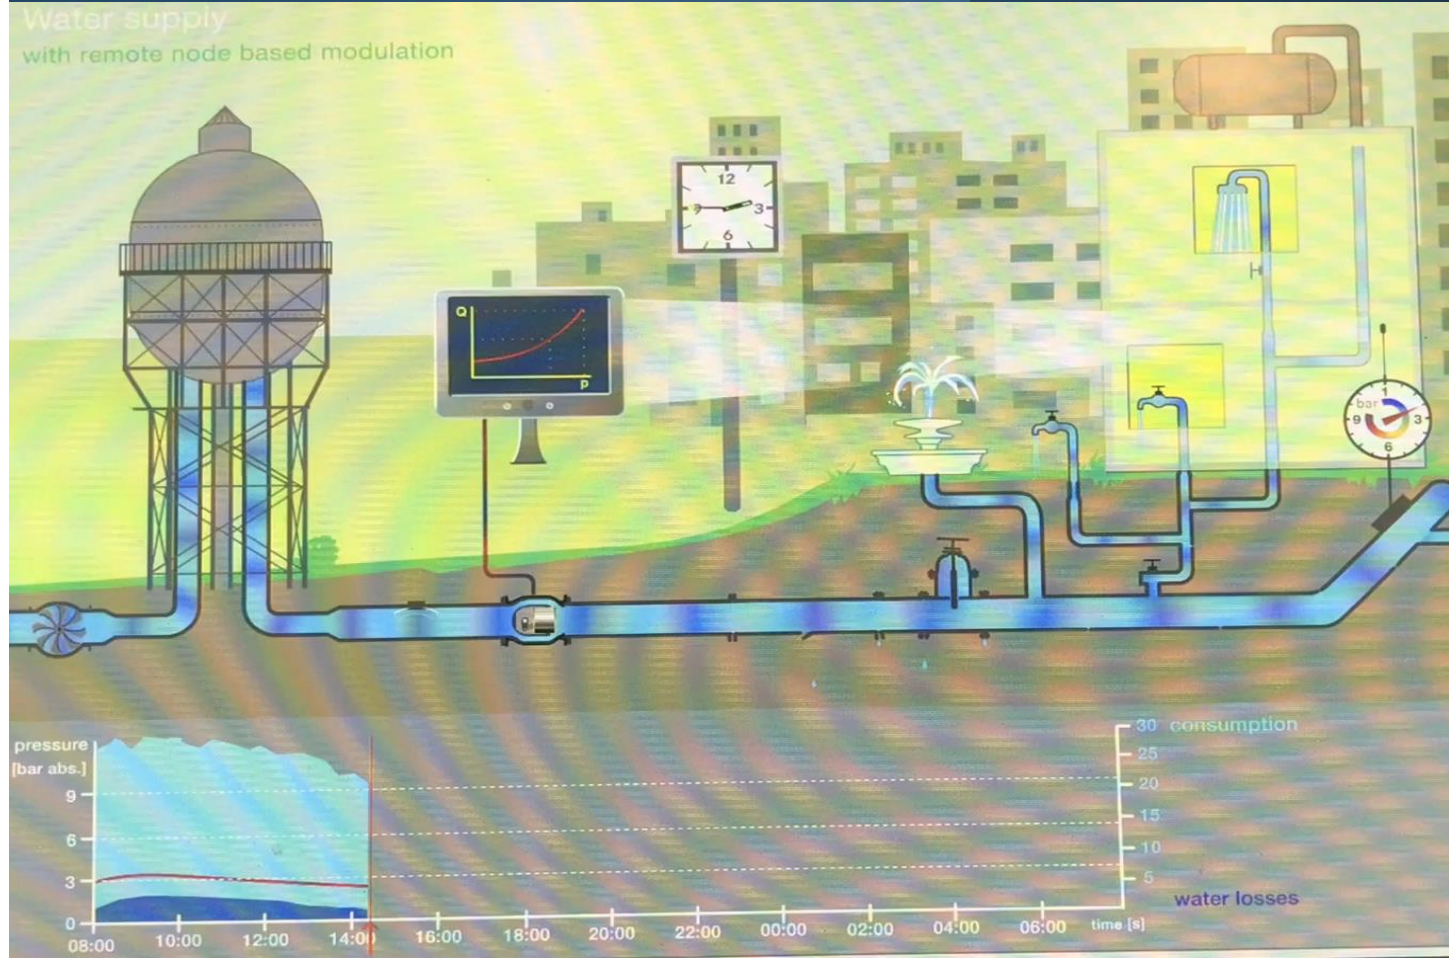
Critical Point Control

Water supply
with remote node based modulation

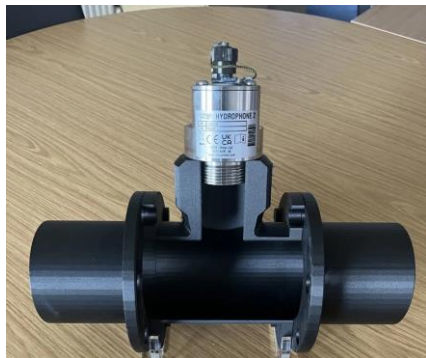
Localization Inside the Pipe

Hydrophone plus Pressure Transducer

- Continuous logging
- Multiple alarm profiles
- Audio & correlation on leak alarm

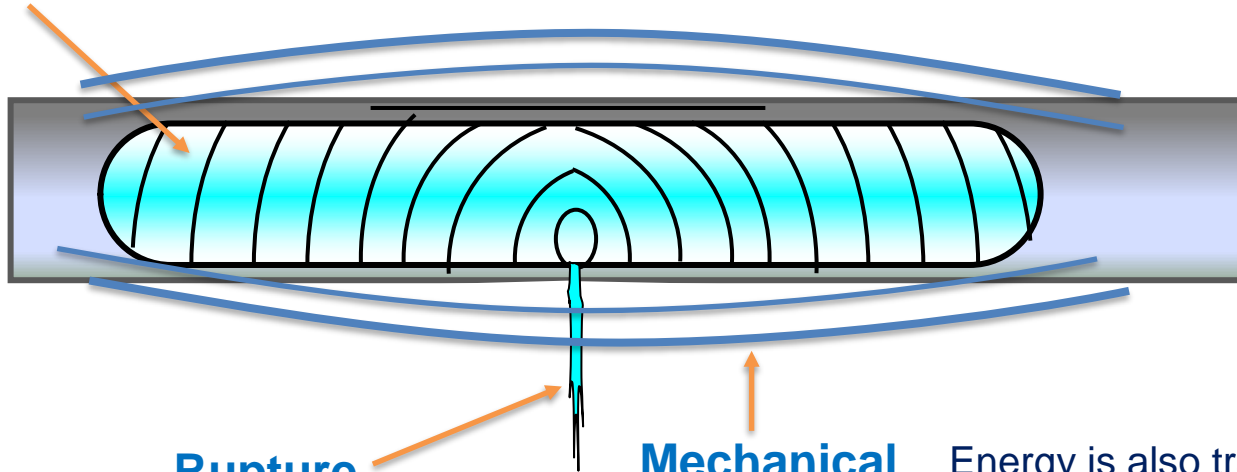
Acoustic Noise Transfer

**Pressure
Wave**

Energy generated from the leak is transmitted through the water

**Mechanical
Vibration**

Energy is also transmitted through the pipe wall

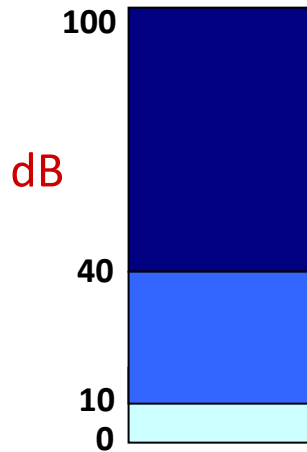
Decibel Ranges

Leaks on plastic pipes are often found at intensities of 20-40 dB.

40 dB - 100 dB - Leak found with conventional methods

10 dB - 40 dB - Leak found with noise loggers and correlation

0 dB - 10 dB - No leaks

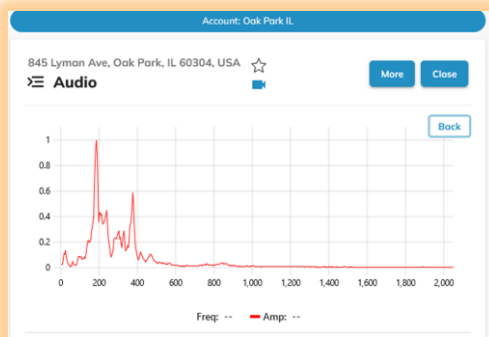
Large OD Pipe Leak

Amplitude by Frequency

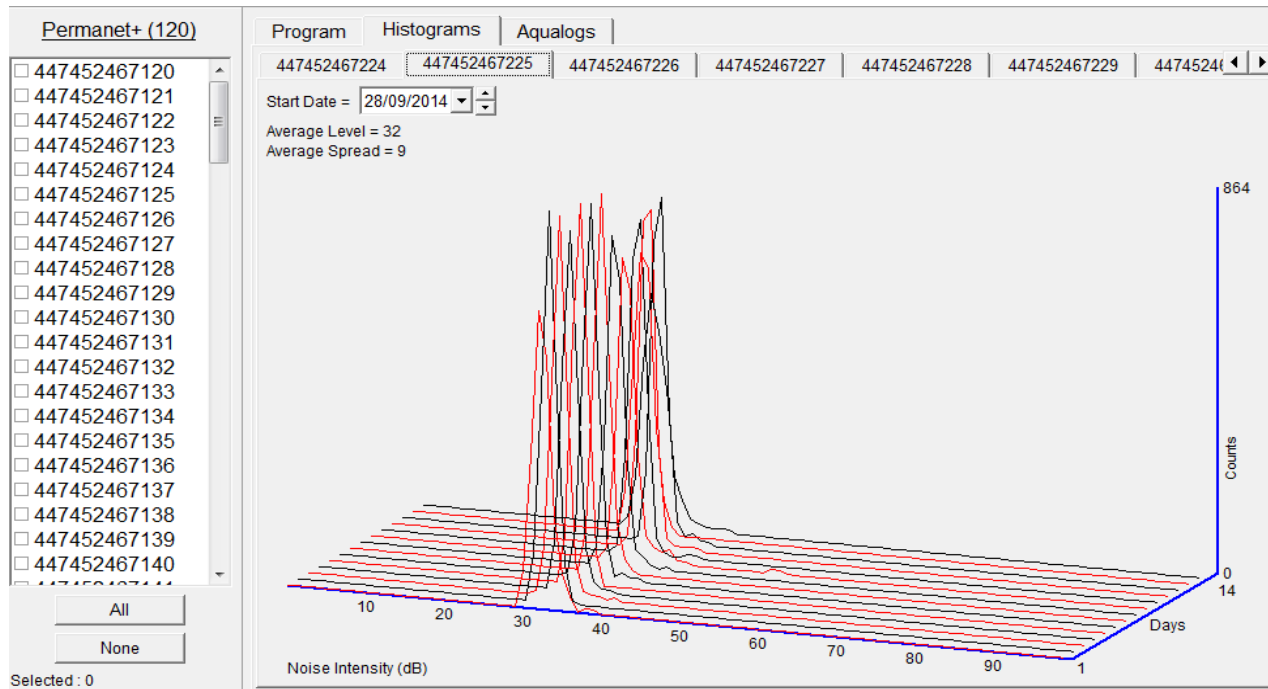
Histograms

- ***Audio Files*** – Listen to the leak from anywhere.
- ***Histograms*** – Detail the noise level, the spread and the peak percentage of the noise levels.
- ***Correlation*** – Calculate leak location distance from multiple sensors with the audio files.
