Archaeological Evaluation Report

Trial Trenching at The Church of the Most Holy Trinity,
Dockhead, Bermondsey, SE1 2BS

Report on archaeological evaluation

Site Code: MLO17

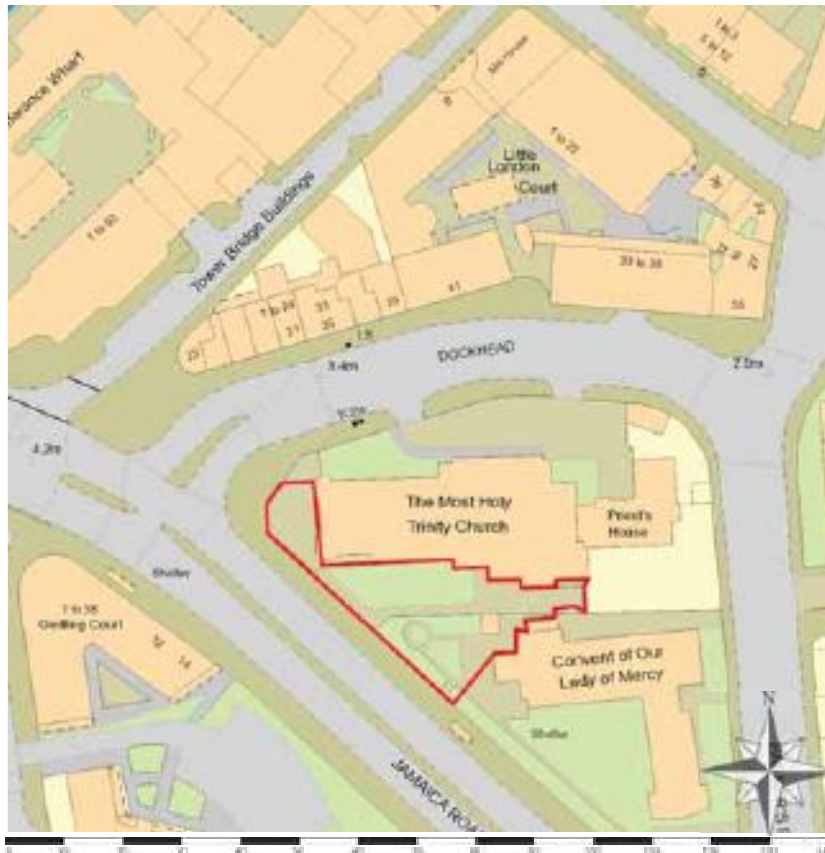
Fig.2. Planning Submissions: Location Plan 1:1250

Scale: 1:1250 | Area 2Ha | Grid Reference: 533925,179680 | Paper Size: A4

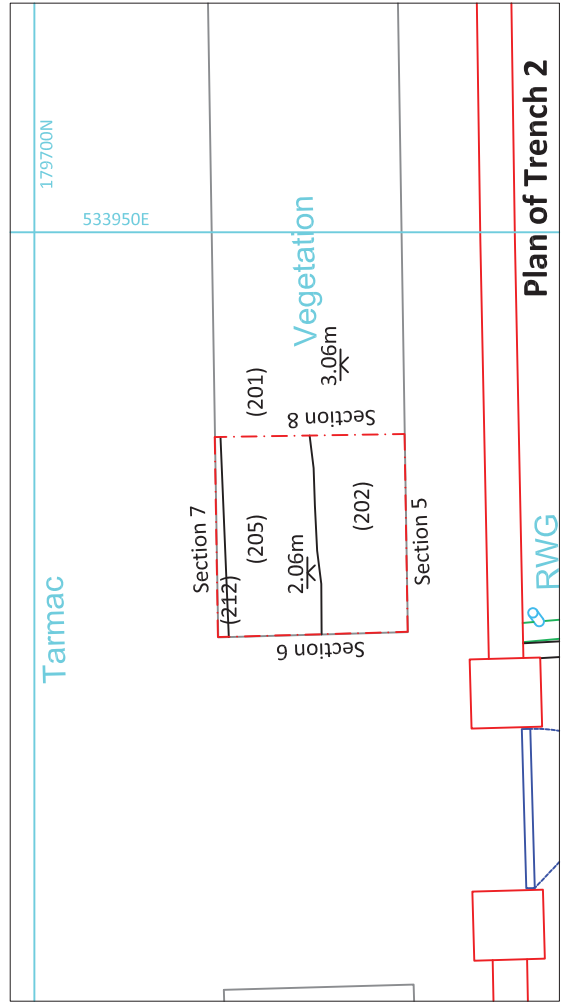
Figure 4: Trench plans, scale 1:50

Trenches were drawn in plan at 1:50 and where relevant sections were drawn at a scale of 1:20; numbered contexts were allocated where appropriate.

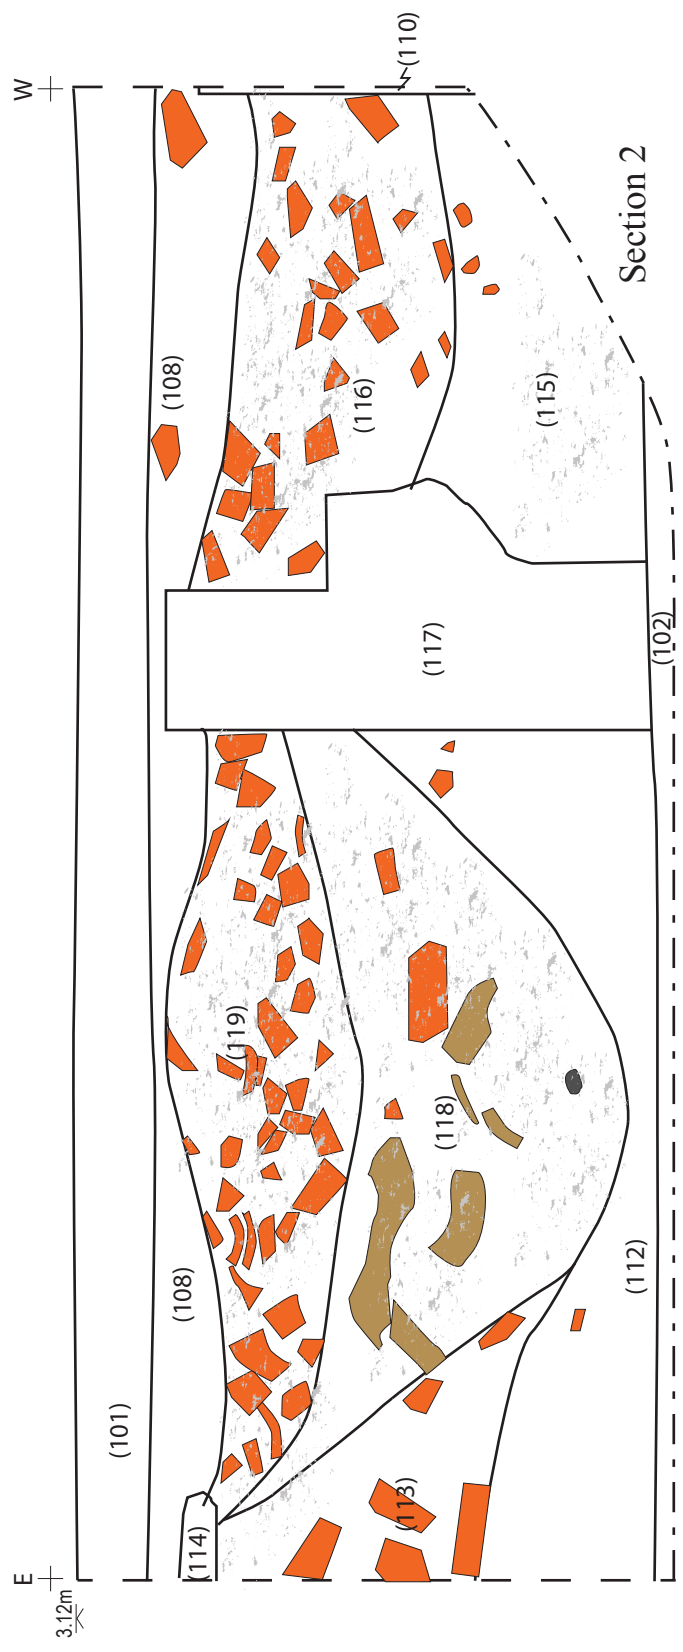
Figure 5: Sections of Trench I

This was followed by deposits of demolition [105] and a re-deposited fragment of a brick wall [106] of 0.54m to the east side (Section 1) was a 0.7m leveling layer of firm, dark brown, clayey silt with frequent brick, mortar, charcoal, coal flakes and occasional large brick fragments and flint [107] to the west side of the section, all post 1950's.

To the south (Section 2) of the trench the alluvium layer was not present. Towards the west of this section, sitting on the natural geology was the corner of a 19th century wall [117], probably English bond with lime mortar, 1.36m high. To the west of the wall was a fairly level layer (0.9m) of demolition deposit of firm, black, clayey silt with occasional large brick fragments, moderate brick and mortar flakes [115] overlain by an even 1.0m of demolition deposit of firm, black, clayey silt with frequent flint cobbles, large brick fragments, brick and mortar flakes and a large fragment of square brick pillar with concrete foundation [116]. To the east of the wall was an undulating layer of demolition deposit, between 0.3m and 0.8m thick of firm, black, clayey silt with occasional large brick fragments, moderate brick and mortar flakes [112]. This was overlain to the east by a 1.0m thick demolition deposit of firm, black, clayey silt with frequent large brick fragments, brick and mortar flakes [113] and to the west by 1.0m of modern backfill of firm, black, clayey silt with frequent large curved yellow ceramic fragments and large brick [118]. Following this was a fairly level 0.5m 1950's demolition layer of firm compaction, black, clayey silt with frequent large brick fragments, brick and mortar flakes [119]. A small section of pavement survived at this level to Section 3 [114]. All contexts were sealed with 0.27m of landscape leveling layer of firm, dark brown,

In the east section there was a 1.3m high, WSW-ESE aligned 19th century, brick and a half thick wall, in English bond with white soft lime mortar [111]. One clay pipe was recovered.

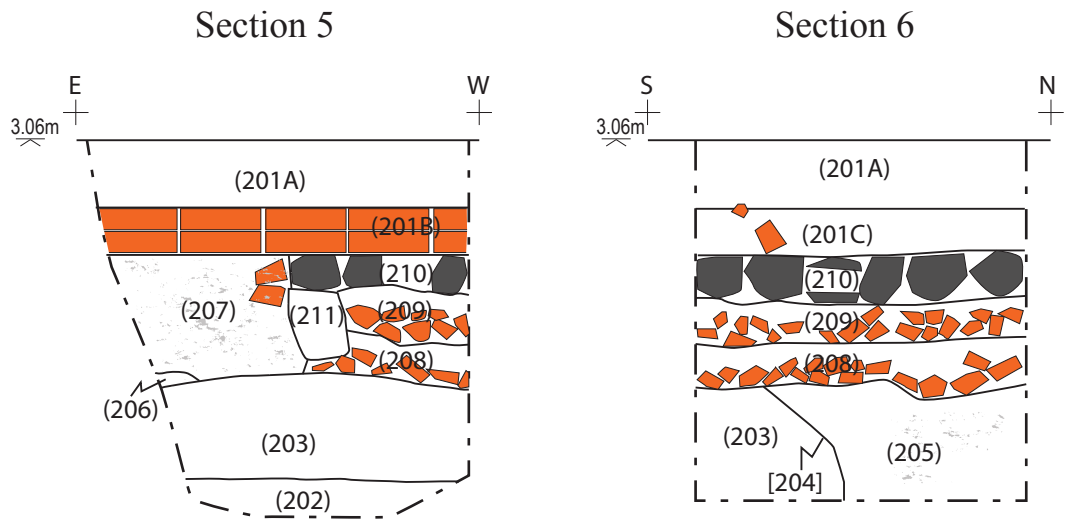
Figure 7: Sections of Trench 2

Natural firm, dark brown, London Clay was encountered at 0.9m [202]. The alluvium layer was not present. To the north side of the trench the natural was truncated by a W-E aligned foundation trench [204] with steep sides back-filled with firm, black loam with small stones mixed with clay and gravel [205]. The foundation trench [204] was cut for the N-S aligned wall in English bond with white mortar [212] that continued east and west beyond the scope of the trench walls and below the base of the trench.

To the south of the trench the natural geology was overlain by a 0.3m deposit of buried 19th century top soil of firm, black loam with small stones [203]. To the east side of the trench a thin 0.3m sloping layer of white mortar fragments mixed with black soil [206] was followed by a 0.6m post 1950's leveling layer of firm, dark grey clay mixed with rubble, occasional mid brown sand lenses and some plastic [207].

To the west side of the trench were several layers of floor construction beginning with 0.15m of large brick fragments surfaced with white lime mortar [208], a second layer of 0.14m of large brick fragments surfaced with white lime mortar [209] and 0.13m of compacted large fragments of dressed stone with yellow coarse sand [210]. A small deposit of black humic soil was within these layers [211].

The south section was finished with two courses of modern tiles [201B] and to the west with light brown bricks and occasional red brick [201C] both to a thickness of 0.12m forming a base for a modern kerb edging [201A]. All contexts were sealed with medium, black loam with occasional small hardcore within which was planted a bush and small tree [201]. No finds were recovered. The wall [212] probably formed part of the former convent (Fig.8).

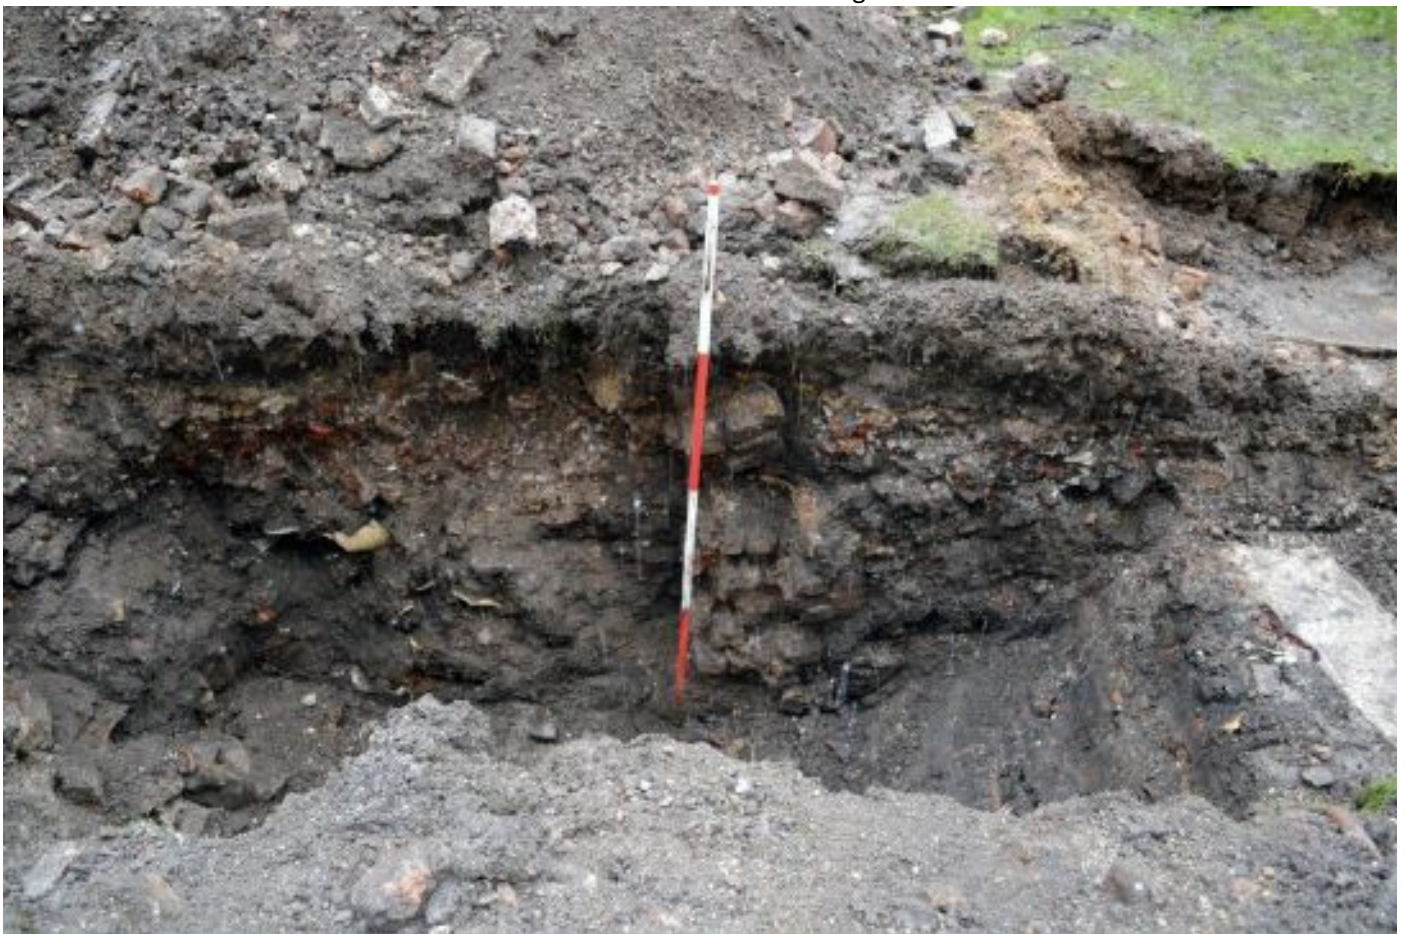
Plate 5: Trench 1 Section 2 Looking south – wall (111)

It appears that wall [117] was a continuation of [111] and both are contemporary with [110].

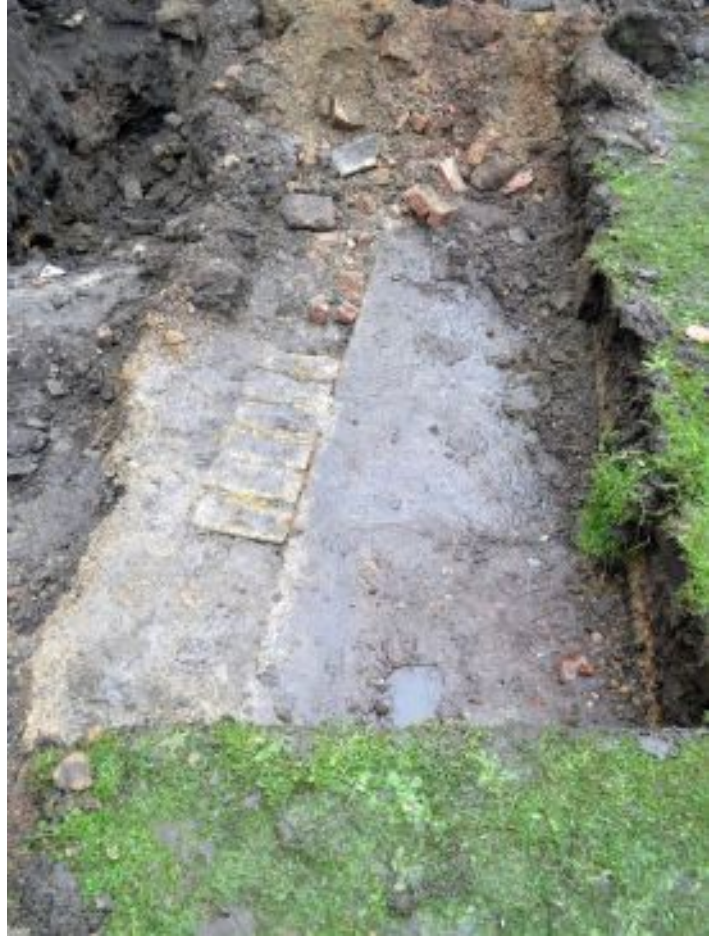
Plate 7: Trench 1 south extension looking east - wall (120)

Two drainpipes were contained within context [104] and it was uncertain whether or not they were still functioning as drainage for the church. In order to determine this the next division was excavated to the depth of the drainage pipe (0.6m) to ascertain its direction and the extent to which it continued within the trench. It was confirmed that the drainage took a diagonal route through the trench and to avoid any further damage, the decision was taken to excavate to the south of the current trench, however, at 0.3m a substantial tarmac pavement [114] and brick foundation wall [120] were uncovered and so this plan was abandoned.
