Archaeological Watching Brief

Boyton Hall, Toppesfield Road, Finchingfield, Essex CM7

**Archaeological Watching Brief at Boyton Hall, Toppesfield Road, Finchingfield,
Essex CM7 4NZ**

Site Code: FFBH16

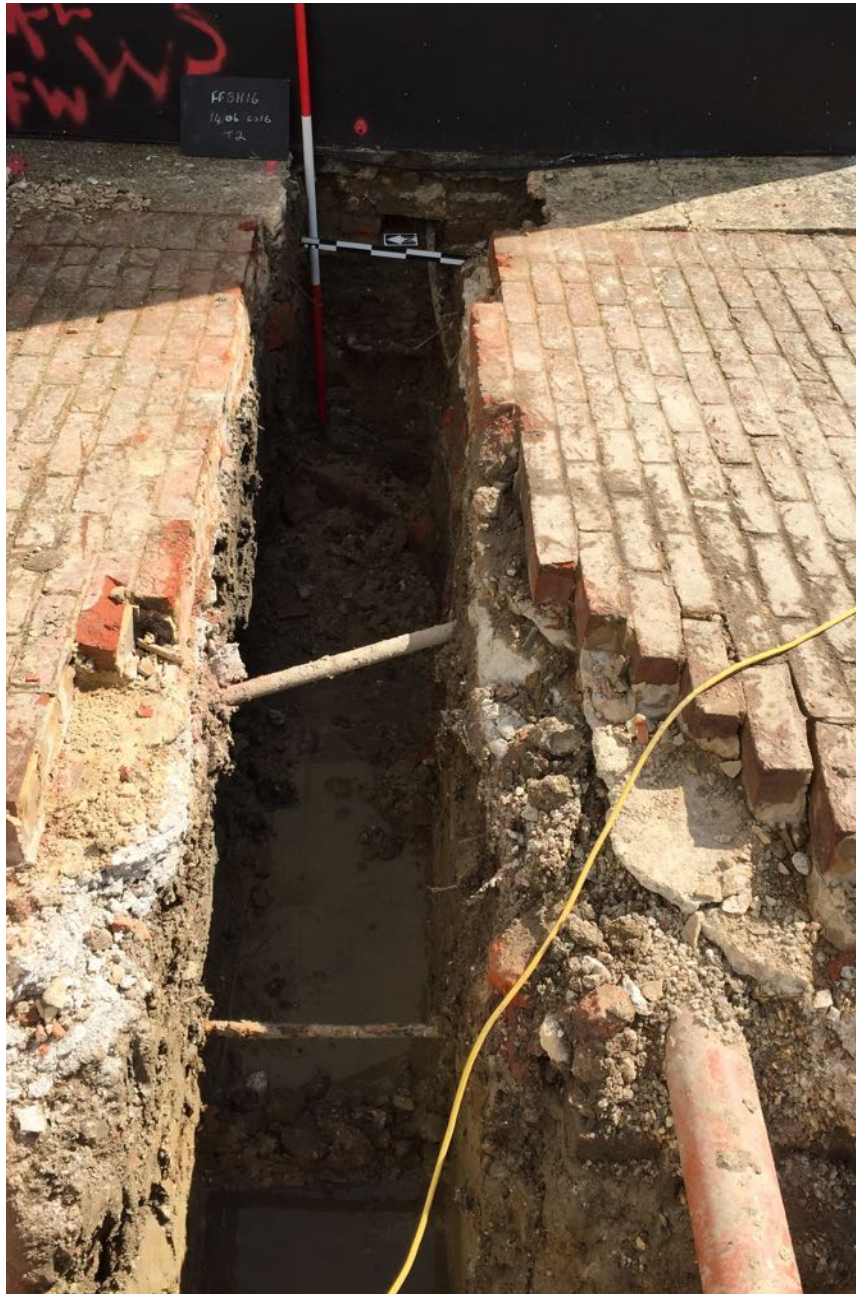
Plate 1. Trench 1 facing East

Trench 1 - 0.45m W x 2.85m L x 1.0m D – East-West Direction

Foundation of west elevation of house. Brick built capped well with grey silt fill (1.3m circumference). Modern metal and plastic pipes running north-south through trench. Made up ground. Natural was at a depth of 0.40m.

The well remains in situ, although a cut of 450mm in width through the centre of it for the new foundation reduced its height by 900mm and mitigation strategies were discussed between the builder and building control to bridge the feature for the creation of the new foundation. The water tank also remains in situ with the west wall removed. The south foundation wall was shallow and removed entirely.

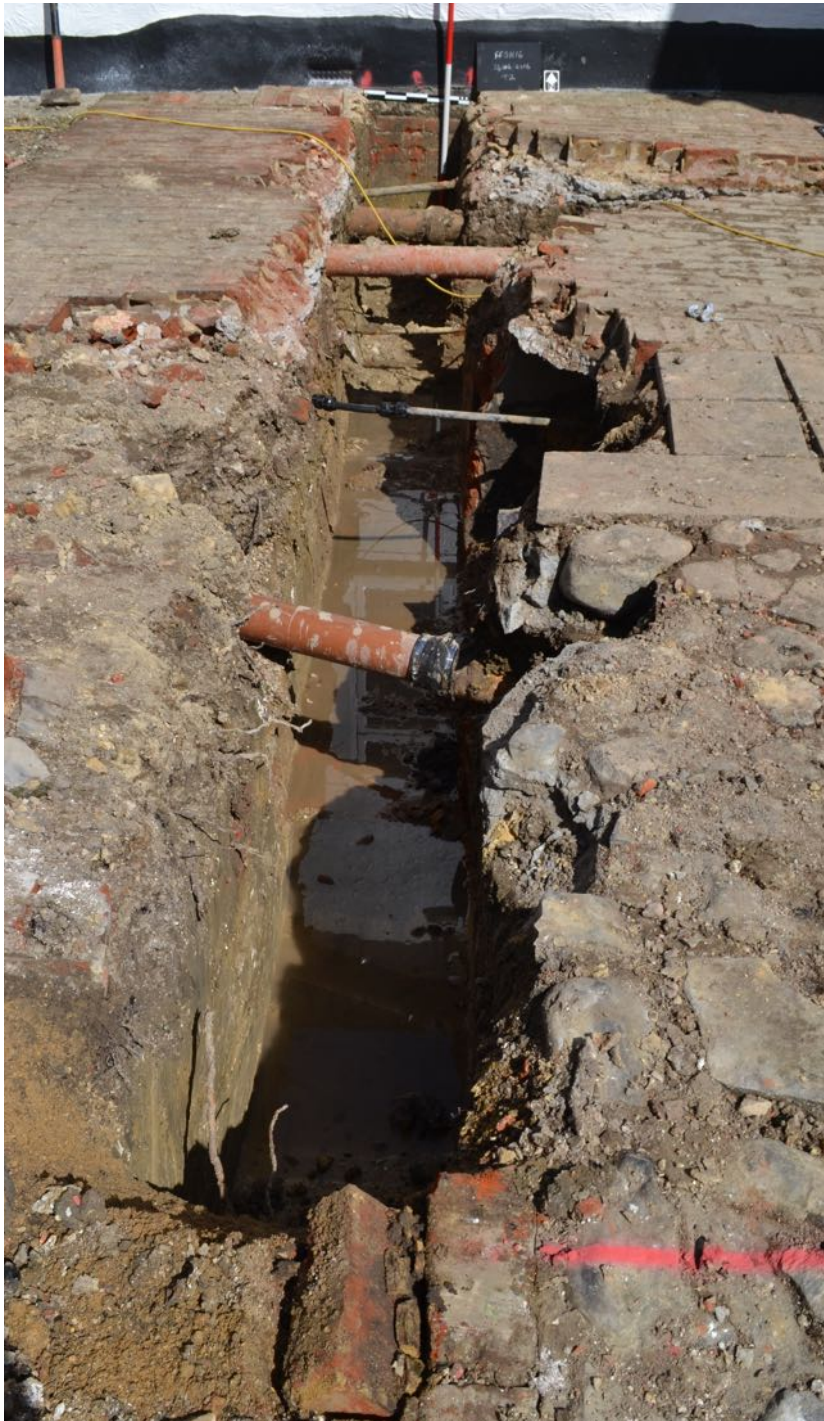
Plate 2. Trench 2 facing North

Trench 2 – 0.45m W x 6.15m L x 1.0m D – North-South Direction

Foundation of south elevation of house. Modern metal and plastic pipes running east-west through trench. Brick built tank with cementitious render finish with pea shingle fill and vertical slate divider. Black silt soil with small stone and oyster shell inclusions. Natural at 0.40m.

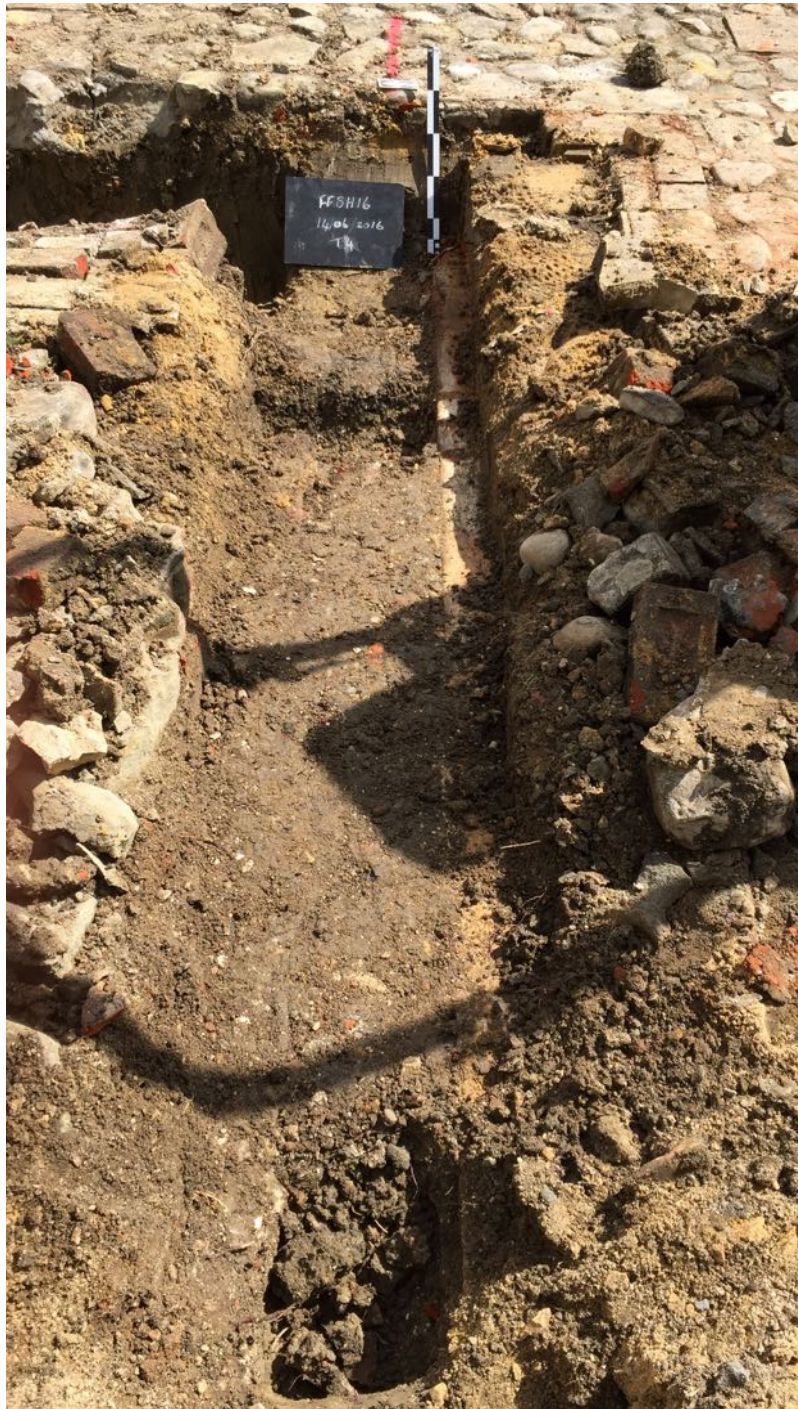
Plate 4. Trench 4 facing East (Brick foundation wall to right wall of trench)

Trench 4 – 0.45m W x 4.4m L x 1.0m D – East-West Direction

Foundation brick wall to south side of trench. Black silt soil with small stone and oyster shell inclusions. Natural at 0.40m.
