**Friary West
Carmelite Way
Maldon
Essex
CM9 5FJ**

3rd November 2014

**Trial Trenching on behalf of
Architect Annabel Brown**

**TOUCHSTONE ARCHAEOLOGY
THE RIDINGS
WHITE ELM ROAD
DANBURY
ESSEX
CM3 4LR**

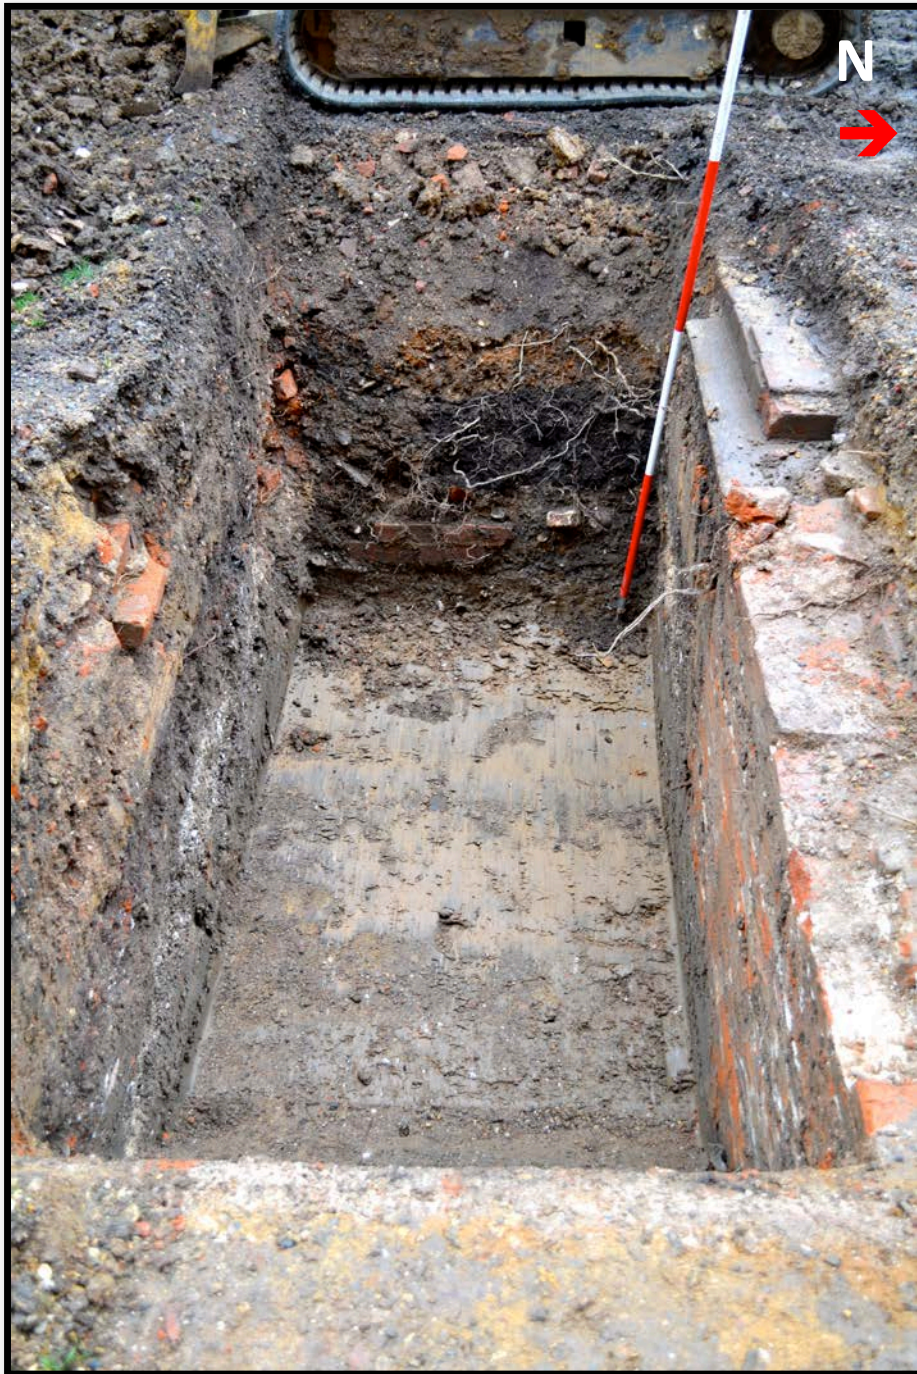
Fig.4. Trench 1

East-West Trench 1 was sited slightly south of the central point of the length of the building because it coincided with the side entrance door, the main entrance and exit to the house. It was decided that this would pose a Health & Safety issue for the occupants of the house. East-West Trench 1 did not cover the entire width of the building, as the machine was unable to access the last 1 metre because of the close proximity to the boundary wall. When excavating Trench 1 an east-west brick wall was uncovered on the north section of the trench within 300mm of ground level. In order to understand the context of the wall the machine was moved and the trench was extended by 200mm to the south and the wall was exposed to its full depth (1.4m), recorded but left in situ. A second wall was uncovered running in a north-south direction and the trench was excavated to the front and rear of it to establish its depth and relationship to the east-west wall. The wall was C19th, only three courses high and set on a clay foundation and the decision was taken to record it, remove it and continue excavating below it. Trench 1 was excavated to a depth of 1.5m to natural.

Trench 1

Direction: East West

Dimensions: 5.18 Sqm – L 3.5m x W 1.480m x D 1.5m

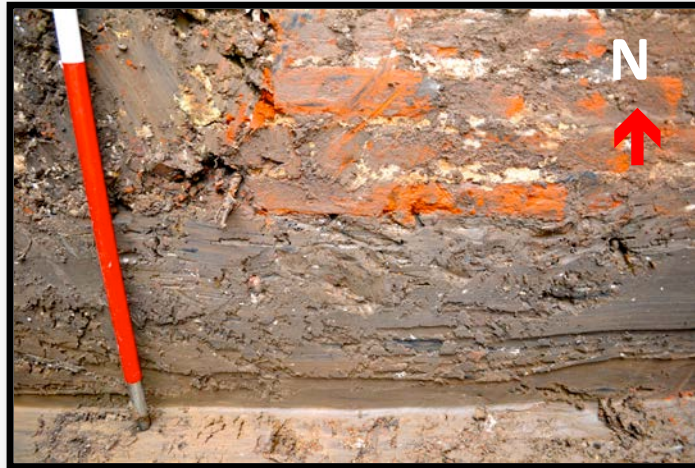
Fig.6. Context 105 – Brick wall set on natural London clay base 102

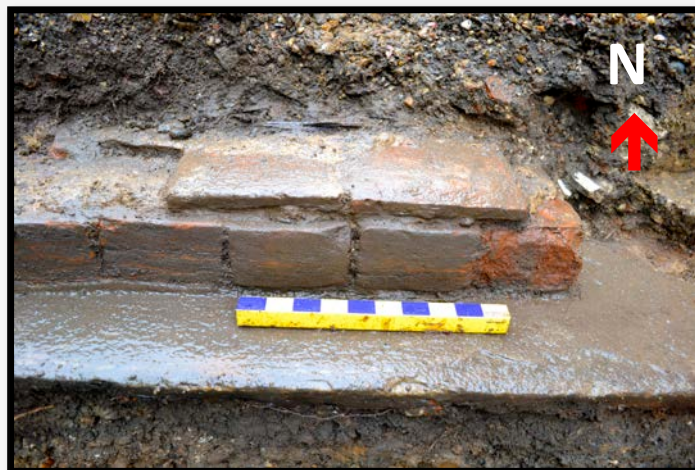
Fig.7. Context 109 – Flagstones supporting bricks and creasing tile

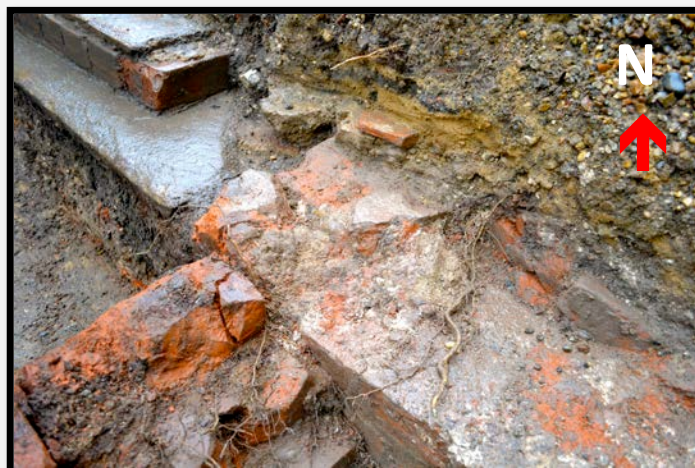
Fig.8. 105 Brick wall abutting 109 Flagstones and joined by north-south wall from Section 2

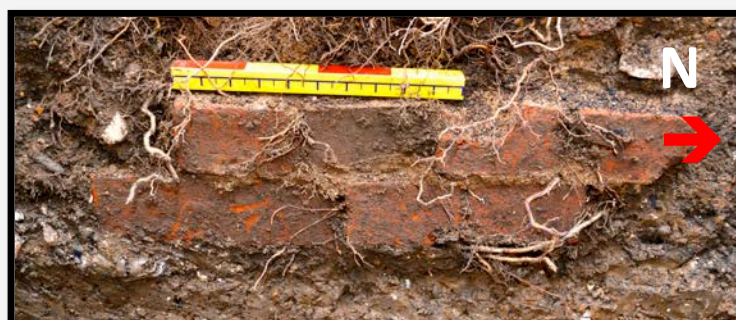
Fig.10. Context 202 - Brickwork

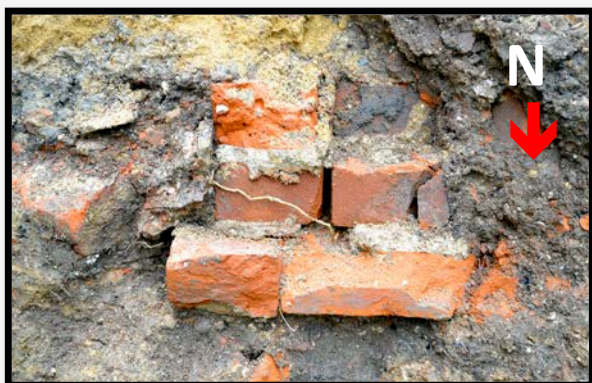
Fig.12. Context 306 – Brickwork

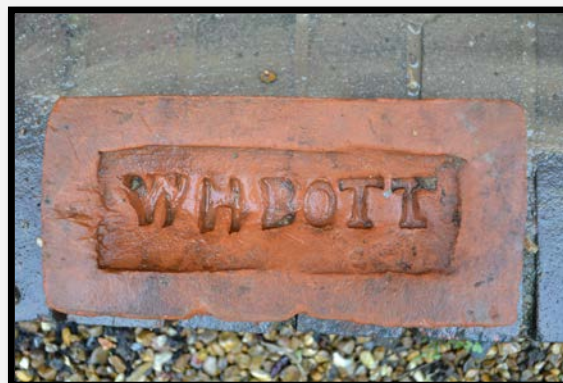
Fig.13. W H Bott brick

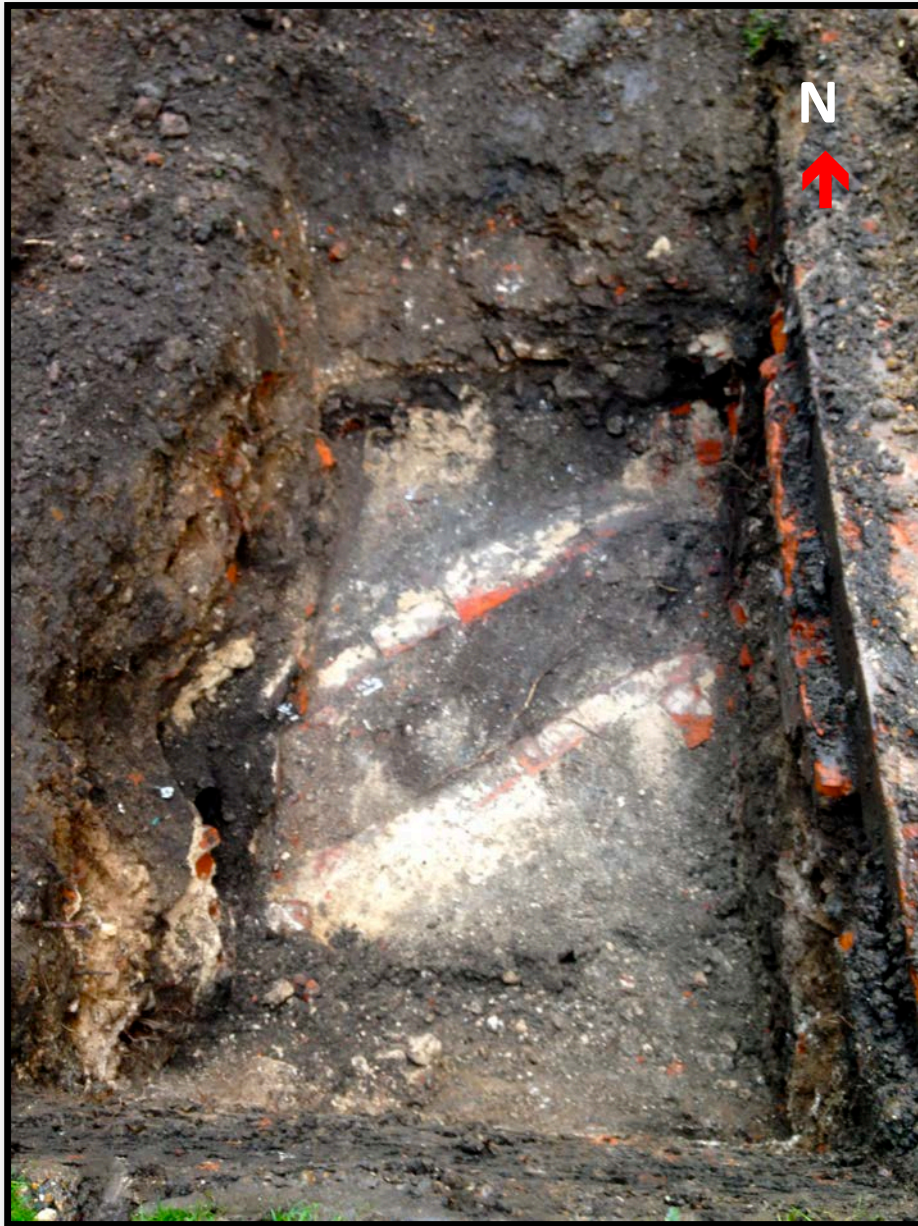
Fig.37. Trench 2

North-south Trench 2 to the south of Trench 1 revealed a north-south brick wall to the east section of the trench within 300mm of ground level. The machine was moved and the trench was extended by 200mm to the west so that the wall could remain in situ and its relationship to the wall in Trench 1 could be ascertained. The wall was recorded and left in situ. The trench was excavated to a depth of 1.4m where the collapsed remains of a drainage culvert C18/19th running Southwest to North east were found filled with modern C20th rubbish (Shower curtain, solar light, number plate). The surface debris was removed and the excavation proceeded to expose the base of the culvert. The trench walls were extremely unstable and the base of the culvert was at a depth of 1.4m, 100mm from natural in the adjacent trench, therefore it was decided that there was no necessity for the excavation to continue further and the base of the culvert was recorded and left in situ.

Trench 2

Direction: North South

Dimensions: 3.92 Sqm – L 2.8m x W 1.4m x D 1.4m

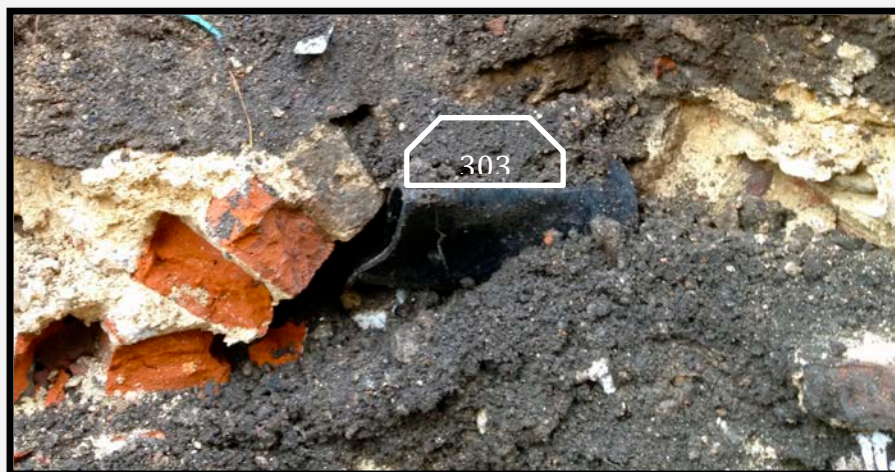
Fig.41. Remains of damaged Victorian arched drainage culvert filled with modern rubbish.

TRENCH 2 CONTAINED A BRICK WALL IN CLOSE PROXIMITY TO THE SURFACE AND A VERY DAMAGED C18TH/19TH CULVERT FILLED WITH C20TH RUBBISH (NUMBER PLATE, SHOWER CURTAIN ETC) AT THE BASE OF THE TRENCH.

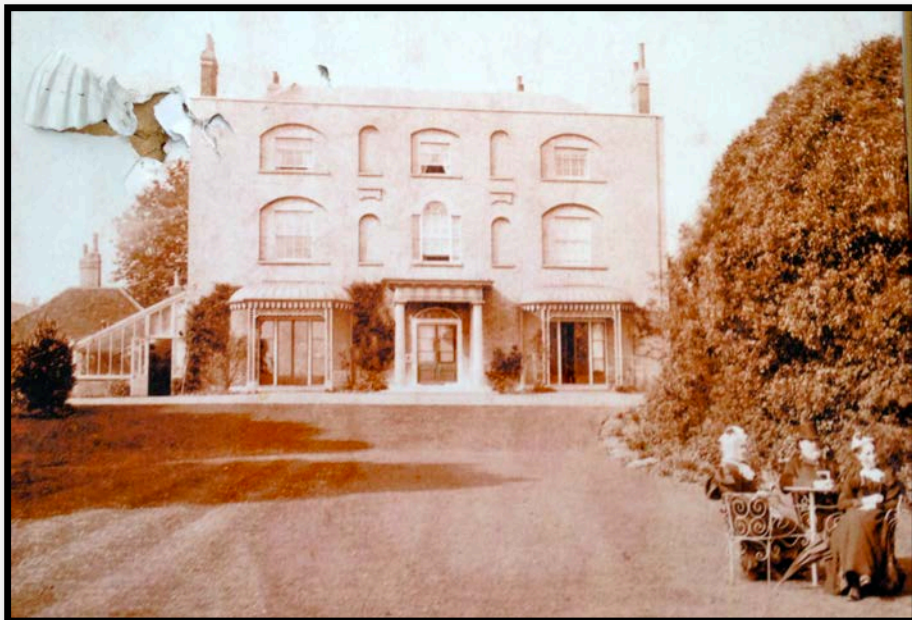
Fig.48. Rear of house C18th/19th showing conservatory to the West elevation

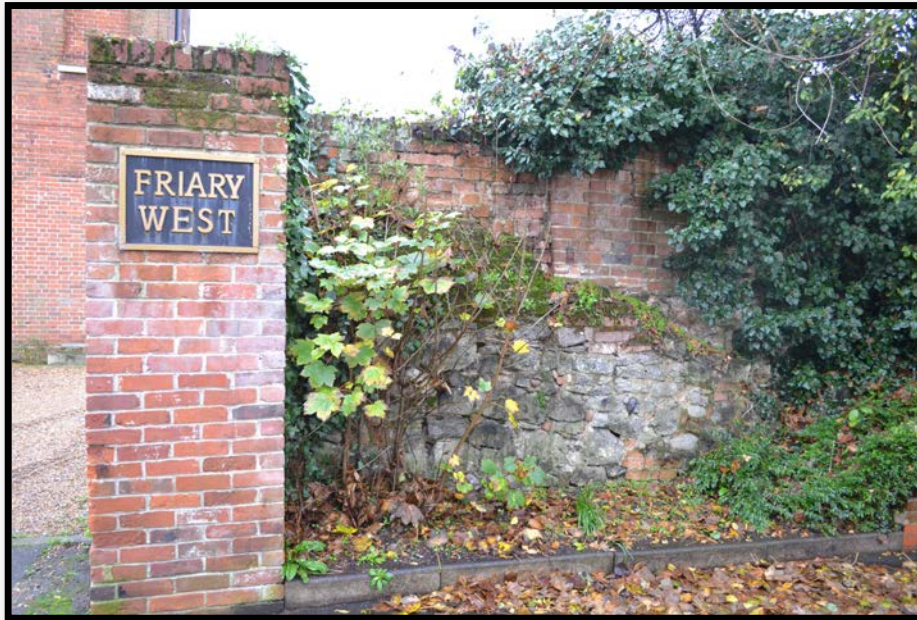
Sections of stonework within existing boundary wall.

Stones of this type were found loose in the garden forming part of flower beds and rockeries (see photographs below), however, there is no evidence that they were historically connected to the site.
