Archaeological Trial Trenching of Land adjacent to Commodity House, Braxted Park Road, Little Braxted, Essex CM8 3EW

Site Code LB15

**Touchstone
Archaeology**

Report on behalf of Smart Planning Ltd

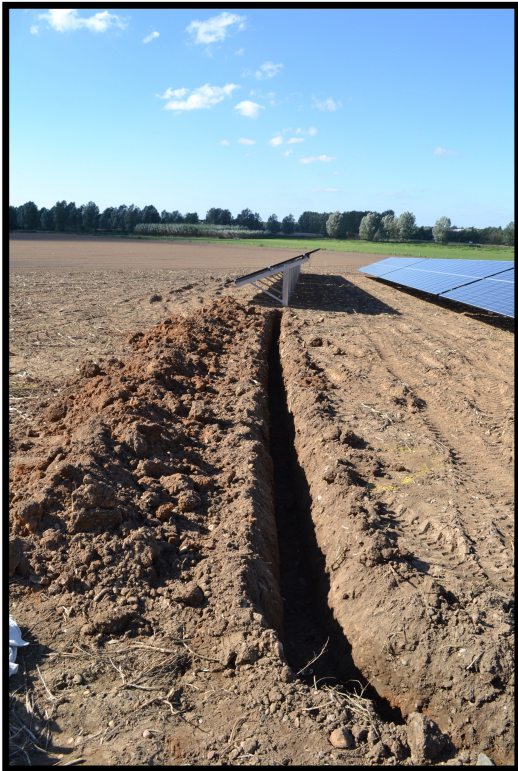
Plate 2. Cutting of service Trench 1 (facing West)

Trench 1: East-West - L.16.3m x W.0.260m x D.0.700m

0 - 100 depth – Topsoil

100 – 600 depth – Clay (orange brown sticky clay clean with no inclusions)

600 – 700 depth – Flint and pebble layer (Flints c.10cm x 50cm, Pebbles c.3cm x 2cm)

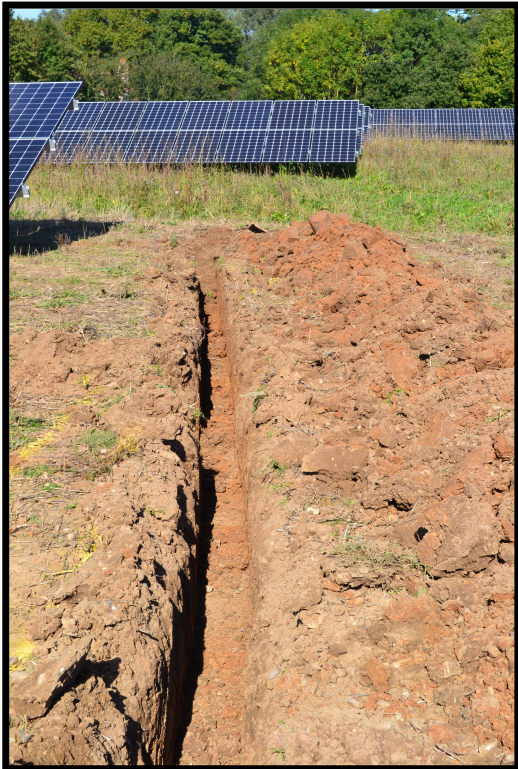
Plate 3. Cutting of service Trench 2 (facing North)

Trench 2: North-South from T1 - L.10.4m x W.0.260m x D.0.700m (Begins at W end of T1)

Trench 2

0.600m from north end gravel fill began and ended at the connection with Trench 4. Google earth pictures revealed a gravel pile sited here during the construction of the Commodity House.

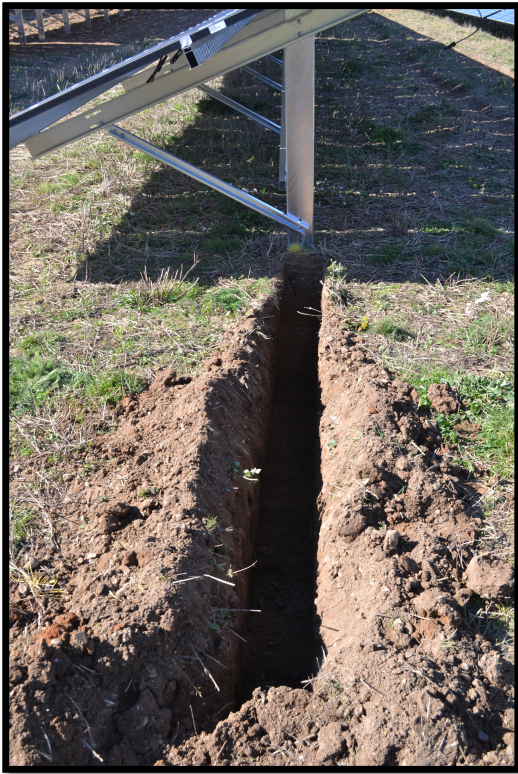
Plate 4. Cutting of service Trench 3 (facing West)

Trench 3: East-West from T2 - L.5.5m x W.0.260m x D.0.700m (Begins on east flank of T2)

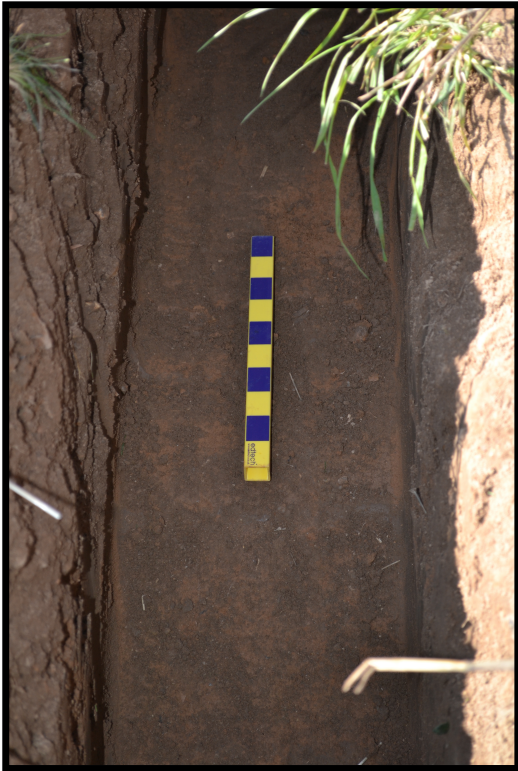
Plate 5. Base of Trench

1.9. Stratigraphy:

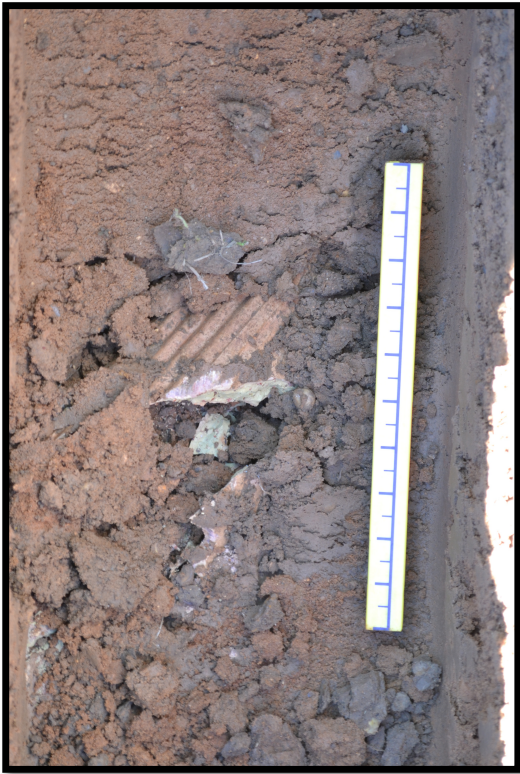
Plate 6. Land Drainage Pipe

Circular fluted Drainage pipe – yellow clay with red slip – overall diameter 100mm, found at a depth of 0.600m, 9.6m north of the mouth of Trench 4.

Circular fluted drainage pipe – yellow clay with red slip – overall diameter 100mm, found at a depth of 0.600m, 9.6m north of the mouth of Trench 4.

The development site is in an area of archaeological potential. Unfortunately there were no archaeological features or finds relating to the cropmarks. The only find was the circular fluted drainage pipe made from yellow clay with a red slip in a diameter of 100mm. It was found at a depth of 0.600m, 9.6m north of the mouth of Trench 4. The discovery of the field drainage was to be expected in a ploughed field that had been farmland for many years. It was not possible to date the field drainage pipe.
