REMEDIAL DESIGN REPORT

250 WATER STREET
New York, New York
NYSDEC BCP No. C231127

May 9, 2022
Langan Project No. 170381202

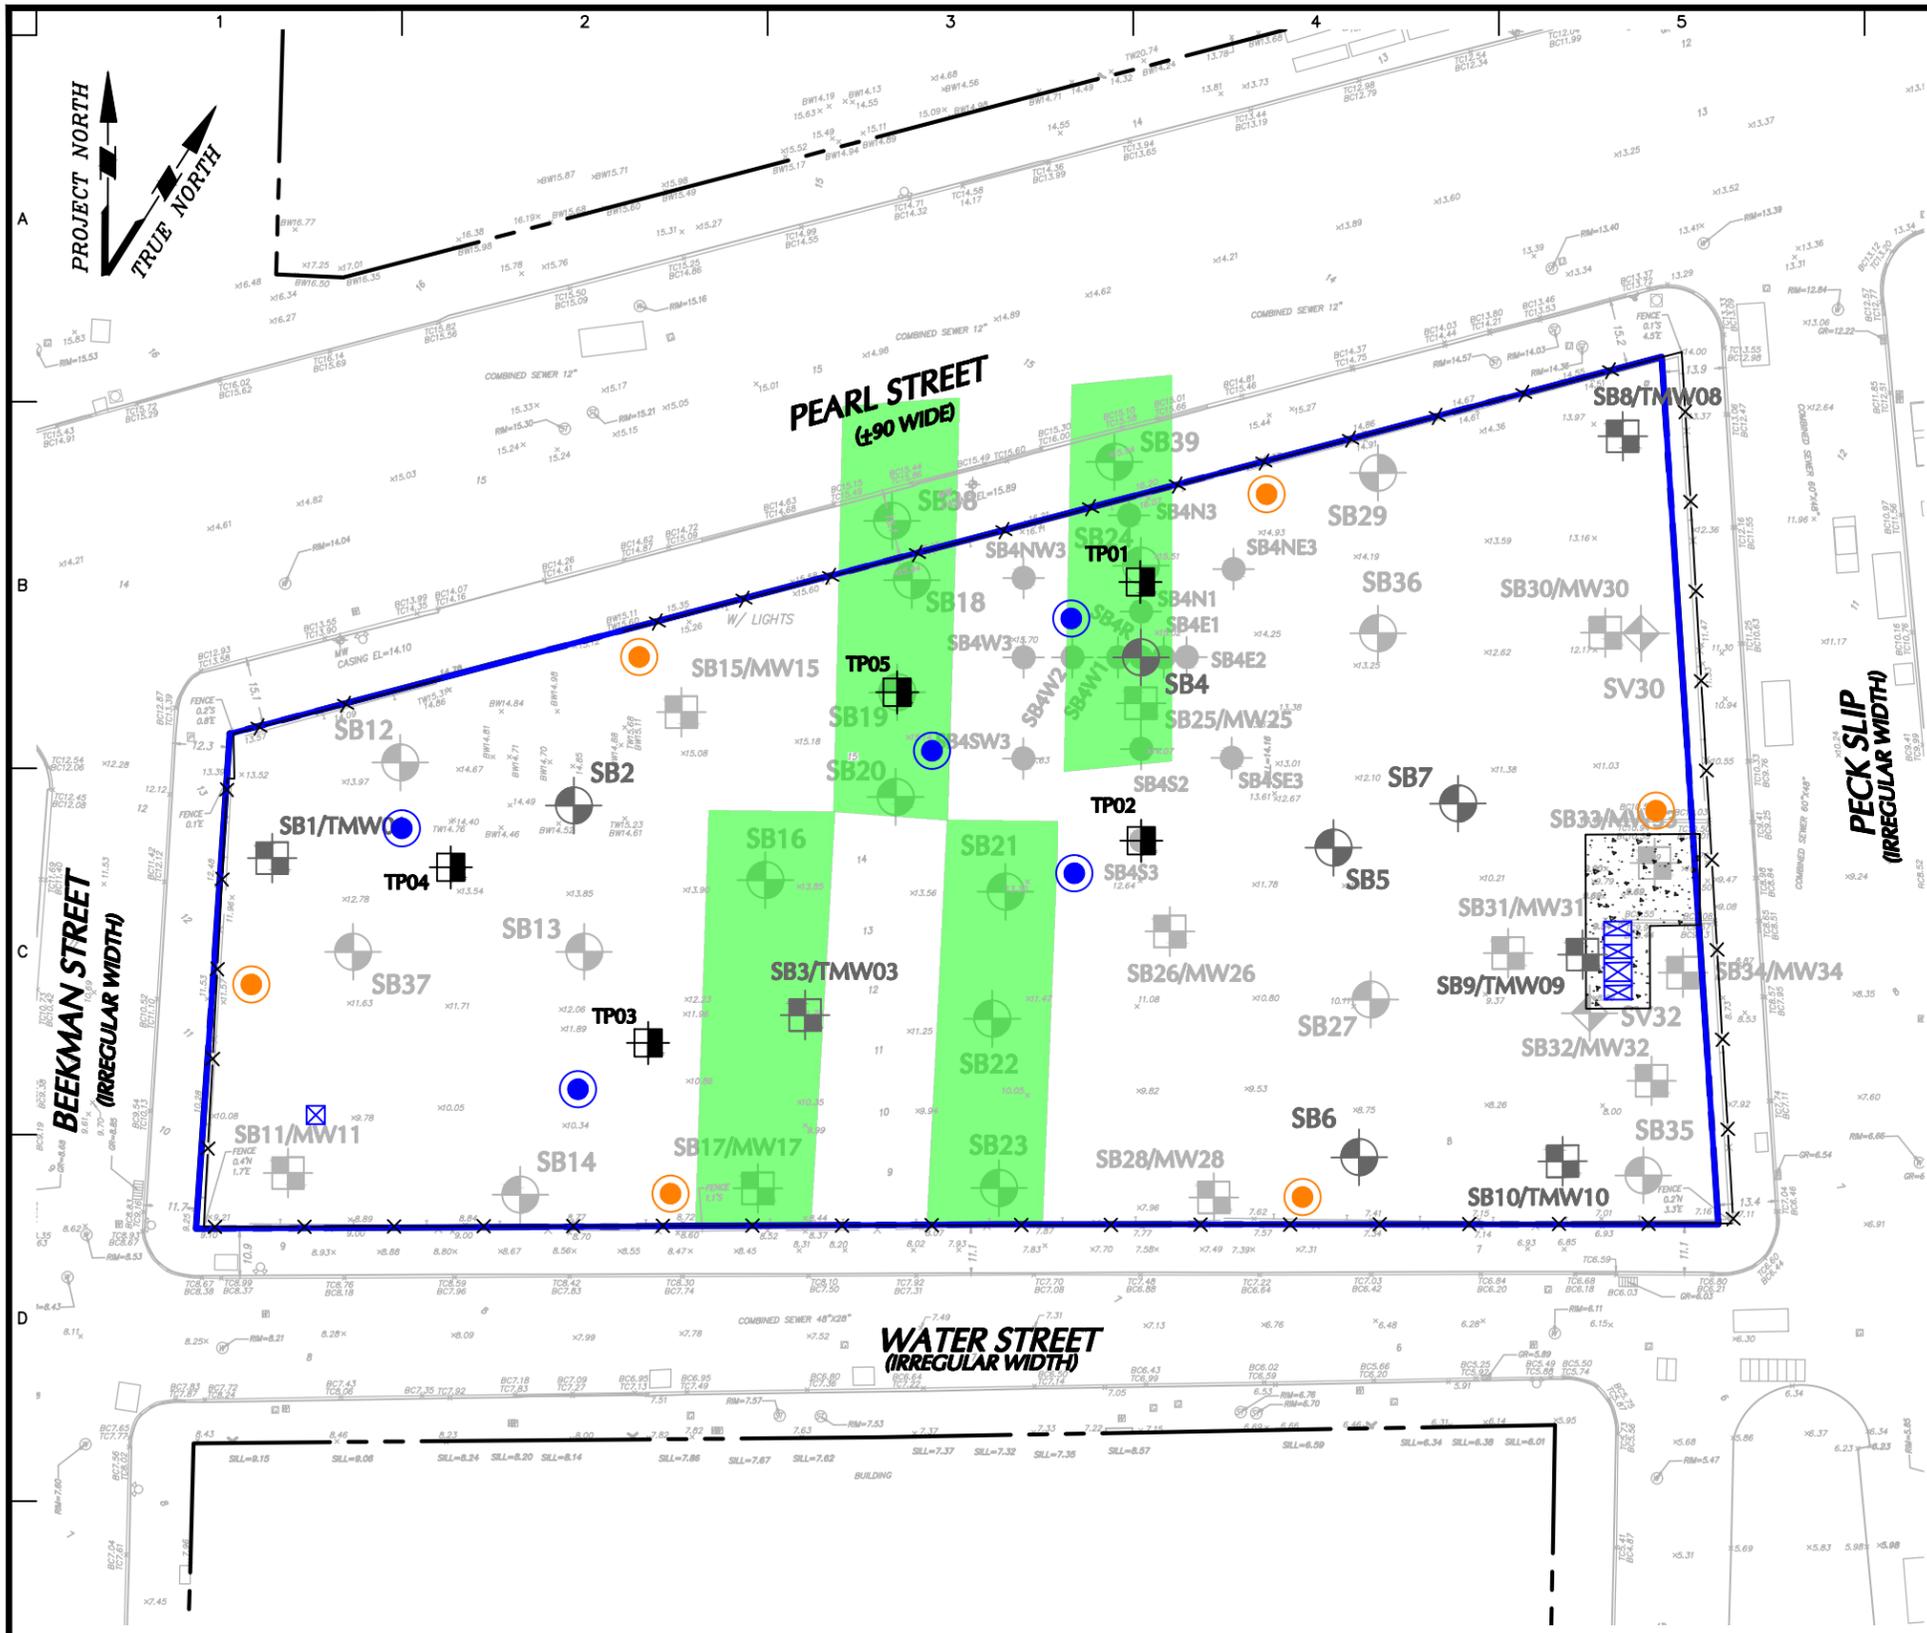
Figure No.
2

A test pit location map is provided as Figure 2.

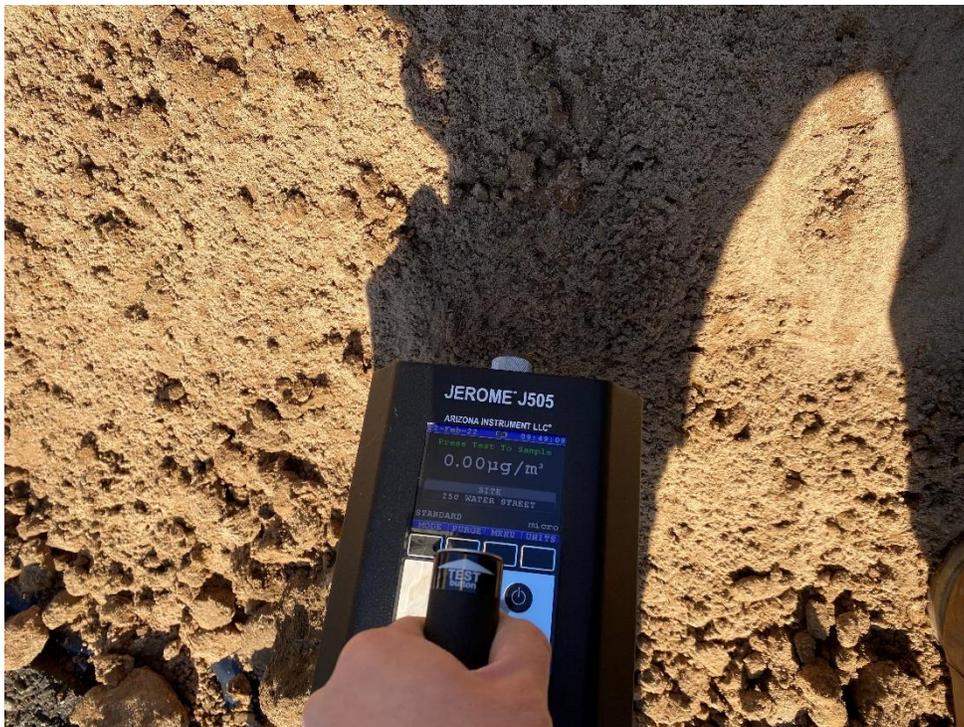
Photo 4: View of Langan screening excavated soil/fill from test pit TP01 using a Jerome® J505 mercury analyzer (02/12/2022)

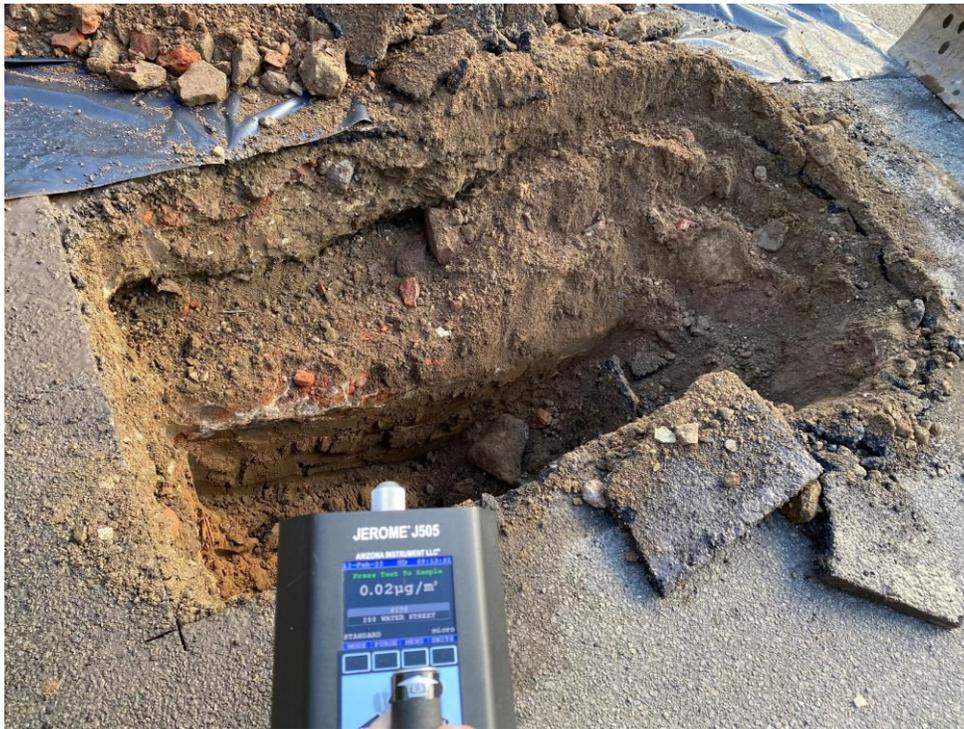
A 2-inch-thick asphalt cover was underlain by historic fill, consisting of brown fine sand with varying amounts of gravel, brick, concrete and ceramics, to a depth of about 2 feet bgs. A 1-foot-thick brick structure from a former building was observed in the eastern portion of the test pit. The historic fill and remnant brick was underlain by apparent native soil, consisting of brown fine sand with varying amounts of gravel, to the test pit termination depth of about 8 feet bgs.

Photo 5: View of test pit TP01 (facing east) (02/12/2022)

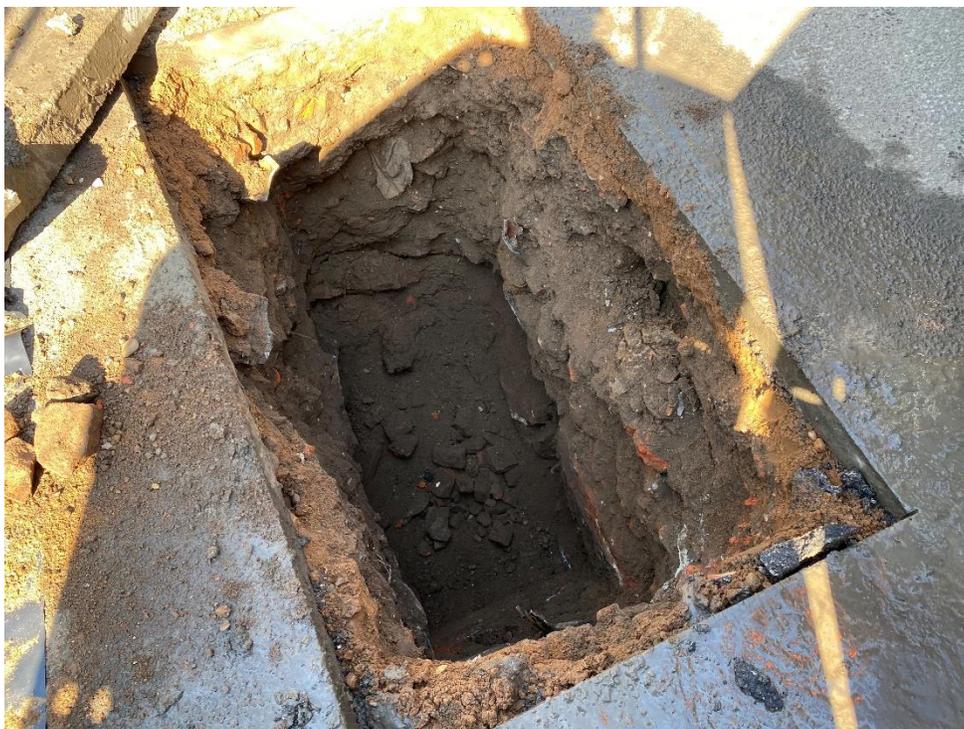
A 5-inch-thick asphalt cover was underlain by historic fill, consisting of brown fine sand with varying amounts of gravel, asphalt, brick and concrete, to the test pit termination depth of about 8 feet bgs.

Photo 6: View of test pit TP02 (facing northeast) (02/12/2022)

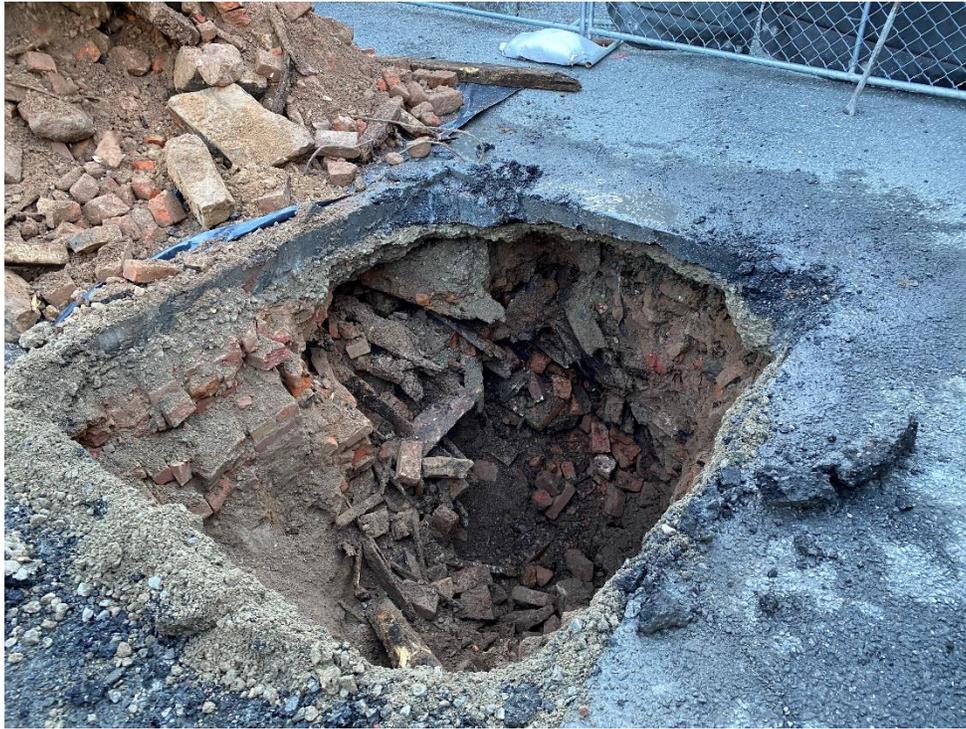
A 4-inch-thick asphalt cover was underlain by an 8-inch-thick layer of apparent 3/4-inch gravel. The gravel layer was underlain by historic fill, consisting of brown fine sand with varying amounts of gravel, brick, and concrete to the test pit termination depth of about 8 feet bgs. A 2-foot-thick brick structure from a former building was observed in the southeastern corner of the test pit and an abandoned utility pipe measuring about 3 inches in diameter was observed along the southern portion of the test pit. An apparent void space, containing wood and brick fragments, was observed in the southwestern portion of the test pit to a depth of about 4.5 bgs.

Photo 7: View of test pit TP03 (facing southwest) (02/12/2022)

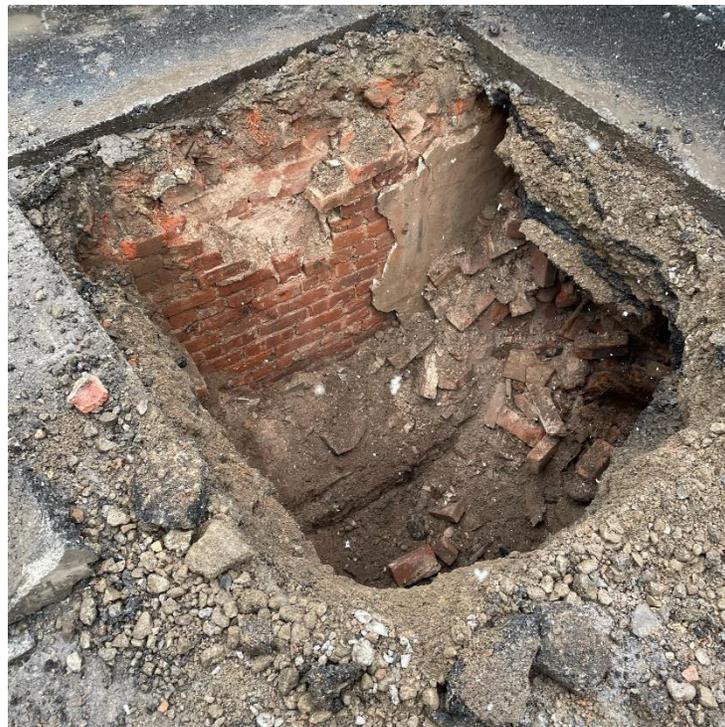
A 4-inch-thick asphalt cover was underlain by a 1-foot-thick layer of historic fill, consisting of brown fine sand with varying amounts of gravel, asphalt, brick, plastic and vegetation, followed by an additional 5-inch-thick layer of asphalt. The asphalt was underlain by historic fill consisting of brown fine sand with varying amounts of gravel, brick, wooden planks, metal and plastic to the test pit termination depth of about 8 feet bgs. A remnant brick wall was observed along the north side of the test pit.

Photo 8: View of test pit TP04 (facing northeast) (02/13/2022)

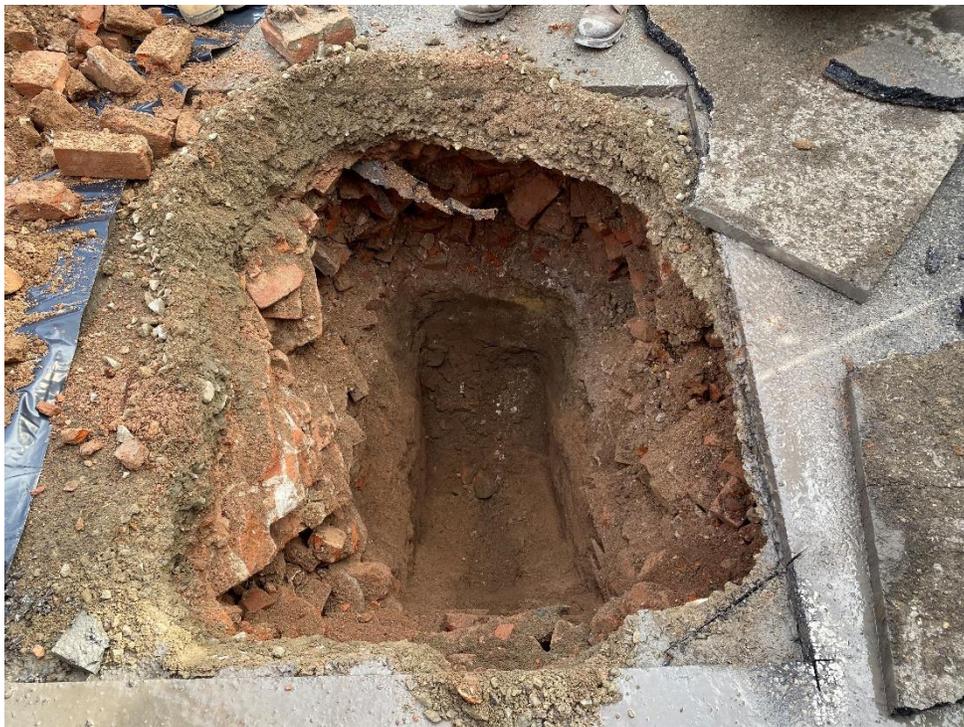
A 2-inch-thick asphalt cover was underlain by a 5-inch-thick layer of historic fill, consisting of light brown fine sand with varying amounts of gravel, brick and concrete, followed by a 3-foot-thick layer of demolished brick from the former building. Historic fill was observed beneath the demolished brick to the test pit termination depth of about 8 feet bgs.

Photo 10: View of test pit TP05 (facing south) (02/12/2022)

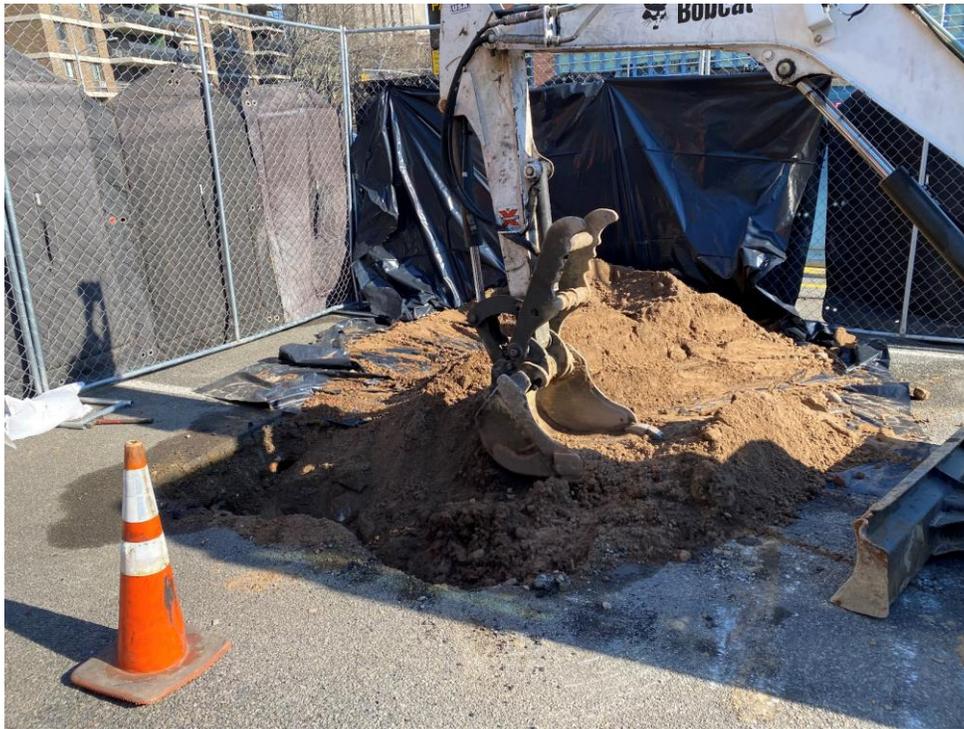
Photo 11: View of AARCO backfilling test pit TP01 (facing northeast) (02/12/2022)

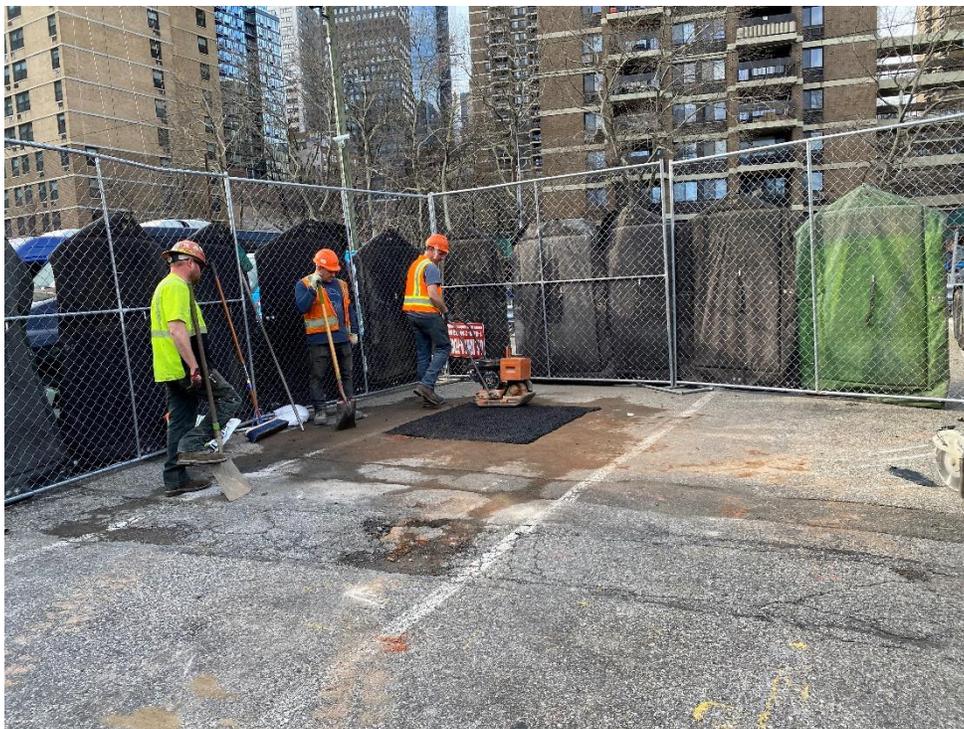
Photo 14: View of AARCO using a vibratory plate tamper to restore test pit TP05 to match the surrounding grade (facing northwest) (02/12/2022)

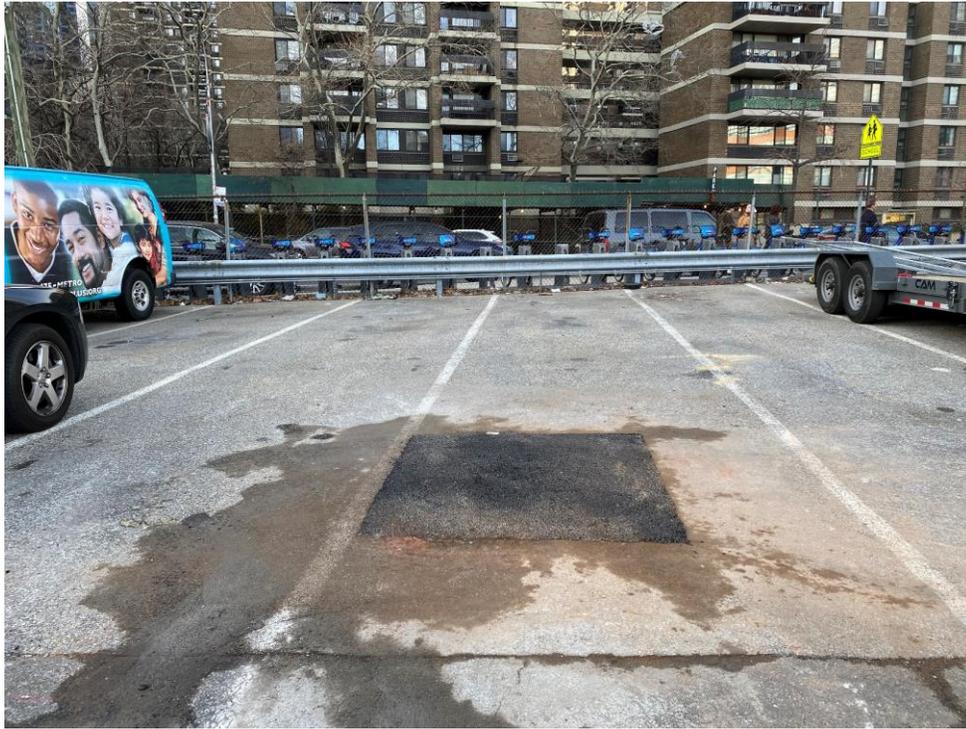
Photo 15: View of test pit TP05, restored to match the surrounding grade surface using cold patch asphalt (facing north) (02/12/2022)

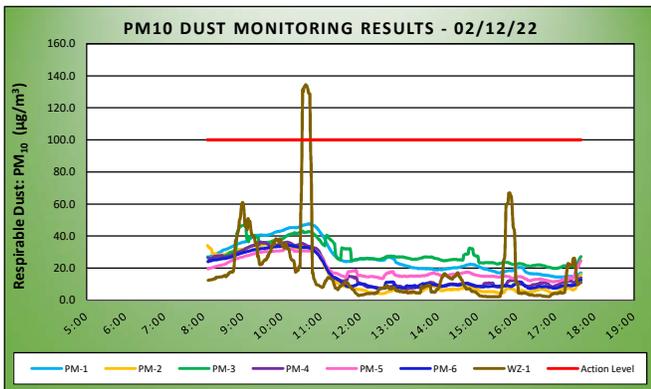
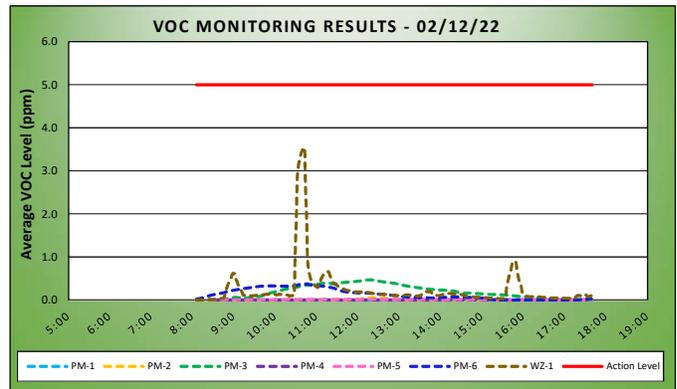
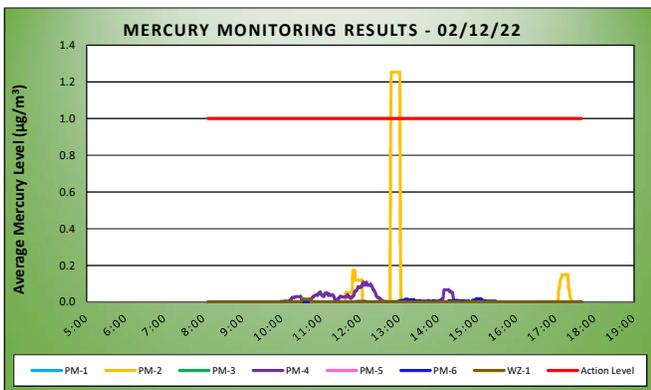
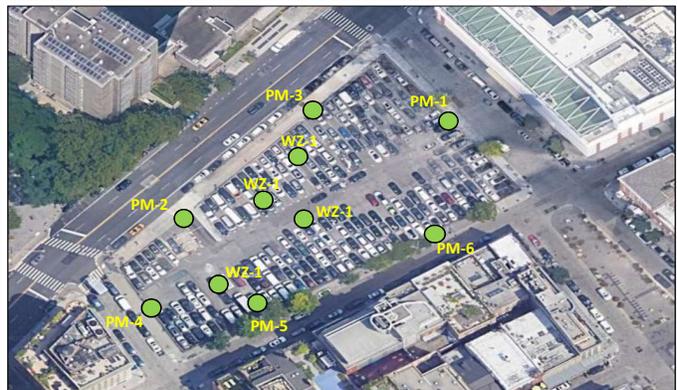
*Mercury vapor concentrations exceeded the action level established in the CAMP from 12:48pm to 1:01pm at perimeter station PM-2, which was located along Pearl Street, next to the parking lot entrance. **The exceedance was determined to be an erroneous high reading resulting from an equipment malfunction or unknown interference and mercury vapor data from the Jerome® J505 mercury analyzer indicate the erroneously high reading is not a result of ground-intrusive activities.** During this time, AARCO was in the process of backfilling test pit TP-02 after the test pit was open for one hour. Perimeter station PM-2 was located about 120 feet and in an upwind direction from the TP-02 work zone.

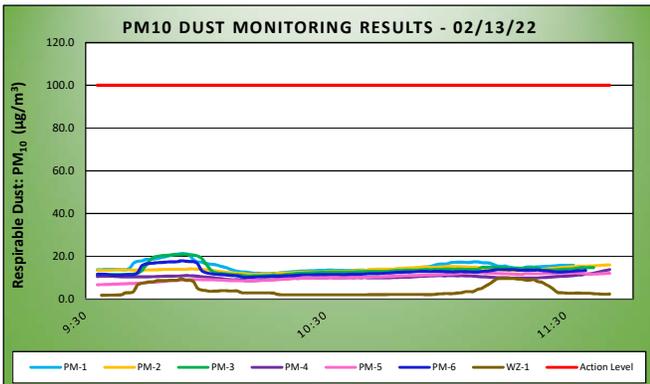
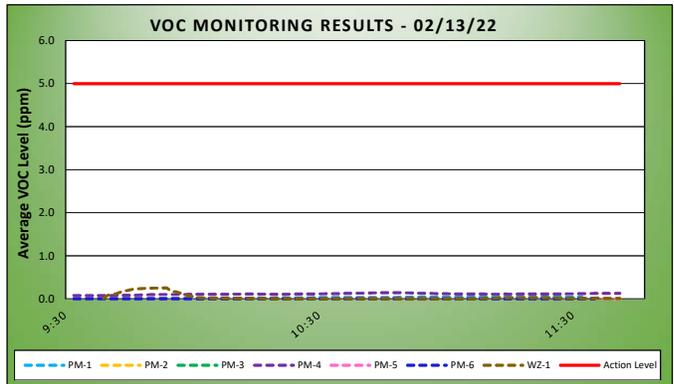
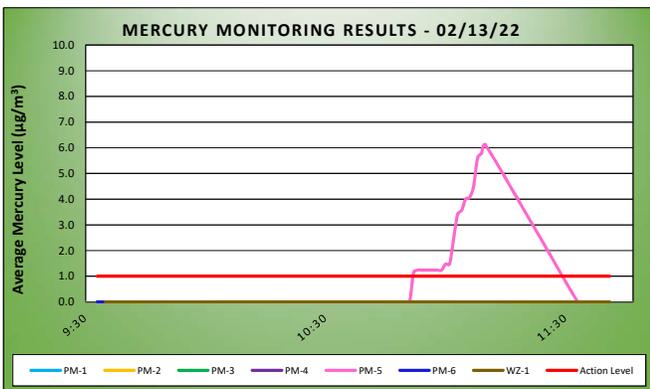
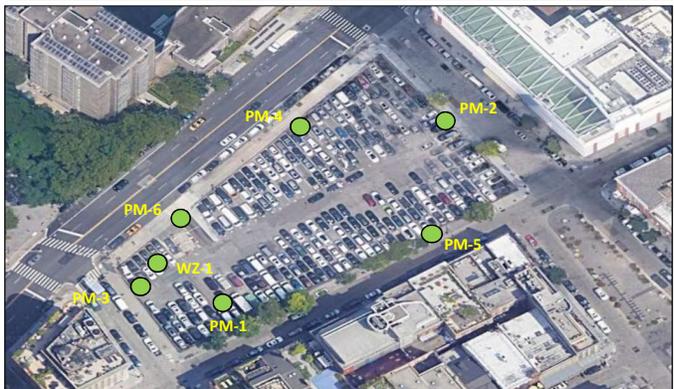
* Mercury vapor concentrations exceeded the action level established in the CAMP from 10:52am to 11:10am at perimeter station PM-5, located along Water Street, closer to Peck Slip. **The exceedances were determined to be erroneous high readings resulting from an equipment malfunction and not a result of ground-intrusive activities associated with test pitting operations.** During this time, AARCO was in the process of backfilling test pit TP-04 after the test pit was open for one hour. Perimeter station PM-5 was located about 200 feet and in an upwind direction from the TP-04 work zone.

- To diagnose the equipment malfunction, the CAMP monitor ran a warm-up function on the Jerome® J405 unit. After running the 5-minute warmup, elevated readings were still observed. The CAMP monitor disconnected the Jerome® J405 from the CAMP unit tubing, and walked towards the work area collecting readings, and the Jerome® J405 unit readings returned to 0.0 $\mu\text{g}/\text{m}^3$ after being disconnected from the CAMP station. The Jerome® J405 unit was reconnected to the CAMP station, and continued to read 0.0 $\mu\text{g}/\text{m}^3$ for the remainder of the operation.

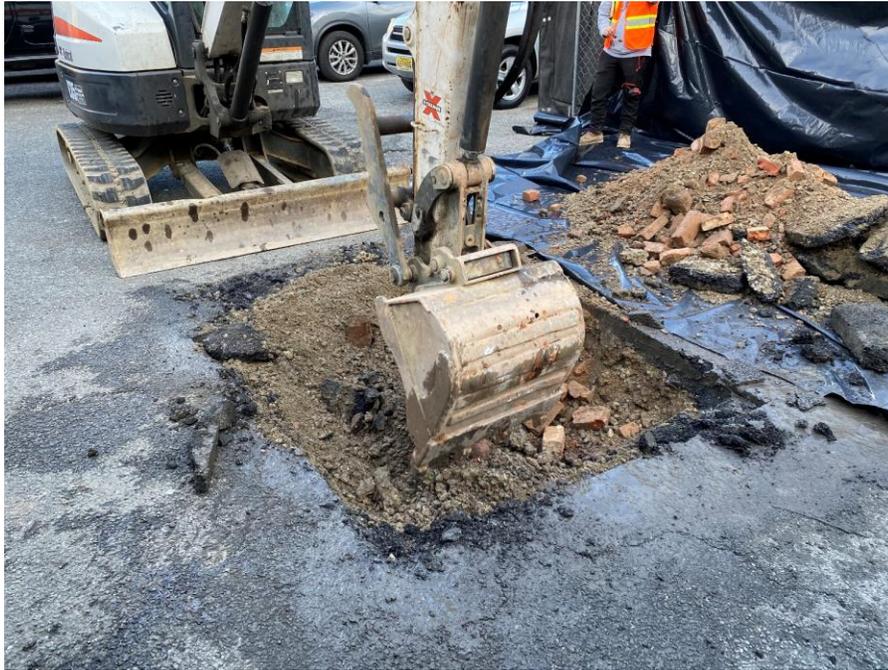
Photo 3: View of AARCO excavating test pit TP03 and stockpiling excavated soil/fill on polyethylene sheeting (facing southeast).

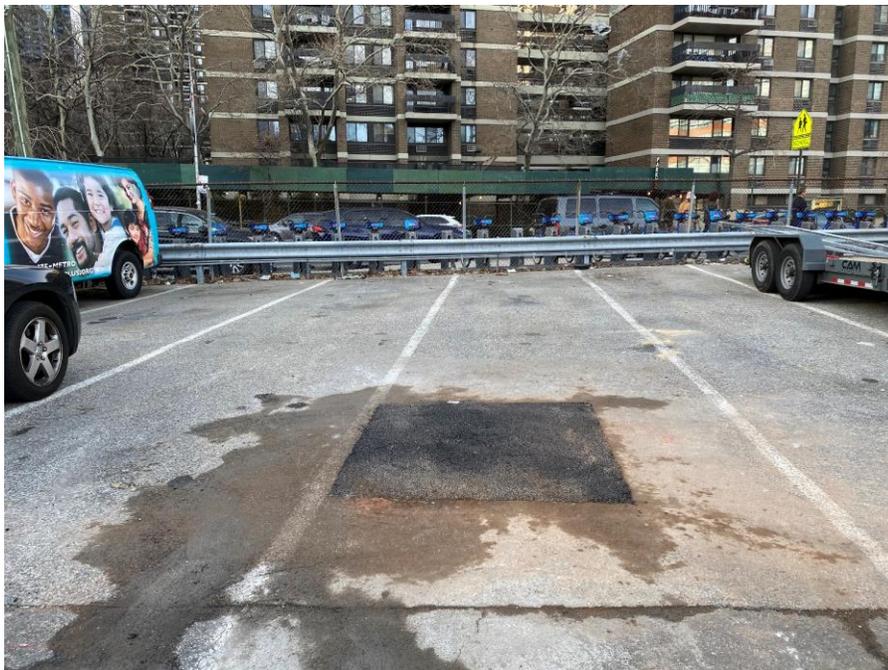
Photo 4: View of test pit TP05, restored to the surrounding grade using cold patch asphalt (facing north).

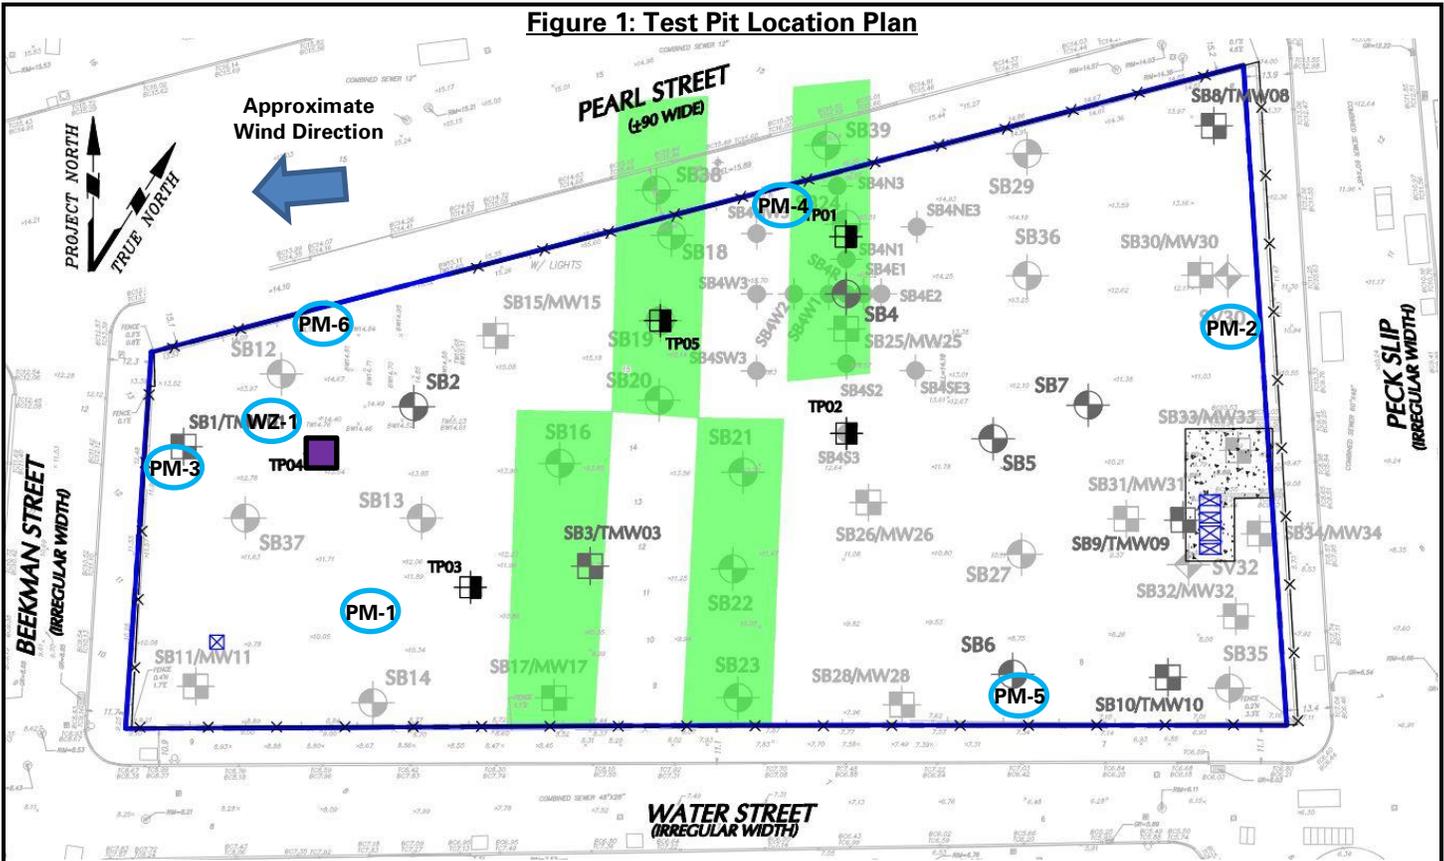
Figure 1: Test Pit Location Plan

- Approximate location of completed test pit
- PM-1 Approximate location of air monitoring station (on-site)
- WZ-1 Approximate locations of work zone air monitoring station

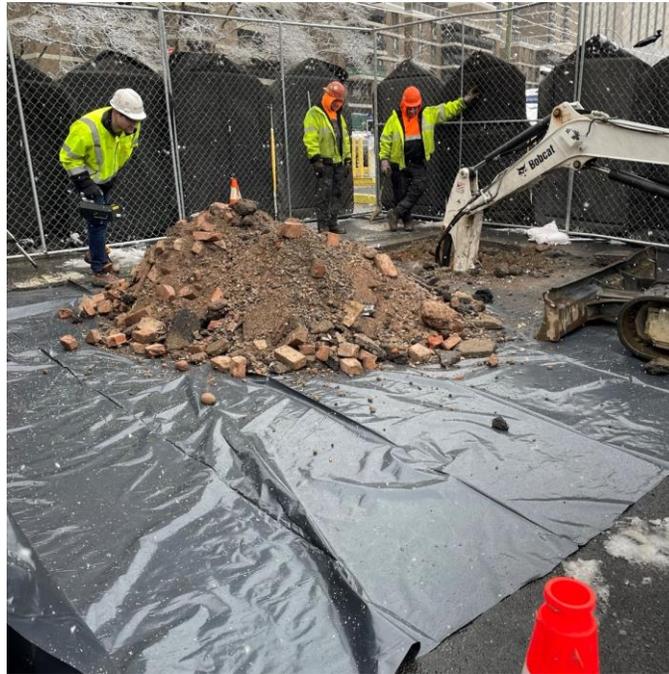
Photo 1: View of AARCO excavating test pit TP04 and stockpiling excavated soil/fill on polyethylene sheeting (facing north).

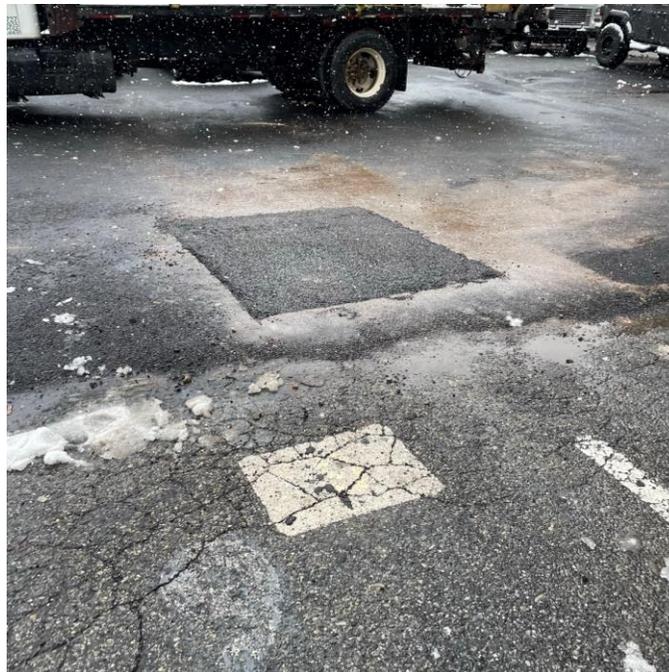
Photo 4: View of test pit TP04, restored to the surrounding grade using cold patch asphalt (facing north).
