SITE OBSERVATION REPORT

<p>PROJECT No.: 170381202</p> <p>PROJECT: 250 Water Street</p> <p>LOCATION: New York, NY</p> <p>BCP SITE ID: C231127</p>	<p>CLIENT: 250 Seaport District, LLC c/o The Howard Hughes Corporation</p>	<p>DATE: Sunday, September 18, 2022</p> <p>WEATHER: Partly Cloudy, 72 °F Wind: WSW @ 13 mph</p> <p>TIME: 9:00 AM – 10:15 AM</p> <p>MONITOR: Farielle Brazier</p>
<p>EQUIPMENT: MiniRAE 3000 PID DustTrak II Jerome J405® Jerome J505® Hand tools CAT 374F Komatsu 969 Komatsu 228 Takeuchi TB290 JCB 110W Hydradig</p>	<p>PRESENT AT SITE: Day 103 Langan (Environmental) – Farielle Brazier Civetta Cousins JV, LLC (CCJV) (Foundation Contractor) - Jack Dettra LendLease (General Contractor) – Marty Cohen</p>	
<p>OBSERVATIONS, DISCUSSIONS, TEST RESULTS, ETC.:</p> <p>Langan was present to document remediation activities in accordance with the NYSDEC-approved November 2021 Remedial Action Work Plan (RAWP) at the 250 Water Street site (NYSDEC Brownfield Cleanup Program [BCP] Site No. C231127).</p> <p>Site Activities</p> <ul style="list-style-type: none"> CCJV covered exposed soil/fill that has not been confirmed to meet Track 2 remediation criteria and construction and demolition (C&

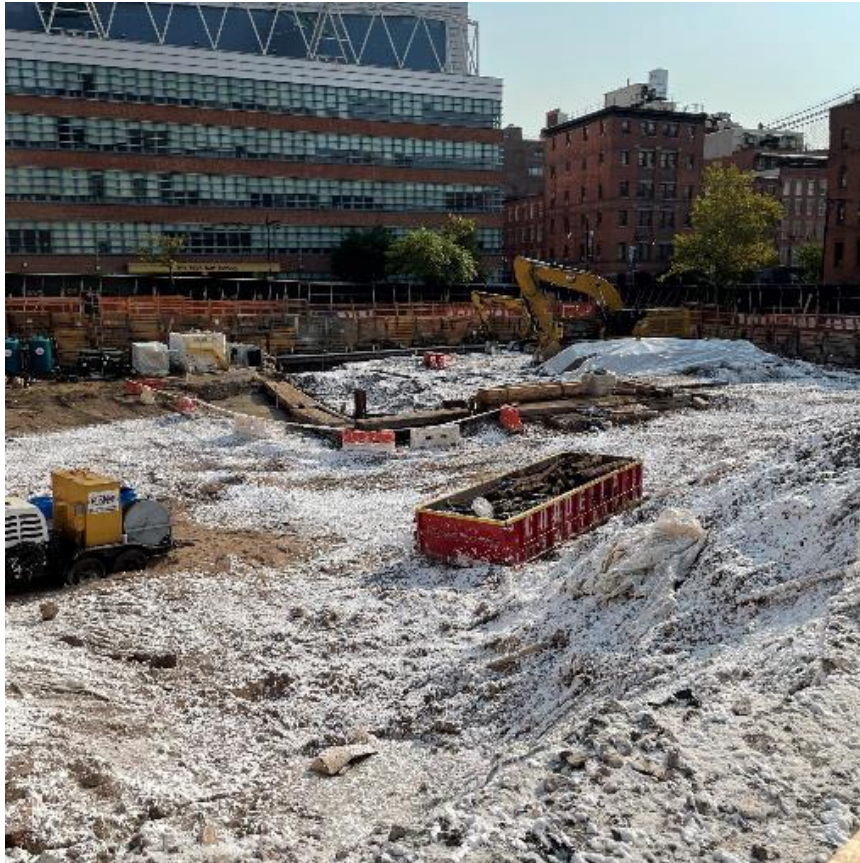
Photo 1: Atmos® AC-645 dust/vapor suppressing foam applied to exposed soil/fill in the southwestern part of the site (facing southwest)
