## SITE OBSERVATION REPORT

<b>PROJECT No.:</b> 170381202  <b>PROJECT:</b> 250 Water Street  <b>LOCATION:</b> New York, NY  <b>BCP SITE ID:</b> C231127	<b>CLIENT:</b> 250 Seaport District, LLC c/o The Howard Hughes Corporation	<b>DATE:</b> Saturday, October 15, 2022  <b>WEATHER:</b> Sunny, 52 – 64 °F Wind: N @ 1.2 mph  <b>TIME:</b> 7:45 AM – 9:30 AM  <b>MONITOR:</b> Laura Grose
---	--	--

Langan was present to document remediation activities in accordance with the NYSDEC-approved November 2021 Remedial Action Work Plan (RAWP) at the 250 Water Street site (NYSDEC Brownfield Cleanup Program [BCP] Site No. C231127).

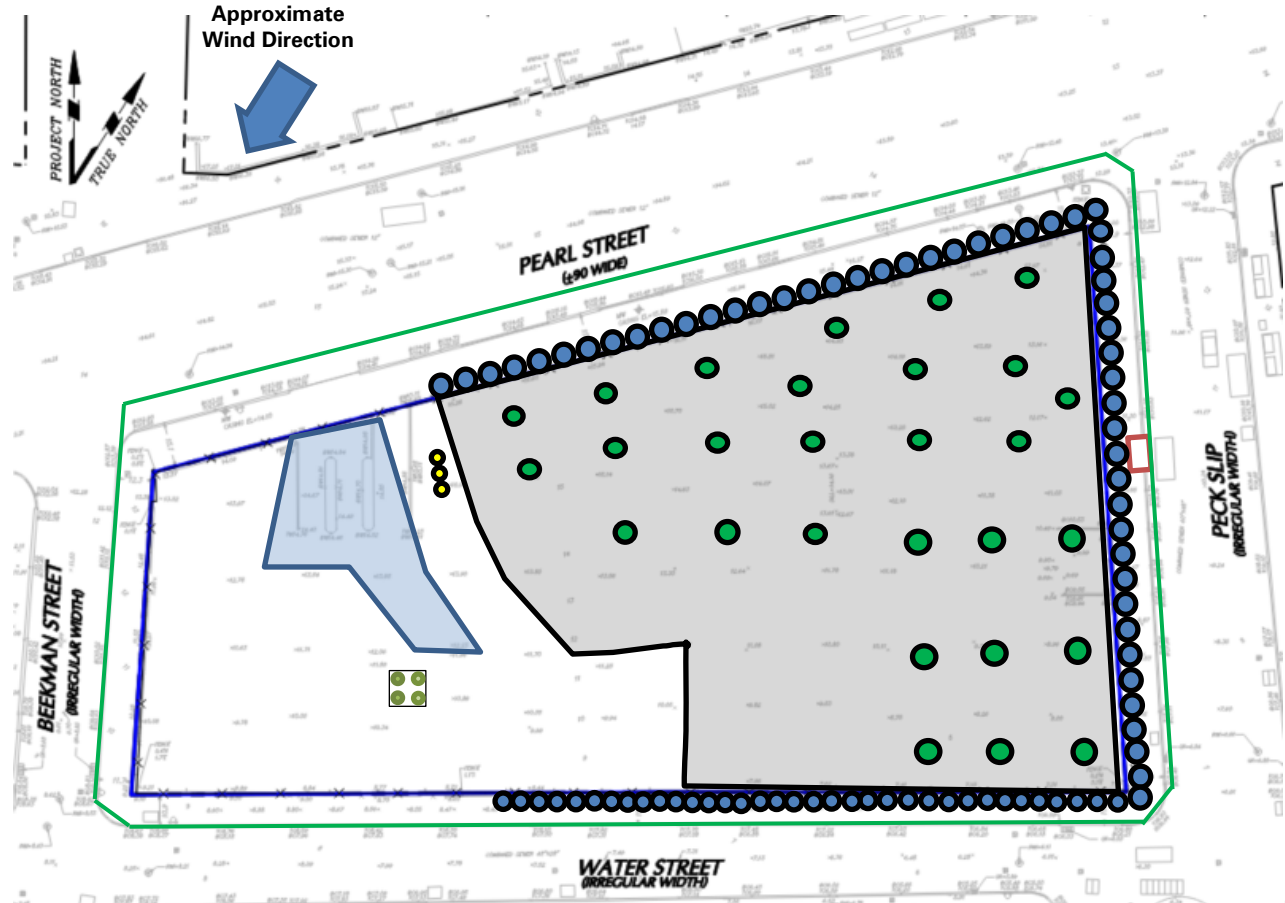
### Site Map

1) Locations of air monitoring stations are approximate.

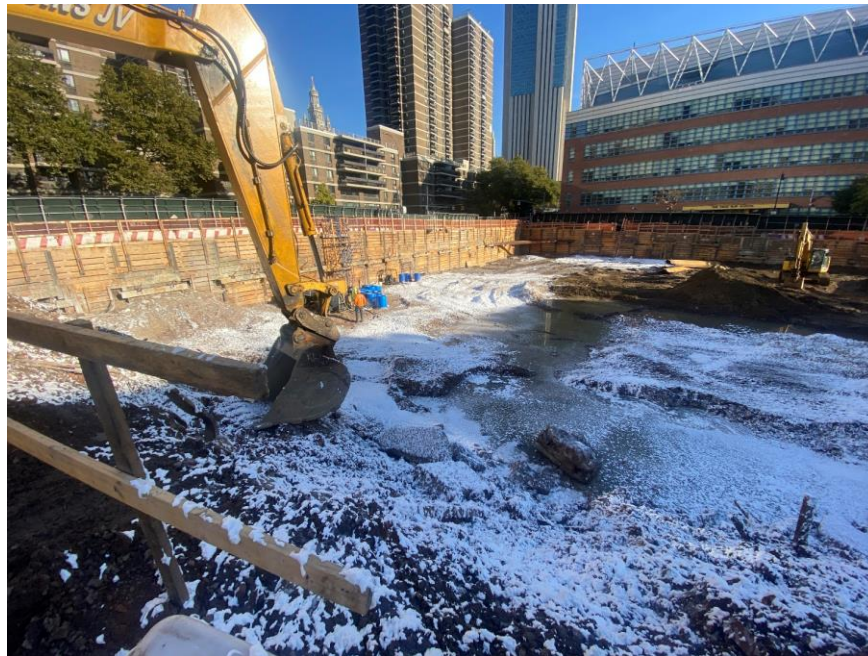
**Photo 1:** Atmos® AC-645 dust/vapor suppressing foam applied to exposed soil/fill for the temporary overnight cover (facing northeast)

- CCJV covered exposed soil/fill that has not been confirmed to meet Track 2 remediation criteria and construction and demolition (C&D) debris with Atmos® AC-645 dust/vapor suppressing foam to create a temporary overnight cover.
