General

Front and rear driveshafts

Rear Driveshaft Service

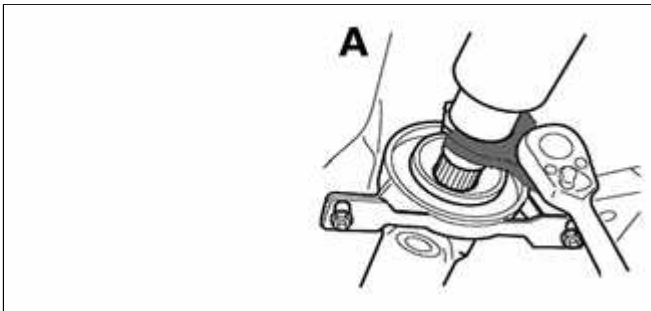
- ◀ Clamping sleeve adjustment tool BMW 26 1 040

✦ Using BMW special tool 26 1 040, loosen threaded clamping sleeve on driveshaft a few turns.

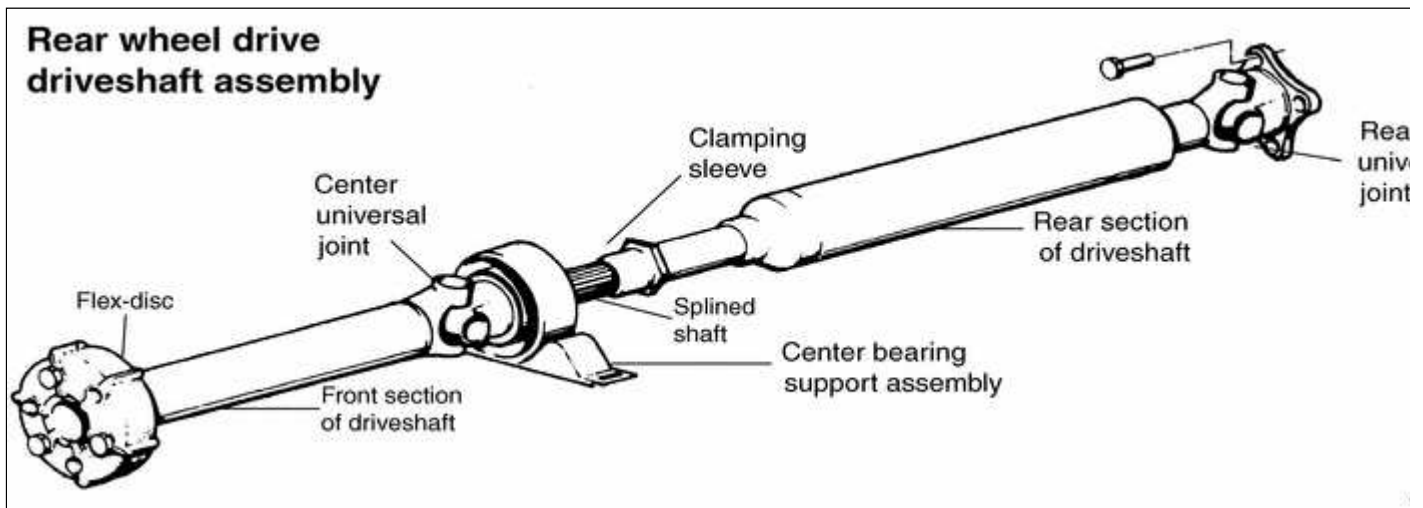
Rear wheel drive driveshaft assembly

The rear driveshaft is a two-piece unit joined in the center by a sliding splined coupling. This coupling compensates for fore and aft movement of the drive line. The driveshaft is connected to the transmission by a rubber flex-disc and to the rear final drive by a universal joint. It is supported in the middle by a center support bearing. The bearing is mounted in rubber to isolate vibration.

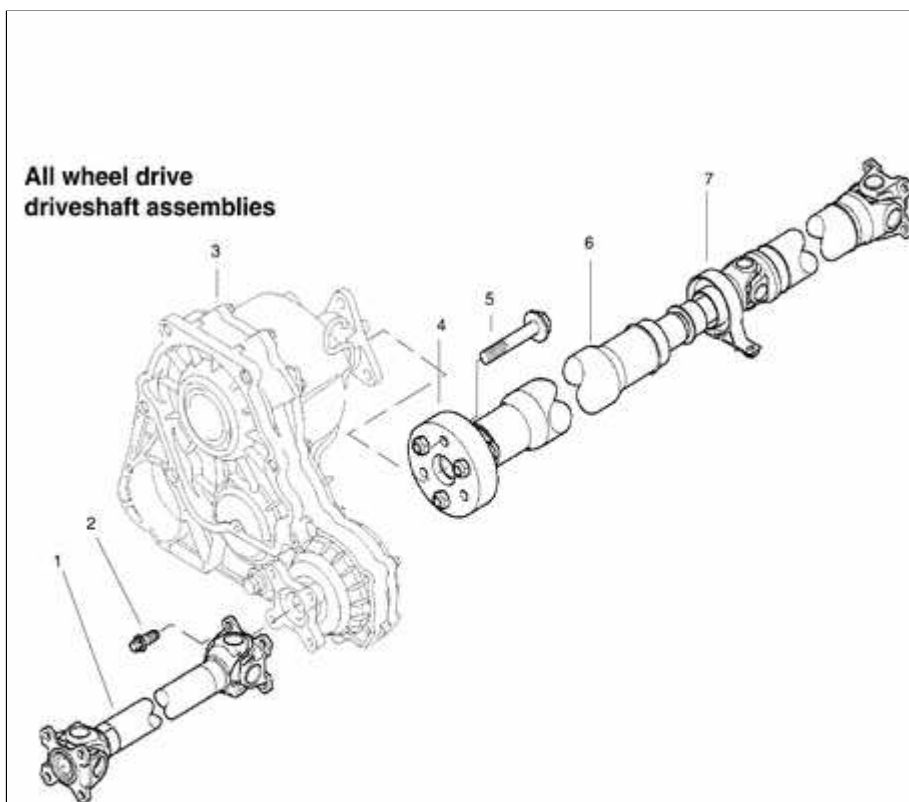
All wheel drive driveshaft assemblies

- 1 - Front driveshaft assembly
- 2 - Torx screw M10
- ◆ tighten to 70 Nm (52 ft-lb)
- 3 - Transfer case
- 4 - Flex disc
- 5 - Bolt M12

◆ tighten to 100 Nm
(74 ft-lb)

6 - **Rear driveshaft
assembly**

7 - **Driveshaft
center bearing
mount**

All wheel drive models incorporate two driveshafts. The rear driveshaft is a two-piece unit with splined center coupling much like that of a rear wheel drive model, but it is shorter and connects the transfer case to the rear differential. A short, one-piece

driveshaft runs from the transfer case to the front differential. The front driveshaft bolts to the transfer case and differential directly, using no flexible rubber disk.

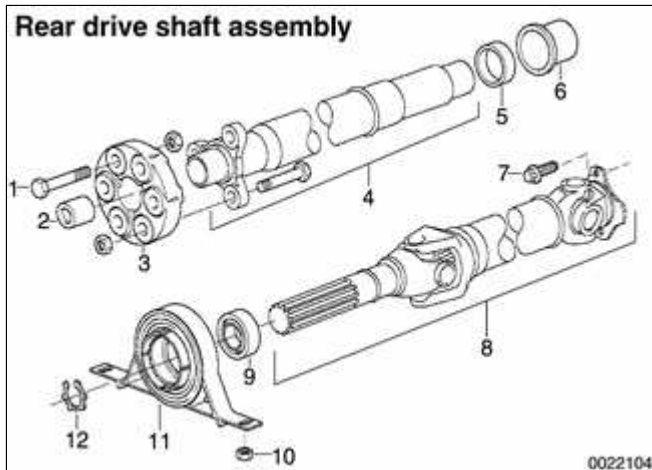
- 1 - Hex bolt, M12
- 2 - Centering sleeve
- 3 - Flexible disk
- 4 - Front section of driveshaft
- 5 - Clamping sleeve
- 6 - Clamping ring
- 7 - Torx screw
- 8 - Rear section of drive shaft
- 9 - Center bearing
- 10 - Nut
- 11 - Center bearing support
- 12 - Lock ring

Repair kits for the universal joints are not available for BMW driveshafts. Worn or damaged universal joints usually require replacement of the driveshaft.

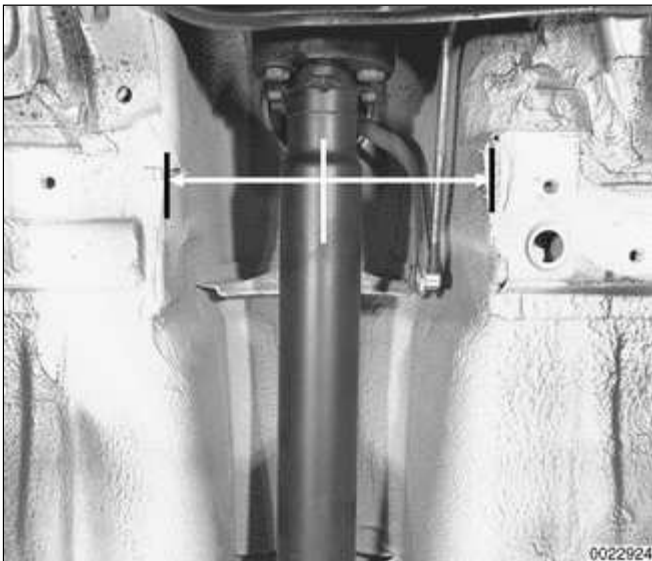
- ✦ To adjust the side-to-side alignment, loosen transmission or engine mounts to reposition them, then retighten mounts. The driveshaft should be exactly centered in driveshaft tunnel.

There are two important driveshaft alignment checks. The first is to make sure that the driveshaft runs straight from the transmission to the final drive, without any variation from side-to-side caused by misalignment of the engine/transmission in its mounts. Make a basic check by sighting along the driveshaft from back to front. Any misalignment should be apparent from the center bearing forward.

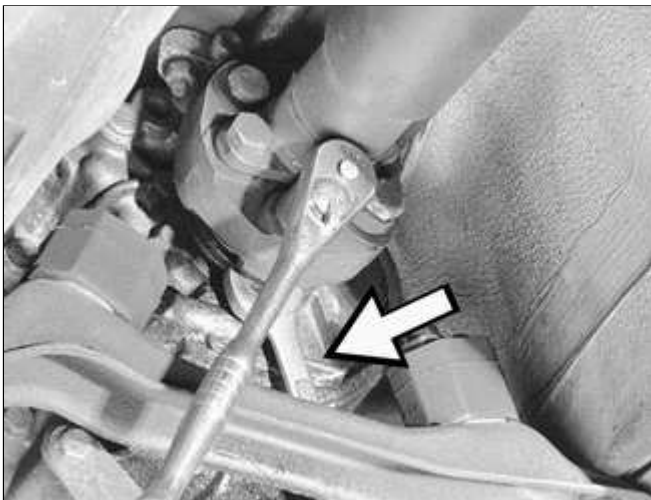
- ▲ Remove driveshaft mounting bolts. Discard old nuts. Note open-end wrench (**arrow**) being used to counterhold bolt at transmission flex-disc.
- Support driveshaft sections from body using stiff wire.

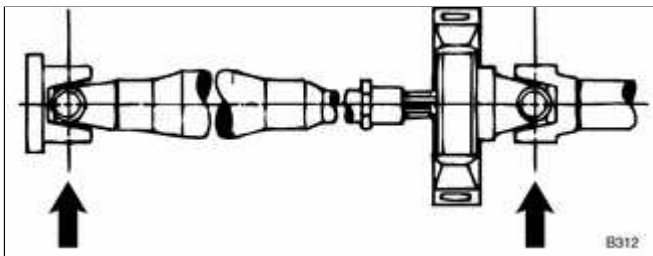
✦ Align driveshaft matchmarks at final drive and then at transmission flange. Centerlines of universal joints (**arrows**) must be parallel or at 90° to each other. Position center support bearing and start attaching nuts. Use new self-locking nuts.

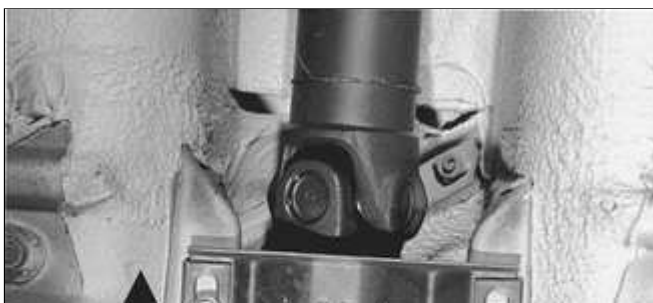
✦ Preload center support bearing by pushing bearing forward (**arrow**) 4-6 mm (0.16-0.24 in.) from center. Tighten attaching bolts.

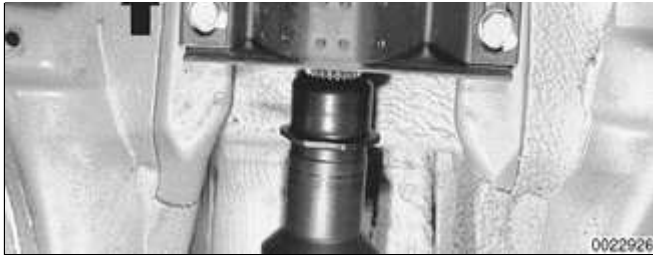
The maximum allowable change in

height of the center bearing or transmission support using shims is 3 mm (0.12 in.).

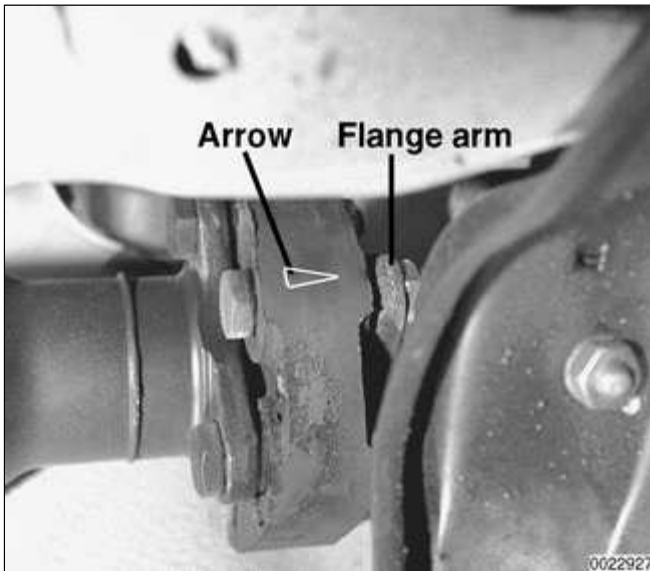
- ✦ Install new flex-disc using new self-locking nuts. Molded arrows on coupling should face flange arms.

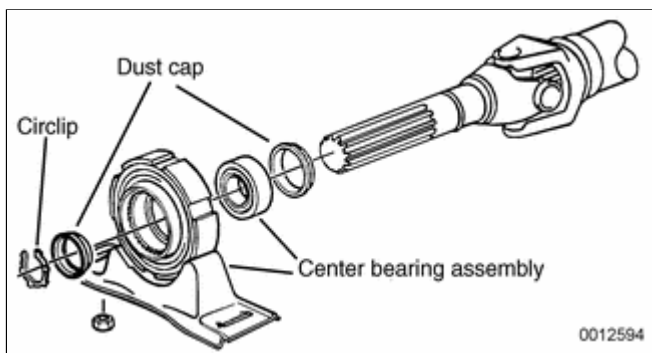
➤ To replace the center bearing assembly, the driveshaft must be removed from the car. The center bearing assembly consists of a grooved ball bearing in a rubber mount. The bearing assembly is pressed onto the front section of the driveshaft and secured by a circlip.

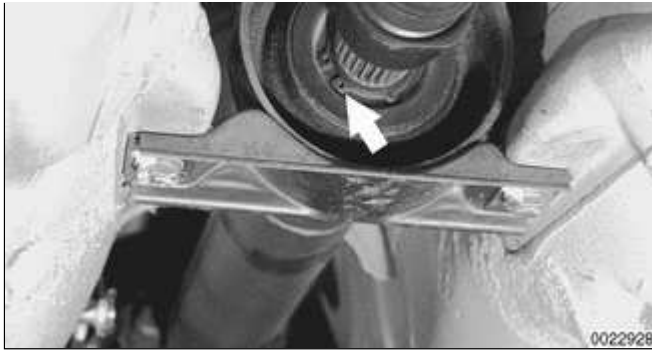
- Install puller so that it pulls on

inner hub of bearing. Pulling on outer ring of mount may tear rubber, and entire bearing assembly will need to be replaced.

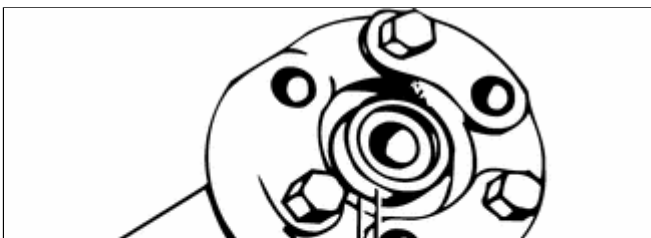
- ▲ When installing new driveshaft centering guide, the sealing lip of the guide should face outward and it should be driven into the driveshaft to drive guide to a protrusion depth of 4.5 mm (.177 in.).
