ALLEGIANCE HOME INSPECTIONS

SWIMMING POOL AND SPA

1234 Main Street
Murrieta, CA 92562

04/25/2025 9:00AM

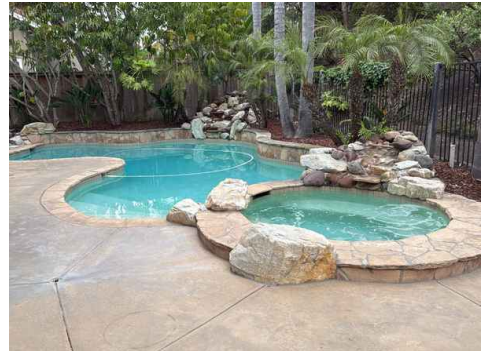
1.1.1 Safety Devices:

NO POOL FENCING

No separate pool area fencing was installed at this time. We recommend upgrading by installing pool fencing.

Recommend pool fencing around entire perimeter

Contact a qualified swimming pool contractor

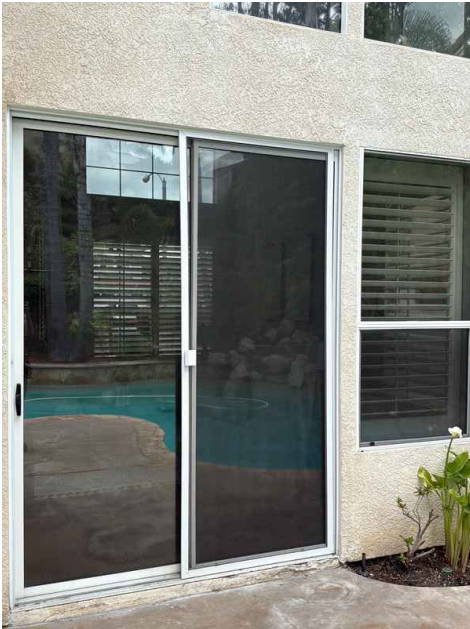
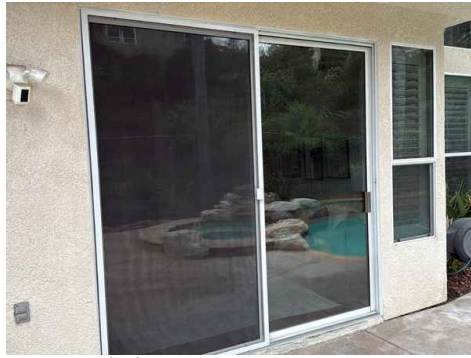
1.1.2 Safety Devices:

DOOR ALARMS ARE NOT INSTALLED.

All doors that lead to the pool area should be protected with door alarms unless separate pool fencing is installed.

Required alarm

Contact a qualified swimming pool contractor

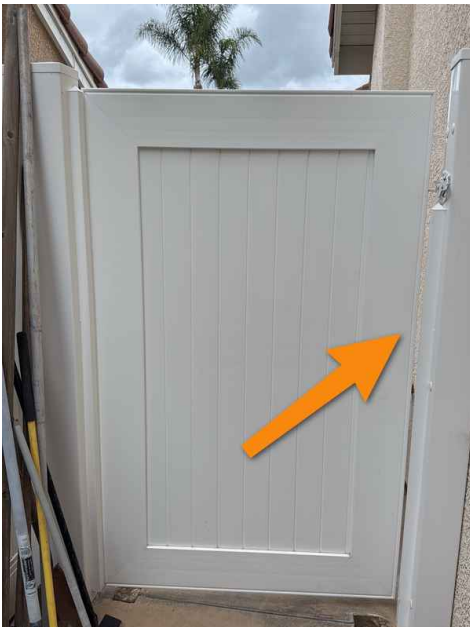
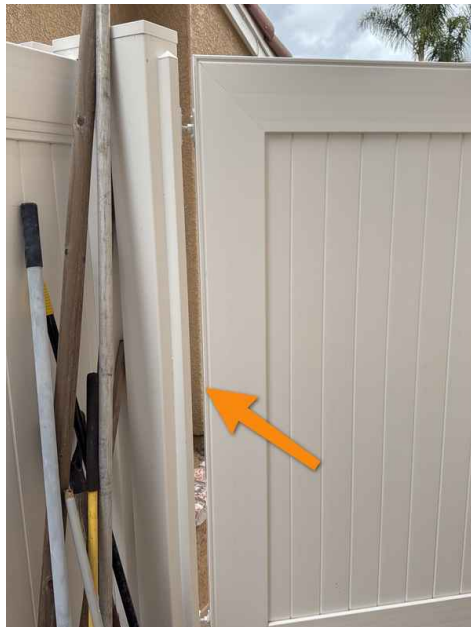
1.1.3 Safety Devices:

PERIMETER GATES DO NOT COMPLY WITH BARRIER REQUIREMENT.

The perimeter gates that provide access to the pool/spa area should be self-closing and self-latching and open away from the pool area.

Self closing device needs adjustment

Contact a qualified professional.

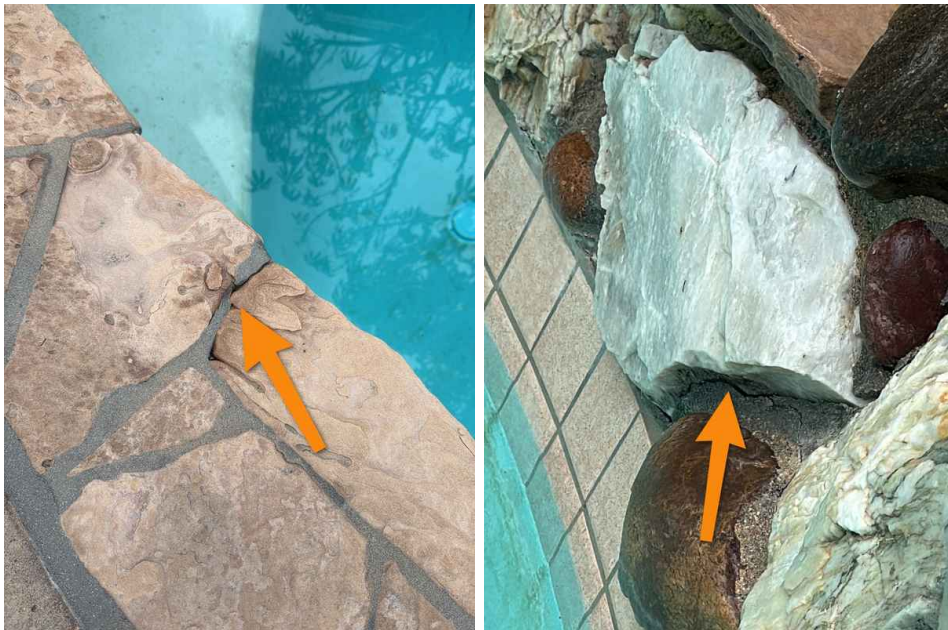
1.2.1 Pool Area Coping, Tile and Decking:

RESEAL COPING

We recommend re-sealed between the deck and coping to prevent water from leaking behind the pool walls.

Contact a qualified swimming pool contractor

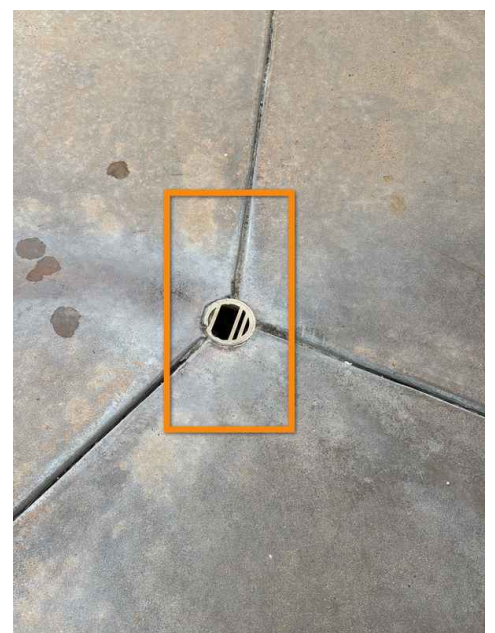
1.2.2 Pool Area Coping, Tile and Decking:

BROKEN DRAIN COVER(S).

The broken deck drain covers should be replaced.

Contact a qualified handyman.

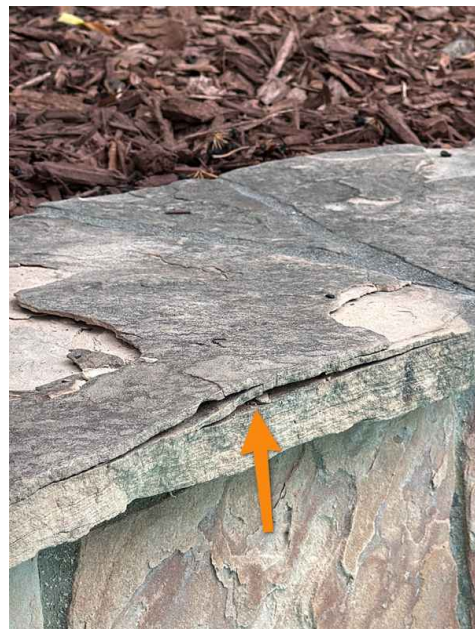
1.2.3 Pool Area Coping, Tile and Decking:

FLAGSTONE LIFTING

Flagstone lifting on bond beam

Contact a qualified masonry professional.

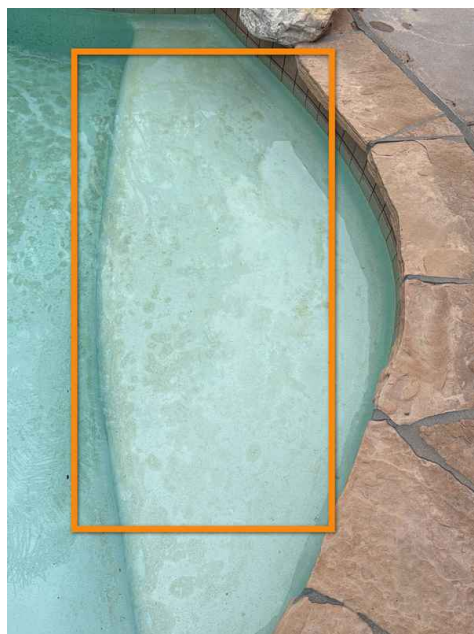
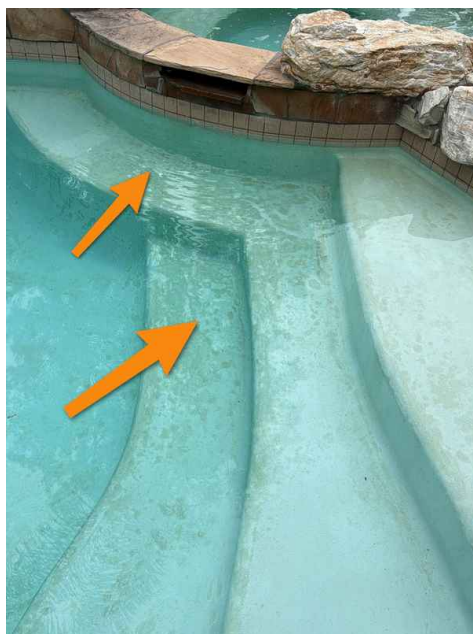
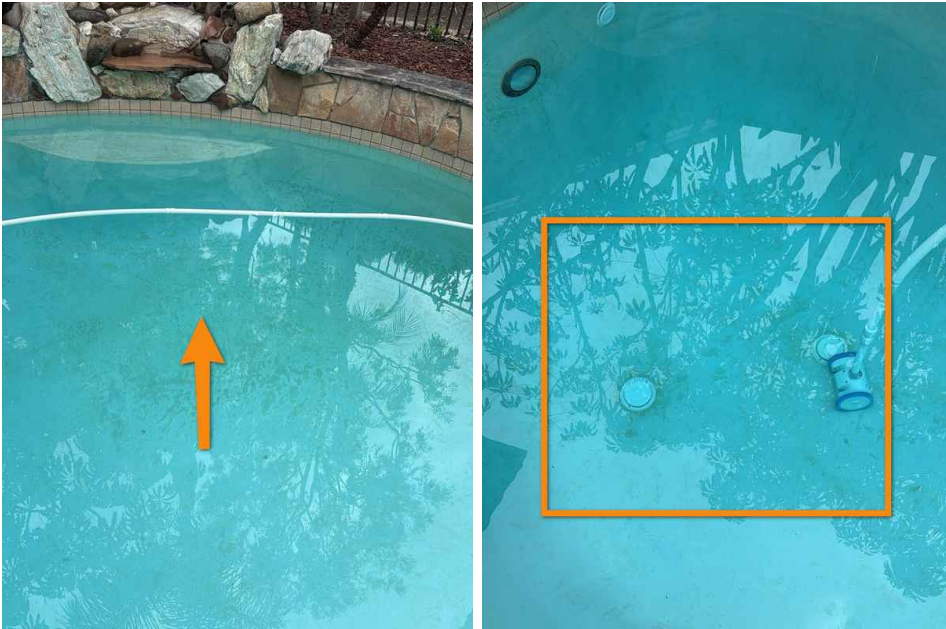
1.3.1 Vessel Surface:

SURFACE DEFECTS NEED FURTHER EVALUATION AND LIKELY REPAIR.

The plaster surface is worn and needs to be re-surfaced.

Contact a qualified swimming pool contractor

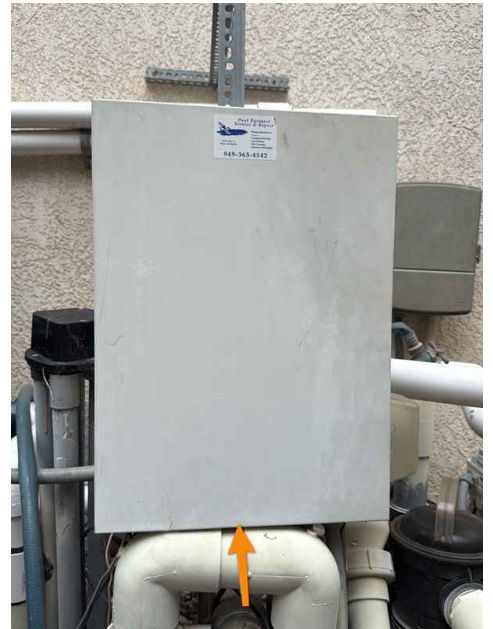
1.5.1 Pool Electrical:

SUBPANEL HARD TO CLOSE

Subpanel difficult to close rubbing on pool, plumbing, recommend raising subpanel slightly

Contact a handyman or DIY project

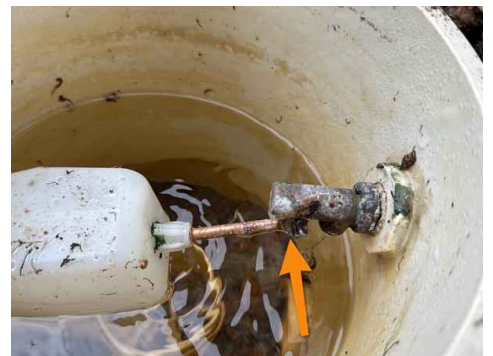
1.8.1 Pool Plumbing:

FILL-VALVE LEAKING

The pool fill valve is leaking and should be repaired.

Contact a qualified handyman.

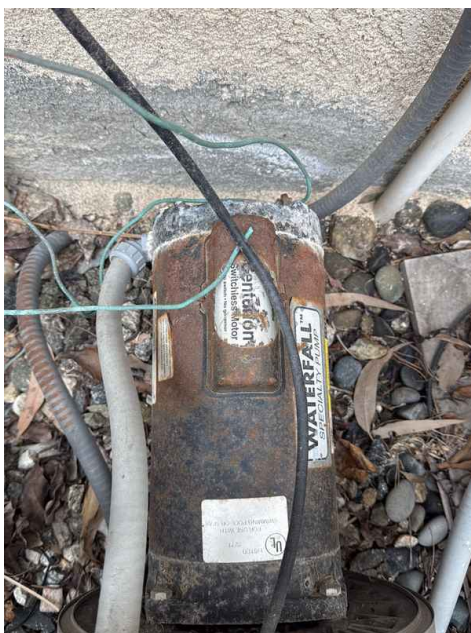
1.9.1 Pumps:

OLD PUMP

Old pump, rusted, and corroded recommend replacing

Contact a qualified swimming pool contractor

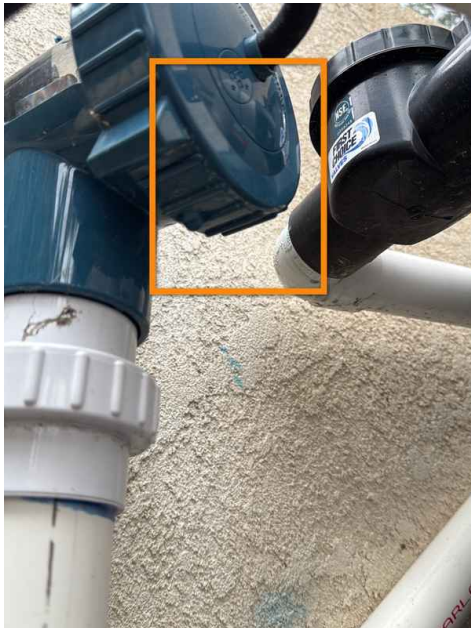
1.9.2 Pumps:

LEAKING FROM SALT CELL

Slow leak from salt cell connection, recommend qualified contractor

Contact a qualified swimming pool contractor

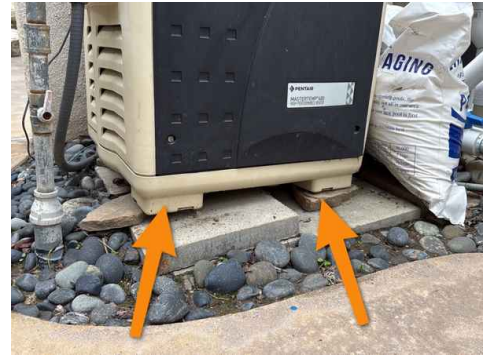
1.11.1 Heating:

LEVELING

Heater leveling is subpar

Contact a qualified swimming pool contractor
