ALLEGIANCE HOME INSPECTIONS

ROOM-BY-ROOM RESIDENTIAL

1234 Main Street
Murrieta, CA 92562

Buyer Name
04/25/2025 9:00AM

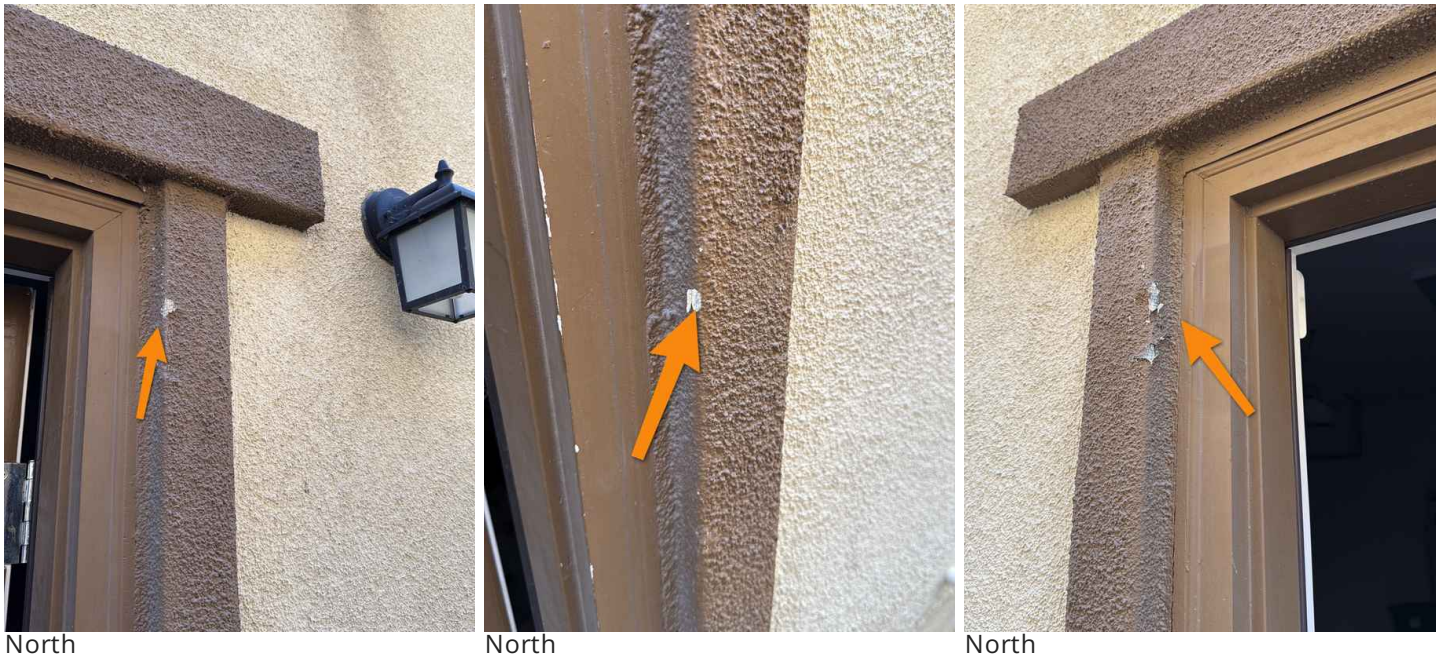
North

3.1.1 Siding & Trim
CRACKING - MINOR

Siding showed cracking in one or more places. This is a result of temperature changes, and typical as homes with stucco age. Recommend monitoring.

Recommendation
Contact a stucco repair contractor

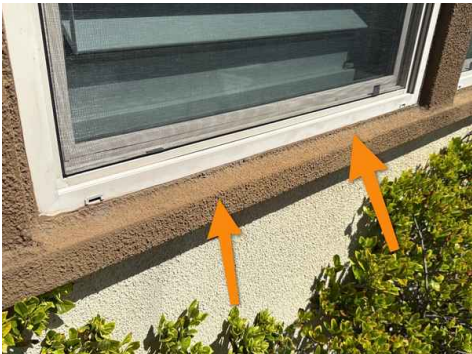
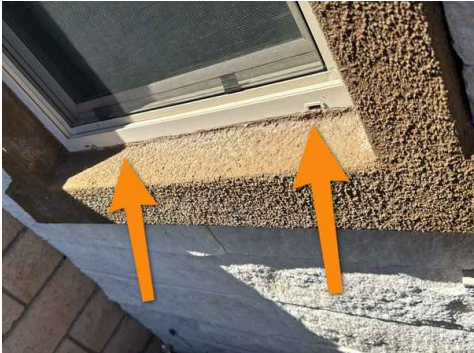
West

3.1.2 Siding & Trim

NEEDS PAINT

Recommend repainting to prevent deterioration.

Contact a qualified painting contractor.

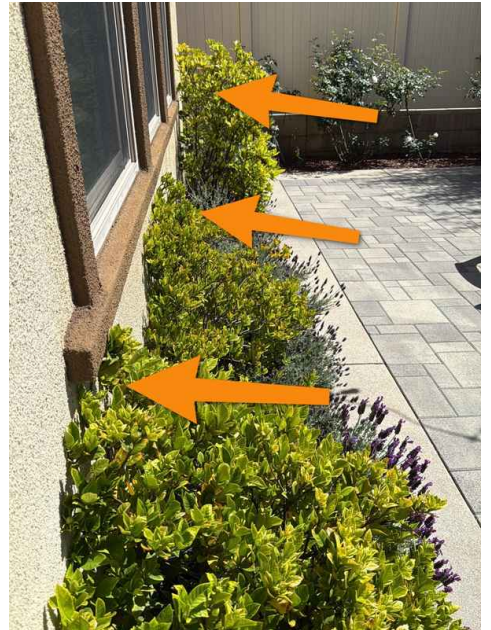
VEGETATION TOO CLOSE TO HOUSE

Vegetation too close to house recommend approximately 6 inches separation to combat from moisture intrusion, pests and insects

Contact a qualified landscaping contractor

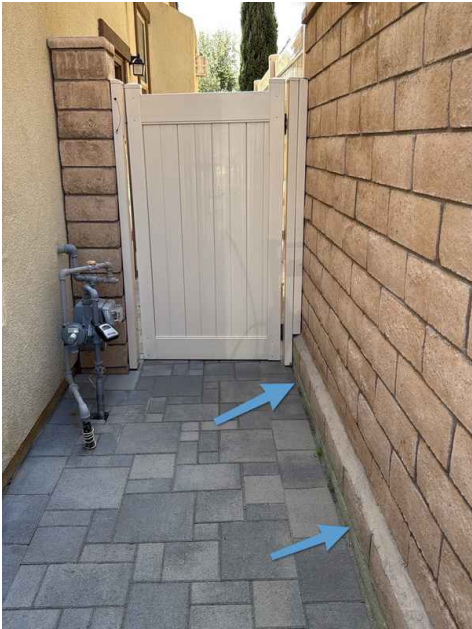
North

UNKNOWN GREEN RESIDUE

Unknown green residue on most of the north retaining wall. Homeowner states it has been there ever since they've moved in. Attempted to remove with scraping and was unsuccessful.

Recommended DIY Project

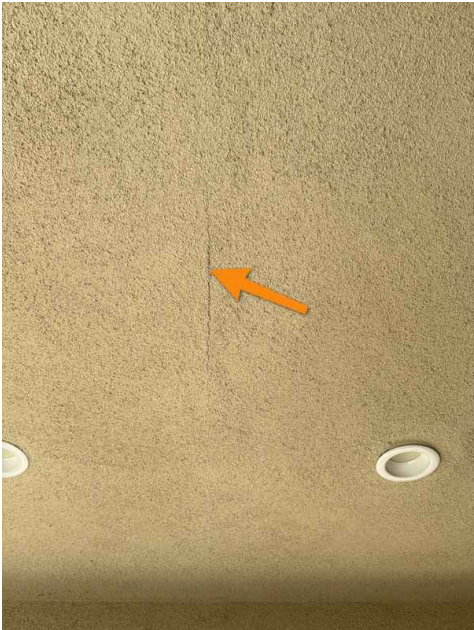
CRACKS IN STUCCO UNDER PATIO

Cracks in ceiling of patio structure. Possible settling crack. Recommend qualified professional.

Contact a stucco repair contractor

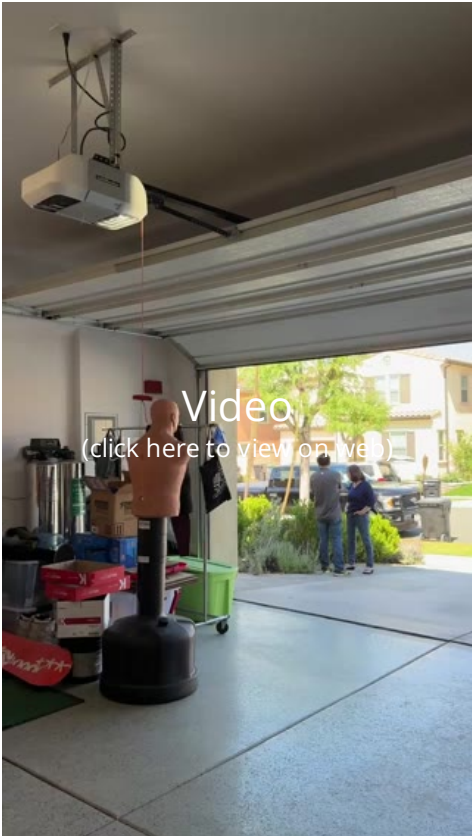
AUTO REVERSE SENSOR NOT WORKING

The auto reverse sensor was not responding at time of inspection. This is a safety hazard to children and pets. Recommend a qualified garage door contractor evaluate and repair/replace.

Contact a qualified garage door contractor.

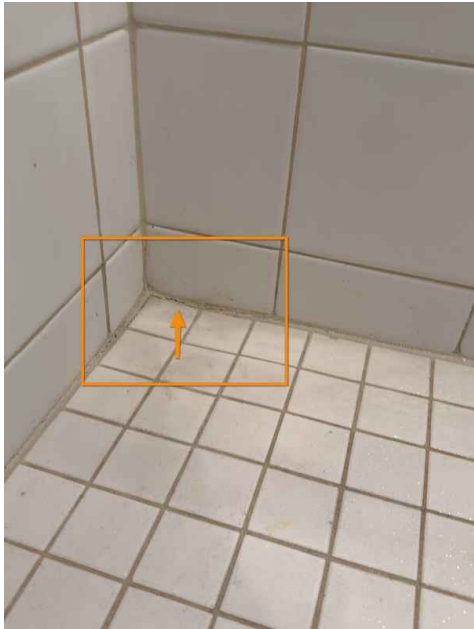
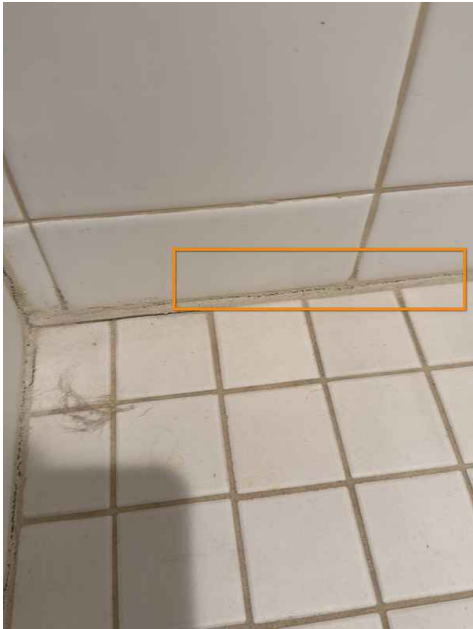
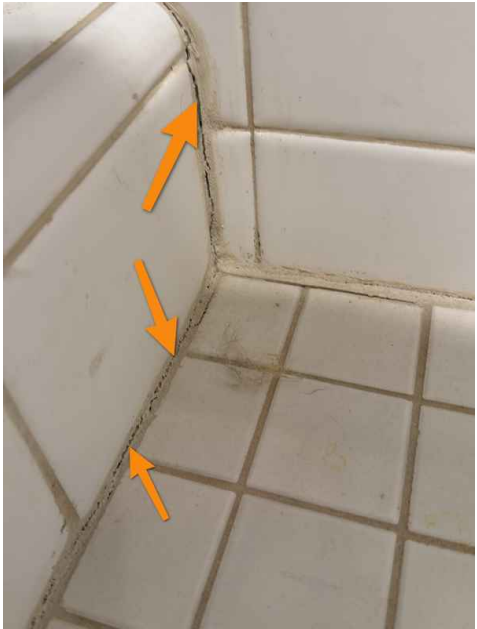
13.3.1 Shower/Tub

GROUT CRACKING

Recommending re-grouting. Recommend handyman or DIY.

Contact a handyman or DIY project
