ALLEGIANCE HOME INSPECTIONS

ROOM-BY-ROOM RESIDENTIAL

1234 Main Street
Murrieta, CA 92562

Buyer Name
04/25/2025 9:00AM

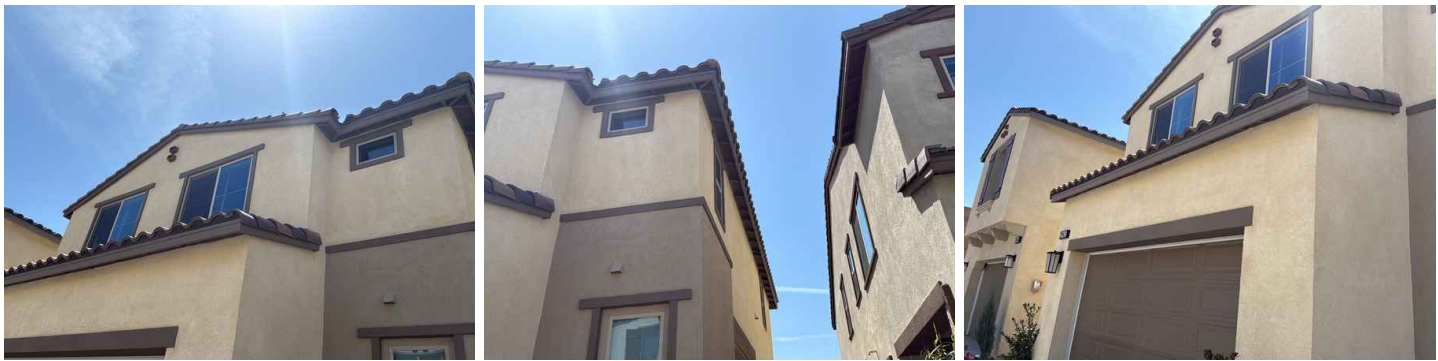
2.2.1 Roof Drainage Systems

GUTTERS MISSING

There are no gutters present on the structure. Gutters are recommended because they collect rain water from the roof and direct it away form the building.

Contact a qualified professional.

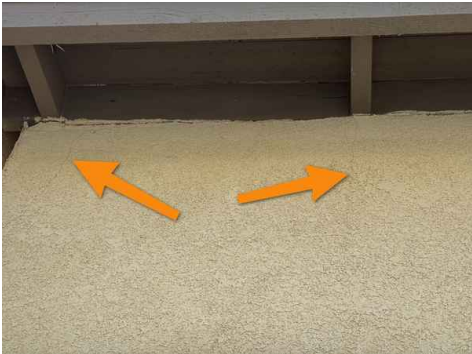
3.1.1 Siding & Trim

CRACKING - MINOR

Siding showed cracking in one or more places. This is a result of temperature changes, and typical as homes with stucco age. Recommend monitoring.

Recommended DIY Project

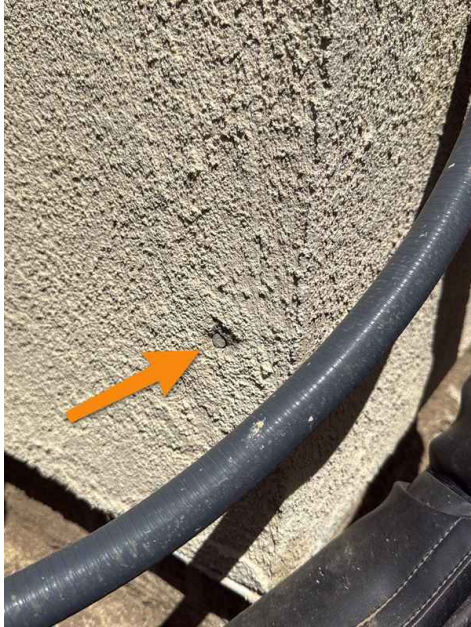
3.1.3 Siding & Trim

STUCCO REPAIR NEEDED

Stucco repair needed recommend qualified, professional

Contact a stucco repair contractor

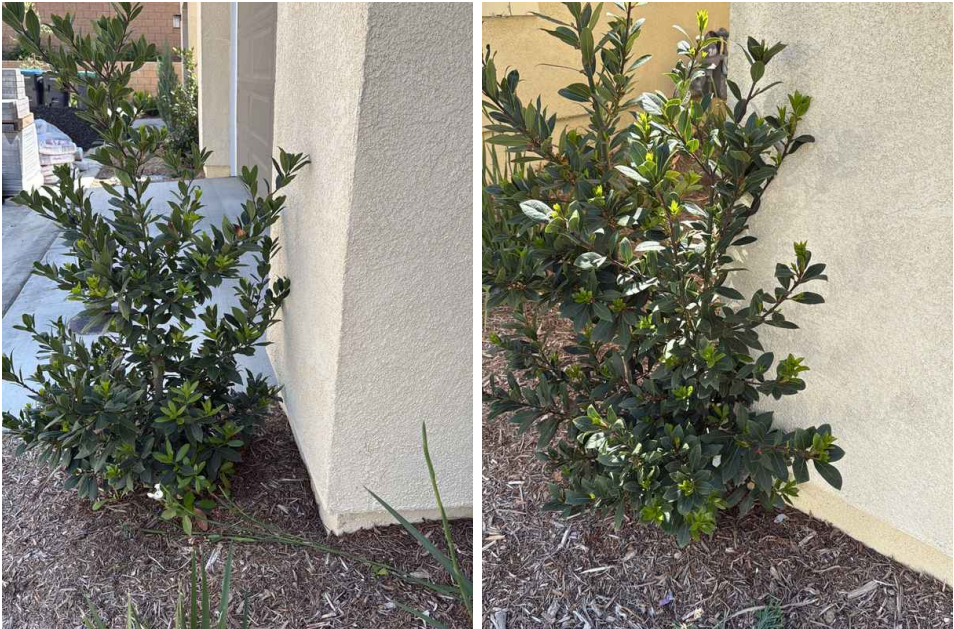
3.7.1 Vegetation, Grading, Drainage & Retaining Walls

VEGETATION TOO CLOSE TO HOUSE

vegetation too close to house recommend approximately 6 inches separation to combat from moisture intrusion, pests and insects

Contact a qualified landscaping contractor

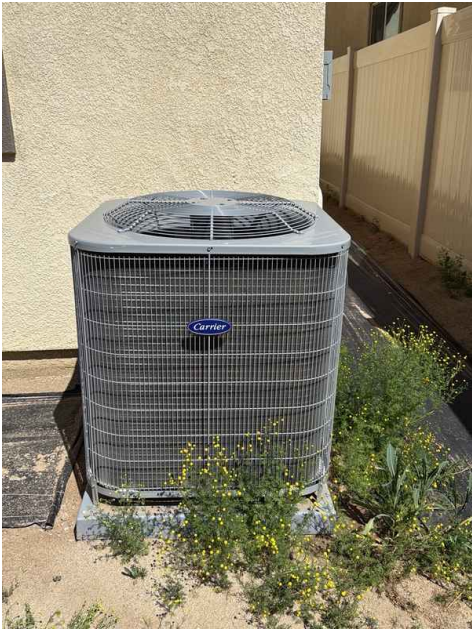
5.1.1 Cooling Equipment

AC PRODUCES LARGE AMOUNT OF CONDENSATION

Per homeowner AC produces a large amount of condensation. Recommend a qualified HVAC contractor to evaluate.

Contact a qualified HVAC professional.

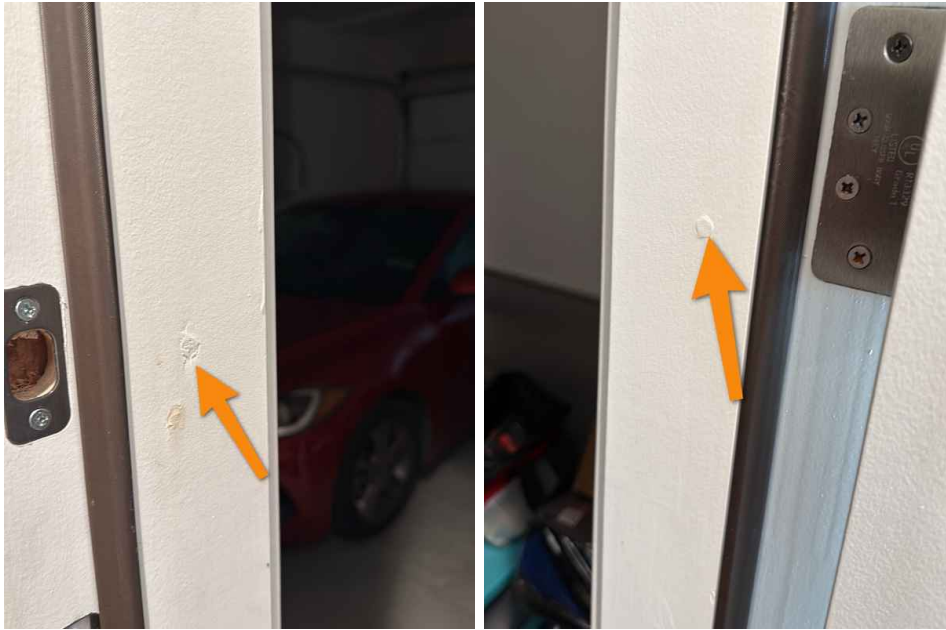
6.5.1 Occupant Door (From garage to inside of home)

PAINT IMPERFECTIONS

Sand and paint

Contact a qualified painting contractor.

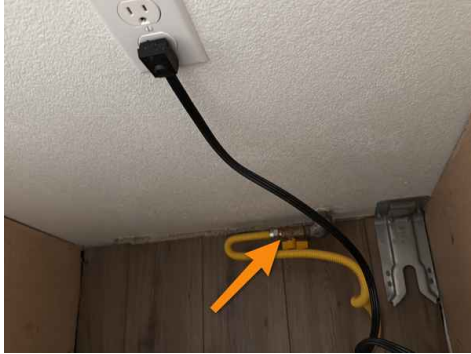
7.3.1 Range/Oven/Cooktop

GAS VALVE NOT ALLOWING RANGE TO SIT FLUSH WITH COUNTERTOP

Homeowner concerned that range is not sitting flush with Countertop gas valve, not allowing range to fully back up to wall

Contact a handyman or DIY project

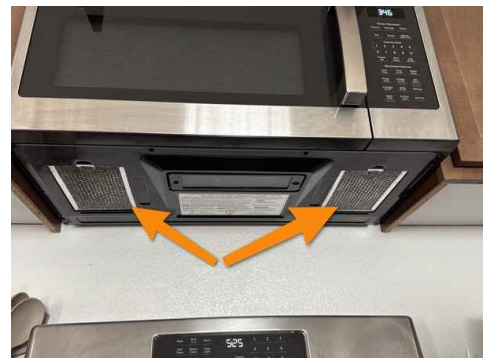
7.6.1 Built-in Microwave

VENTILATION FAN IS INADEQUATE

Homeowner concerned that the ventilation fan is inadequate and wants fan evaluated and corrected.

Contact a qualified appliance repair professional.

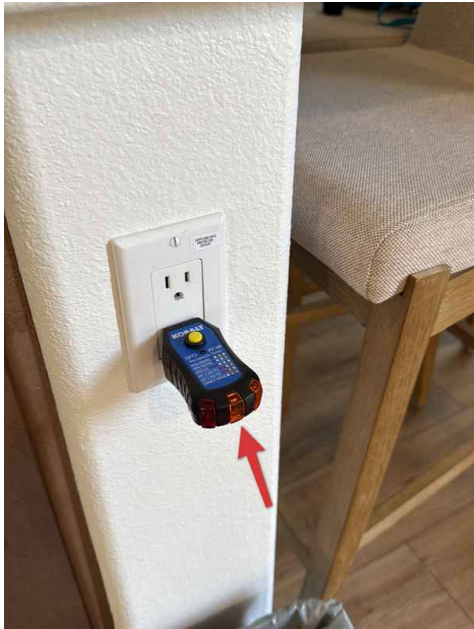
7.8.1 GFCI

GFCI INOPERABLE

GFCI was tripped and unable to rest. Recommend qualified electrician to evaluate.

Contact a qualified electrical contractor.

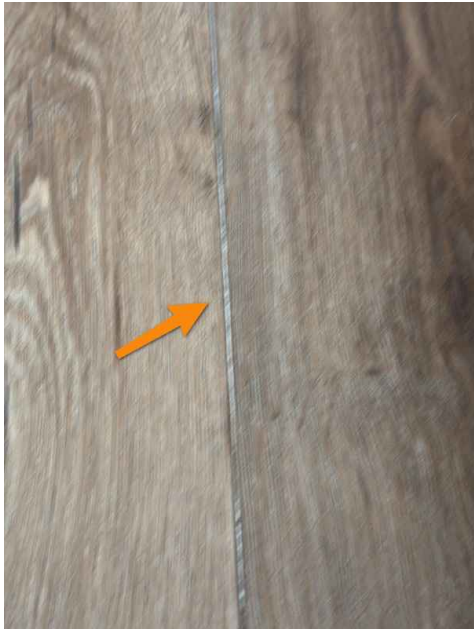
7.9.1 Flooring

DISCOLORATION TO SEAMS

Homeowner concerned with discoloration of seams in vinyl flooring.

Contact a qualified flooring contractor

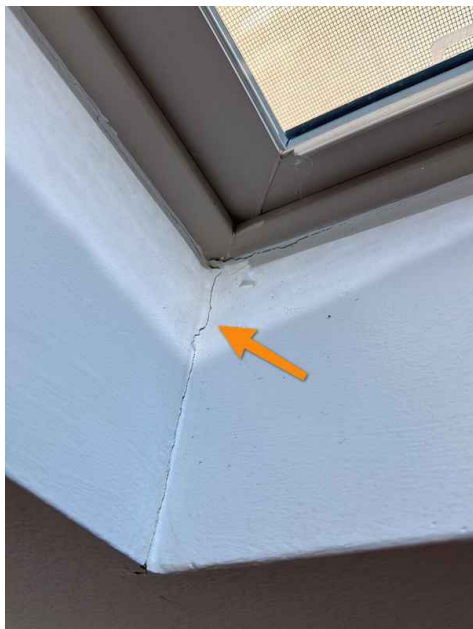
9.3.1 Windows

CRACKED WINDOW SEAL

Contact a qualified drywall contractor.

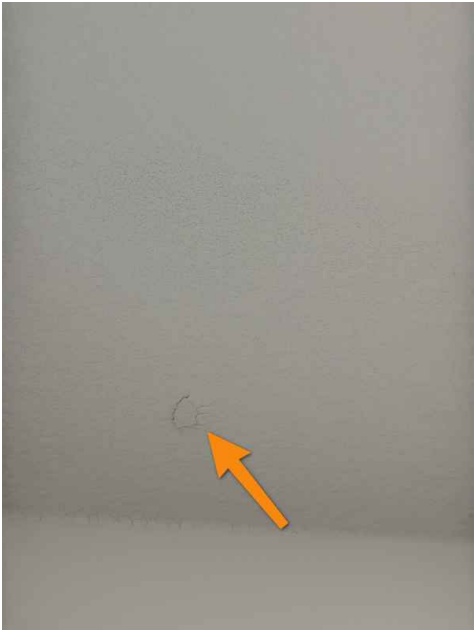
10.6.1 Ceilings

NAIL POP

Patch and paint

Contact a qualified drywall contractor.

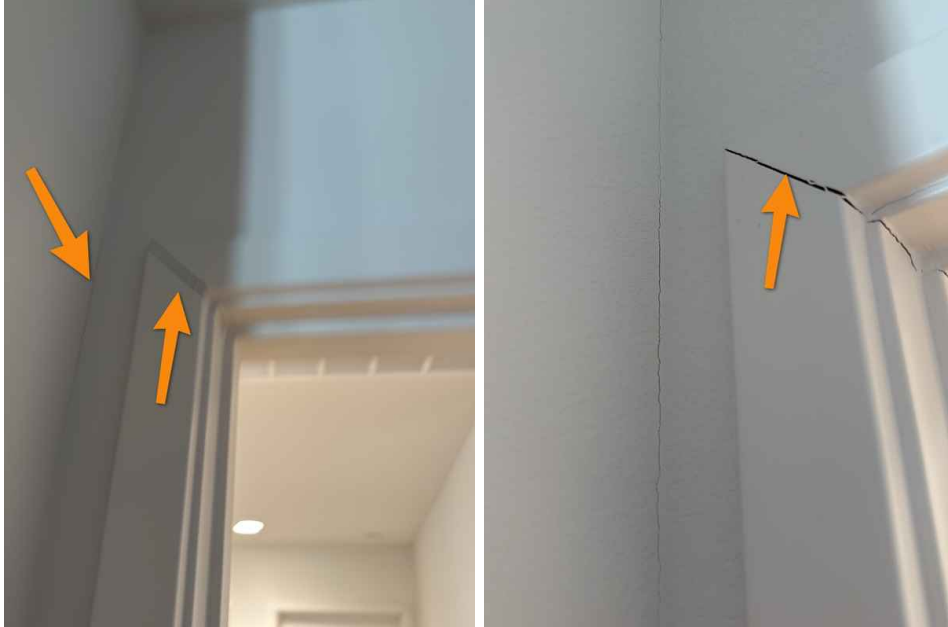
12.5.1 Walls

MINOR CORNER CRACKS

Minor cracks at the corners of doors and windows in walls. Appeared to be the result of long-term settling. Some settling is not unusual in a home of any age and these cracks are not a structural concern.

Contact a qualified painting contractor.

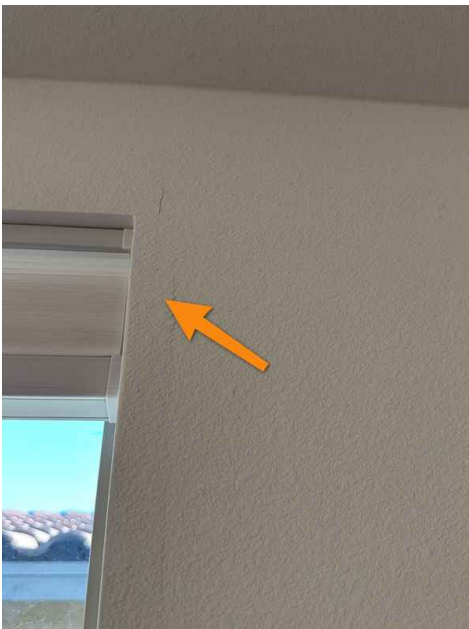
14.4.1 Walls

PAINT CRACKING

Wall paint was cracking in one or more areas. Recommend a qualified painter evaluate and apply a new coat.

Contact a qualified painting contractor.

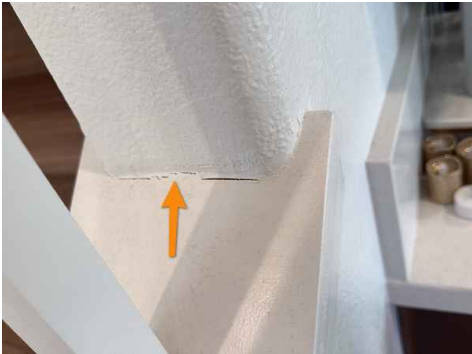
Baluster on 1st Floor

CRACK IN BALUSTER CAULKING

Baluster needs re caulked. Recommend qualified pain contractor.

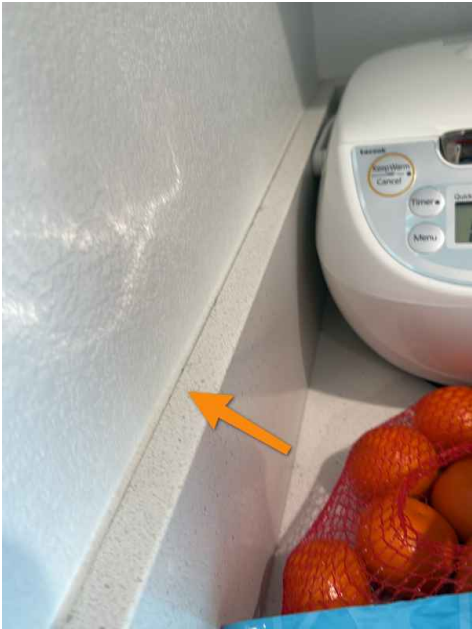
Kitchen

GROUT DETERIORATING

Grout lines were cracked. Recommend a qualified contractor repair or replace grout.
