ALLEGIANCE HOME INSPECTIONS

MANUFACTURED HOME TEMPLATE

2842 Blue Spruce Dr
Hemet, CA 92545

Susan Hall
06/28/2025

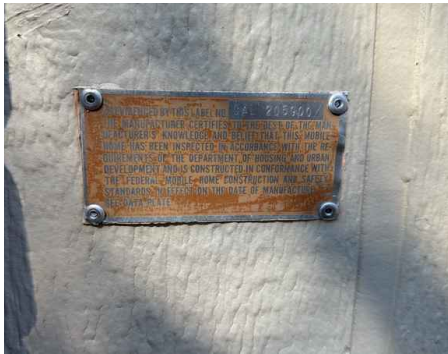
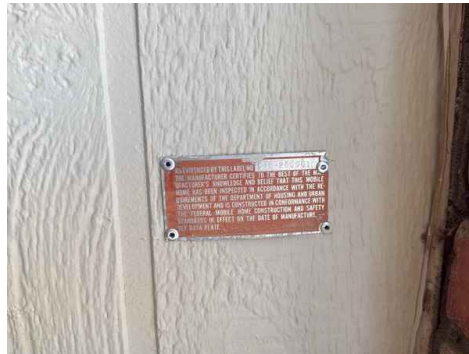
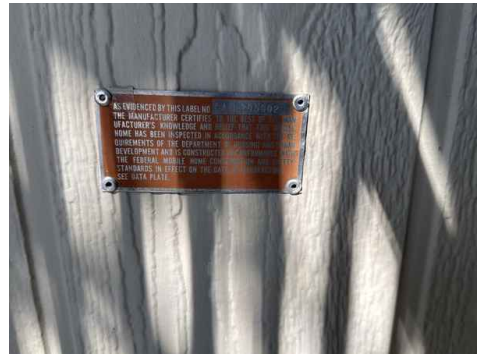
HUD data plate

The Data Plate includes the manufacturer name, serial number model and date of manufacture, as well as wind, rood load and thermal zone maps. If the Data Plate is missing or the Inspector is unable to locate it, the Inspector must report this in the report and is not required to secure the Data Plate information from another source.

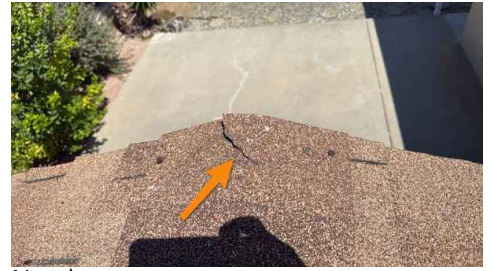
The asphalt composition shingle roof had torn or split shingles which could lead to moisture intrusion. Recommend a qualified roofing contractor repair.

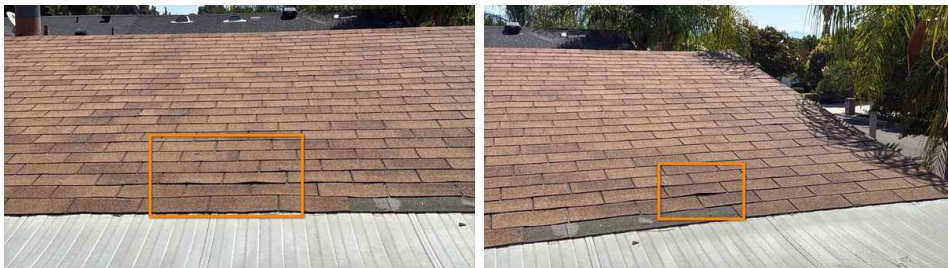
2.1.2 Coverings

Moisture is the most common cause of buckling and curling. It can be the result of moisture absorbed in the roof decking during the roof replacement process prior to the installation of your new roof. Unwanted moisture can cause the decking to shift and the shingles to buckle.

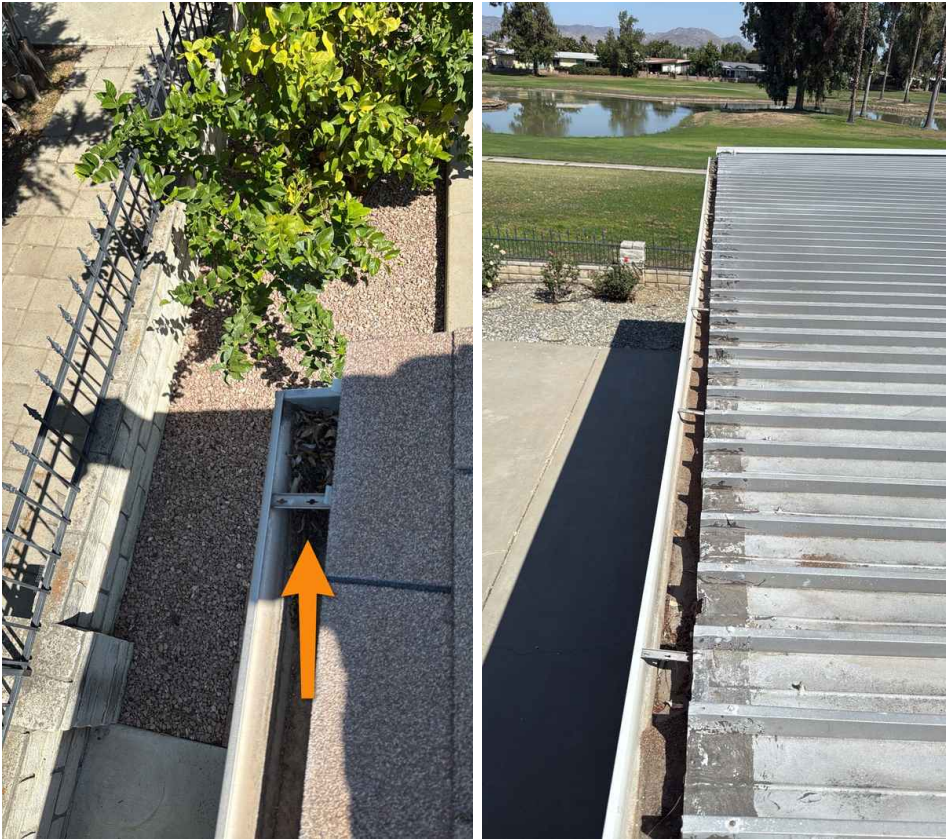
2.2.1 Roof Drainage Systems

DEBRIS

Debris has accumulated in the gutters. Recommend cleaning to facilitate water flow.

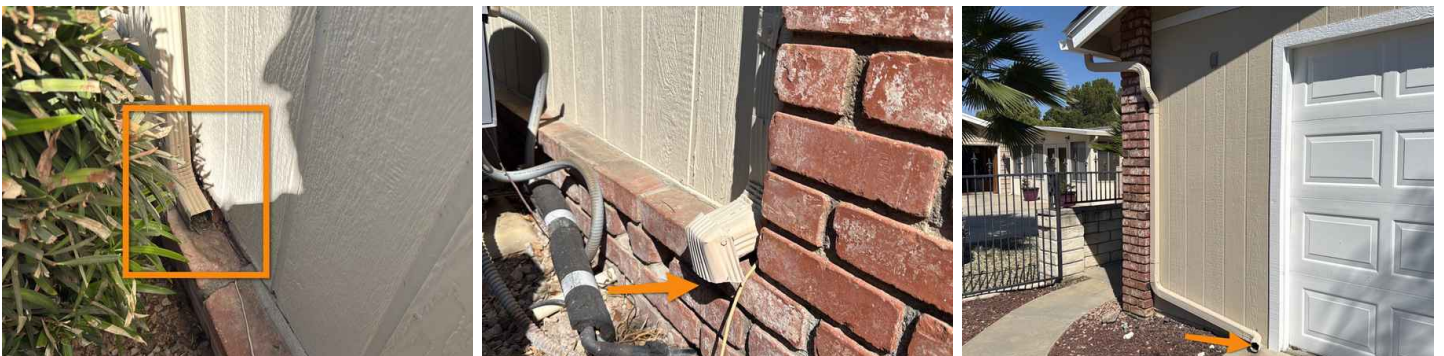
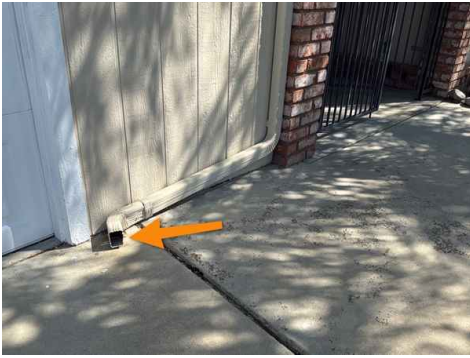
2.2.2 Roof Drainage Systems

DOWNSPOUTS DRAIN NEAR HOUSE

One or more downspouts drain too close to the home's foundation. This can result in excessive moisture in the soil at the foundation, which can lead to foundation/structural movement. Recommend a qualified contractor adjust downspout extensions to drain at least 6 feet from the foundation.

Contact a qualified roofing professional.

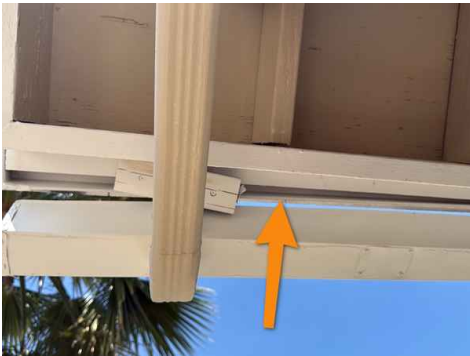
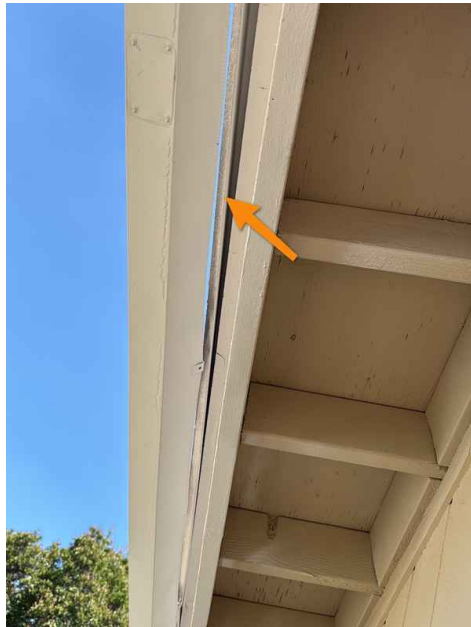
2.2.3 Roof Drainage Systems

GUTTER LOOSE

The gutter(s) is loose and needs to be re-fastened to fascia and pitched properly.

Contact a qualified handyman.

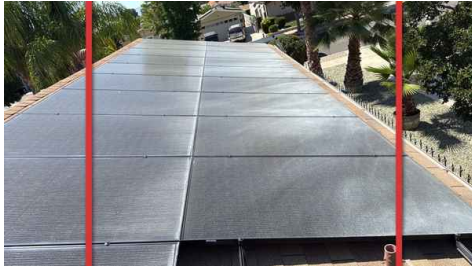
West

2.5.1 Solor panels

Contact a qualified solar panel contractor.

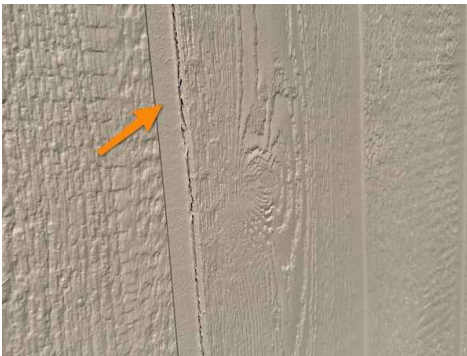
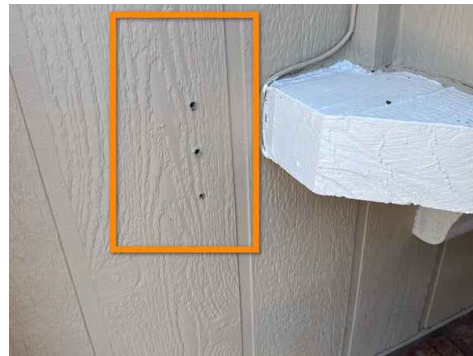
CRACKING - MINOR

Siding showed cracking in one or more places. This is a result of temperature changes, and typical as homes with age. Recommend sealing.

Recommended DIY Project

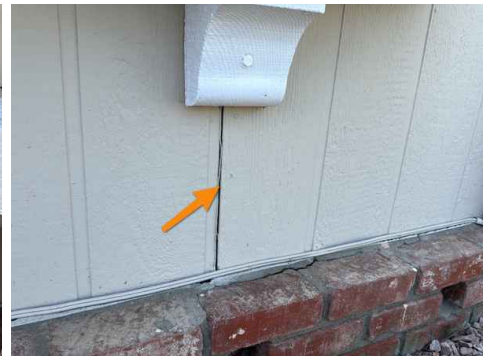
North

3.2.1 Siding, Flashing & Trim

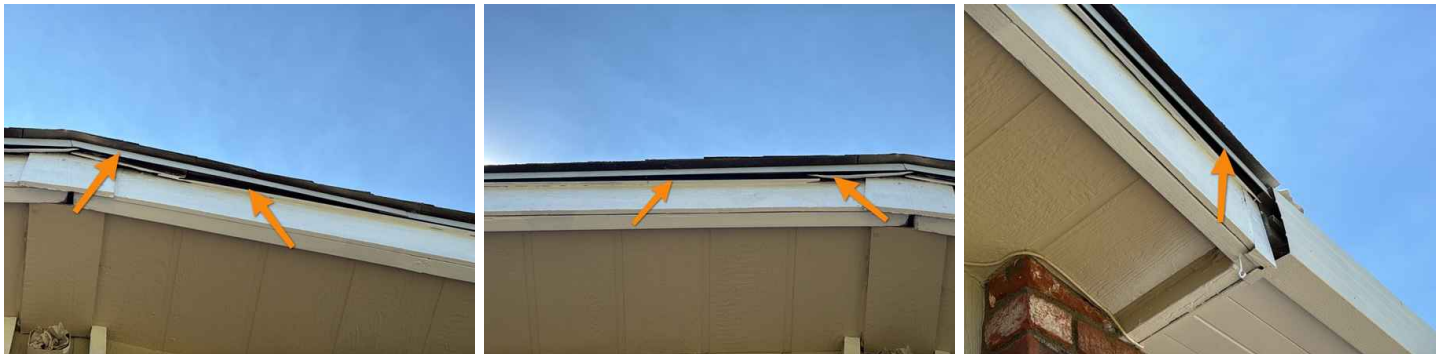
3.2.2 Siding, Flashing & Trim

FLASHING/TRIM IMPROPERLY INSTALLED

Flashing & trim pieces were improperly installed, which could result in moisture intrusion and damaging leaks. Recommend a qualified siding contractor evaluate and repair.

Contact a qualified professional.

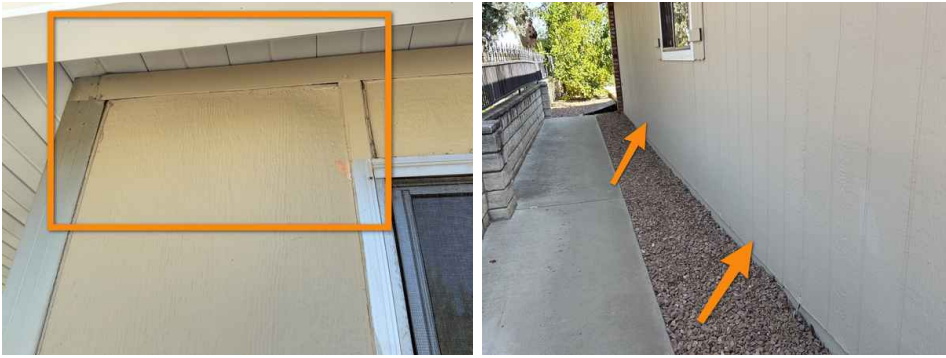
3.2.3 Siding, Flashing & Trim

WARPING/BUCKLING

Vinyl siding was warping or buckling in areas. This is often as a result of nailing siding boards too tight to the home, preventing expansion/contraction. Recommend a qualified siding contractor evaluate and repair.

Contact a qualified professional.

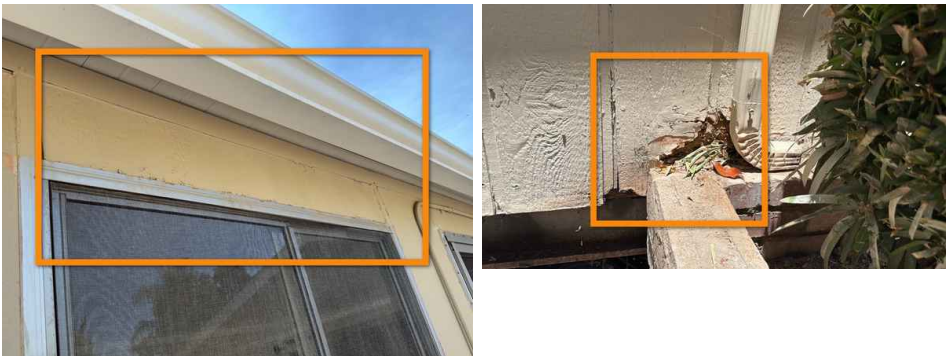
3.2.4 Siding, Flashing & Trim

WOOD ROT

Wood rot on house siding can lead to serious structural and health issues if left unaddressed. It weakens the siding, making it susceptible to further damage from weather and pests, and can also create a breeding ground for mold and mildew, impacting indoor air quality

Contact a qualified siding specialist.

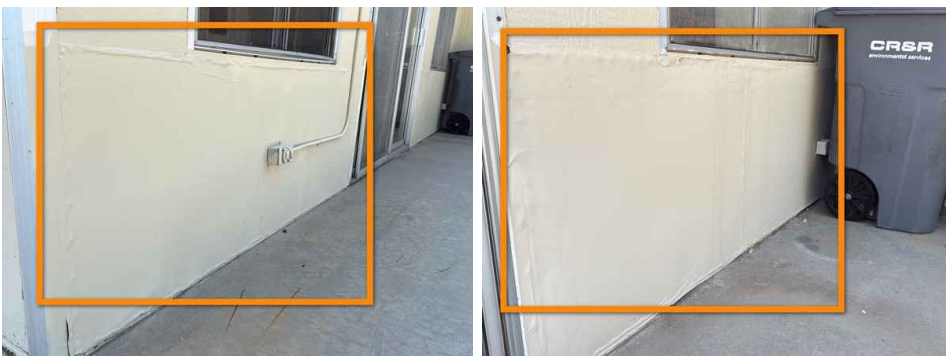
3.2.5 Siding, Flashing & Trim

REPLACED SIDING

Recommend asking seller if there were past repairs.

Contact the seller for more info

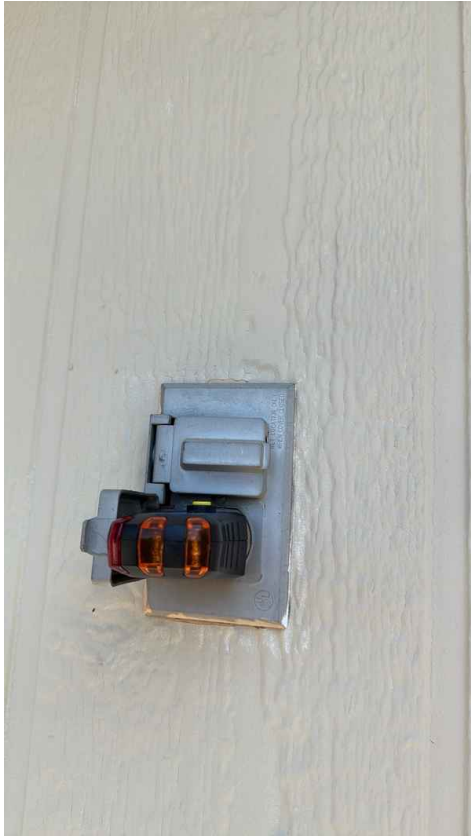
3.4.1 GFCI & AFCI

NO GFCI PROTECTION INSTALLED

No GFCI protection present in all locations. Recommend licensed electrician upgrade by installing ground fault receptacles in all locations.

Contact a qualified electrical contractor.

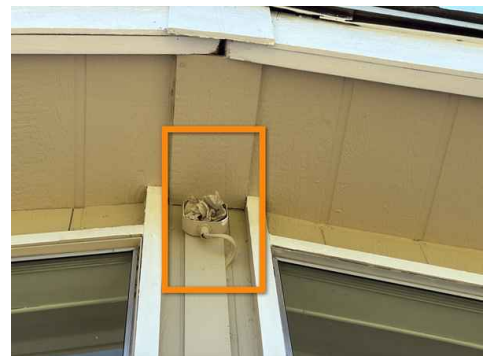
3.4.2 GFCI & AFCI

MISSING COVER PLATE

Recommend adding cover plate

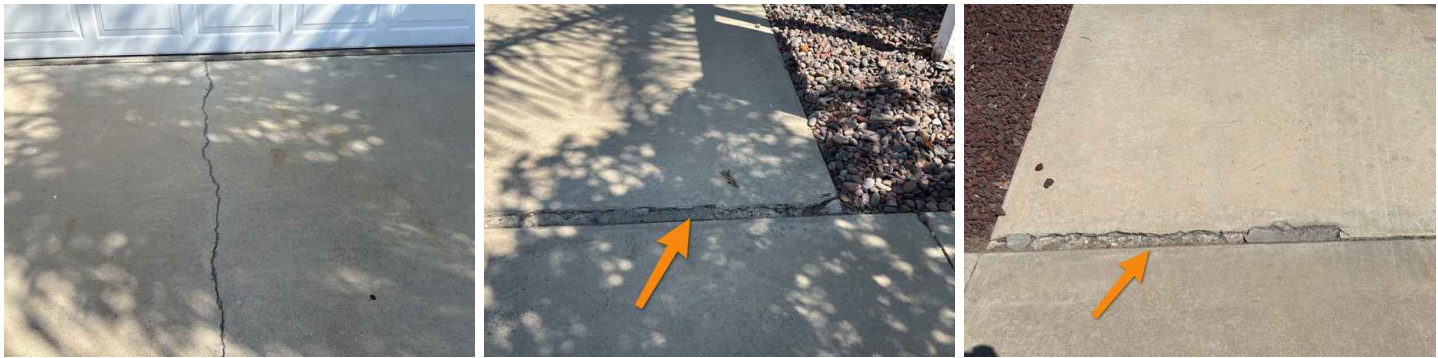
3.5.1 Walkways, Patios & Driveways

DRIVEWAY CRACKING - MAJOR

Major cracks observed. Recommend concrete contractor evaluate and replace.

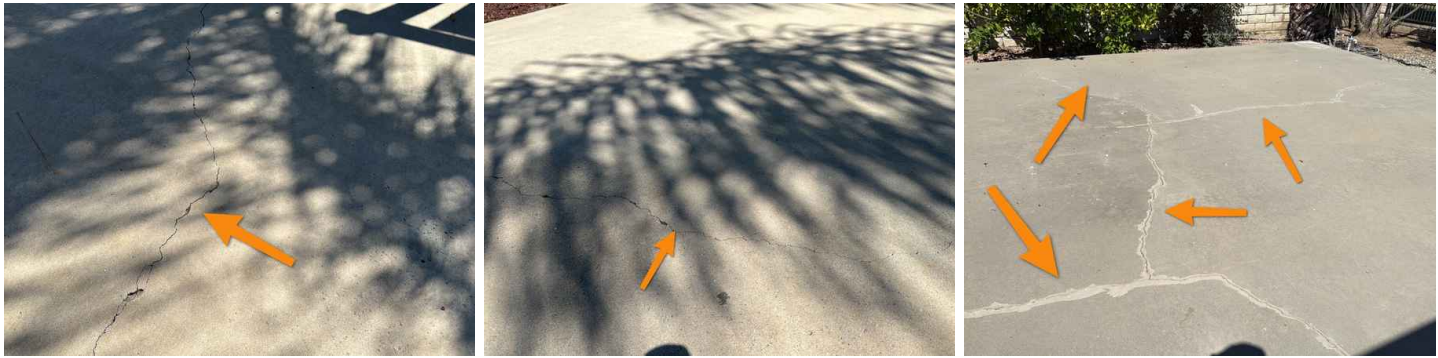
3.5.2 Walkways, Patios & Driveways

DRIVEWAY CRACKING - MINOR

Minor cosmetic cracks observed, which may indicate movement in the soil. Recommend monitor and/or have concrete contractor patch/seal.

Contact a qualified concrete contractor.

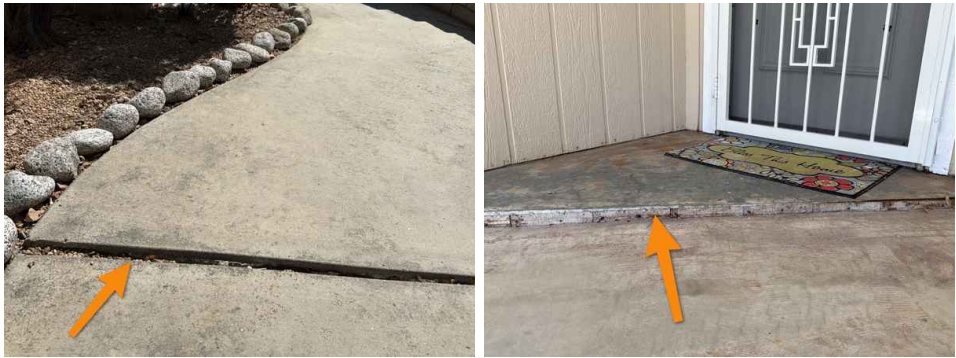
3.5.3 Walkways, Patios & Driveways

DRIVEWAY AND/OR WALKWAY TRIP HAZARD

Trip hazards observed. Patch or repair recommended.

Recommended DIY Project

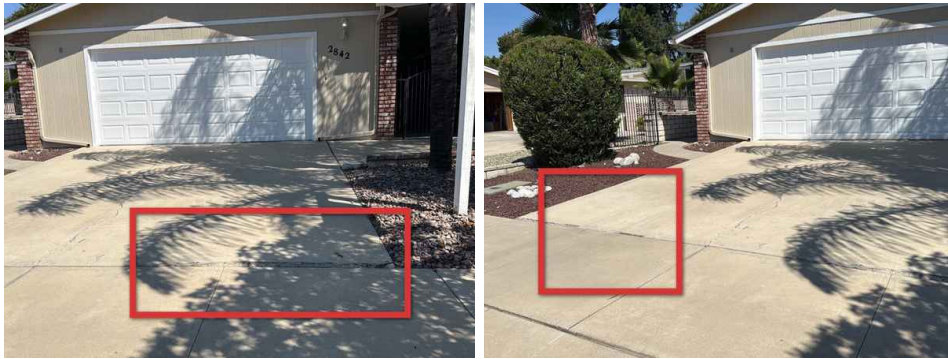
3.5.4 Walkways, Patios & Driveways

Rain can cause a driveway to heave, particularly during freeze-thaw cycles, due to water seeping into the soil and expanding when frozen. This expansion can push the driveway upward, creating cracks and uneven surfaces. Proper drainage is crucial to prevent this issue

Contact a qualified driveway contractor.

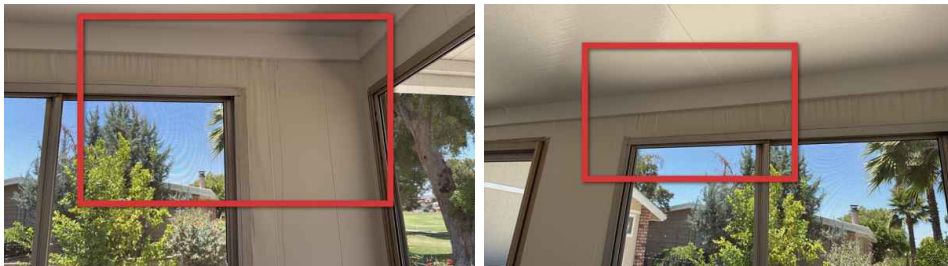
3.6.1 Decks, Balconies, Porches, Sun Room and Steps

WOOD ROT

Wood rot on house siding can lead to serious structural and health issues if left unaddressed. It weakens the siding, making it susceptible to further damage from weather and pests, and can also create a breeding ground for mold and mildew, impacting indoor air quality

Contact a qualified professional.

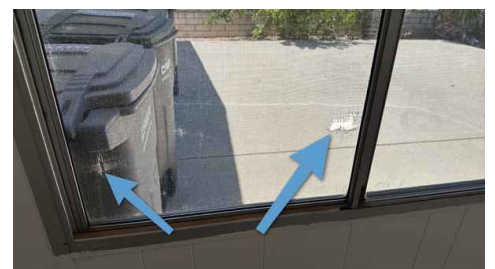
DAMAGED SCREEN

Recommend replacing

Contact a handyman or DIY project

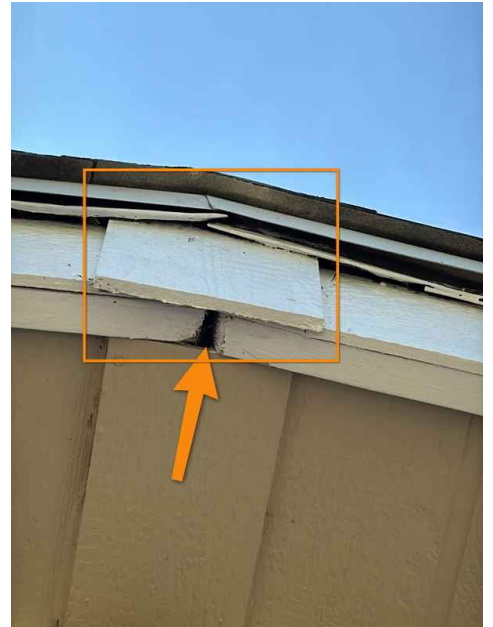
3.7.1 Eaves, Soffits & Fascia

EAVES - DAMAGED

One or more sections of the eaves are damaged. Recommend qualified roofer evaluate & repair.

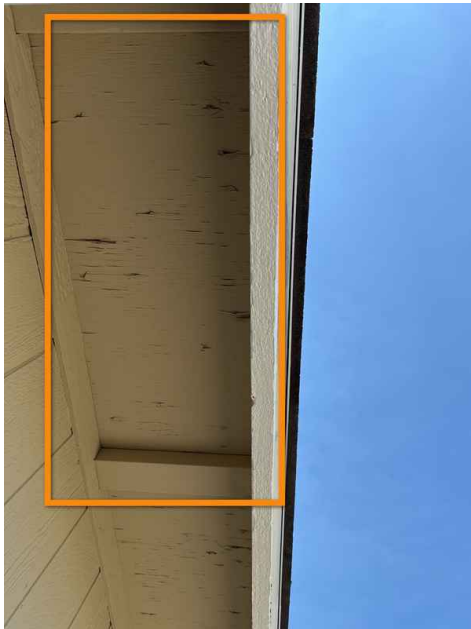
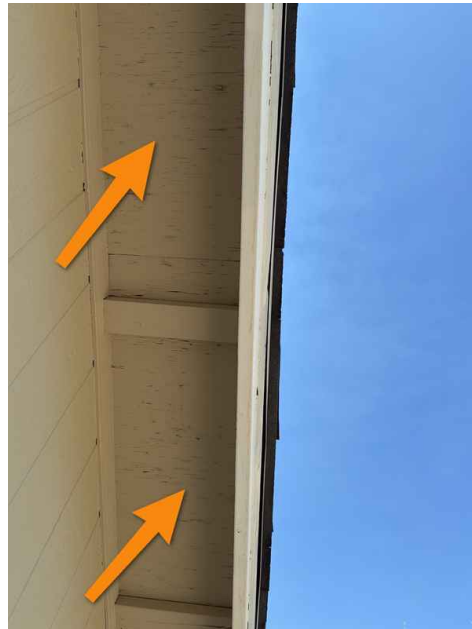
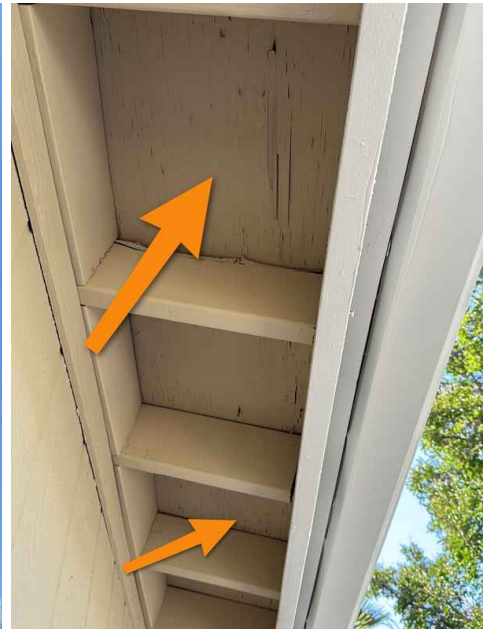
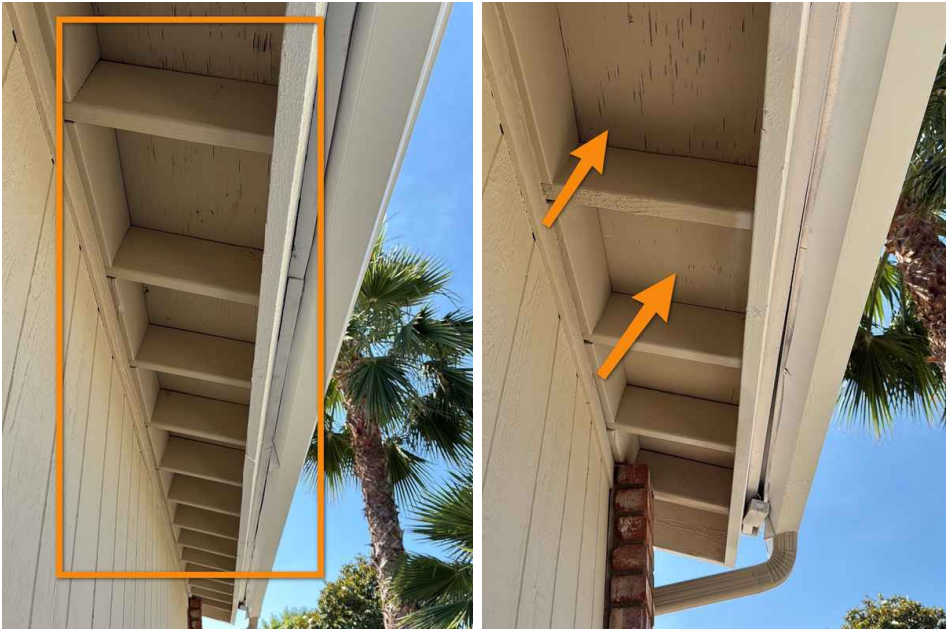
3.7.2 Eaves, Soffits & Fascia

PAINT/FINISH FAILING

The paint or finish is failing. This can lead to deterioration and rot of the material. Recommend that the areas be properly prepared and painted / finished.

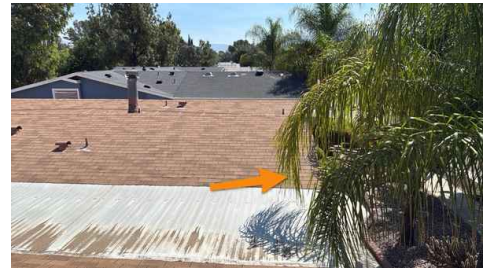
3.8.1 Vegetation, Grading, Drainage & Retaining Walls

Repair Needed**TREE OVERHANG**

Trees observed overhanging the roof. This can cause damage to the roof and prevent proper drainage. Recommend a qualified tree service trim to allow for proper drainage.

Contact a qualified tree service company.

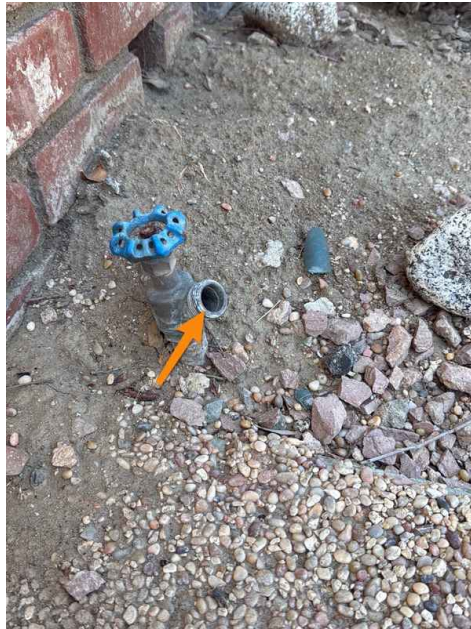
3.9.1 Hose bibs and water pressure

Repair Needed**MISSING BACKFLOW DEVICE**

Typically backflow device required to protect the portable water supply from contamination. Recommend qualified plumbing contractor to evaluate and correct.

Contact a handyman or DIY project

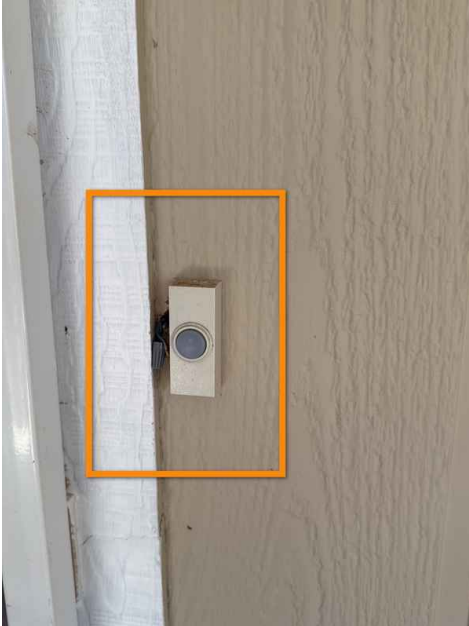
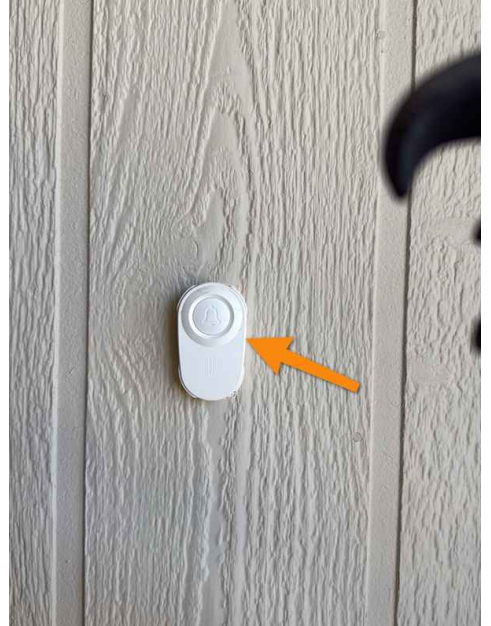
3.10.1 Doorbell

DOORBELL INOPERABLE

Recommend replacing

Contact a handyman or DIY project

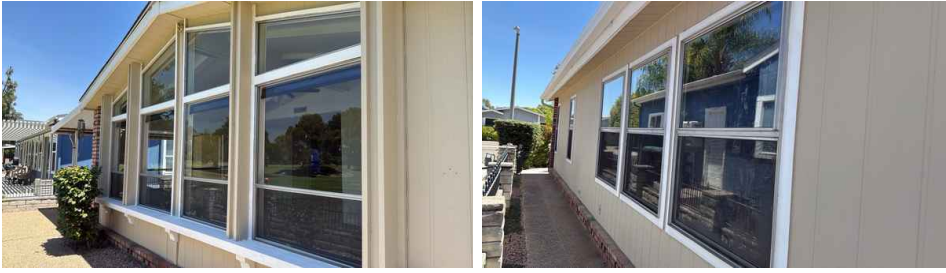
3.11.1 Windows

ALL WINDOWS

Be advised that all windows are original and are single pain. Single-pane windows have several common issues including poor energy efficiency, difficulty maintaining indoor temperatures, noise infiltration, and condensation problems. They also tend to be less durable and can be more prone to breakage.

Contact a qualified window repair/installation contractor.

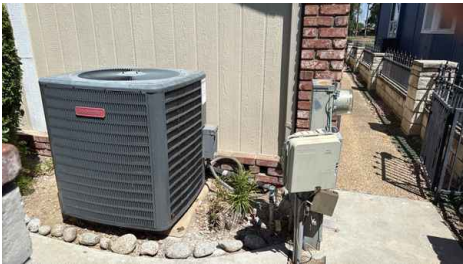
Cooling Equipment: Energy Source/Type
Electric, Central Air Conditioner

Cooling Equipment: Location
Exterior South

Cooling Equipment: Manufactured date
10/19

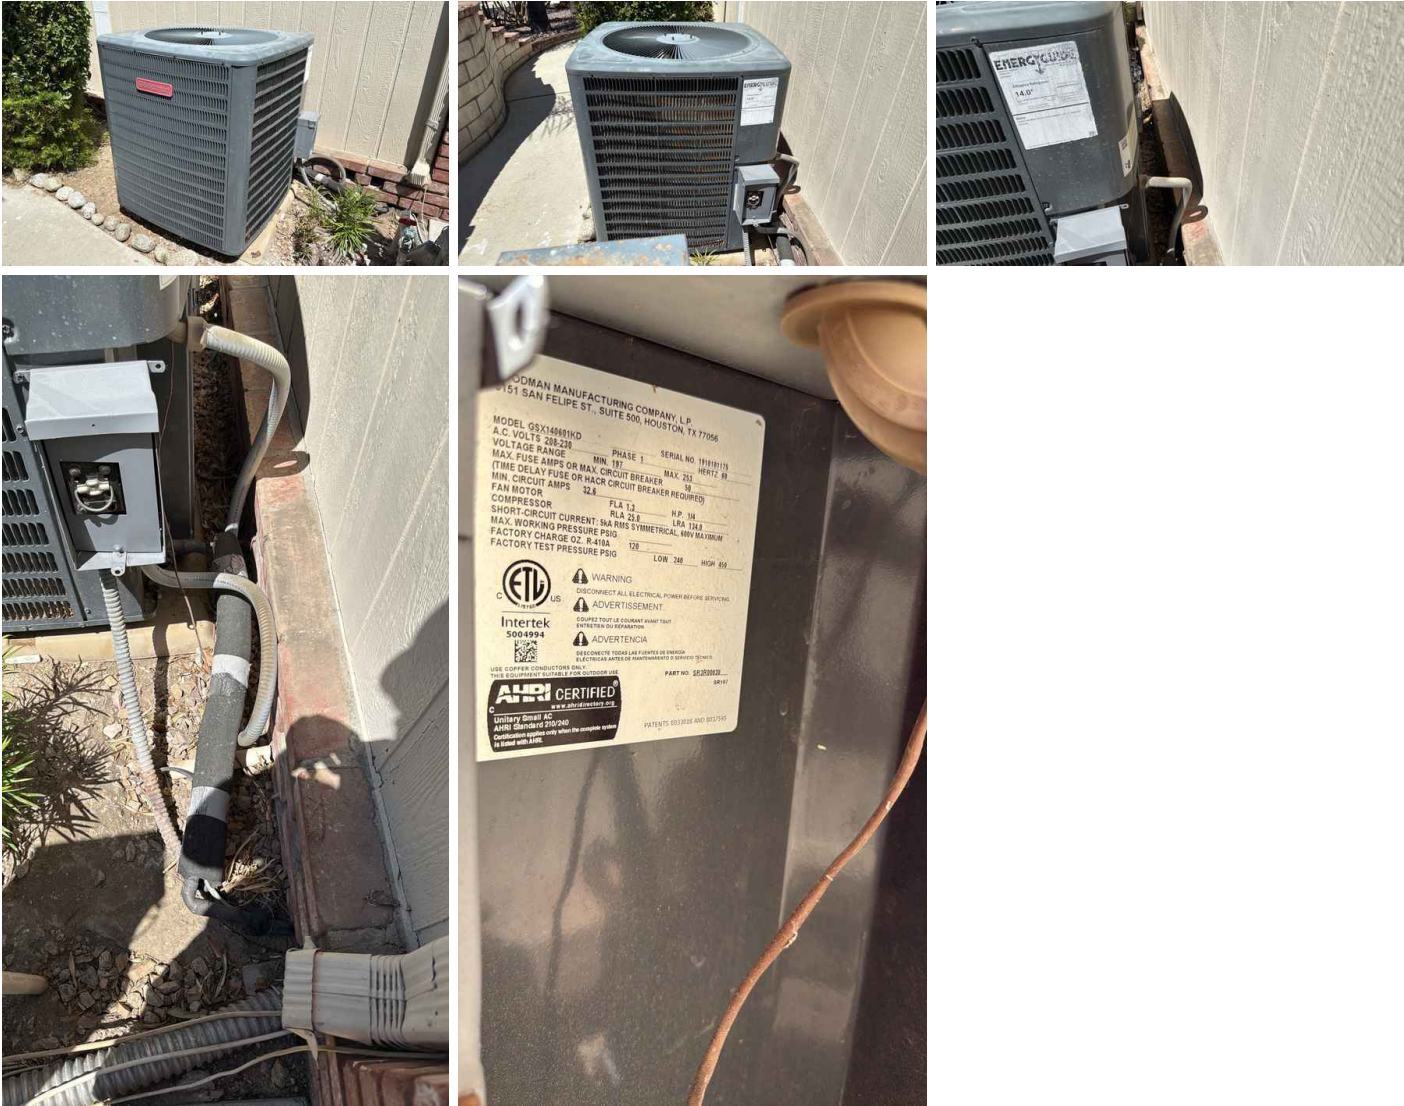
Cooling Equipment: Brand Goodman

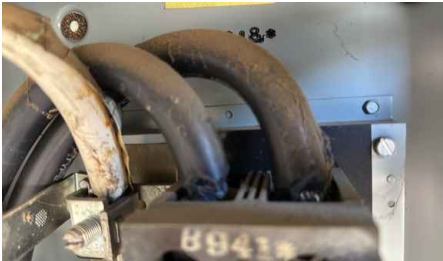
Service Entrance Conductors:
Electrical Service Conductors
Below Ground, Aluminum

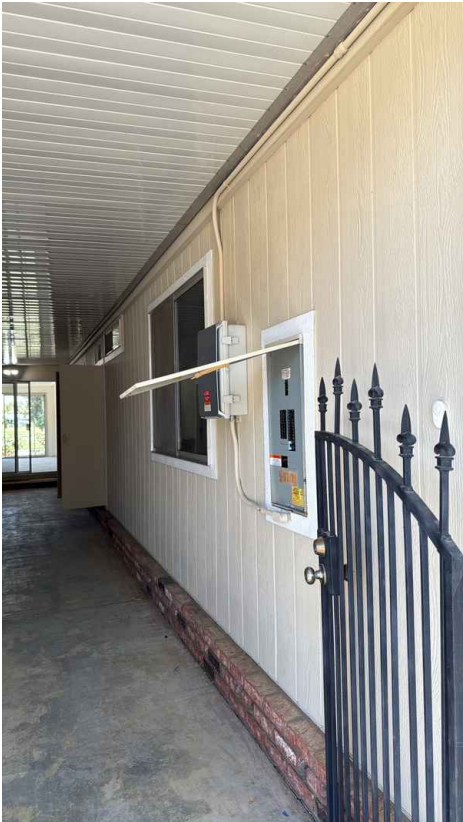
Main & Subpanels, Service & Grounding, Main Overcurrent Device: Main Panel Location
Entryway to garage

Main & Subpanels, Service & Grounding, Main Overcurrent Device: Panel Capacity
200 AMP

Main & Subpanels, Service & Grounding, Main Overcurrent Device: Panel Manufacturer
General Electric

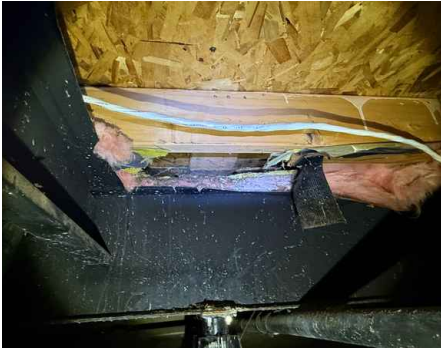
Floor Structure: Sub-floor
OSB

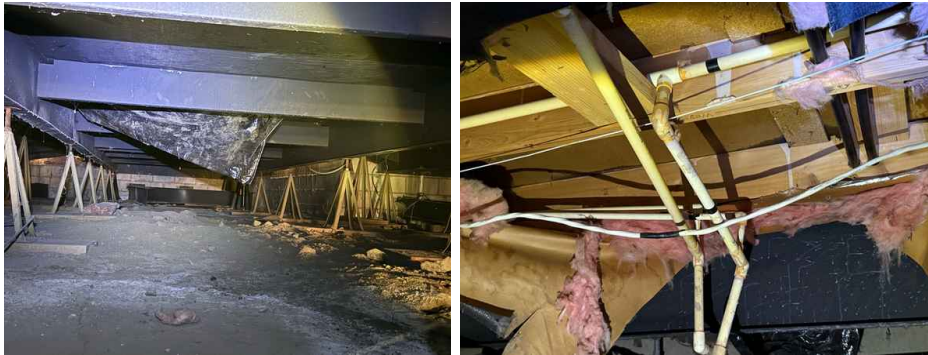
Floor Structure: Material
Steel I-Beams, Wood Beams

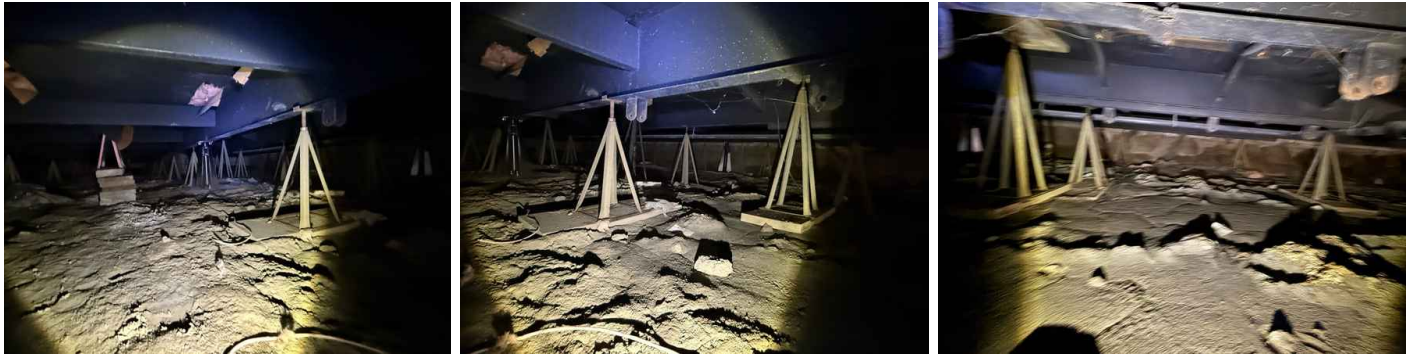
Floor Structure: Basement/Crawlspace Floor
Dirt

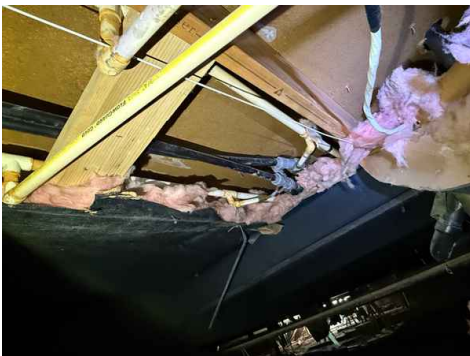
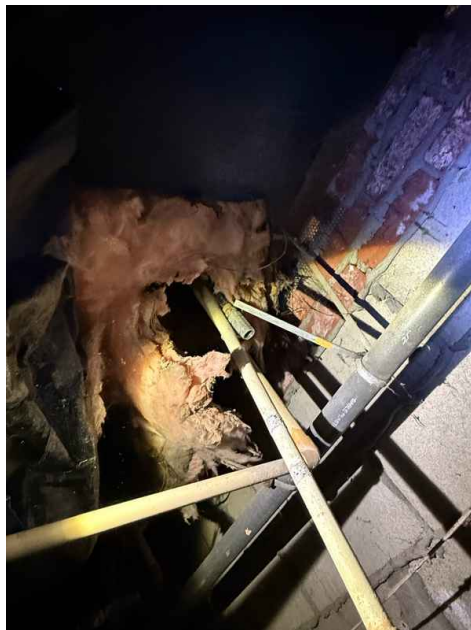
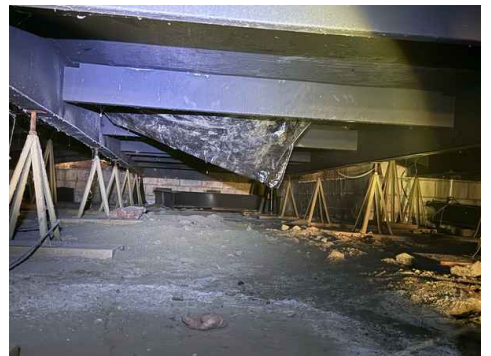
VAPOR BARRIER DAMAGED

Vapor barrier is damaged in one or more areas. Recommend insulation contractor repair or replace.

Contact a qualified insulation contractor.

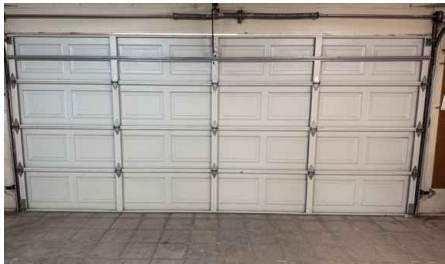
Garage Door: Material
Aluminum

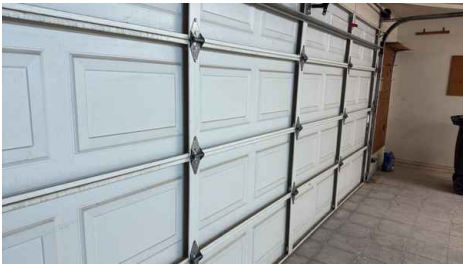
Garage Door: Type
Sectional

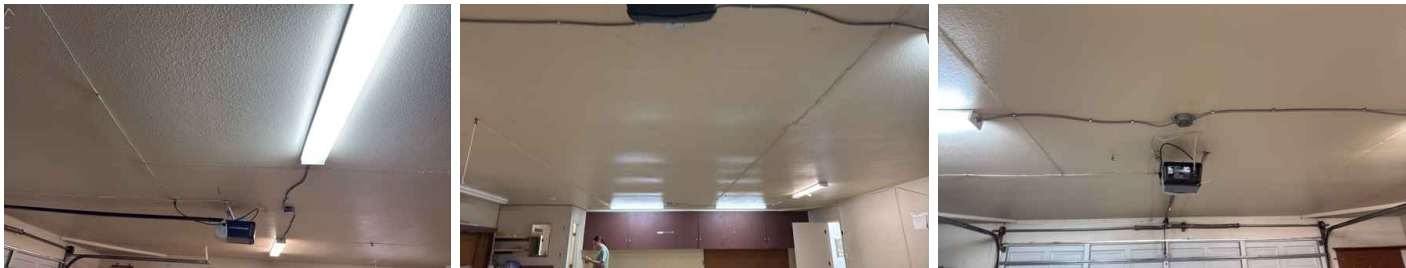
Ceiling: Pictures

7.1.1 Ceiling
CRACKING DRYWALL AT SEAMS
Recommend patching and repainting
Recommendation
Contact a handyman or DIY project

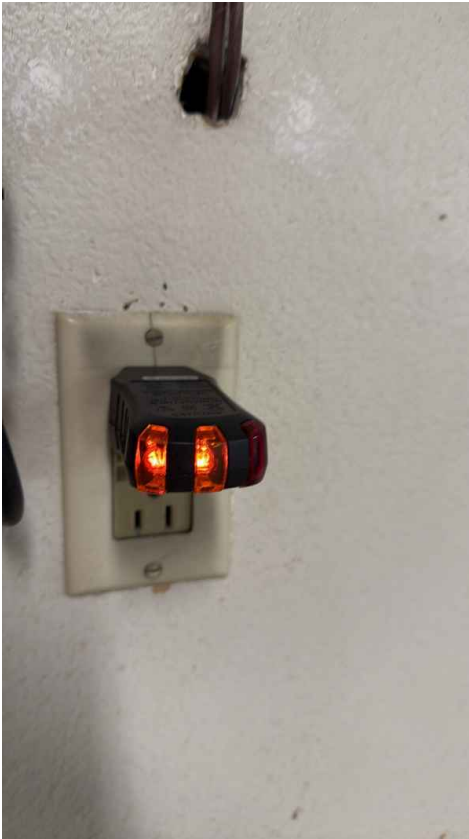
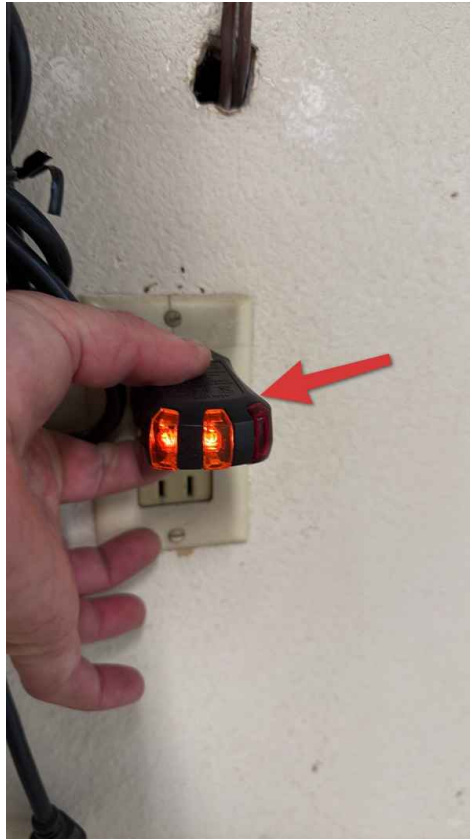
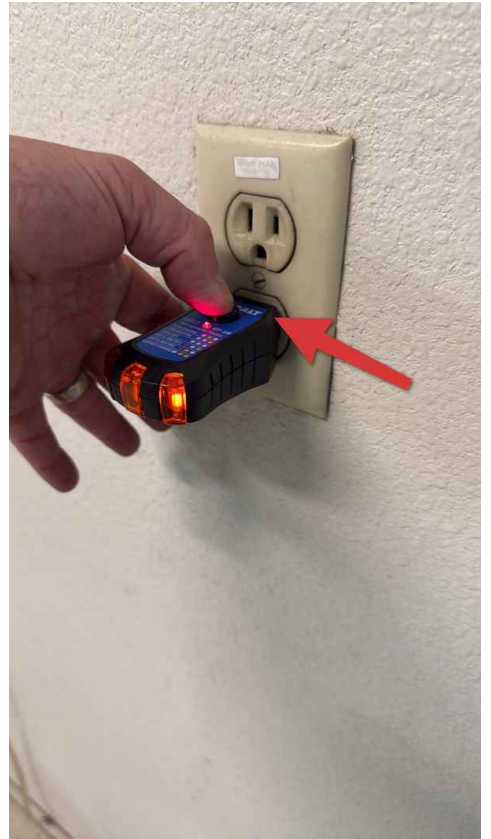
7.3.1 GFCI & AFCI

GFCI INOPERABLE

GFCI Inoperable recommend qualified electrician to replace.

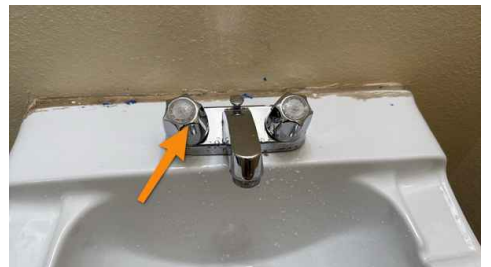
7.8.1 Bathroom

BATHROOM FIXTURE HOT WATER VALVE INOPERABLE

Recommend qualified plumber to evaluate repair and/or replace

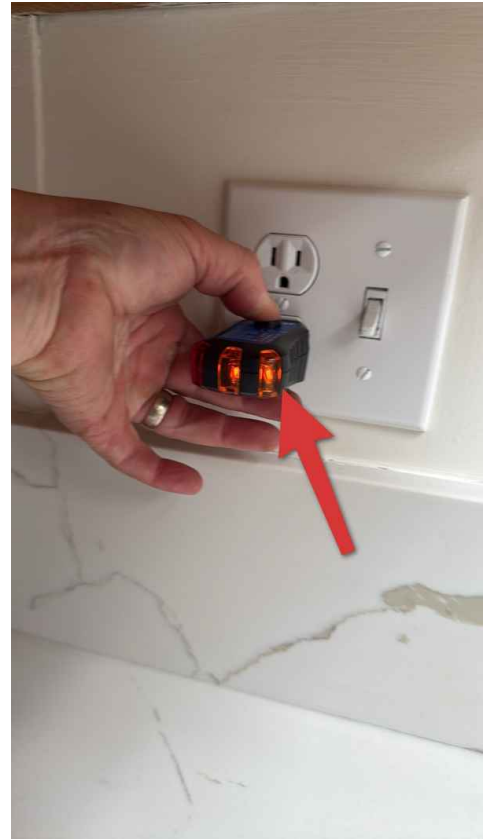
No GFCI protection present in all locations. Recommend licensed electrician upgrade by installing ground fault receptacles in all locations.

Contact a qualified electrical contractor.

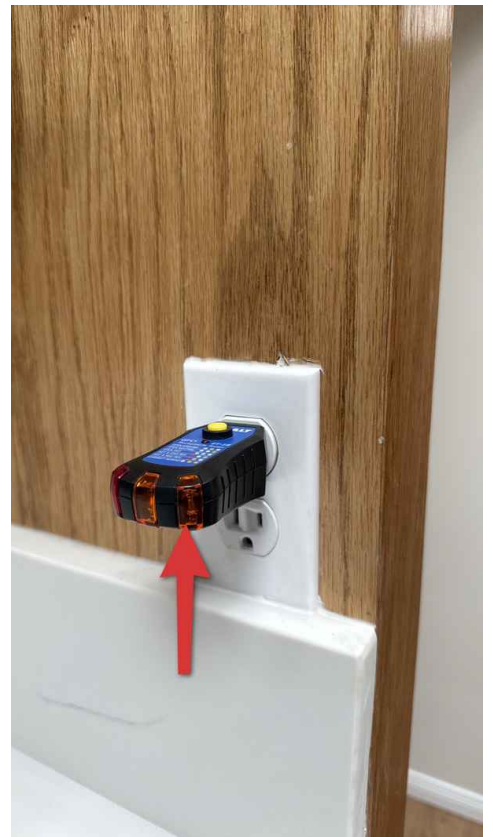
8.2.2 GFCI & AFCI

HOT AND NEUTRAL REVERSED

Reversing the hot and neutral wires in an electrical outlet, also known as reversed polarity, can create dangerous shock and fire hazards. While electronic devices might still function, the reversed polarity can lead to a number of problems, including electric shock, short circuits, and potential fires.

Contact a qualified electrical contractor.

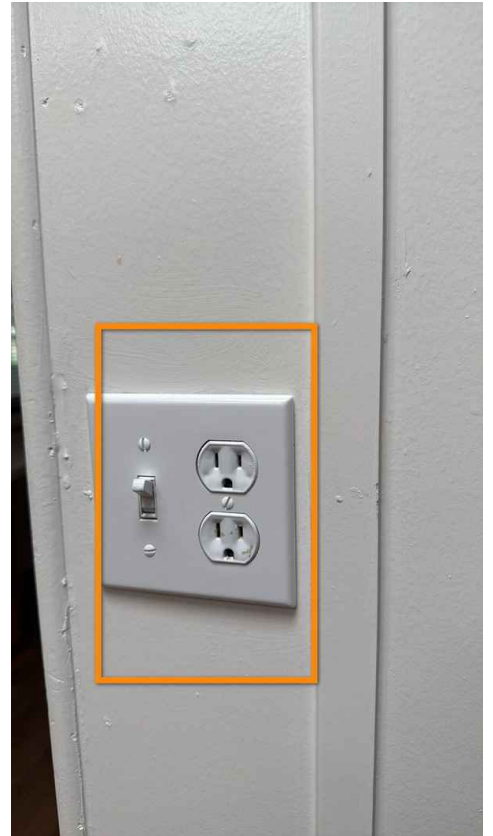
8.2.3 GFCI & AFCI

ELECTRICAL BOX LOOSE

Recommend securing box.

Contact a qualified electrical contractor.

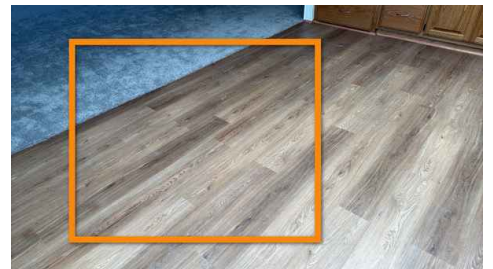
8.7.1 Floors

CREAKING FLOORS

Creaking floors in a manufactured home can be caused by a variety of factors, including issues with the subfloor, joists, or even the flooring material itself. Common causes include loose or undersized fasteners, wood expansion and contraction due to moisture, or shifting of the foundation. Addressing creaking floors often involves identifying the source of the noise and then employing methods like tightening screws, adding blocking between joists, or even potentially addressing foundation issues

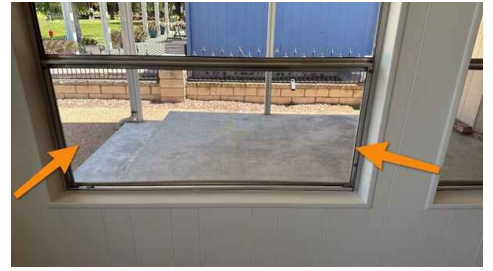
Window slide locks inoperable, recommend qualified window contractor to evaluate repair or replace

Contact a qualified window repair/installation contractor.

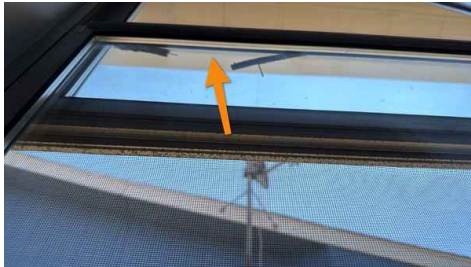
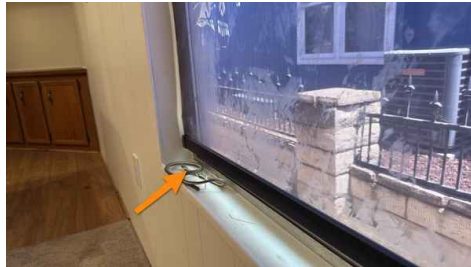
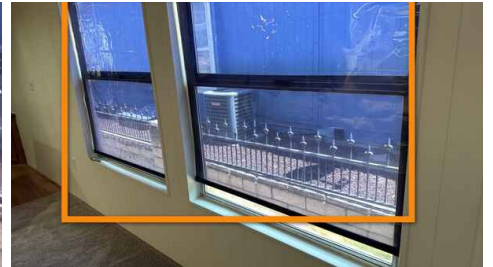
FAILED WEATHER STRIPPING

Failed window weatherstripping, recommend qualified window contractor to repair or replace

Contact a qualified window repair/installation contractor.

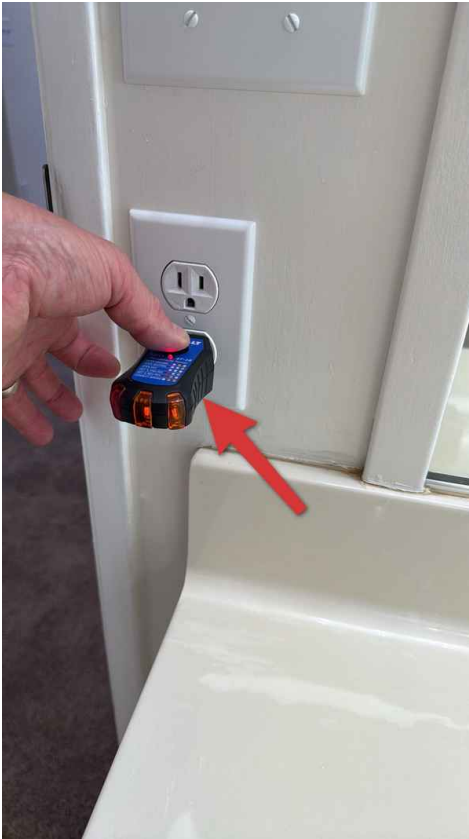
11.3.1 GFCI & AFCI

No GFCI protection present in all locations. Recommend licensed electrician upgrade by installing ground fault receptacles in all locations.

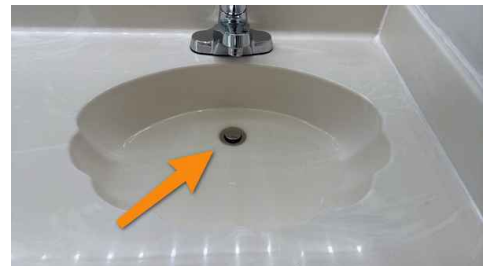
11.4.1 Water Supply, Distribution Systems & Fixtures

Repair Needed**SLOW DRAINING DRAIN**

Slow draining drain, recommend diy or handyman to evaluate and correct

Contact a handyman or DIY project

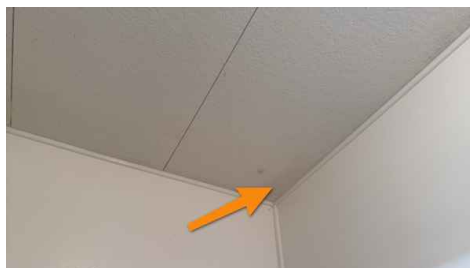
11.6.1 Ceiling

WATER STAINS ON CEILING

Stain on ceiling possibly from moisture accumulation, recommend monitoring

Recommend monitoring.

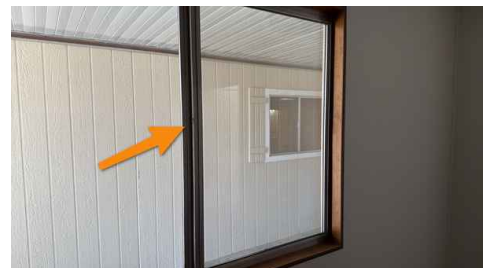
12.3.1 Windows

MISSING WINDOW HANDLE

Missing window handle window will not open, recommend qualified window contractor to evaluate repair or replace

Recommendation

Contact a qualified window repair/installation contractor.

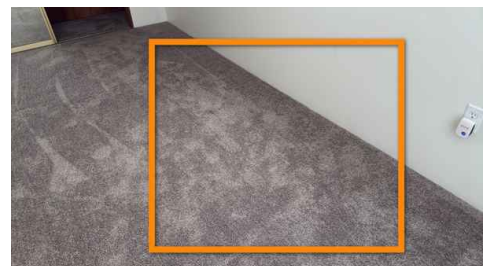
12.4.1 Floors

Creaking floors in a manufactured home can be caused by a variety of factors, including issues with the subfloor, joists, or even the flooring material itself. Common causes include loose or undersized fasteners, wood expansion and contraction due to moisture, or shifting of the foundation. Addressing creaking floors often involves identifying the source of the noise and then employing methods like tightening screws, adding blocking between joists, or even potentially addressing foundation issues

Recommendation

Contact a qualified professional.

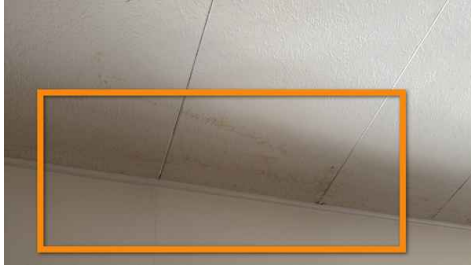
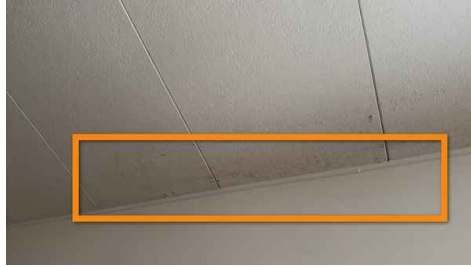
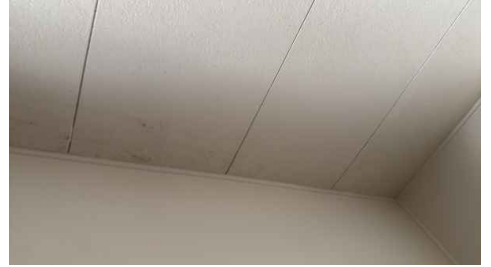
STAIN(S) ON CEILING

There is a stain on ceiling/wall that requires repair and paint. Source of staining should be determined.

Recommendation

Contact a qualified professional.

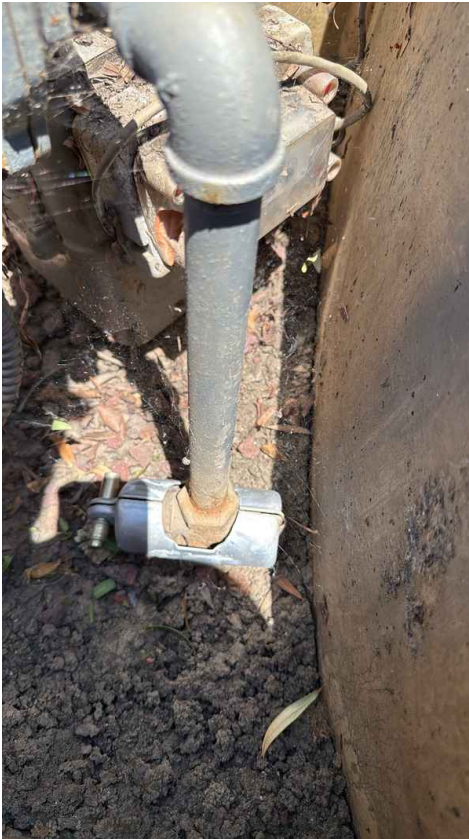
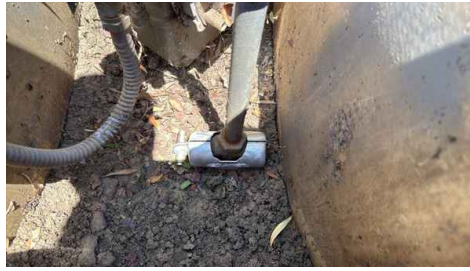
GAS SHUT OFF

GAS TURNED OFF AT MAIN UNABLE TO TEST.

Gas was off at the main. Recommend local utility company turn on and check all gas appliances prior to deadlines.
