ALLEGIANCE HOME INSPECTIONS

MANUFACTURED HOME TEMPLATE

2842 Blue Spruce Dr
Hemet, CA 92545

Susan Hall
06/28/2025

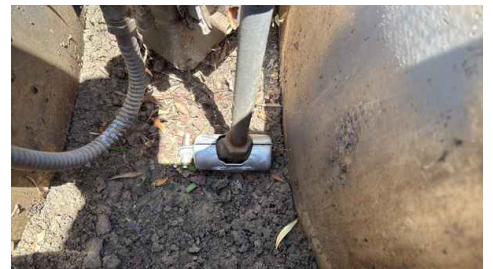
14.4.1 Hot Water Systems, Controls, Flues & Vents

No expansion tank was present. Expansion tanks allow for the thermal expansion of water in the pipes. These are required in certain areas for new installs. Recommend a qualified plumber evaluate and install.

Contact a qualified plumbing contractor.

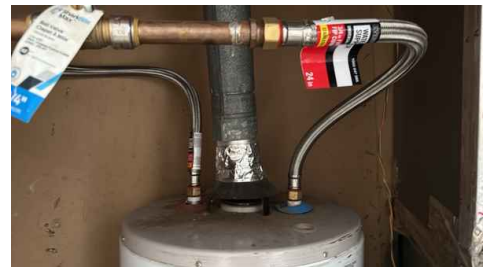
14.4.2 Hot Water Systems, Controls, Flues & Vents

Water heater sloped to the right, recommend qualified plumber to evaluate and correct

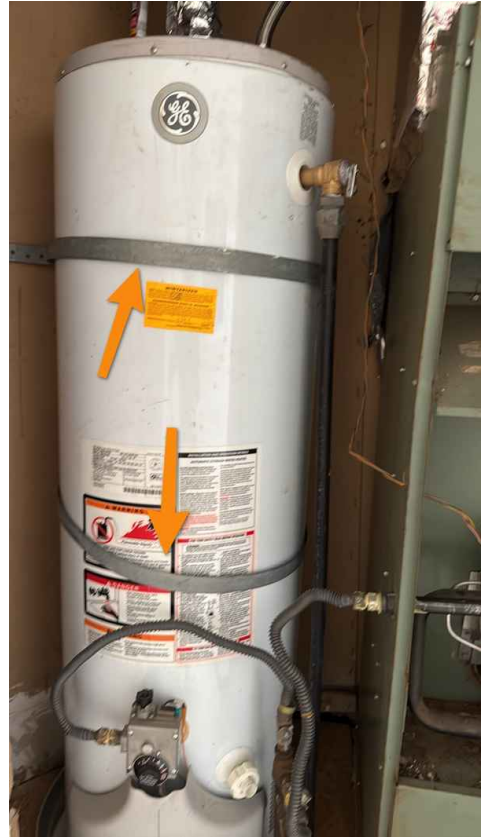
14.4.3 Hot Water Systems, Controls, Flues & Vents

Earthquake strapping is loose recommend tightening

Contact a qualified plumbing contractor.

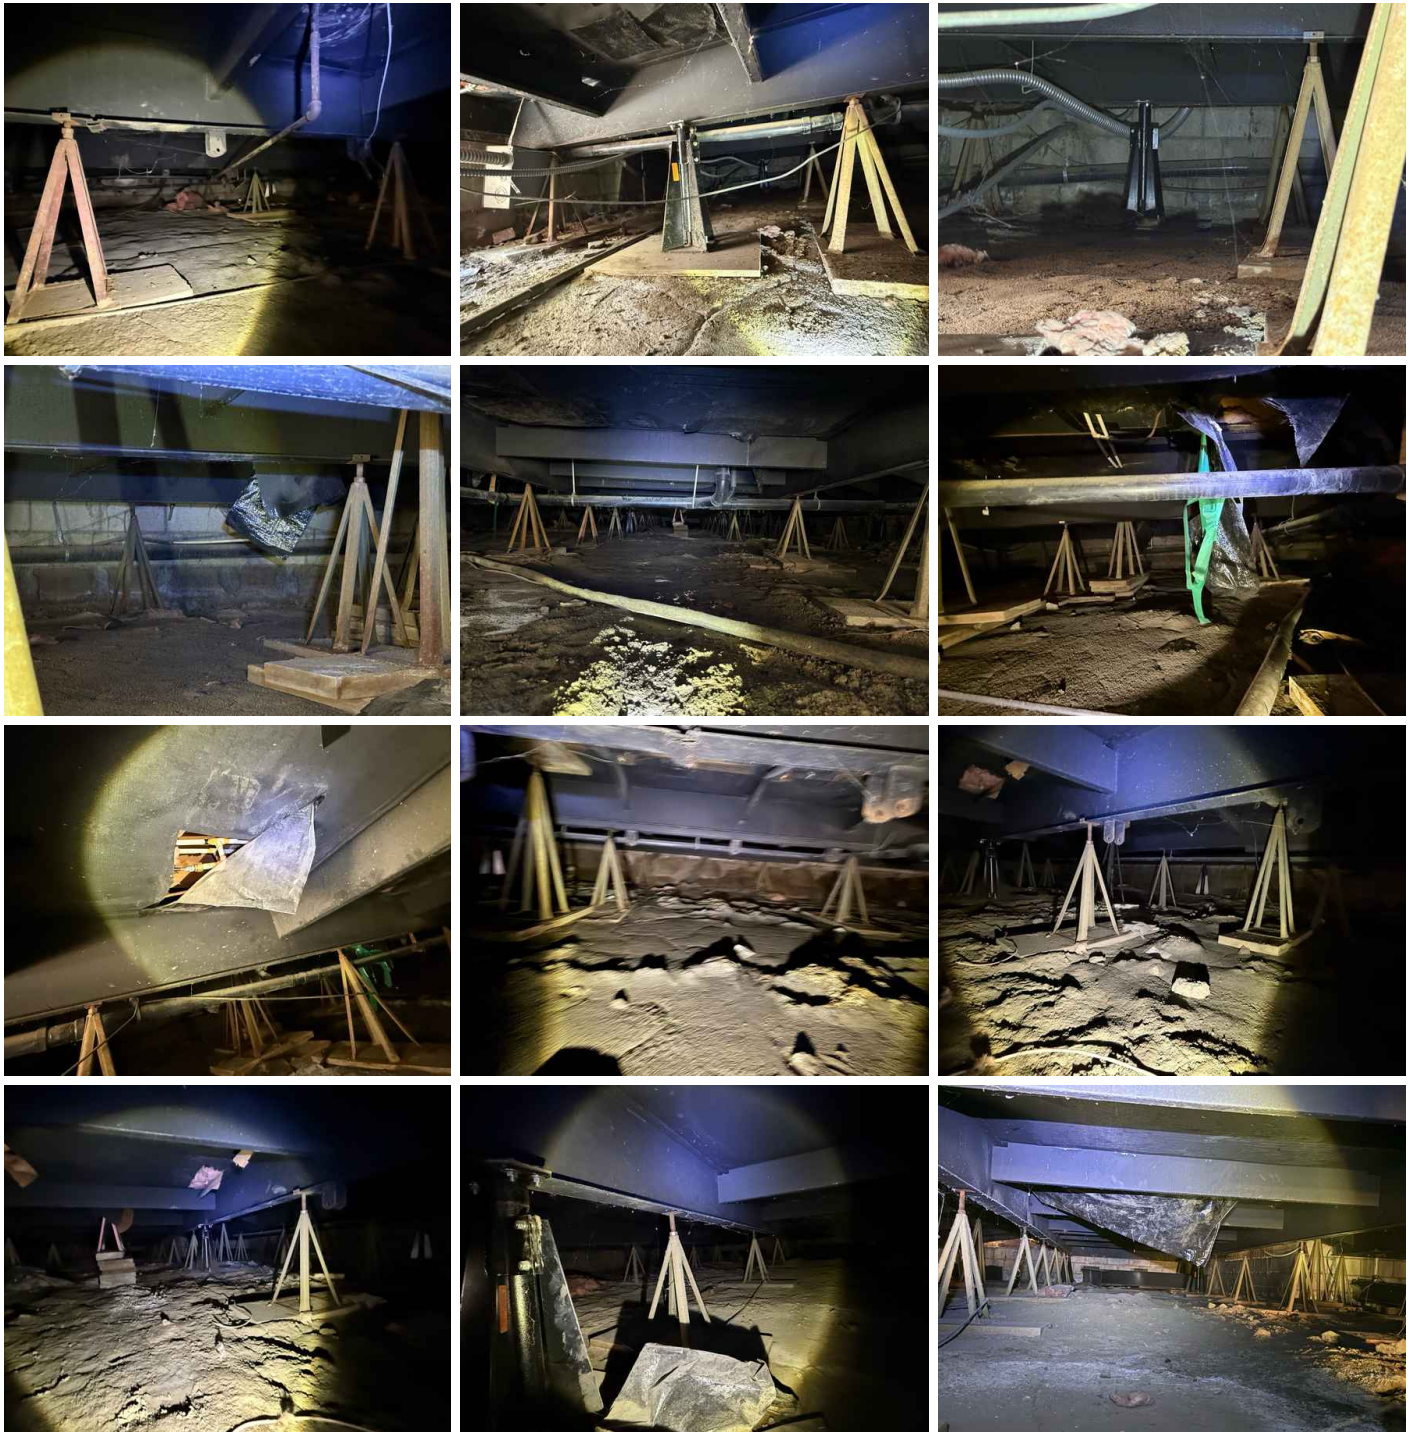
Are the masonry piers in contact with the steel frame?

Masonry piers are used to support the weight of the manufactured home. Those piers that are not in contact with the frame are not contributing to the support of the home and can cause excessive deflection in the beams, which can ultimately lead to structural damage. Contact a certified installer to correct any loose or non-supporting piers.

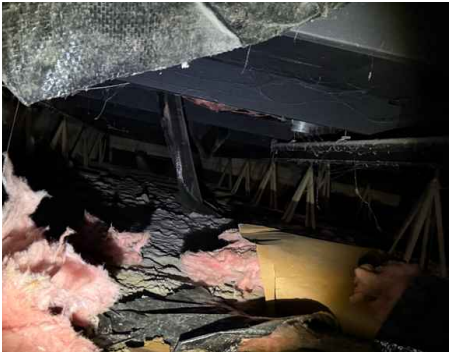
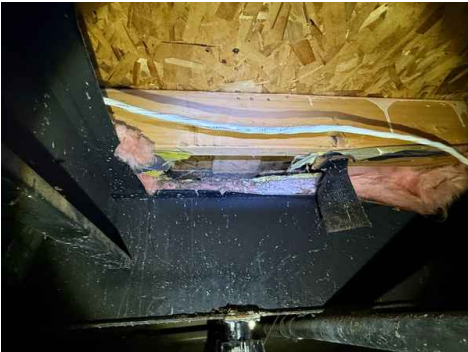
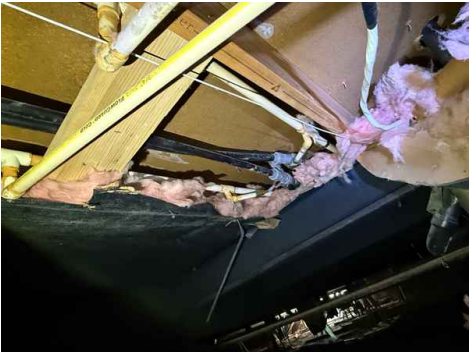
17.1.1 Crawlspace Insulation and Vapor Barrier

DAMAGED INSULATION AND VAPOR BARRIER

Insulation and Vapor Barrier appears to have been pulled out and/or damaged in various locations by contractor. Recommend a qualified insulation contractor evaluate and repair.
