COMMERCIAL WINDSTORM MITIGATION INSPECTION REPORT (OIR-B1-1802)

Banana Bay Condominium

200 Banana River Blvd S, Building 1800, Units 1801-1804
Cocoa Beach, FL 32931

As of 5/20/2022

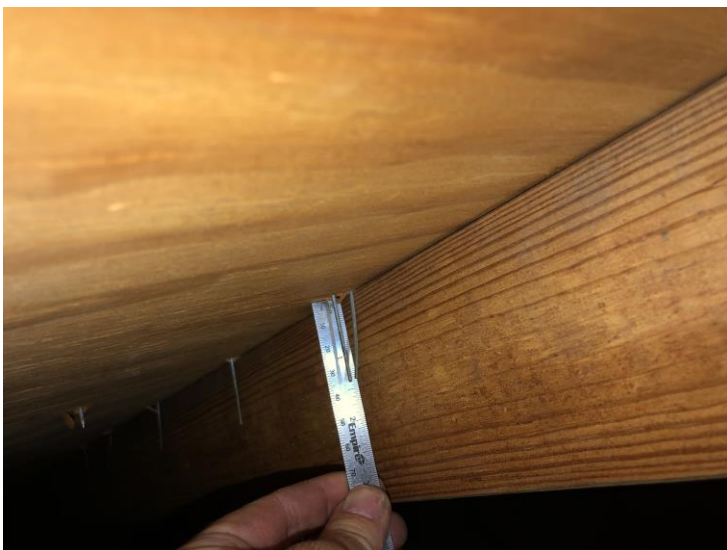
Roof Construction

- 3. Roof Deck Attachment:** **Level C**
Comments: Inspection verified 1/2" plywood roof deck attached with 8d nails at a minimum 6" on the edge & 6" in the field.

- 4. Roof to Wall Attachment:** **Clips**
Comments: Inspection verified hurricane clips fastened with a minimum of three nails.
- 5. Roof Geometry:** **Other Roof**
Comments: Inspection verified hip and gable roof shapes. The gable sections of the roof account for greater than 10% of the total roof perimeter.
