# WETLAND DELINEATION REPORT SOCIETY TURN HIGHWAY 145 IMPROVEMENT PROJECT

SAN MIGUEL COUNTY, COLORADO

Revised and Updated: August 2022

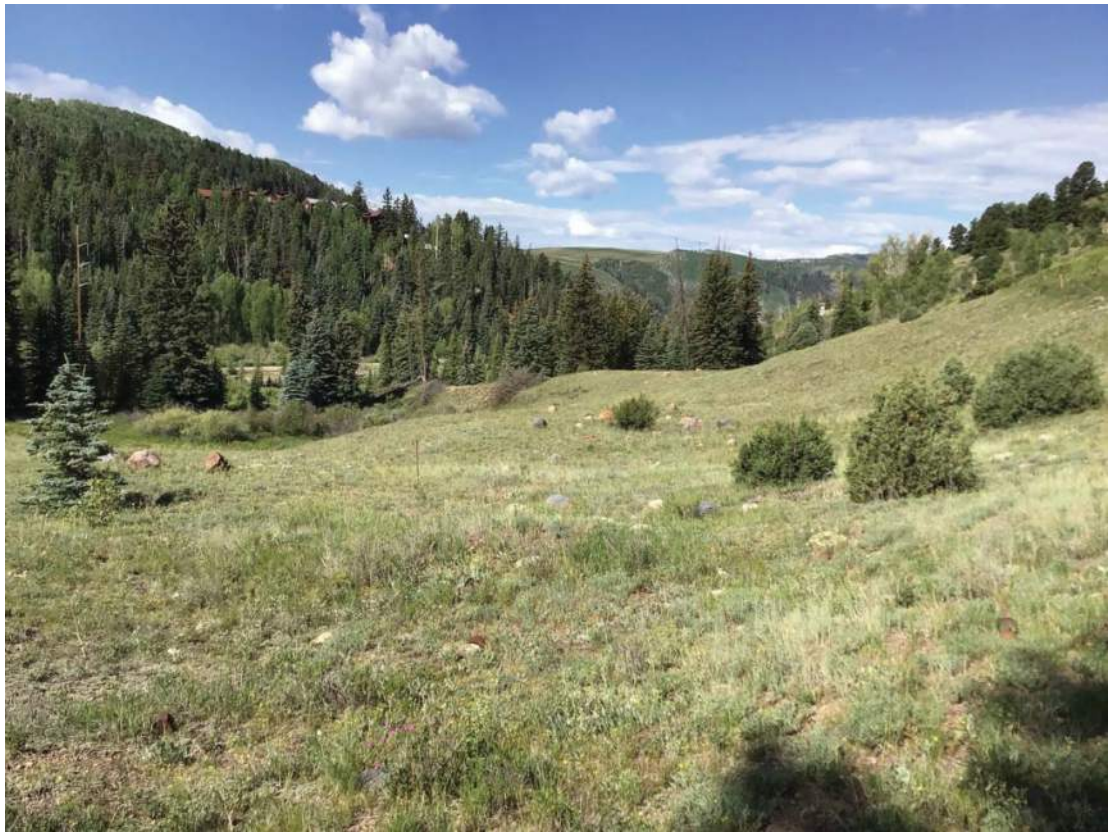
**Photo Point 1 (P1)**  
West End of property, proposed augmentation pond location. Obvious upland characteristics, no hydrologic features at all.

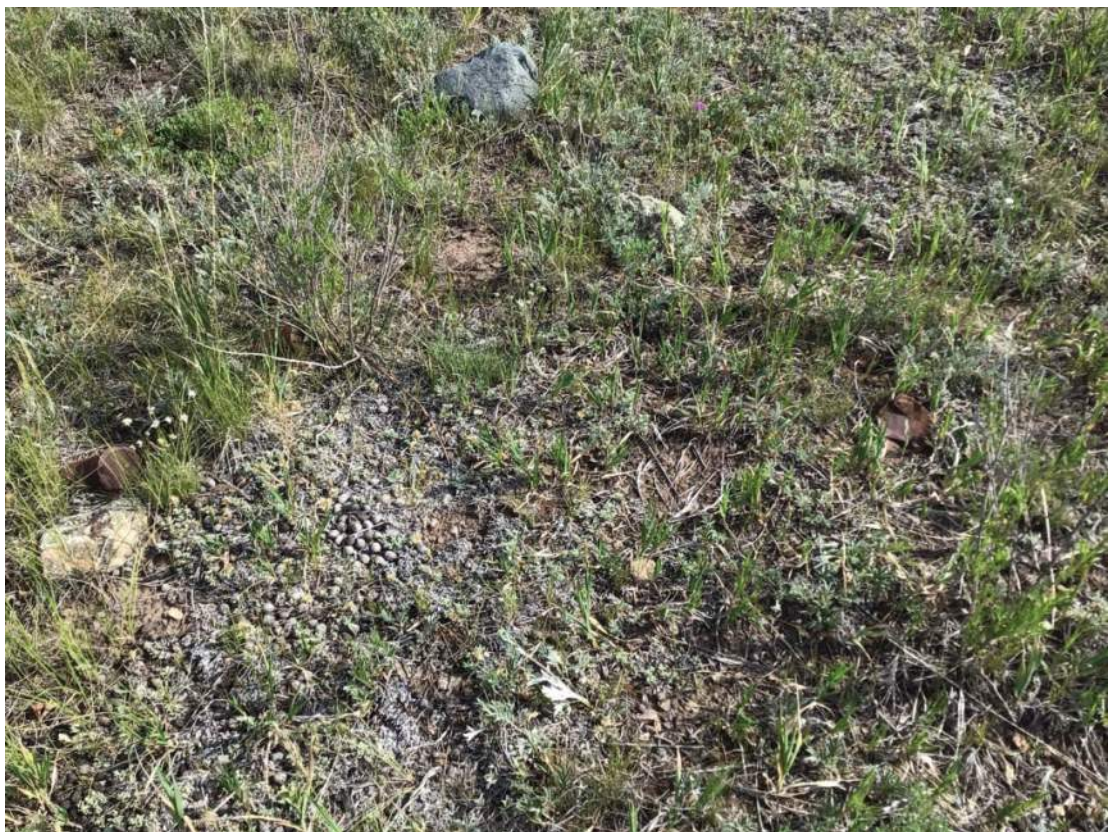
**Photo Point 2 (P2)**  
Typical surface conditions in the augmentation pond location. Significant accumulation of elk droppings indicative of some seasonal use. Vegetation dominated by smooth brome and anserina, with scattered rabbitbrush and wormwood. All upland indicators.

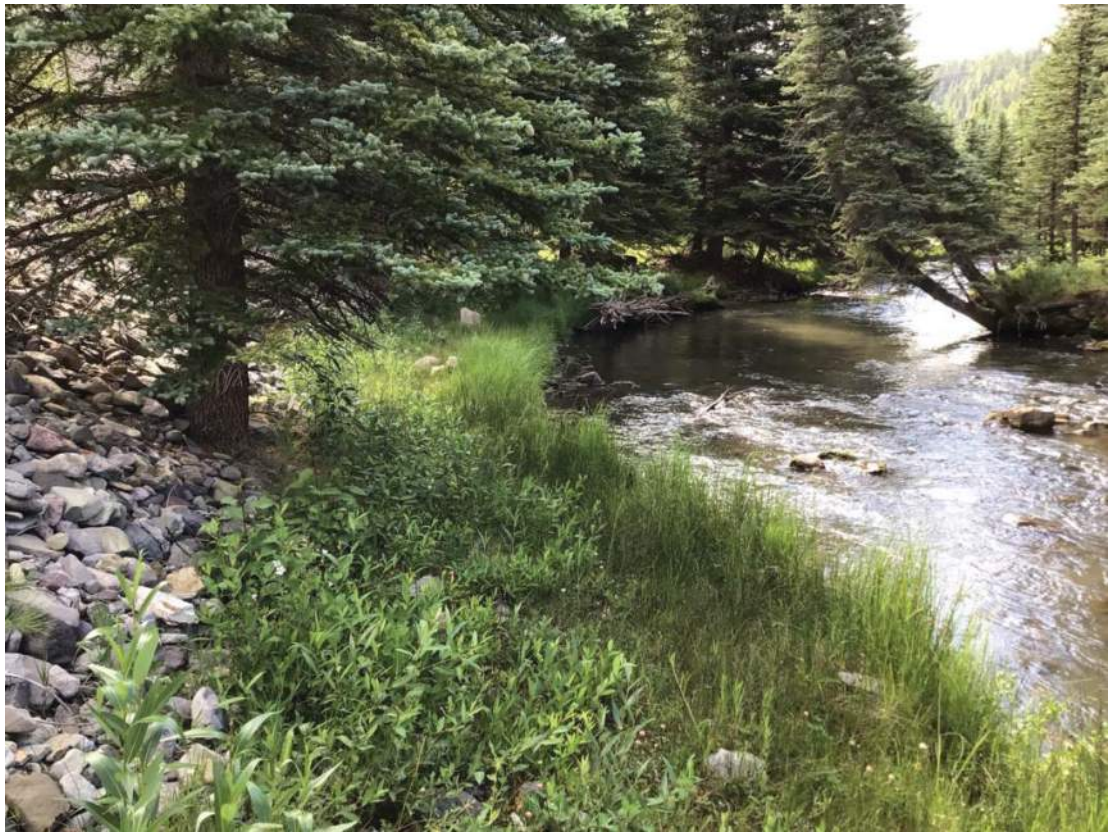
**Photo Point 3 (P3)**

Conditions on the upstream side of the Remine Creek confluence with the San Miguel River. The existing delineation remains accurate, with a narrow but defined wetland fringe dominated by *Juncus balticus*, occupying a fringe along the bank approximately 6 feet wide.

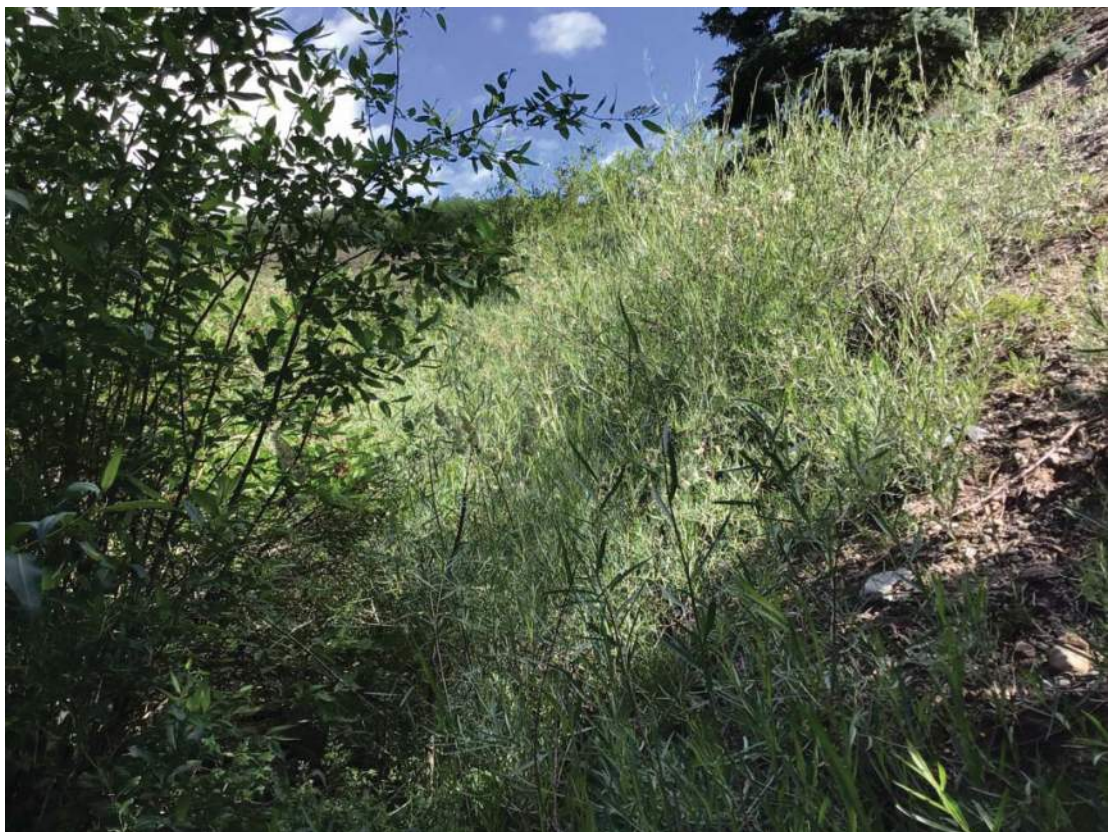
**Photo Point 4 (P4)**

Typical conditions along the Remine Creek corridor, upchannel from the San Miguel River. As described in previous delineations, it is a deeply incised creek with a narrow wetland fringe dominated by coyote willow and narrowleaf cottonwood saplings. Lesser components of Booth's willow, cow parsnip, twinberry, etc.

Wetland/riparian character is confined to the bottom of the incised channel, and does not extend up to top-of-bank.

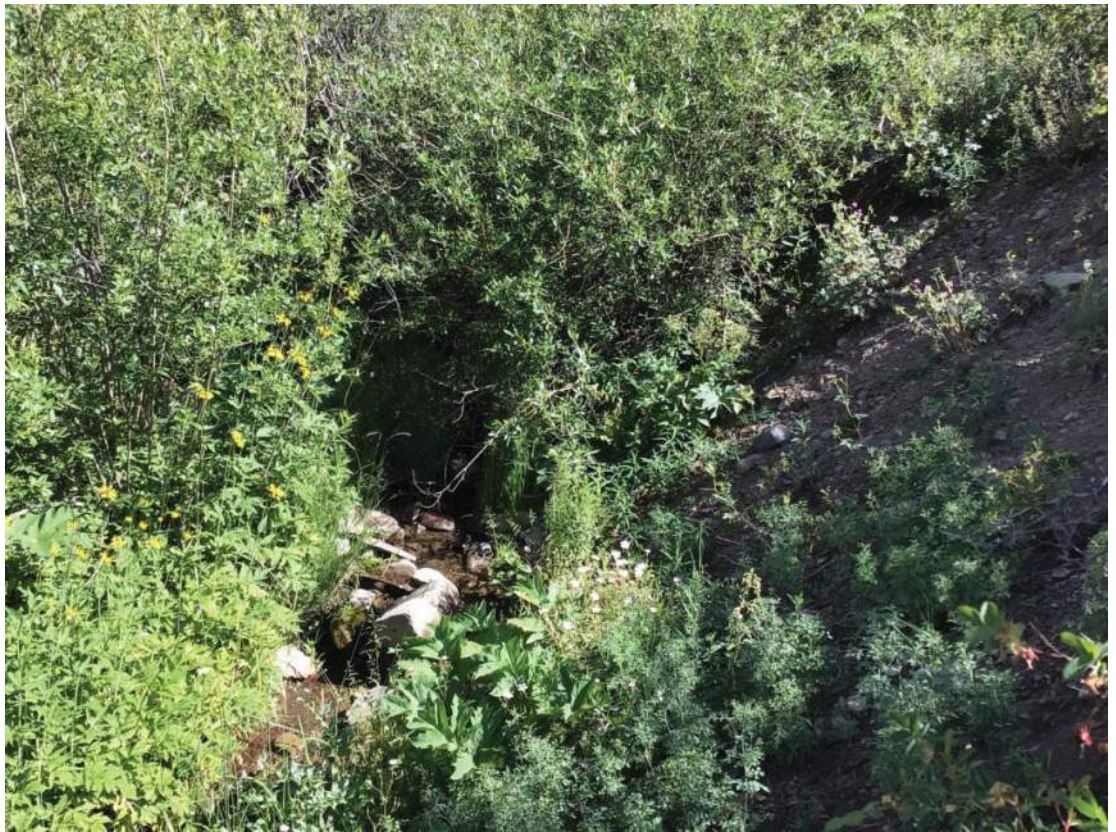
**Photo Point 5 (P5)**  
 View of Remine Creek from the top-of-bank, with narrow channel visible. Note rapid transition to upland conditions visible at right, along the steep cutslope.

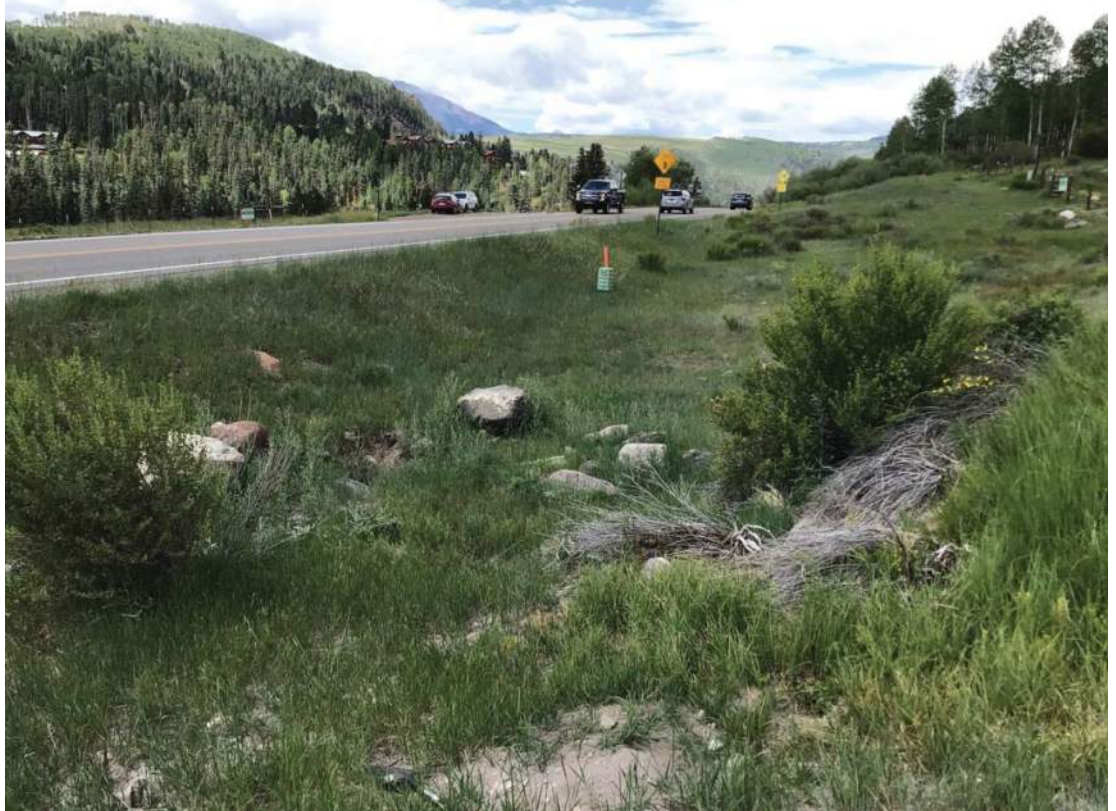
**Photo Point 6 (P6)**  
 Isolated "County Wetland" present on uphill side of Highway 145 within CDOT right-of-way. Note the clear edge of wetland vegetation visible at viewer's near right. Any occasional flow discharges through bar ditch into culvert at viewer's mid left. No defined channel, no wetland vegetation, no downstream connectivity.

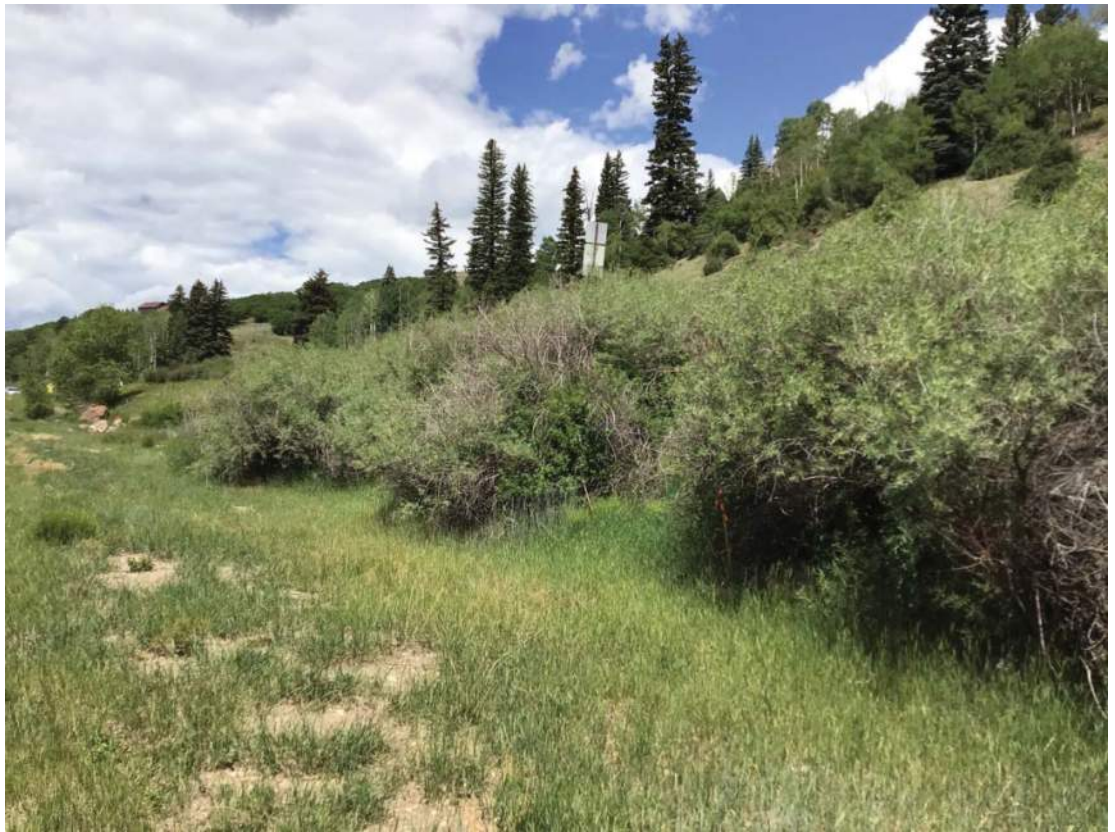
**Photo Point 7 (P7)**

Coyote willow monoculture along the downslope embankment of highway. east of proposed entrance zone. No of proposed entrance zone. No apparent surface water source. No apparent surface water discharge. No apparent soil saturation. Possibly water provided by leakage from the adjacent sewer main? Mapped as "County Wetlands", but clearly does not constitute a jurisdictional wetland under Section 404 CWA due to lack of hydric soils or connectivity to natural hydrology.

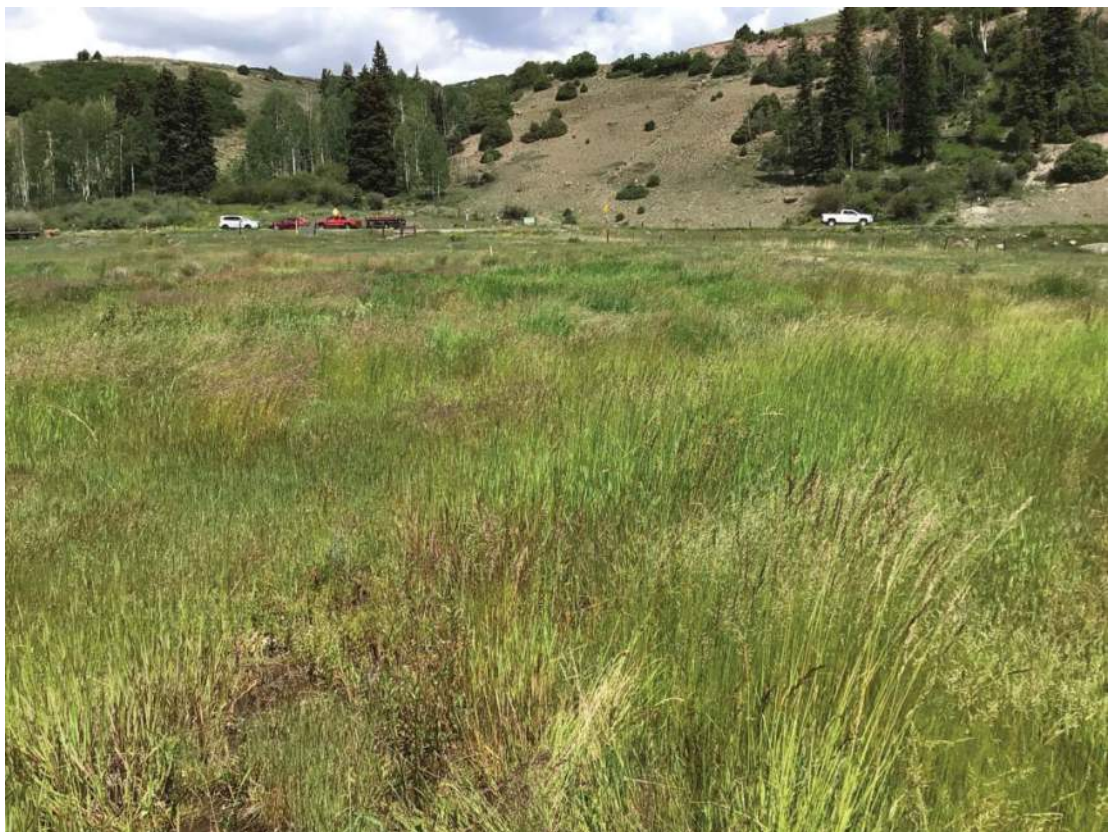
**Photo Point 8 (P8)**

Typical conditions during the growing season within the irrigated portions of the pasture. Dominance by agricultural cultivars, including intermediate wheatgrass, bluegrass, redtop. some wetland facultative/FACW species are present in non-dominant amounts, including willowherb (Epilobium), speedwell (Veronica), etc. Clearly supported by artificial irrigation delivered through artificially-excavated channels.

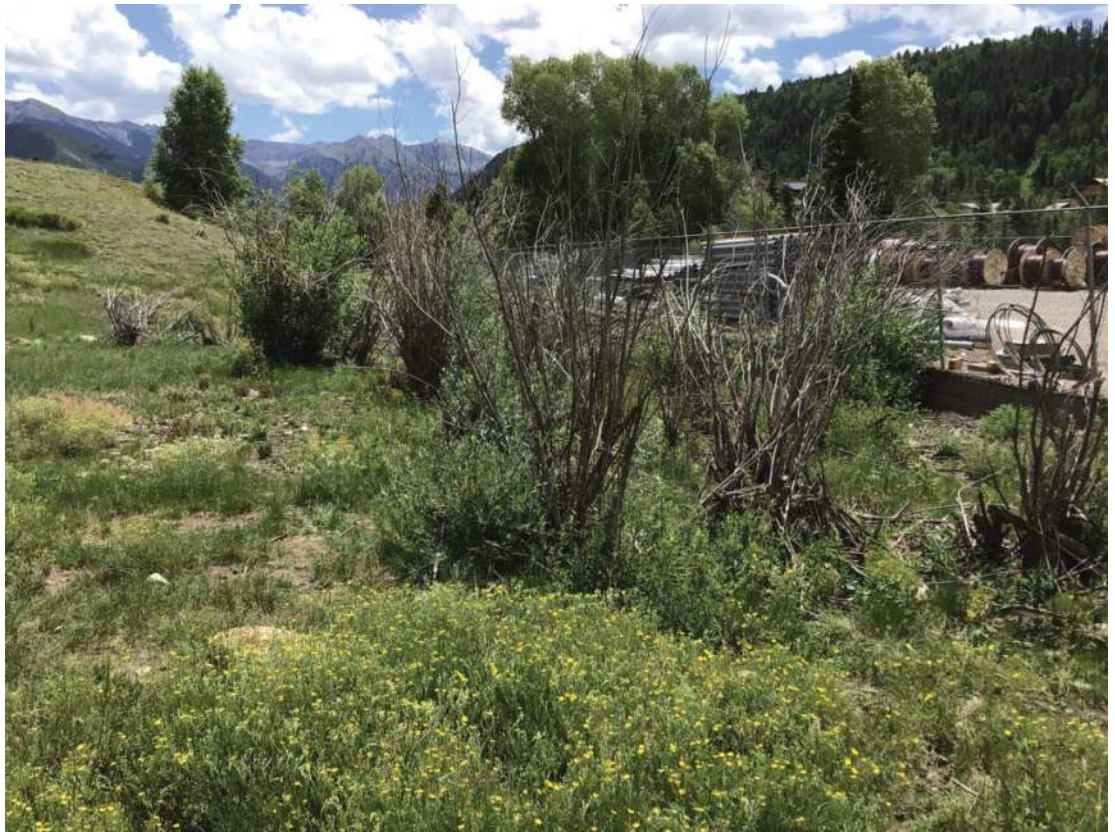
**Photo Point 9 (P9)**

The "dead willow" area was re-investigated. Currently, most willows have minor re-sprout, marginal vigor for plain willow, more vigor for mountain willow. Willow remains a non-dominant component of the vegetation. This area is included in the portion of the property that would be transferred to the Town's WTP, and is not further considered in SMVC's application material.

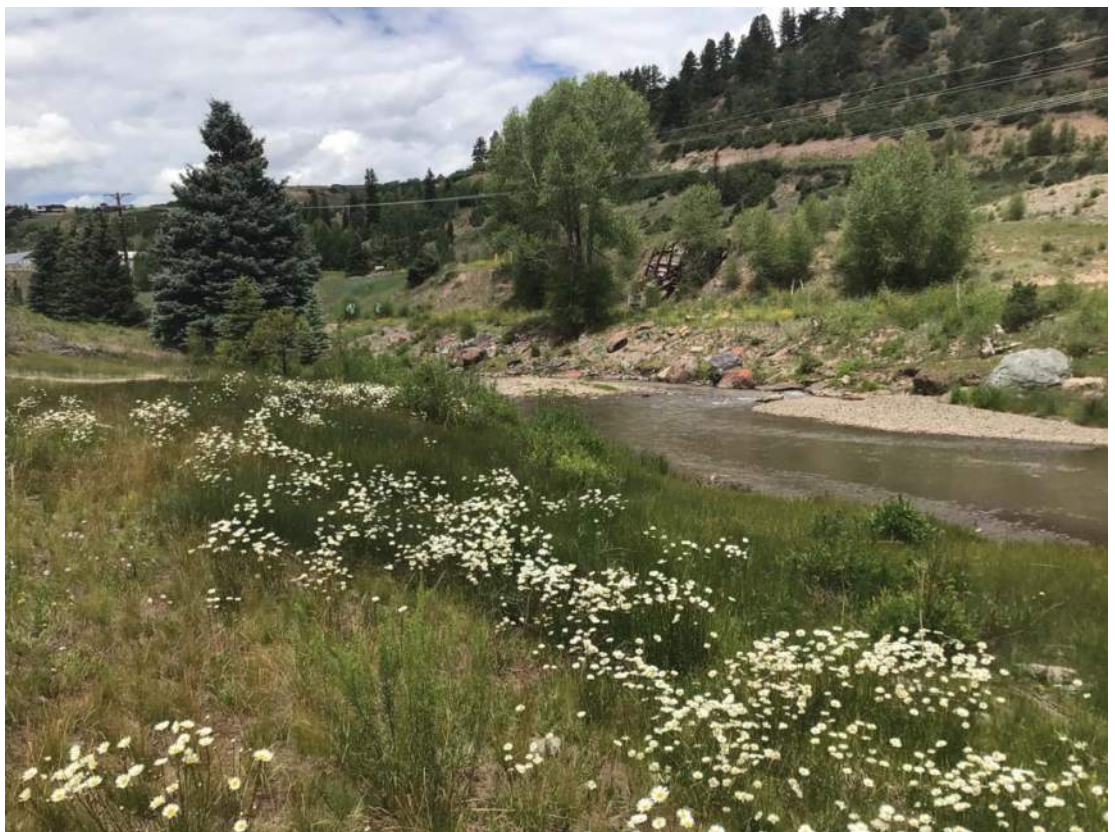
**Photo Point 10 (P10)**

Conditions along the south bank of the San Migue River are unchanged from previous reports. A narrow fringe abutting the river, dominated by Carex and Juncus and ox-eye daisy. An elevated upland strip at top of bank separates the river-adjacent wetlands from some small areas of wetlands back of bank (see P11).

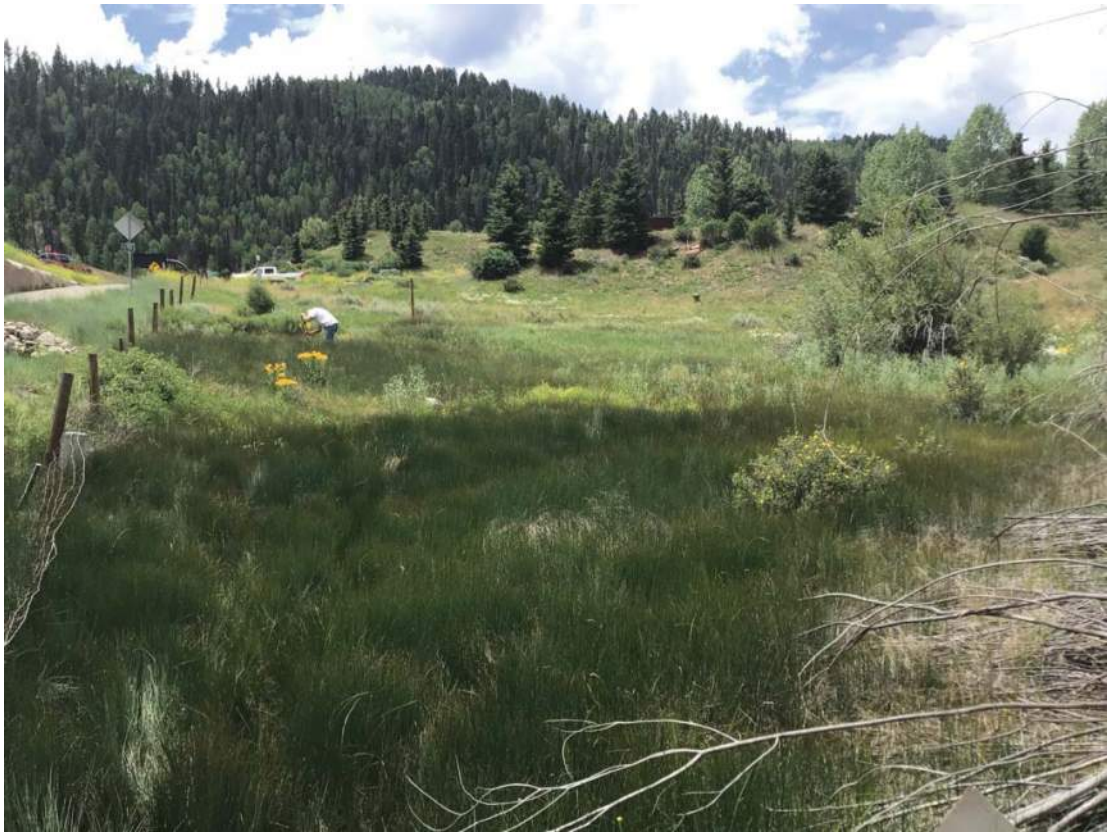
**Photo Point 11 (P11)**  
 Wetland conditions appear unchanged at this location. Obvious wetland conditions with *Juncus* monoculture in foreground, and "County Wetlands" visible where SGM staff is digging. Confirmed that "County Wetlands" continue to show no sign of hydric soils, as previously reported.

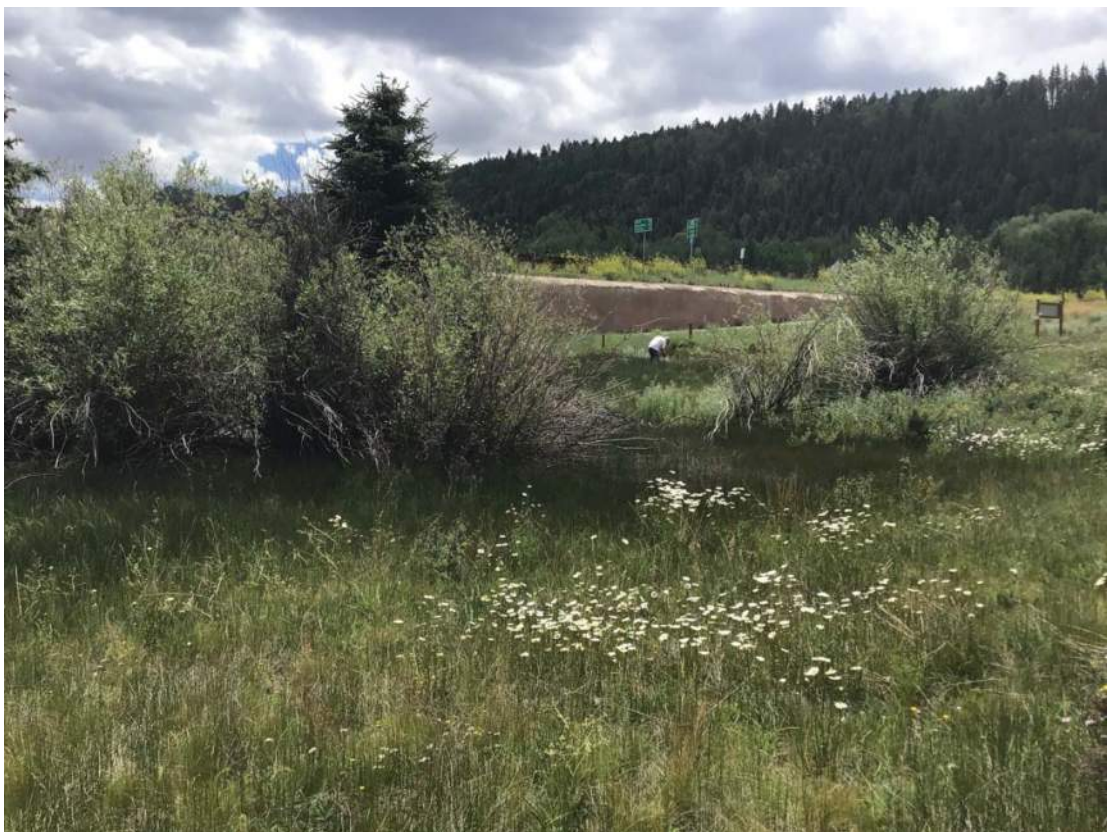
**Photo Point 12 (P12)**  
 Area of wetland vegetation. Quality is poor, with minimal supporting hydrology or connectivity, and near-monoculture of herbaceous vegetation (*Juncus balticus*).

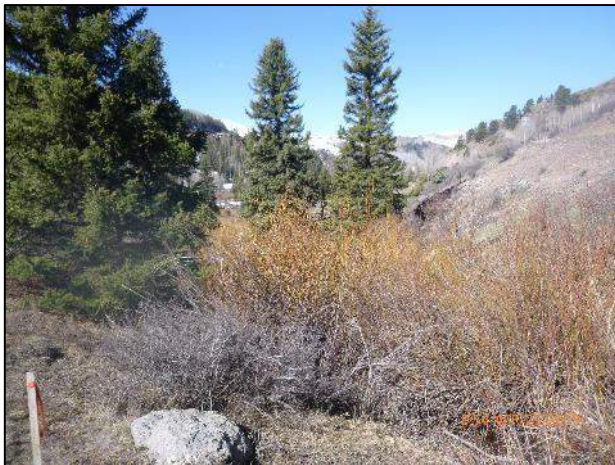
Photo 3. Wetland with willows along Remine Creek (WDDF 4).

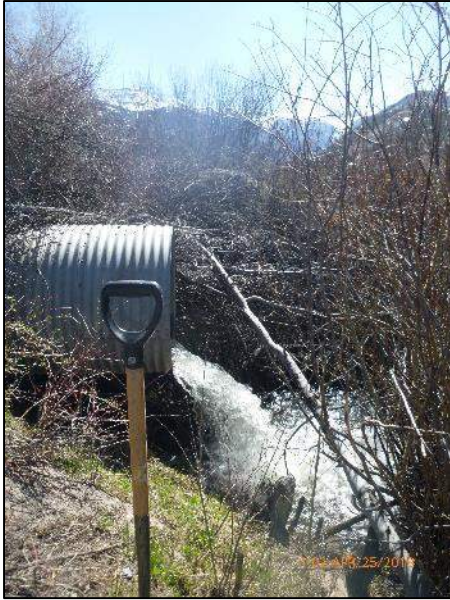
Photo 5. Wetland at culvert along Remine Creek.

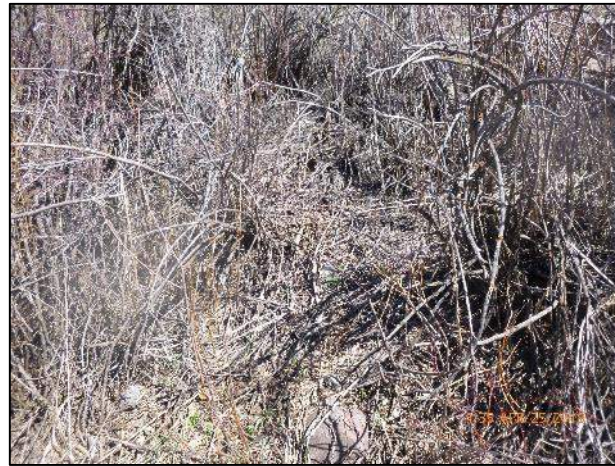
Photo 10. Close-up of old dead willows.

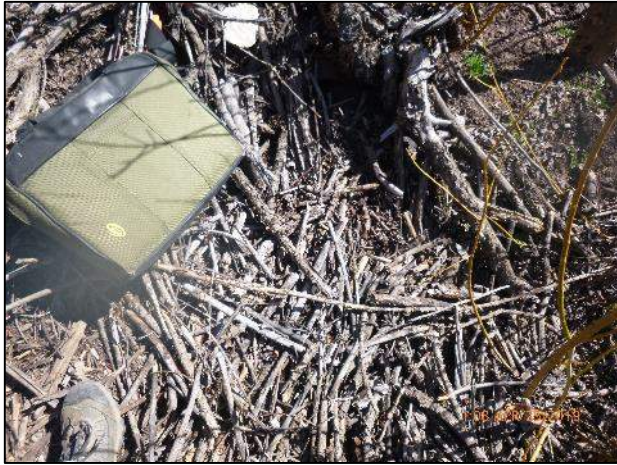
Photo 11. Close-up of dead willow branches on ground (litter).

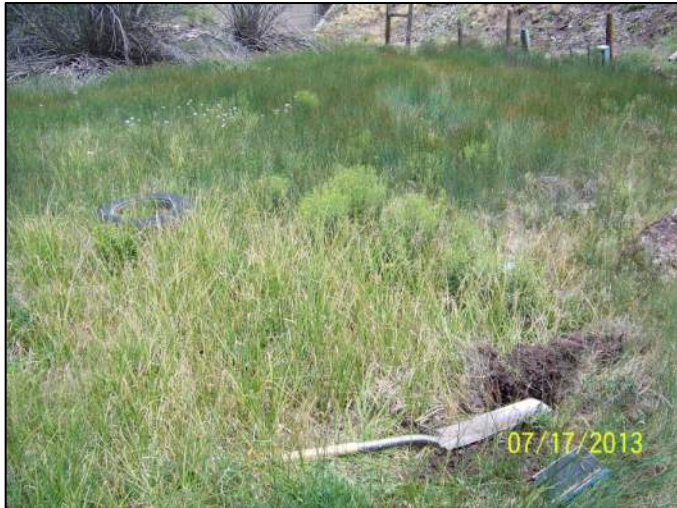
Photo 6. Area at WDDF 3. Vegetation is beaked sedge and Baltic rush.

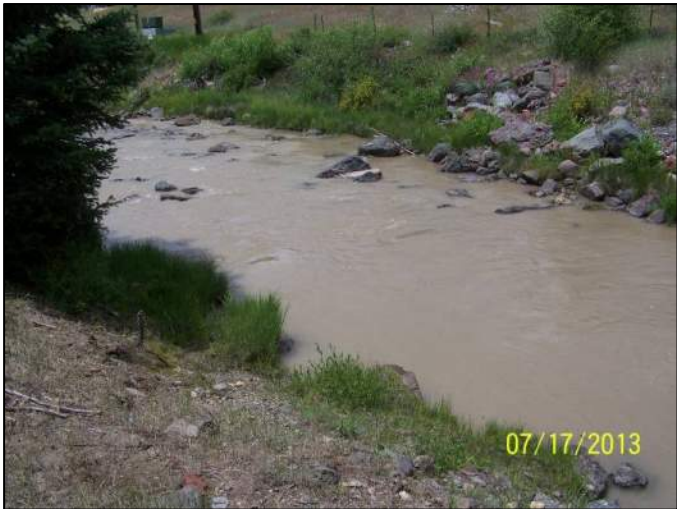
Photo 9. Narrow wetland along south bank of river.

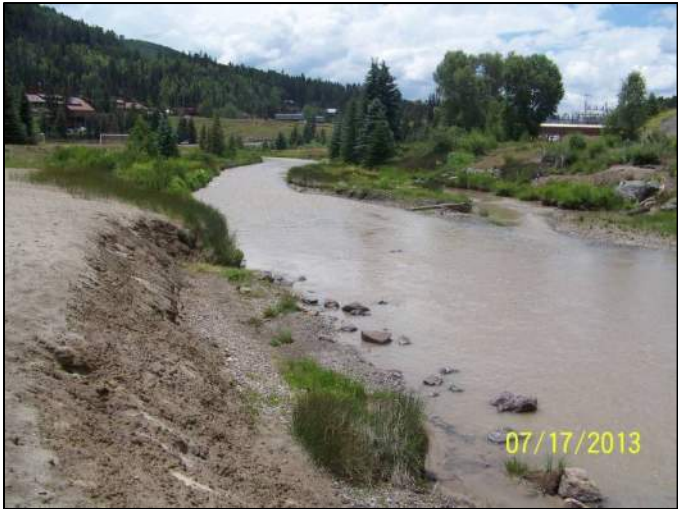
Photo 10. Narrow band of wetlands on north bank.
