RADIO AGE

The Newsletter of the
Mid-Atlantic Antique Radio Club

Atwater Kent – Three-Tube TA Units

BY RAY THOMPSON AND LEIGH BASSETT

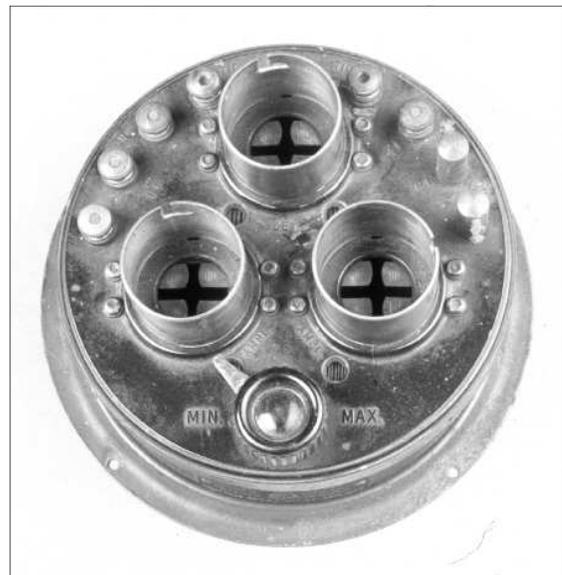
Figure 1. Detector/amp unit # 3812, Type 1, top view.

The earliest two-tube units, both the # 3676 detector/amp and the # 3634 two-stage audio amp, had knurled thumb nuts for all external connections. In contrast, the earliest three-tube units (part # 3812, Fig. 1) used knurled thumb nuts for all connections except for B+ and the plate of the second audio tube, which used round-head slotted screws to secure the connections for the headphones or a speaker. The B+ post had four holes, one for the battery connection and three for headphones and/or speakers, while the audio tube plate post had three holes.

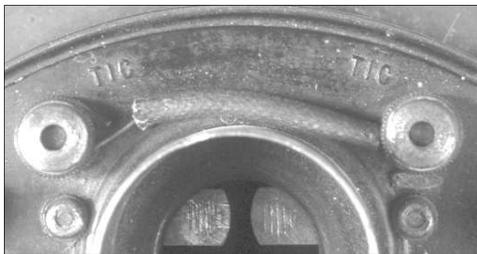
Figure 2. TIC terminal labels on the # 3821 Type 1.

There are two knurled thumb nut connections provided, labeled "TIC" (an abbreviation for tickler coil) that allow the owner to make the unit regenerative (Fig. 2). Mr. Kent did not have a license for the Armstrong regenerative patent, so he could not configure units with this capability at the factory. The T/A was sold with a removable jumper installed between these two terminals. The owner could remove it and connect a variometer (AK part # 3714 or # 3488) to enable regeneration.

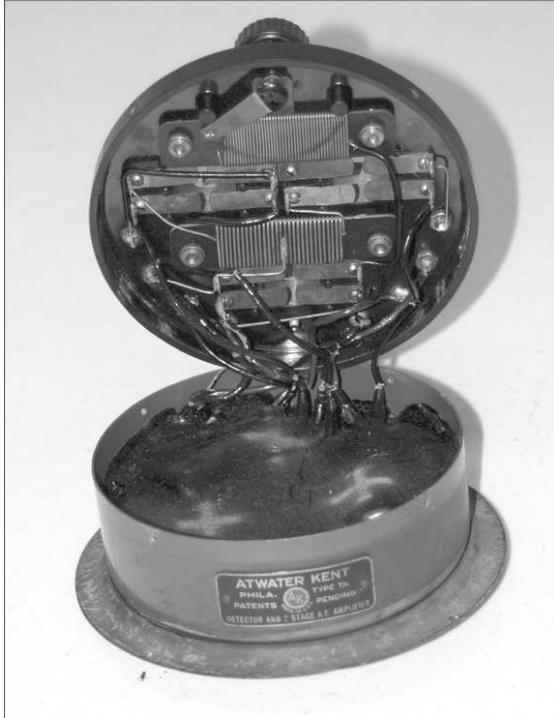
Figure 5. # 3812, Type 1 – internal view.

Ten wires emerge from the tar for connection to components mounted on the Bakelite top. The grid leak condenser and resistor are connected together at one end under the tar. A single lead from this junction comes out of the tar block for connection to the detector grid pin. The other end of the grid leak resistor is tied to circuit common (the -A -B terminal), while the other end of the grid leak condenser connects to the INPUT terminal.

The 2000-pF phone condenser is physically attached to the first audio transformer in the tar. One end is connected directly to the transformer’s plate winding contact, and a lead from both is brought out to the second TIC terminal. The other end is connected directly to the first audio grid return winding contact. A jumper wire is connected to the

second audio grid return contact, also under the tar. A lead is brought out to the circuit common bus (the **-A-B** terminal). The remaining leads attach to appropriate points on the top, as shown on the accompanying schematic.

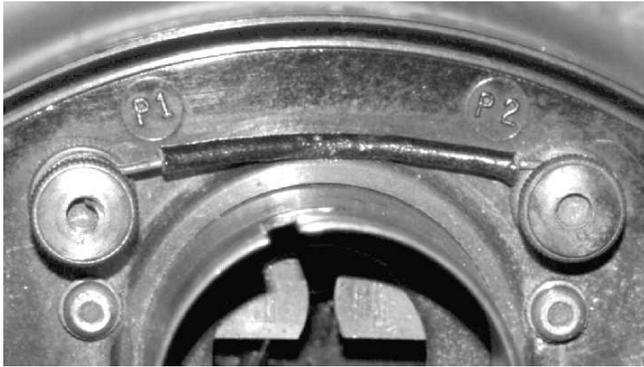
Figure 8. # 3812, Type 2 – P1 P2 label detail.

The # 3812 Type 2 is electrically identical to Type 1, with the exception of the 2000 pF phone condenser. It is also mechanically identical with the sole exception of the variometer connection labels. The **TIC** designa-

tion used on Type 1 was replaced with **P1** and **P2**, as shown in Fig. 8. Only brown rheostat knobs were available.

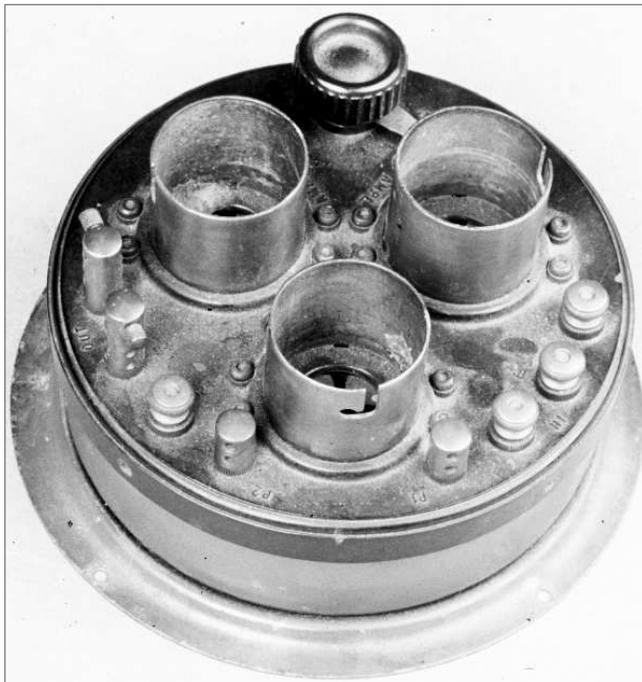
Figure 12. # 3812, Type 6 (a.k.a. #4135) –top (rear) view.

mechanical design change. Unless you examine the unit closely, you might miss the fact that the first audio stage tube socket brass ring (left front) has been rotated 90 degrees counter-clockwise. This relocated the filament pins, permitting the shortest possible wiring arrangement.

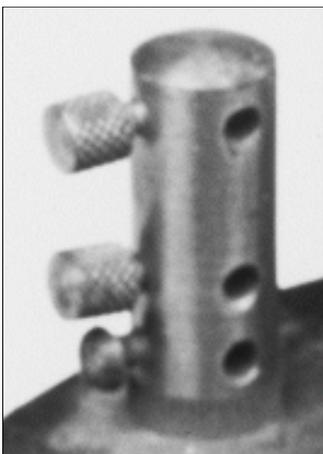
Figure 14. # 3812, Type 6 (a.k.a. # 4135) – new 2/3-hole output posts.

The brown Type 6 TAs had the early three- and four-hole output posts, the same as described for the earlier green TAs. However, the black TAs were fitted with a new style of two- and three-hole posts. These posts are the same height as the previous parts, but the second hole from the top has been removed from each style. The bottom hole (of three) on the new B+ post still uses a slotted round-head screw to secure the B+ supply line. But the two separated holes on each new style now use small knurled screws to connect the leads to the headphones or speaker. The middle hole which had appeared on earlier parts was eliminated to provide more finger clearance to the knurled screws.

Some Type 6 TAs were fitted with the earlier three- and four-hole output posts, but with the new knurled screws in the top and third holes. Nothing was installed in the second hole.

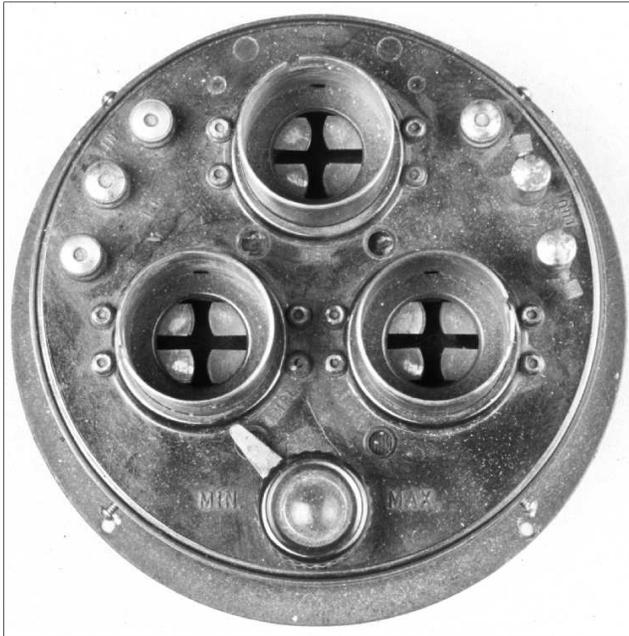
Figure 15. # 4520 – top view.

Part # 4520 was the last of the three-tube TAs, and was based on a redesign of the #3812 Type 7.
