## PART II—REPRODUCER UNIT

### (4) MAKING REPLACEMENTS ON RCA LOUDSPEAKER 100A

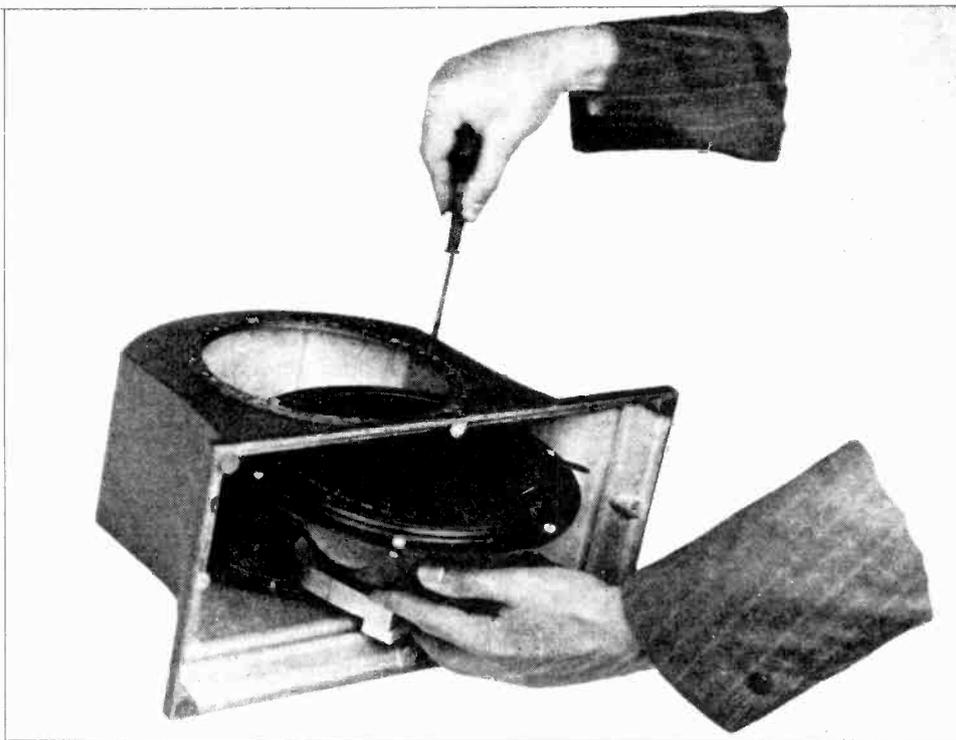
*Figure 3—Removing mechanism assembly from housing*

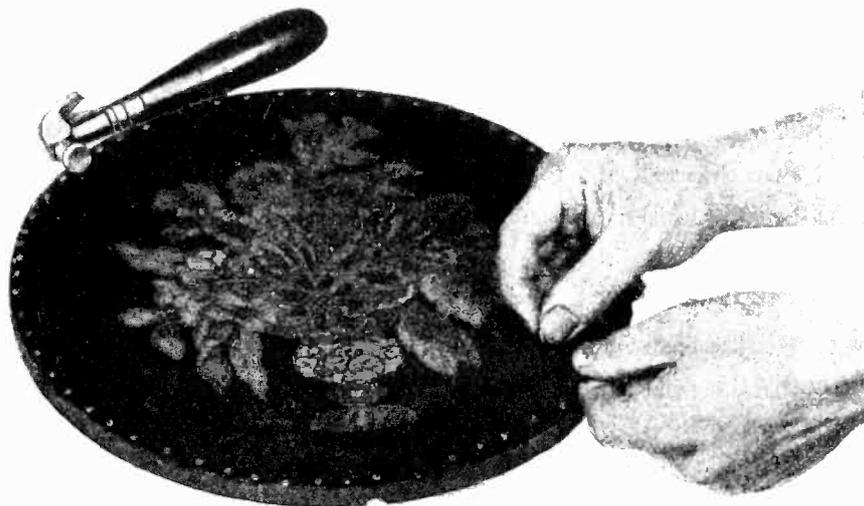
*Figure 14—Tacking the grille tapestry in place on the baffle board*

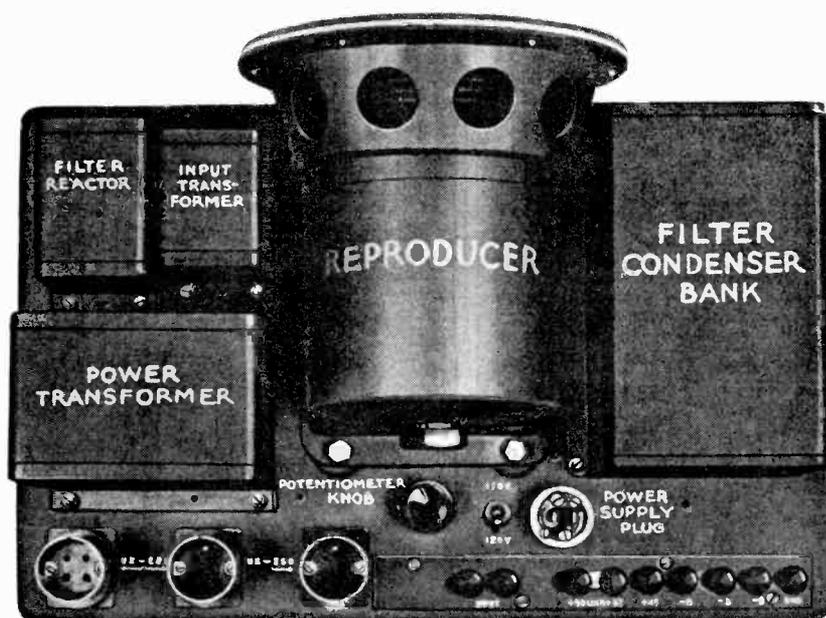
Figure 2—Top view of chassis assembly.
